SITE NUMBER AND NAME: NC083 – West of Wildhay River	HIGHWAY AND KM: 40:30, km 37.368	PREVIOUS INSPECTION: May 30, 2023	CURRENT INSPECTION: June 11, 2024
LEGAL DESCRIPTION: SE-08-53-27-W5	NAD83 COORDINATES: UTM11U 5935069N, 437757E		RISK ASSESSMENT: PF: 11 CF: 5 Total: 55
AVERAGE ANNUAL DAILY TRAFFIC (AADT): 1,690 (2023)		CONTRACTOR MAINTENANCE AREA (CMA): 508

Client/Project: Transportation and Economic Corridors
 Geohazard Monitoring Program
 NC83 – West of Wildhay River

2024 Site Inspection Photos at NC083

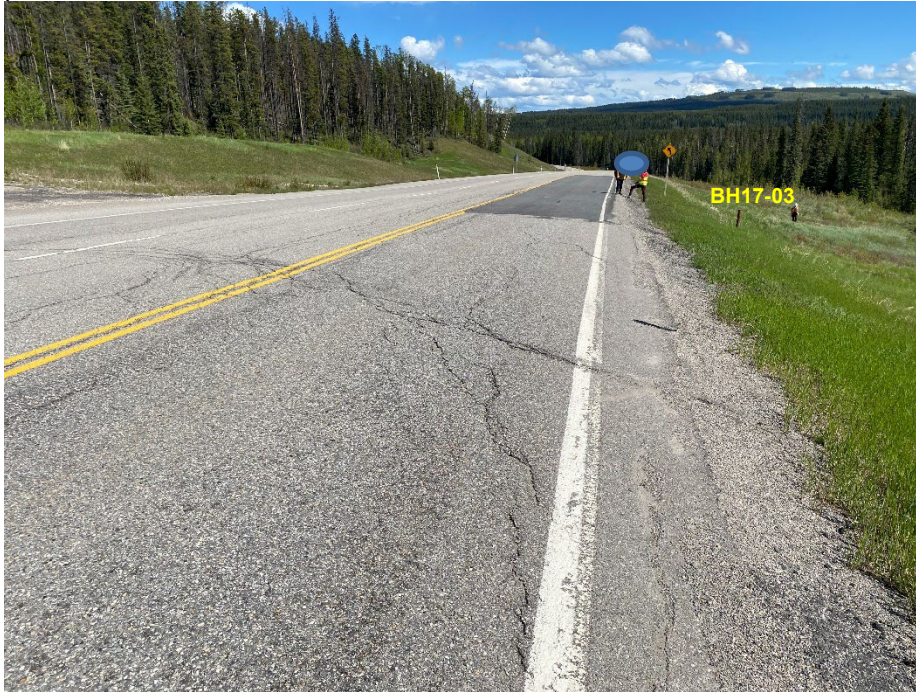
Photo 1: Pavement cracking in SBL near BH17-02. Looking southeast.

- All pavement cracks should be sealed to reduce surface water infiltration into the landslide.
- Riprap or gravel should be placed at the C/L culvert outlet. If the erosion is left unchecked, it could lead to further channeling and embankment movement.

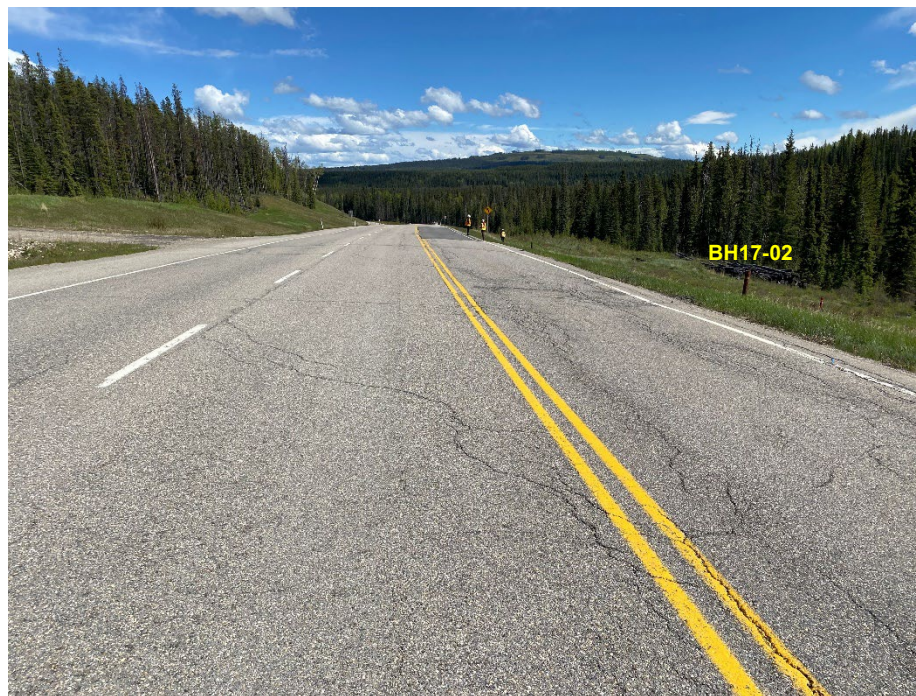
Photo 2: Pavement cracking on highway near BH17-02. Looking southeast.

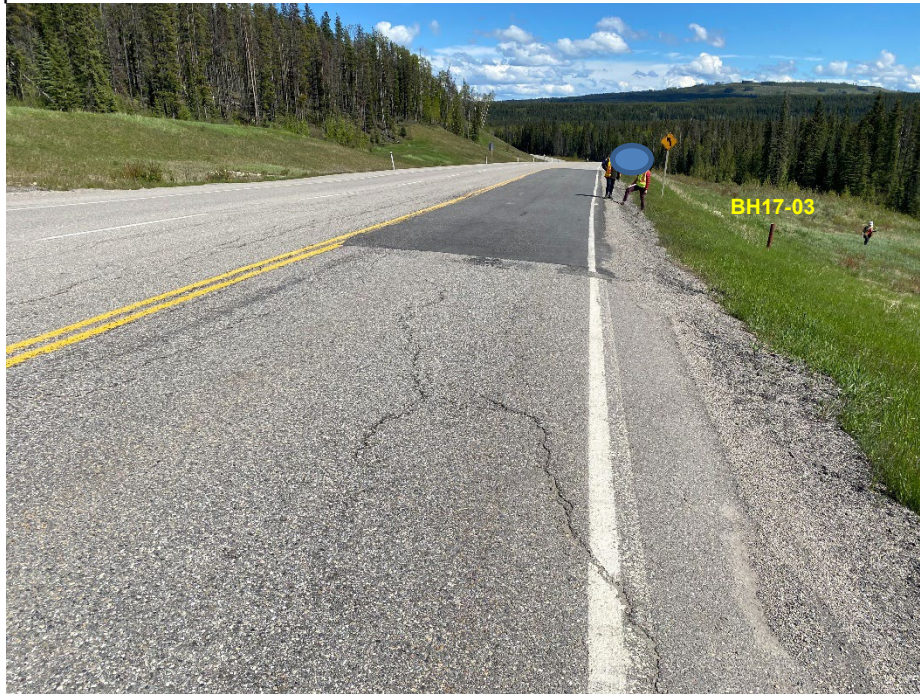
Photo 3: Pavement cracking in SBL between BH17-02 and BH17-03. SBL milled and filled. Looking southeast.

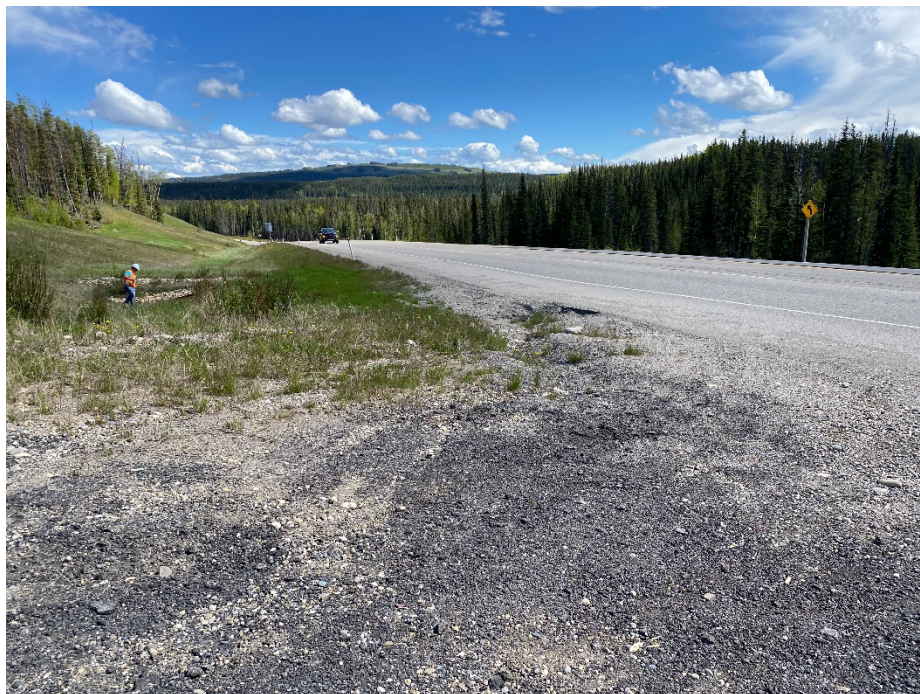
- An erosion channel was observed at the entrance to the gravel access road, where it followed the highway and entered the east ditch where it had eroded. The edge of pavement at this location was also broken over several meters (Photo 4).
- The south slope appeared to have a “hummocky” appearance and was soft and spongy to traverse (Photos 8, 9, 10 and 12).
- Erosion features with ponded water were observed near the timber stockpile, in a similar condition to the previous site inspection (Photo 10).
- Seepage was observed at the south slope in the previously observed vehicle tracks, as well as in a newly observed set of tracks northwest of BH17-02 (Photo 8).
- All three SIs at the site continues to show movement with movement rates ranging from 1 mm/year to 13 mm/year. Piezometric levels remain high ranging from 0.4 m to 0.8 m below ground surface.

Photo 4: Minor erosion at edge of pavement at east corner of entrance to gravel pit. Looking southeast.

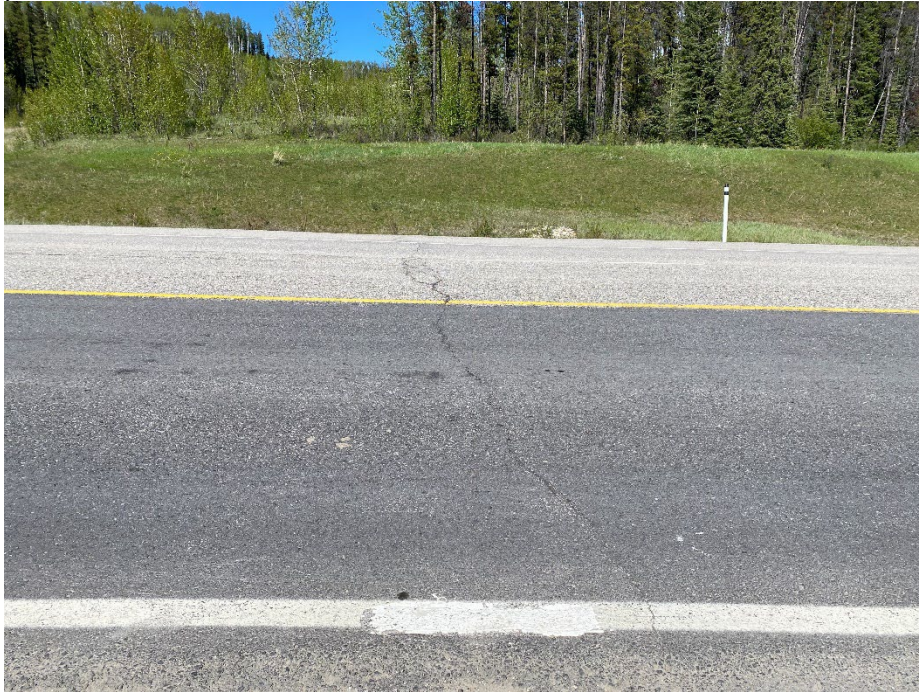
Photo 5: Pavement crack along C/L culvert alignment. Looking northeast.

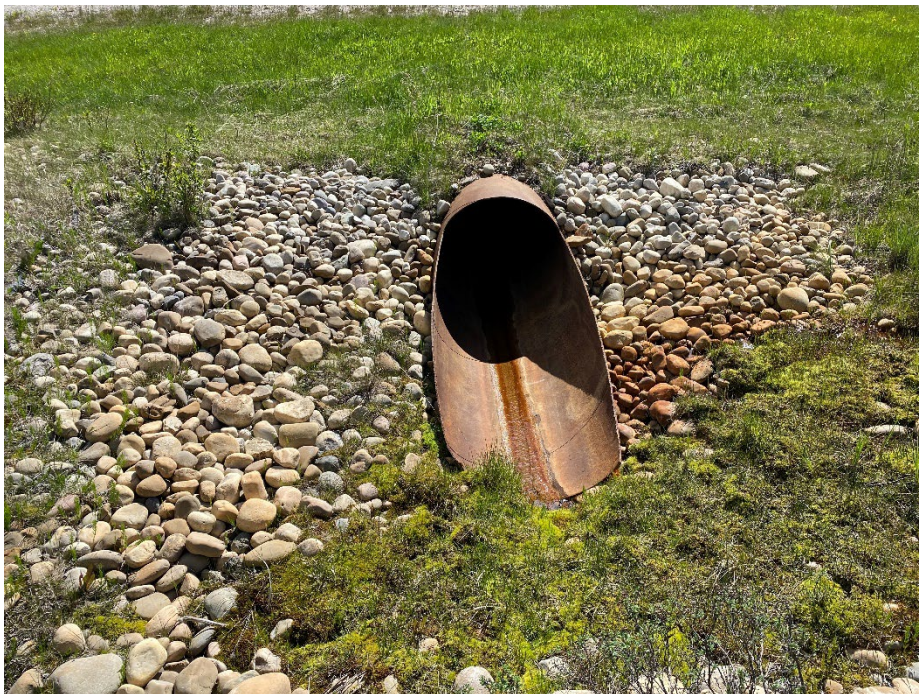
COMMENTS
<ul style="list-style-type: none"> • No significant changes to site conditions were observed. • Pavement cracks not covered by the milling and filling in the south bound lane appeared to have worsened in comparison to the previous inspection and consisted of: <ul style="list-style-type: none"> – Semi-circular crack across all 3 lanes at the entrance to the gravel pit access road (Photos 1 and 11). – Semi-circular crack along SBL between BH17-02 and BH17-03 – 50 mm high crack along SBL shoulder northwest of BH17-03, extending past the C/L culvert crossing. – 20 mm wide pavement crack along the alignment of the C/L culvert, reflecting through pavement patch (Photo 5). • Both culverts at the site appear to be in good condition. An erosion channel about 400 mm wide and deep was observed at the C/L culvert outlet, which is blocked by vegetation (Photos 6 and 7).

Photo 6: North ditch at C/L culvert inlet. Looking southwest.

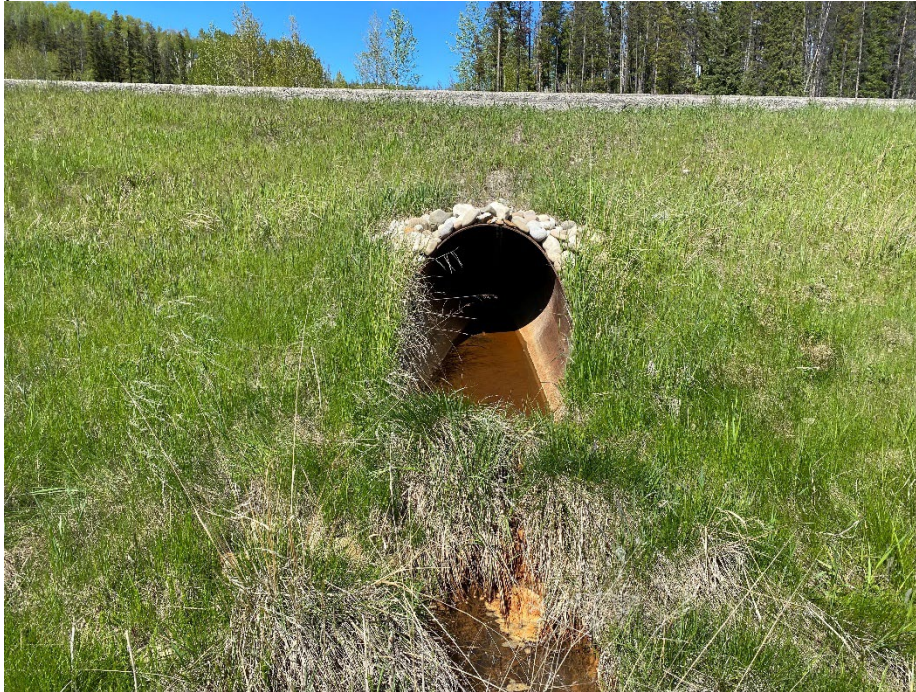
Photo 7: Vegetation blocking C/L culvert outlet. Looking northeast.

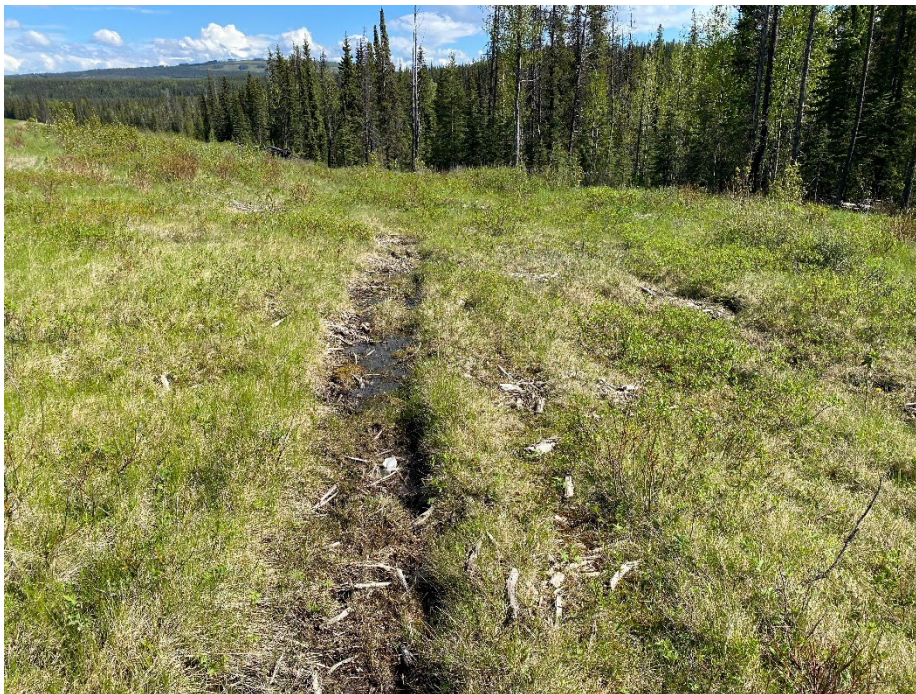
Photo 8: Seepage in vehicle track northwest from BH17-02. Looking southeast.

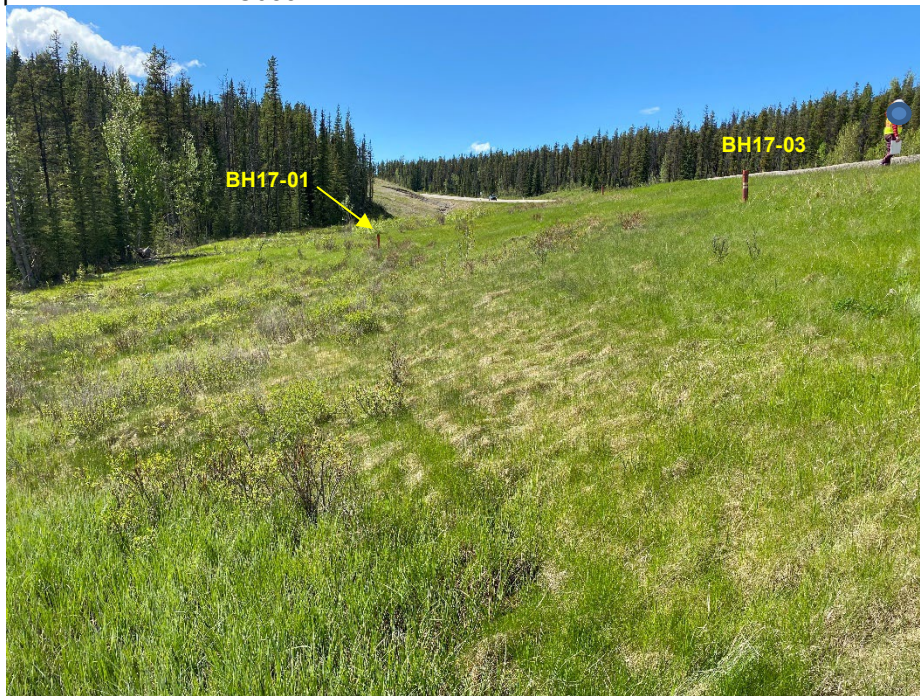
Photo 9: Overall view of south slope. Looking northwest.

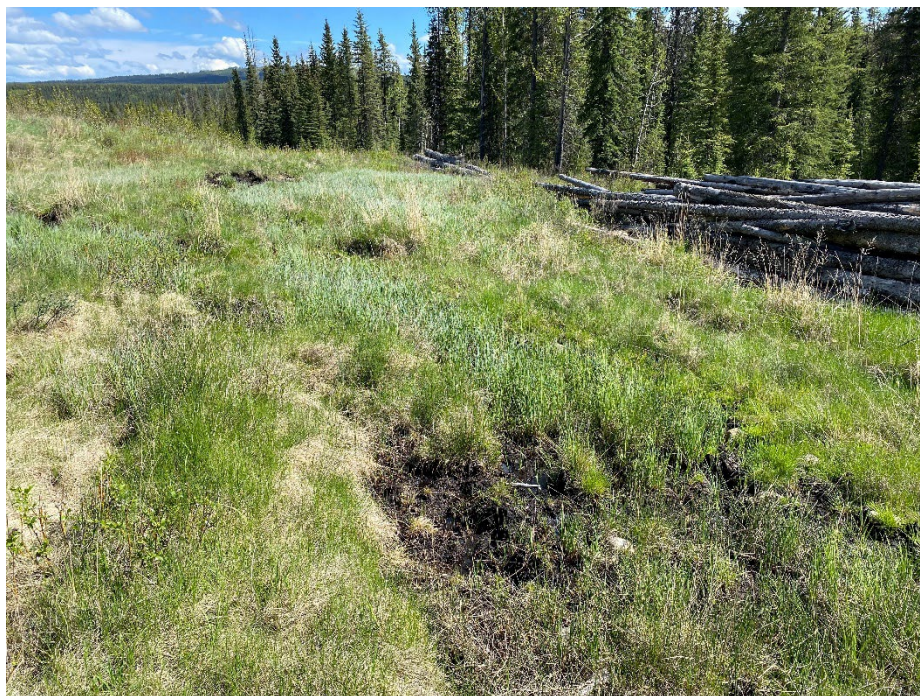
Photo 10: Erosion and ponded water in tree clearing area. Looking southeast.

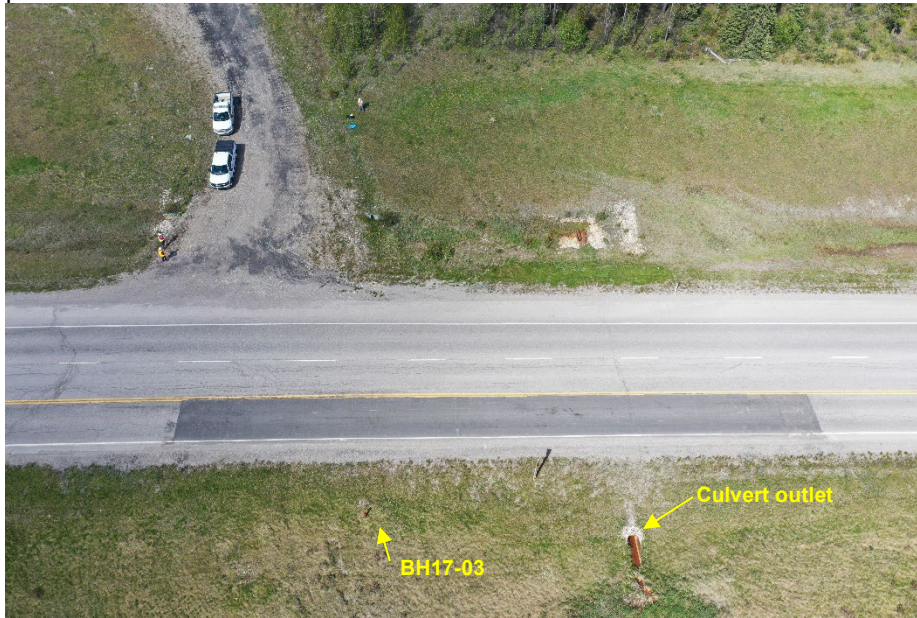
Photo 11: Site overview photo, taken by drone. Looking northeast.

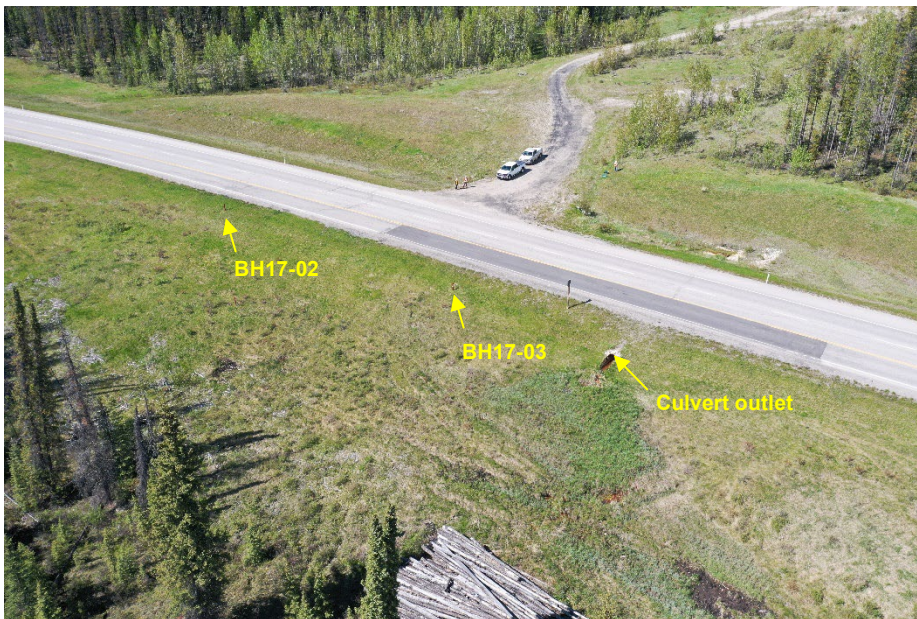
Photo 12: Site overview photo, taken by drone. Looking north.
