To:	Amy Driessen	From:	Leslie Cho and Xiteng Liu
	Transportation and Economic Corridors		Stantec Consulting Ltd.
File:	123315222	Date:	June 18, 2024

Reference: North Central Region, Edson, Site NC083 - Highway 40:30 West of Wildhay River, Spring 2024 Instrumentation Monitoring Report

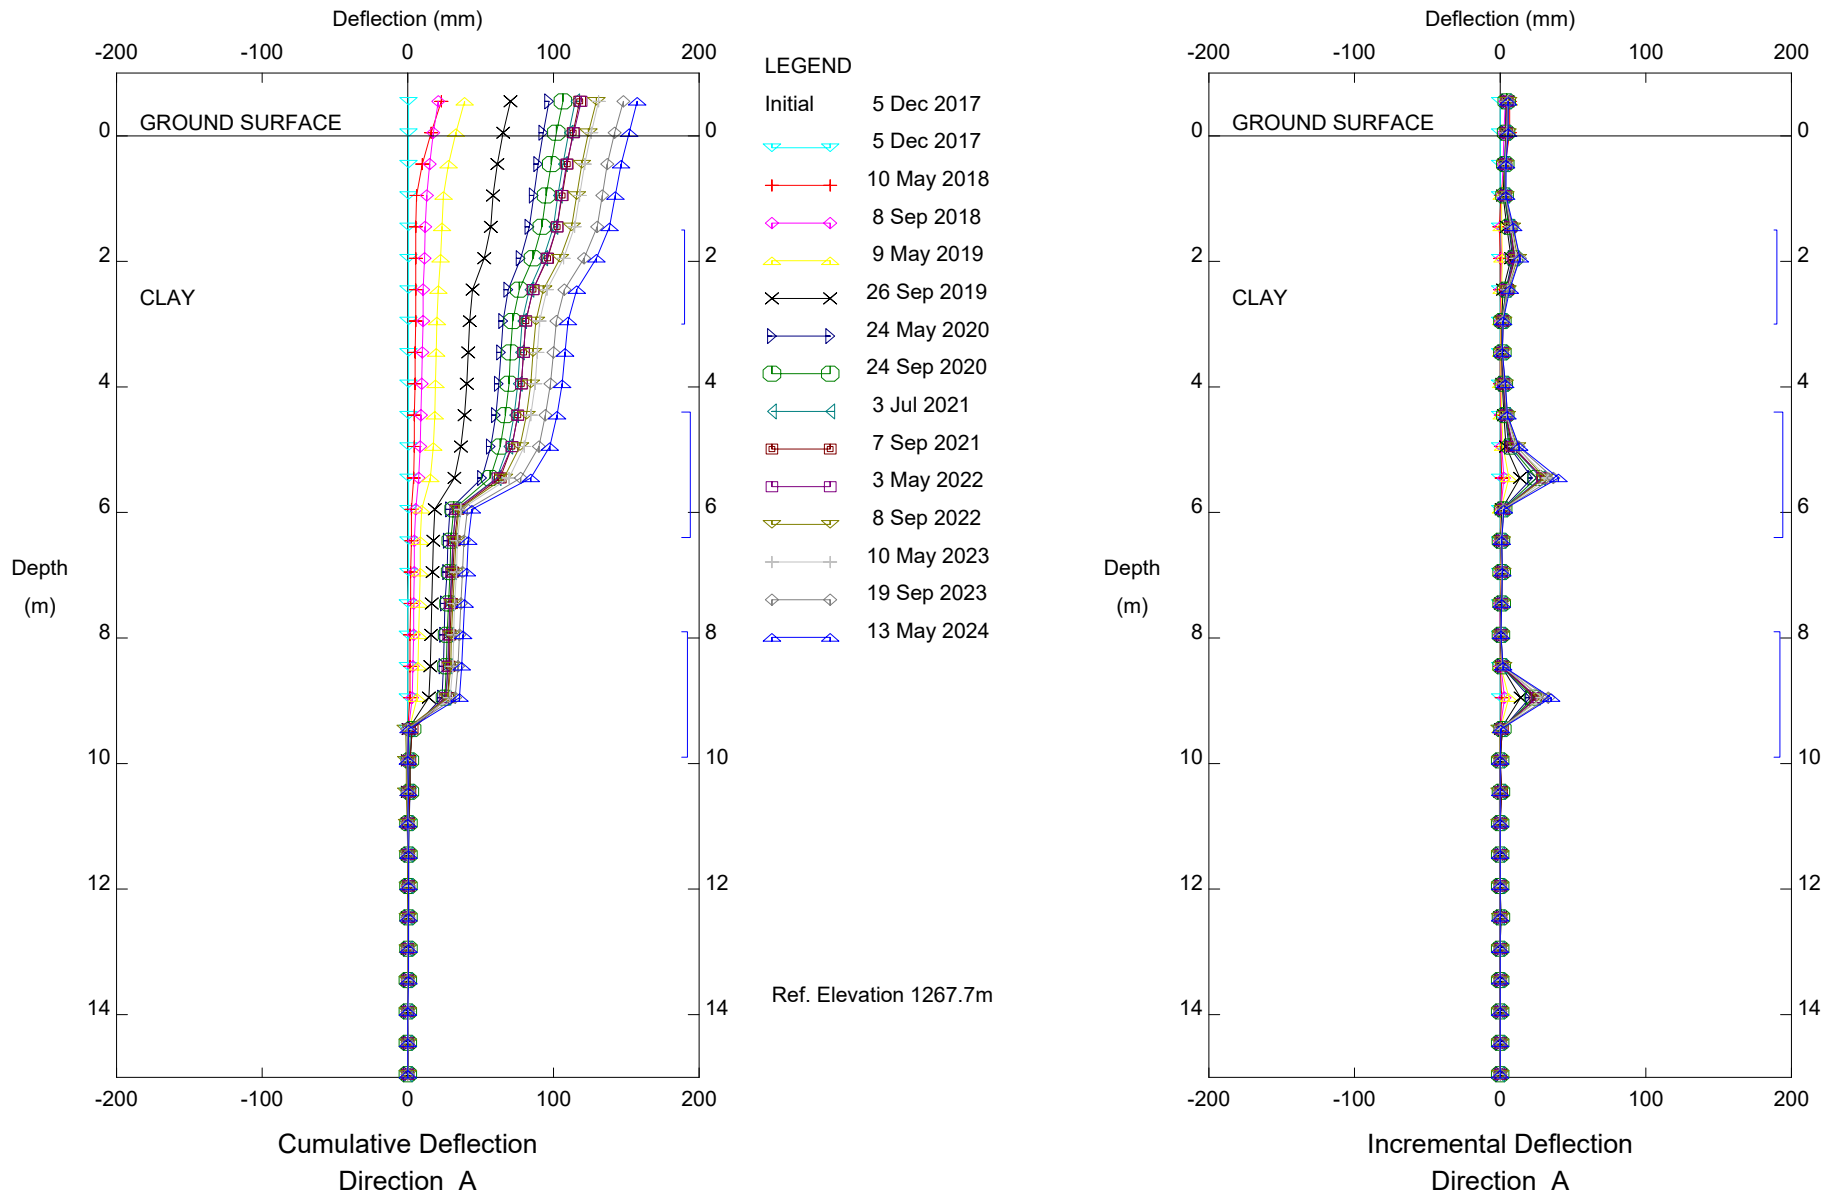
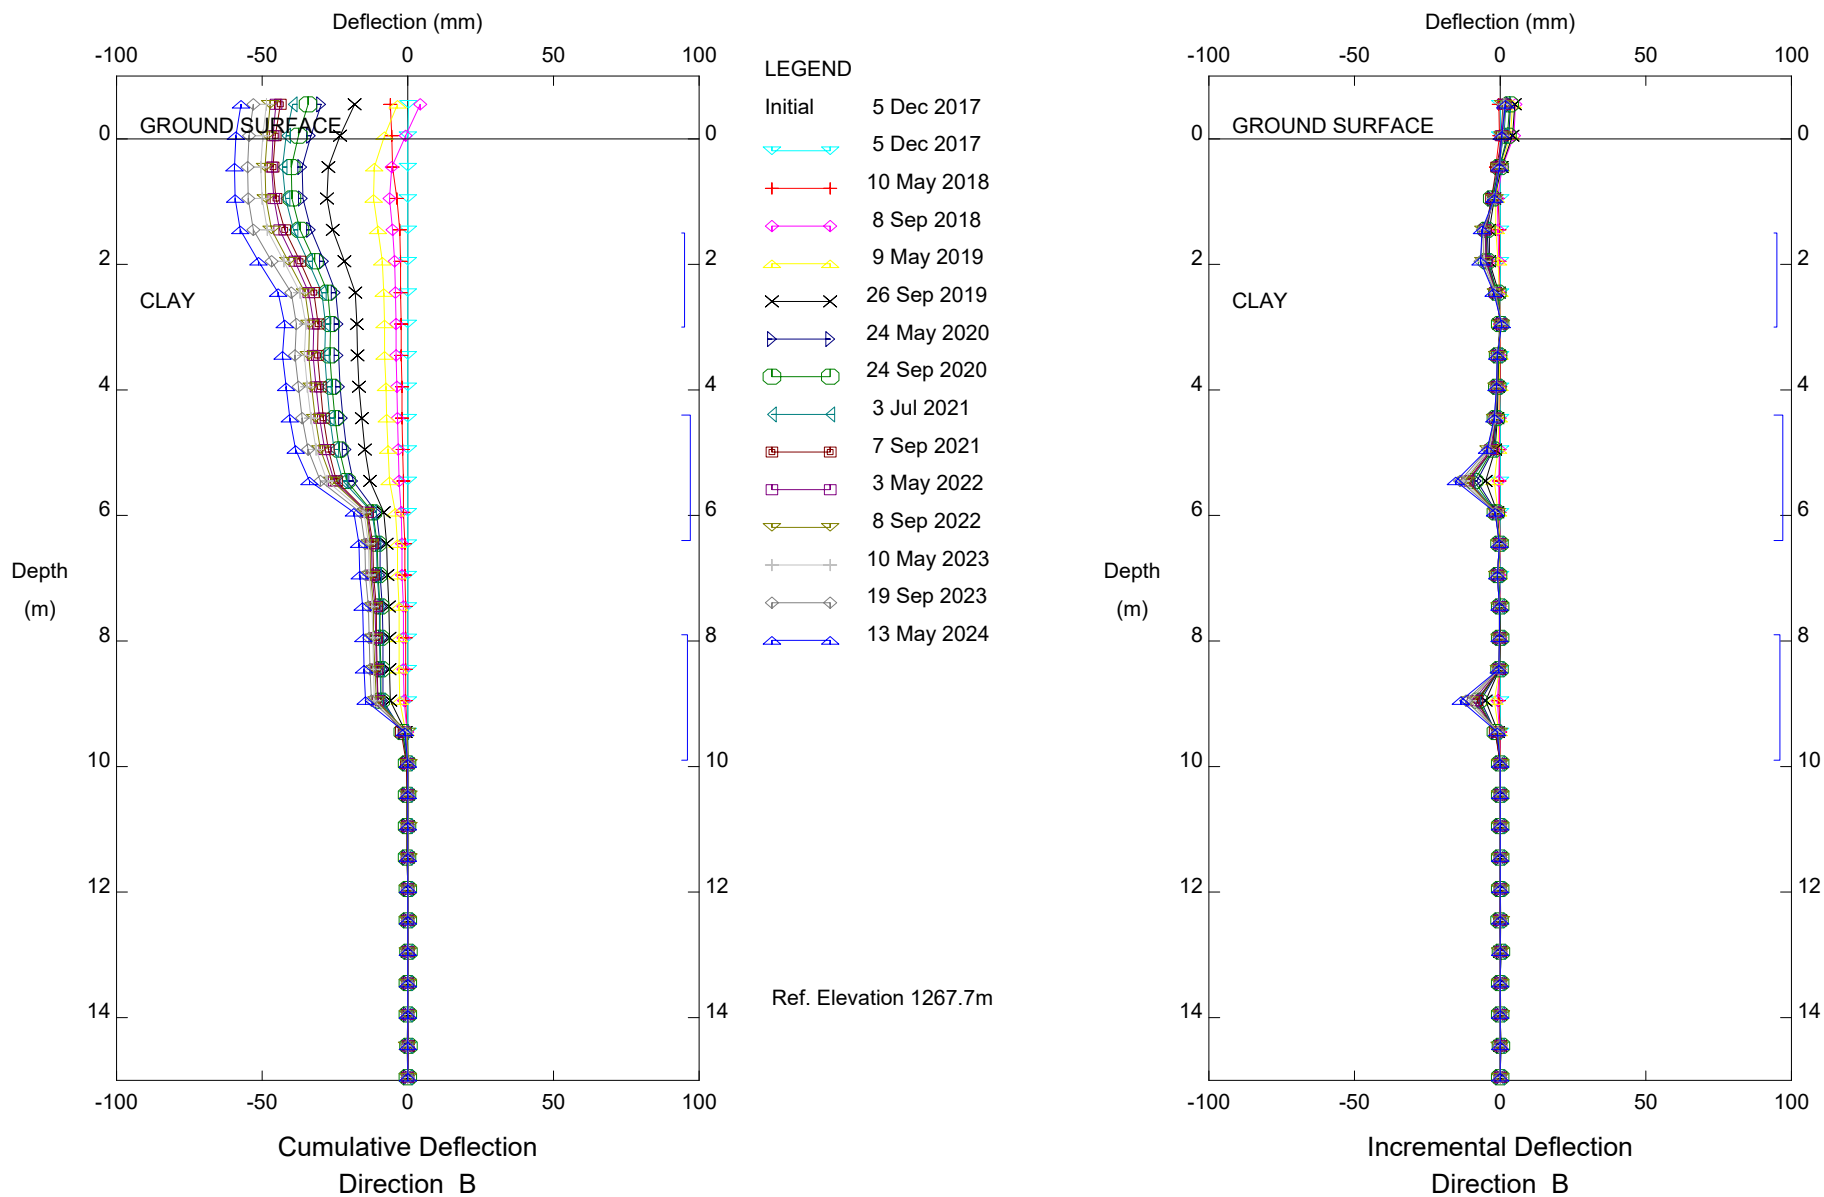
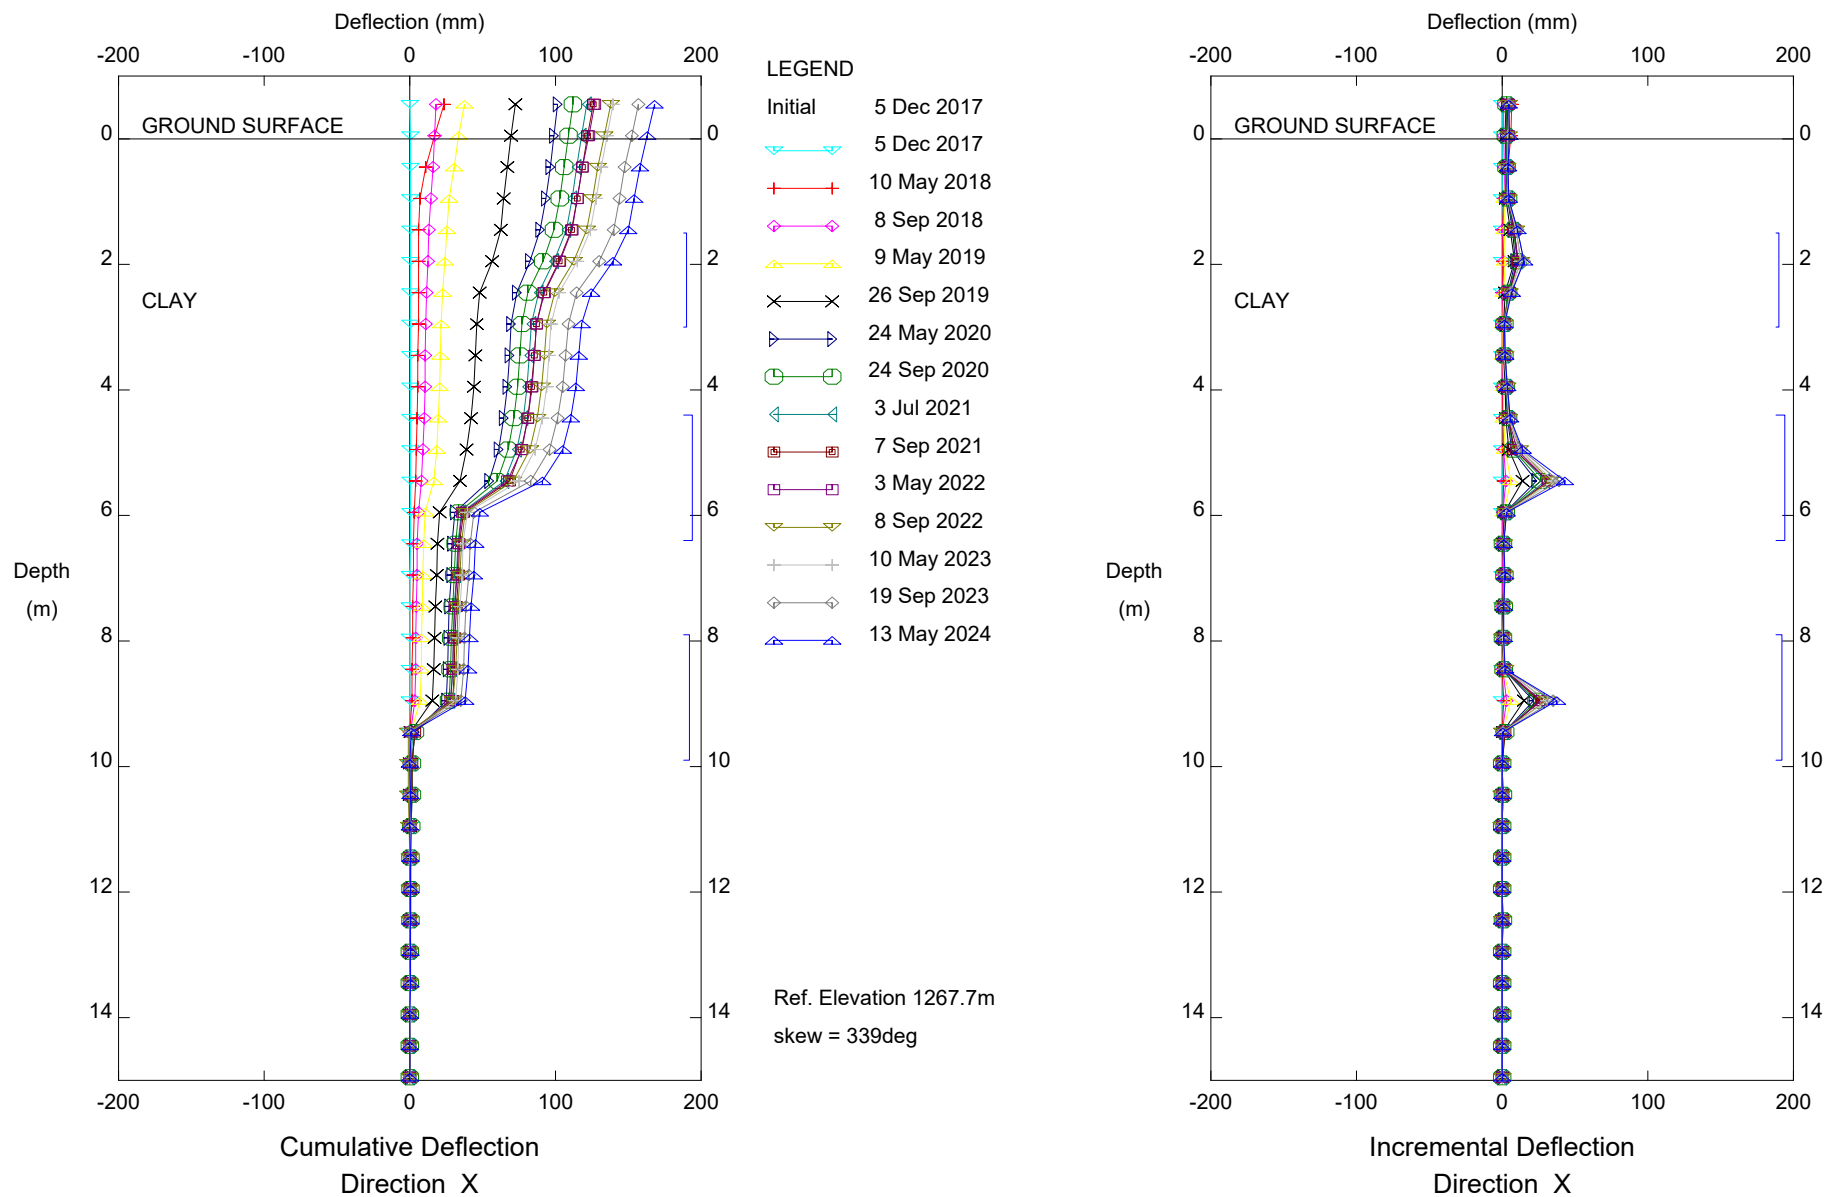
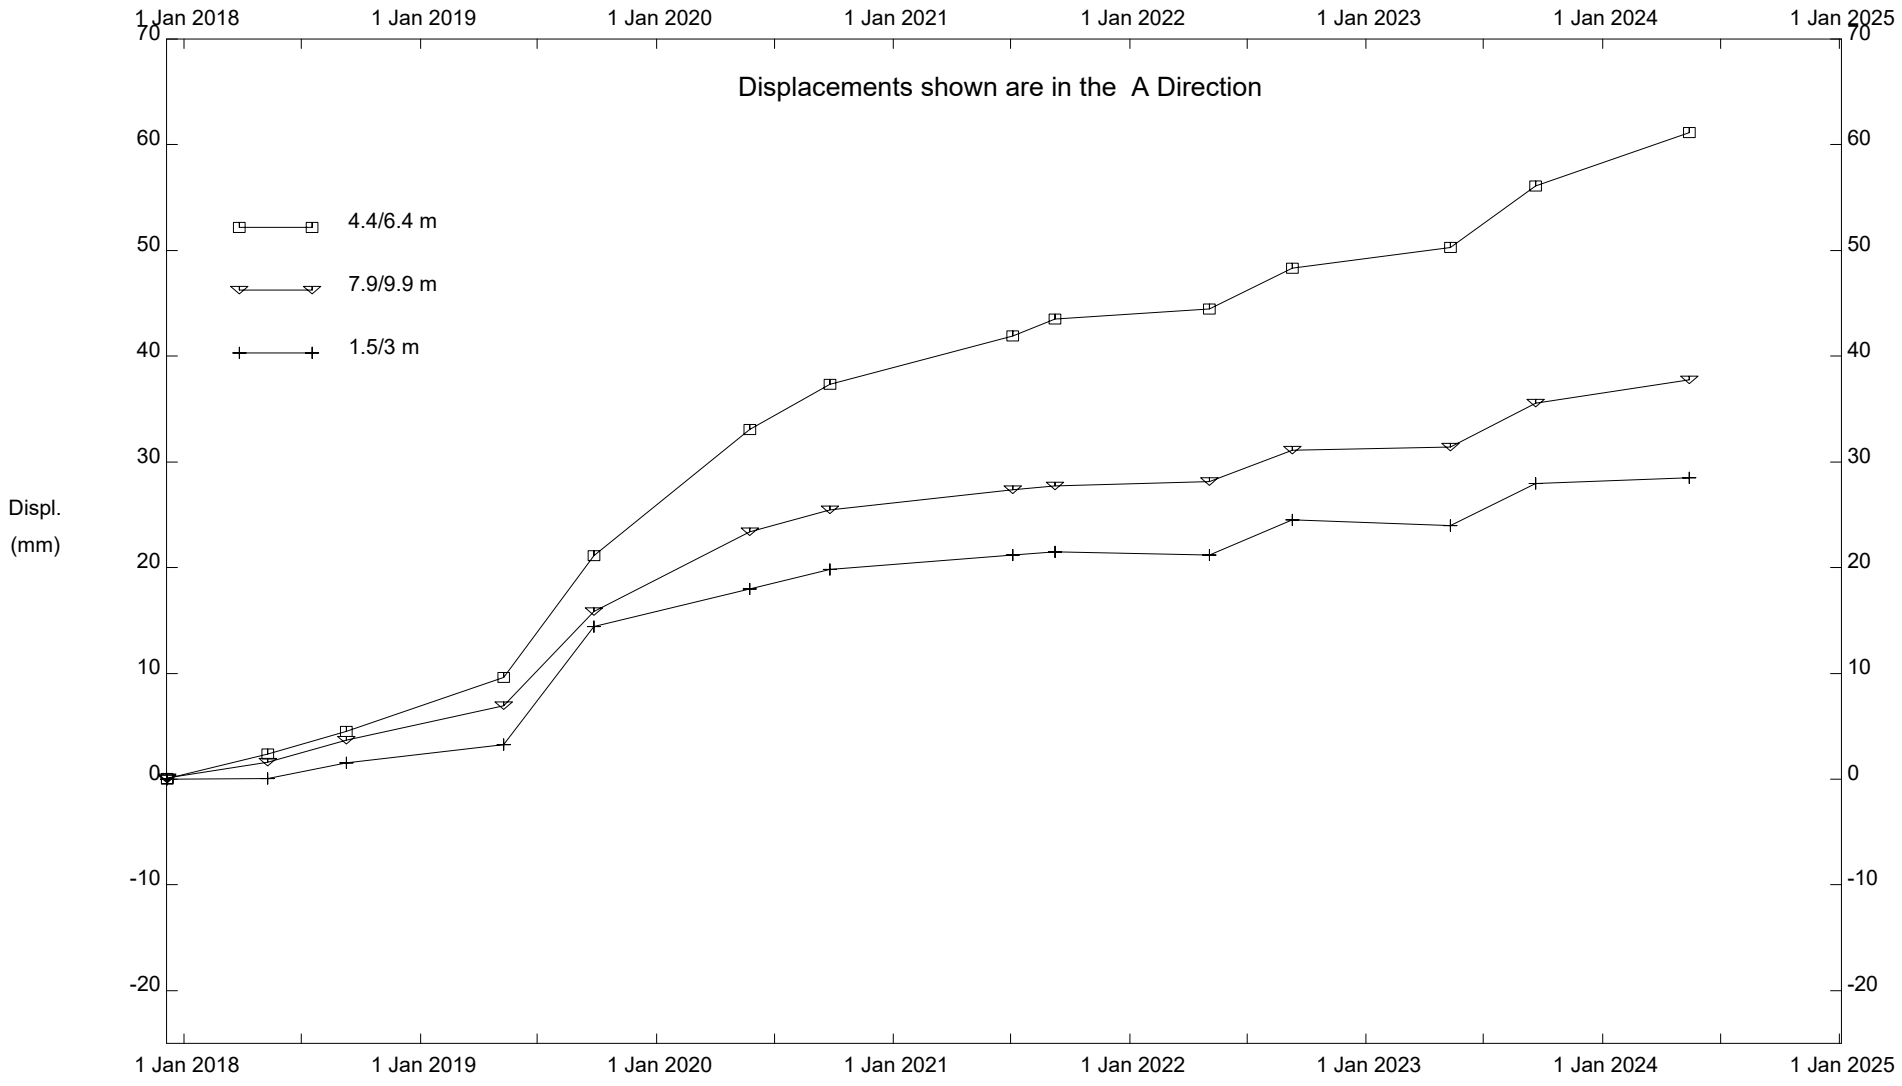
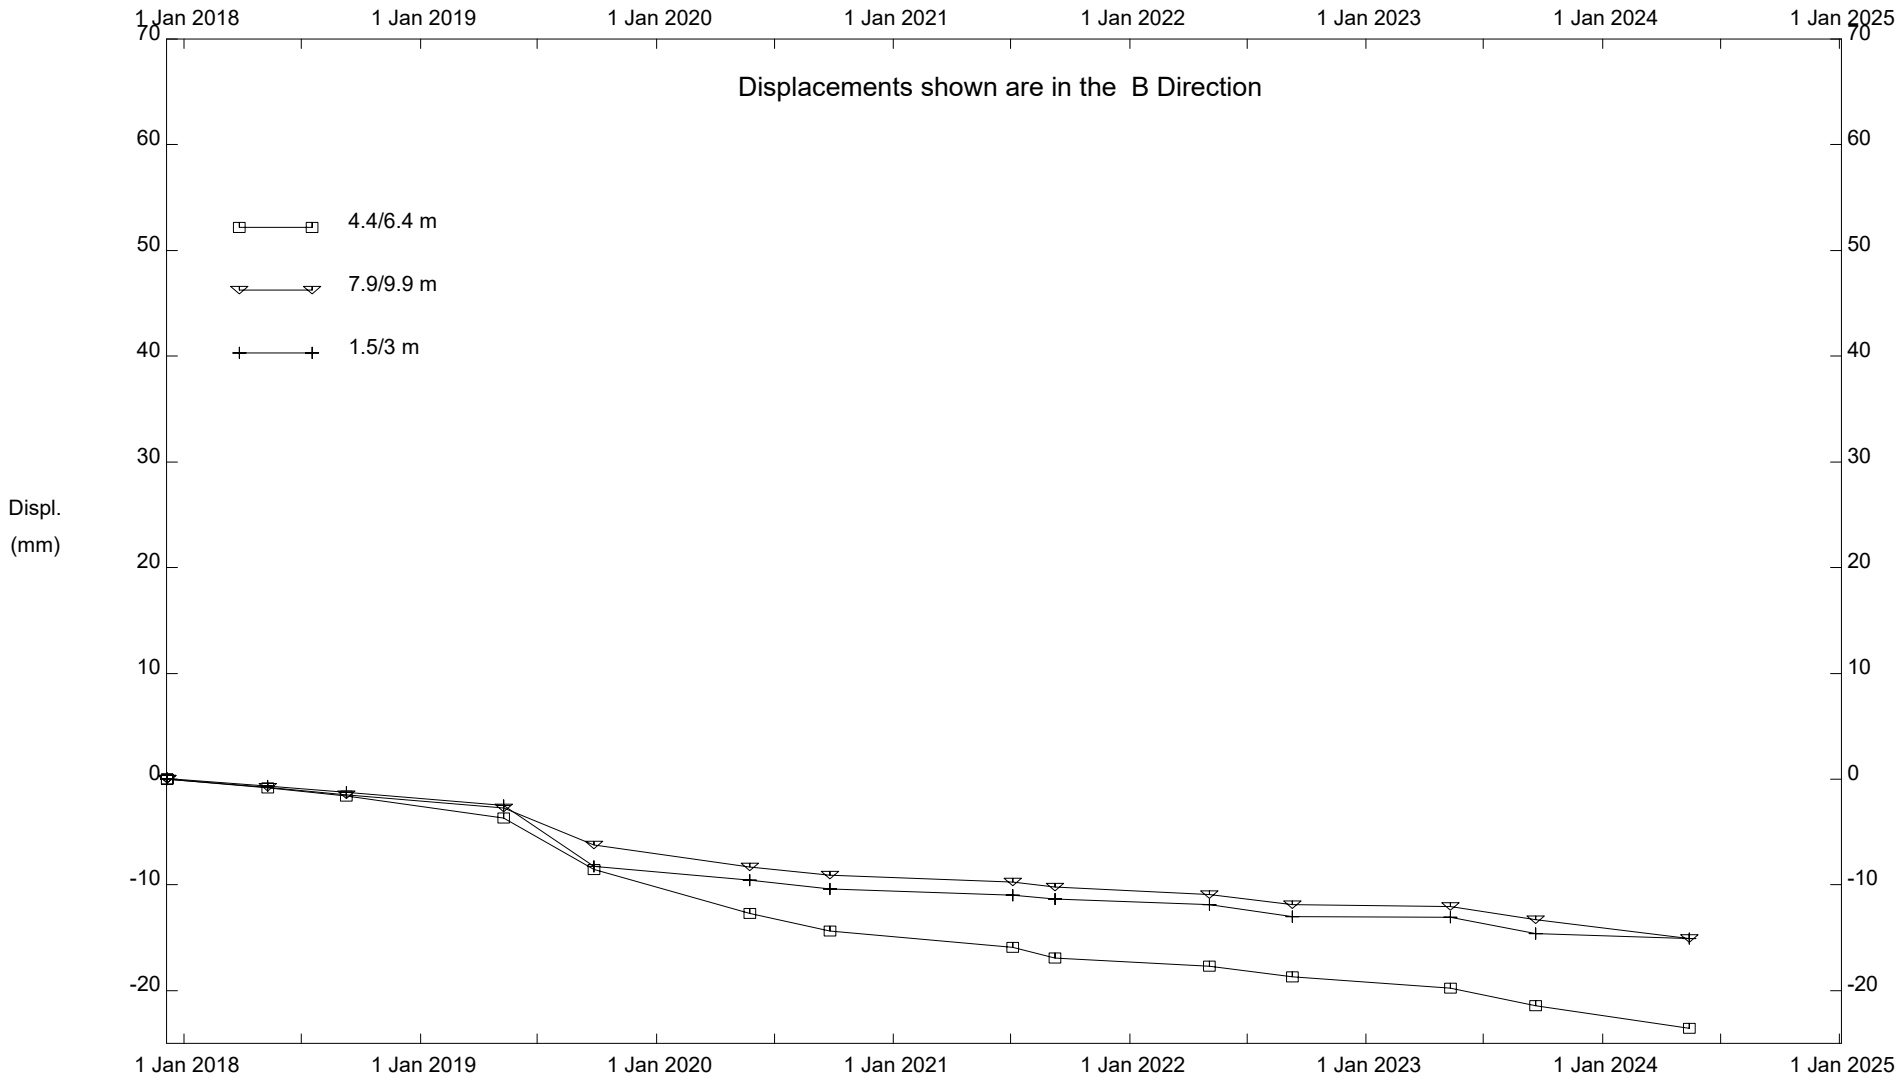
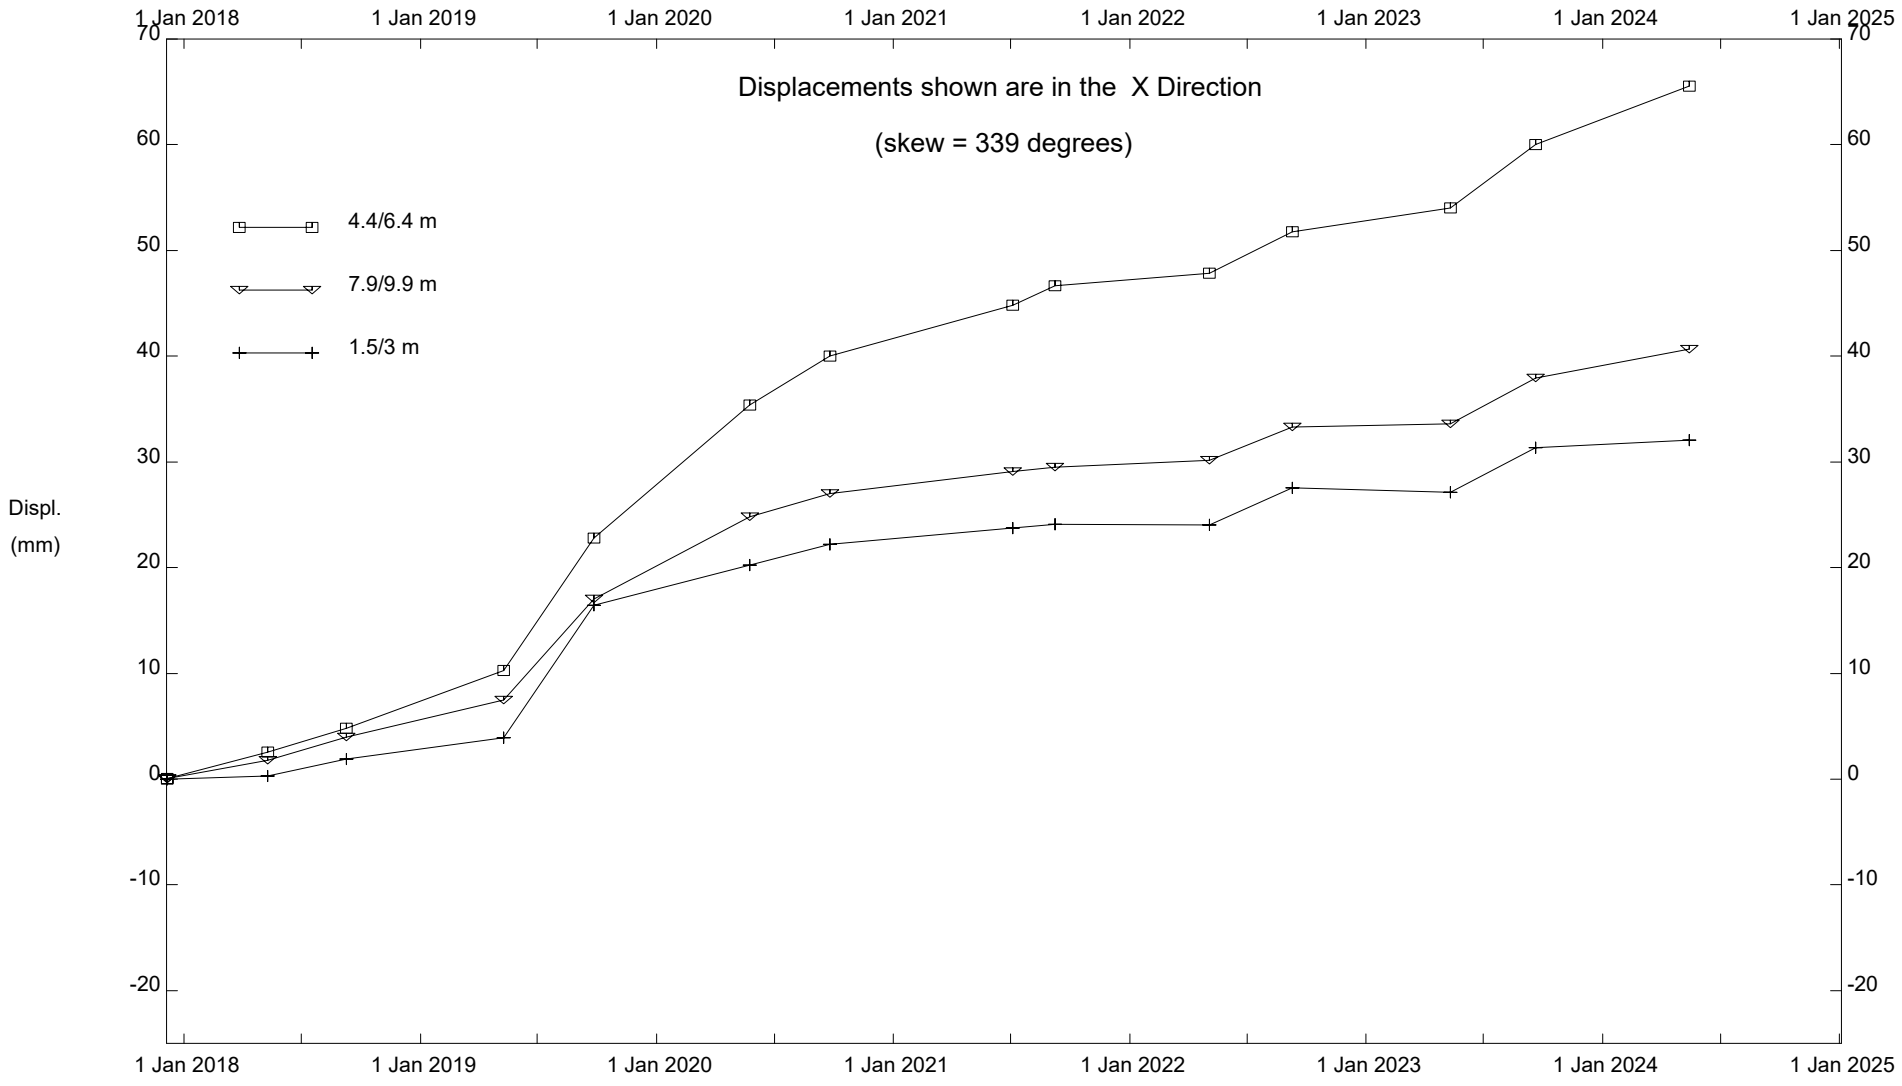
HWY 40:30 West of Wildhay River (NC83), Inclinometer SI17-01

SI17-01 shows three zones of movement at approximately 2 m, 6 m and 9 m below ground surface (bgs). Since initialization in December 2017, SI17-01 has accumulated 32 mm, 66 mm and 41 mm of movement in the upper, middle and lower shear zones, respectively. Their current respective rates of movement for the three zones are 1 mm/yr, 8 mm/yr and 4 mm/yr. All three shear zones showed decreased rates of movement compared to the last reading cycle in Fall 2023.
