To:	Amy Driessen	From:	Leslie Cho and Xiteng Liu
	Transportation and Economic Corridors		Stantec Consulting Ltd.
File:	123315222	Date:	June 18, 2024

Reference: North Central Region, Edson, Site NC083 - Highway 40:30 West of Wildhay River, Spring 2024 Instrumentation Monitoring Report

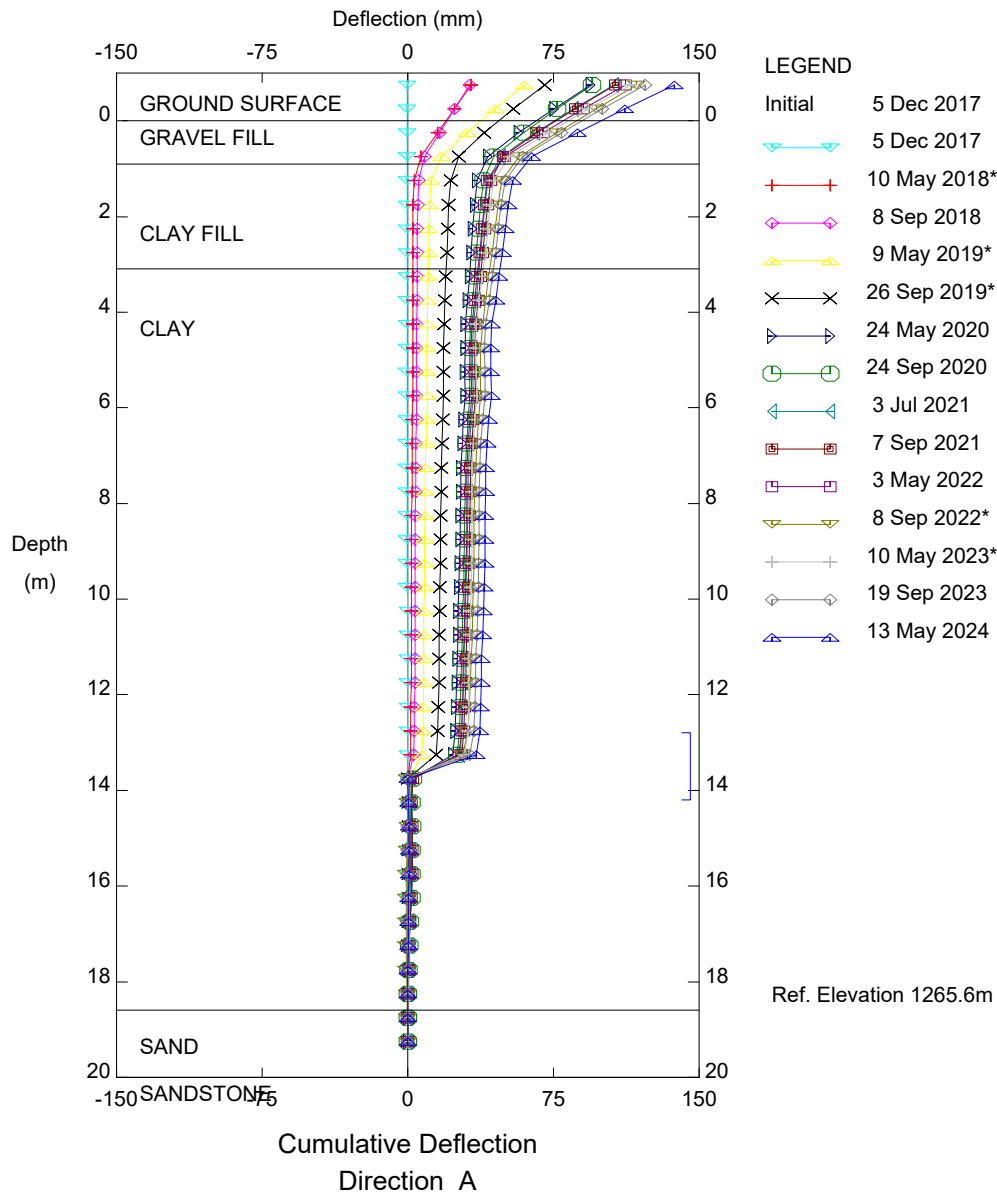
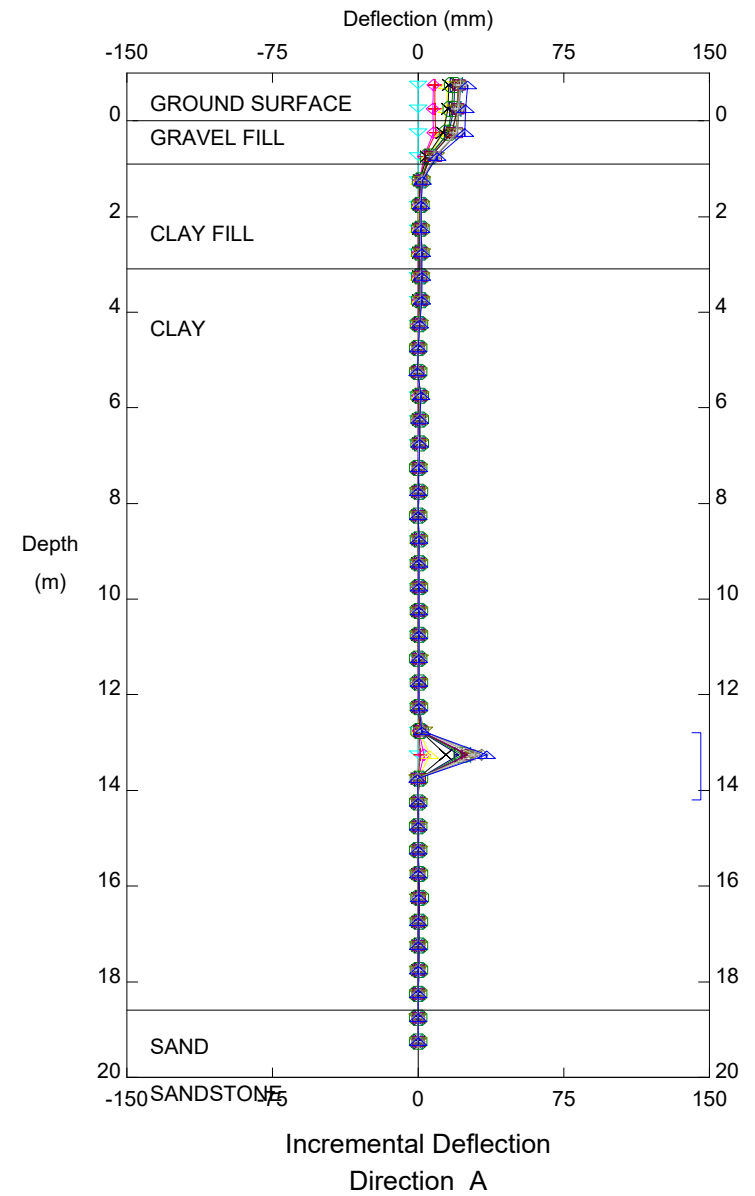
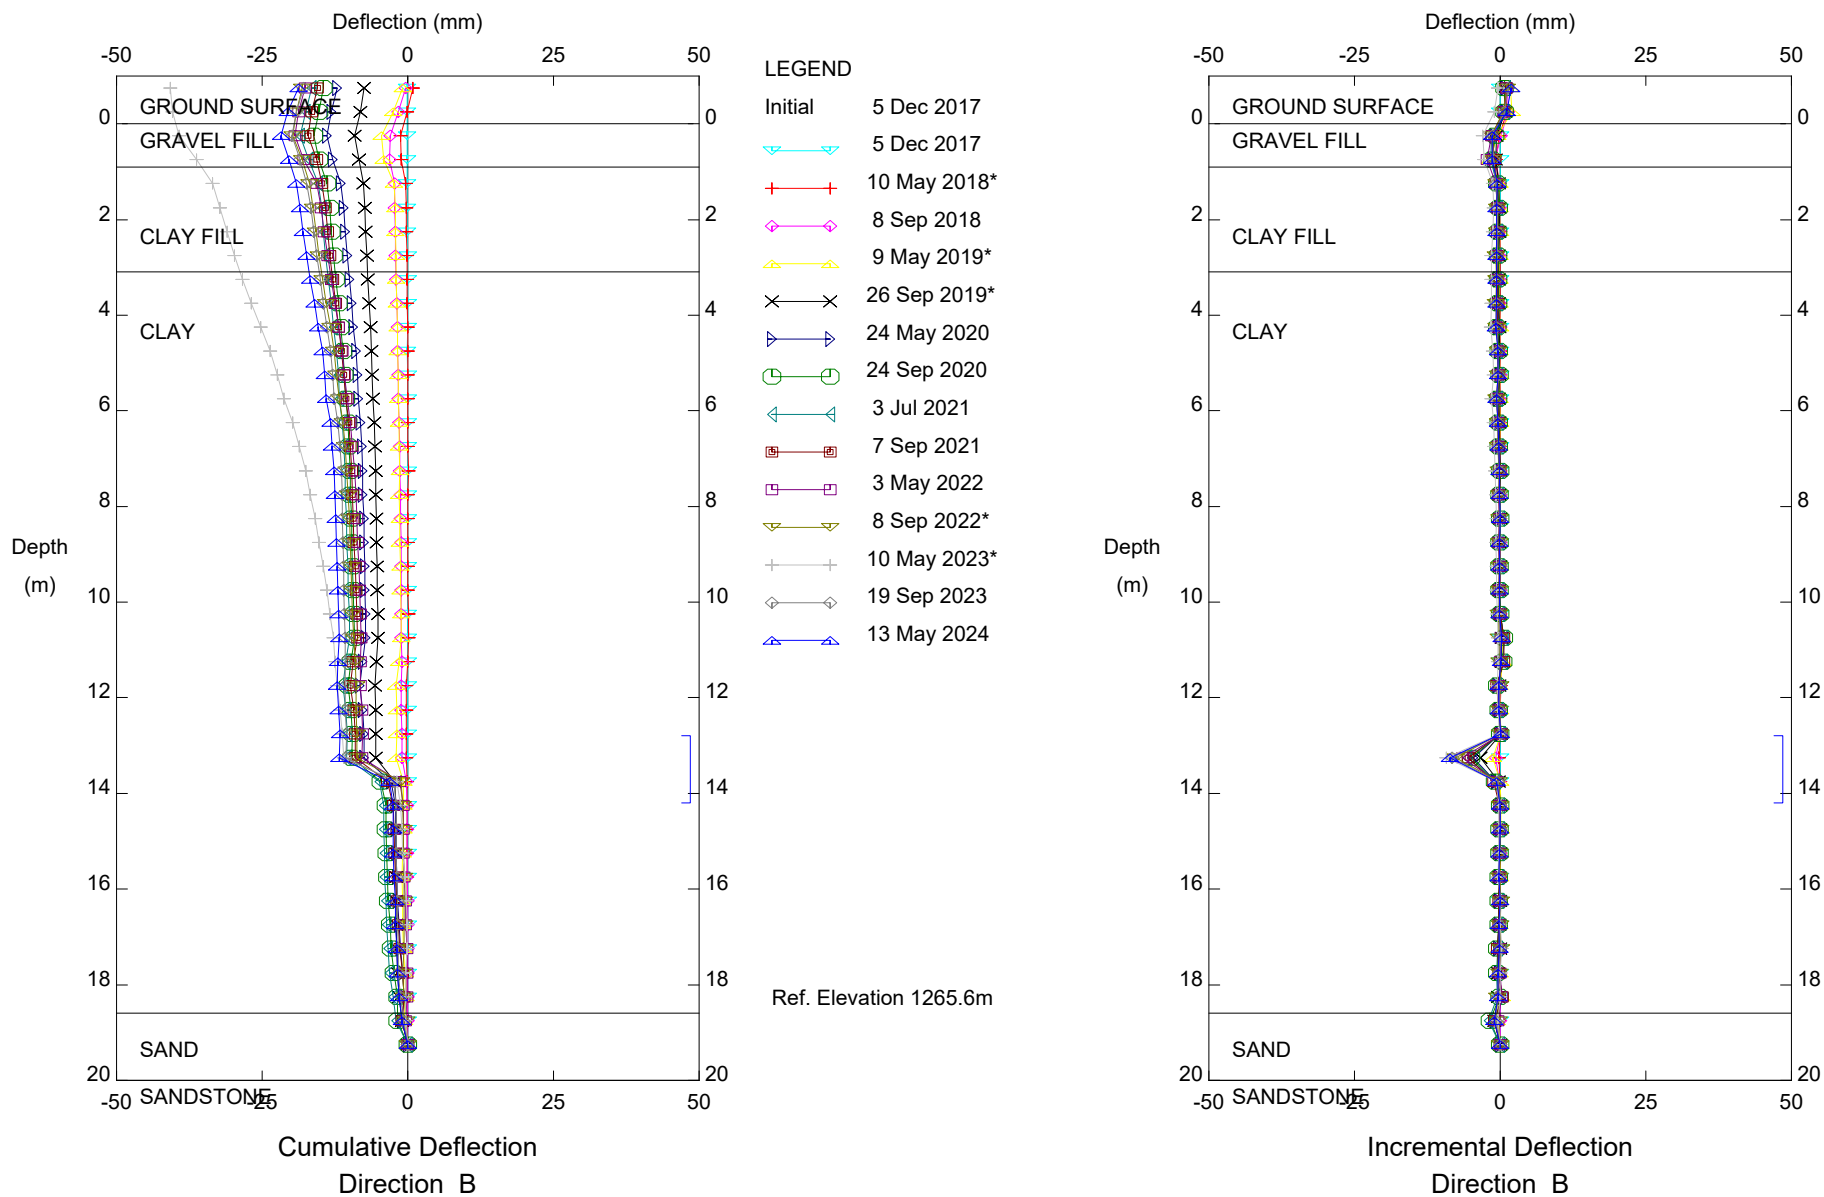
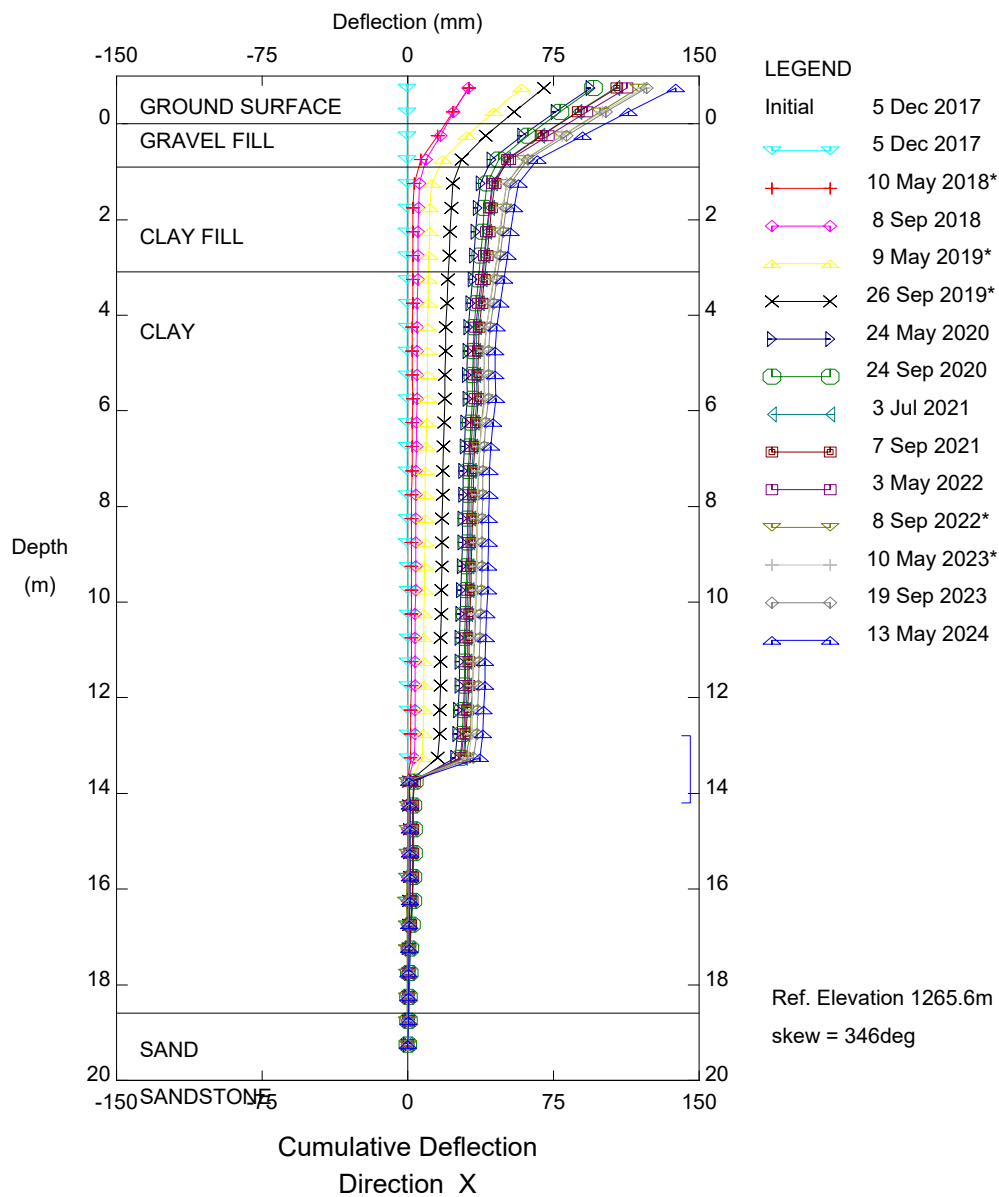
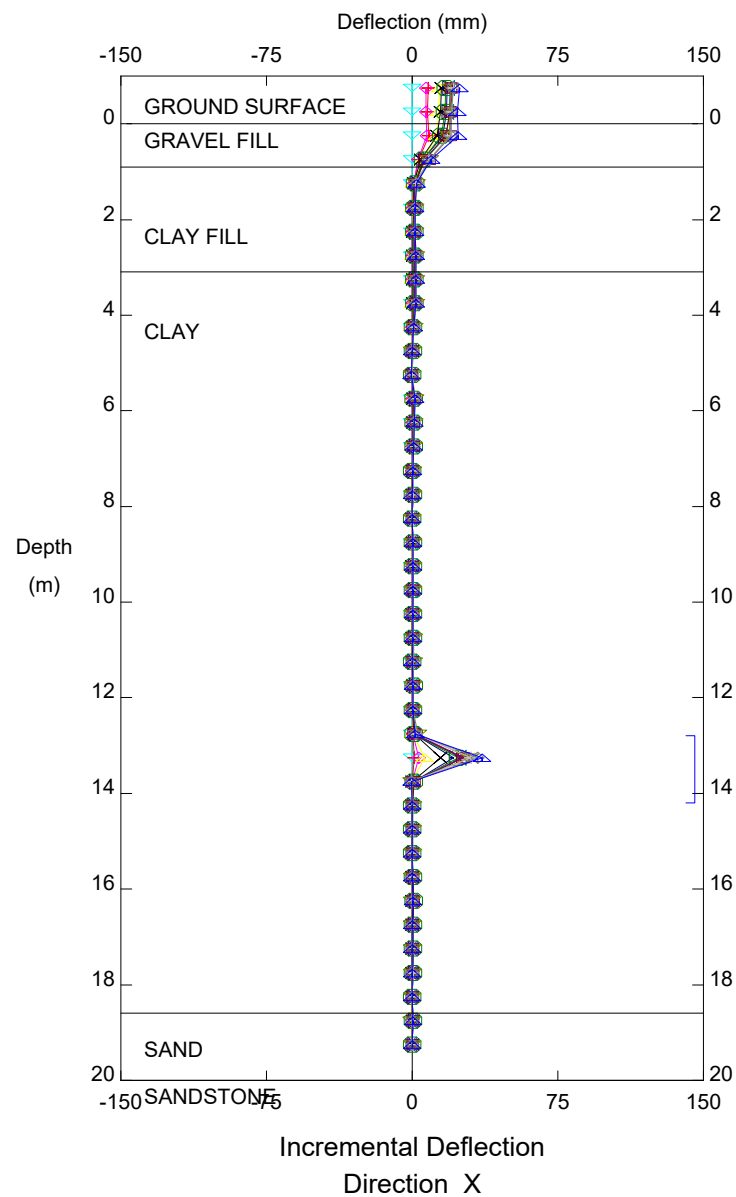
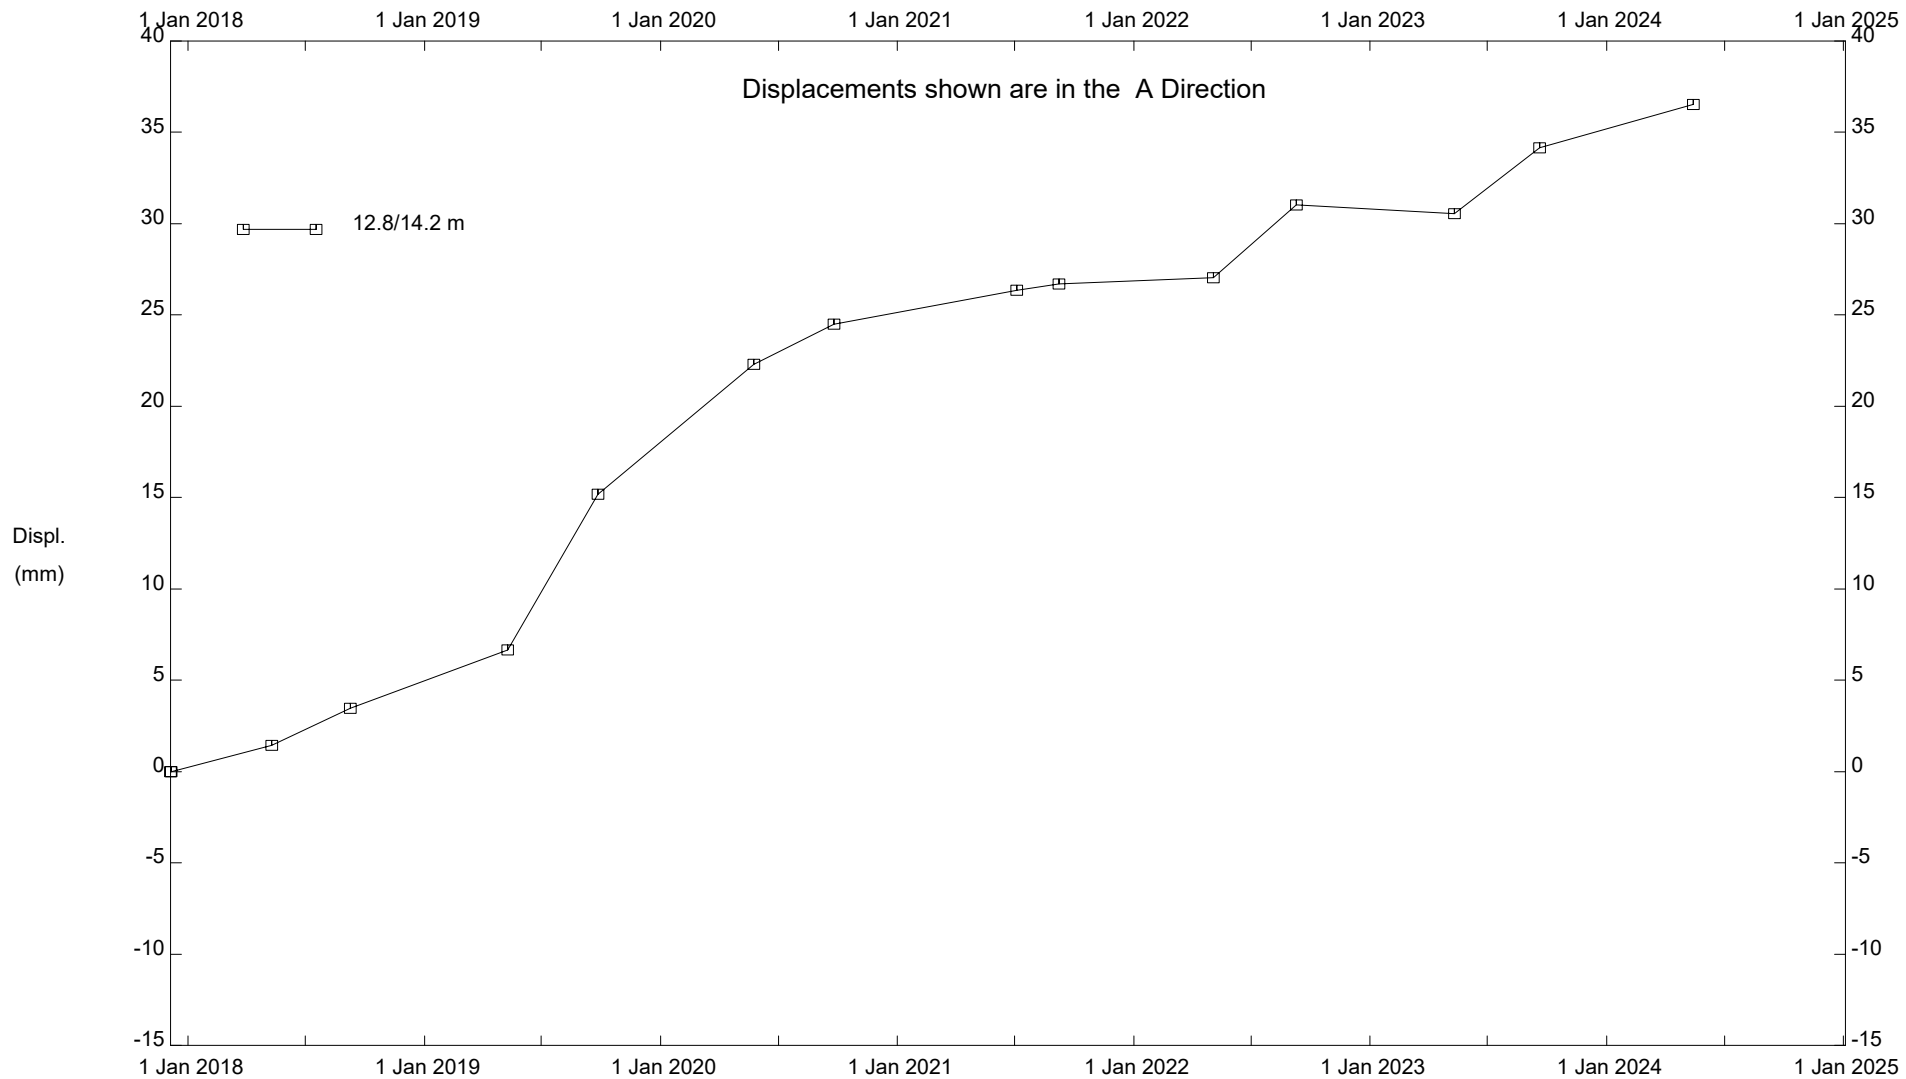
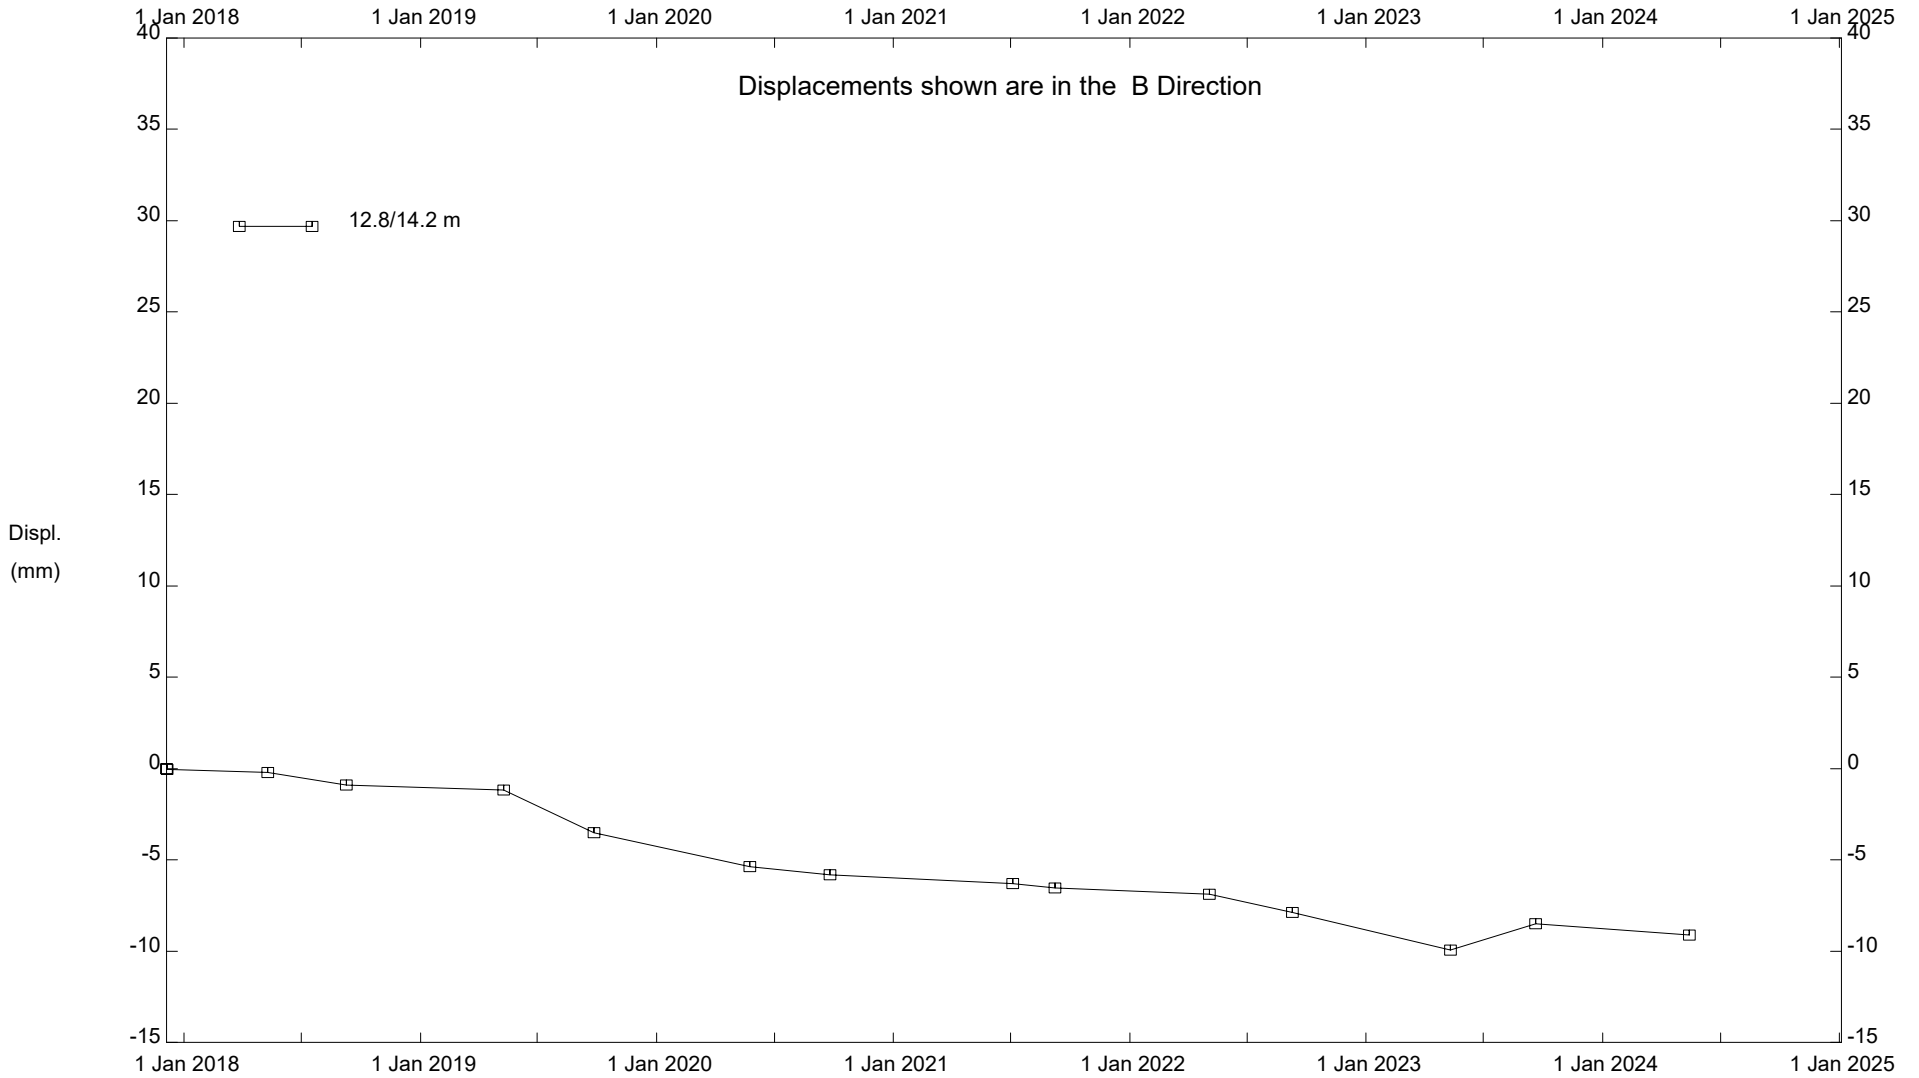
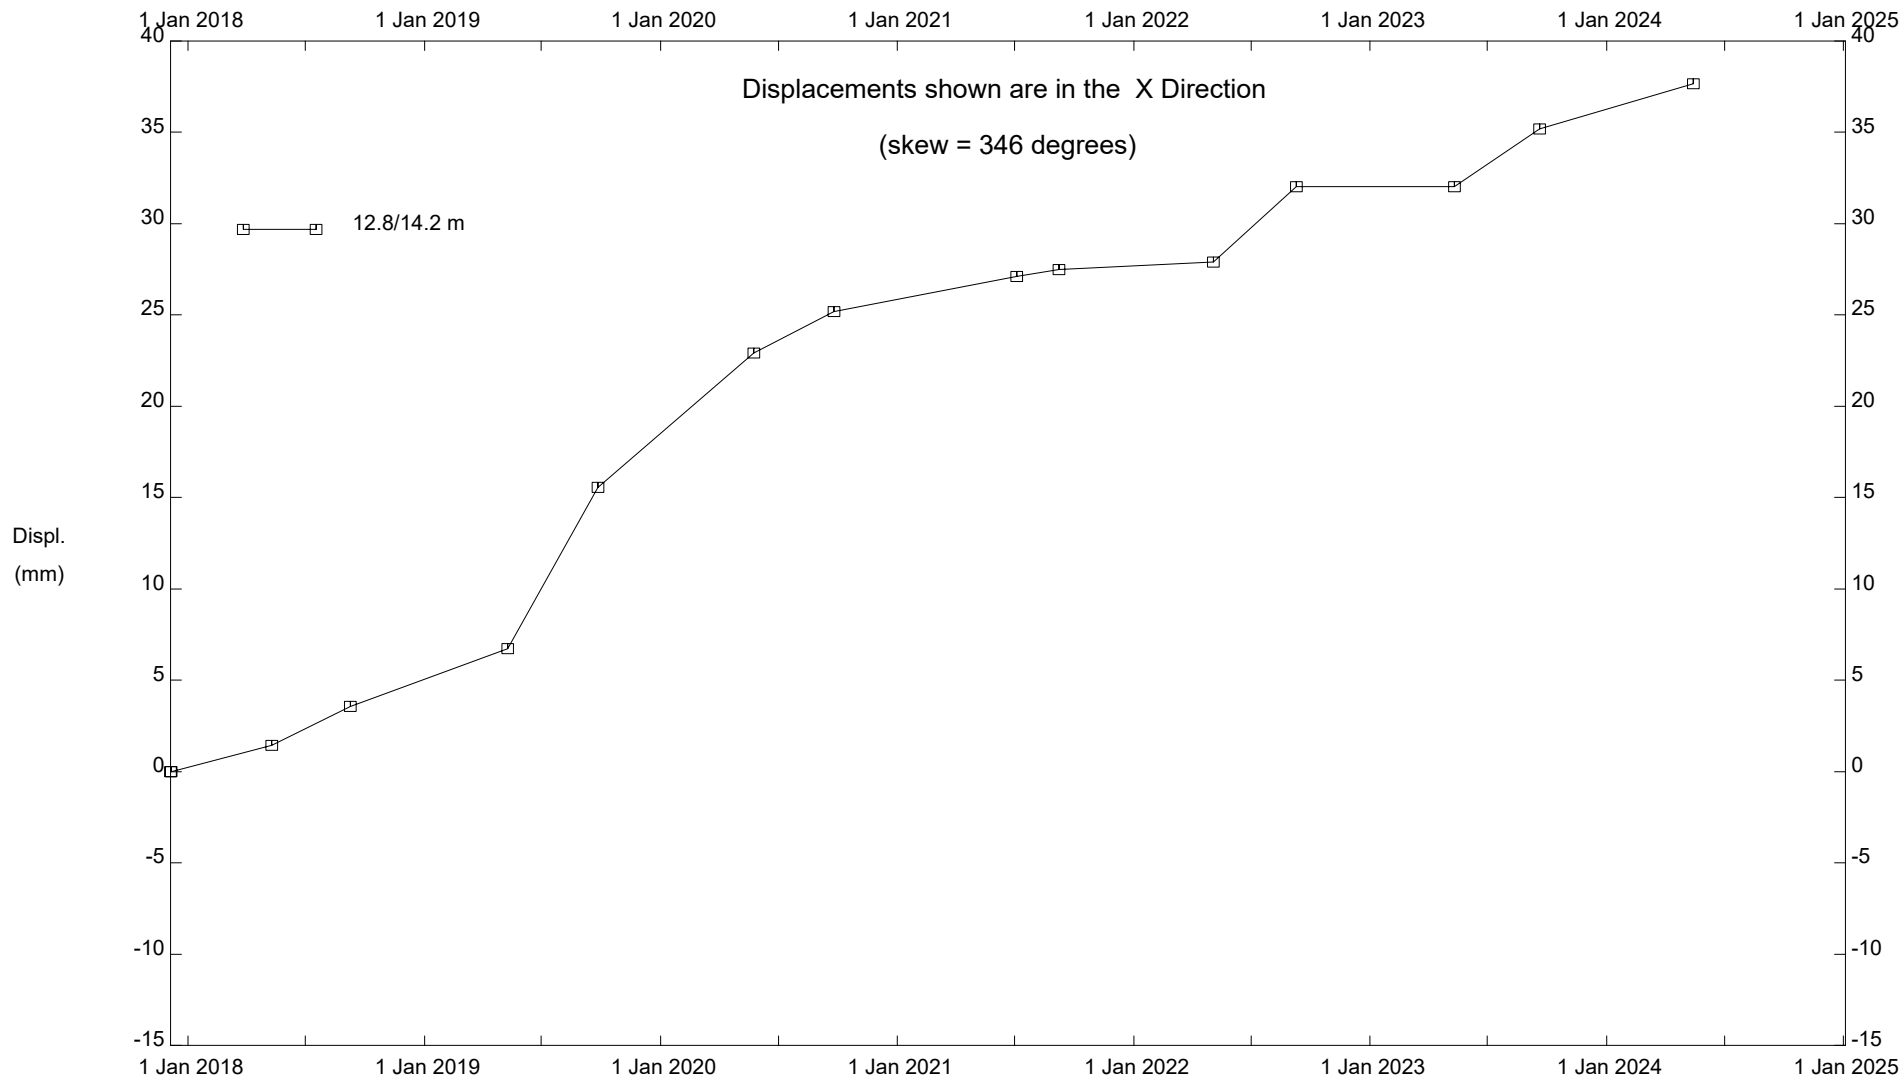
HWY 40:30 West of Wildhay River (NC83), Inclinerometer S117-02

SI17-02 shows approximately 4 mm/yr in the rate of movement during this reading cycle with 38 mm of cumulative movement.
