To:	Amy Driessen	From:	Leslie Cho and Xiteng Liu
	Transportation and Economic Corridors		Stantec Consulting Ltd.
File:	123315222	Date:	June 18, 2024

Reference: North Central Region, Edson, Site NC083 - Highway 40:30 West of Wildhay River, Spring 2024 Instrumentation Monitoring Report

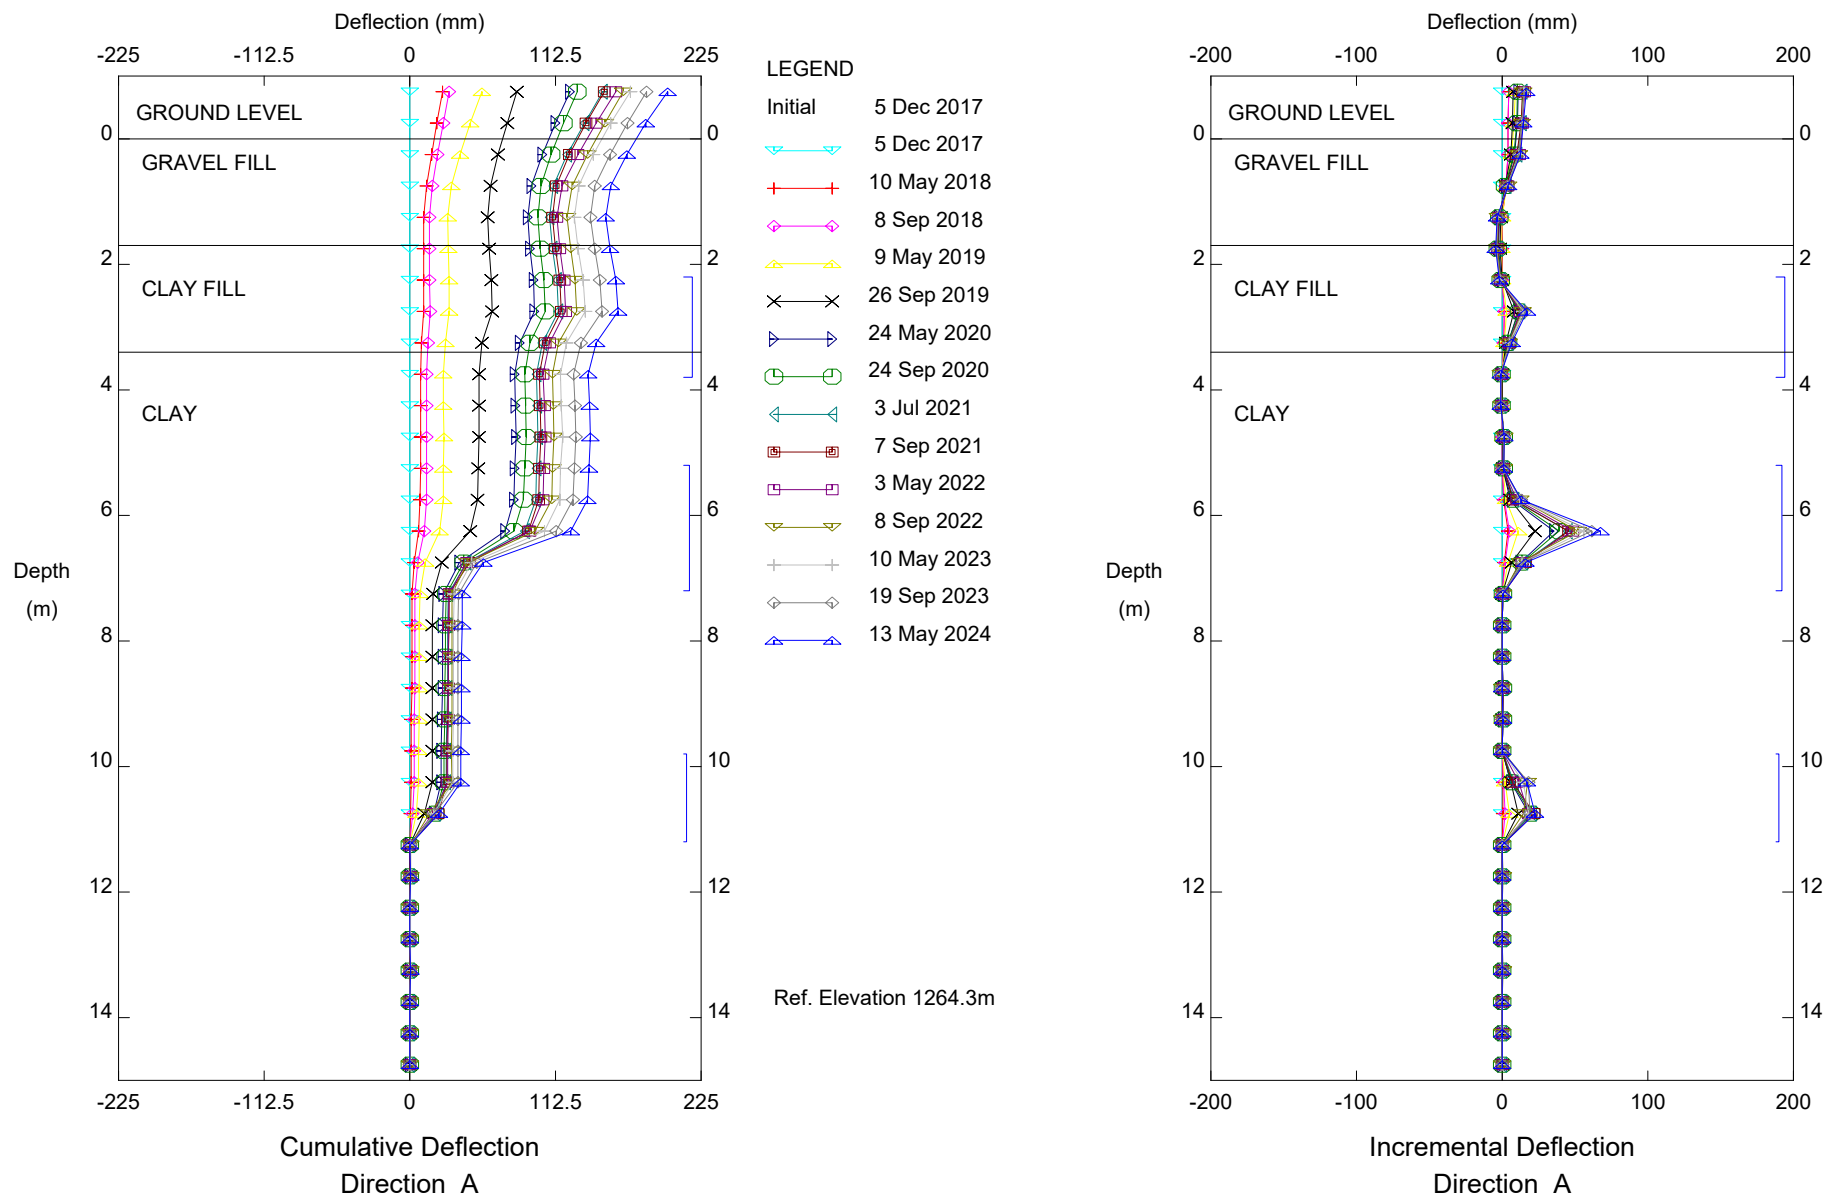
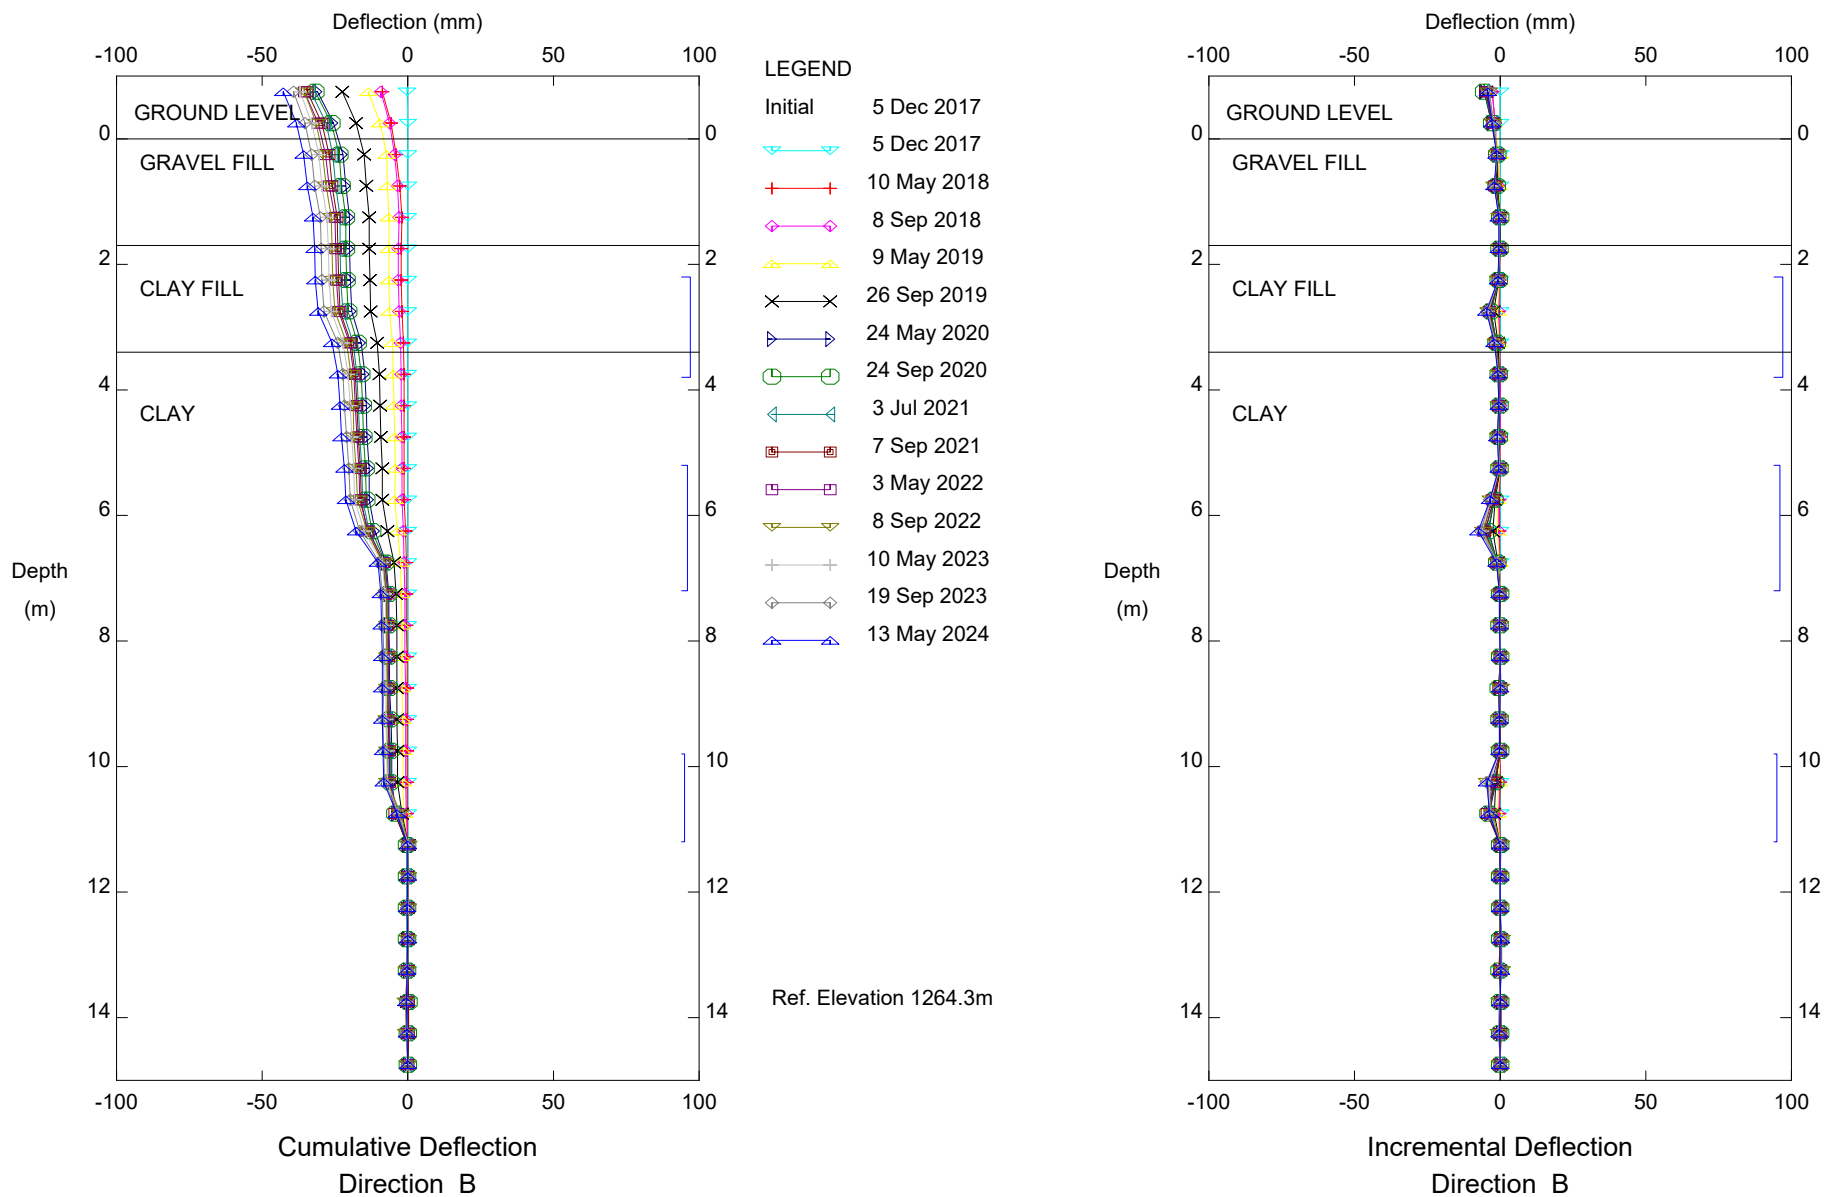
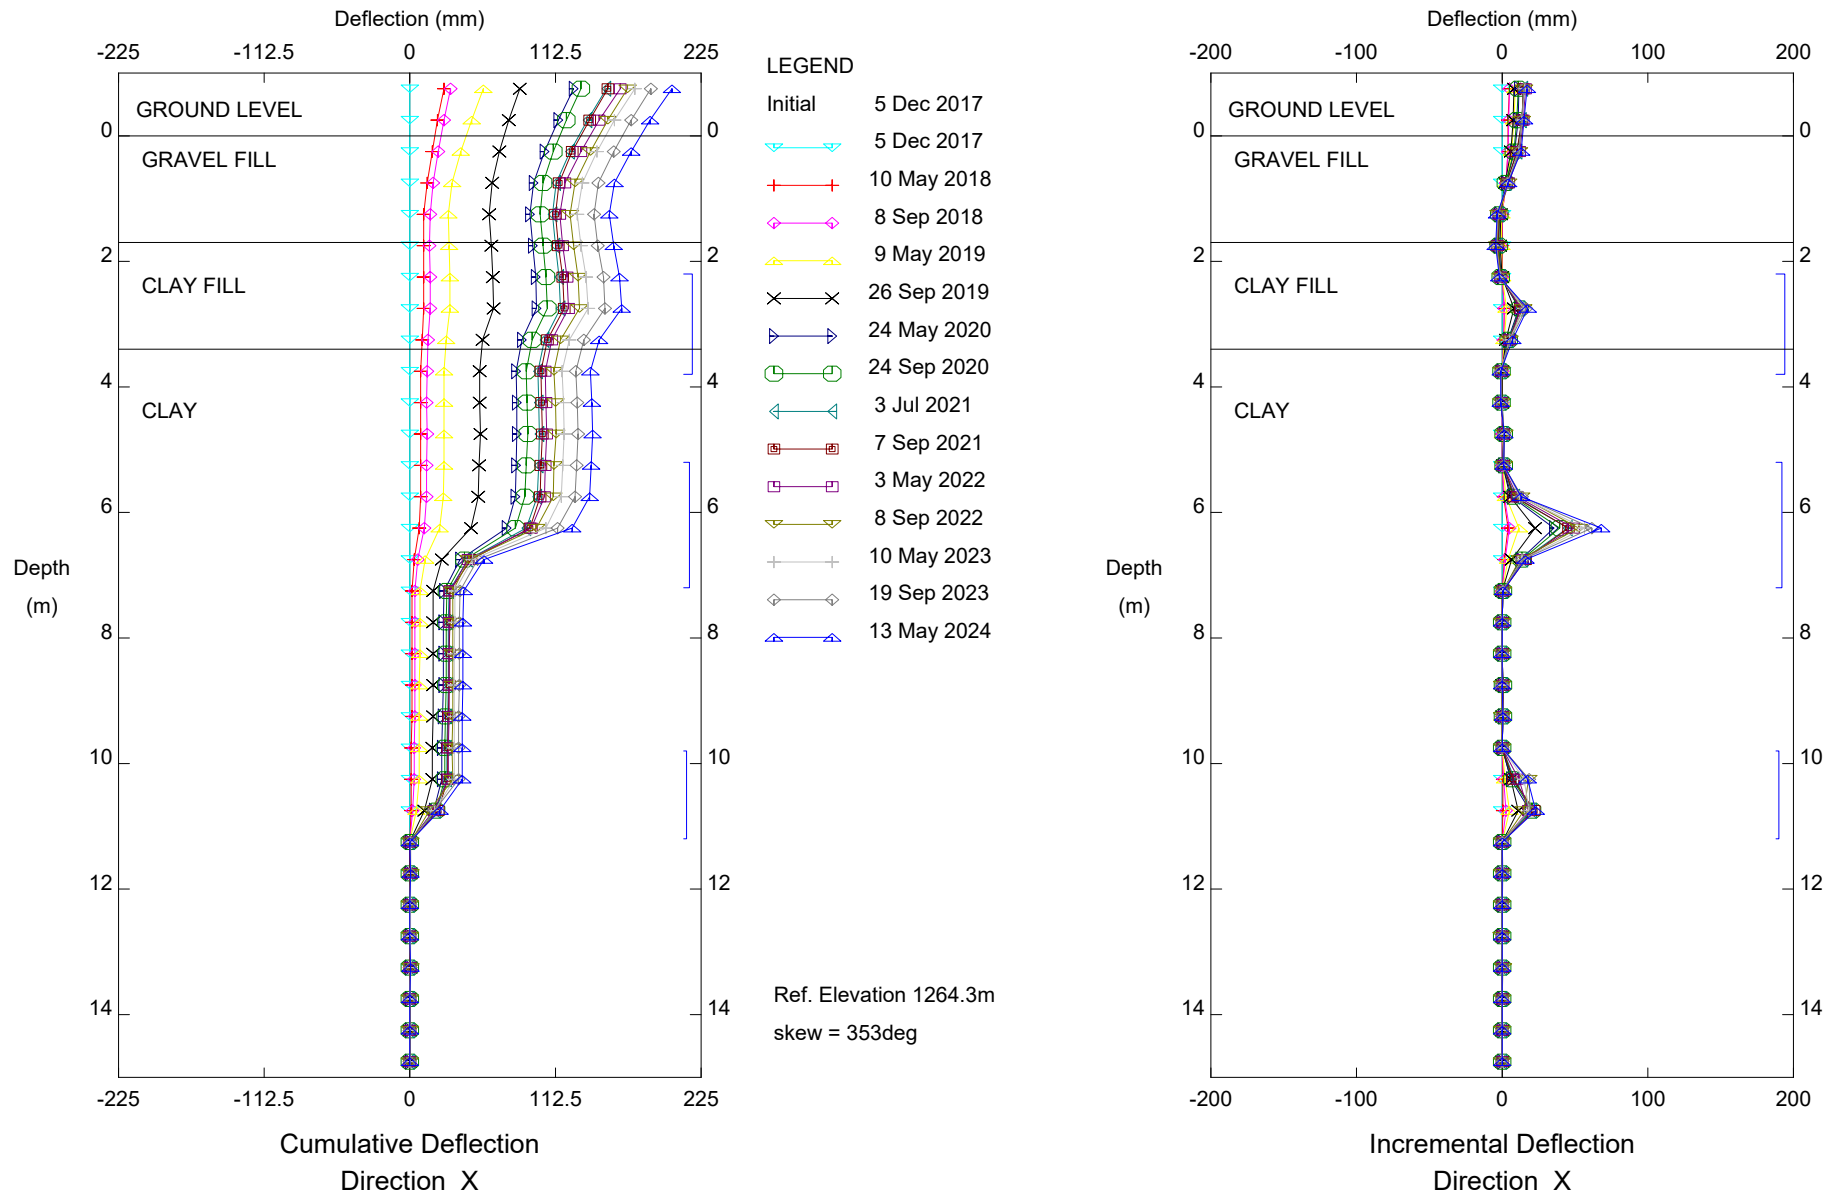
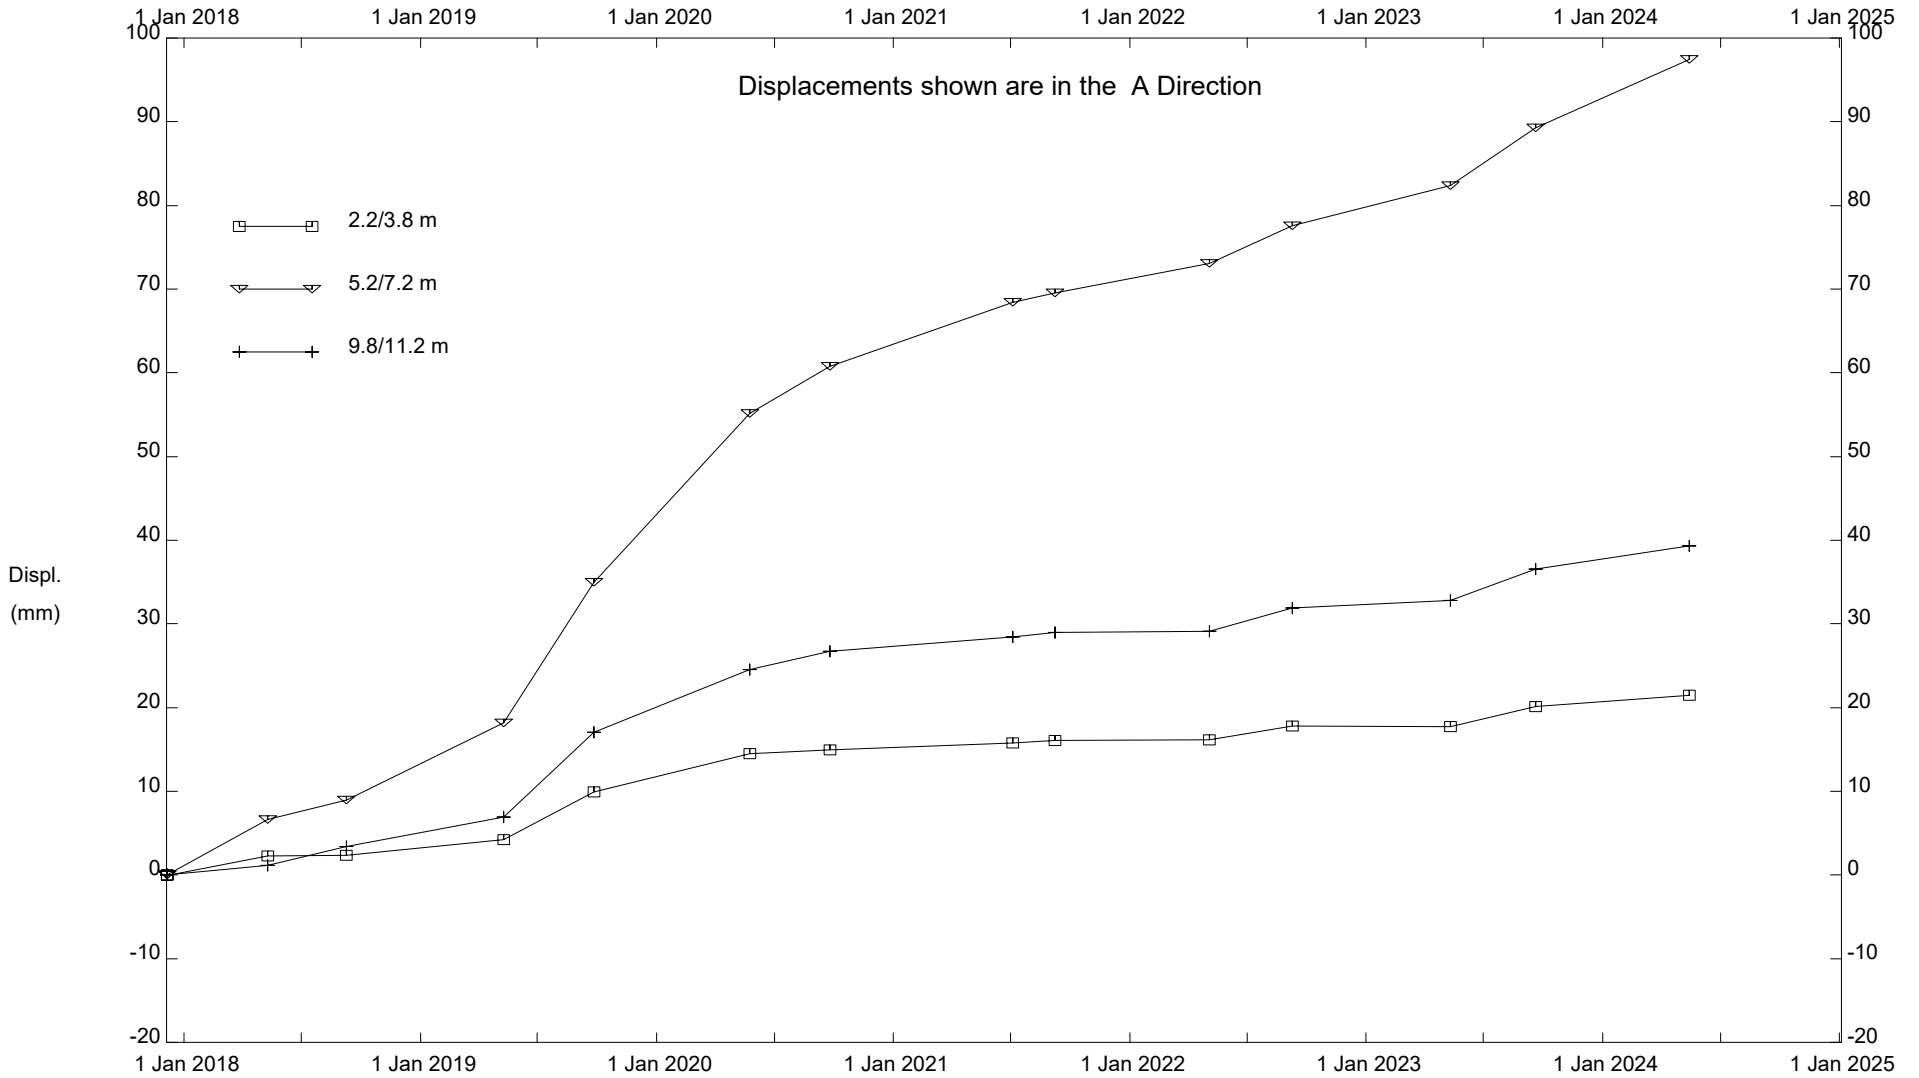
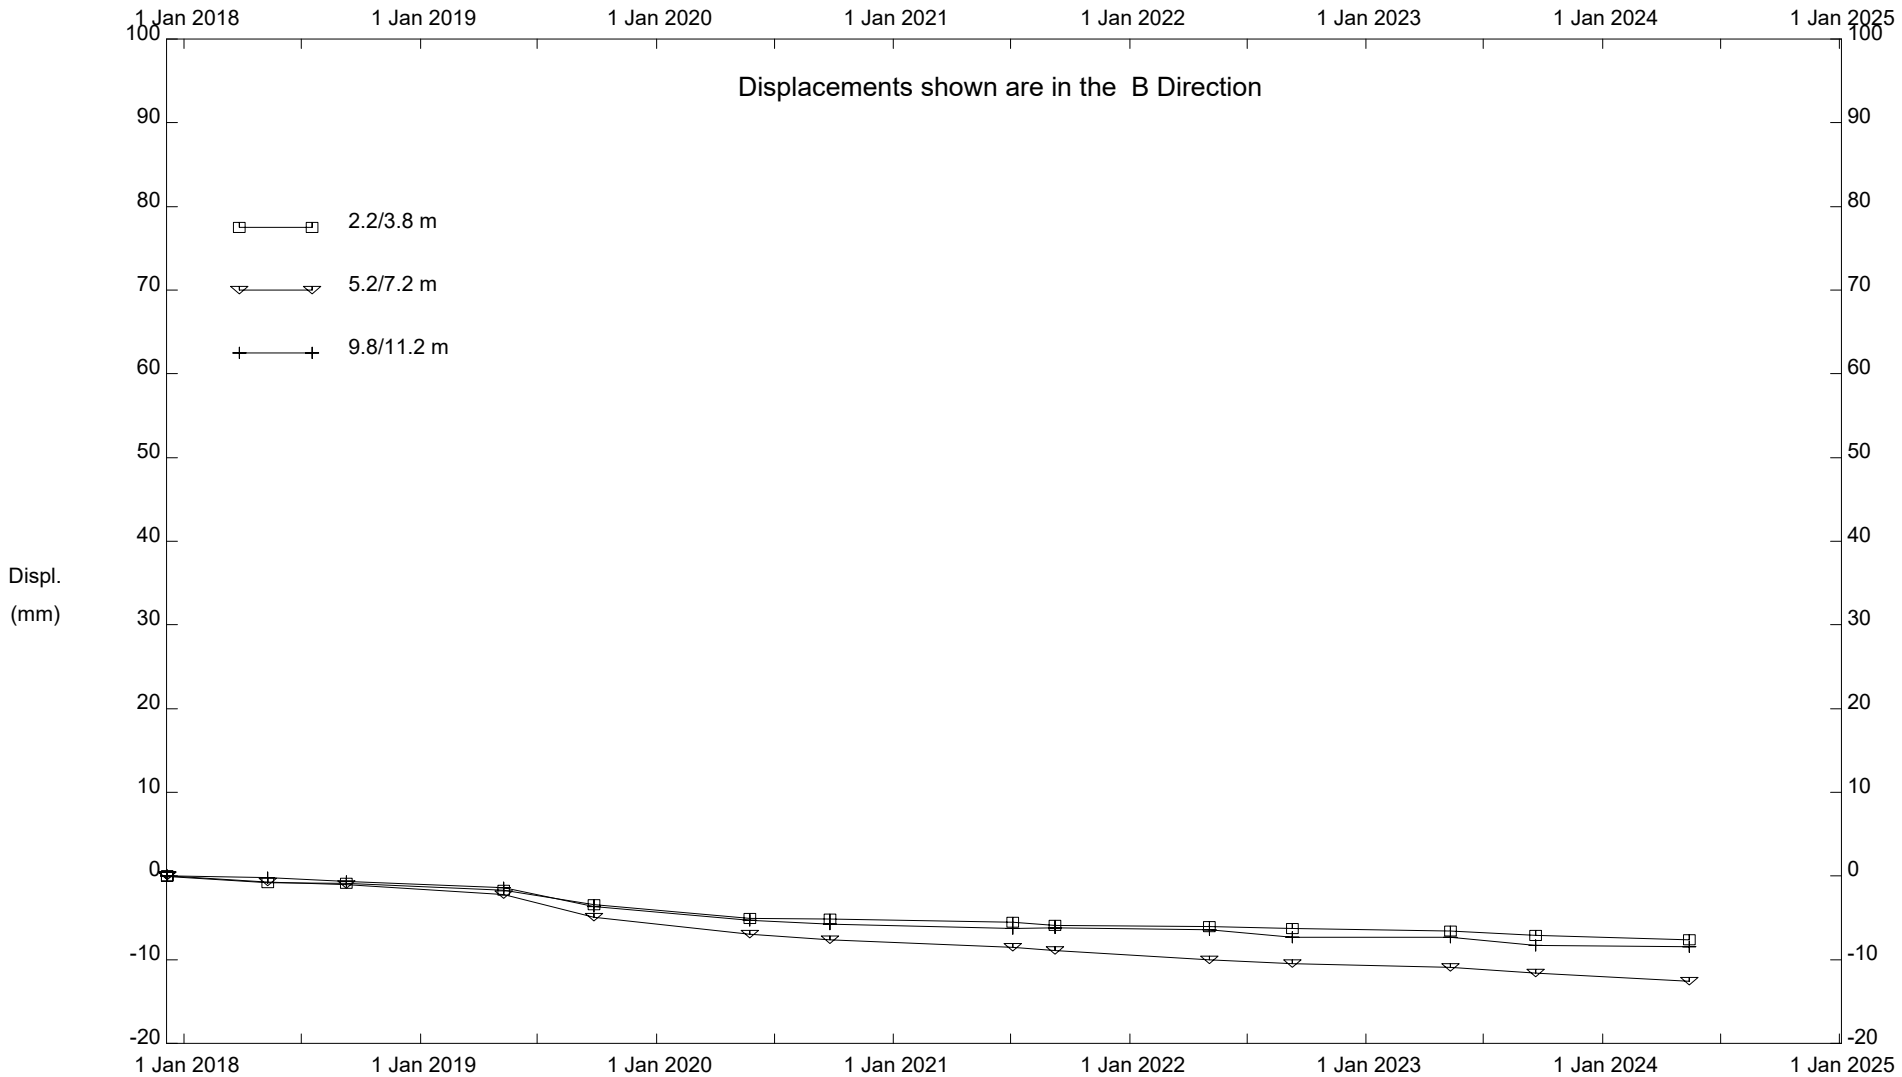
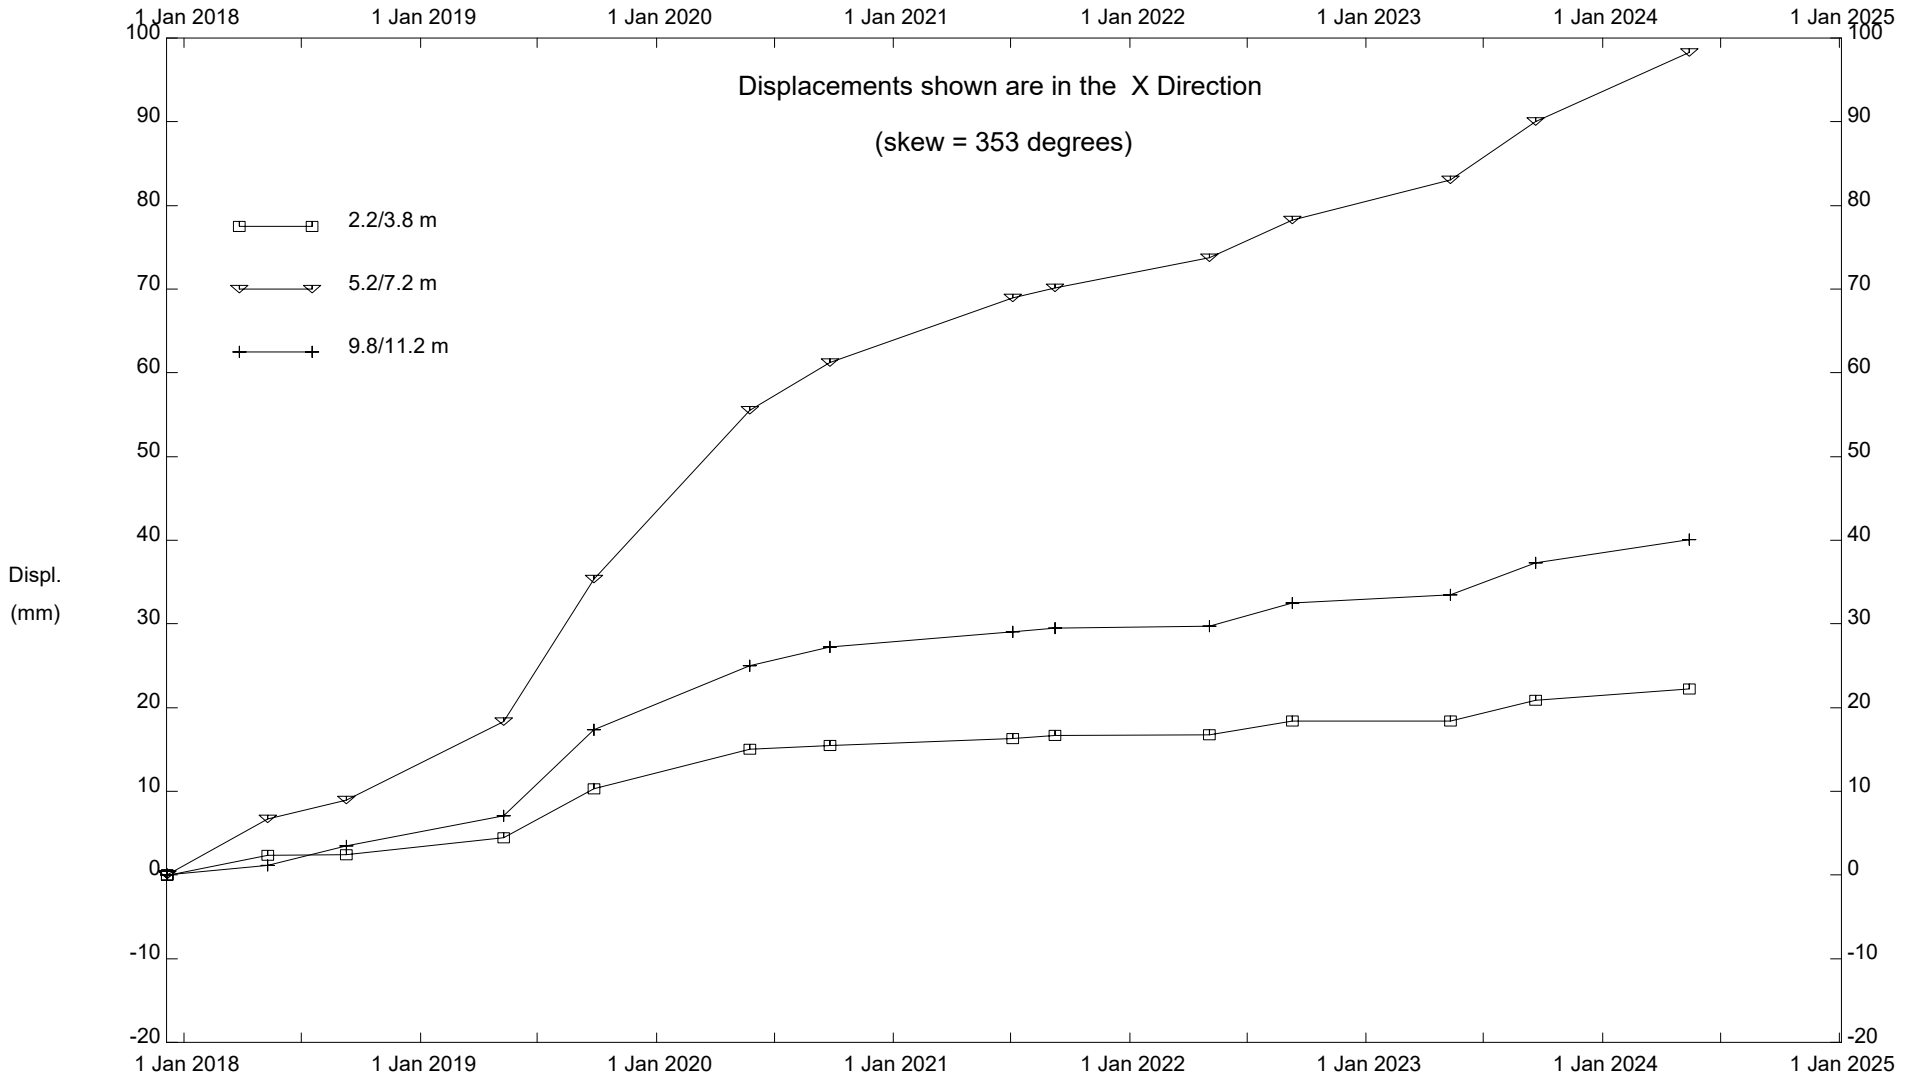
HWY 40:30 West of Wildhay River (NC83), Inclinometer S117-03
 Transportation & Economic Corridors

SI17-03 has three zones of movement at approximately 3 m, 6 m and 10 m bgs. The upper movement zone is located within the fill and shows a rate of movement of about 2 mm/yr. The middle movement zone at 6 m bgs shows current movement rate of 13 mm/yr corresponding to a decrease of 7 mm/yr. The lower movement zone at 10 m bgs shows a decrease in rate of movement of 6 mm/yr since the previous reading cycle. The current rate of movement for this lower movement zone is about 4 mm/yr.

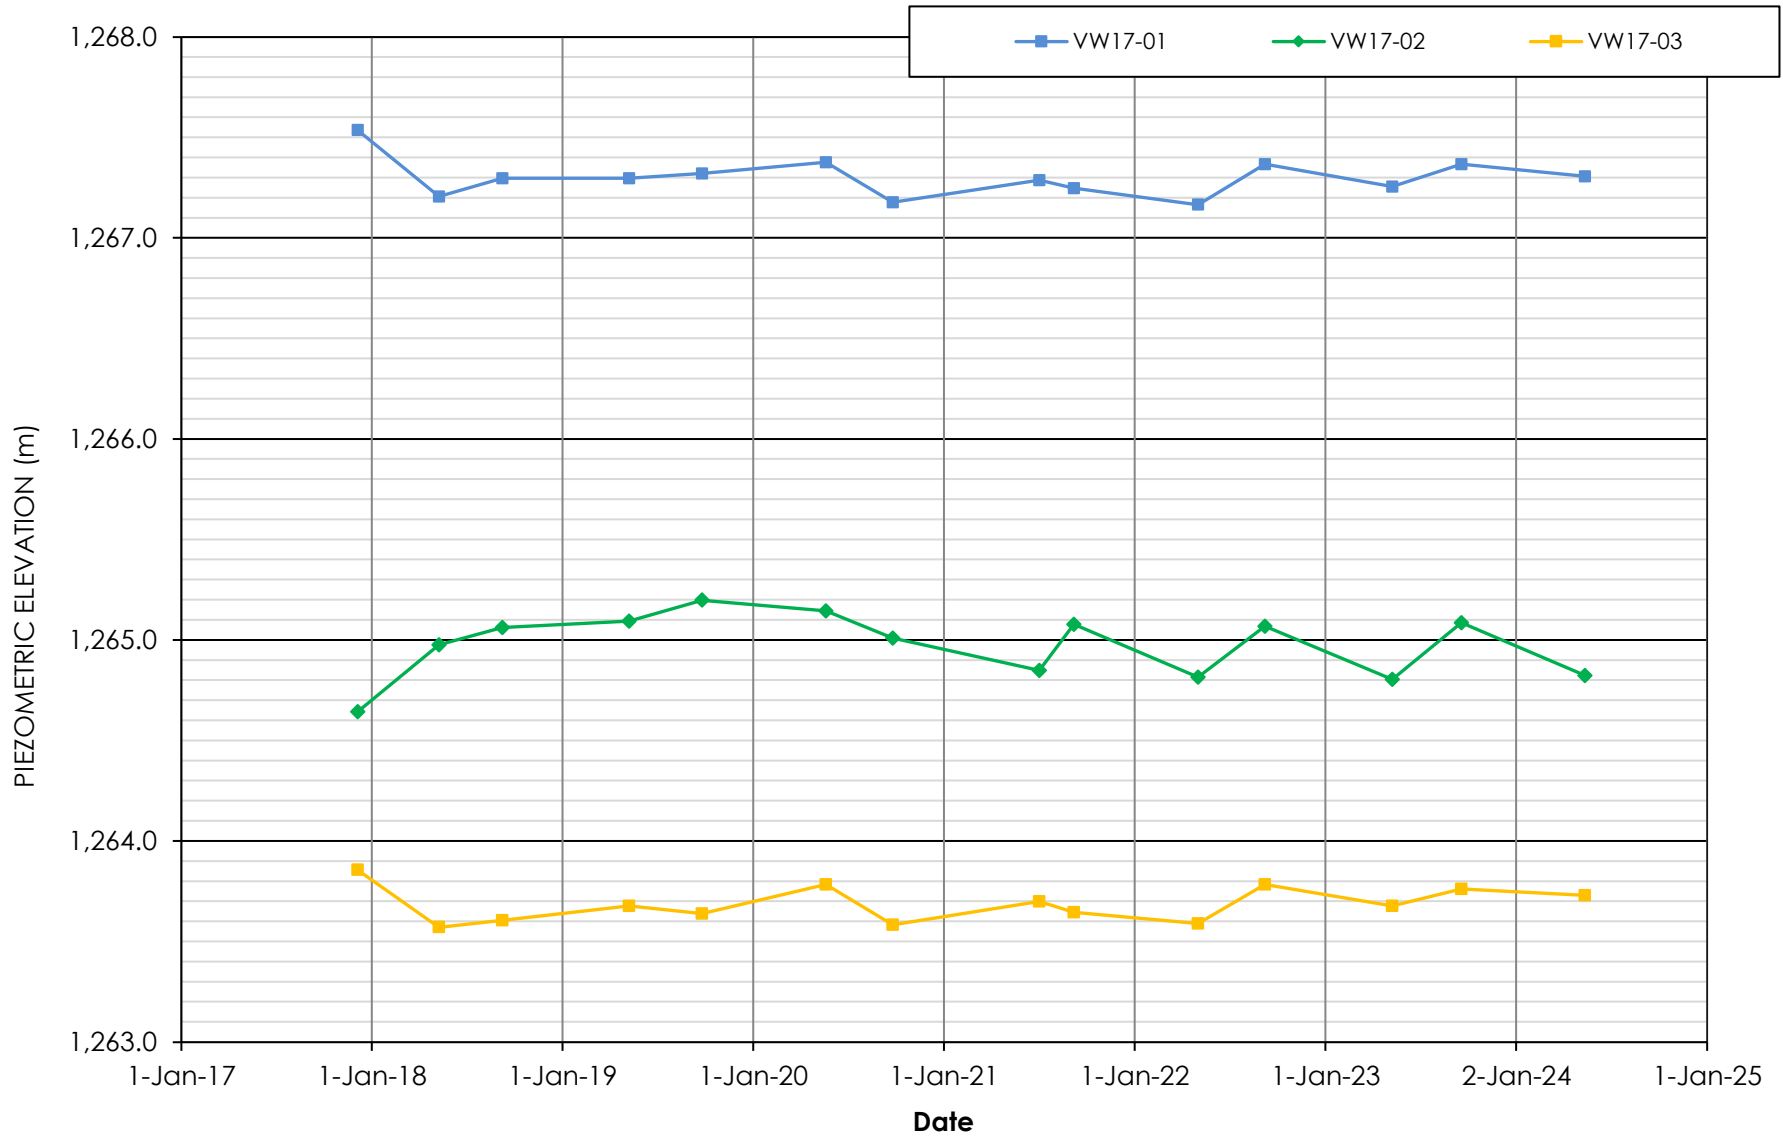
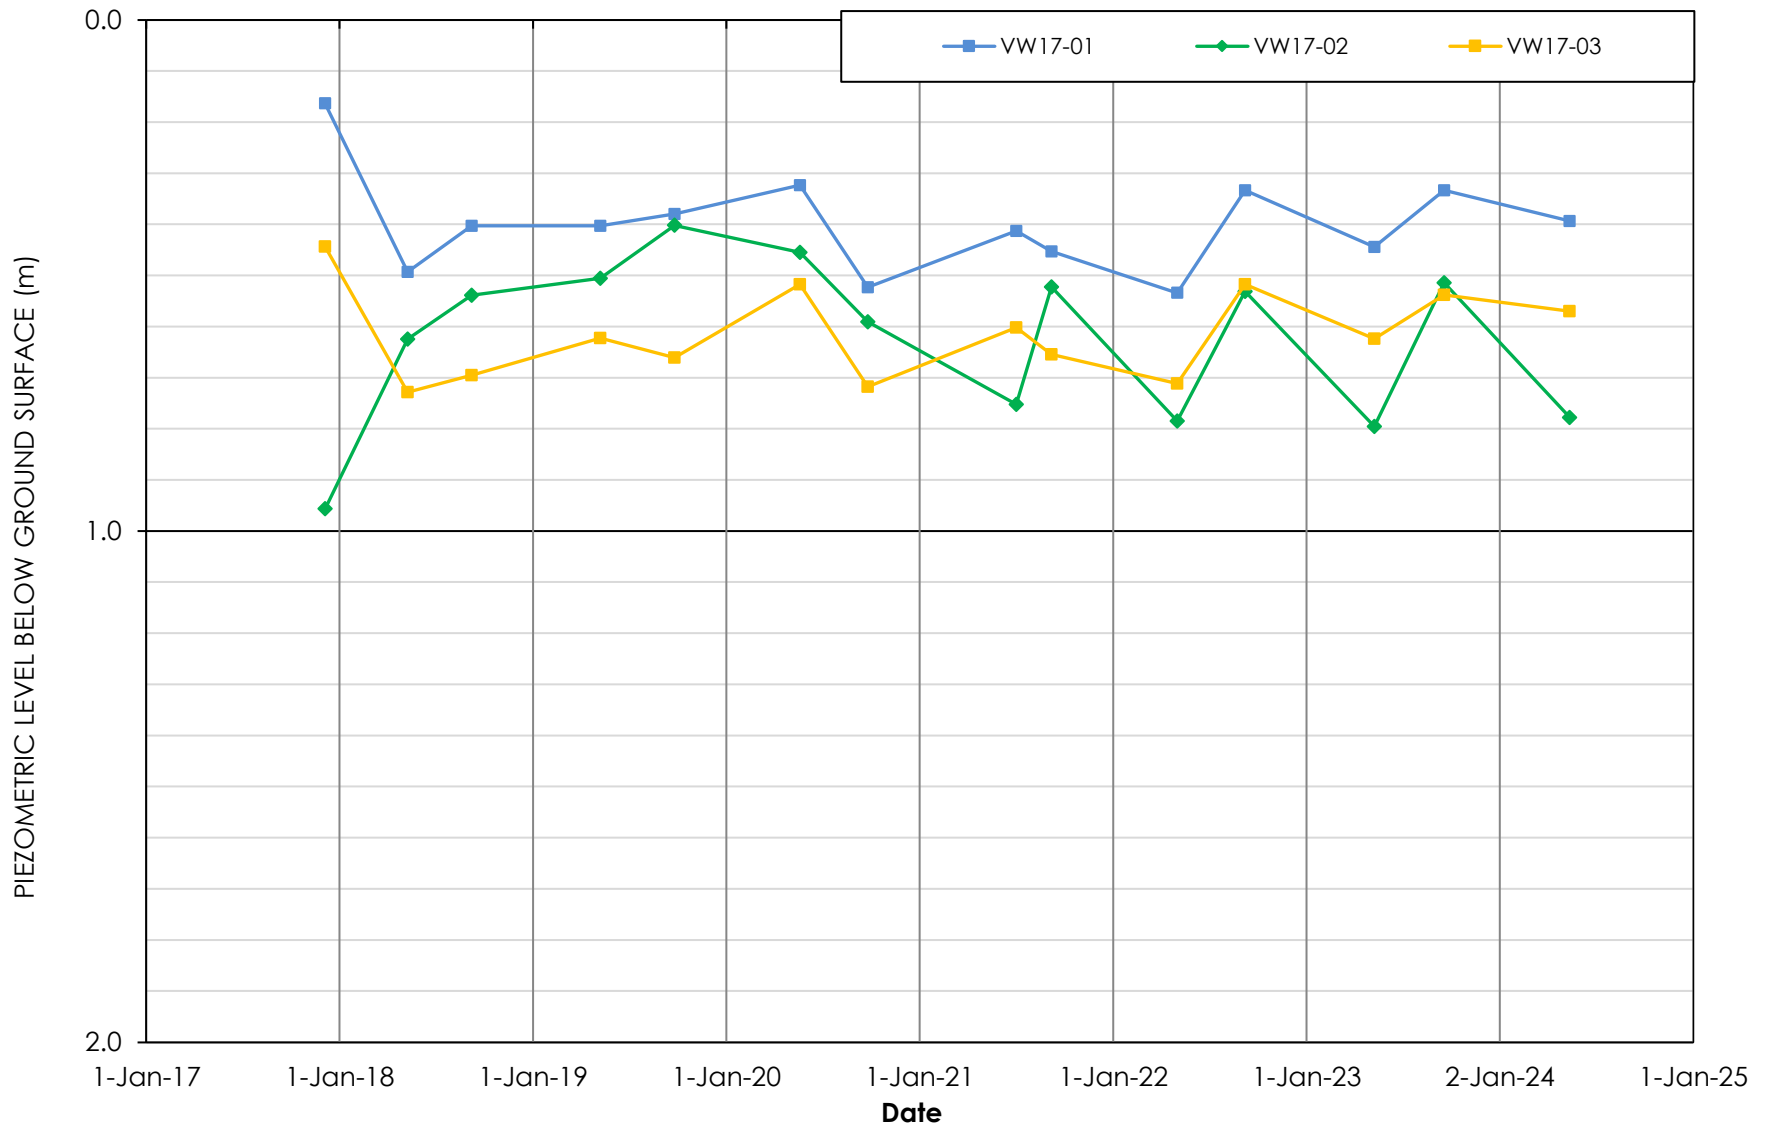
PIEZOMETER DATA

All piezometers showed a decrease in water level between 0.1 m and 0.3 m for the current reading cycle. The piezometric levels measured were between 0.4 m and 0.8 m below ground surface (bgs). In general, the piezometric levels have been in the same range since Spring 2018. Seasonal fluctuations of higher groundwater table in the fall are observed in the piezometers.
