GEOHAZARD RISK MANAGEMENT PROGRAM North Central Region – Edson / Stony Plain Area

2020 Inspection Report

Site Number	Site Name		Hwy	km
NC01	Whitcourt East Hill		43:16	1.9
Legal Land Description	NW 26-59-12-W5M			
UTM Coordinates (NAD 83)	Zone 11U	N5999334	E586330	
Operational Site Instrumentation	Slope Inclinometers		7	
	Pneumatic Piezometers		6	
	Vibrating Wire Piezometers		0	
	Standpipe Piezometers		9	
Date of Last Instrumentation Readings	May 25, 2020

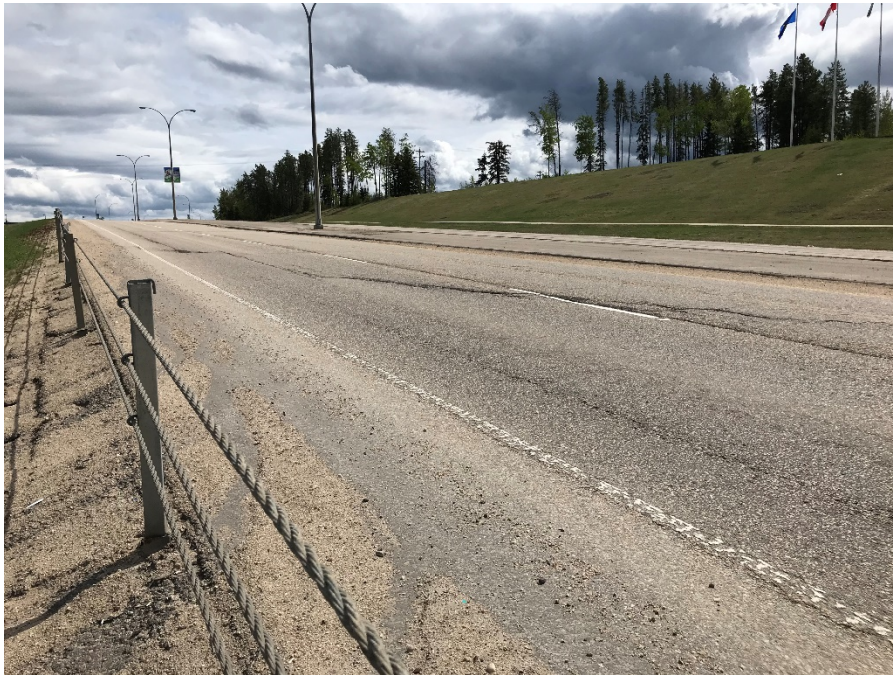
Discussion	<p>The east and west cracks at stations 1+920 and 1+850 are shown in Photos 1 and 2, respectively. The east crack appeared to have more of a vertical difference than in previous years. The other existing pavement distress along Highway 43 appeared to be relatively unchanged.</p> <p>The overall slope north of Highway 43 are shown in Photos 3 and 4. Signs of slope instability were not observed along this slope during the inspection.</p> <p>An erosion gully about 150 mm wide and 150mm deep upslope from the half culvert near SI-12 was observed as shown in Photo 5. There was an accumulation of debris and garbage in the half culvert.</p> <p>Water ponding was observed between BH14-01 and SP06-1 as shown in Photo 6. It appeared that water from the culvert and gullies upslope flowed to this ponding area.</p> <p>Water ponding at SI10 has been observed since 2018.</p> <p>The slight settlement of the light standard at approximately 1+880 appeared to be unchanged.</p>

Photo 1: East crack at approximately Sta 1+920. Looking west.

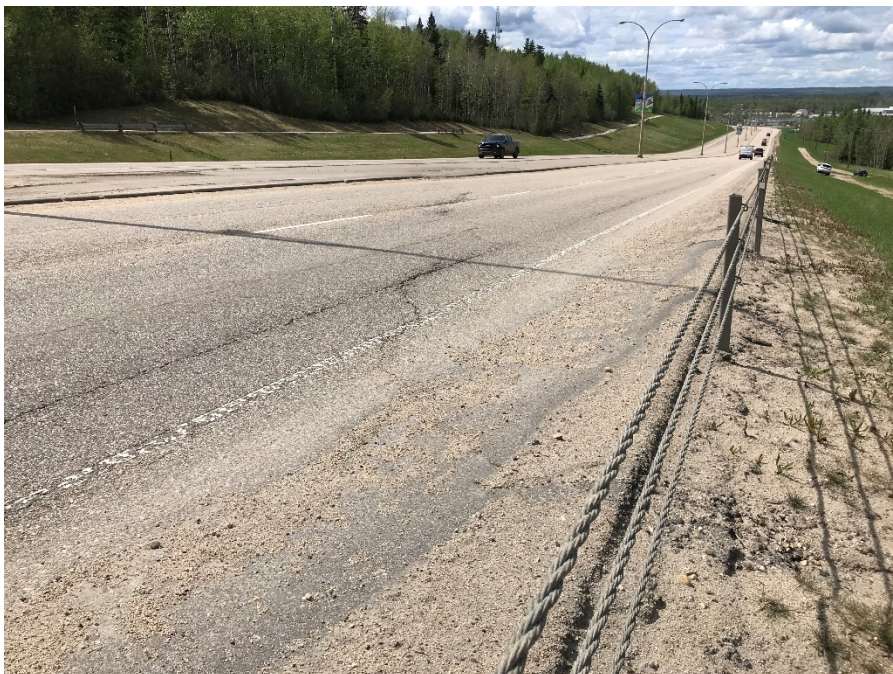
Photo 2: Approximately Sta 1+850. Cracking on westbound lane reflecting through 2014 overlay. Looking west.

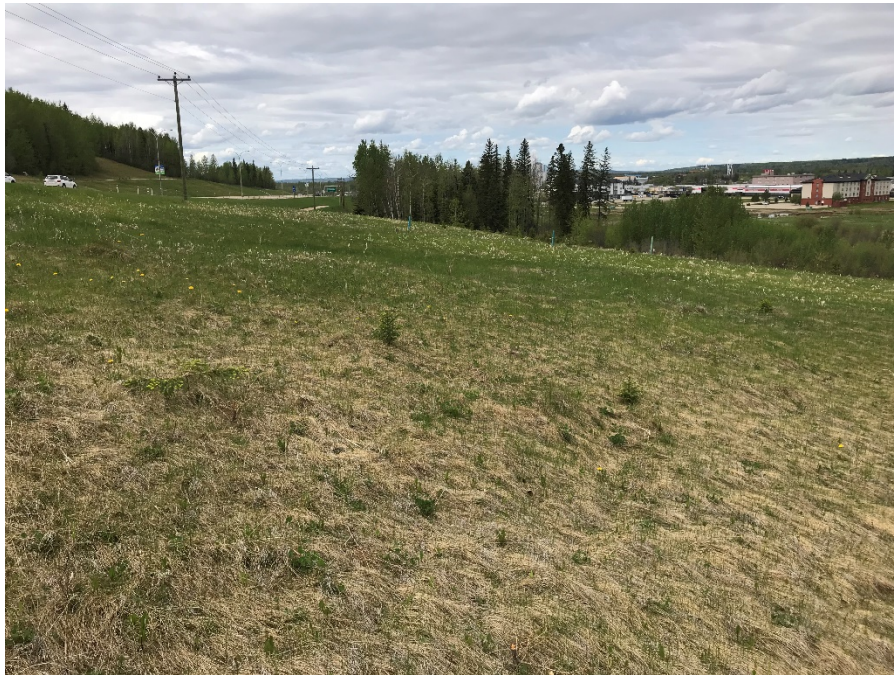
Photo 3: Overall view of north slope. Looking northwest.

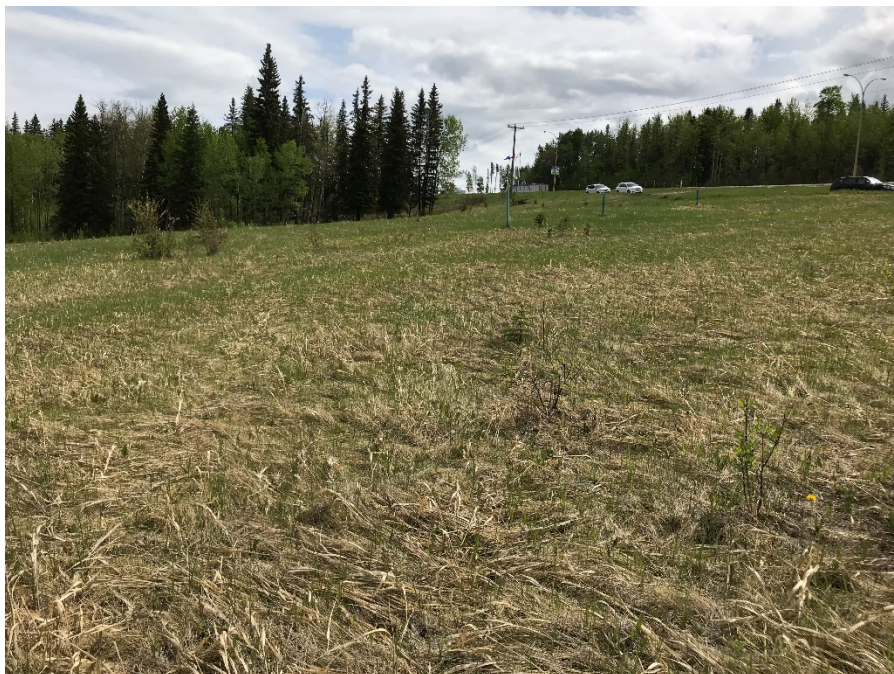
Photo 4: Overall view of north slope. Looking southeast.

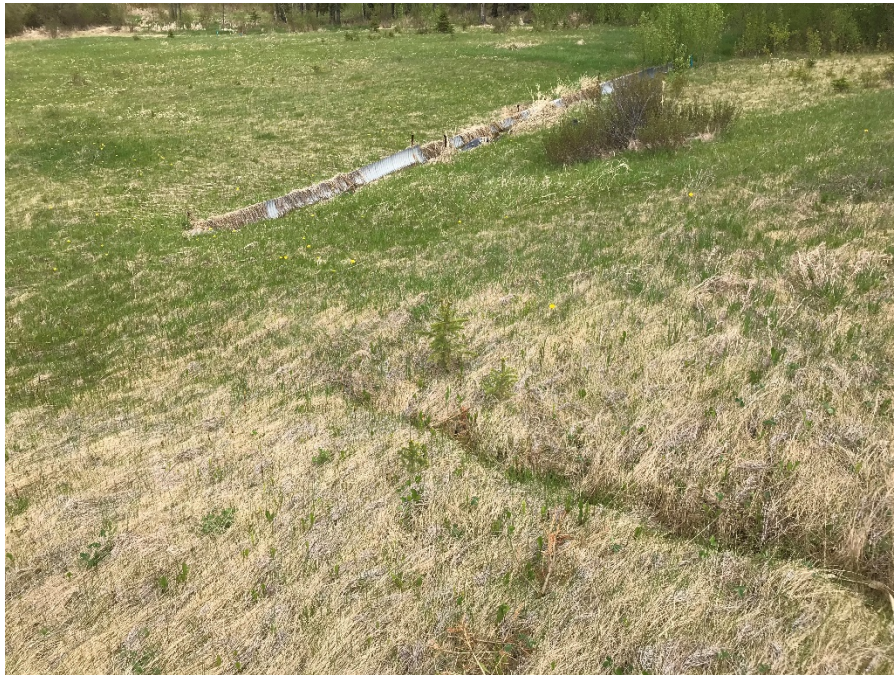
Photo 5: Erosion gully upslope from half-culvert. Looking east.

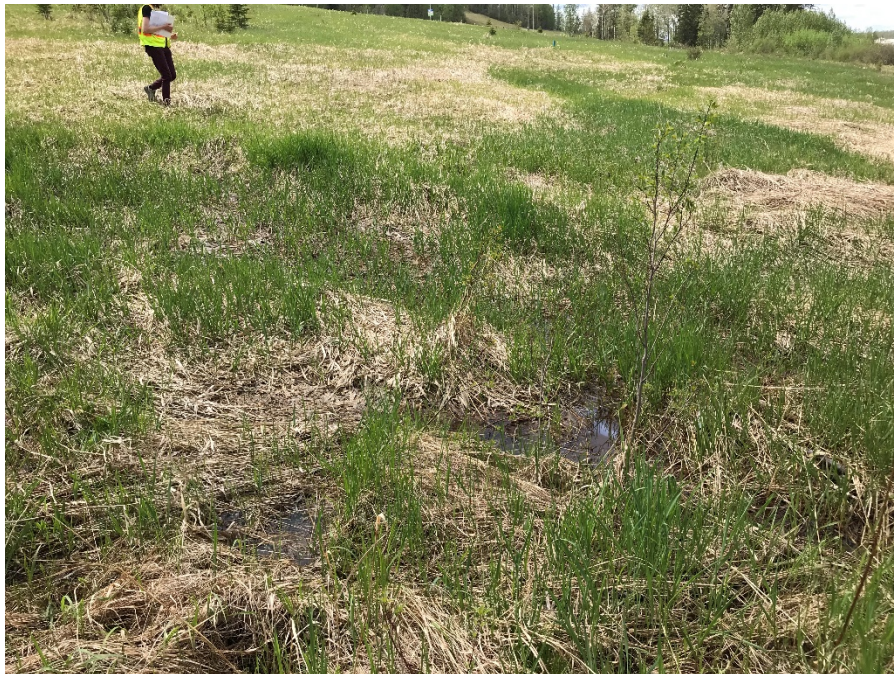
Photo 6: Standing water at toe of slope between BH14-01 and SP06-1. Looking west.
