**NORTH CENTRAL REGION GRMP
EDSON / STONY PLAIN
SITE INSPECTION FORM**

SITE NUMBER AND NAME: NC001 – Whitecourt East Hill	HIGHWAY AND KM: 43:16, km 1.707	PREVIOUS INSPECTION: May 25, 2020	CURRENT INSPECTION: June 16, 2022
LEGAL DESCRIPTION: NE 26-59-12-W5M	NAD83 COORDINATES: UTM11U 5999334N, 586330E		RISK ASSESSMENT: PF: 10 CF: 4 Total: 40
AVERAGE ANNUAL DAILY TRAFFIC (AADT): 12,800 (2021)		CONTRACTOR MAINTENANCE AREA (CMA): 508

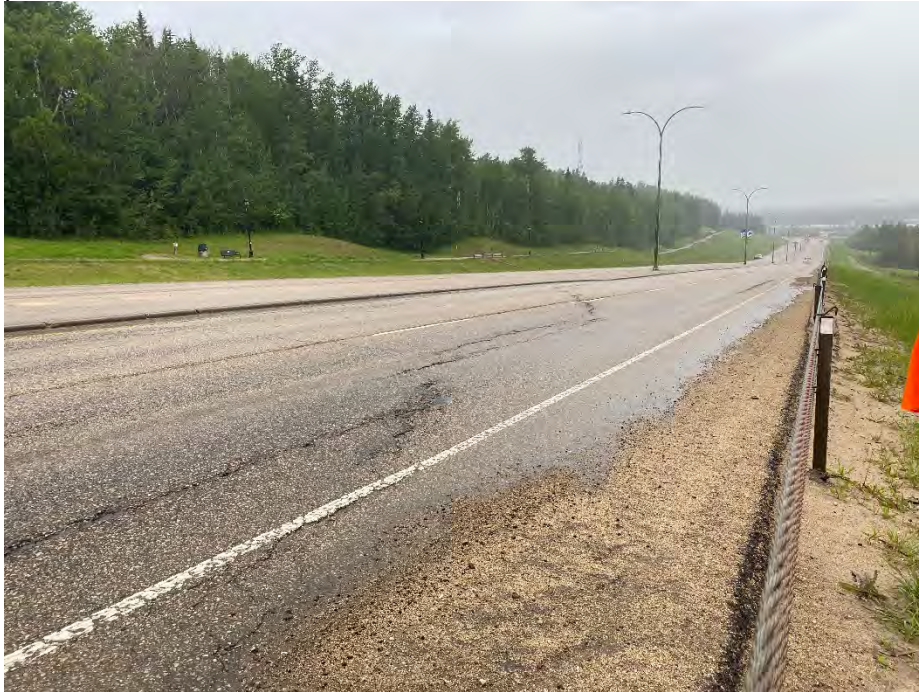
COMMENTS
<ul style="list-style-type: none"> • Pavement cracking in the east and west bound lanes were noted. The west and east cracks in the west bound lane did not appear to have widened, however there is now a visible differential at the east crack (Photos 1 and 2). • The median along Highway 43 is cracked and has a visible differential on the north side at approximately 1+845, just west from the west crack (Photo 3). • Erosion rills were observed at approximately STA 1+750 (Photo 4). • The overall slope north of Highway 43 was well vegetated. Signs of slope instability were not observed along the slope during the inspection (Photos 5 and 6).

Photo 1: East crack at approximately STA 1+920. Looking west.

- Pavement cracks should be sealed to reduce surface water infiltration into the embankment. Additional pavement patches are not recommended since it is considered an additional driving force on the embankment. Mill and fill could be completed to address the vertical displacement until remediation is completed.

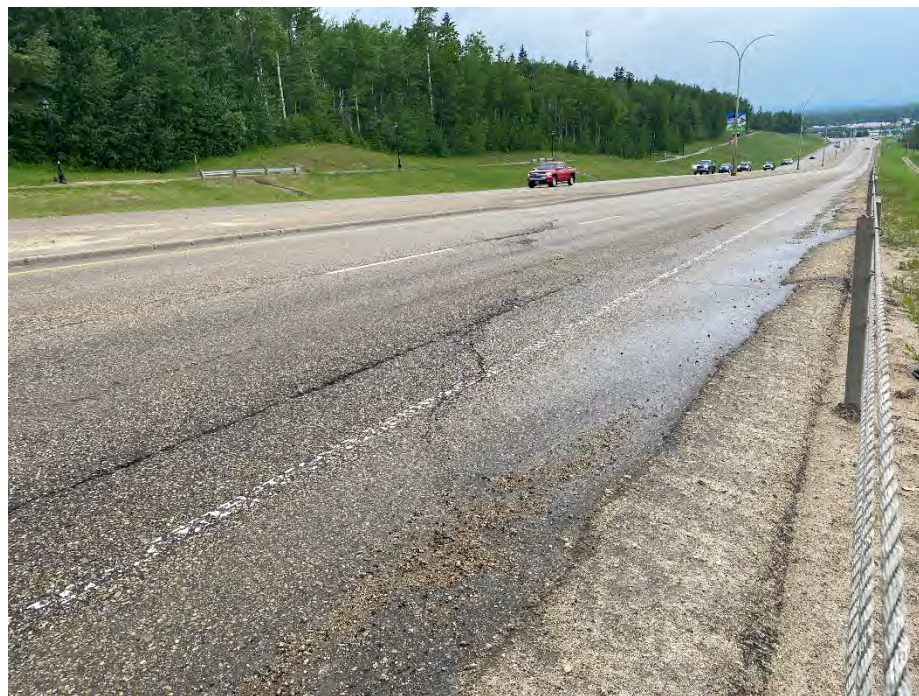
Photo 2: West crack at approximately STA 1+850. Cracking on westbound lane reflecting through 2014 overlay. Looking west.

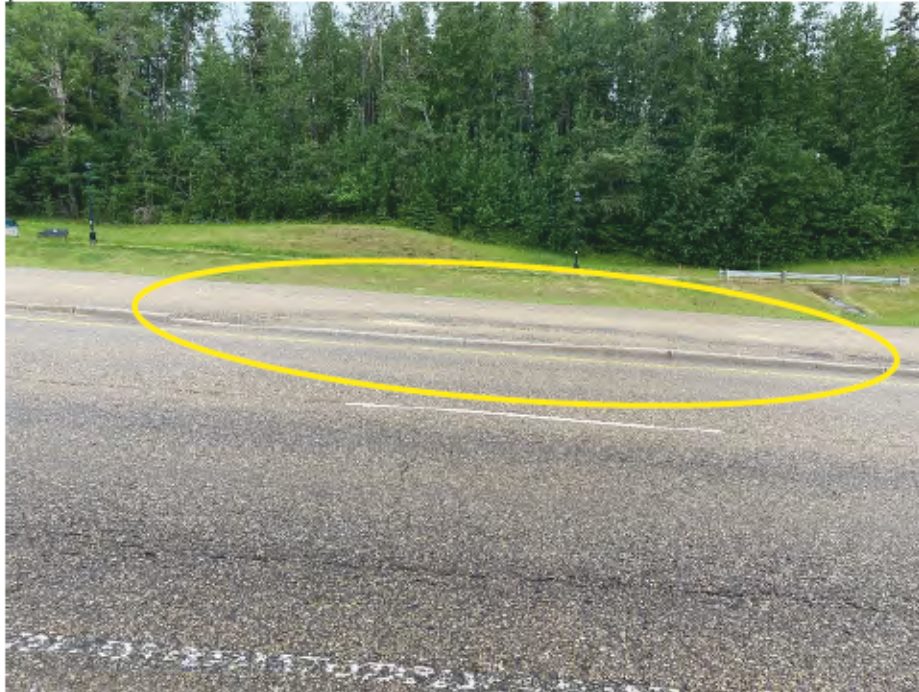
Photo 3: Visible dip in median at approximately STA 1+845. Looking southwest.

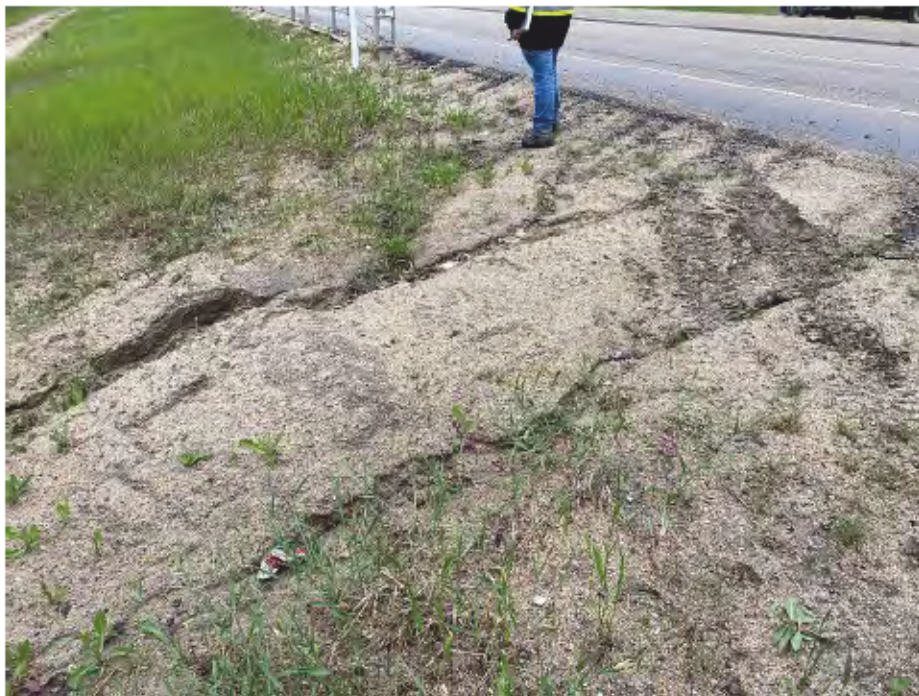
Photo 4: Erosion gullies at approximately STA 1+750. Looking southeast.

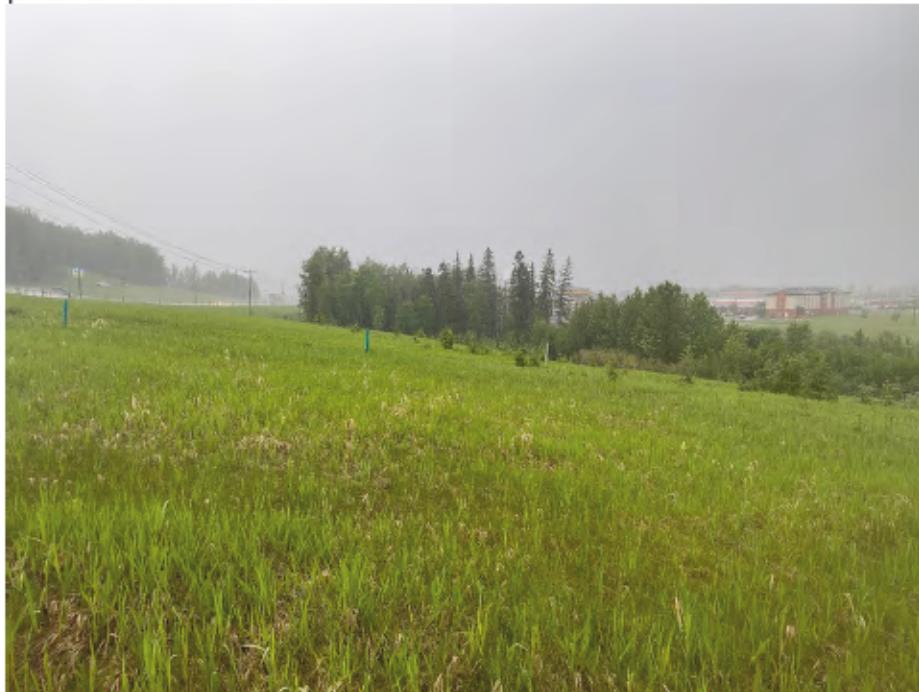
Photo 5: Overall view of north slope. Looking northwest.

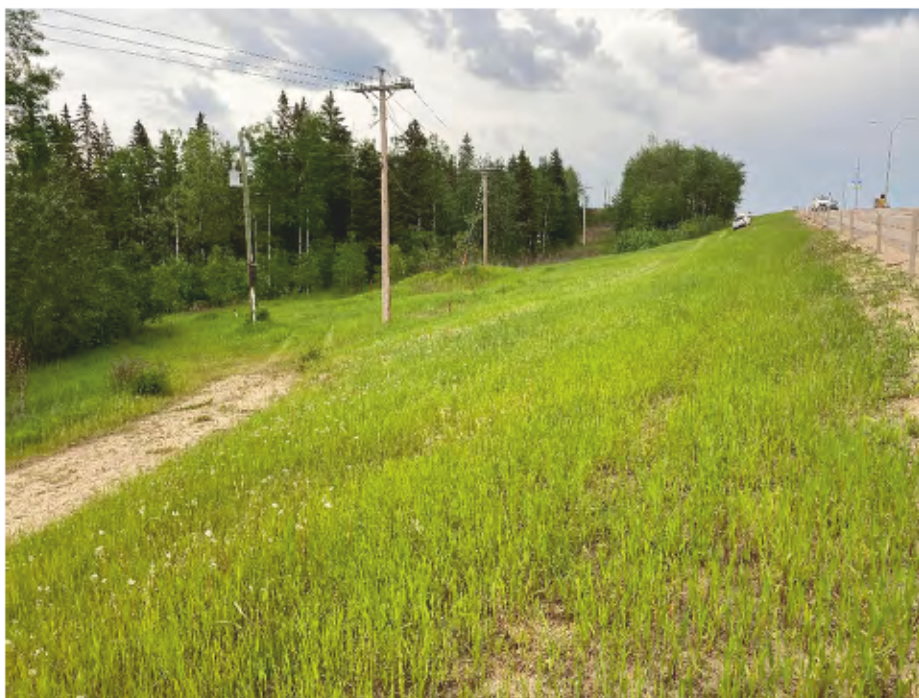
Photo 6: Overall view of north slope near highway. Looking southeast.

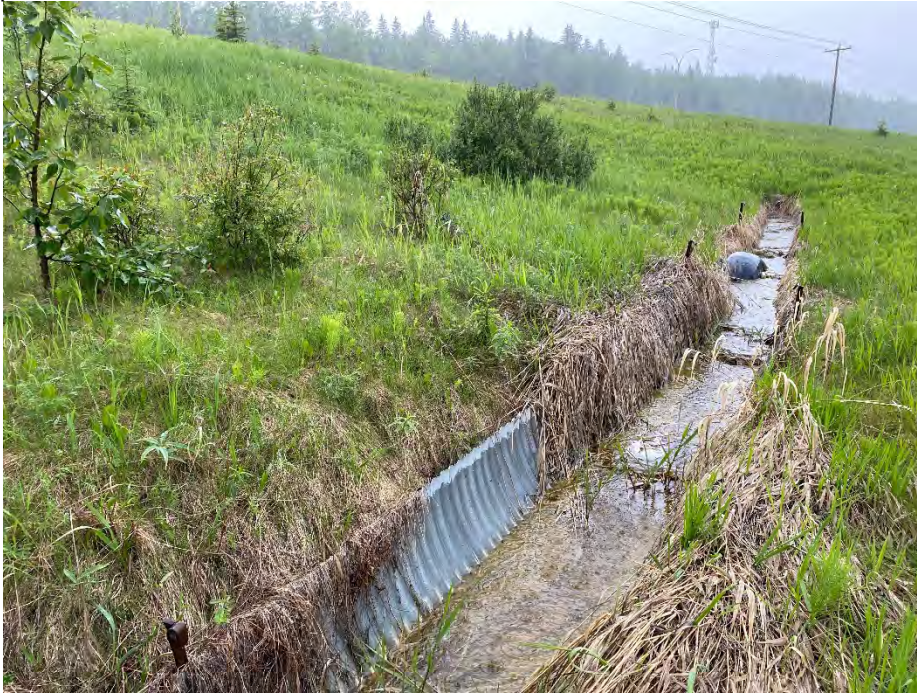
- The half culvert was flowing; however there was an accumulation of debris in the culvert (Photo 7).
- The depression feature near the half culvert was well vegetated and appeared unchanged (Photo 8).
- The slight settlement around the light standard at approximately Station 1+880 appeared to be unchanged.
- The inclinometers at SI06-1, SI06-2, and TH14-02 continue to show slope movement ranging from less than 1 mm/yr to 2 mm/yr.
- Many of the interpreted failure planes occurred within the lower portions of the glaciolacustrine clay deposits. This deposit sits on top of a sand and gravel deposit underlain by clay till. It is unlikely that the slope failure would be deep enough to penetrate the sand and gravel layer since it is free draining or the clay till layer due to its strength and low piezometric levels.

Photo 7: Half-culvert on north slope. Looking west.

- All culverts and sub-drains should be cleaned and inspected on a regular basis to reduce the risk of pore pressures building up in the slope.
- For remediation of the east and west cracks, toe berms could be a potential solution. Assuming a 4 m high toe berm spanning the distance of both cracks, the estimated cost of construction is \$250,000 to \$400,000 excluding engineering. This option would require installation of additional instrumentation to determine its feasibility.

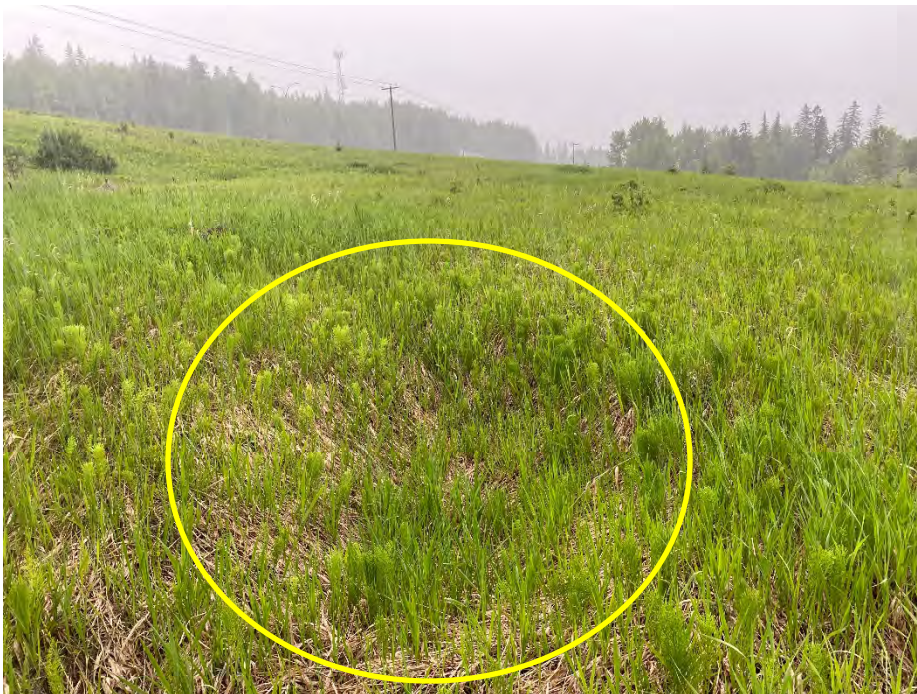
Photo 8: Depression in north slope between SI-12 and SP06-1. Looking west.
