To: Amy Driessen
Alberta Transportation
File: 123315222

From: Leslie Cho and Carrie Murray
Stantec Consulting Ltd.
Date: June 13, 2022

Reference: North Central Region, Edson, Site NC001 - Highway 43:16 Whitecourt East Hill Spring 2022 Instrumentation Monitoring Report

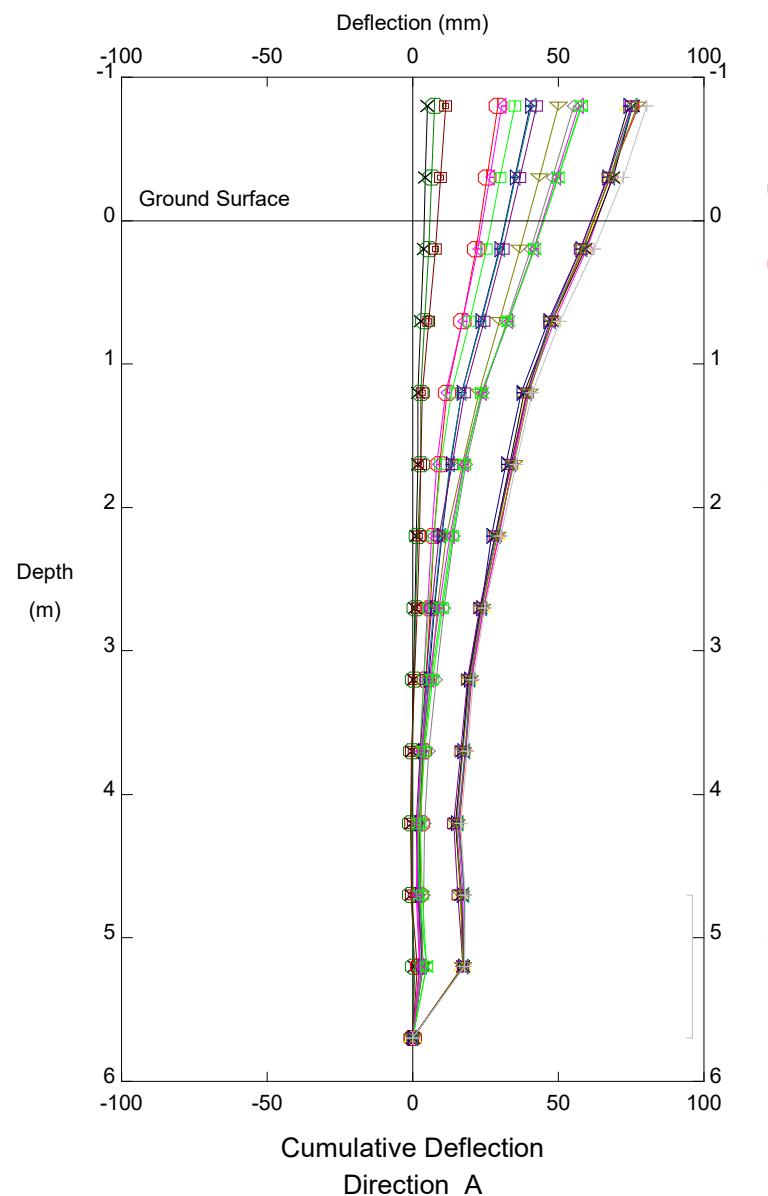
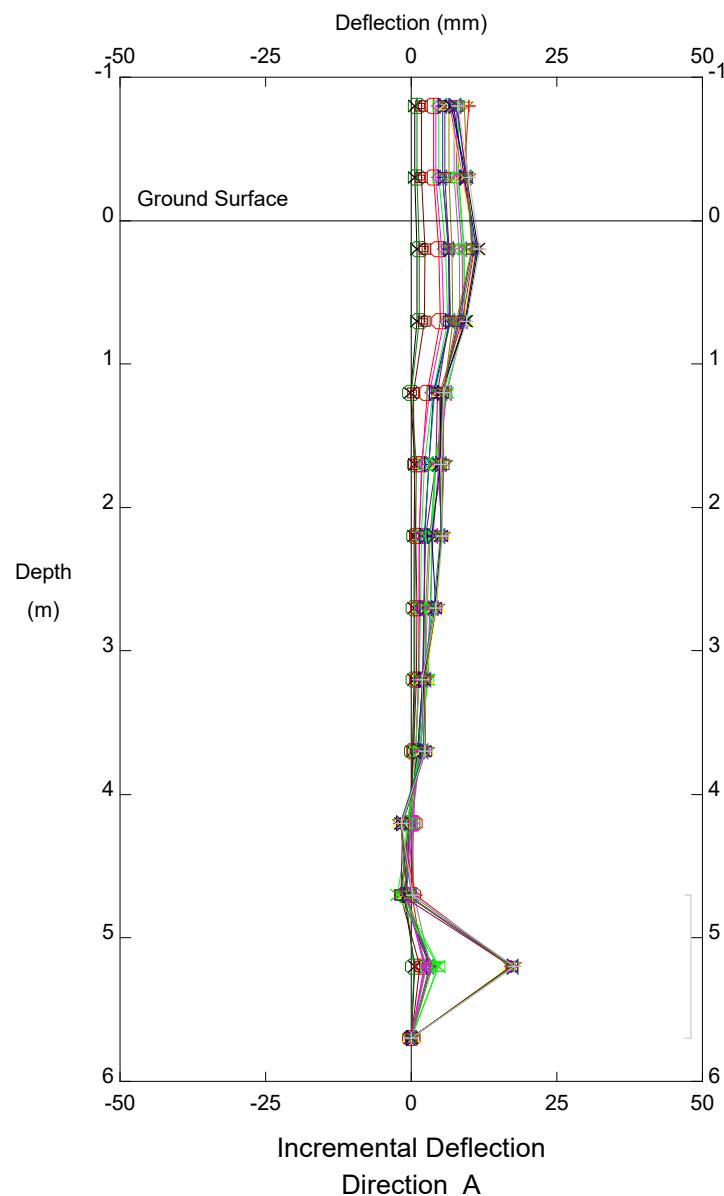
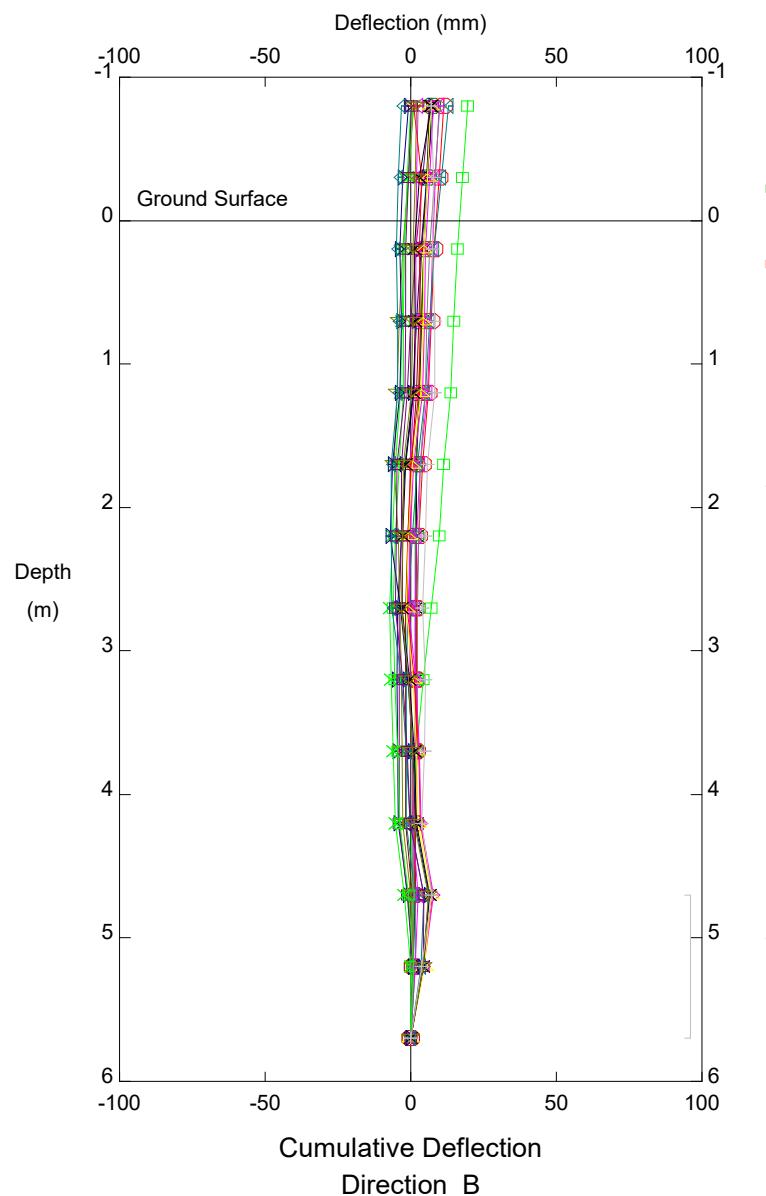
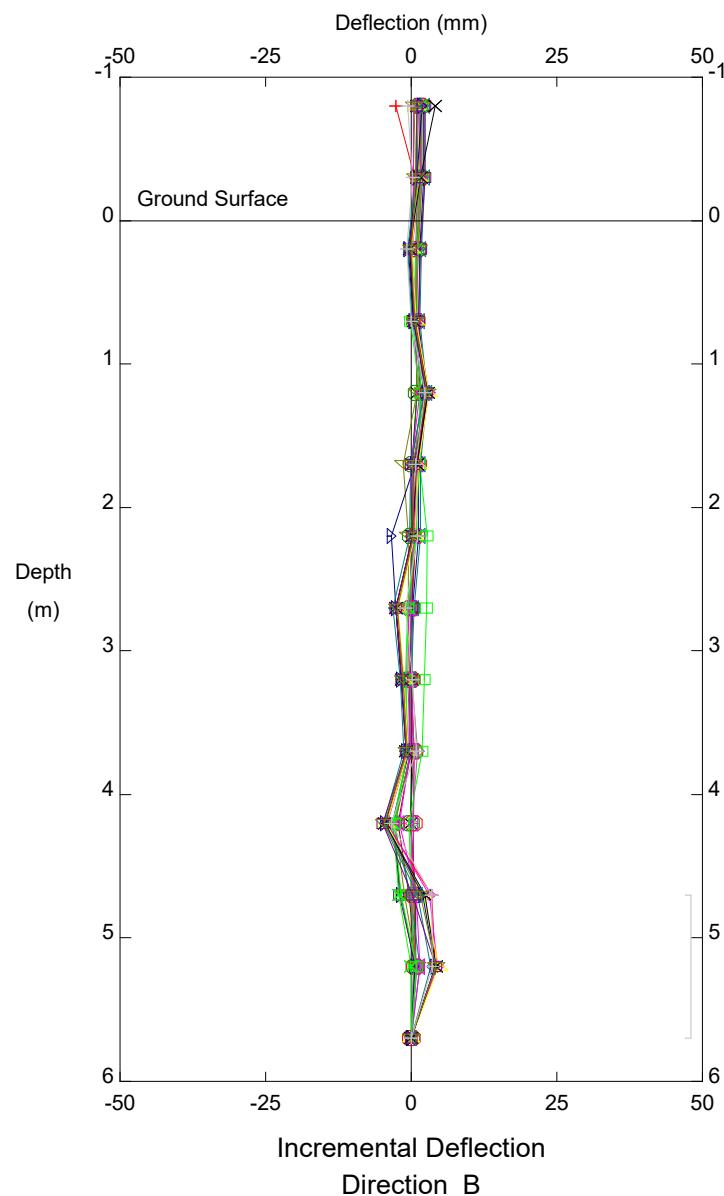
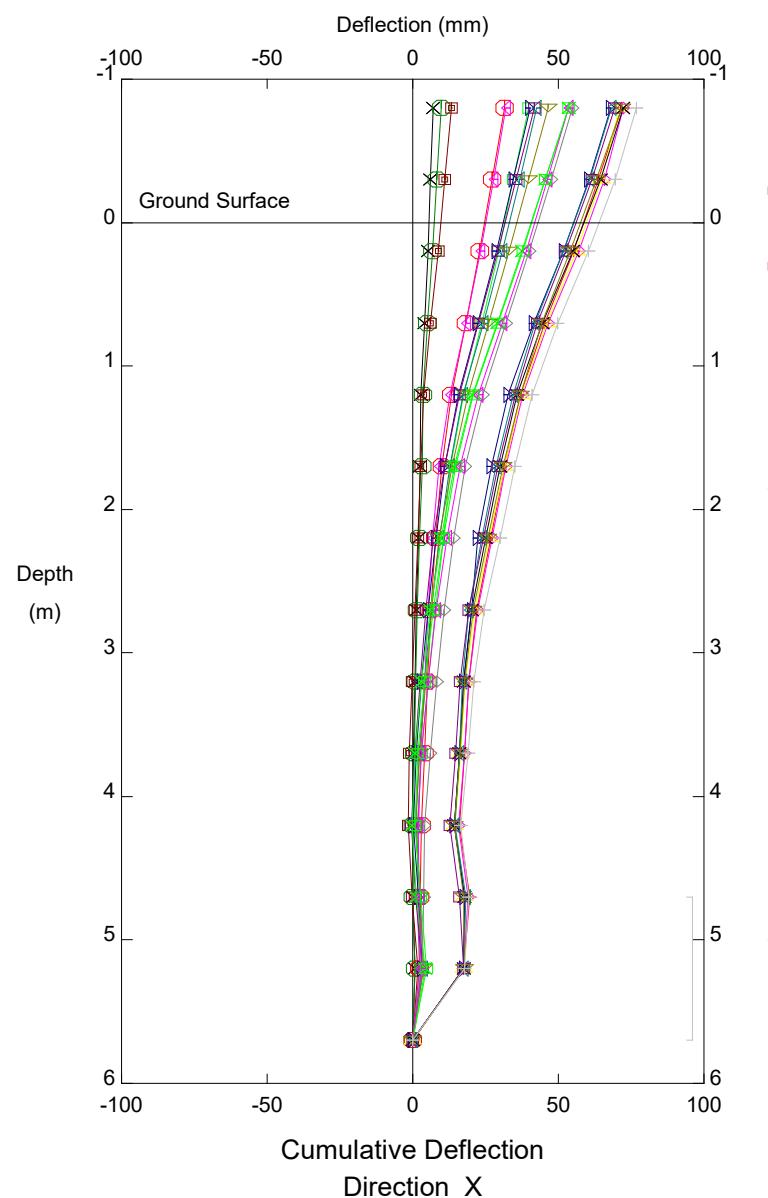
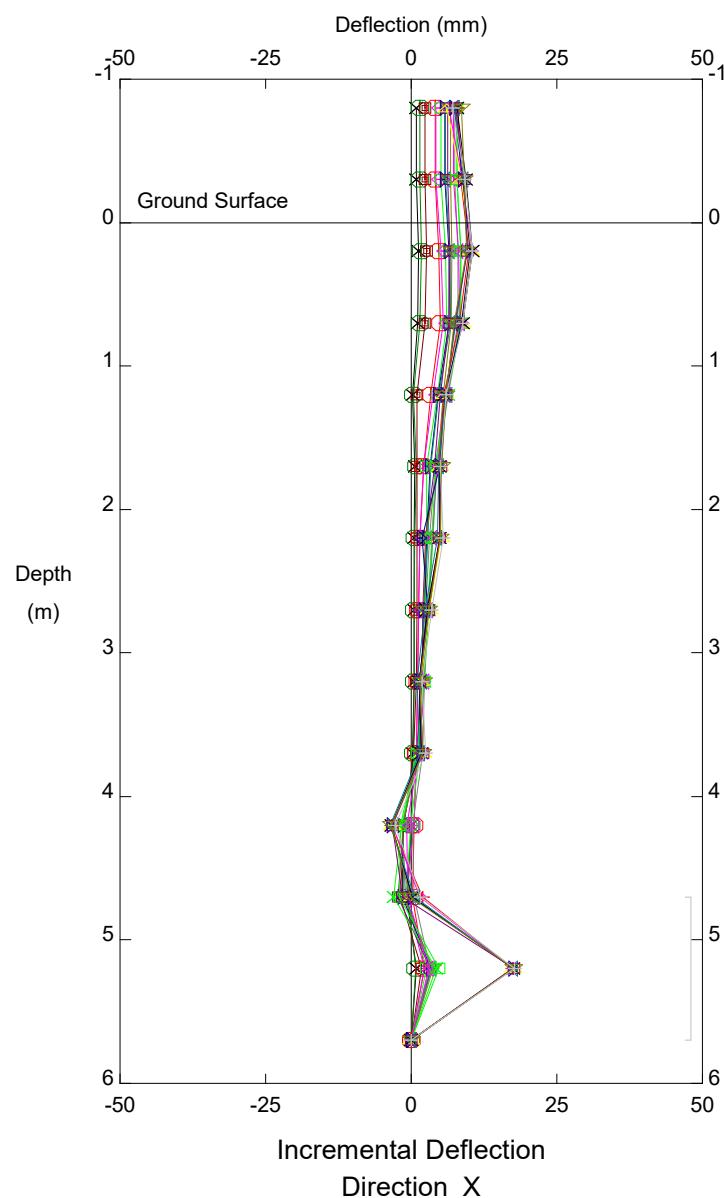
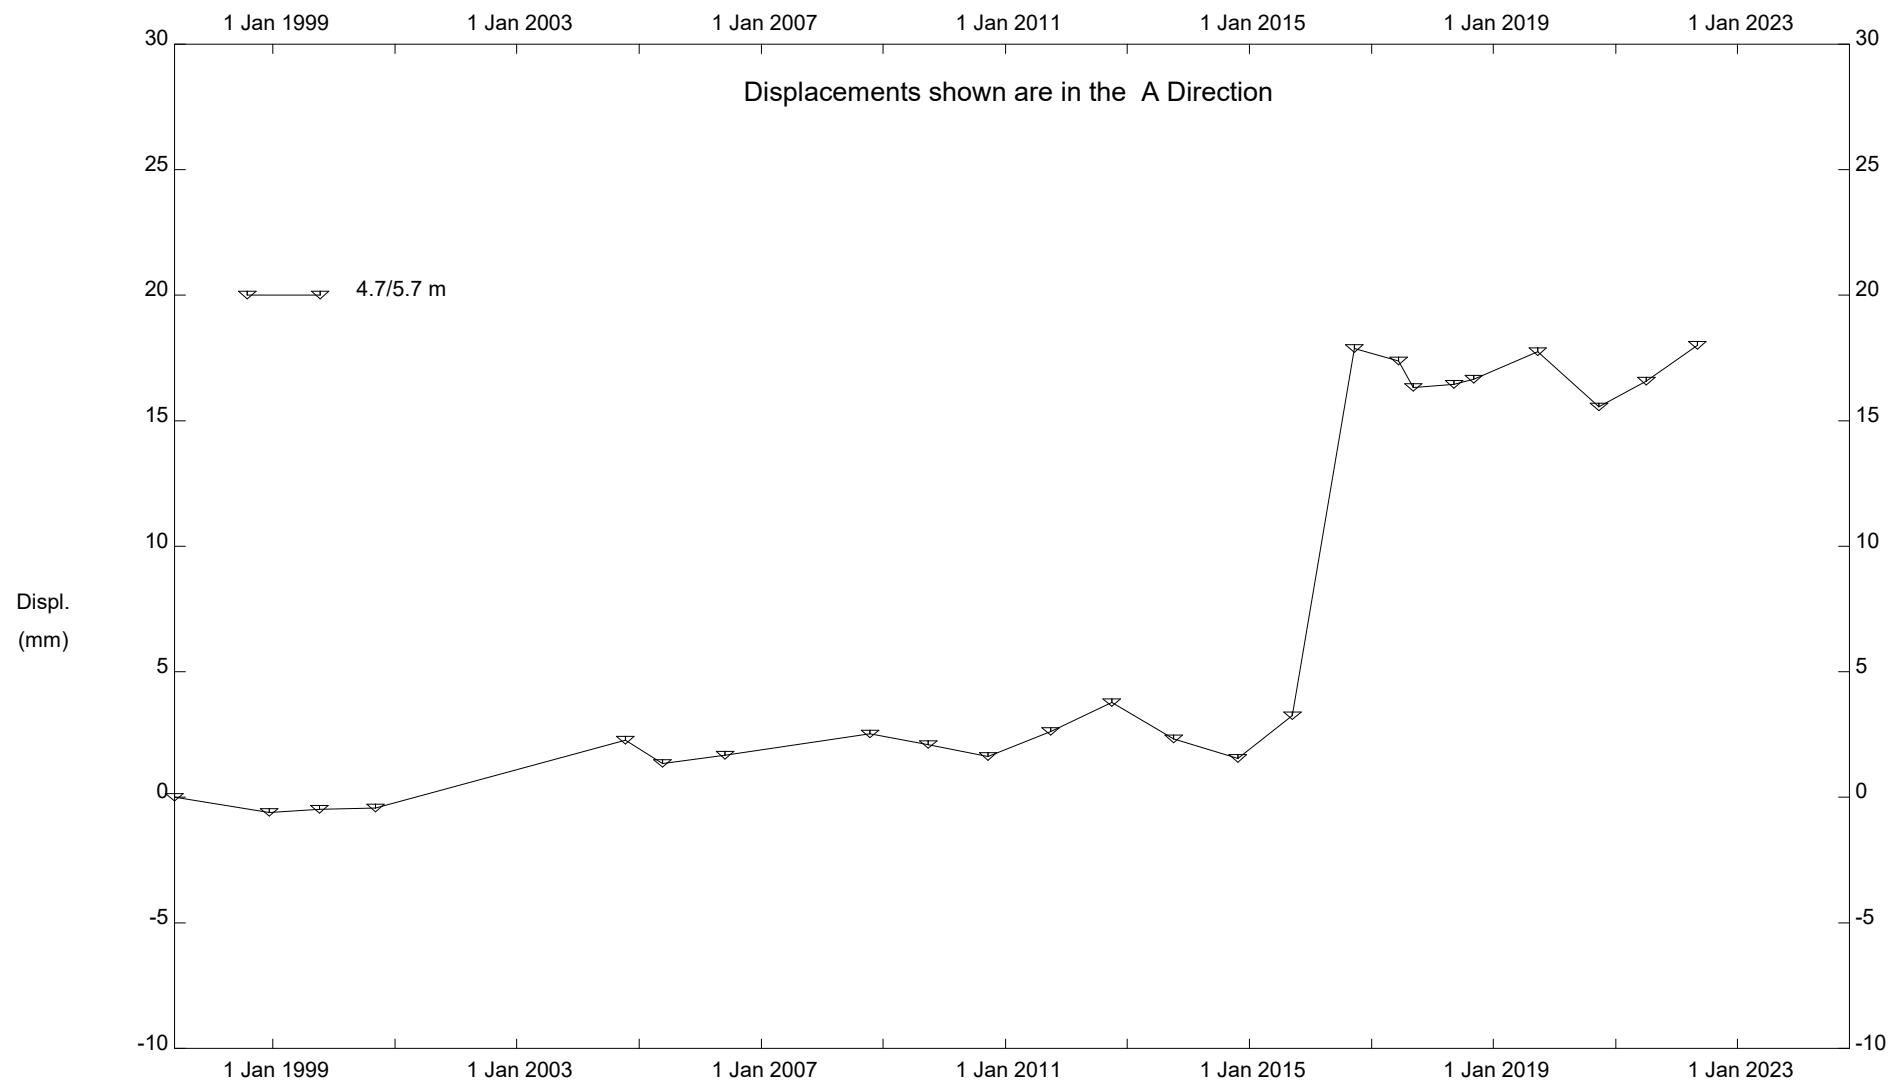
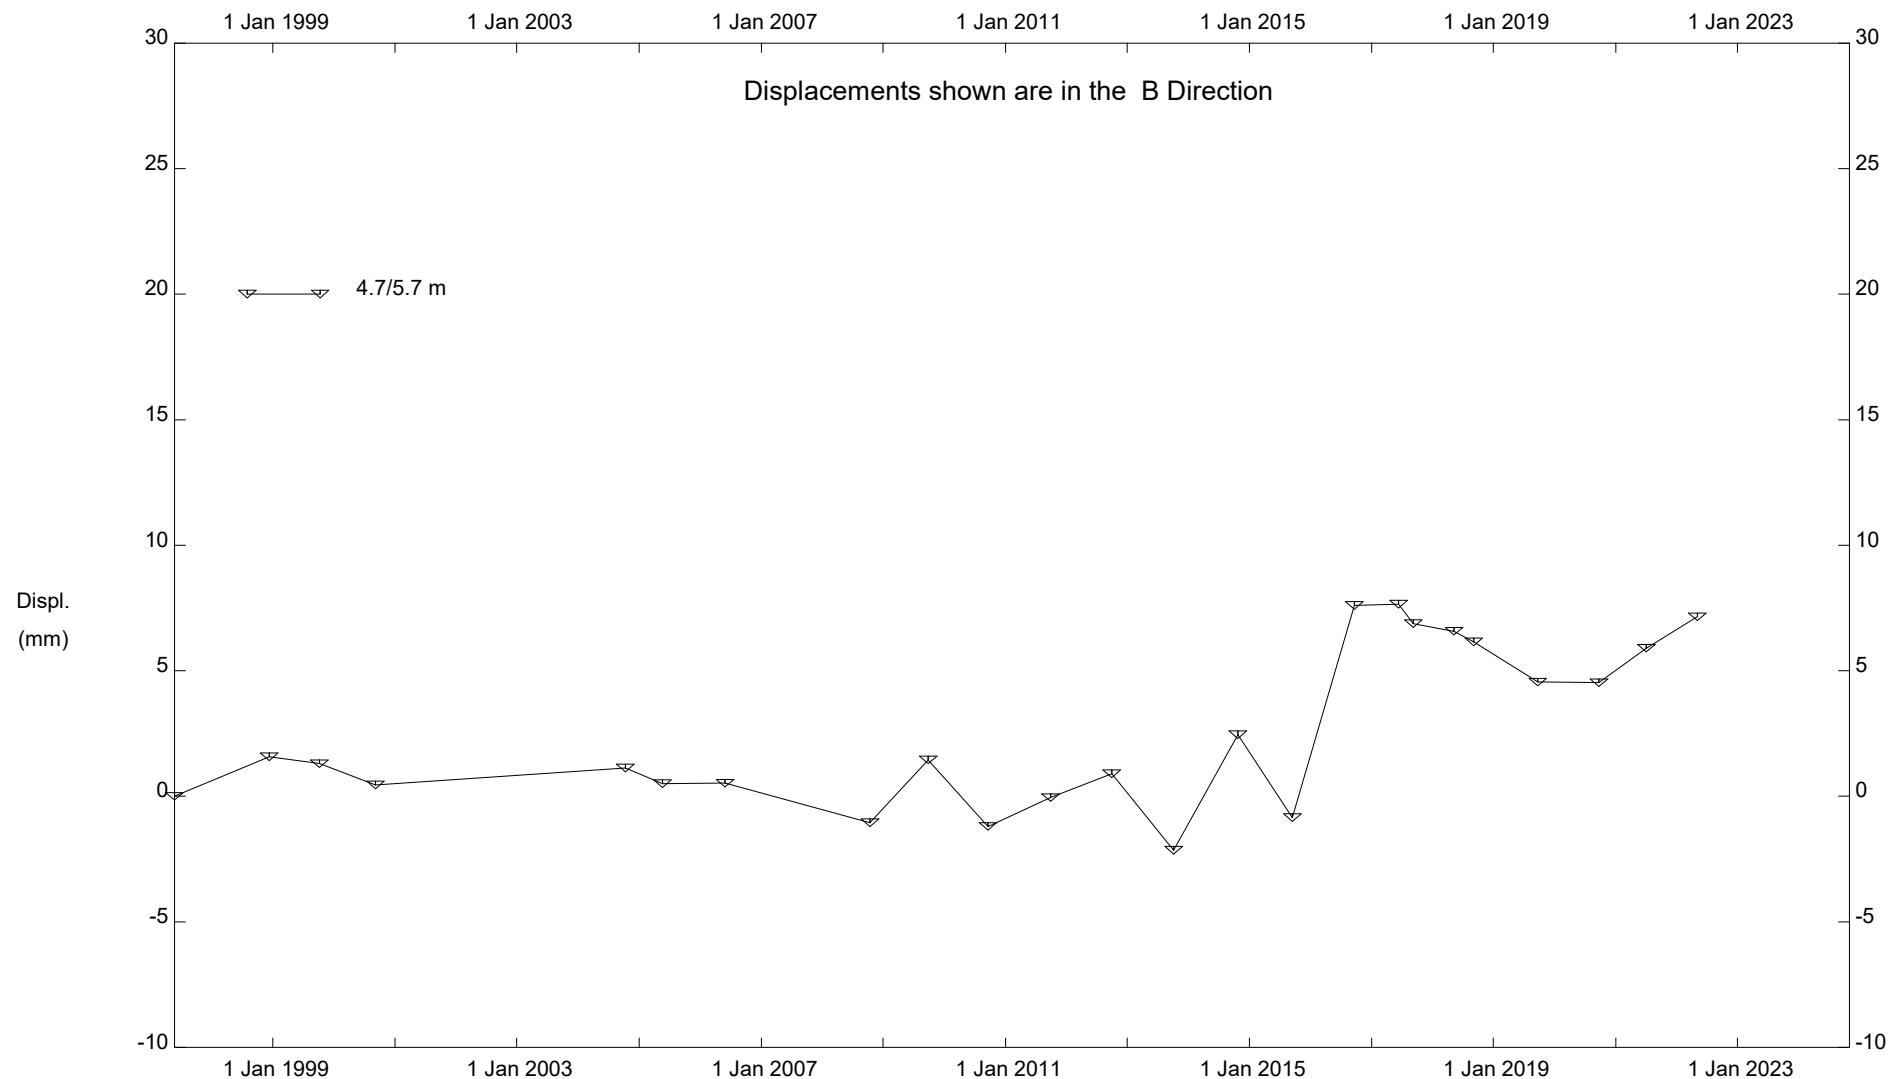
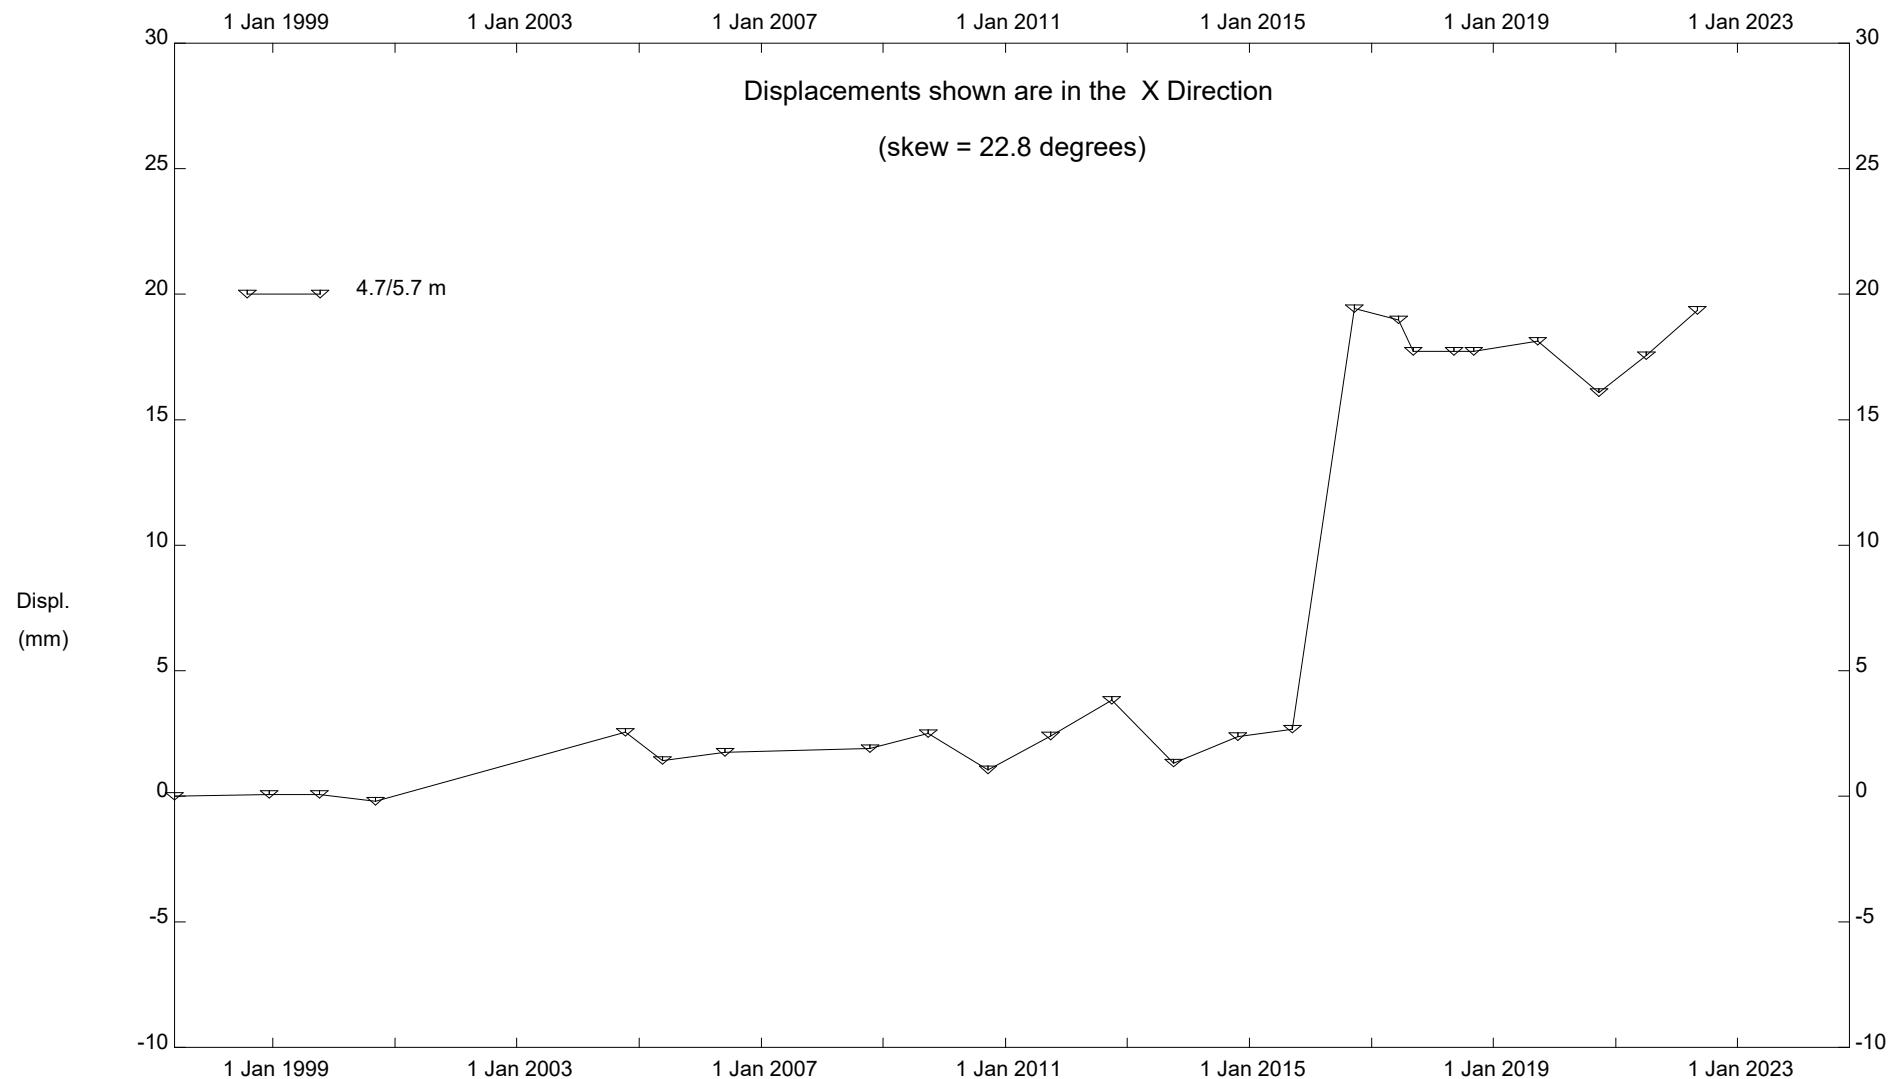
HWY 43:16 Whitecourt East Hill (NC1), Inclinometer SI5

SI5 recorded an incremental movement of about 2 mm corresponding to a current rate of movement is 2 mm/year. However, the overall trend appears to indicate negligible movement since 1996. The abrupt movement recorded between Fall 2015 and Spring 2016 is likely associated with the change of SI probe rather than actual movement.

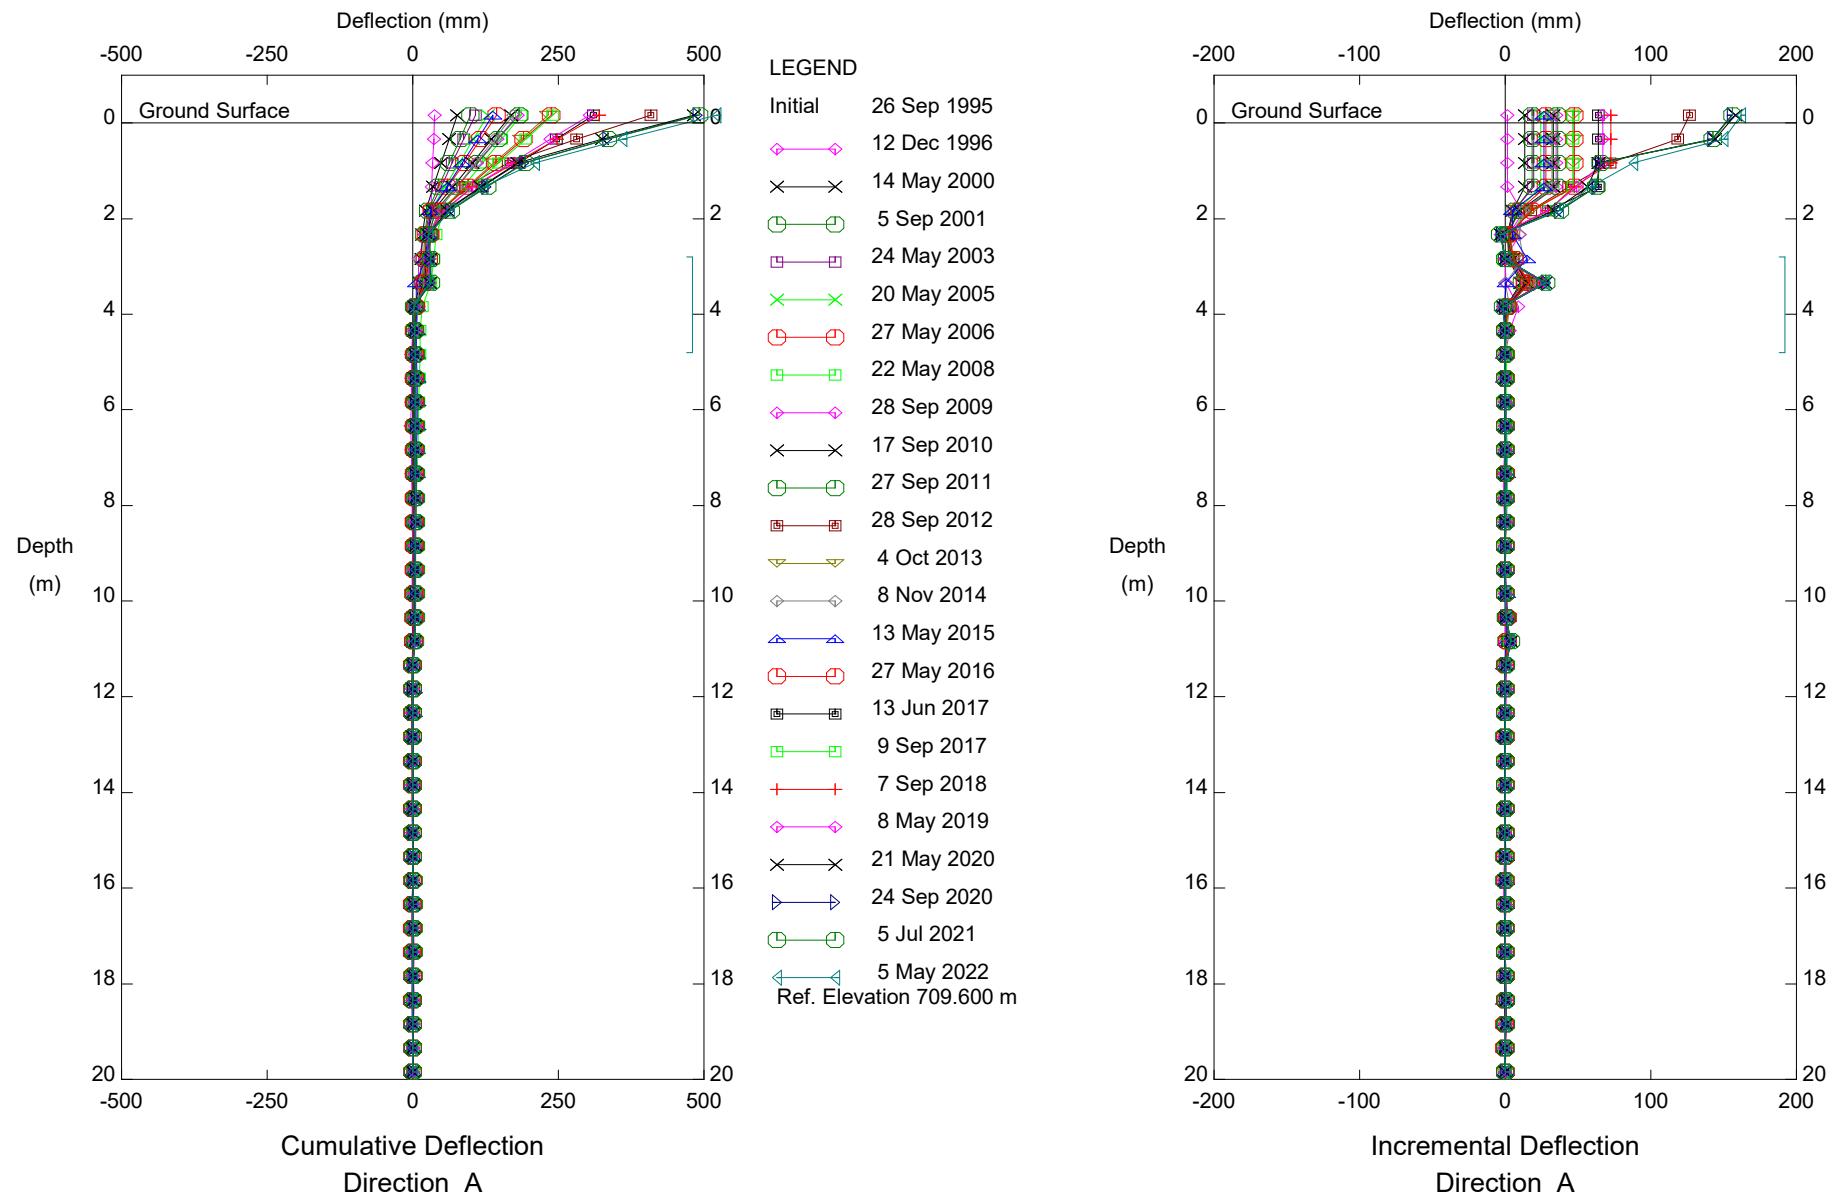
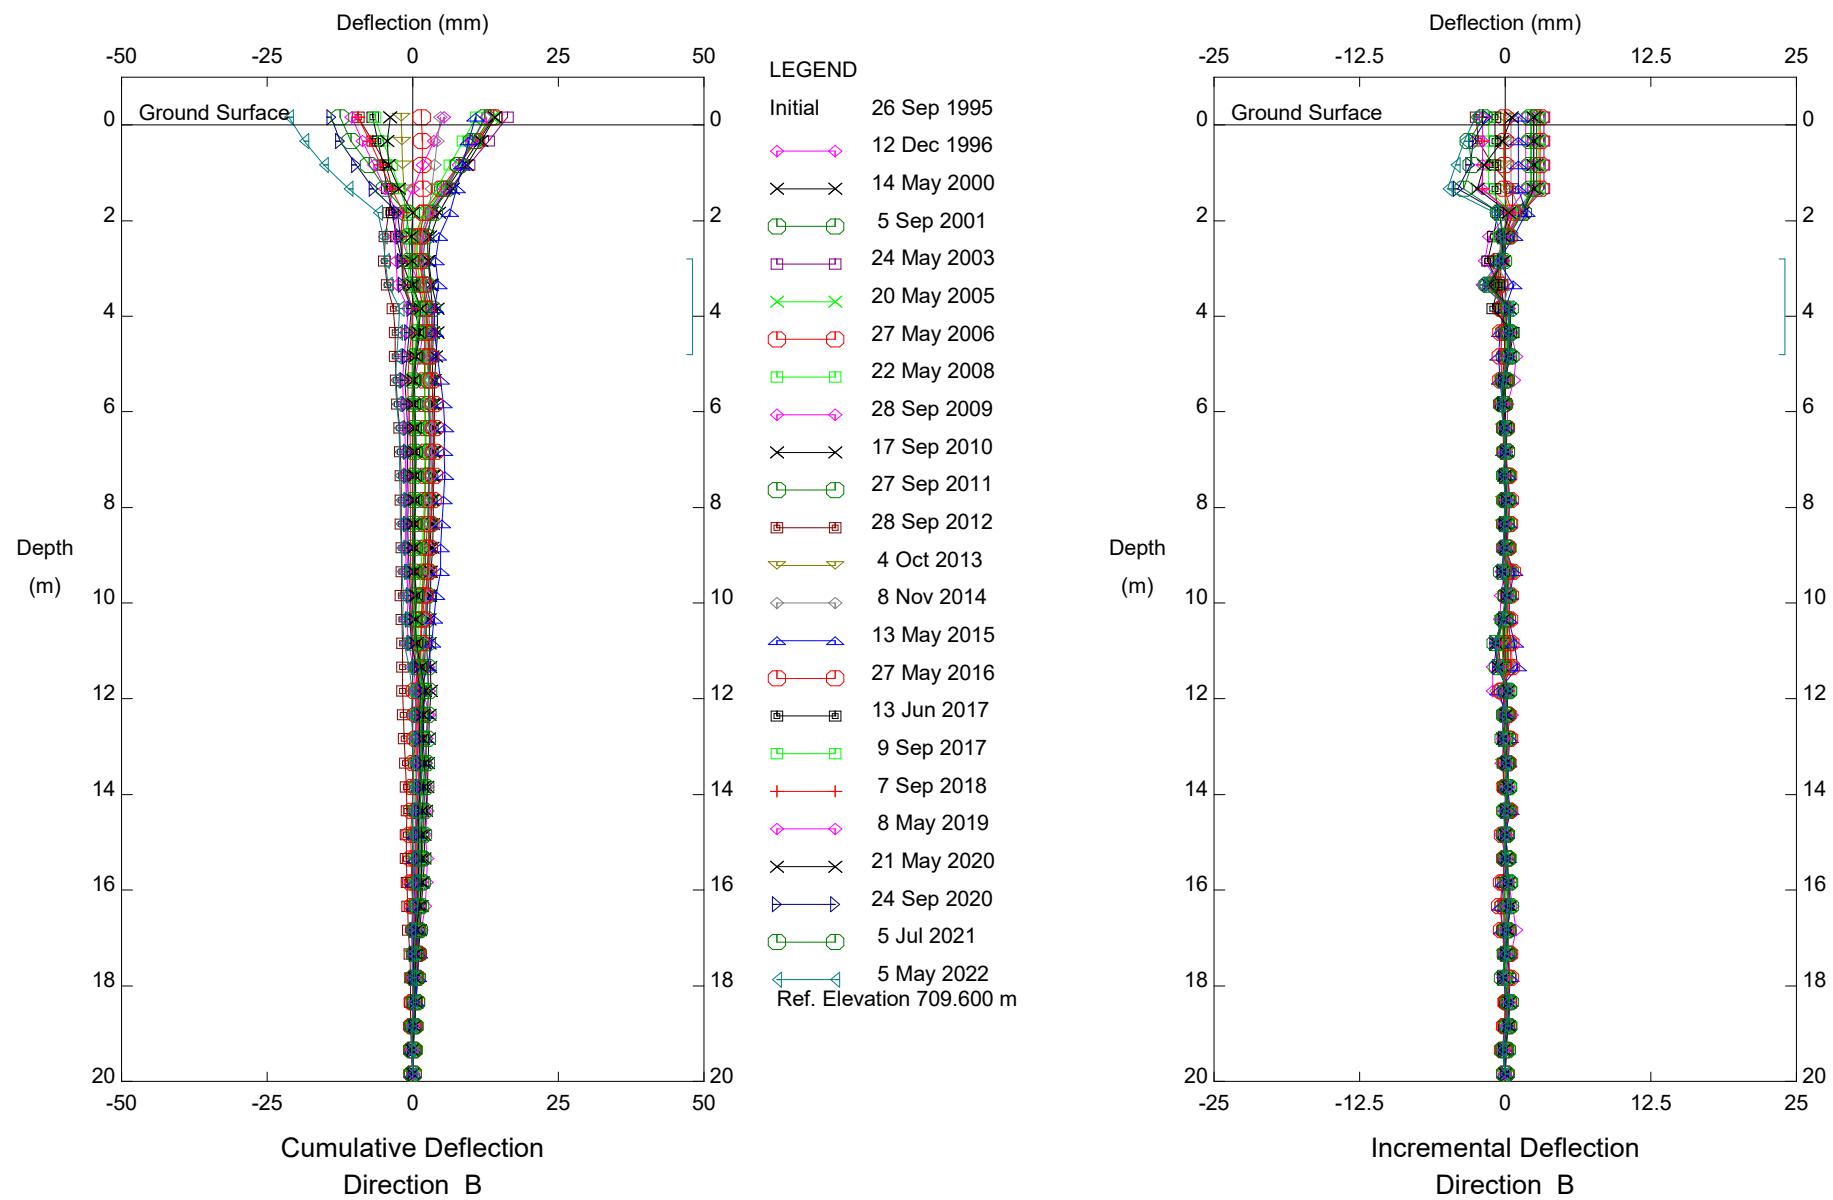
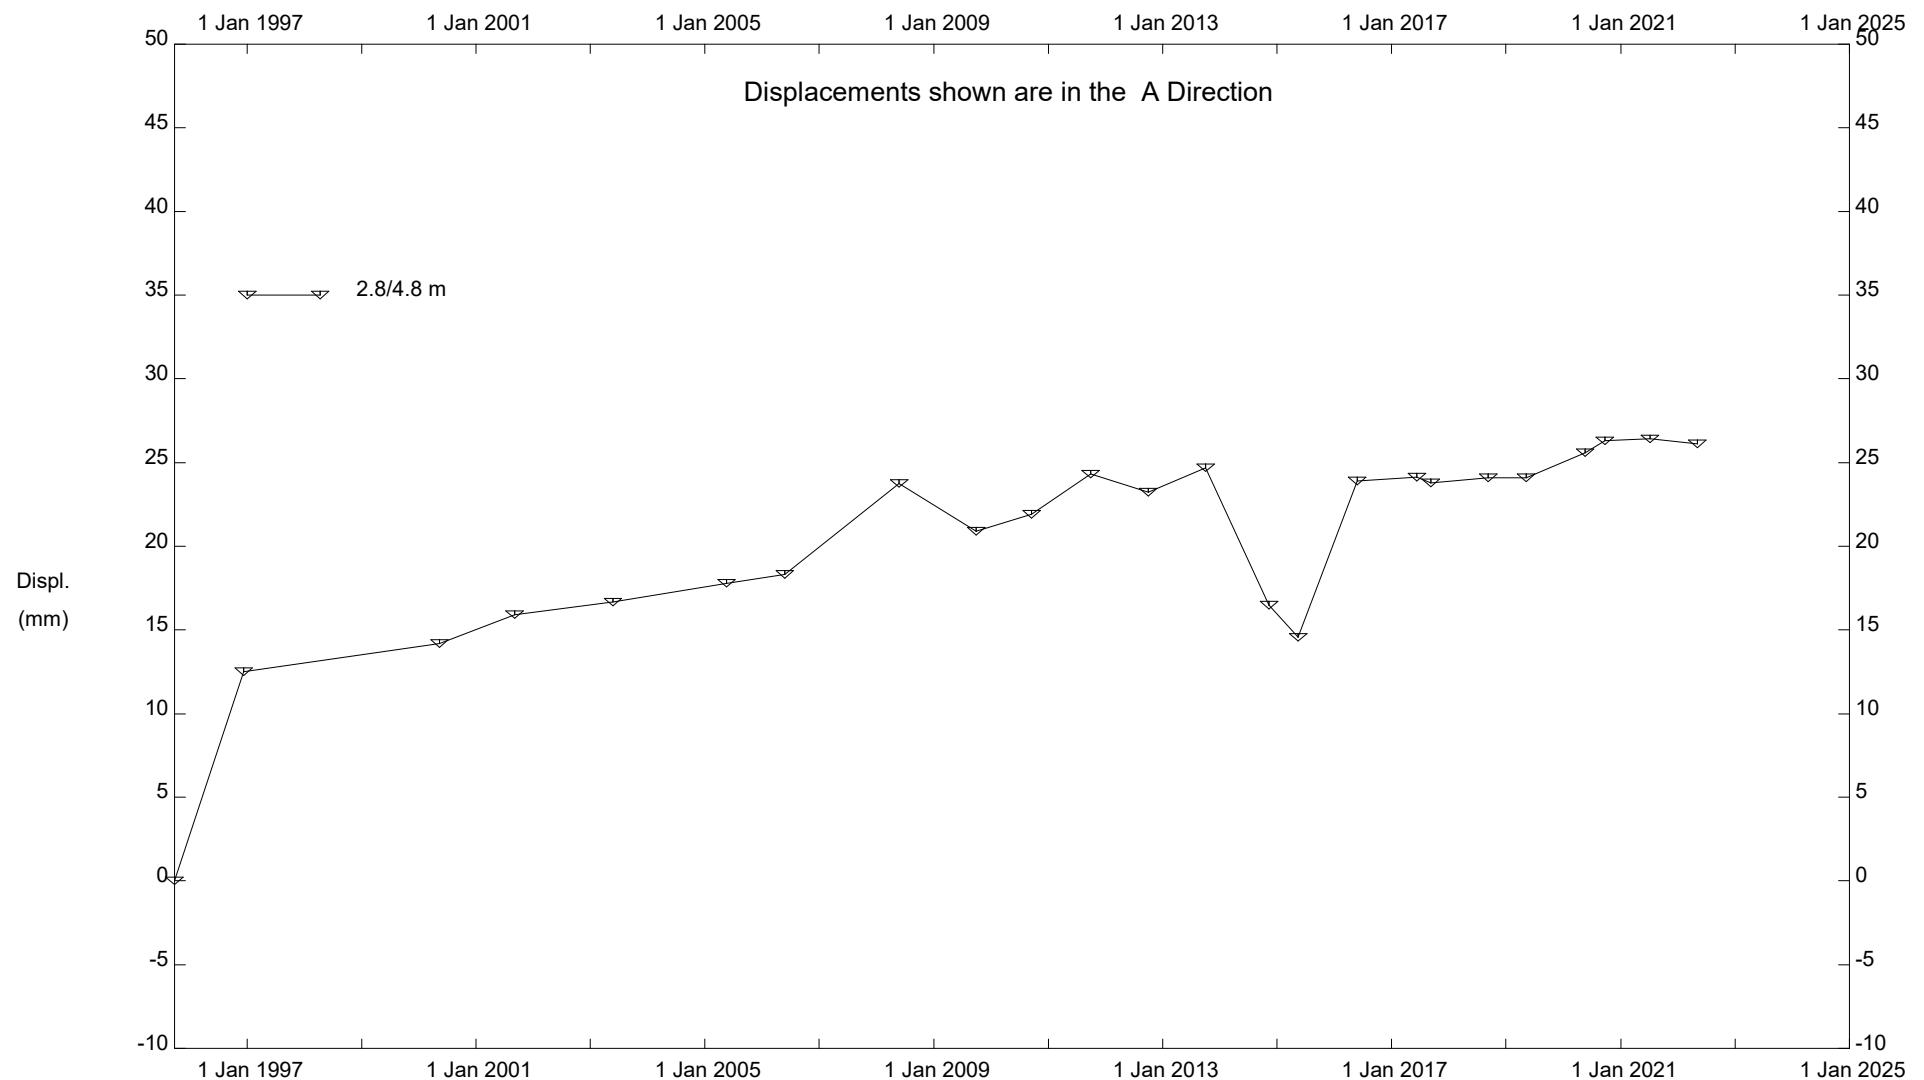
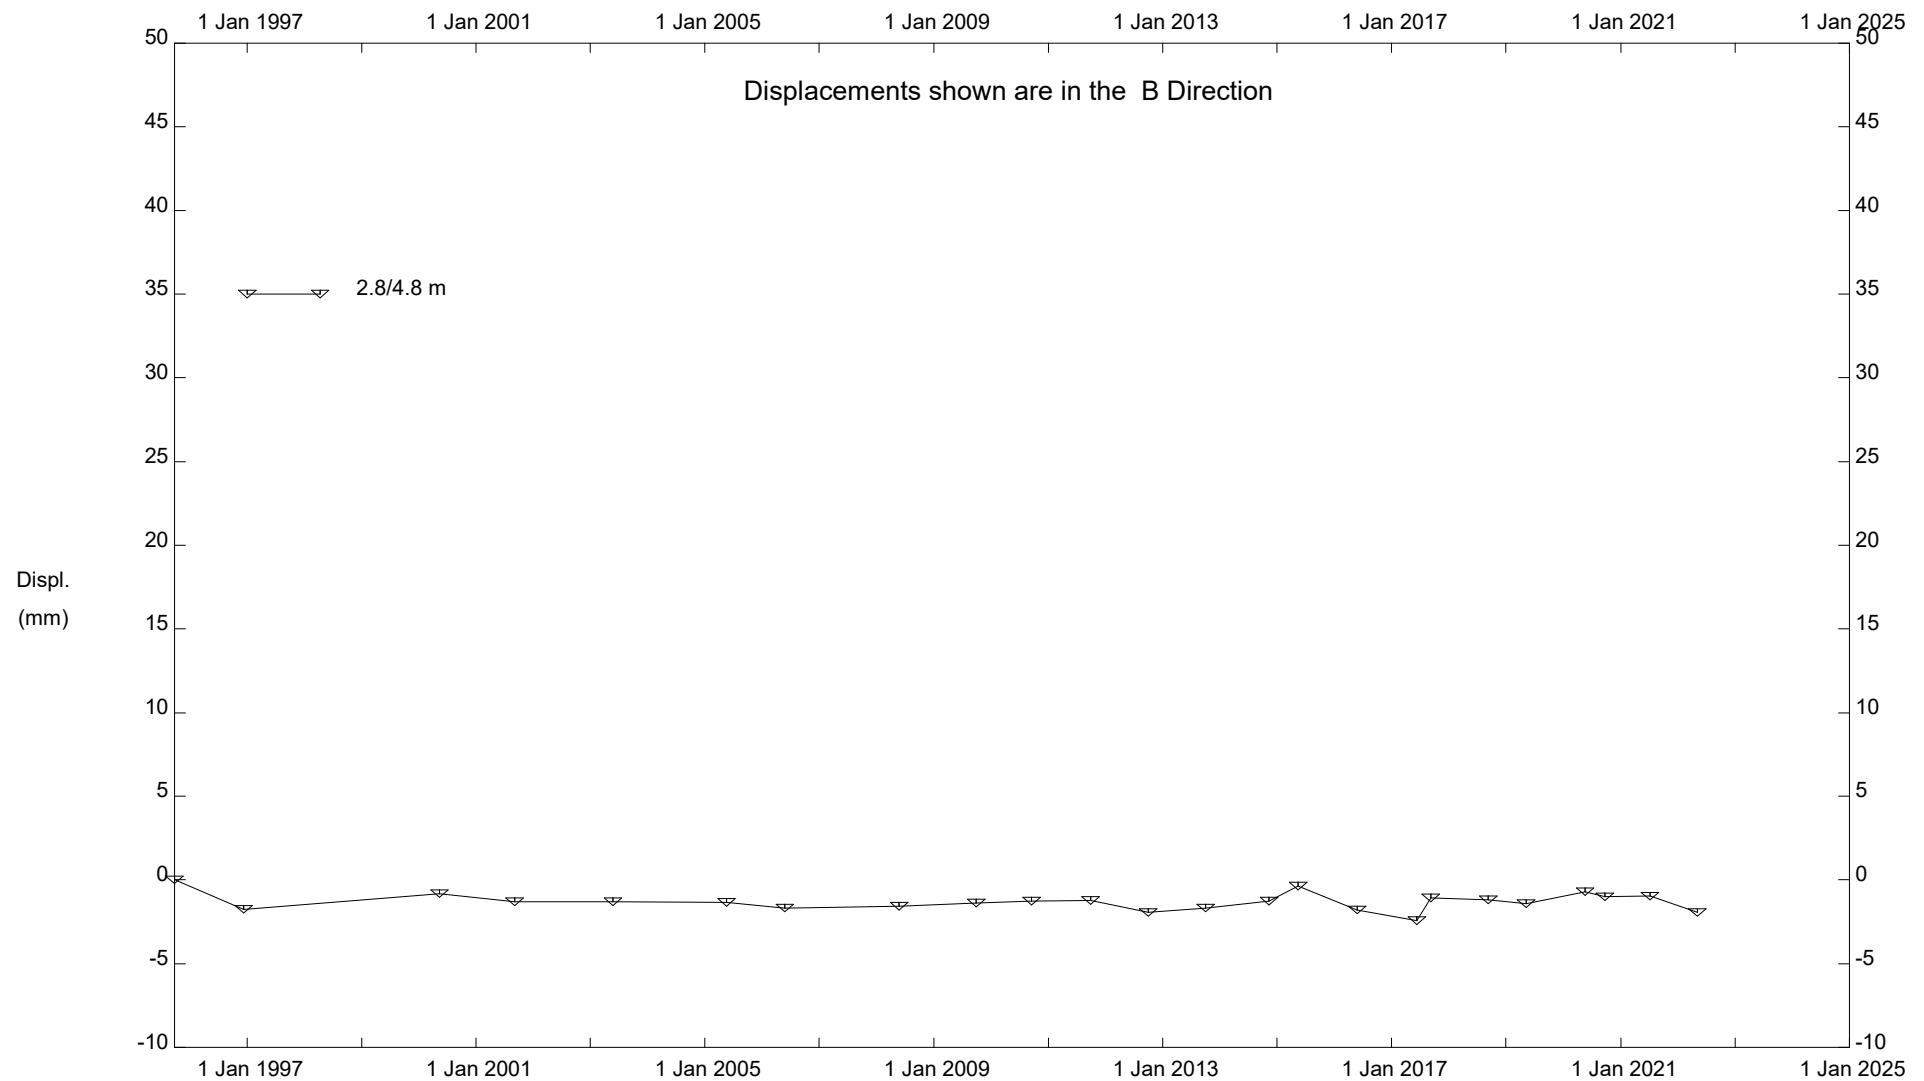
HWY 43:16 Whitecourt East Hill (NC1), Inclinometer SI31

SI31 is showing creep movement of less than 1 mm/year since 1997 at a shear zone between approximately 2.8 m and 4.8 m. The Spring 2022 readings showed less than 1 mm of incremental movement corresponding to a movement rate of less than 1 mm/year
