To: Amy Driessen
Alberta Transportation
File: 123315222

From: Leslie Cho and Carrie Murray
Stantec Consulting Ltd.
Date: June 13, 2022

Reference: North Central Region, Edson, Site NC001 - Highway 43:16 Whitecourt East Hill Spring 2022 Instrumentation Monitoring Report

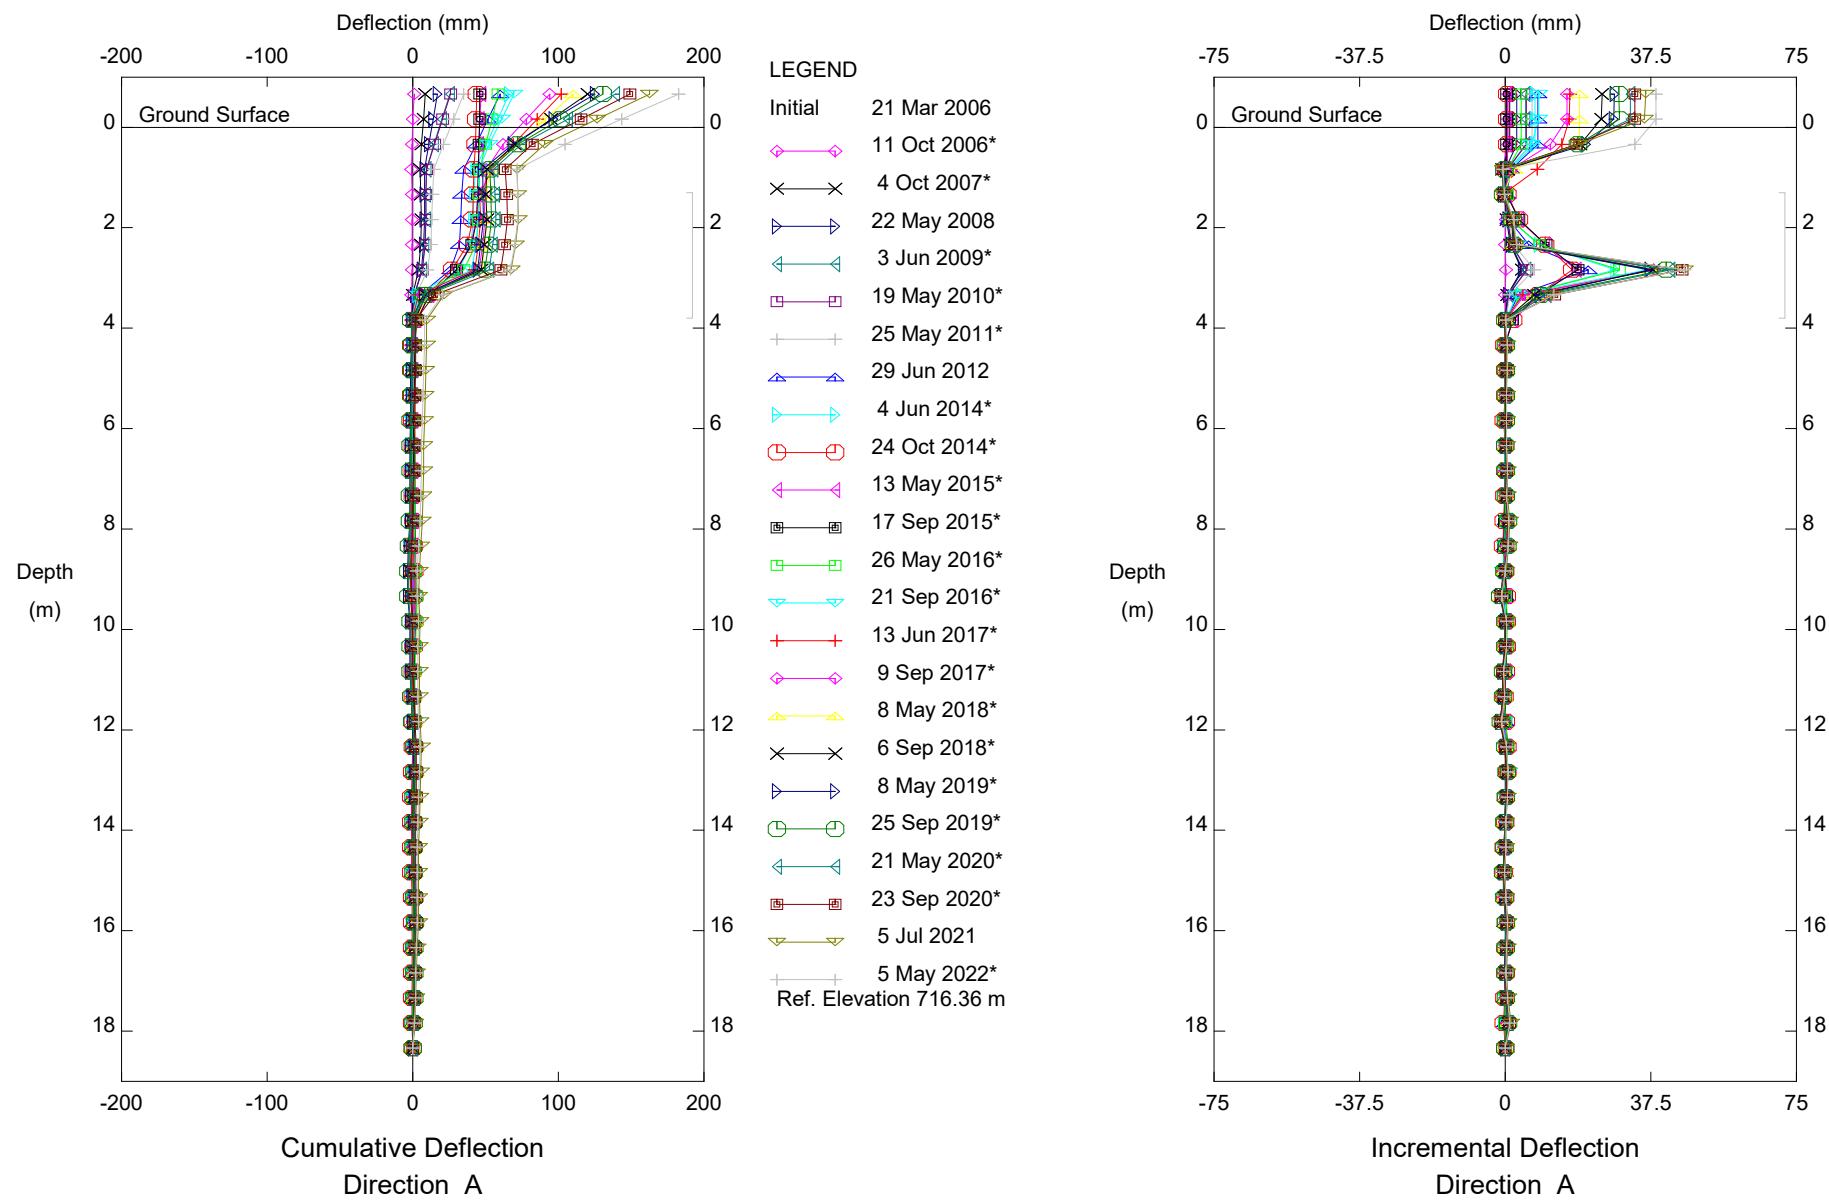
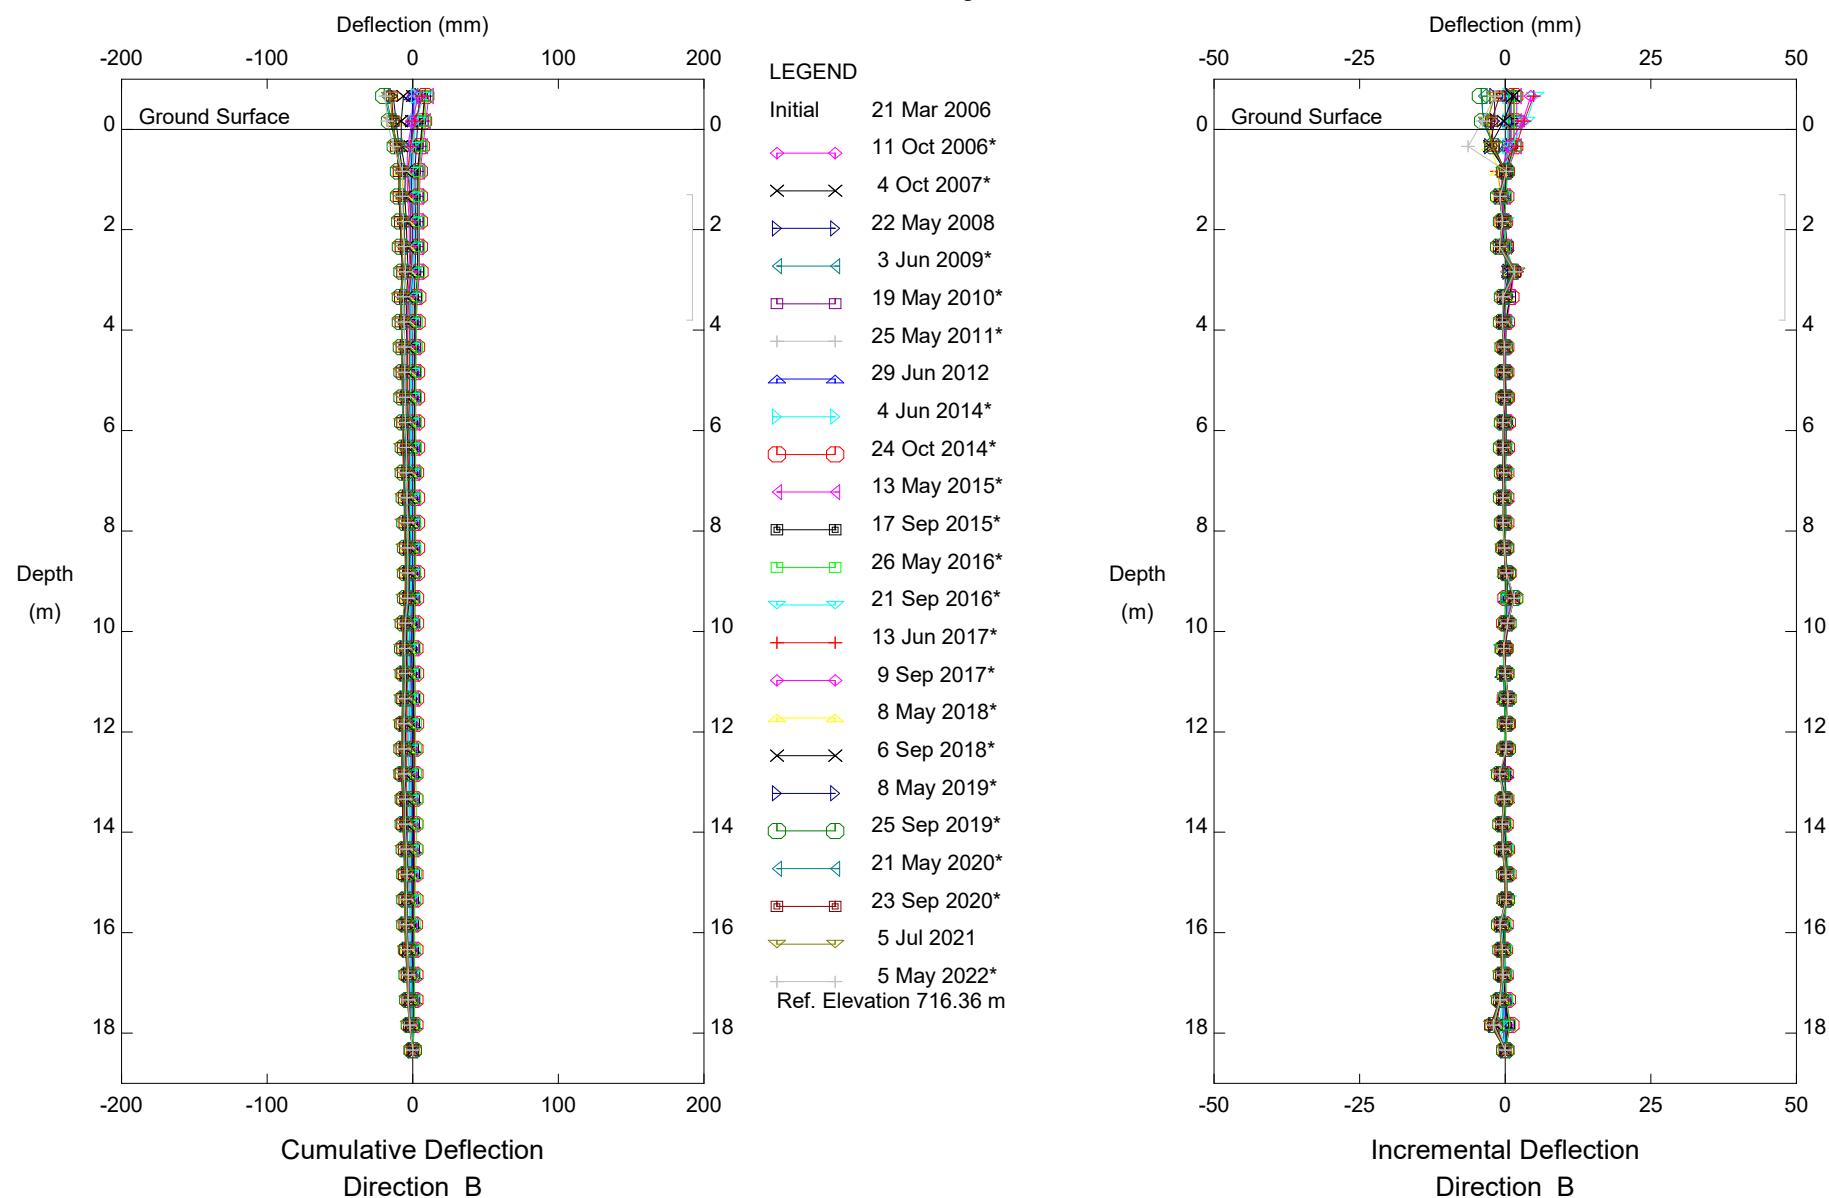
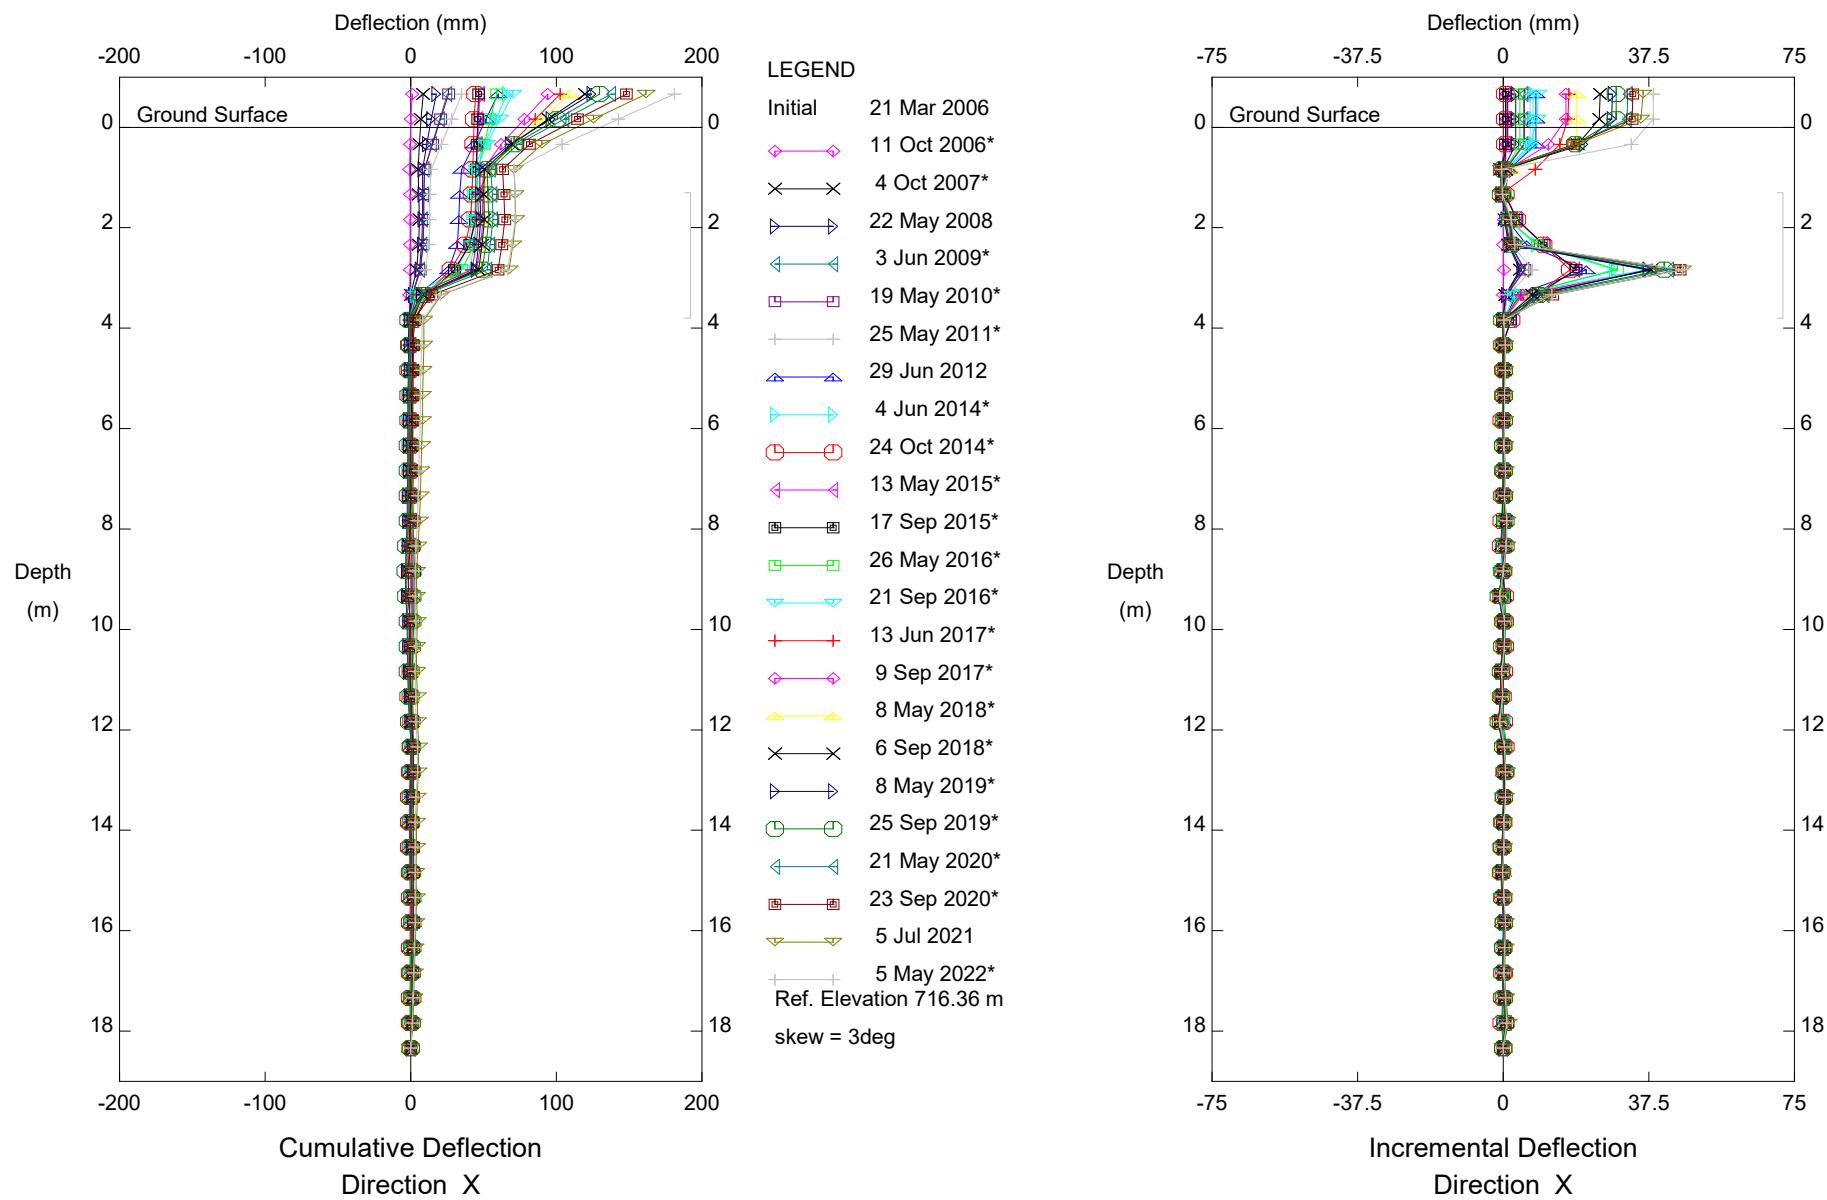
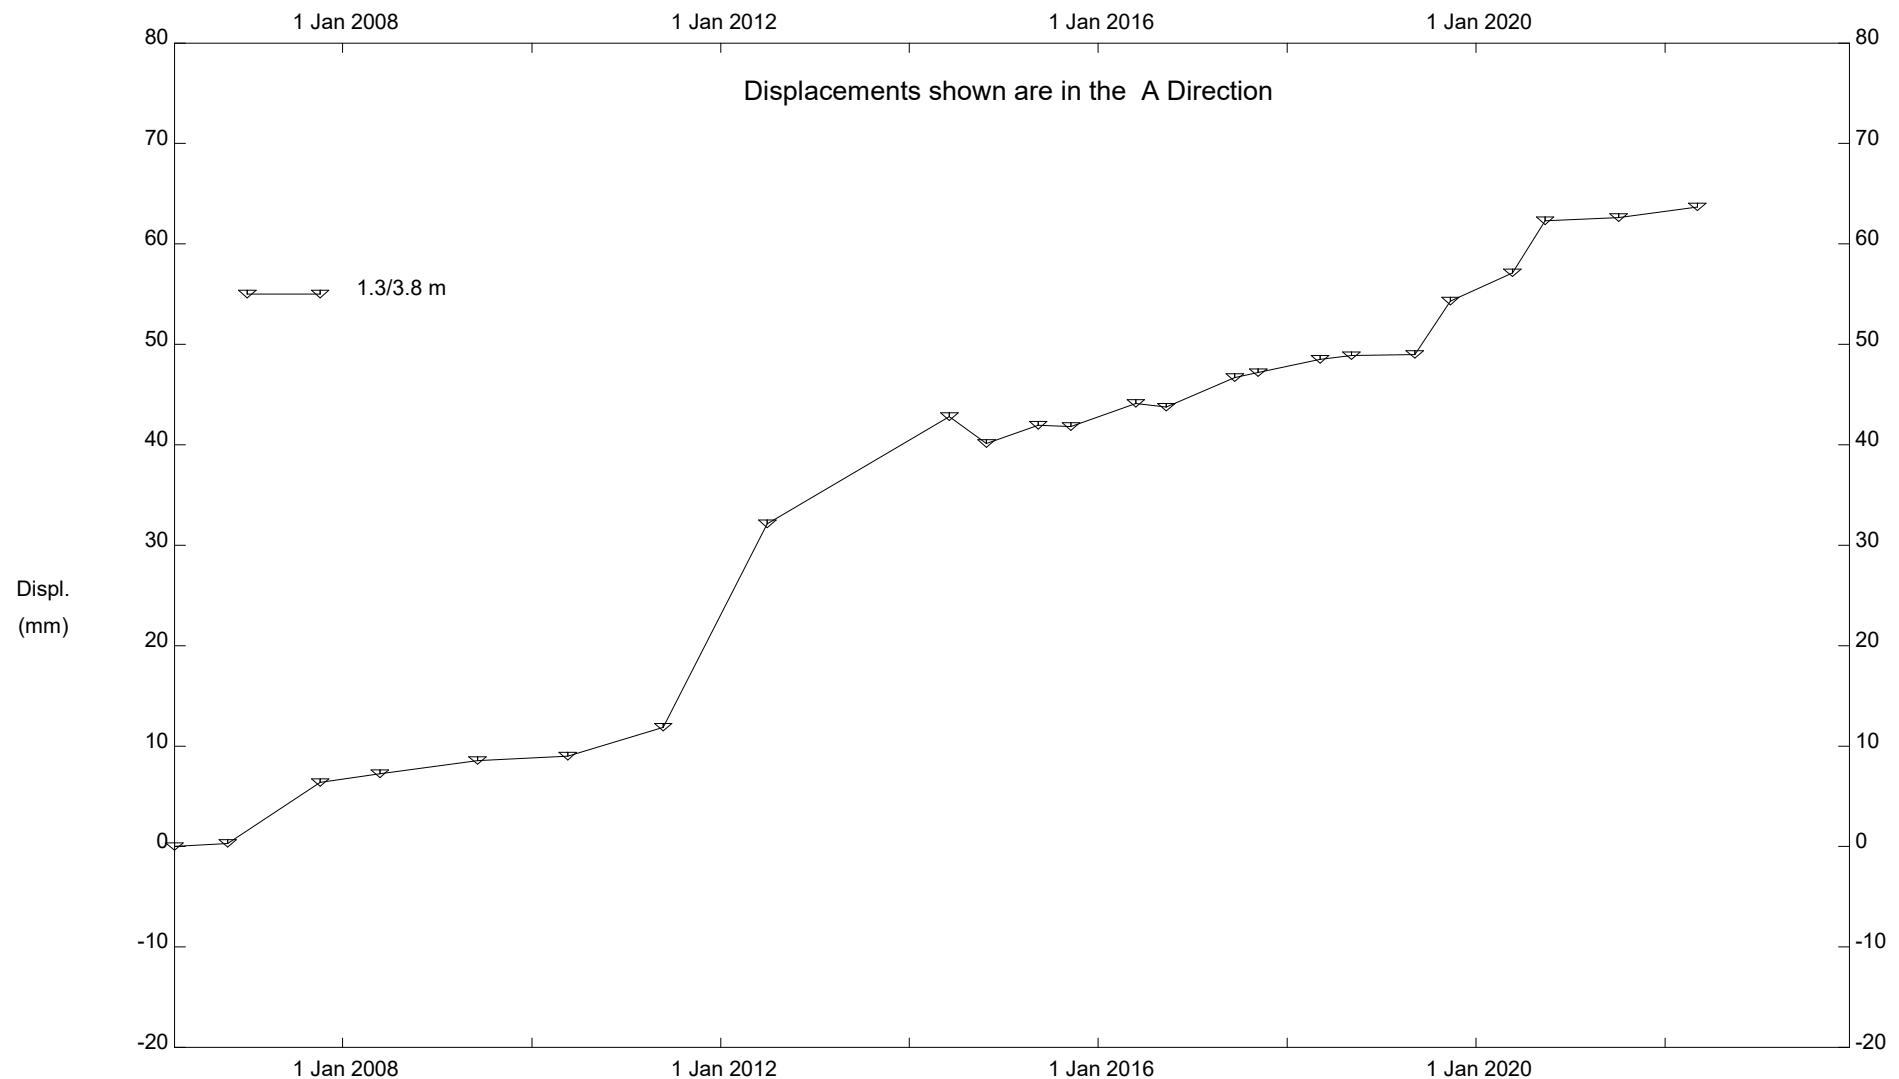
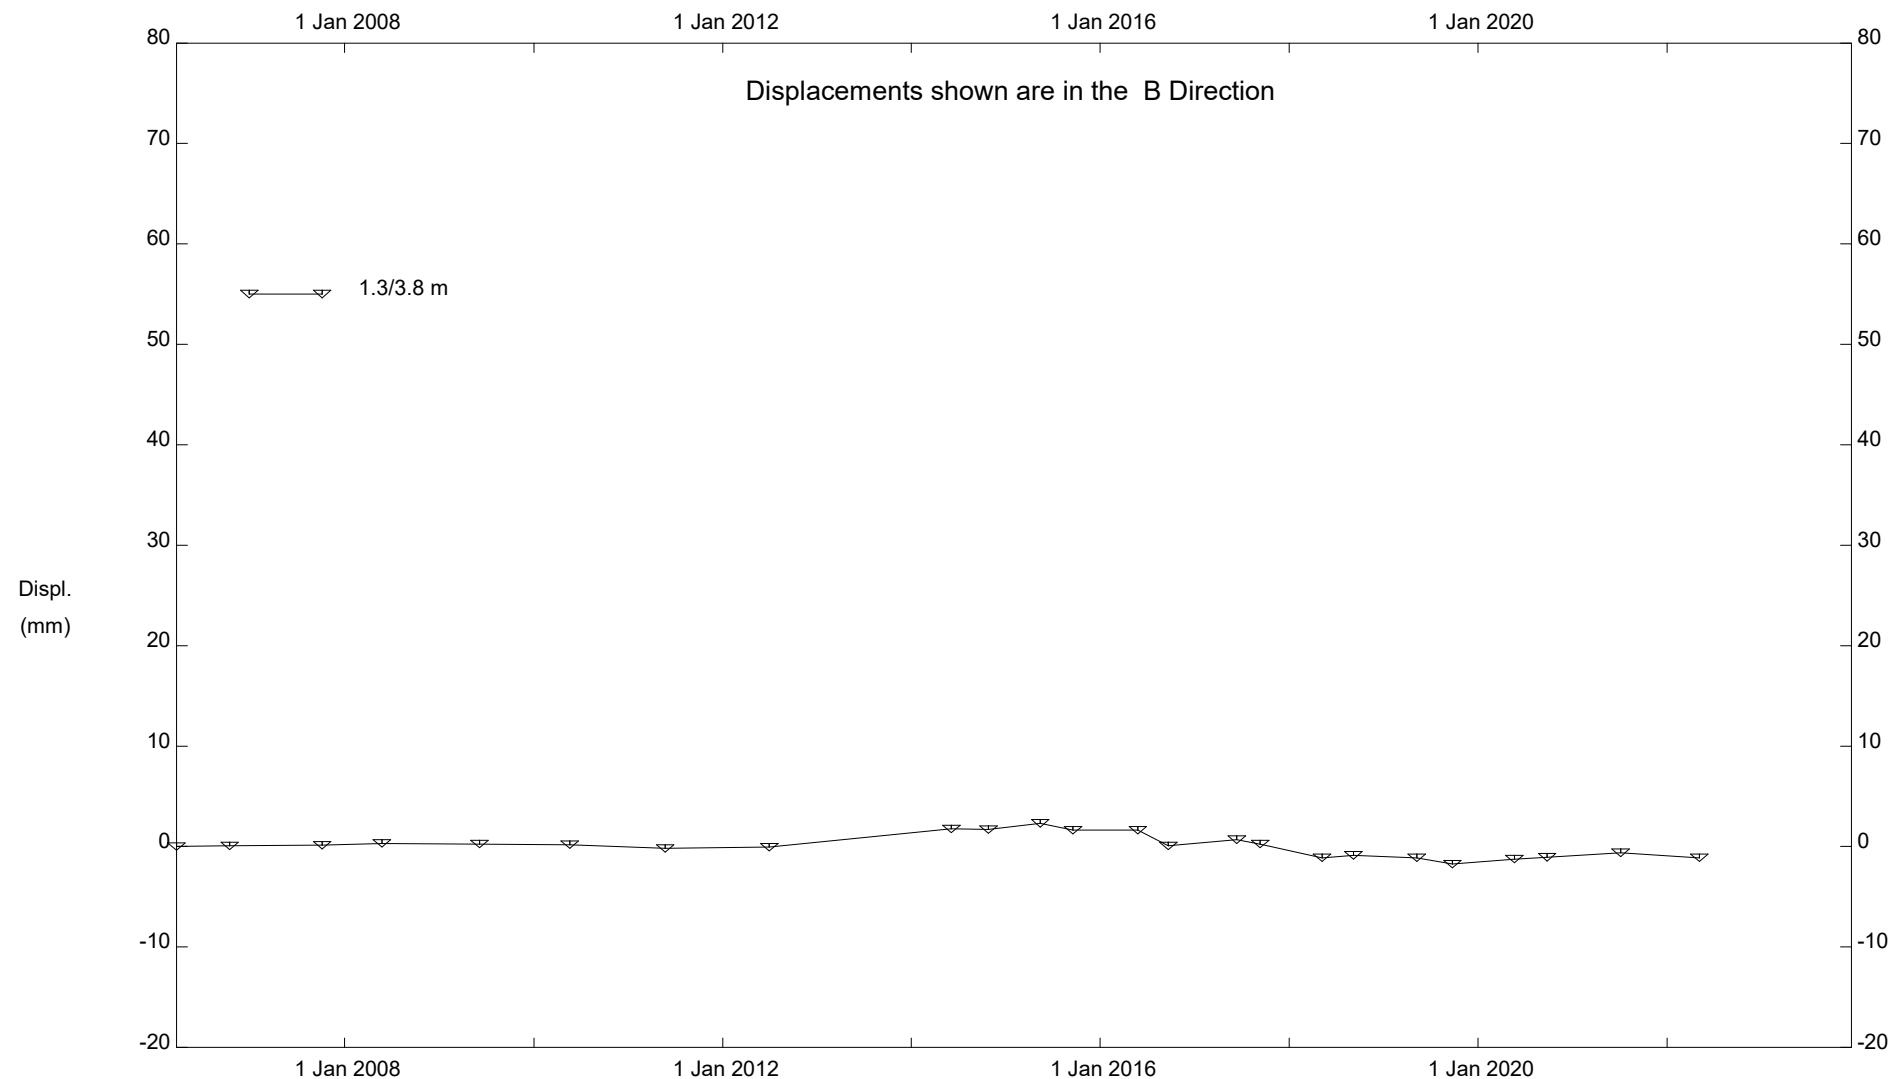
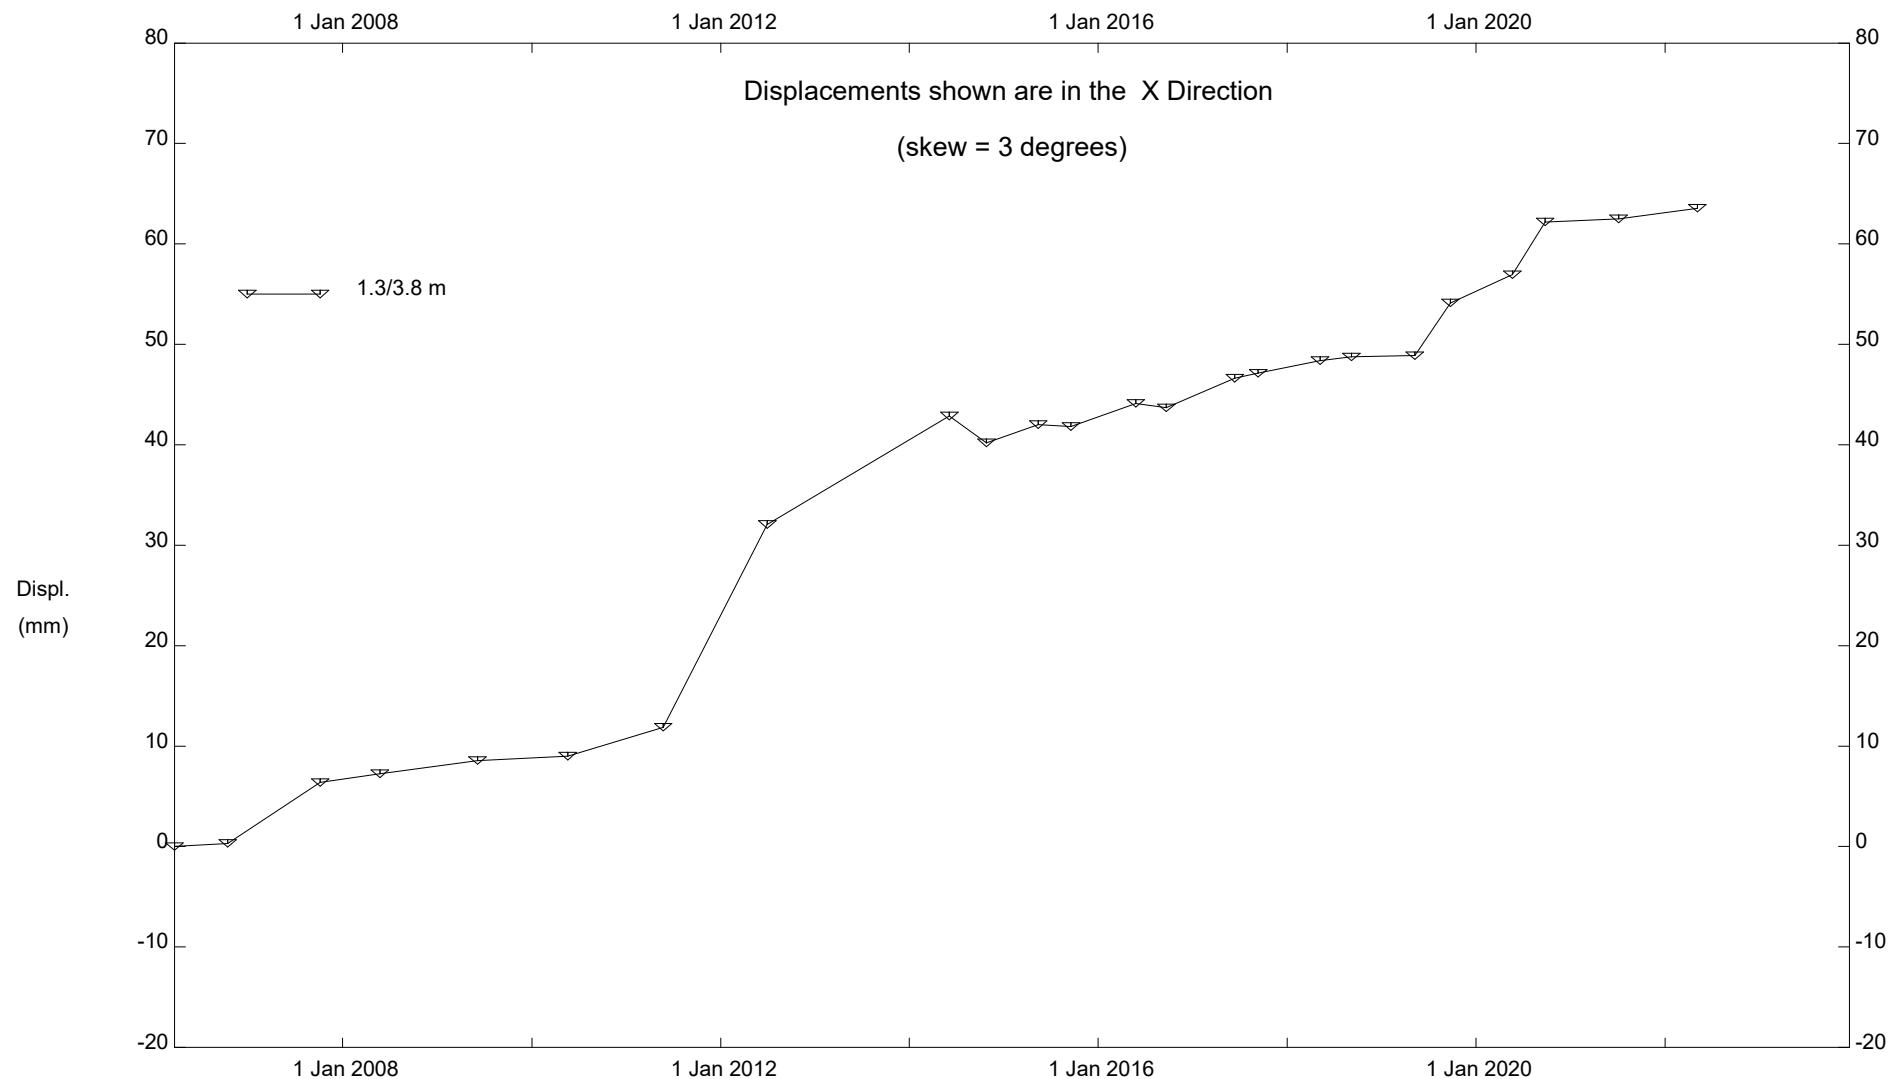
HWY 43:16 Whitecourt East Hill (NC1), Inclinometer SI06-1

SI06-1 has a distinct movement zone at about 3 m depth with 64 mm of cumulative movement. During the Spring 2022 reading cycle the rate of movement increased by less than 1 mm/yr compared to the previous reading, corresponding to a rate of movement of 1 mm/yr.
