To: Amy Driessen
Alberta Transportation
File: 123315222

From: Leslie Cho and Carrie Murray
Stantec Consulting Ltd.
Date: June 13, 2022

Reference: North Central Region, Edson, Site NC001 - Highway 43:16 Whitecourt East Hill Spring 2022 Instrumentation Monitoring Report

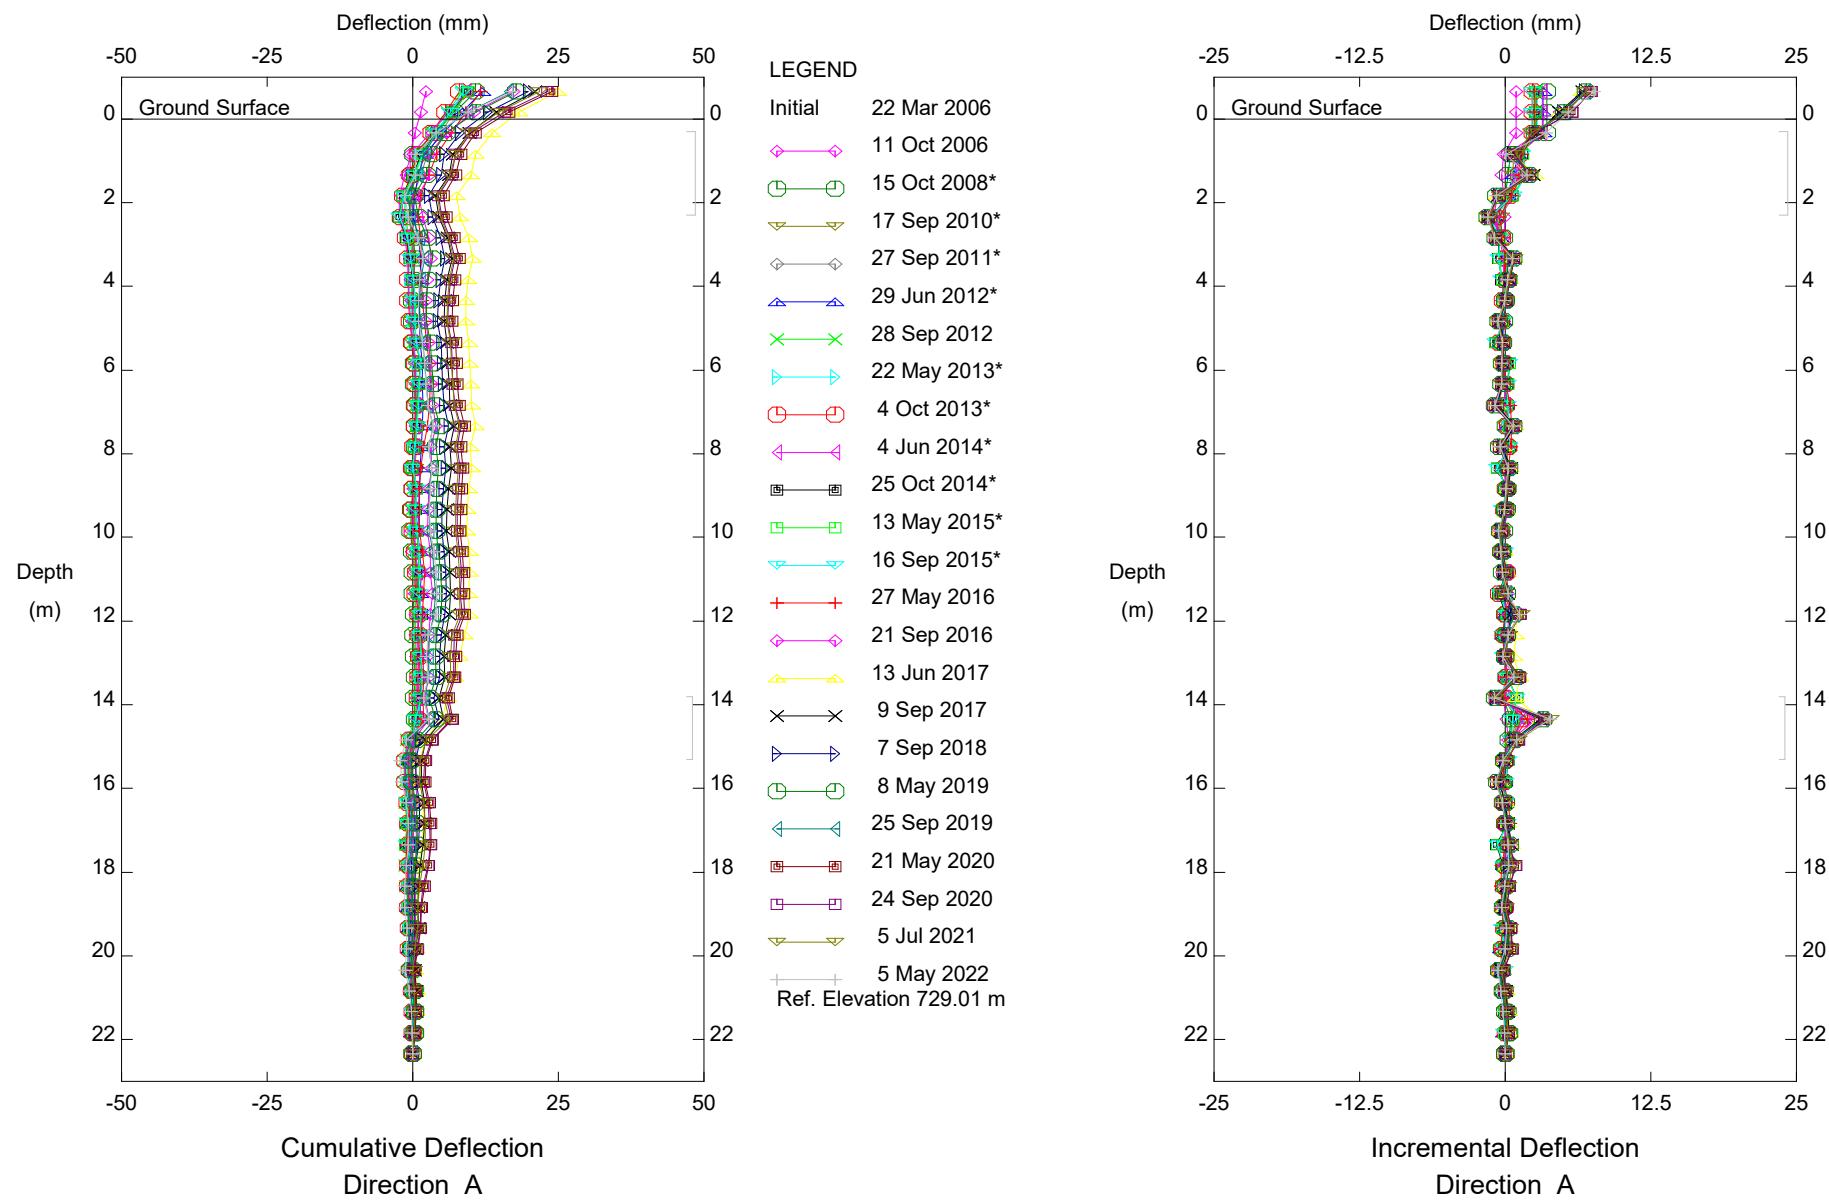
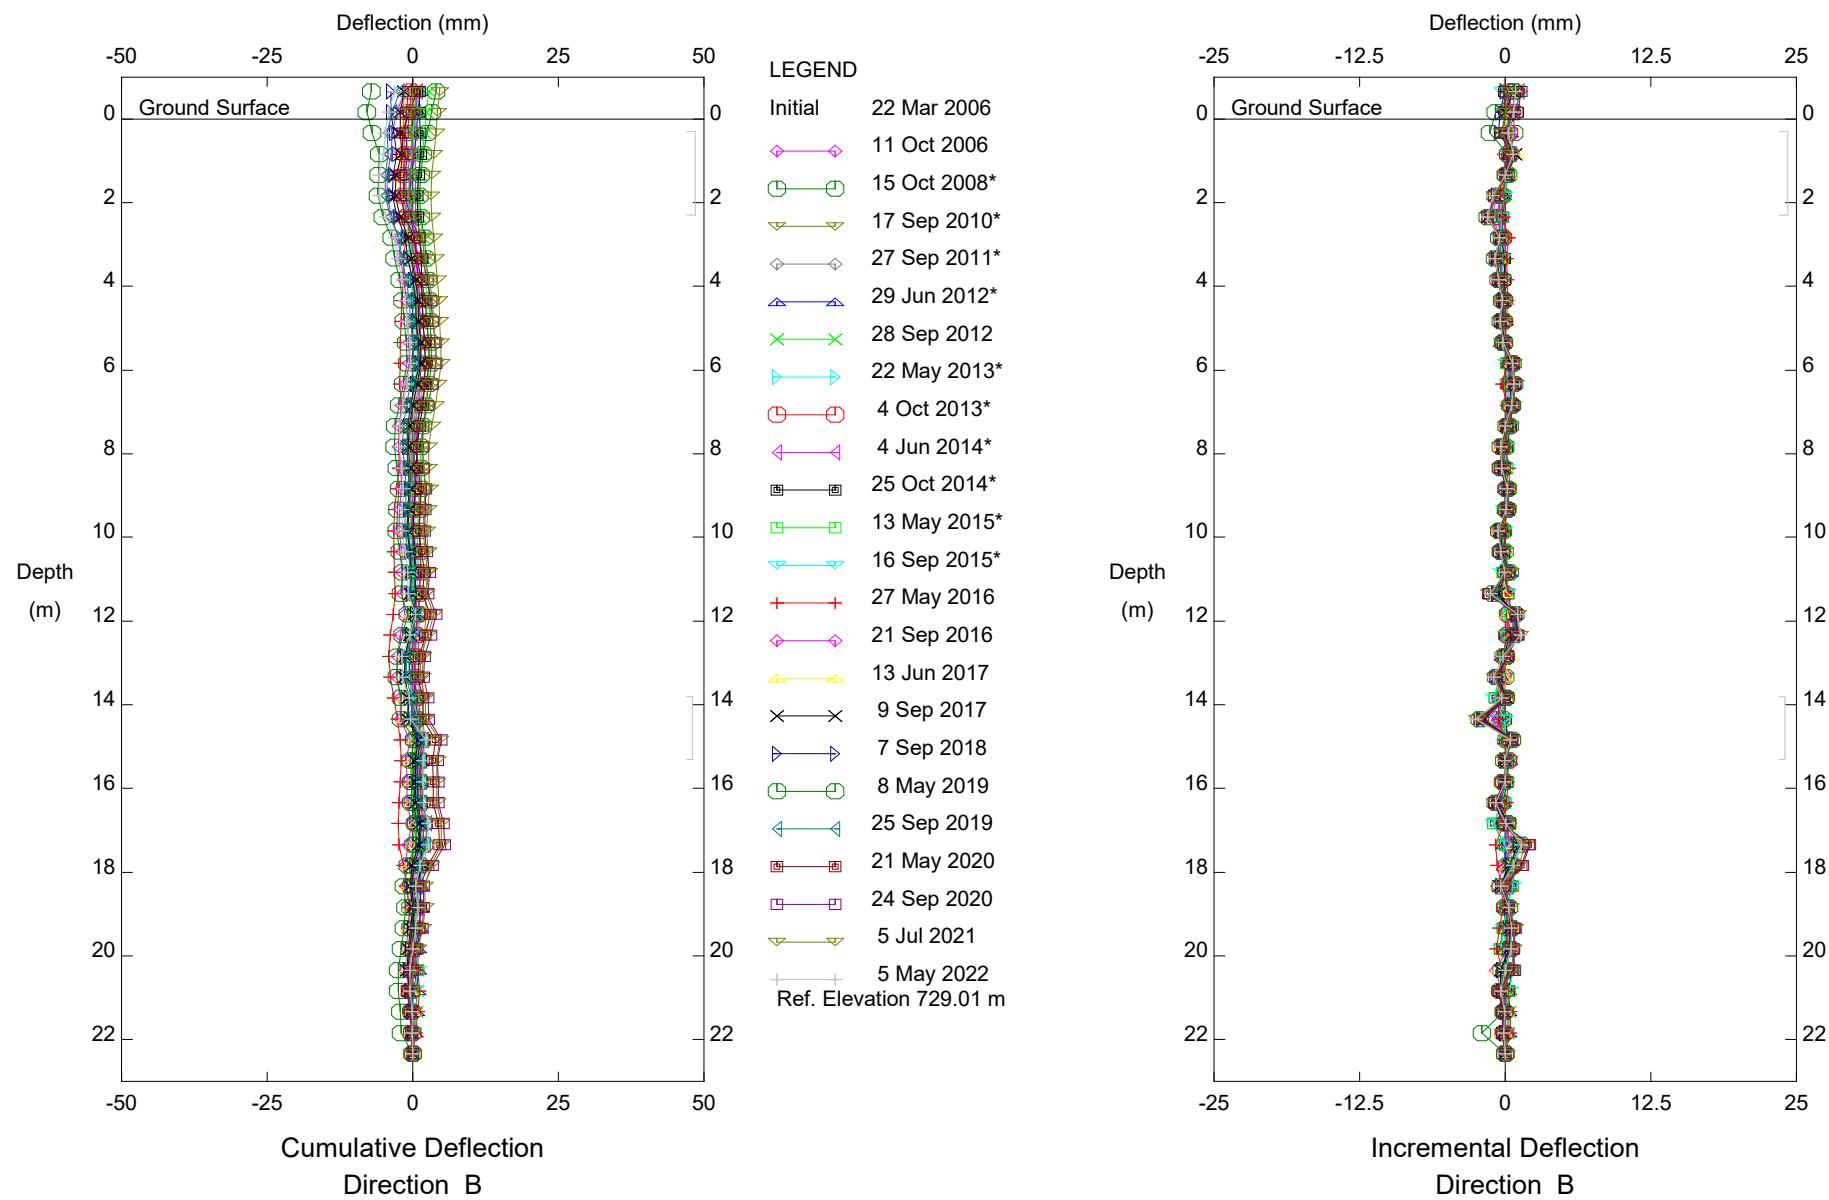
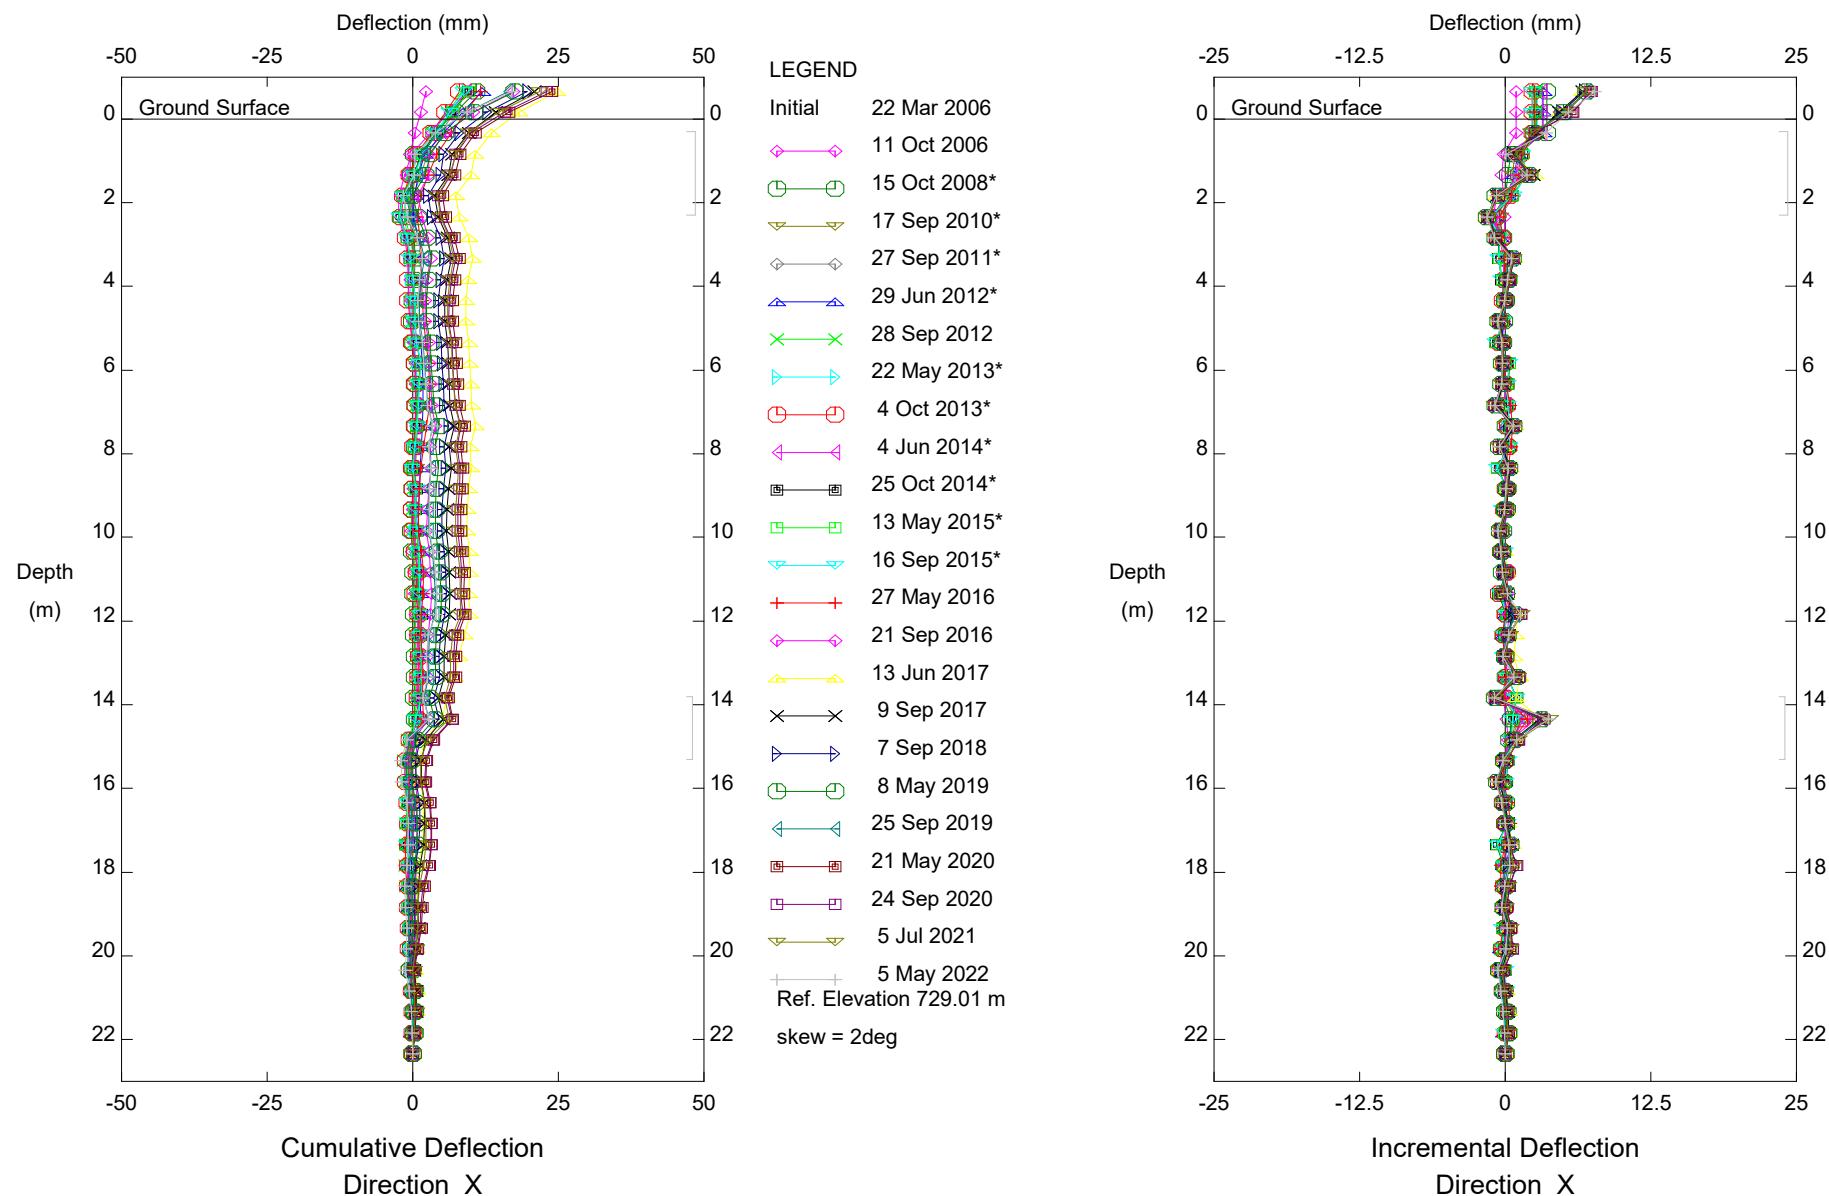
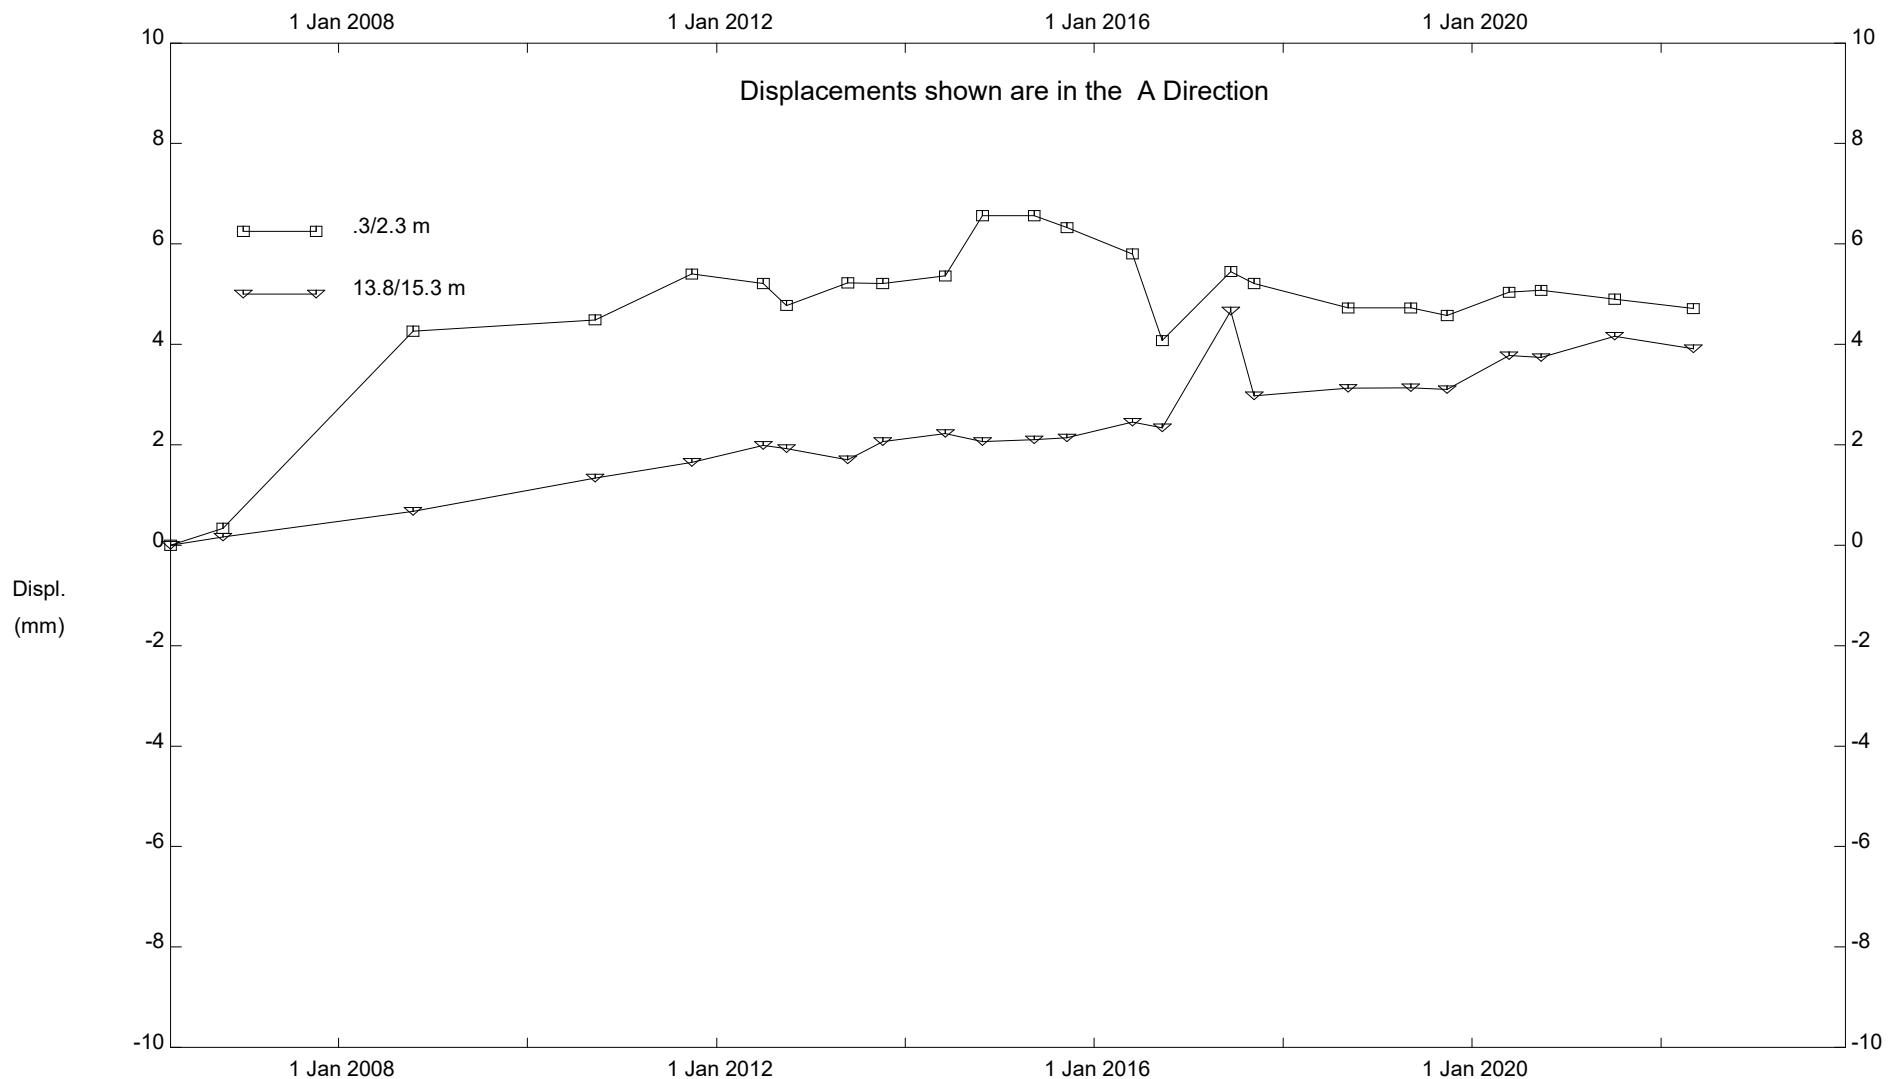
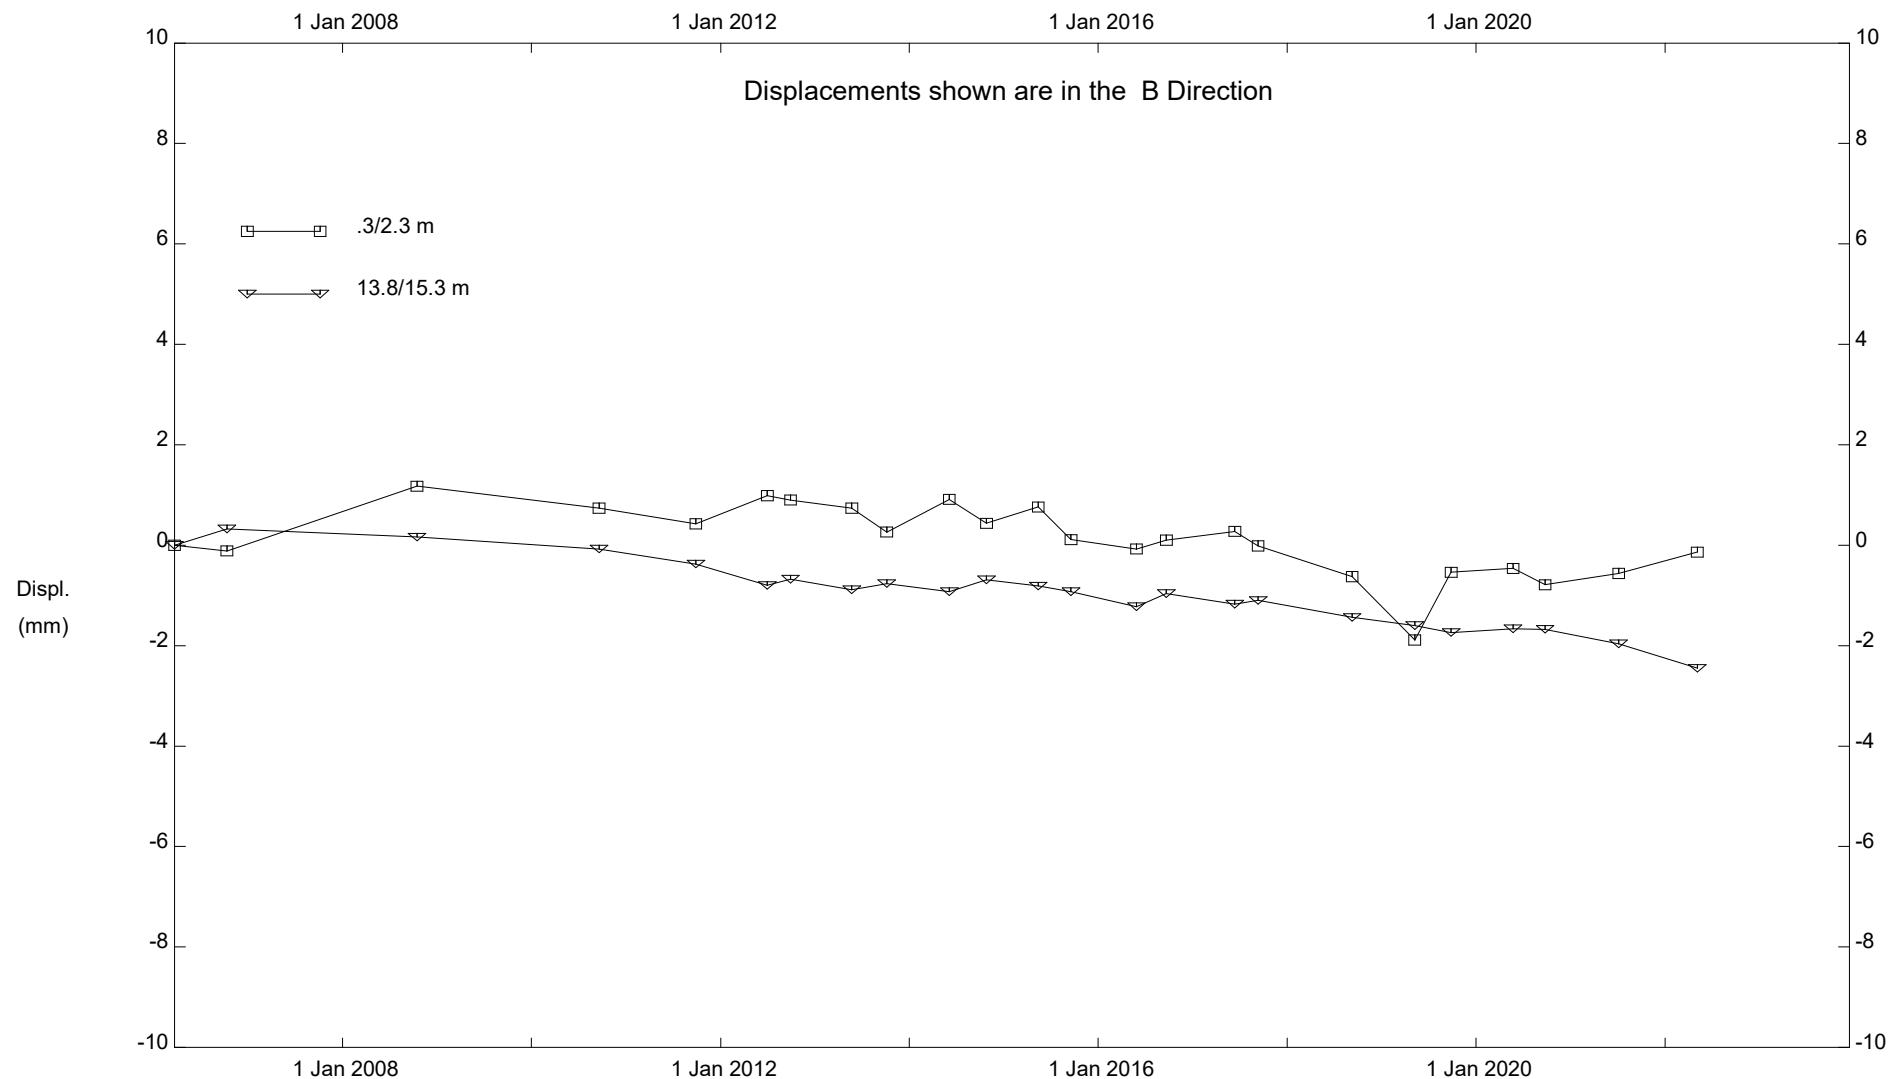
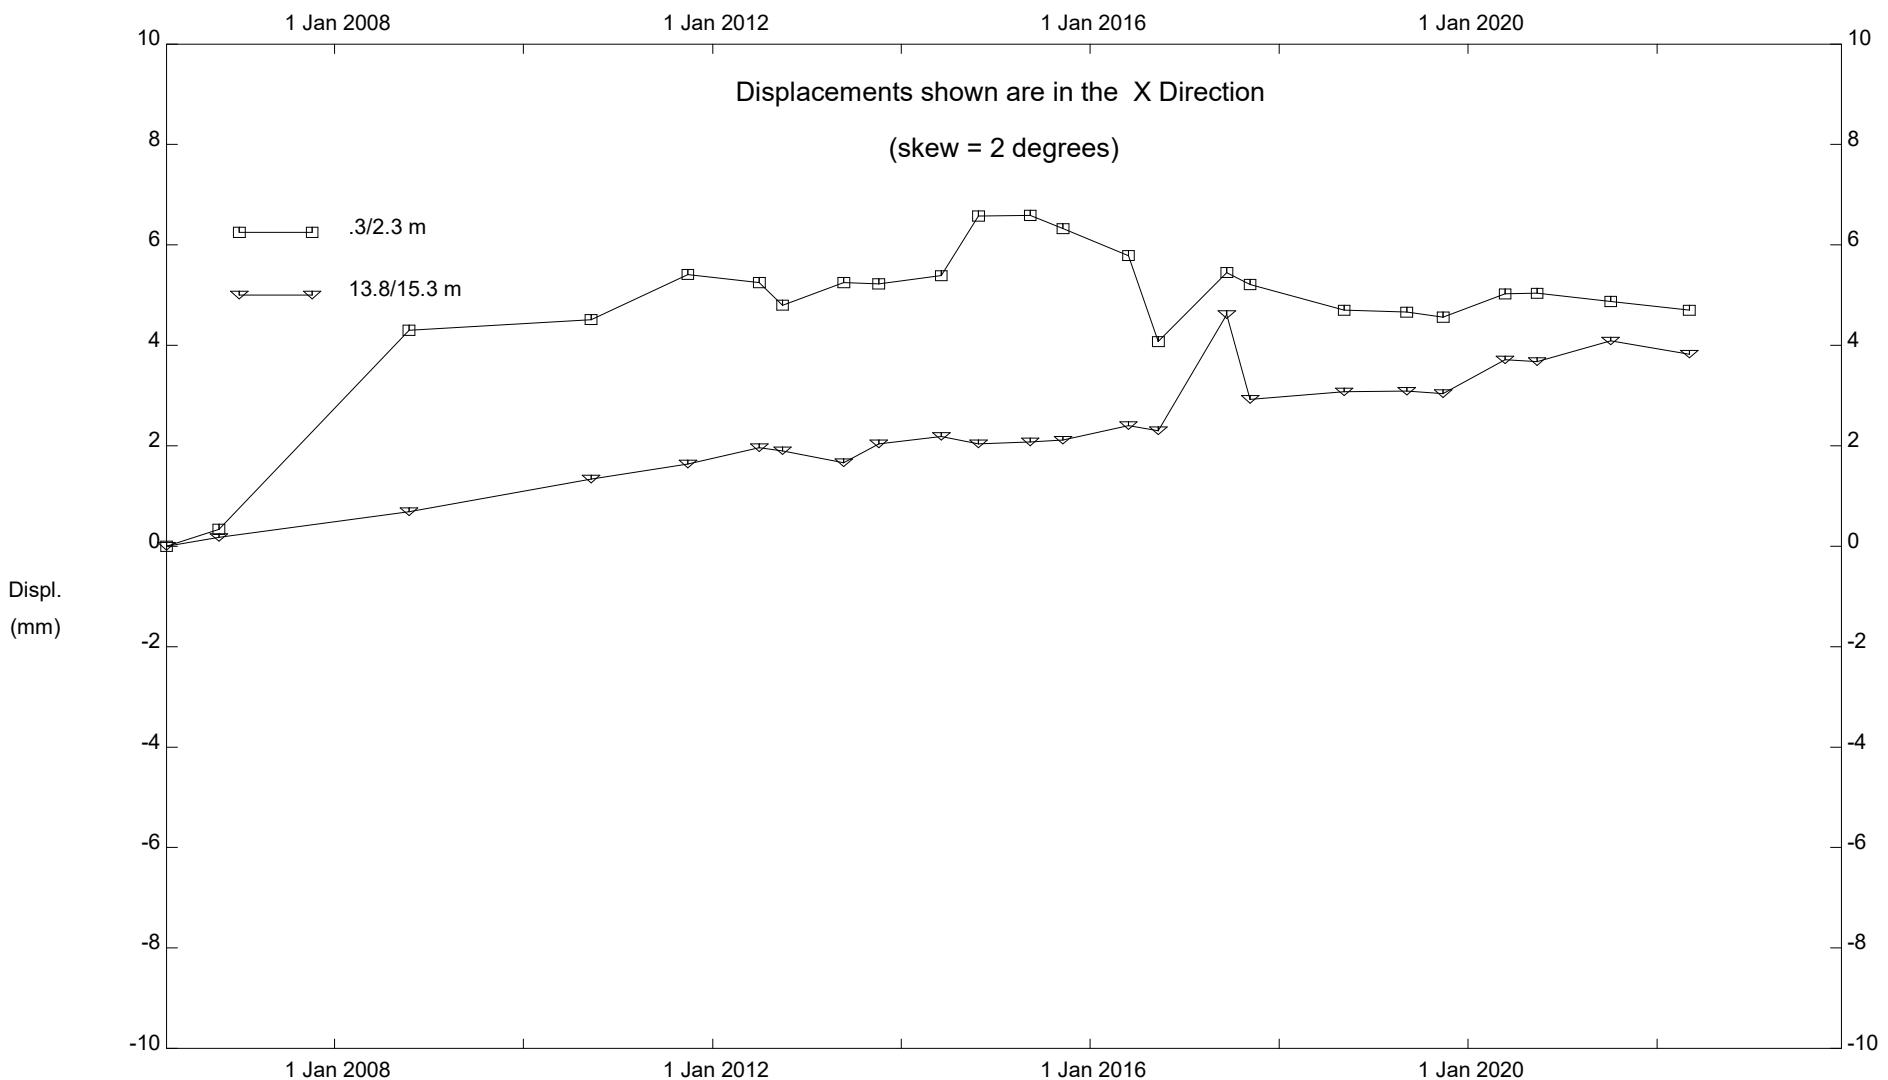
HWY 43:16 Whitecourt East Hill (NC1), Inclinometer SI06-2

SI06-2 is showing creep at a rate of movement of less than 1 mm/yr since installation in the shear zone from 13.8 m to 15.3 m. A sudden spike recorded in Spring 2016 is likely a reading error.
