To: Amy Driessen
Alberta Transportation
File: 123315222

From: Leslie Cho and Carrie Murray
Stantec Consulting Ltd.
Date: June 13, 2022

Reference: North Central Region, Edson, Site NC001 - Highway 43:16 Whitecourt East Hill Spring 2022 Instrumentation Monitoring Report

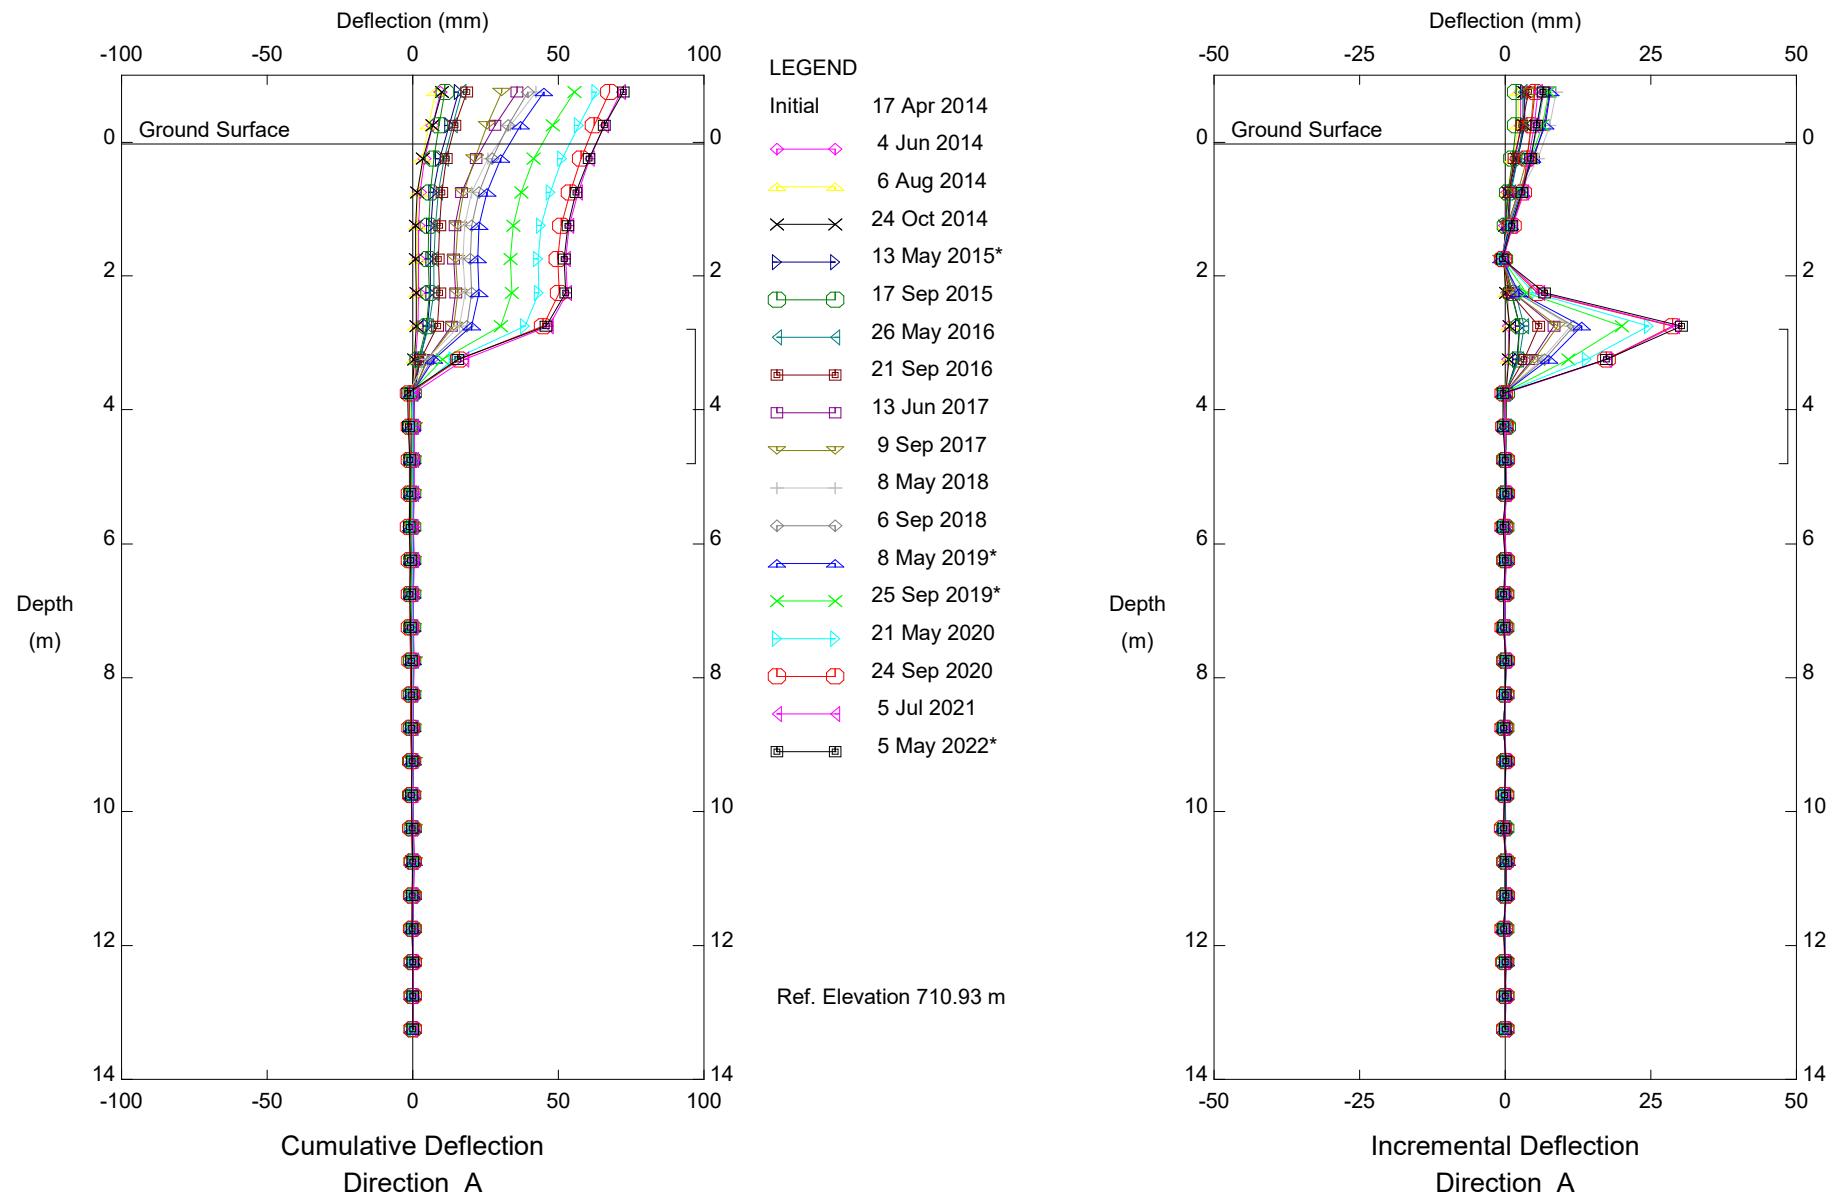
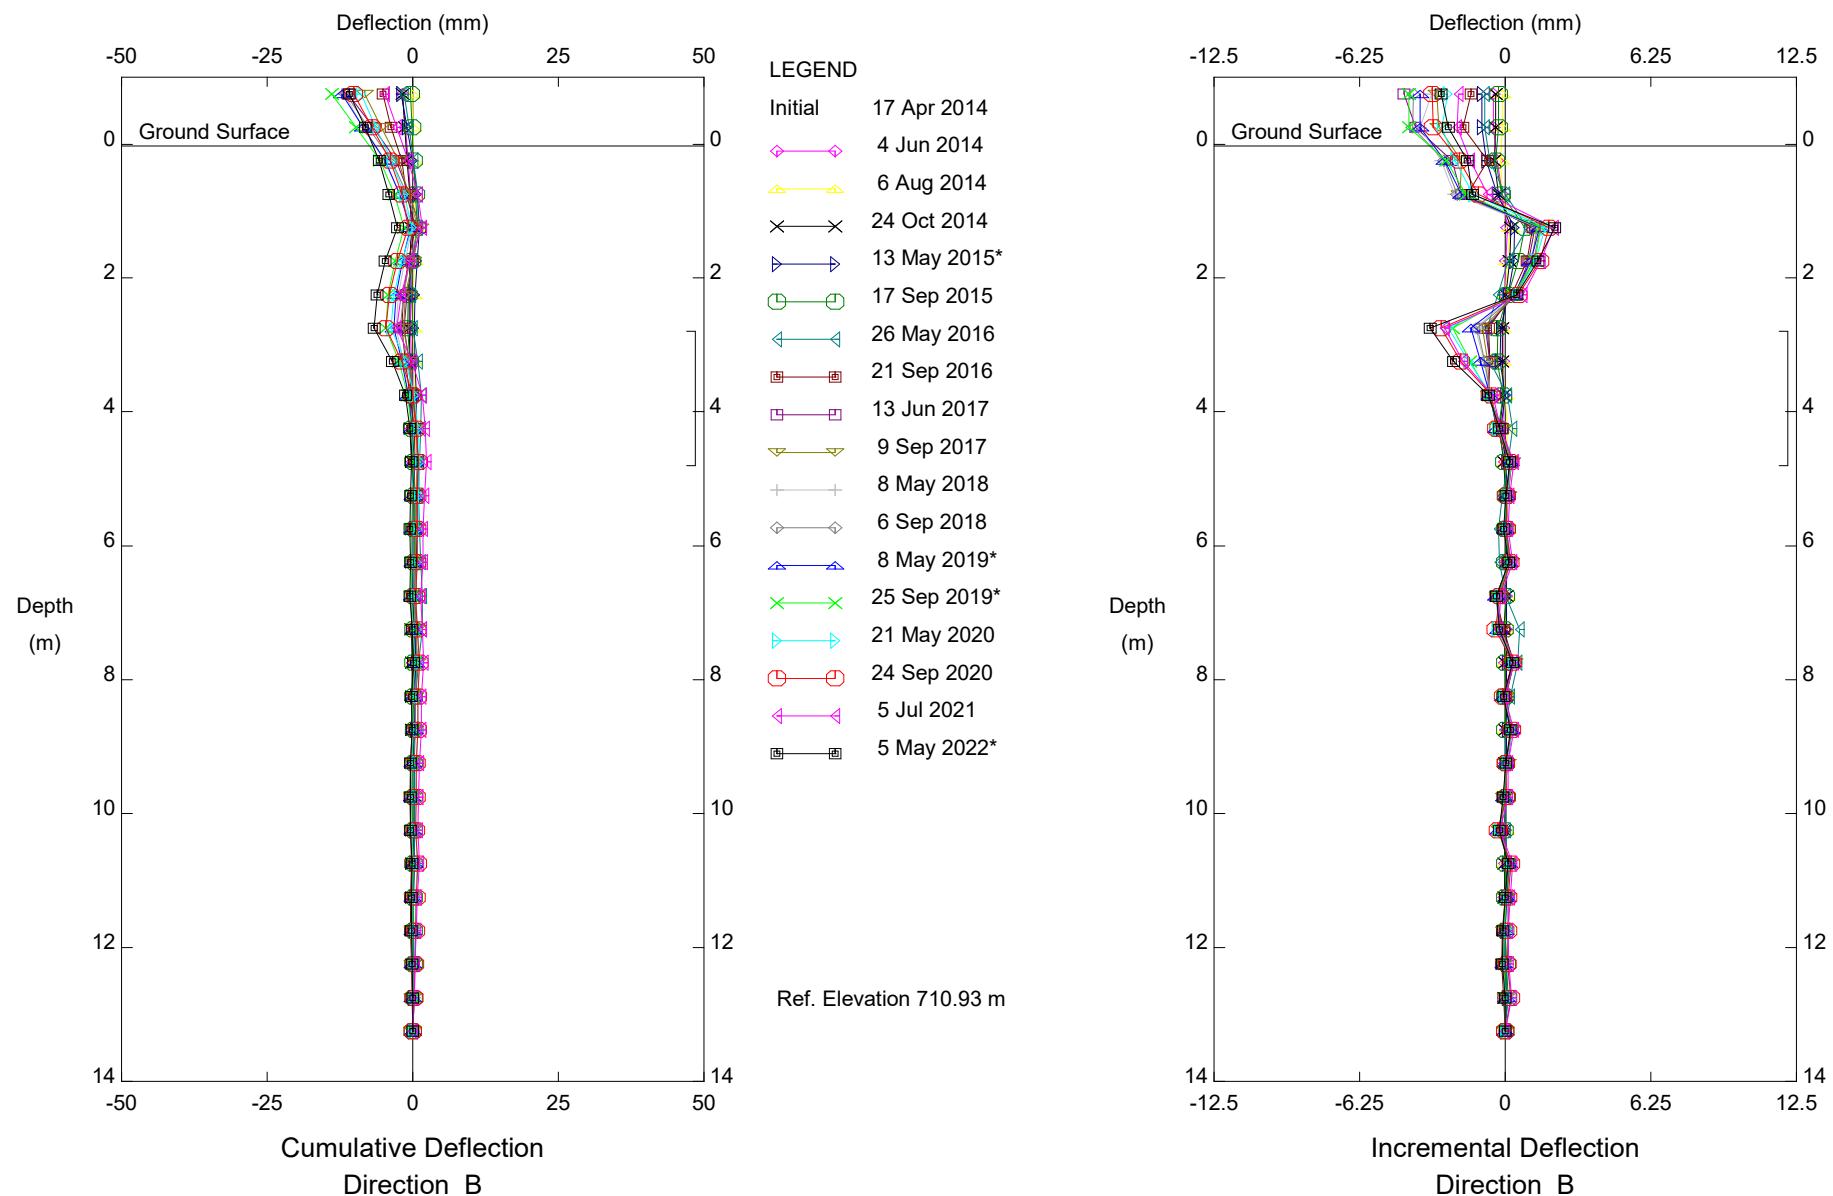
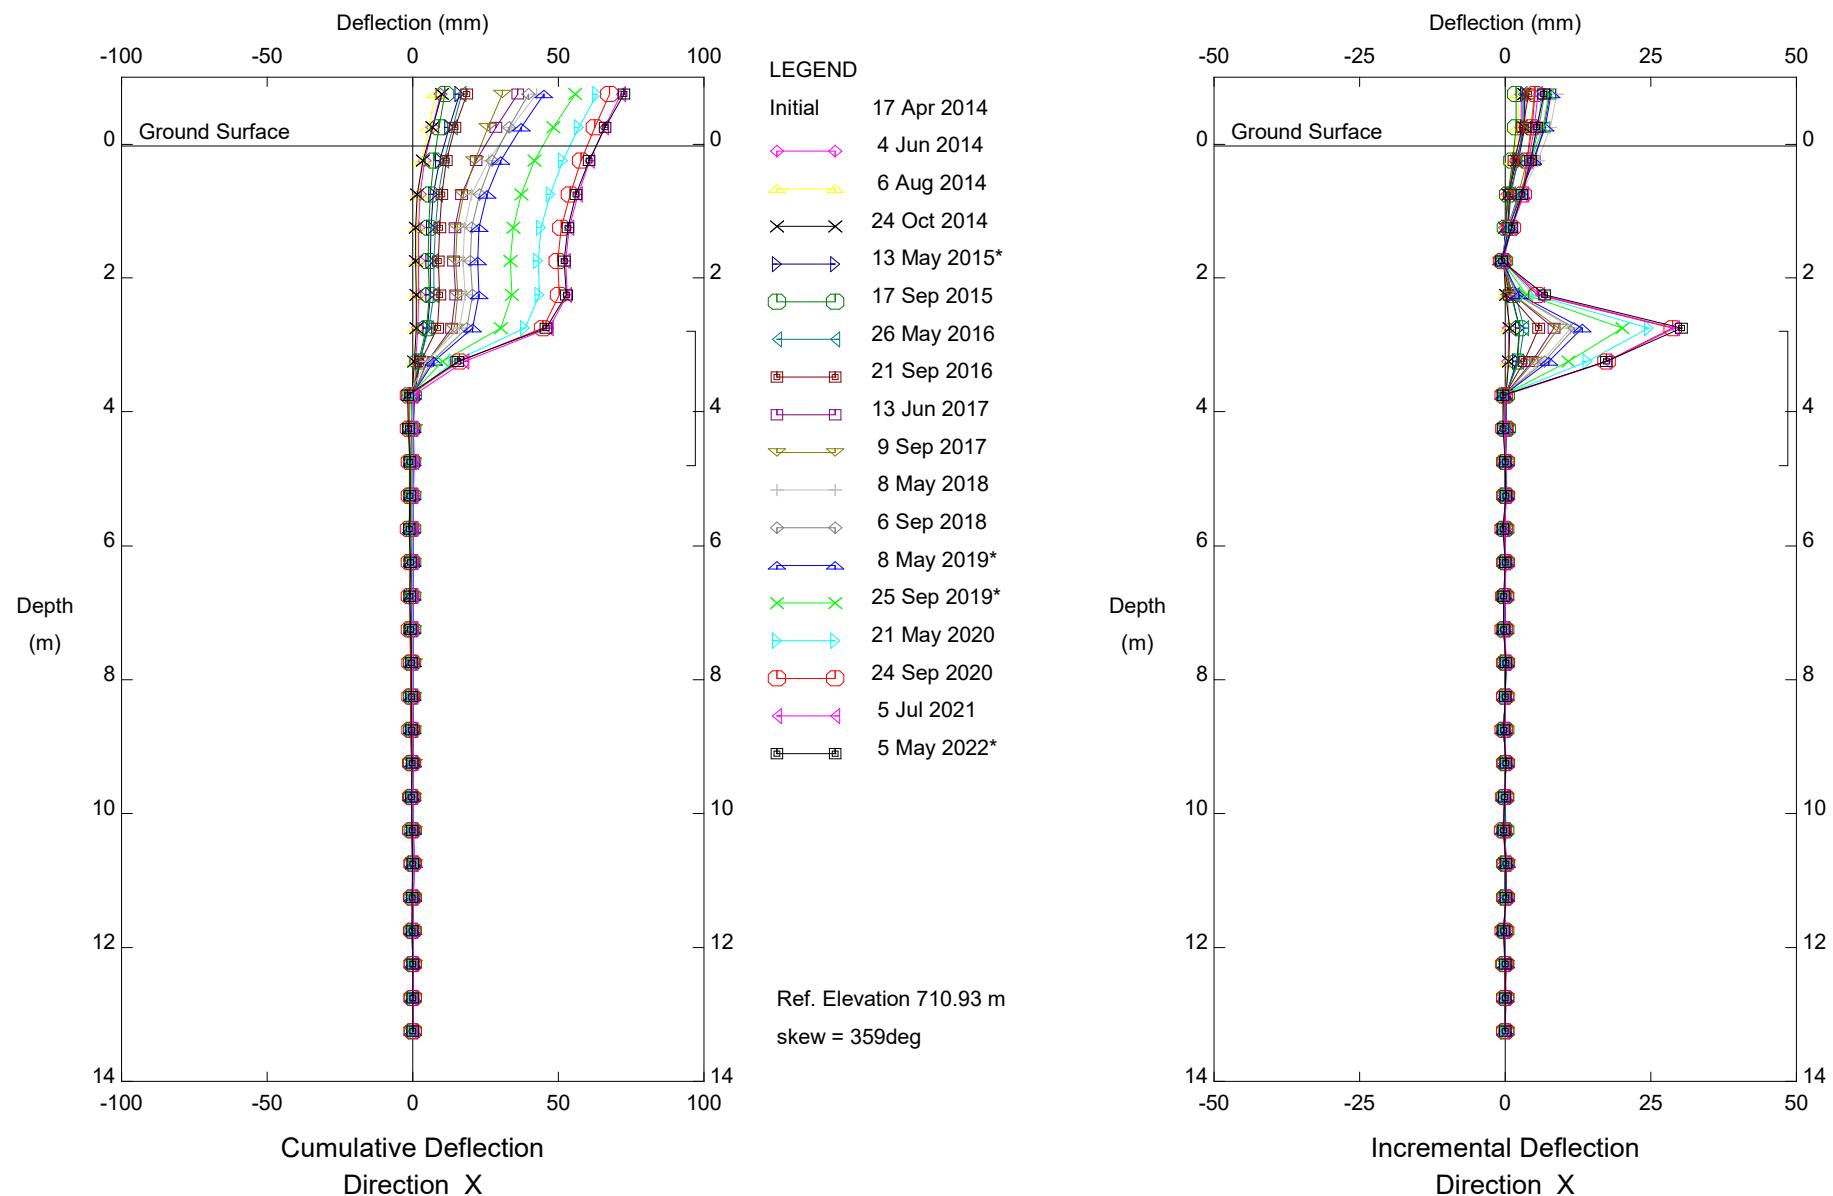
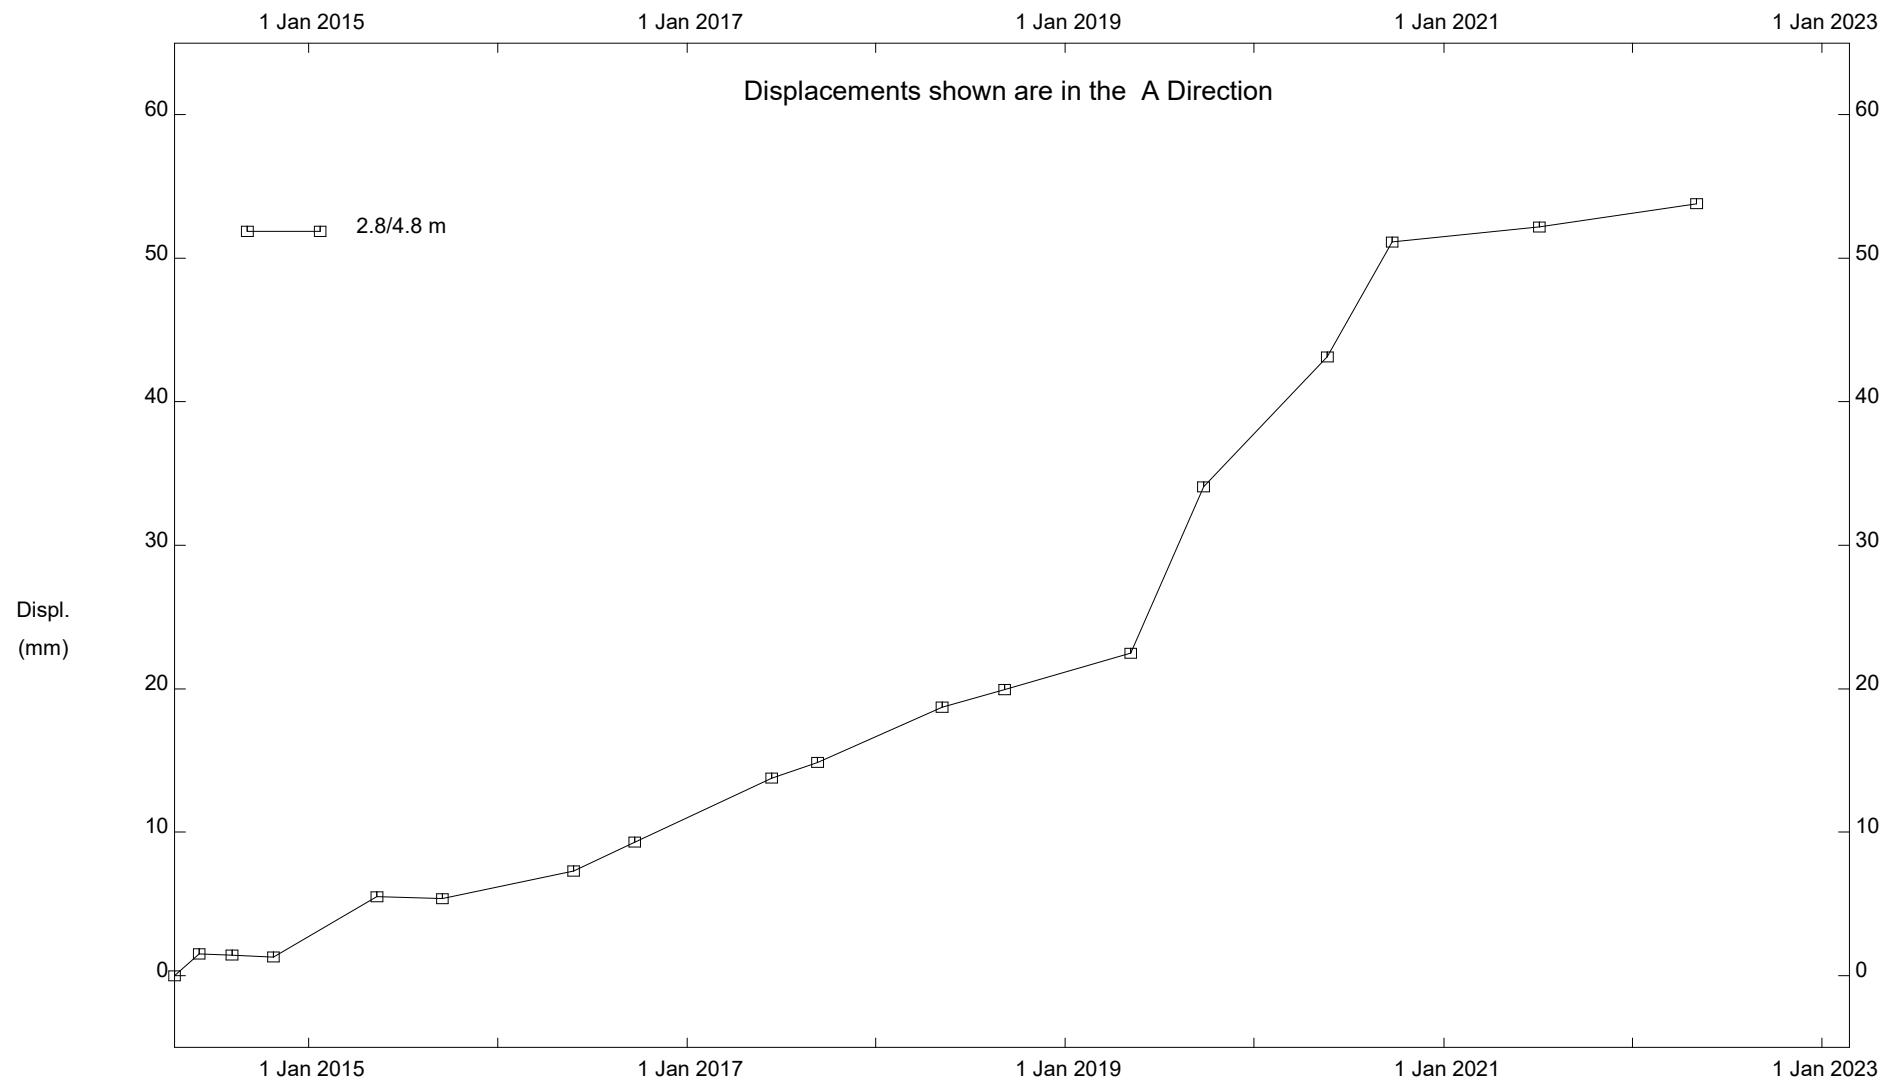
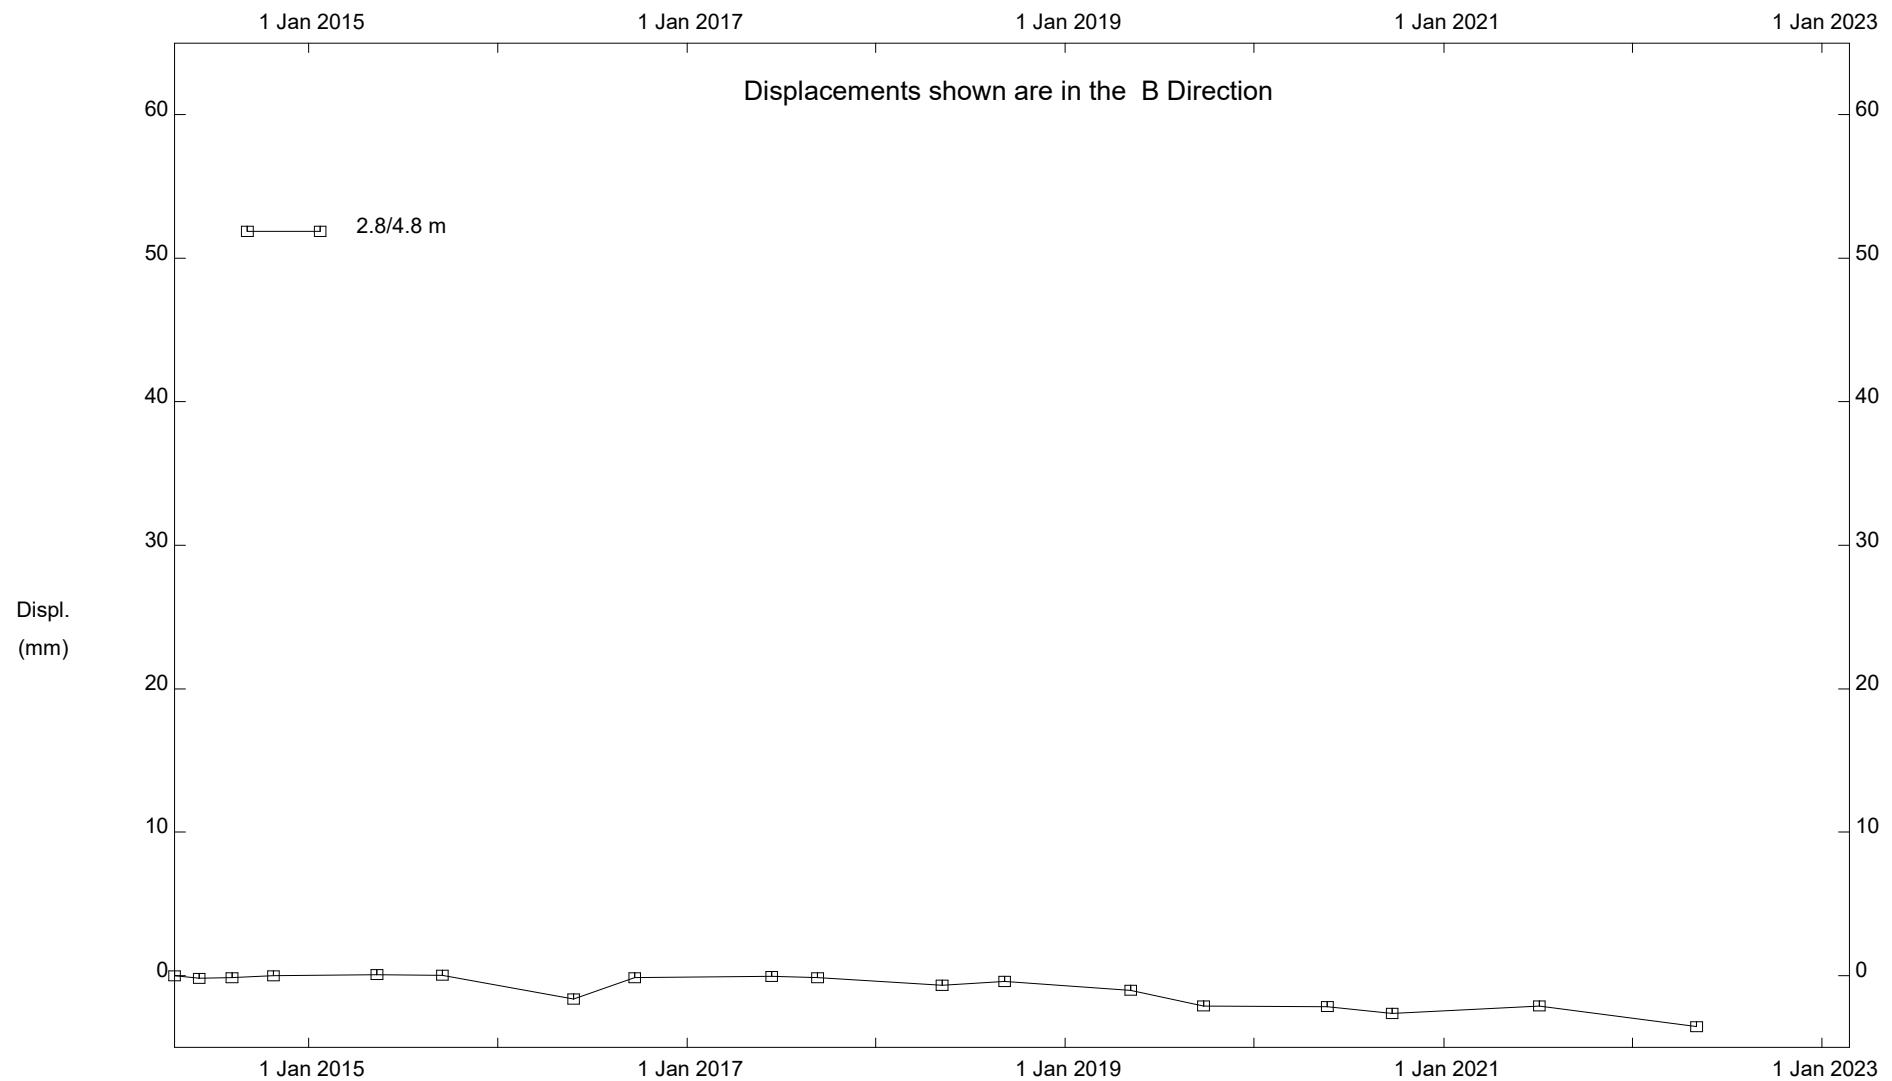
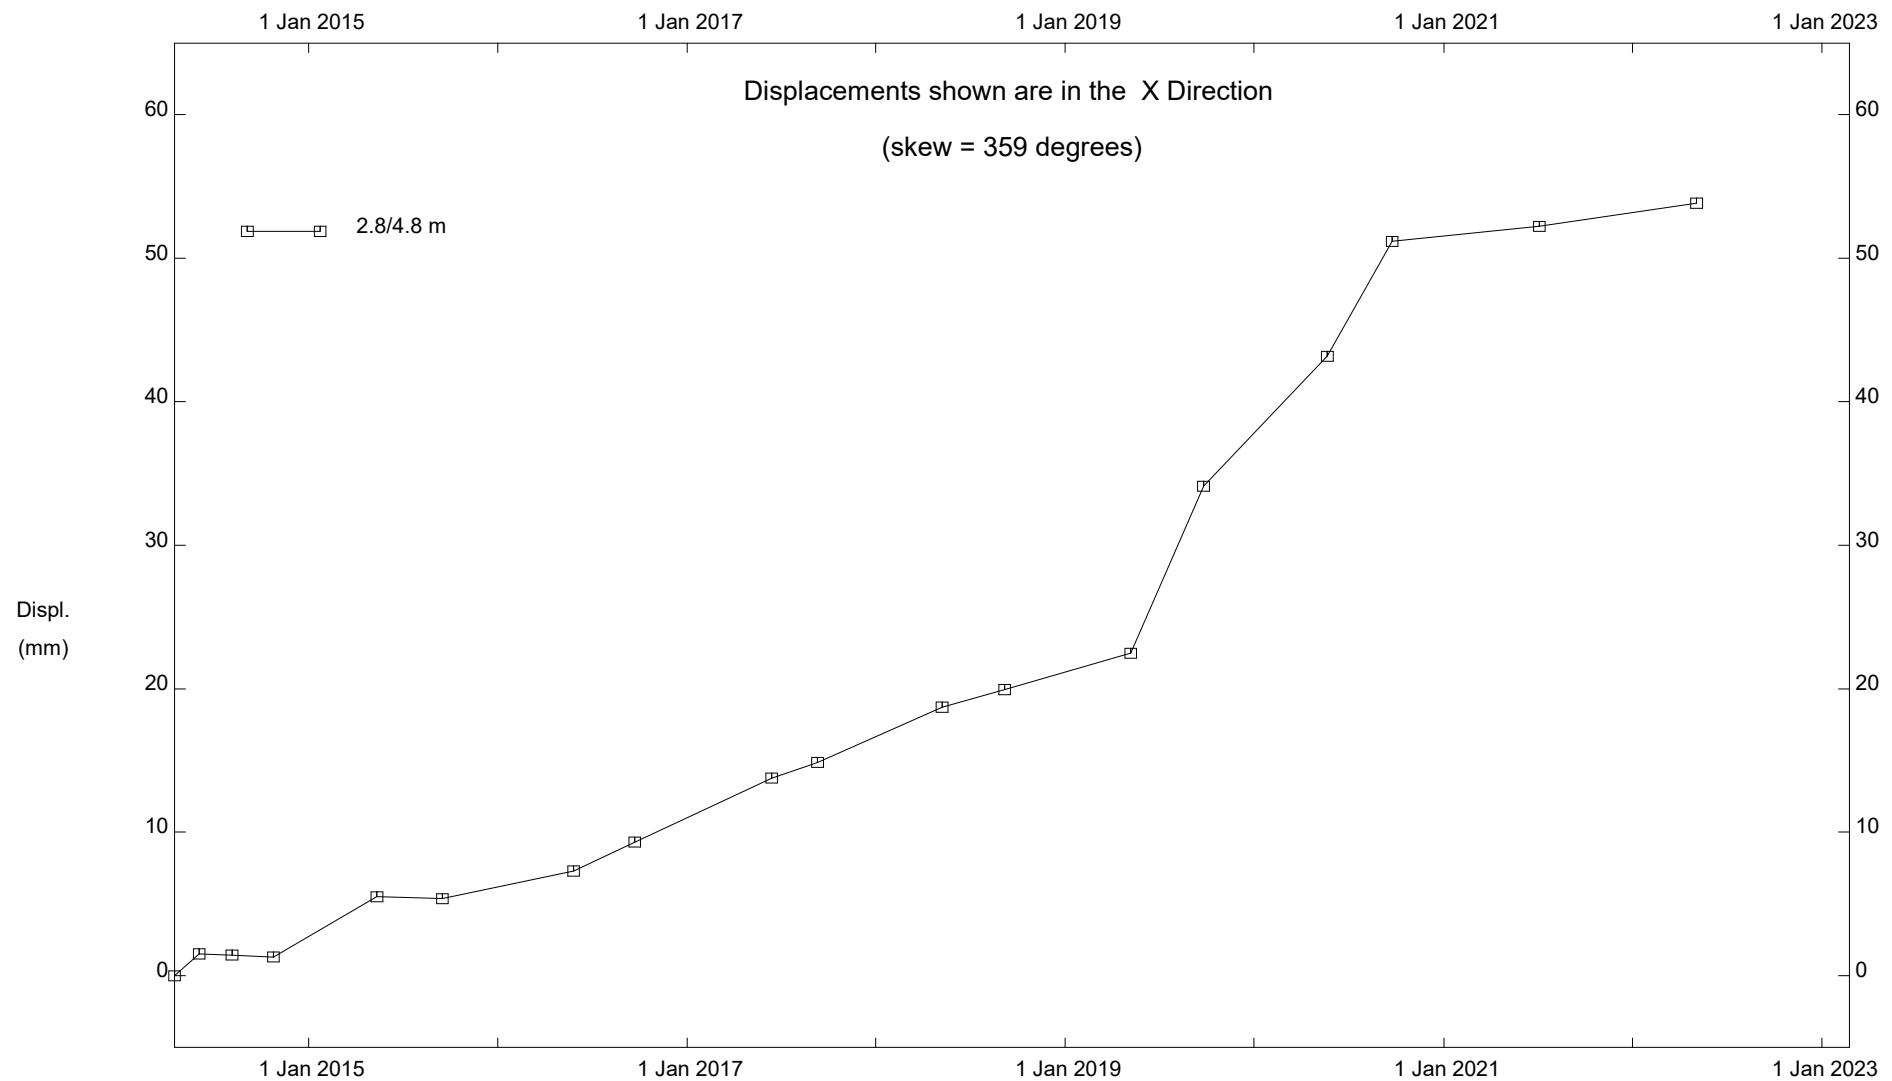
HWY 43:16 Whitecourt East Hill (NC1), Inclinometer SI14-02

SI14-02 has an average rate of movement of about 5 mm/yr since initiation to Spring 2019 at a depth of about 2.8 m to 4.8 m. The rate of movement began increasing in Fall 2019 to a movement rate of about 24 mm/yr during the Fall 2020 reading cycle. The current movement rate slowed down to 2 mm/yr with less than 1 mm of incremental movement.

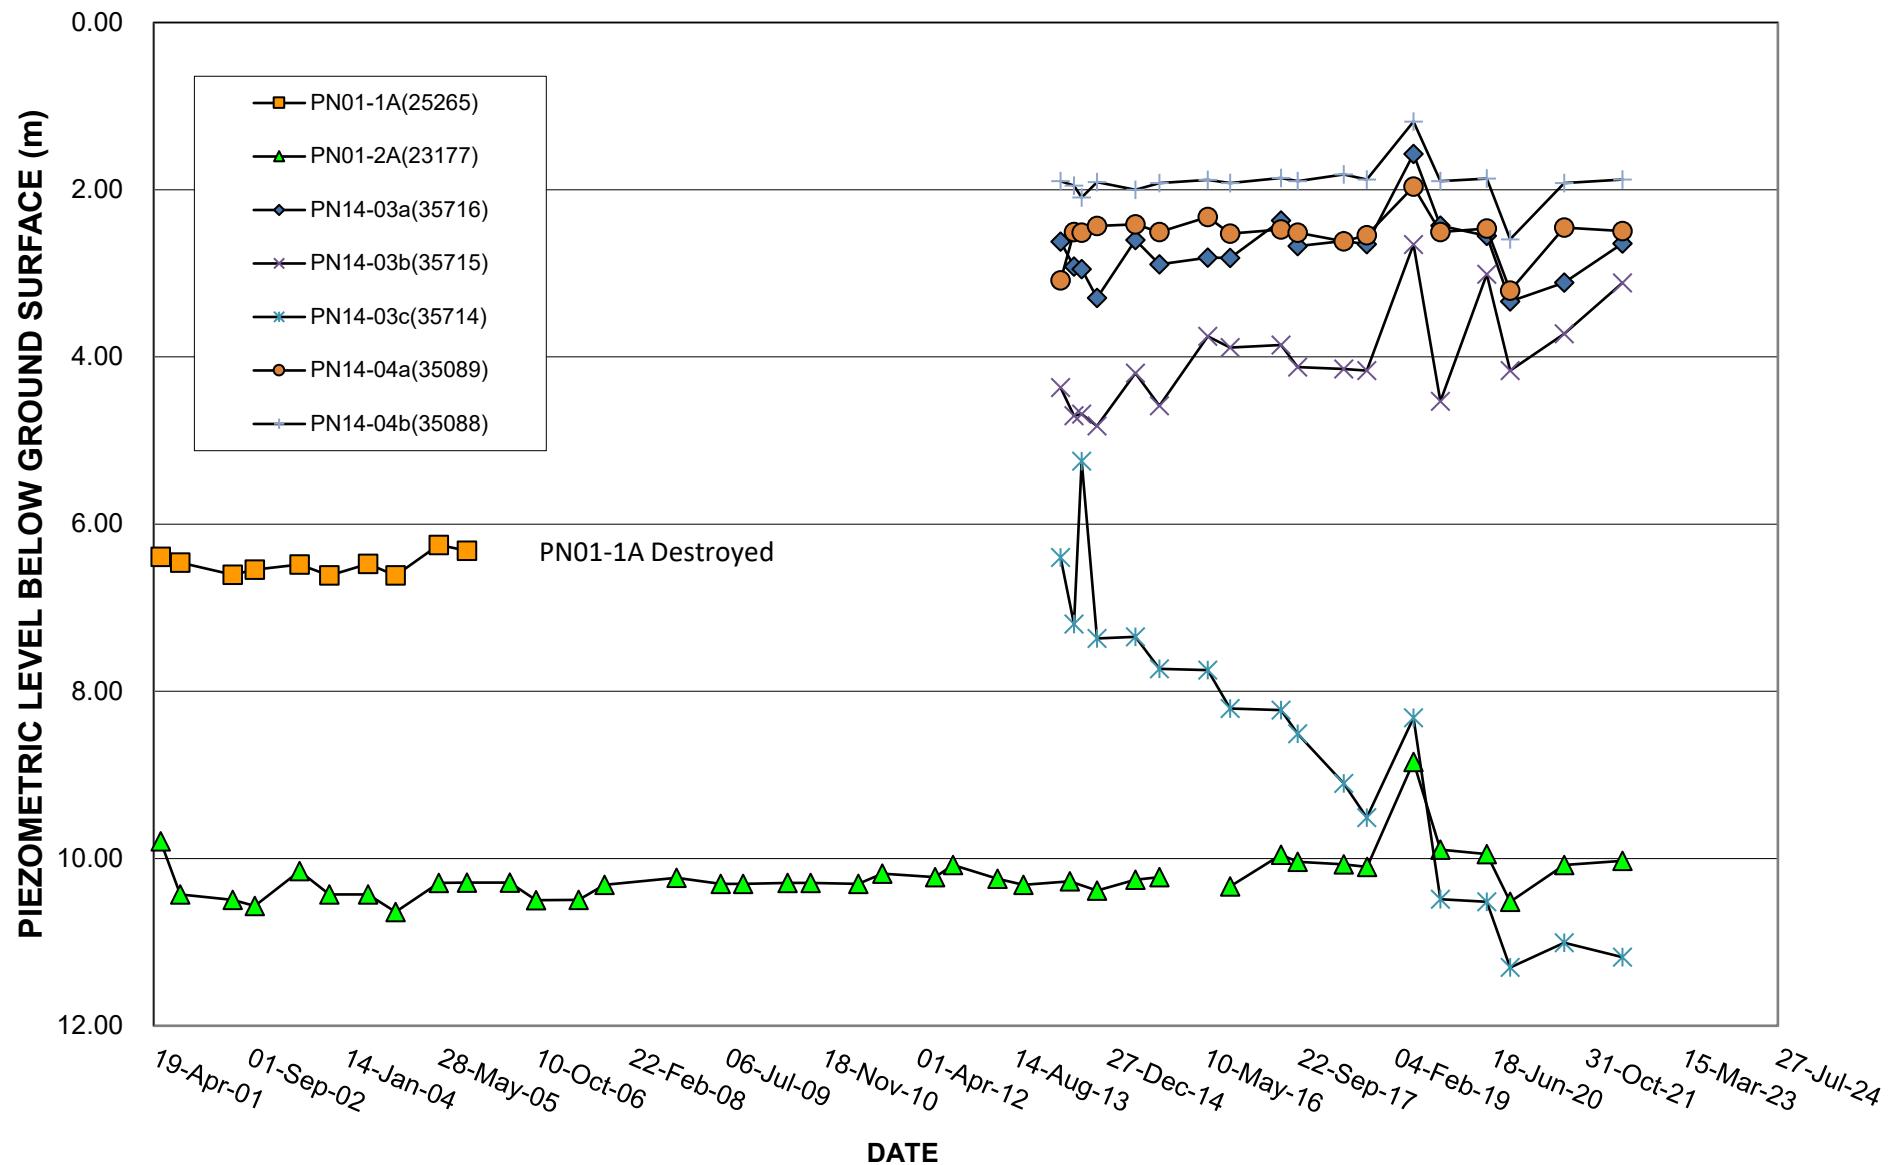
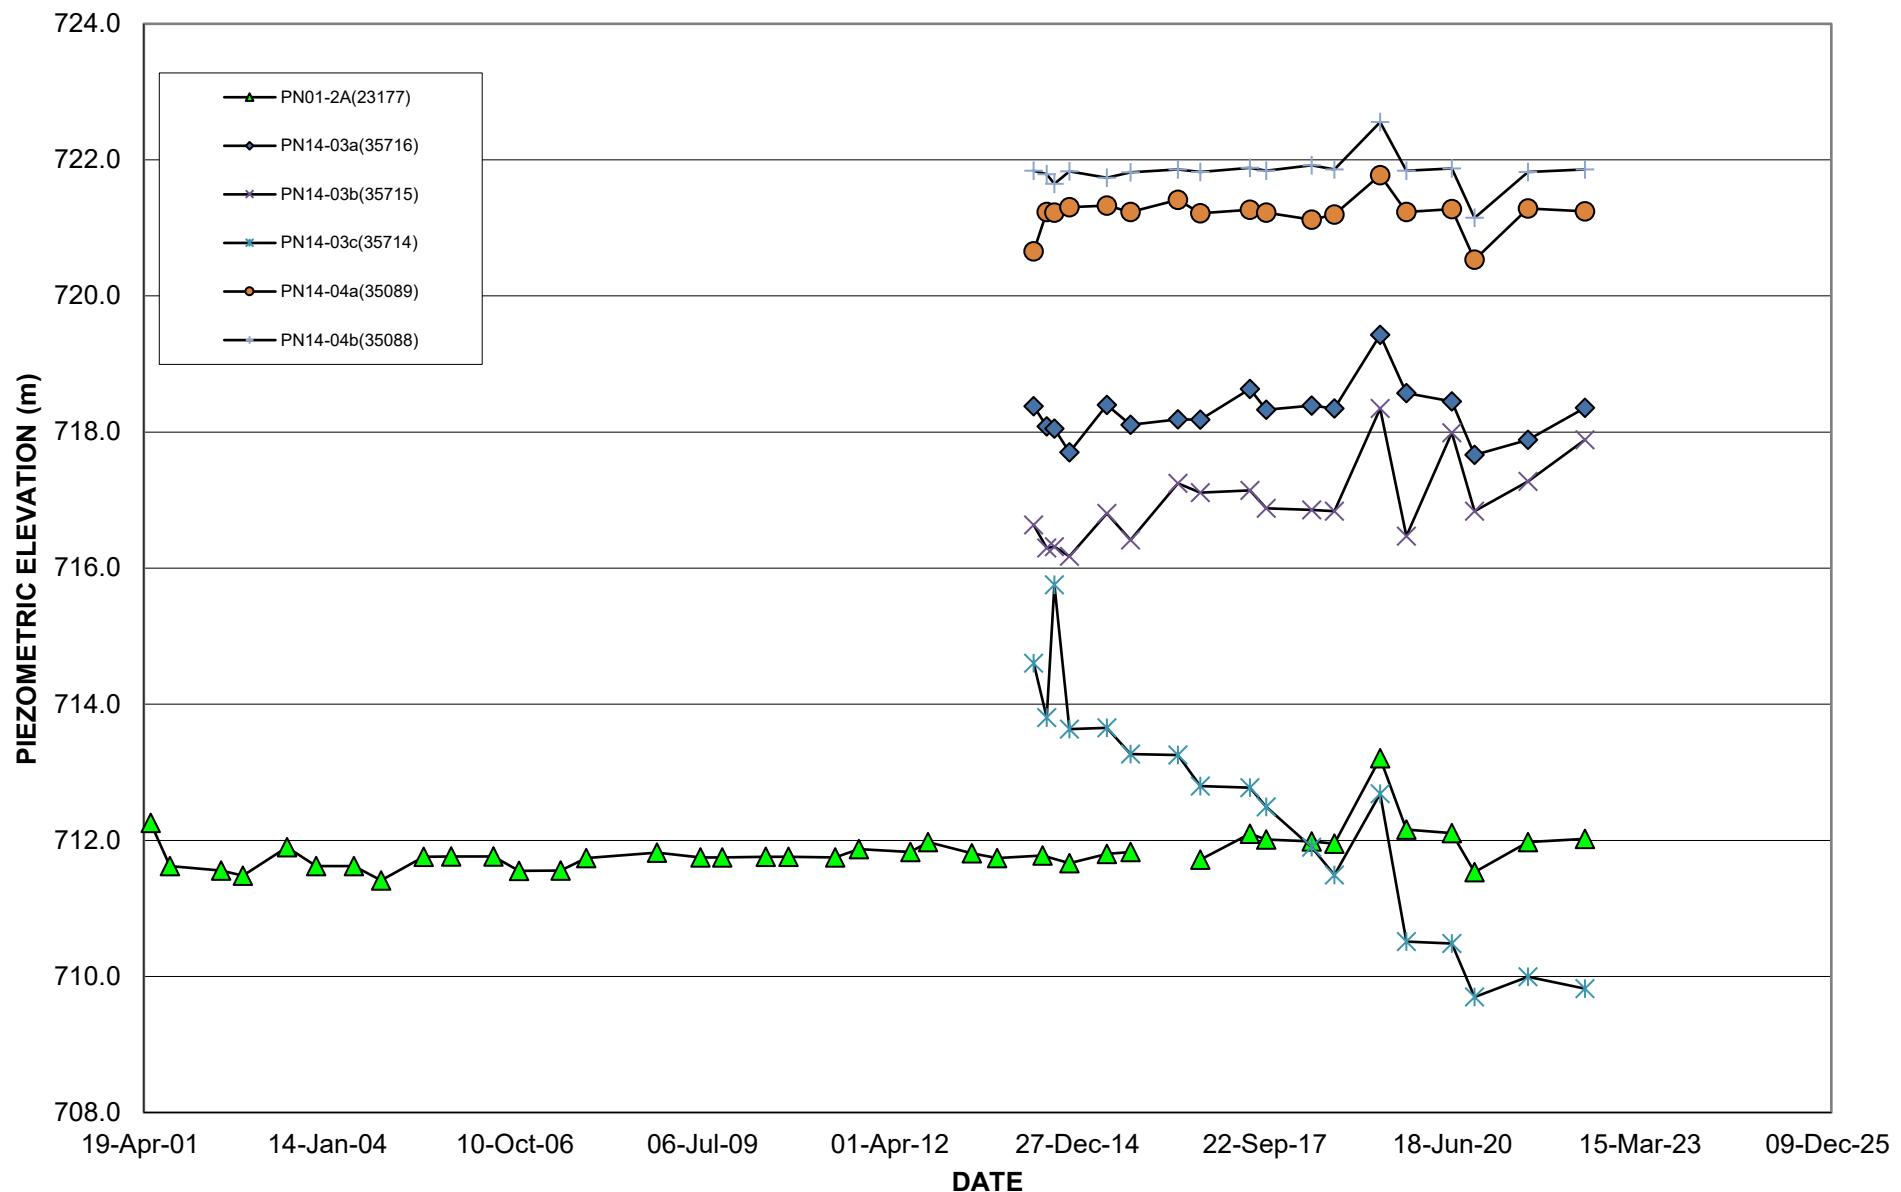
PNEUMATIC PIEZOMETER DATA

Generally, the PNs show an increase in water level up to 0.6 m since the Spring 2021 reading cycle except for PN14-03 which showed a decrease of 0.2. Most of the pneumatic piezometers have marginal changes since initialization except for PN14-03c which has decreased by about 4.9 m since initialization in 2014.

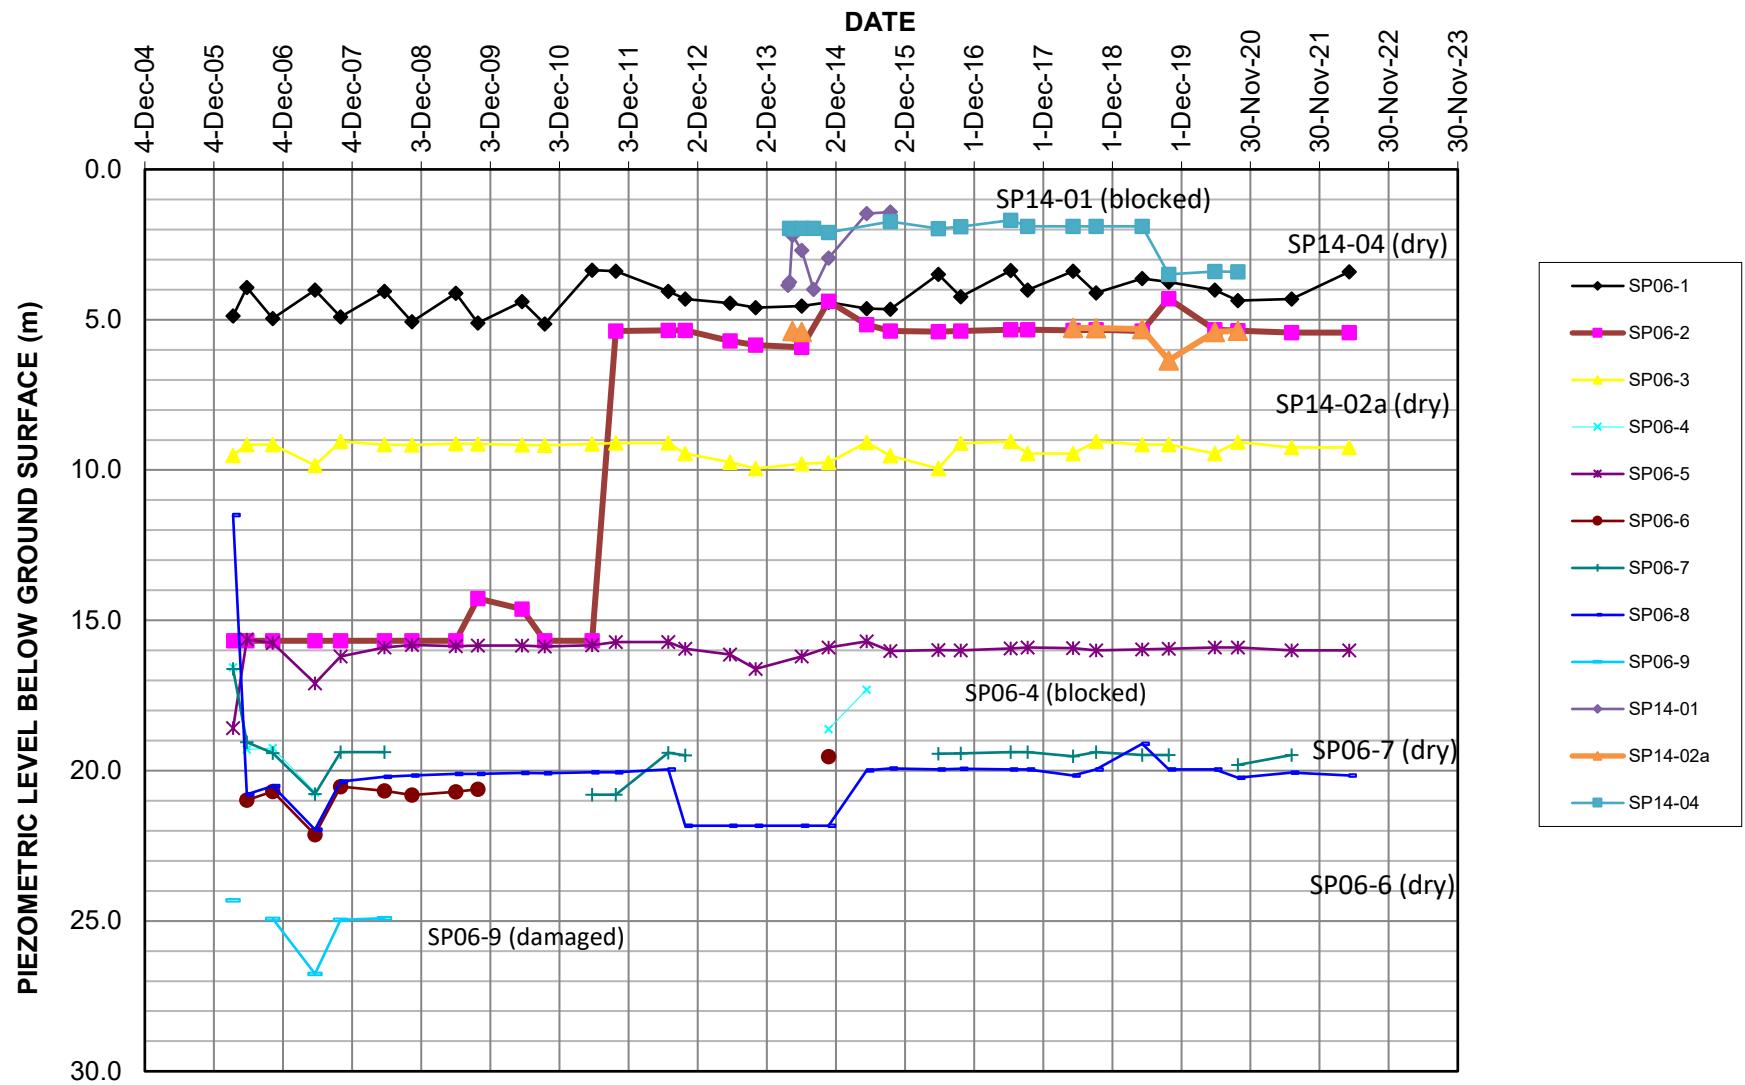
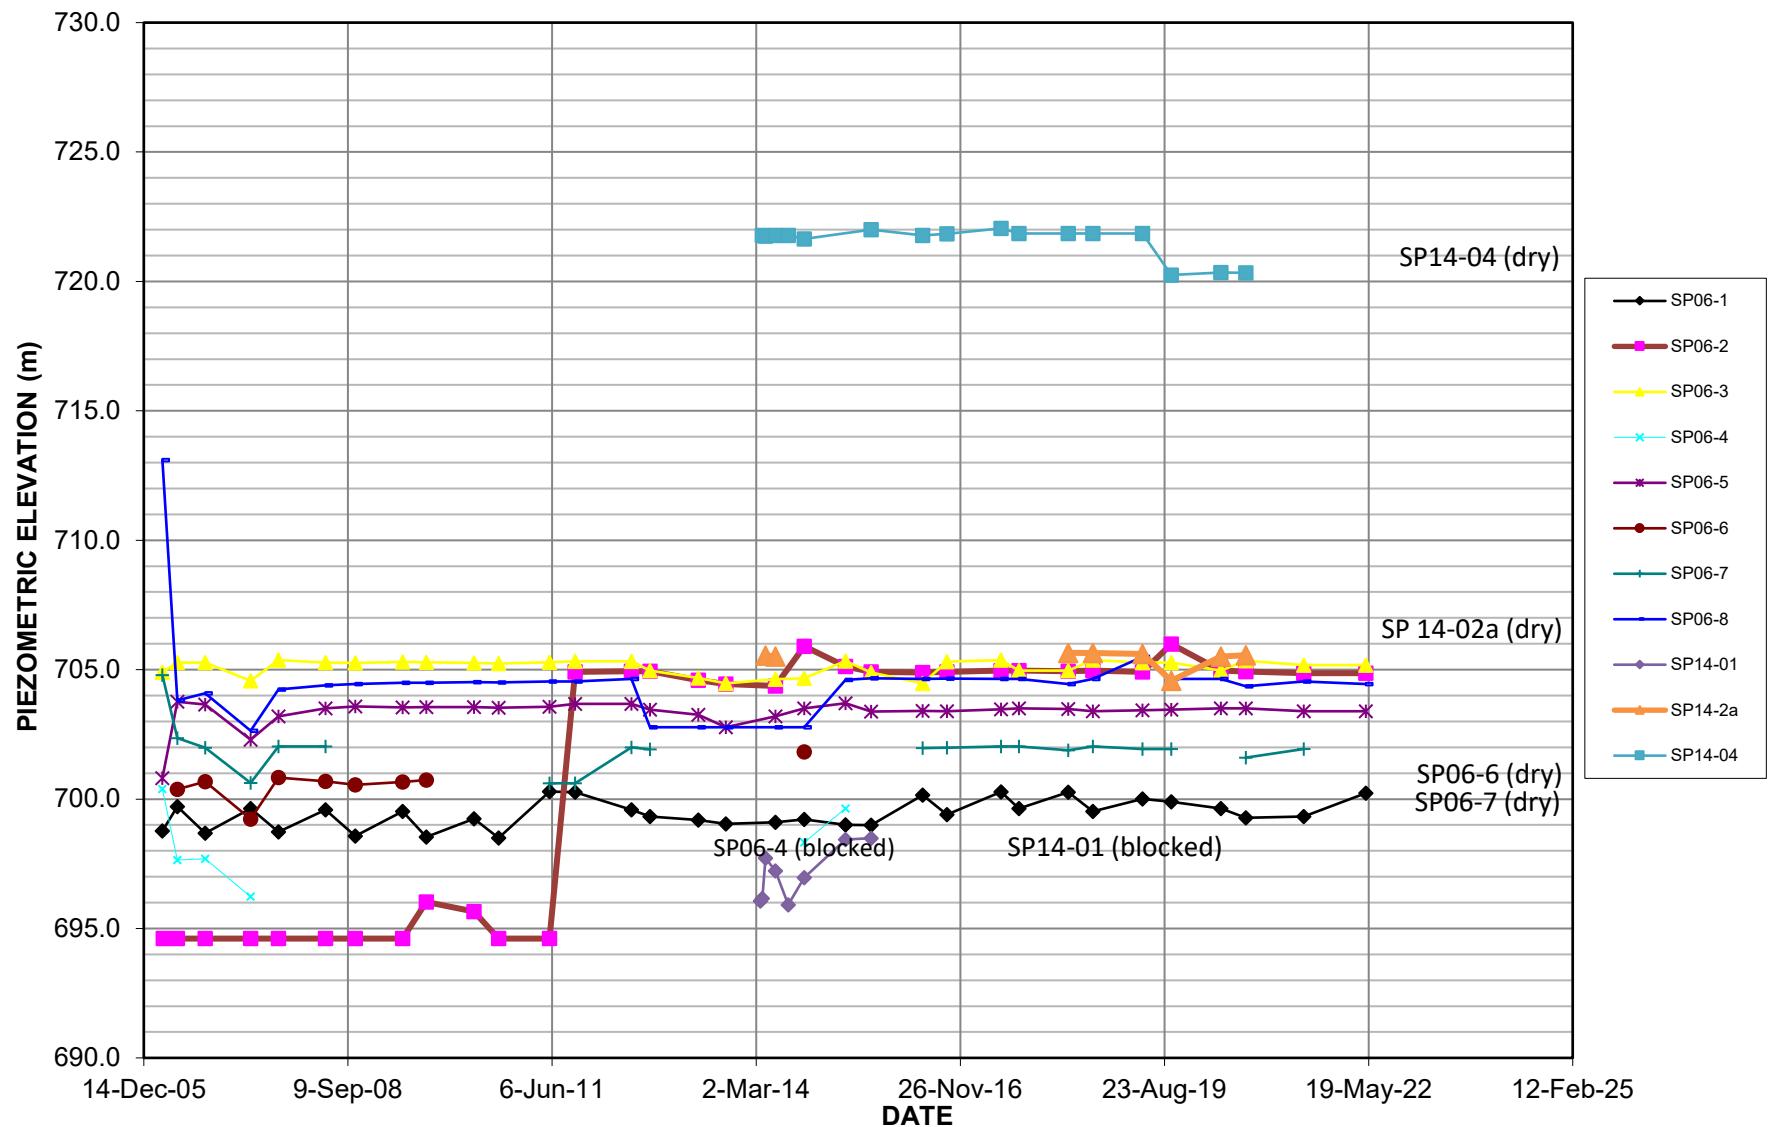
STANDPIPE PIEZOMETER DATA

The current SP water level readings generally showed change in piezometric levels from 0.1 m decrease to 0.1 m increase since Spring 2021 except for SP06-1 which showed an increase in water level of 0.9 m. In addition, SP06-7 previously recorded water at 19.5 m below ground surface (bgs) and was found dry to standpipe bottom (20.8 mbgs) during the current reading. Most of the standpipes have marginal changes since about 2006.

SP14-04 (deep) SP was measured for the first time in Spring 2022 reading cycle and piezometric level observed to be 3.4 m bgs.
