To:	Amy Driessen	From:	Leslie Cho and Xiteng Liu
	Transportation and Economic Corridors		Stantec Consulting Ltd.
File:	123315222	Date:	June 18, 2024

Reference: North Central Region, Edson, Site NC001 - Highway 43:16 Whitecourt East Hill Spring 2024 Instrumentation Monitoring Report

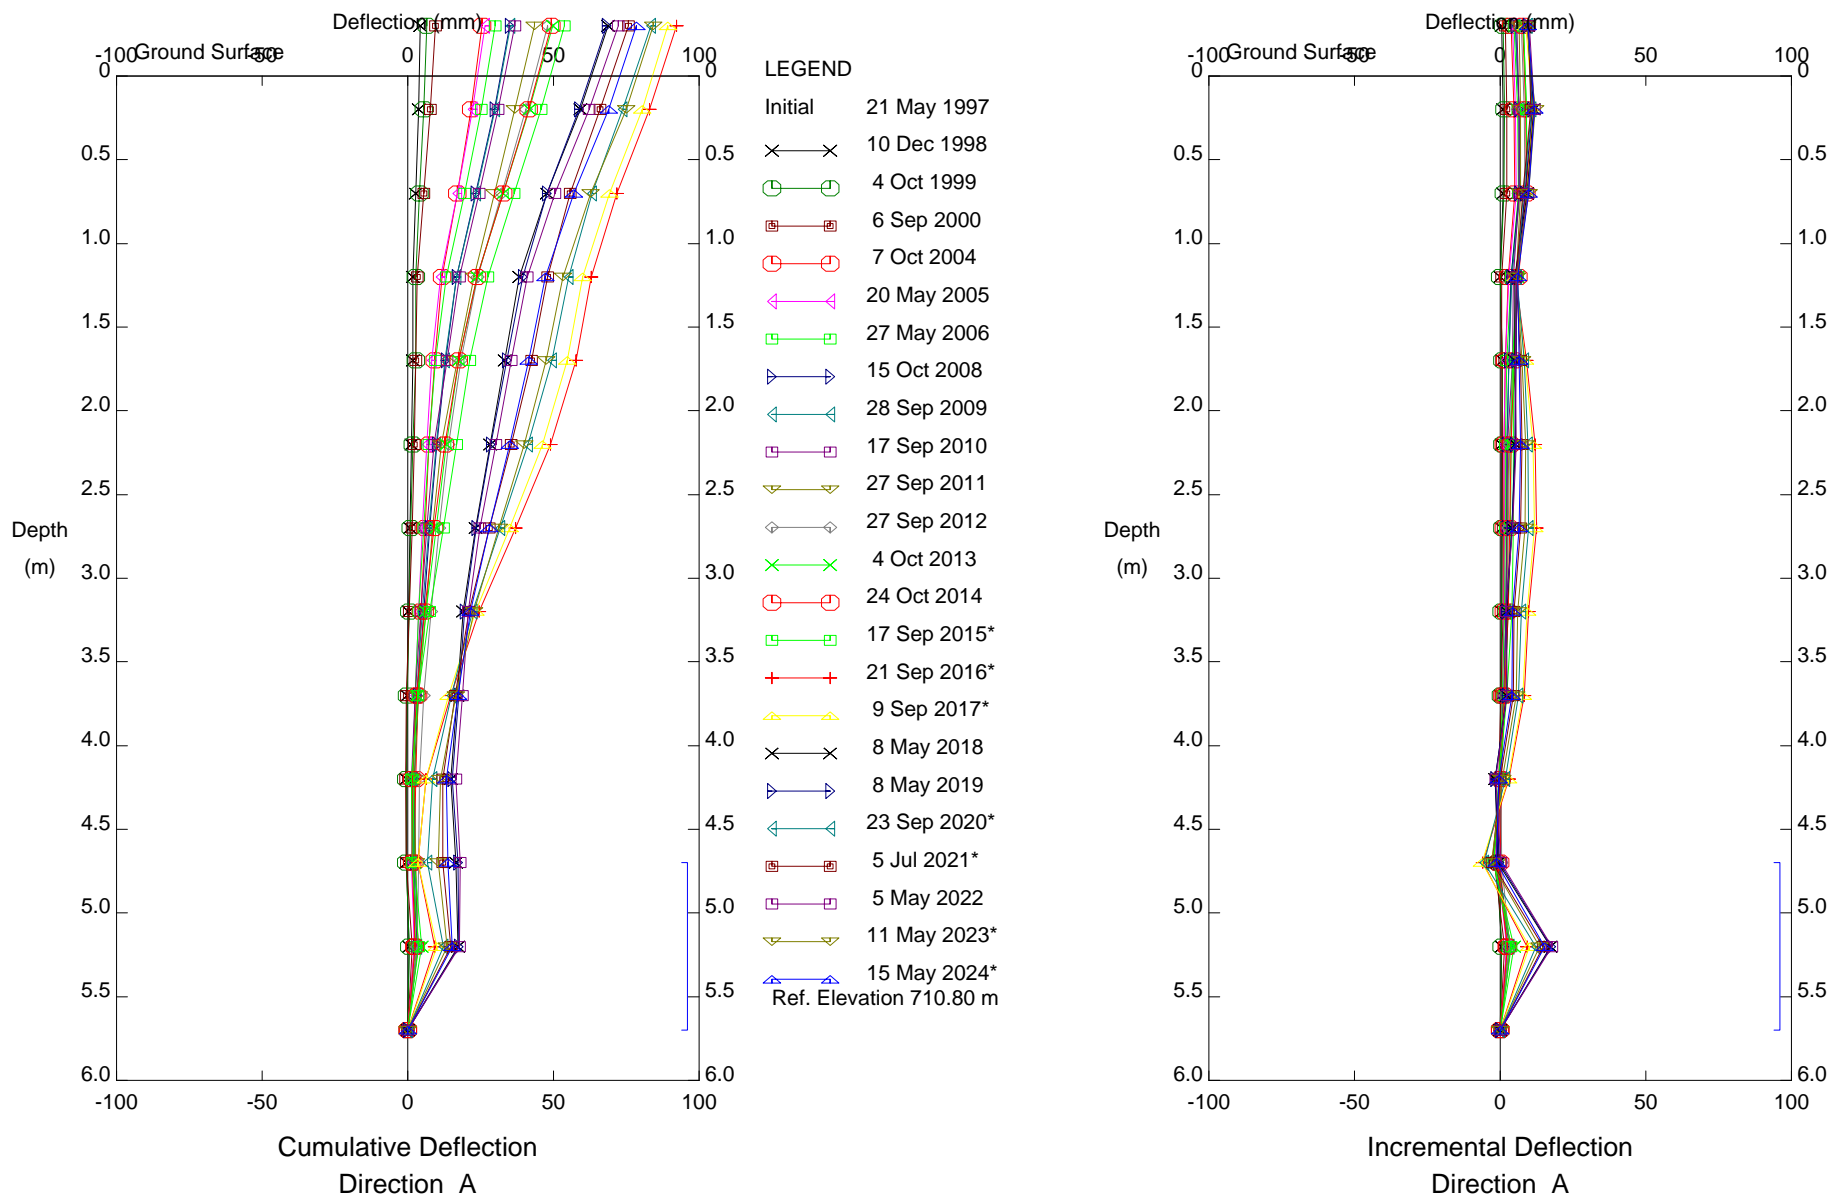
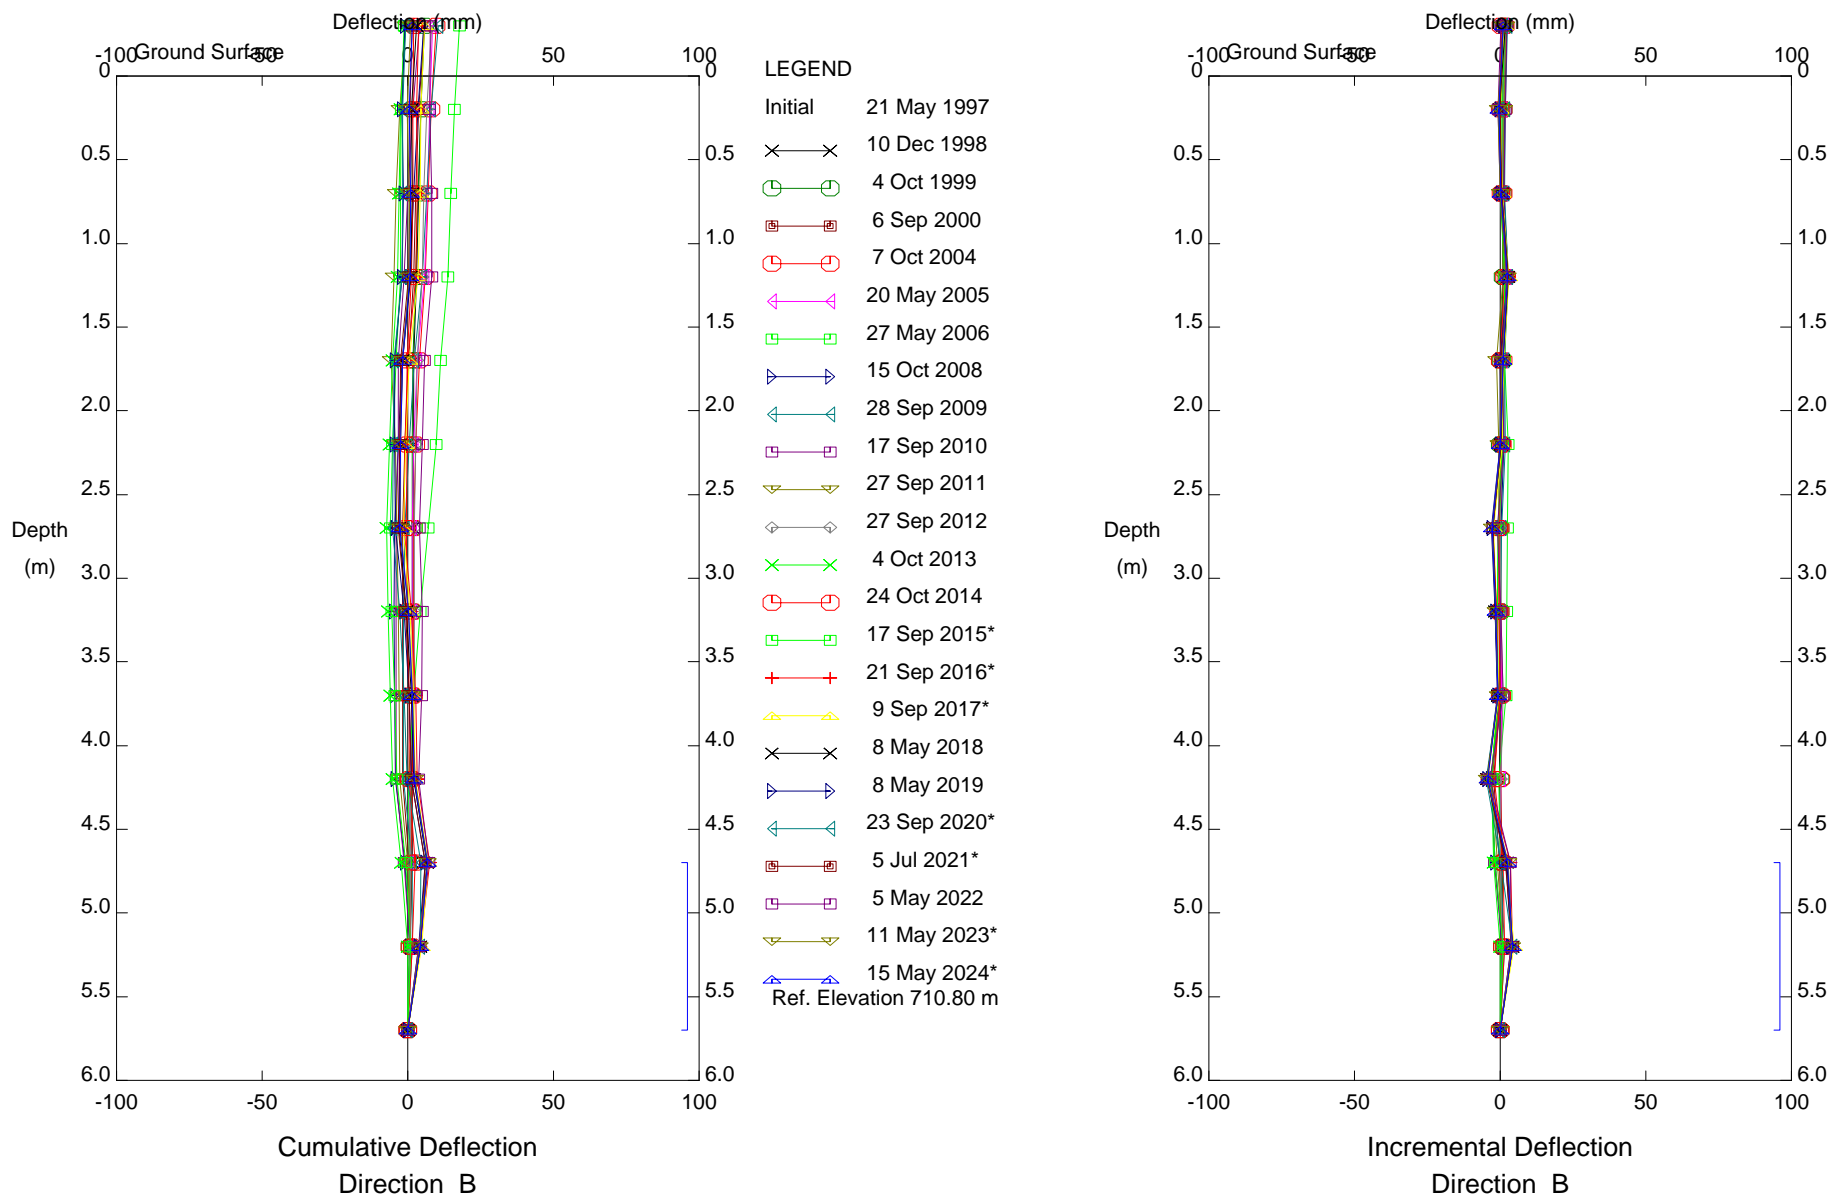
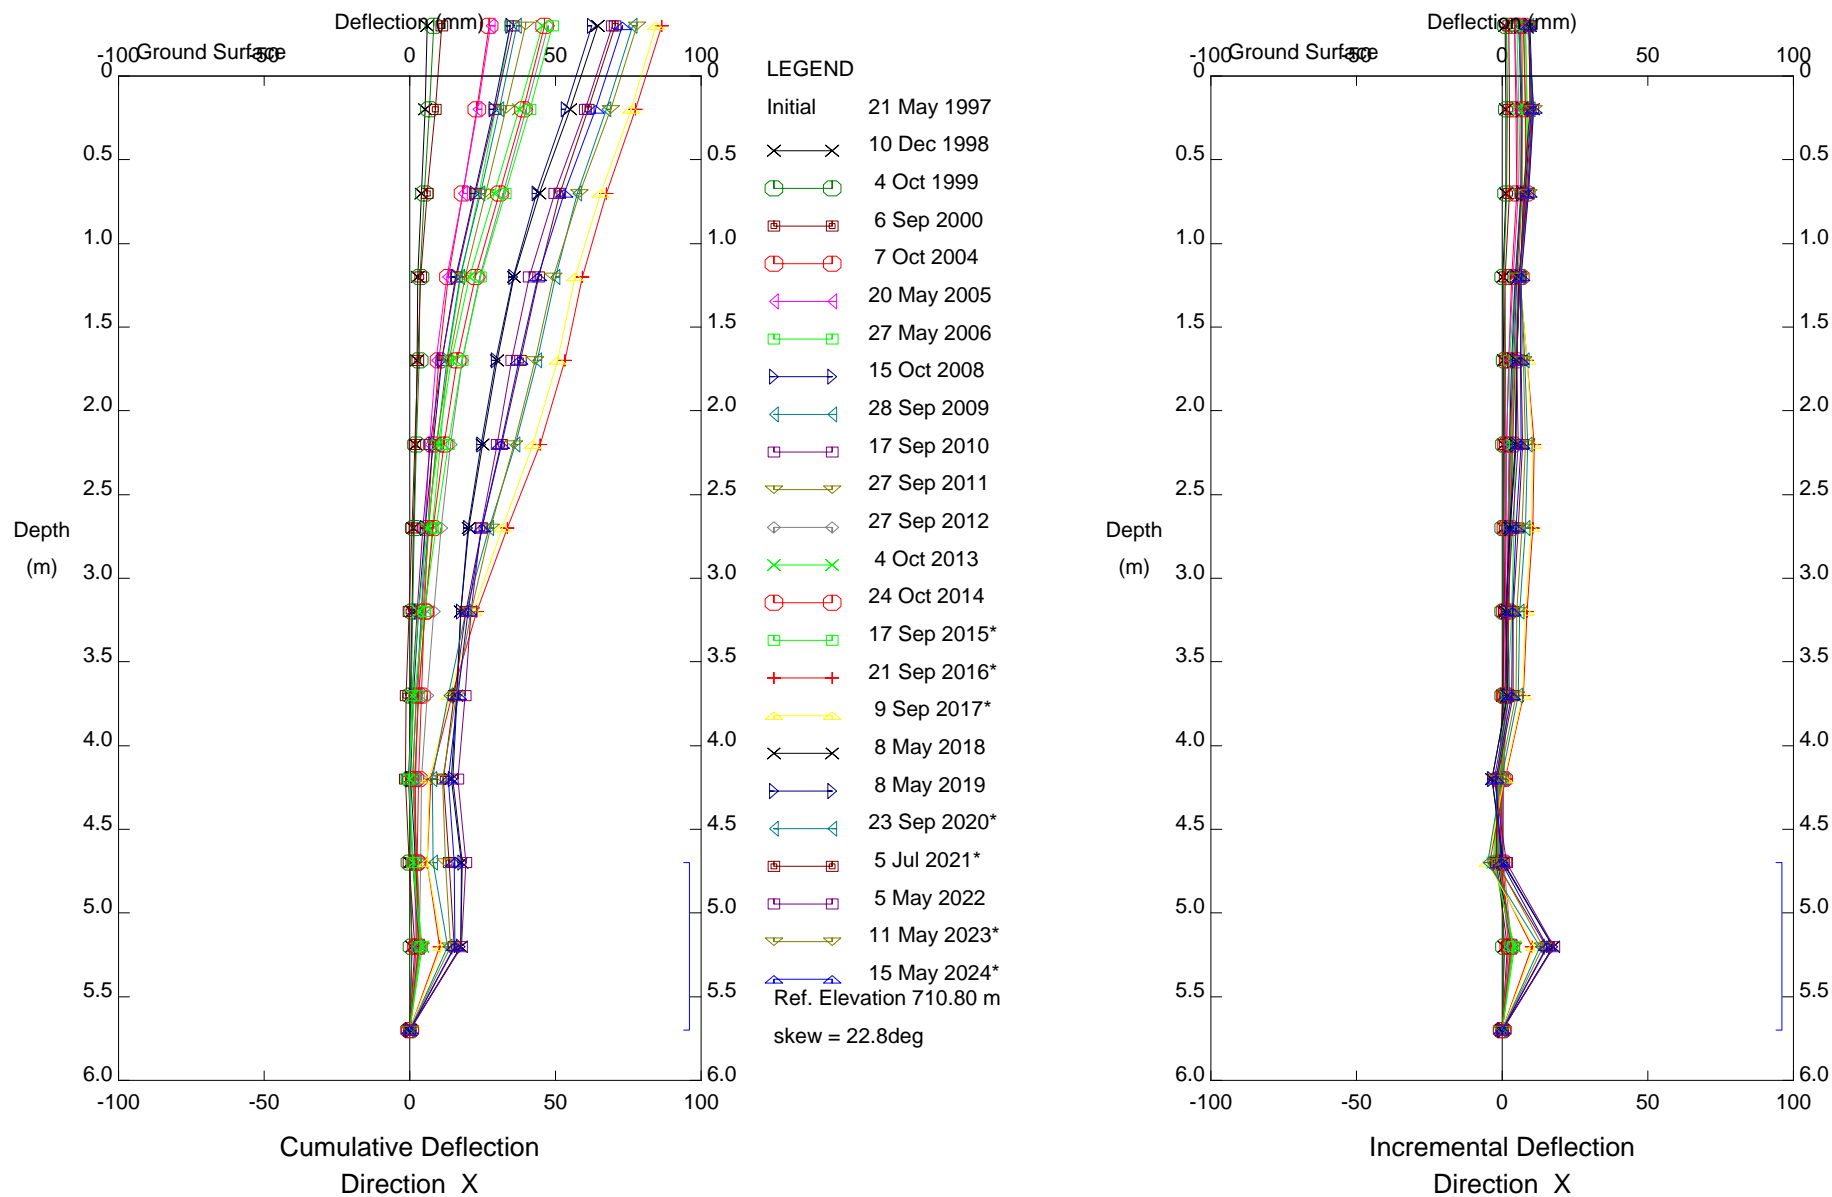
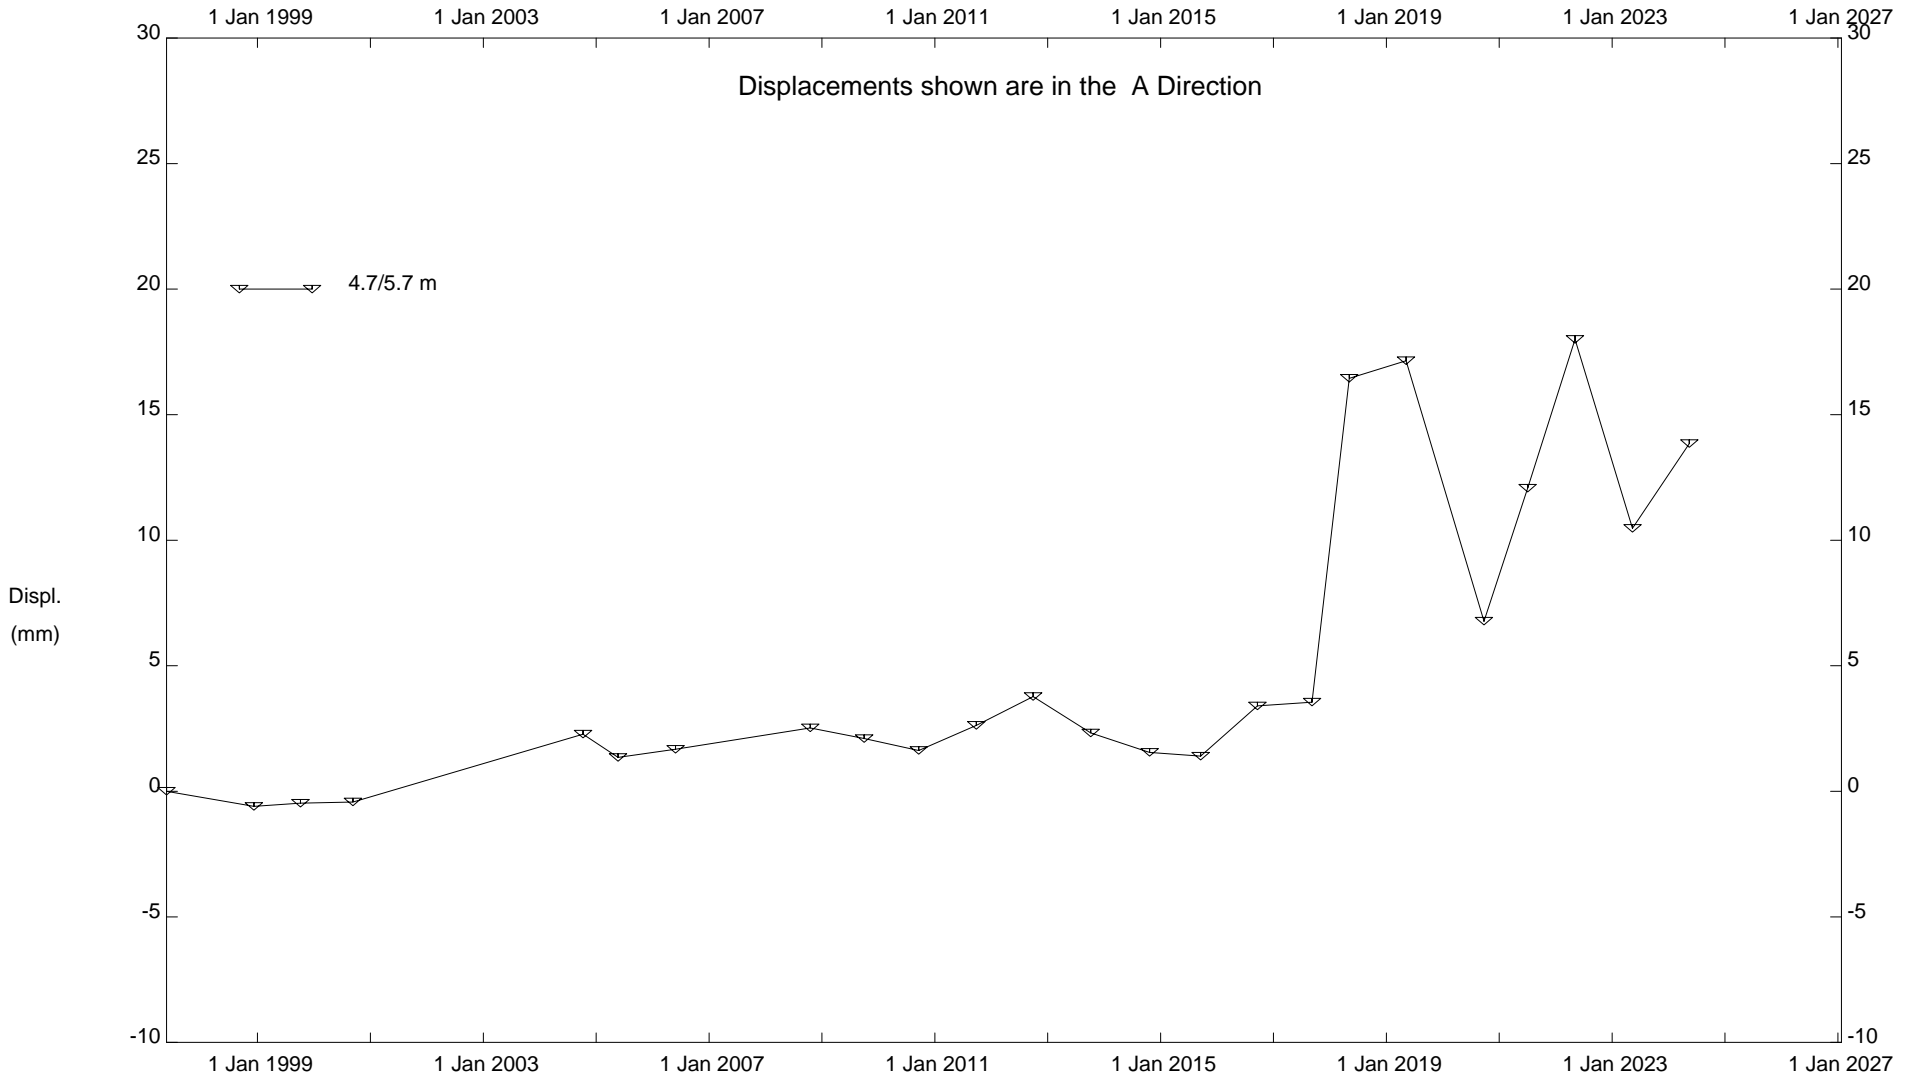
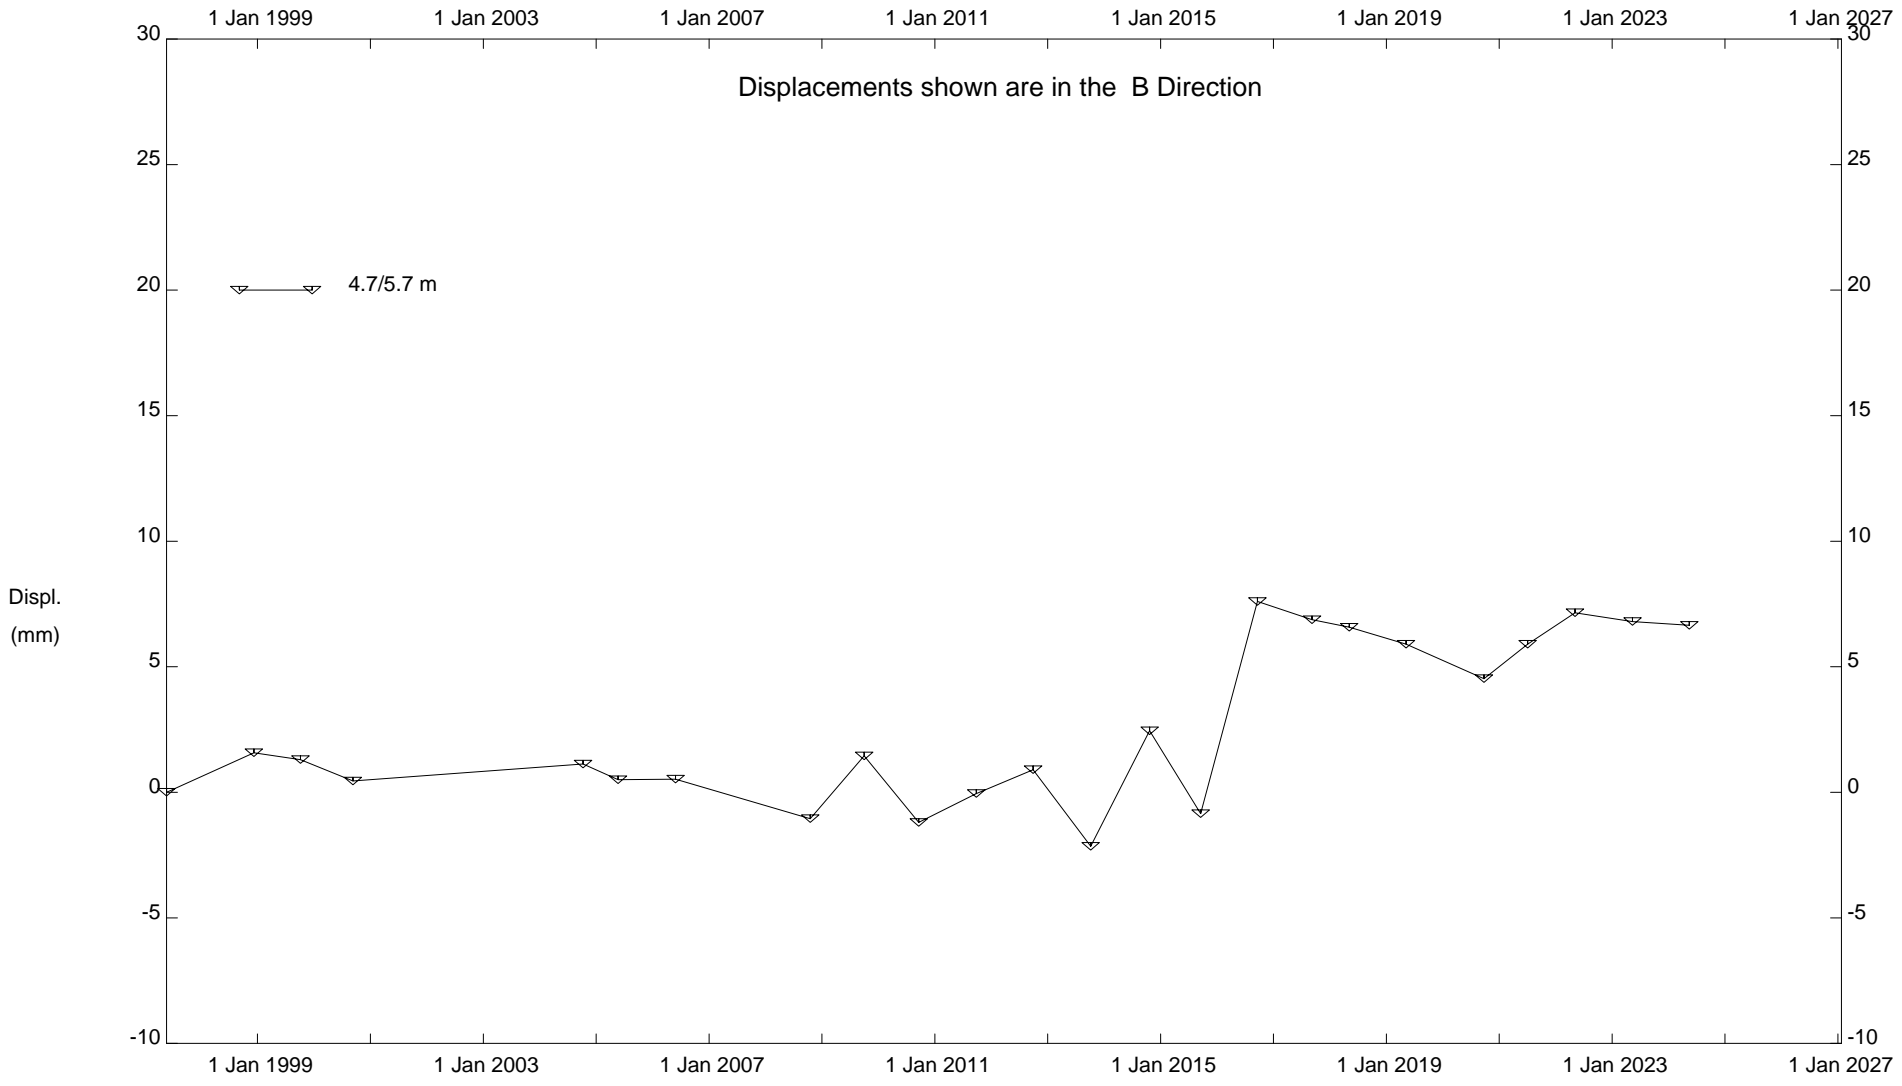
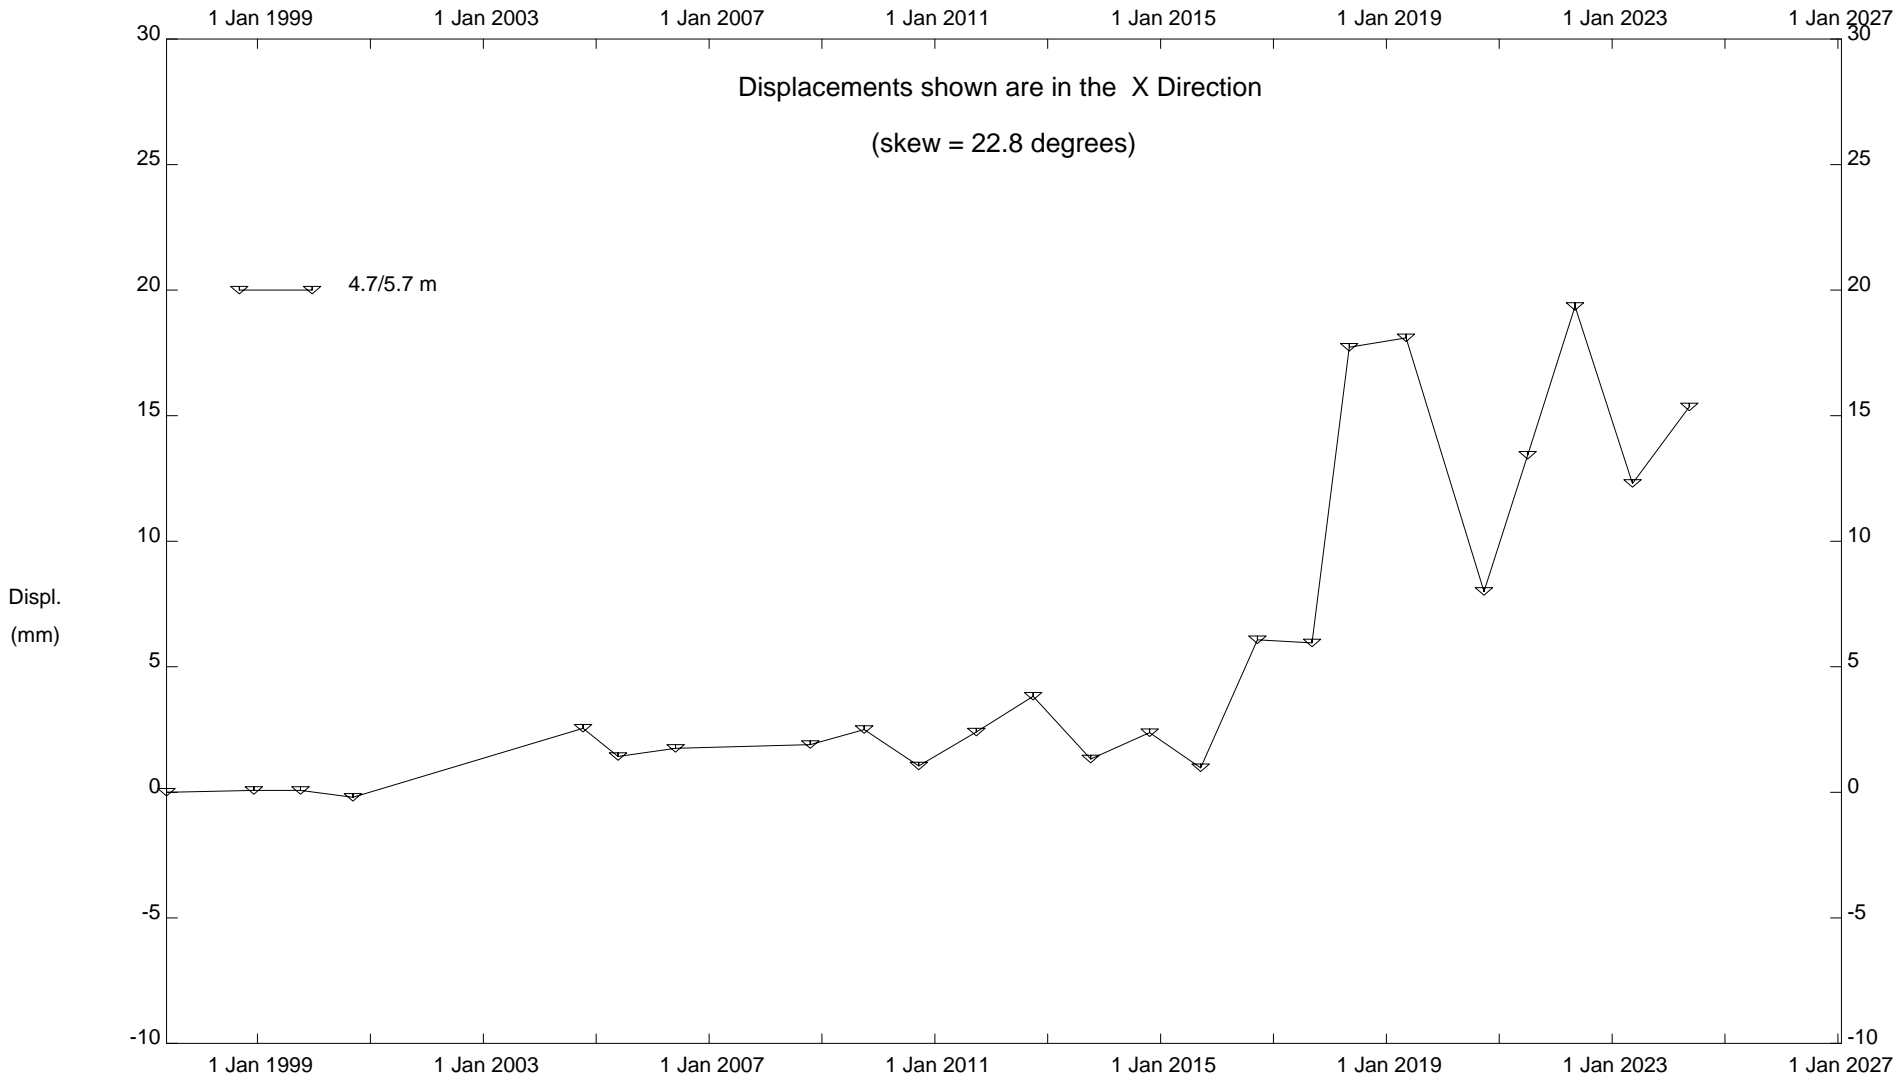
HWY 43:16 Whitecourt East Hill (NC1), Inclinometer SI5
 Transportation & Economic Corridors

SI5 recorded a total cumulative movement of 15 mm, with a current movement rate of 3 mm/yr. The abrupt movement recorded between Fall 2015 and Spring 2016 is likely associated with the change of SI probe rather than actual movement.

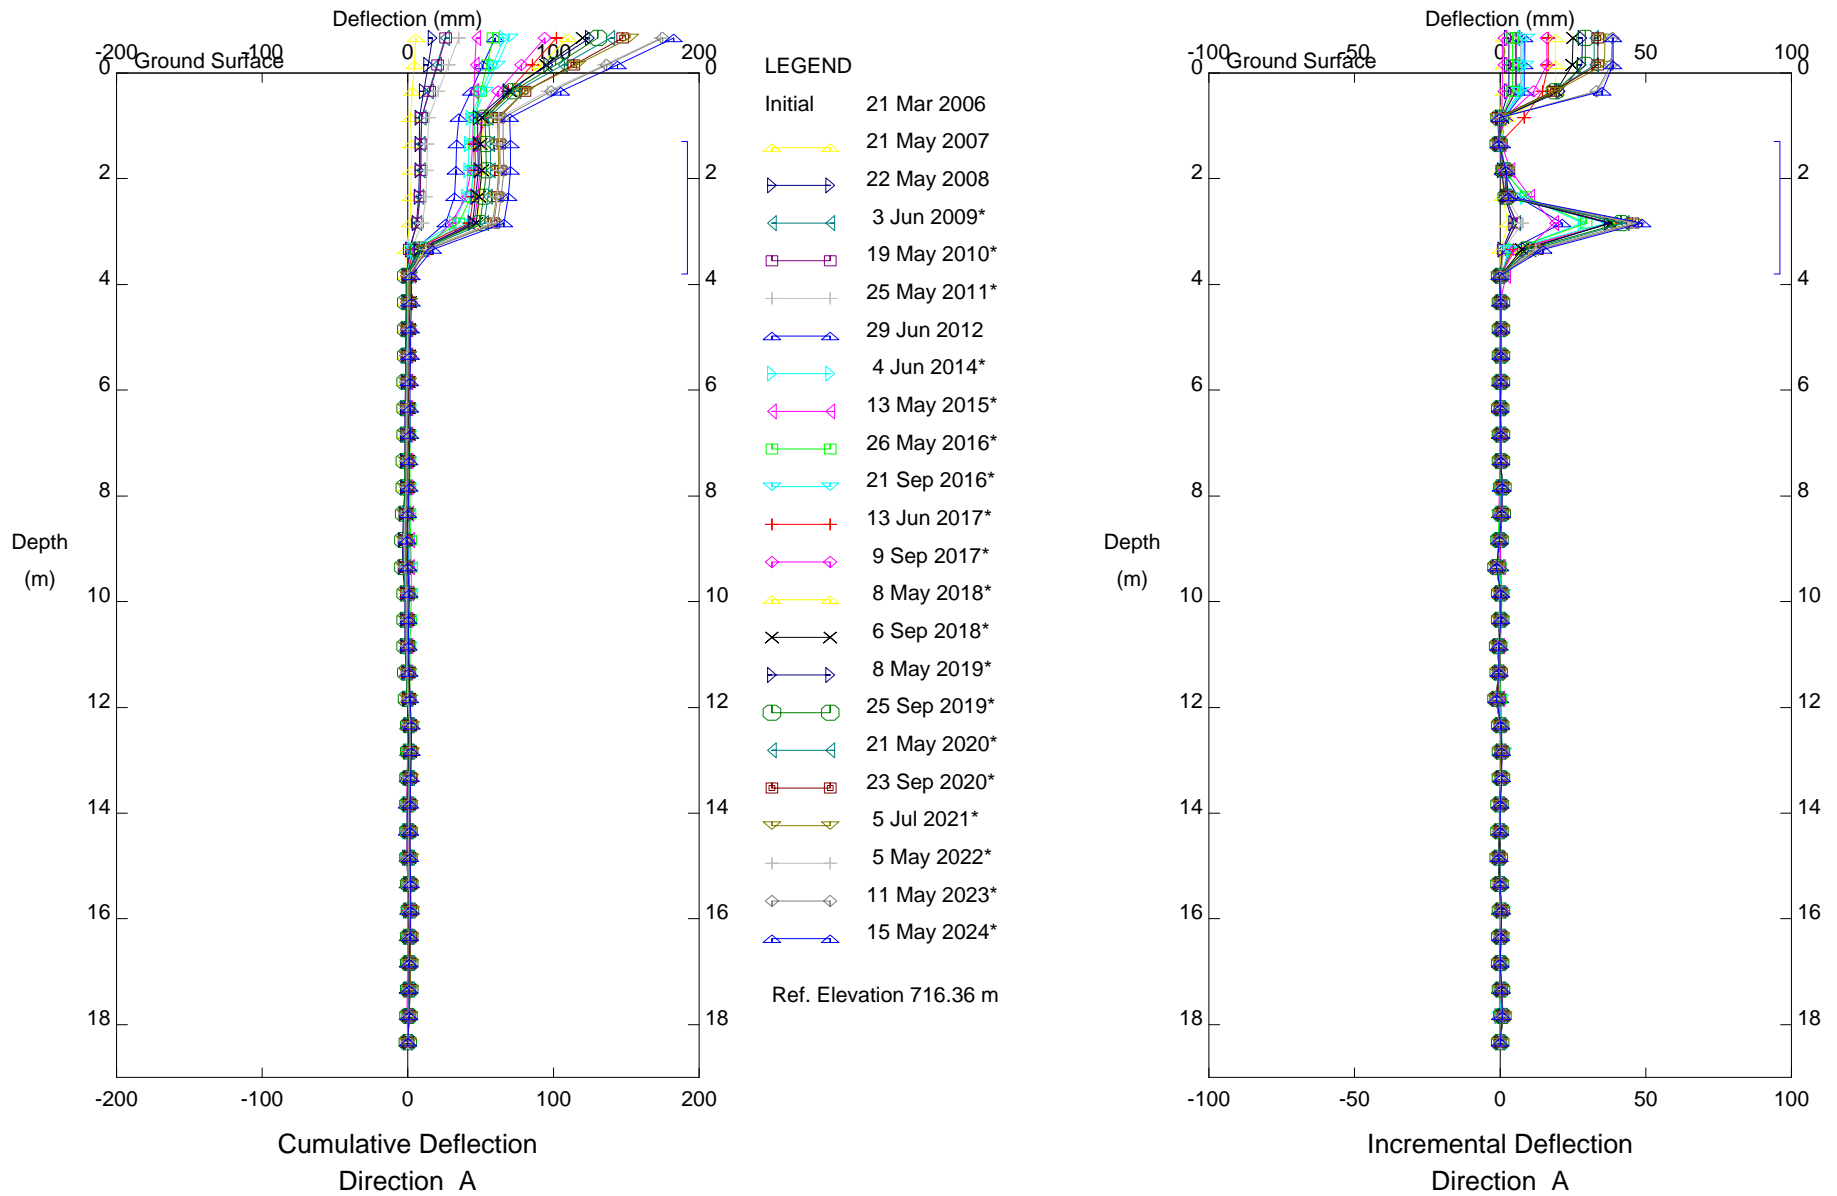
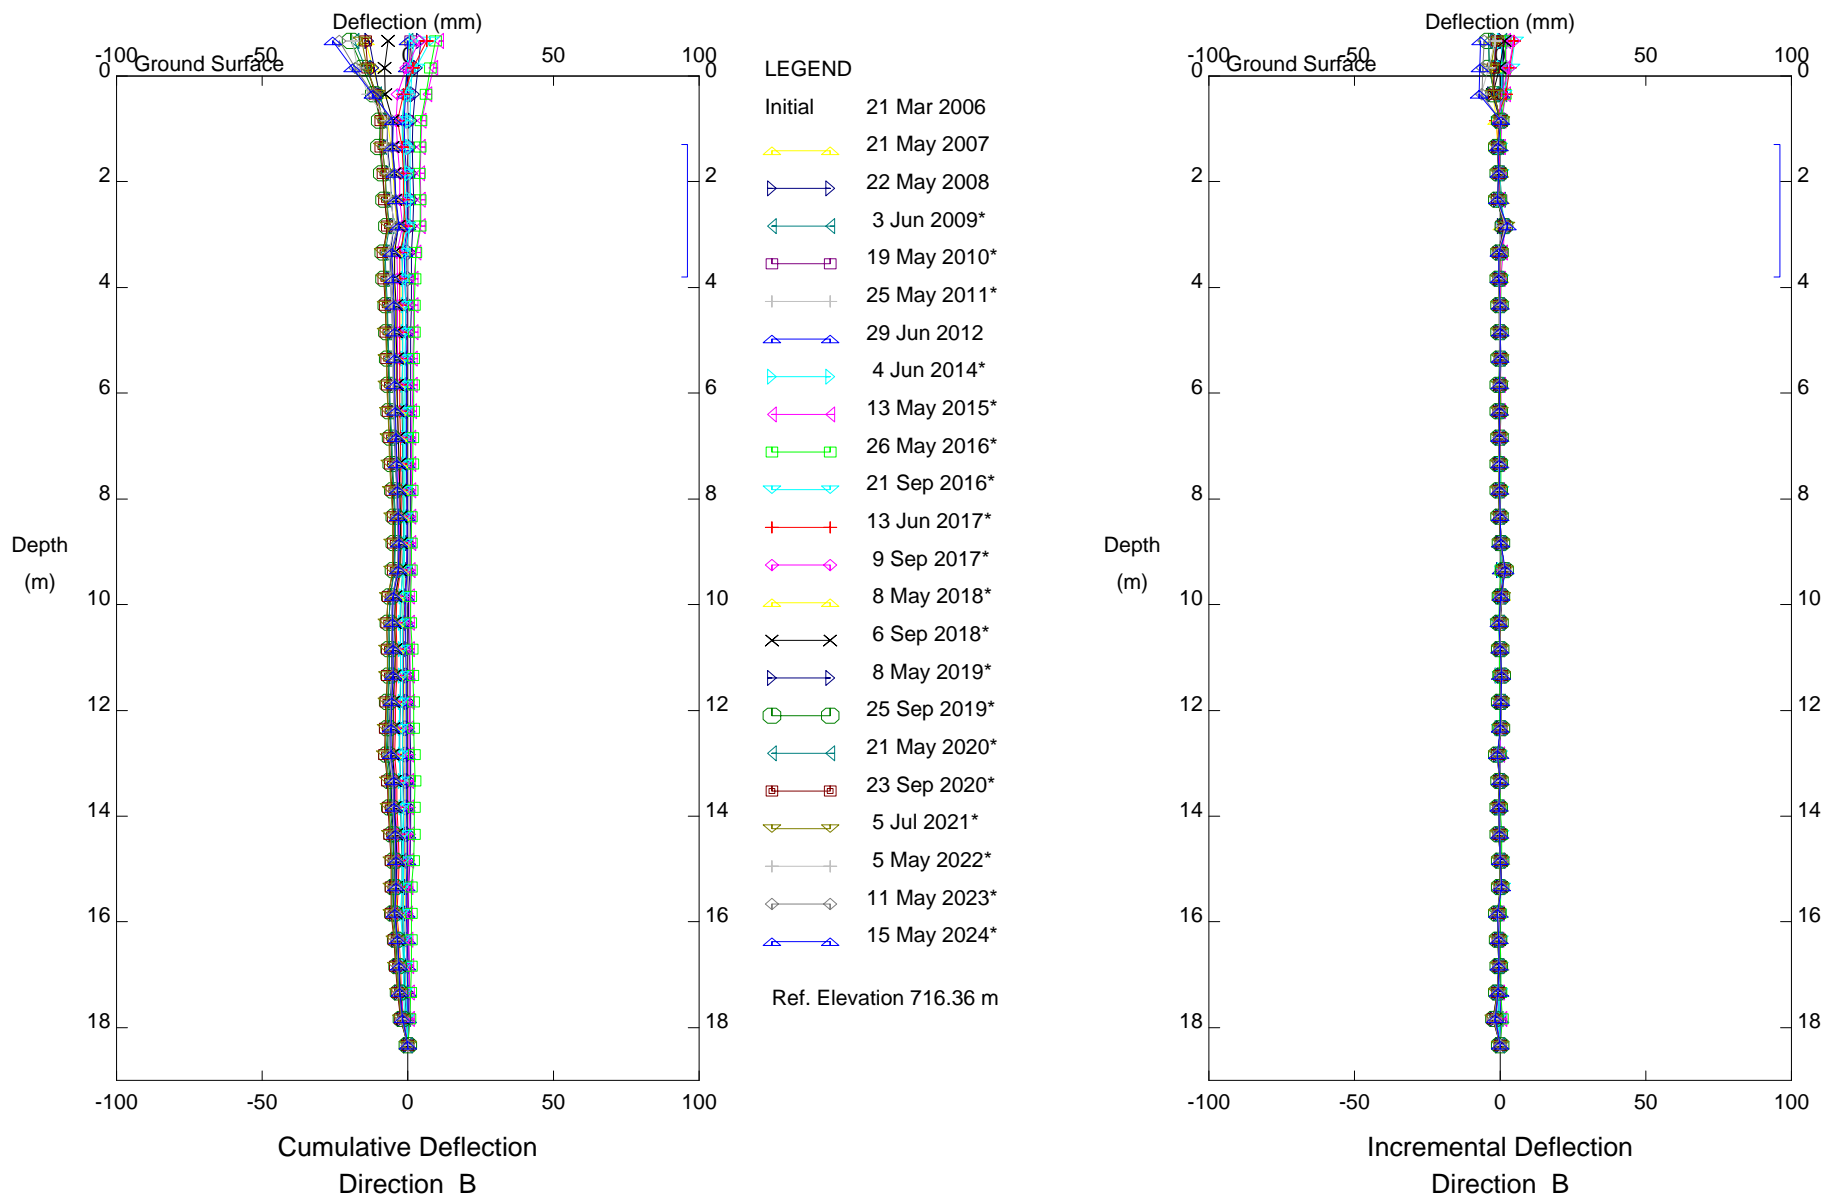
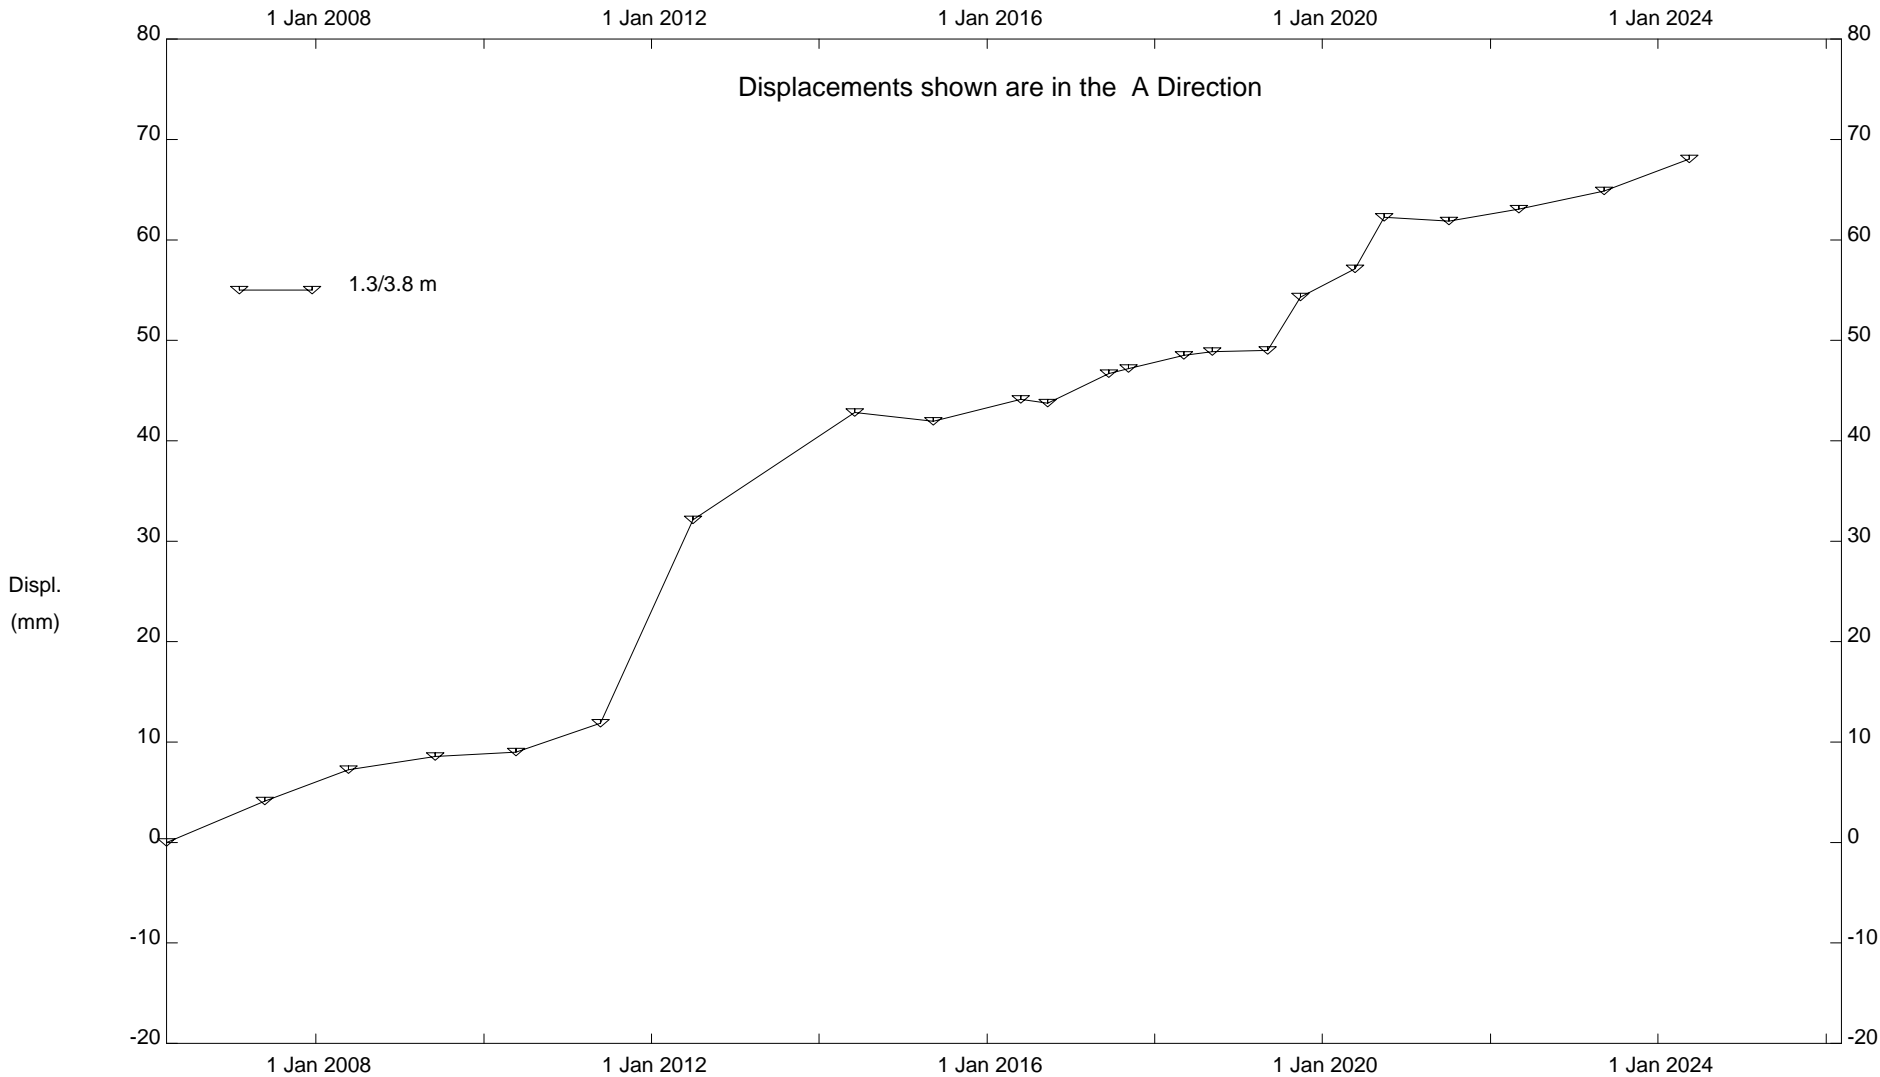
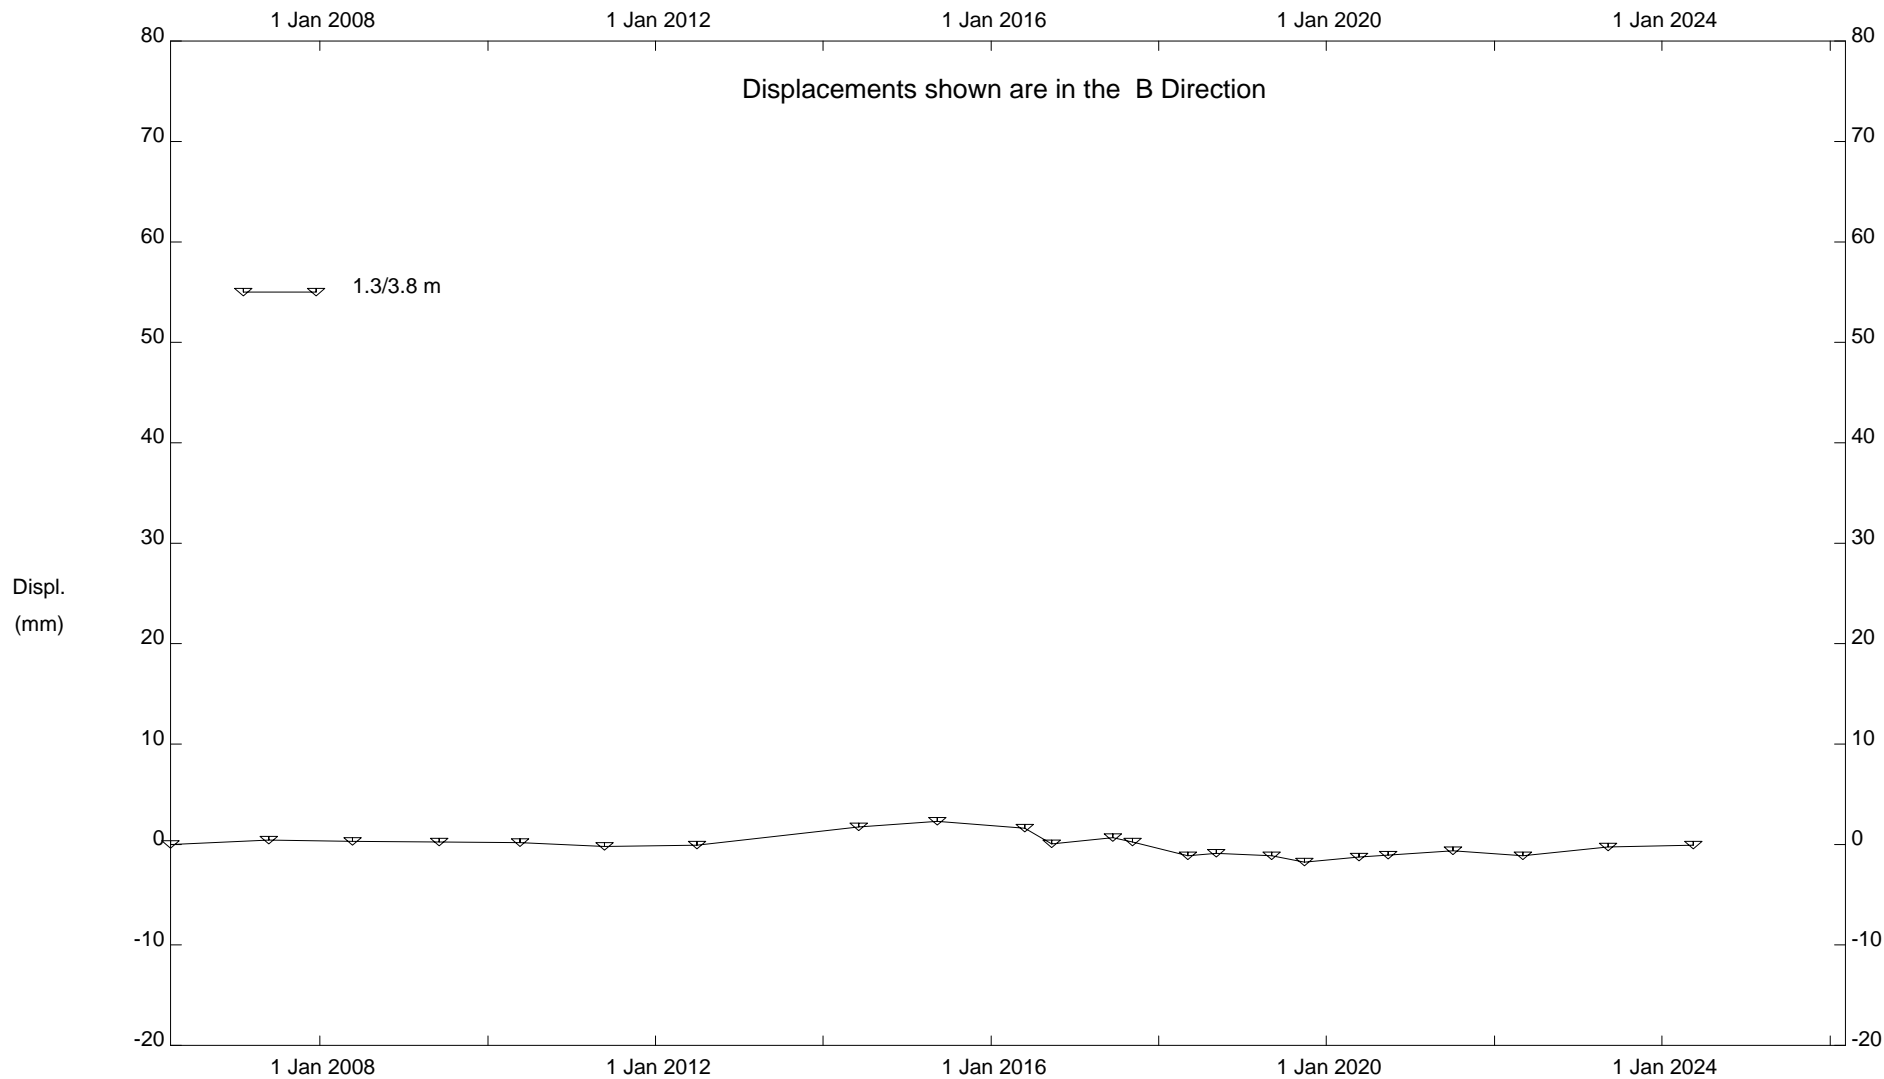
HWY 43:16 Whitecourt East Hill (NC1), Inclinometer SI06-1

SI06-1 has a distinct movement zone at about 3 m depth with 68 mm of cumulative movement. During the Spring 2024 reading cycle the rate of movement increased by about 1 mm/yr to a total of 3 mm/yr.
