To:	Amy Driessen	From:	Leslie Cho and Xiteng Liu
	Transportation and Economic Corridors		Stantec Consulting Ltd.
File:	123315222	Date:	June 18, 2024

Reference: North Central Region, Edson, Site NC001 - Highway 43:16 Whitecourt East Hill Spring 2024 Instrumentation Monitoring Report

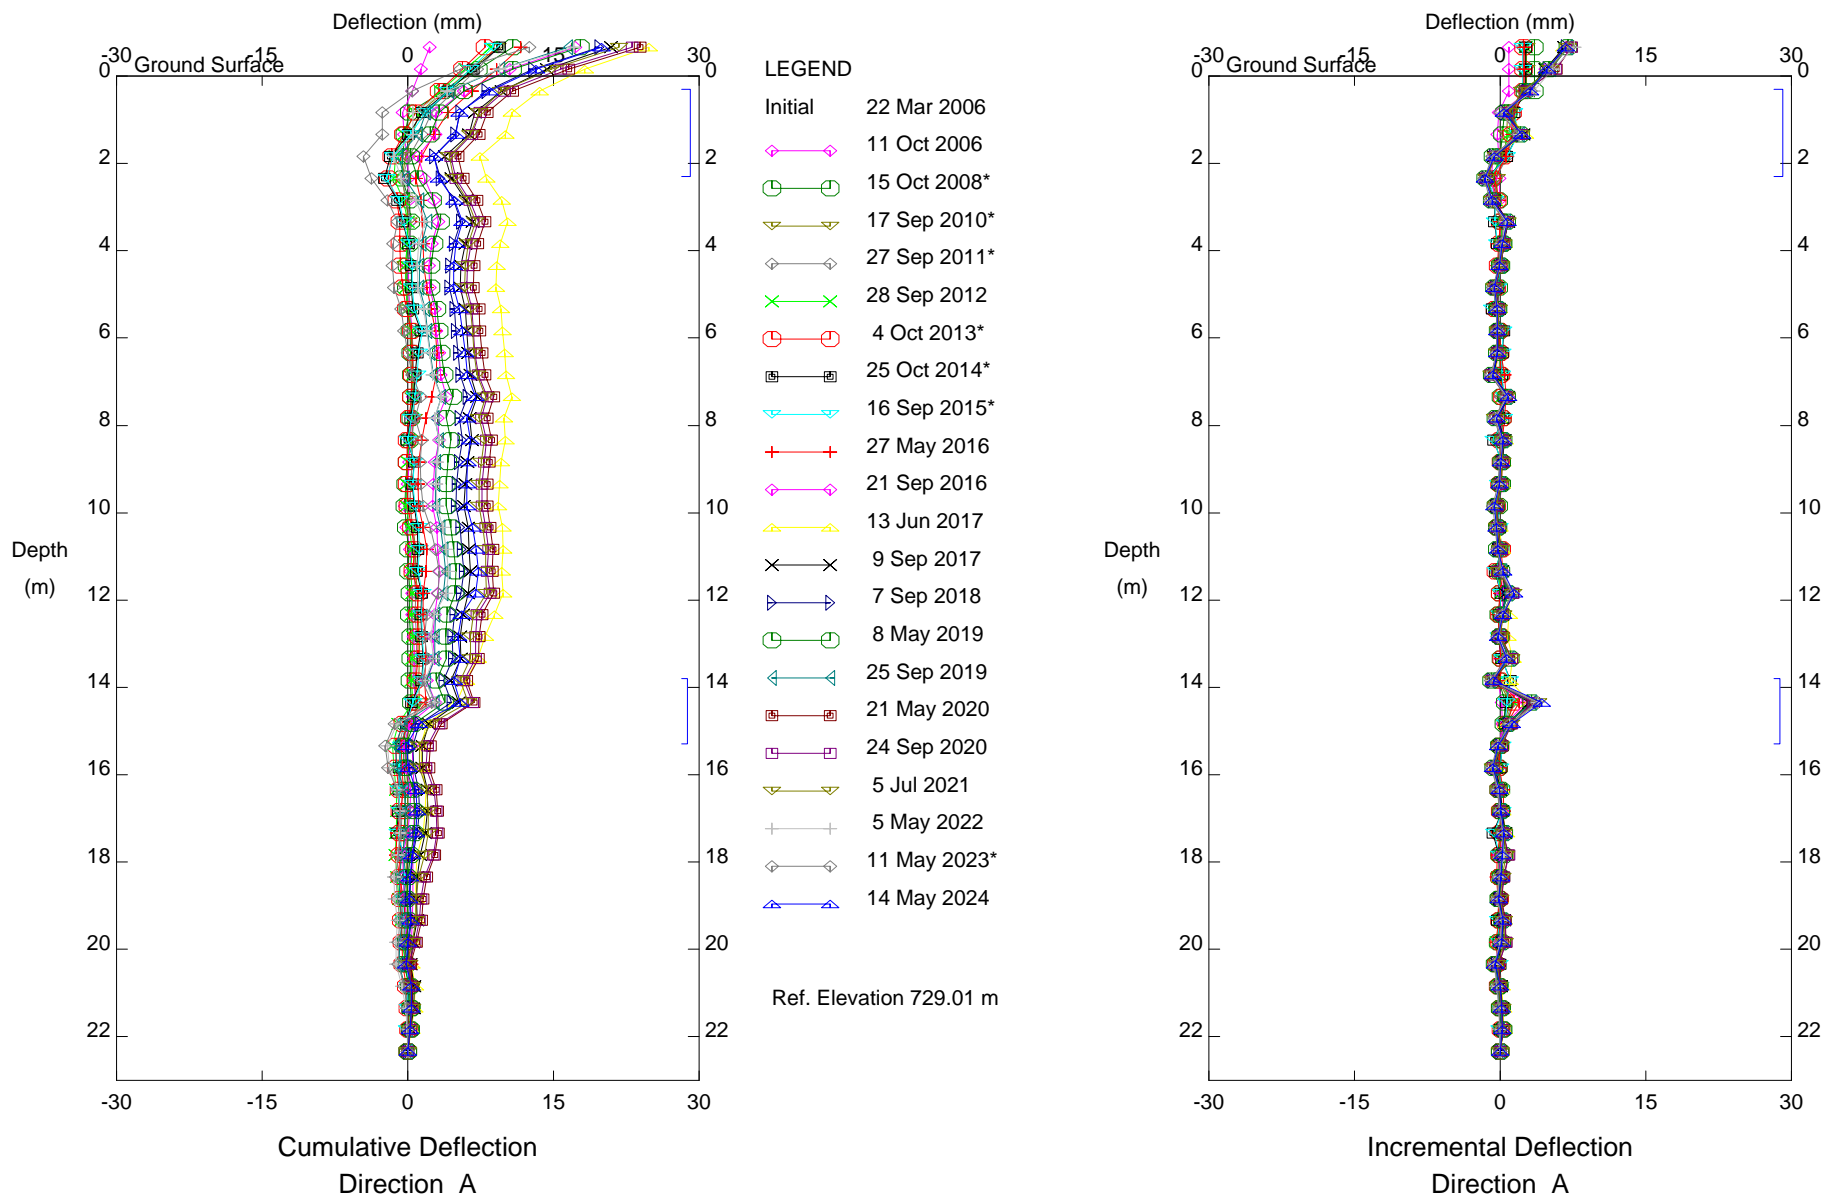
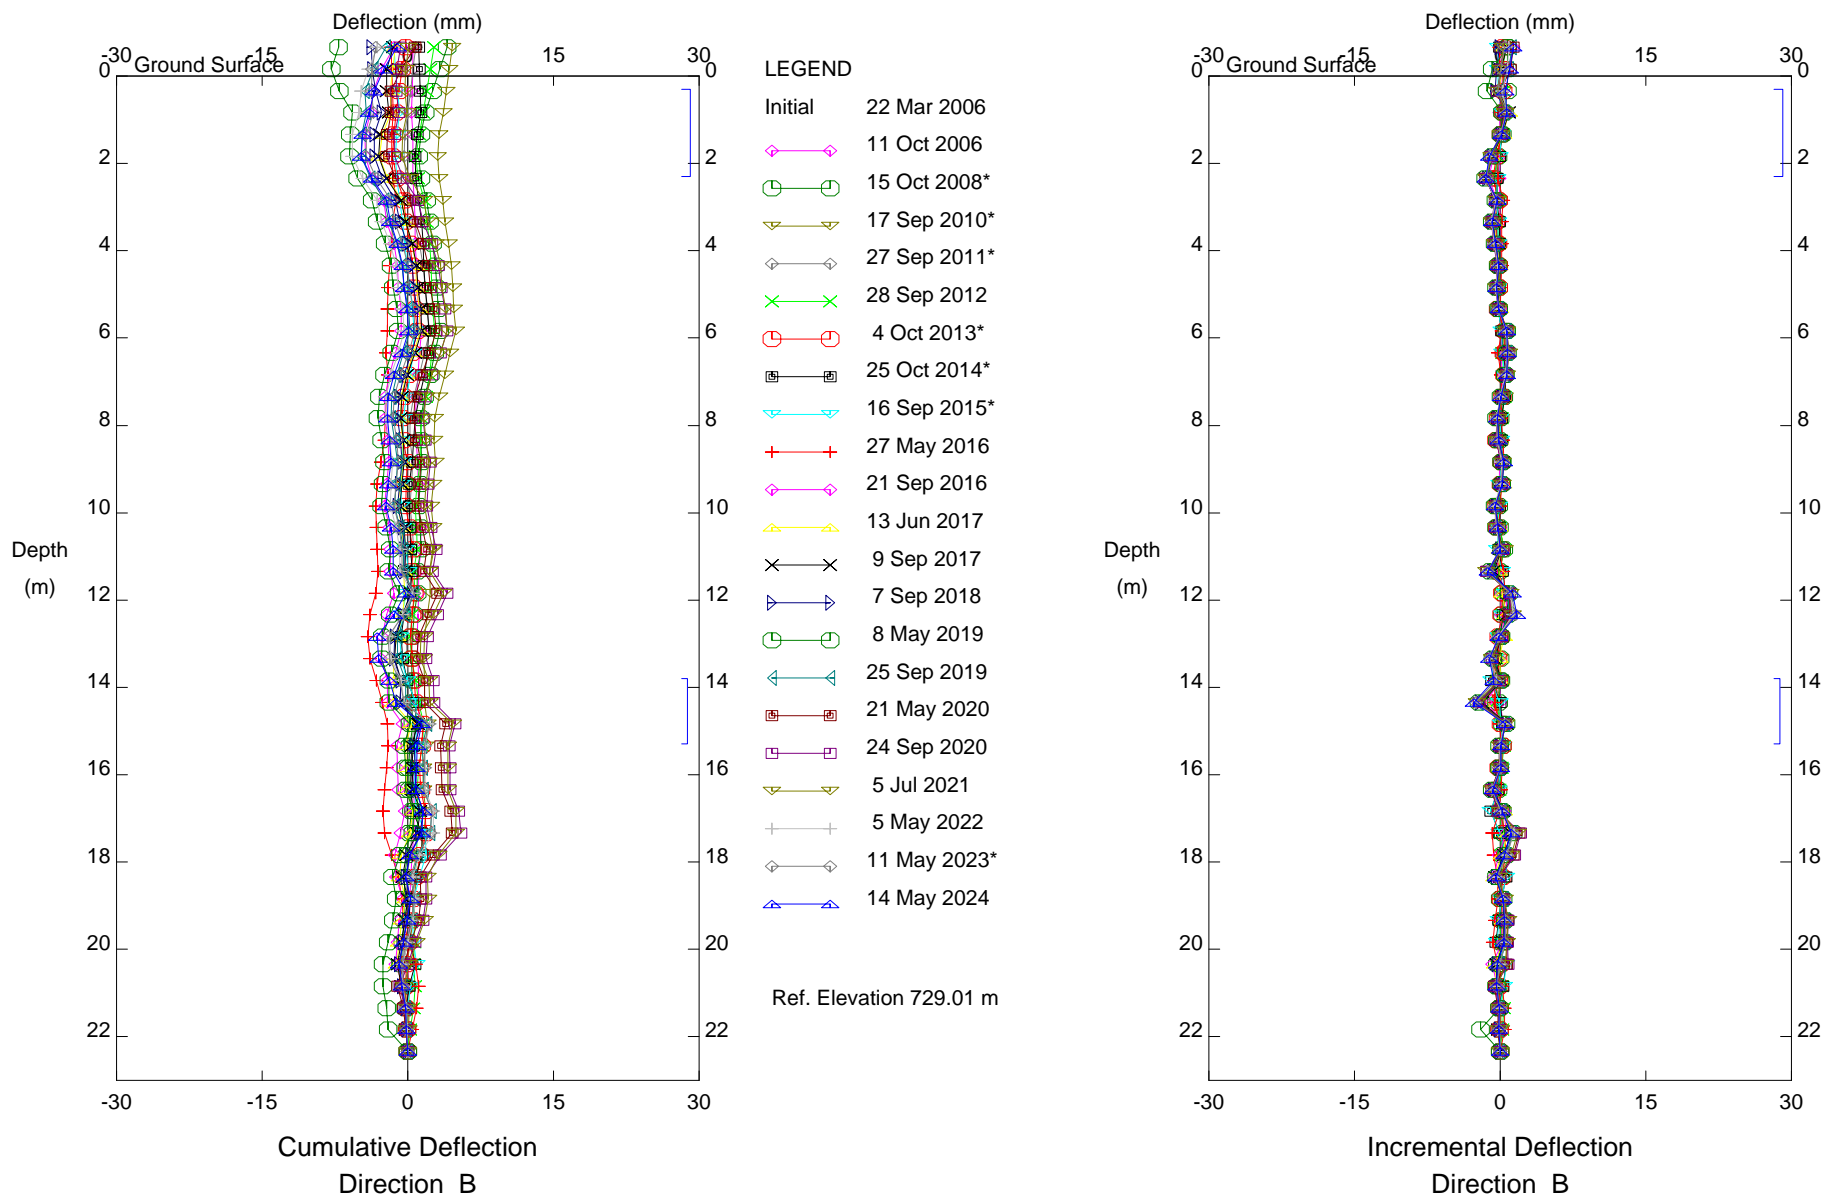
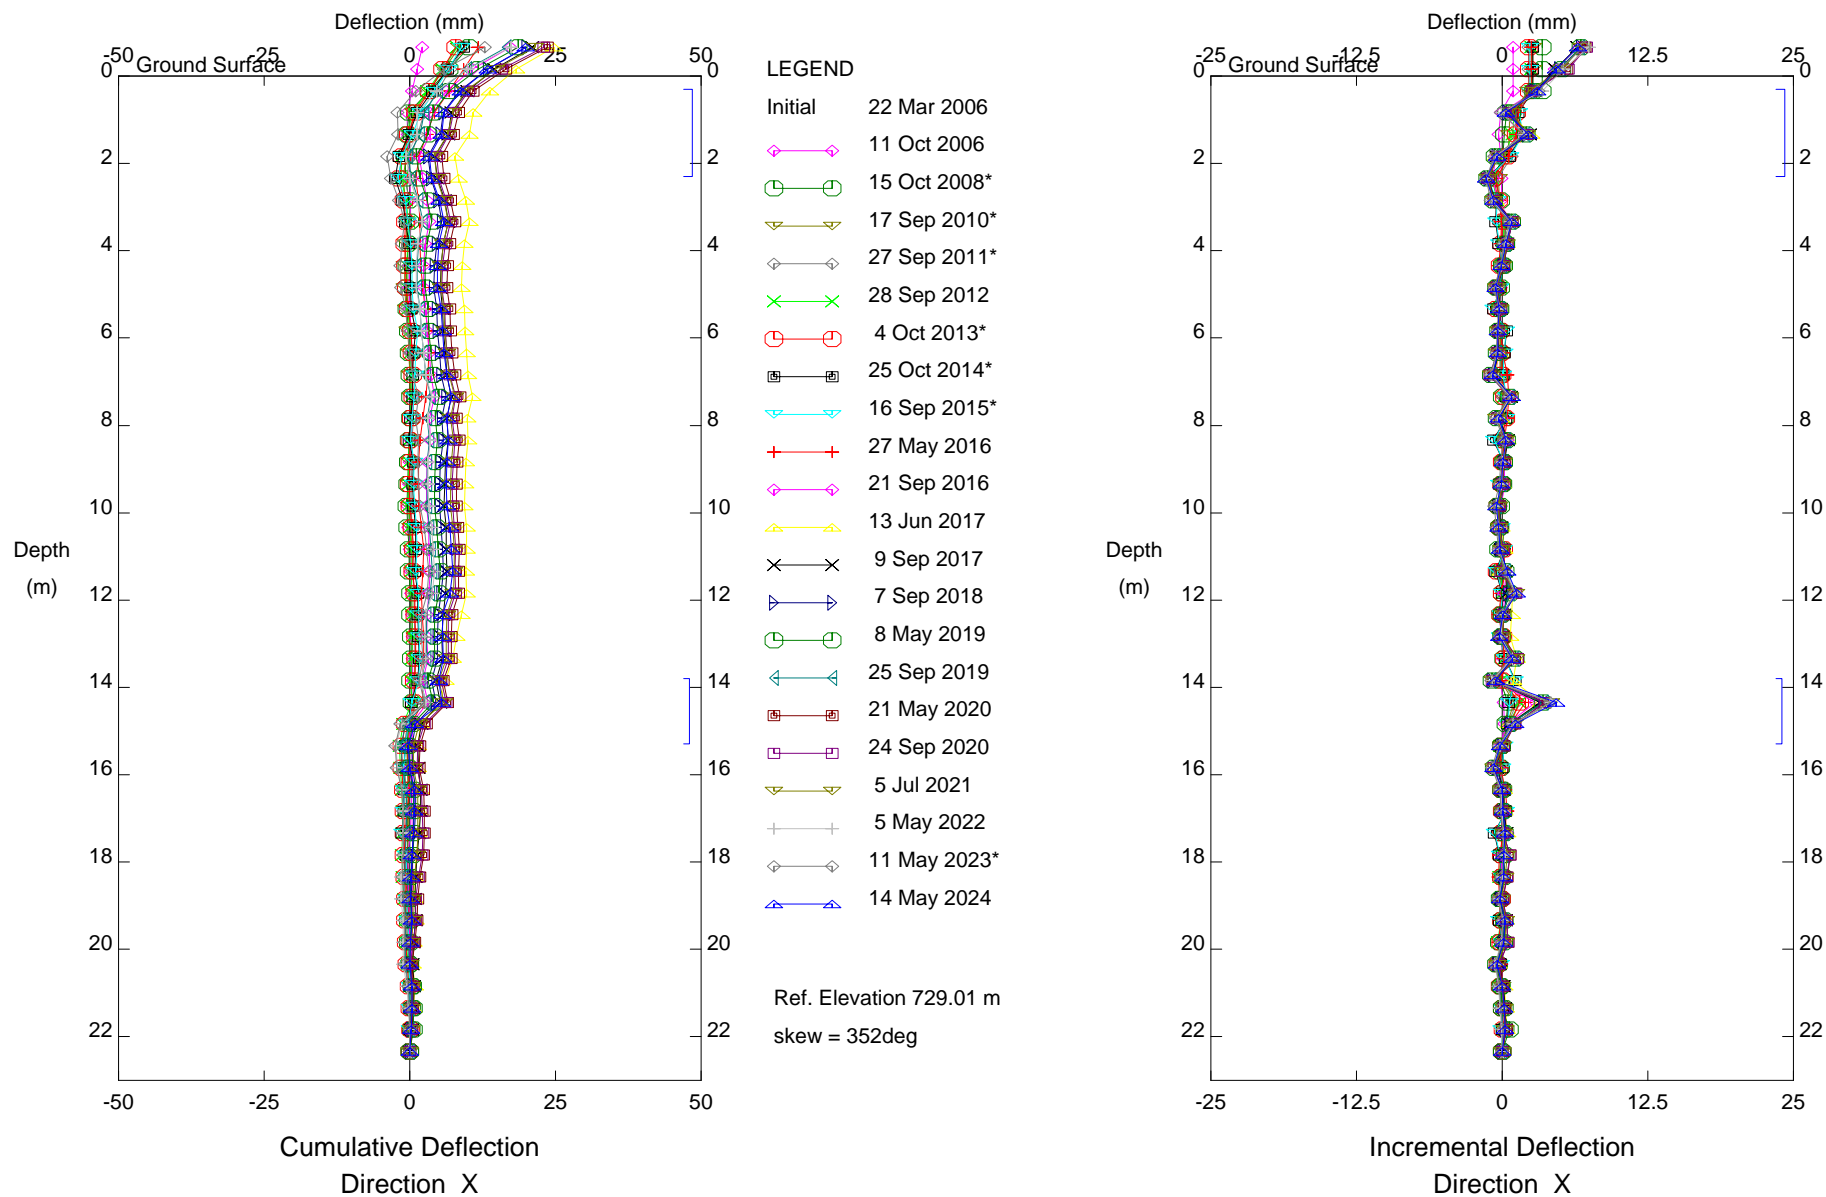
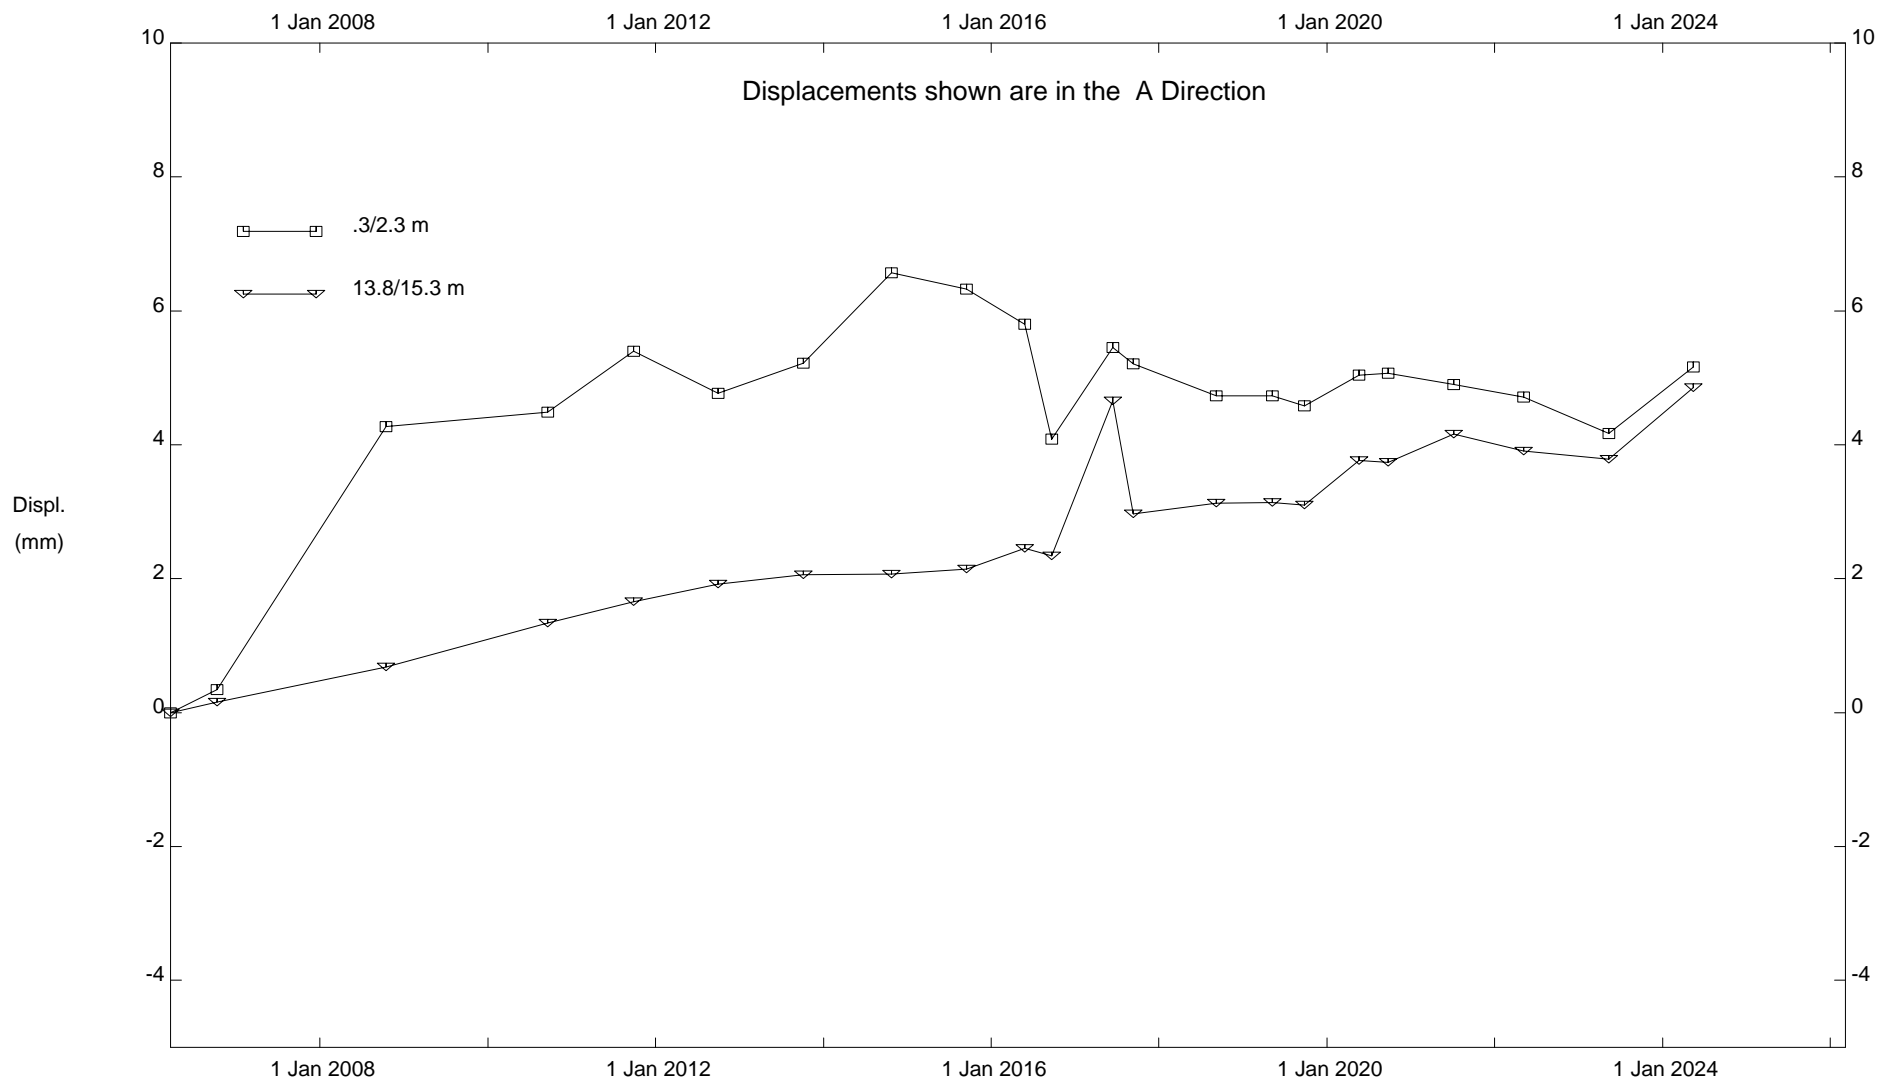
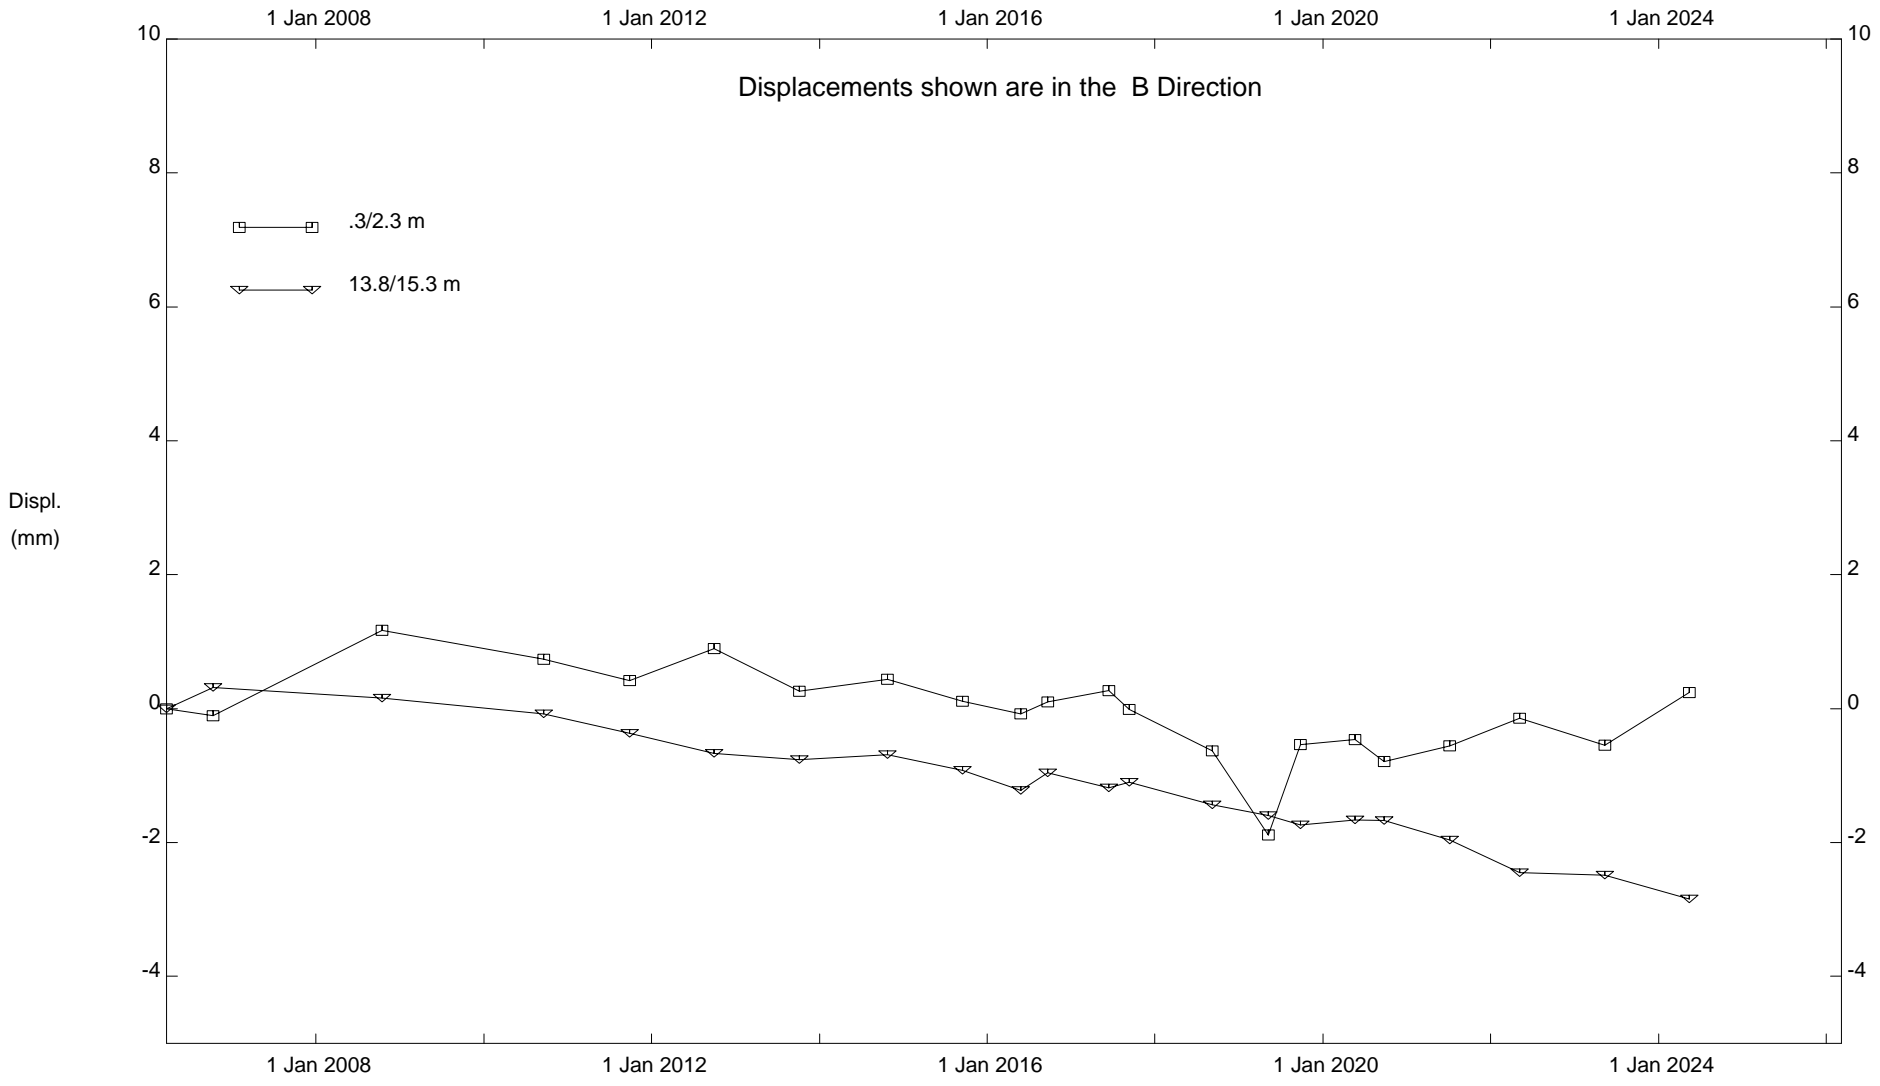
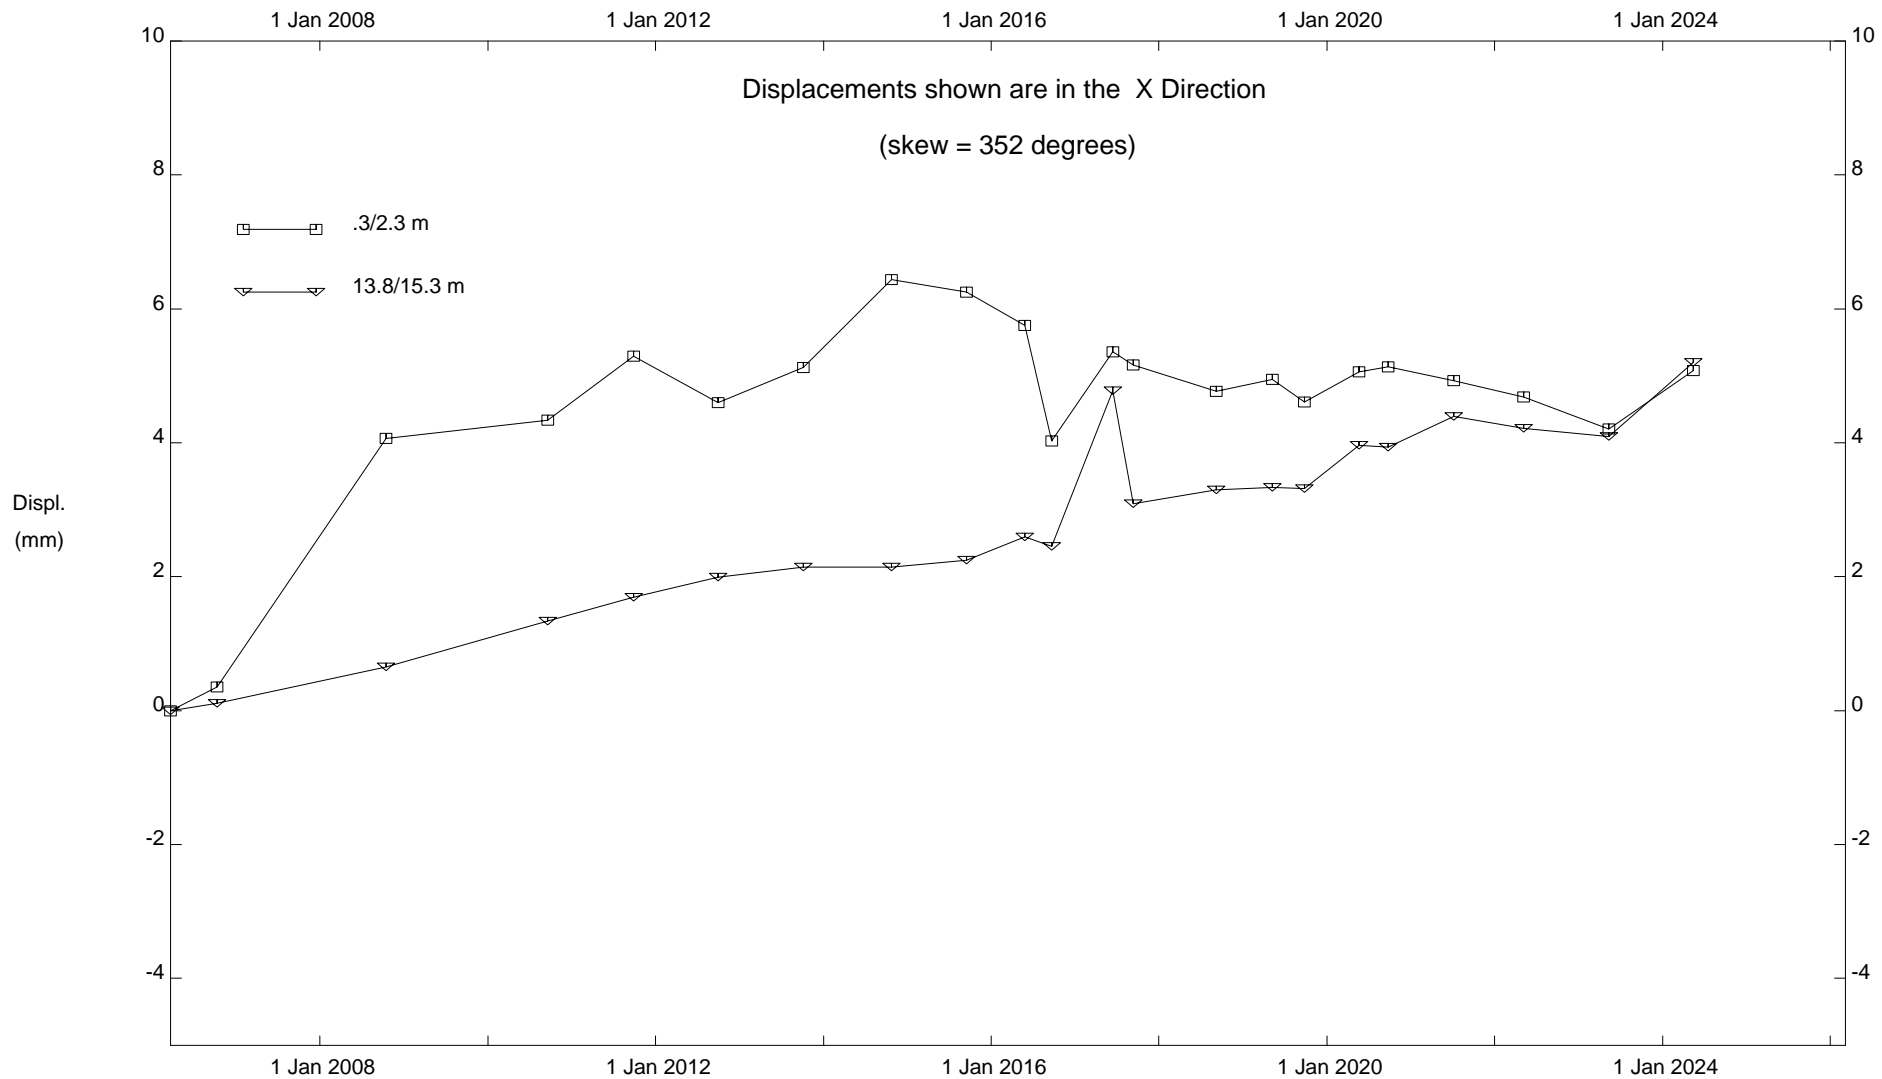
HWY 43:16 Whitecourt East Hill (NC1), Inclinometer SI06-2

SI06-2 is showing creep at a rate of movement of about 1 mm/yr since installation in the shear zone from 13.8 m to 15.3 m. A sudden spike recorded in Spring 2016 is likely a reading error.
