To:	Amy Driessen	From:	Leslie Cho and Xiteng Liu
	Transportation and Economic Corridors		Stantec Consulting Ltd.
File:	123315222	Date:	June 18, 2024

Reference: North Central Region, Edson, Site NC001 - Highway 43:16 Whitecourt East Hill Spring 2024 Instrumentation Monitoring Report

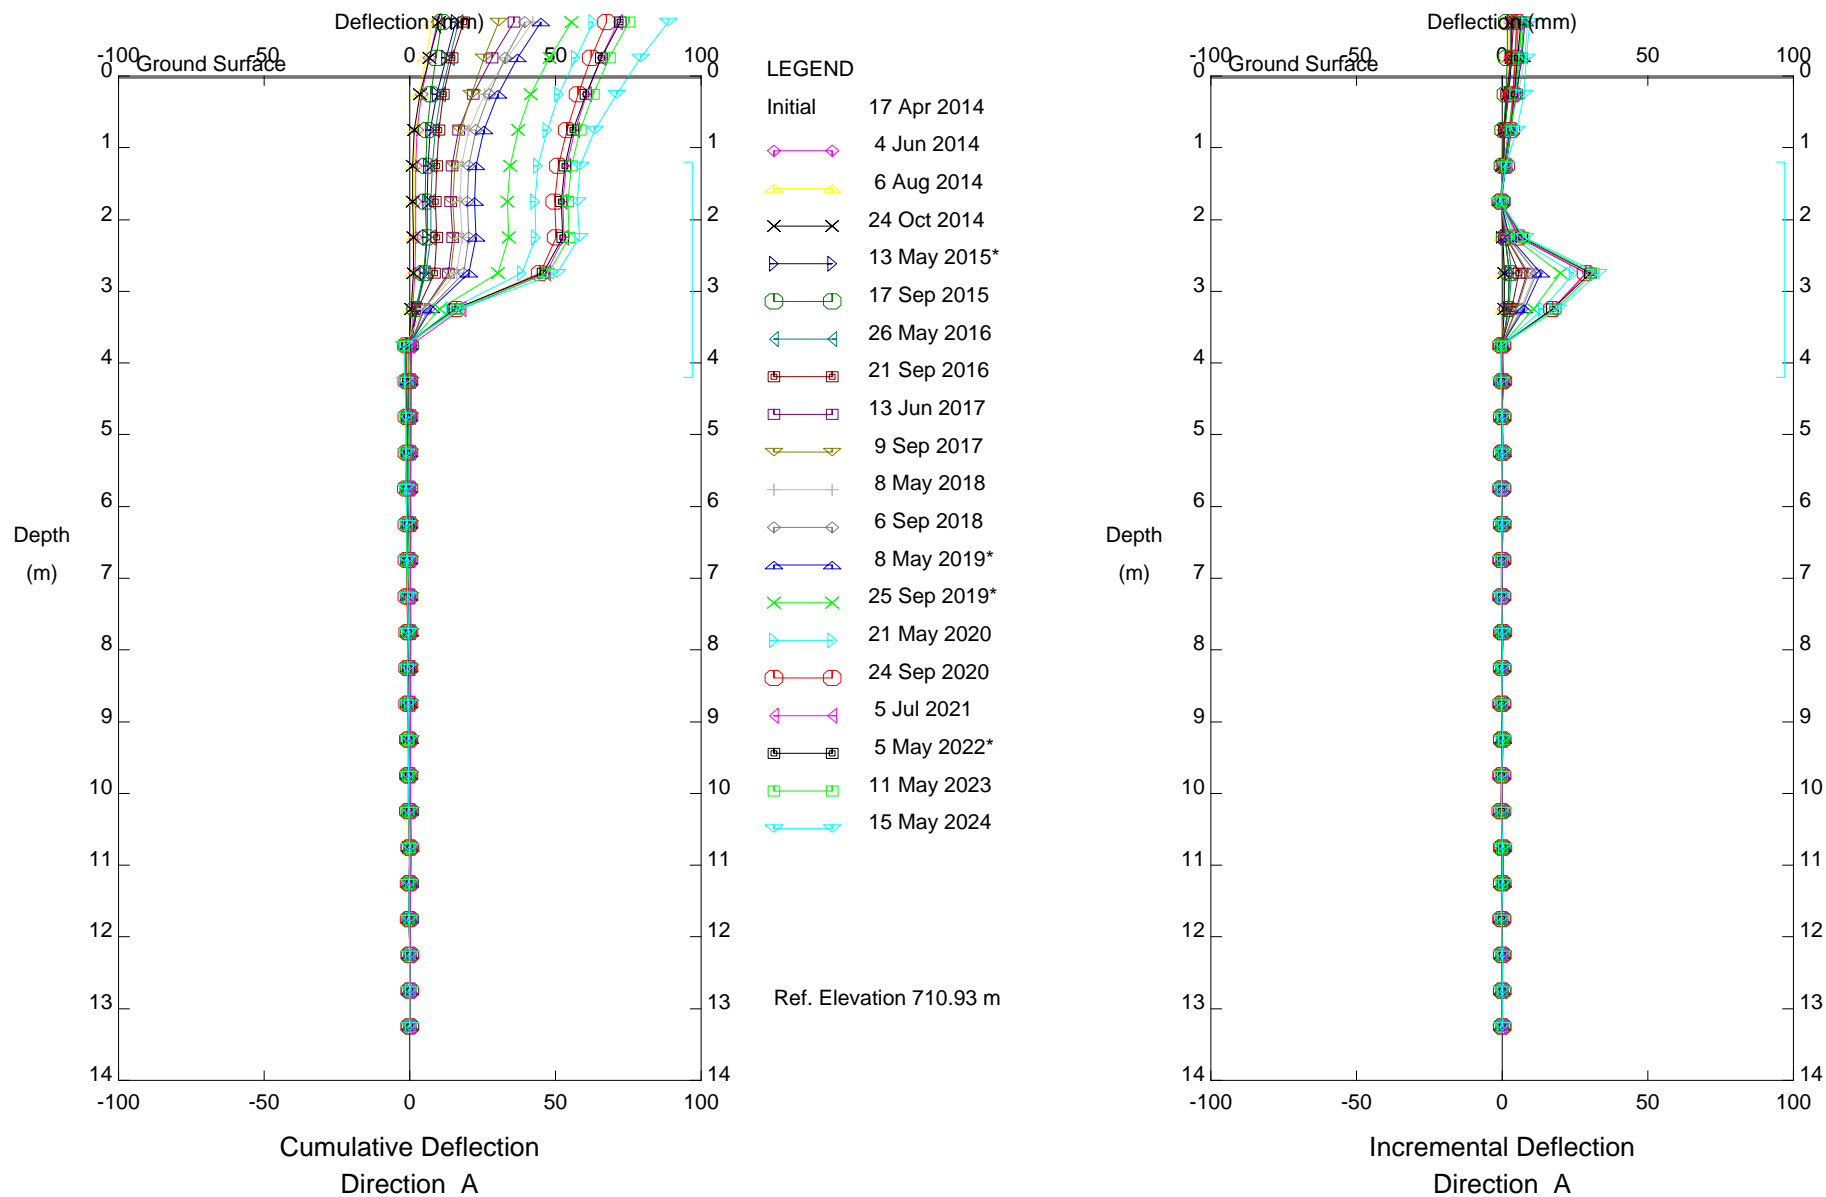
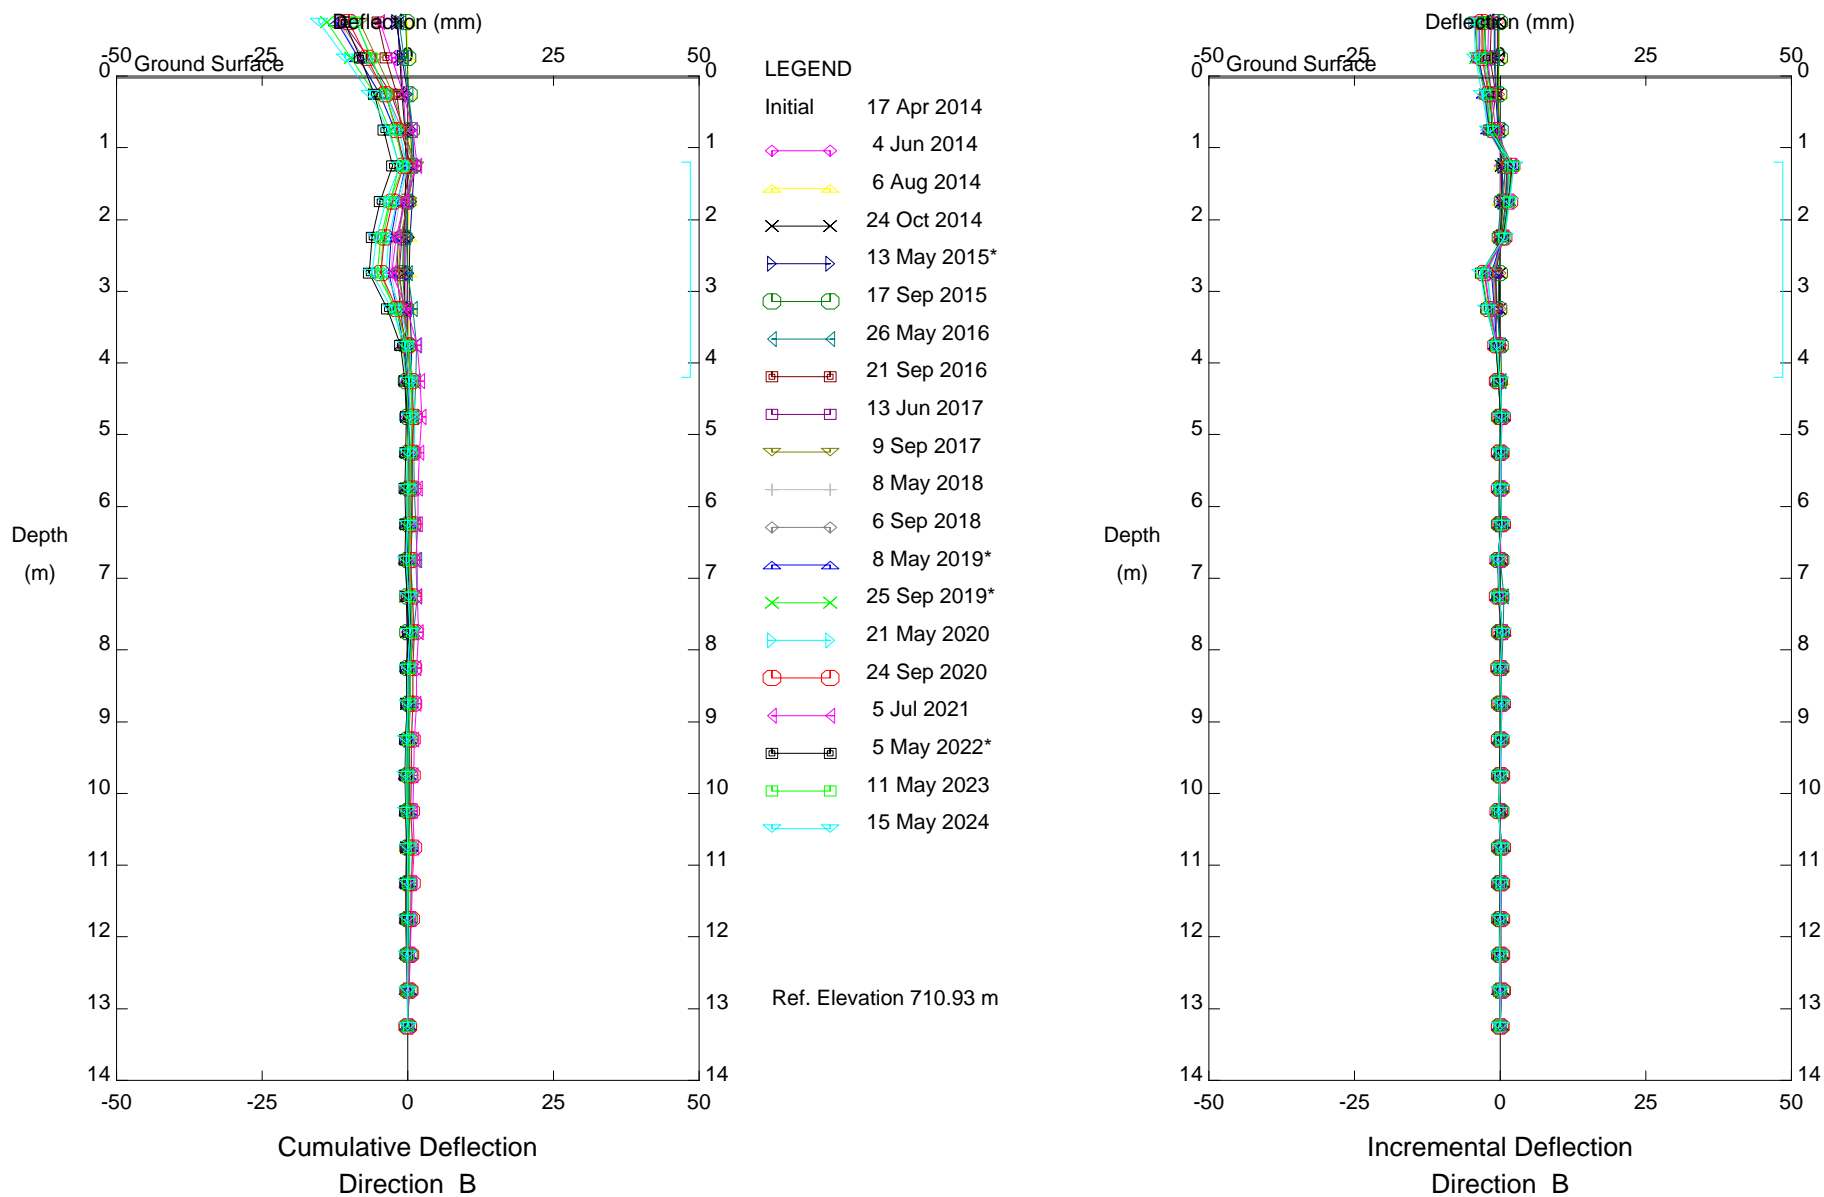
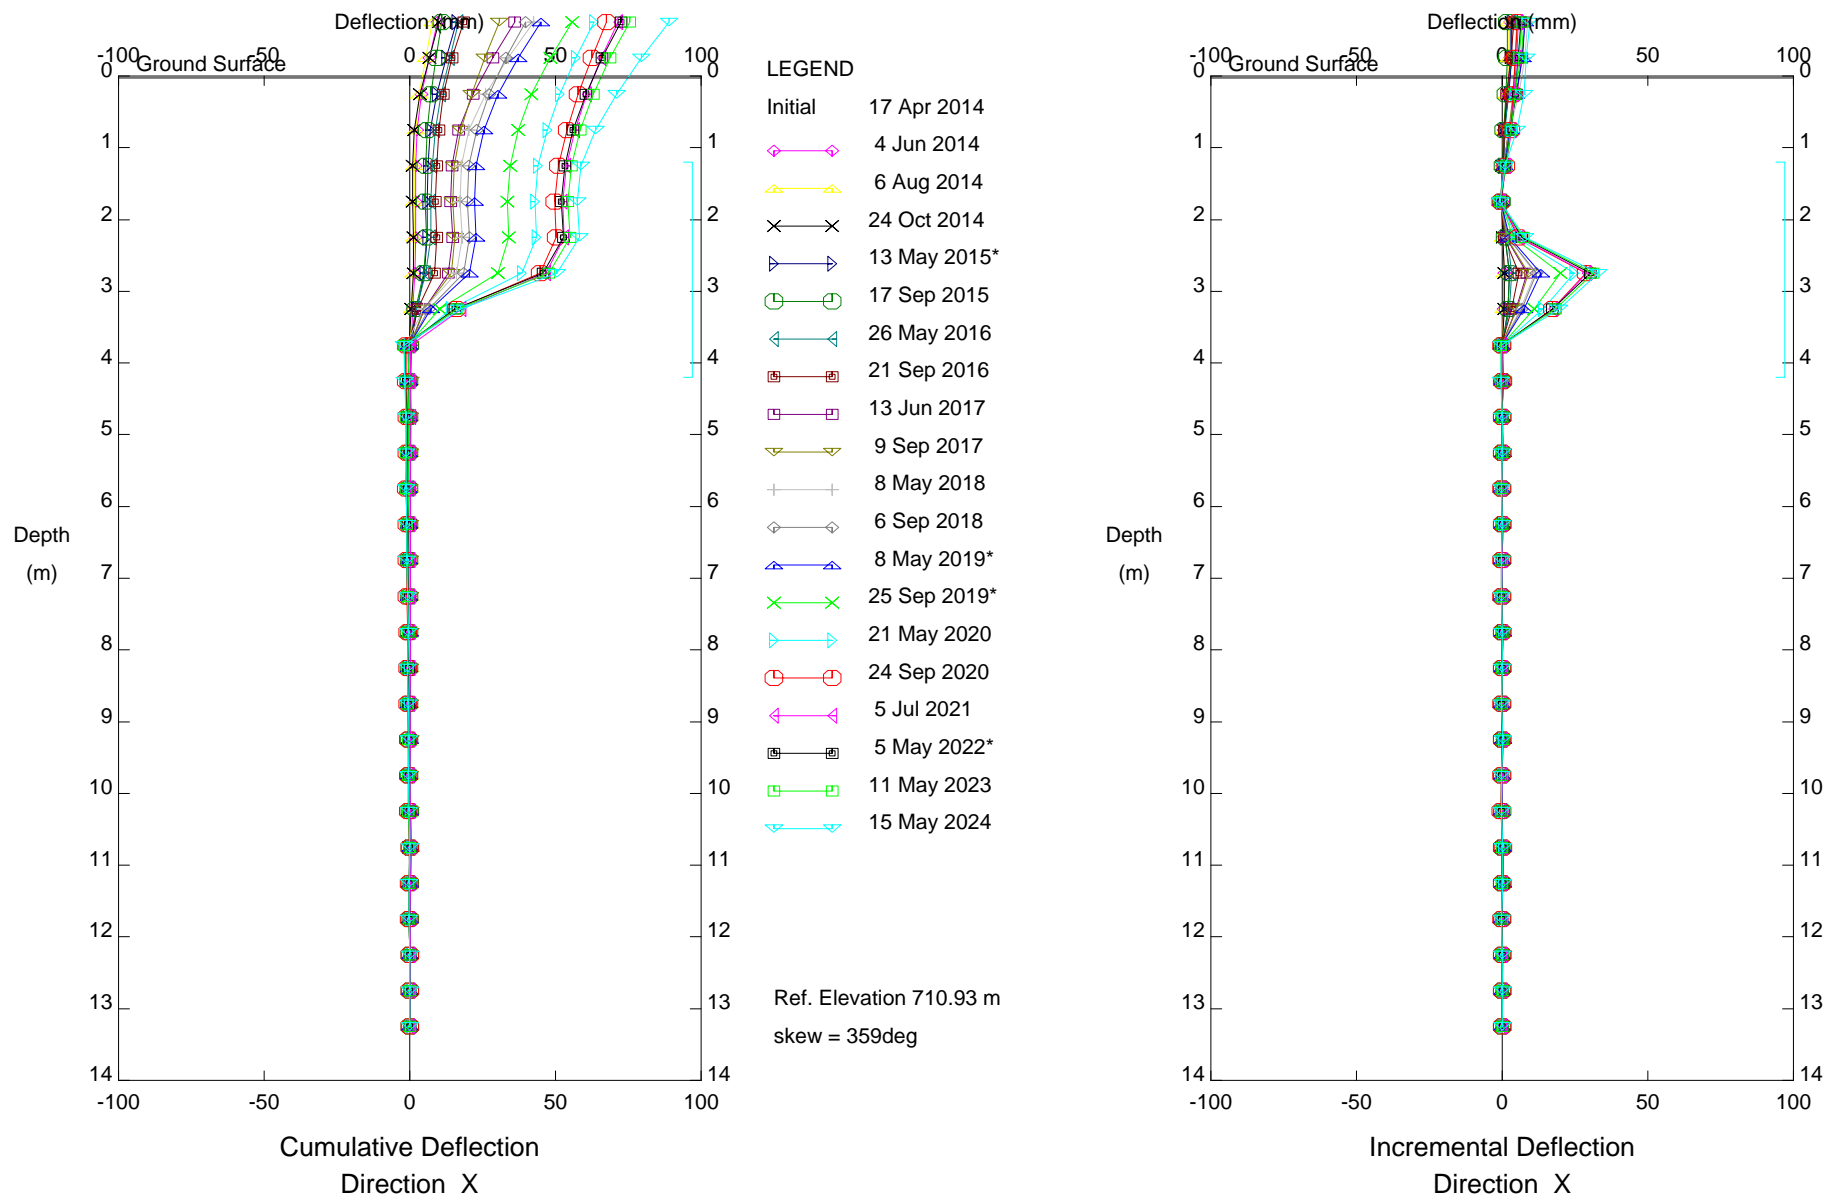
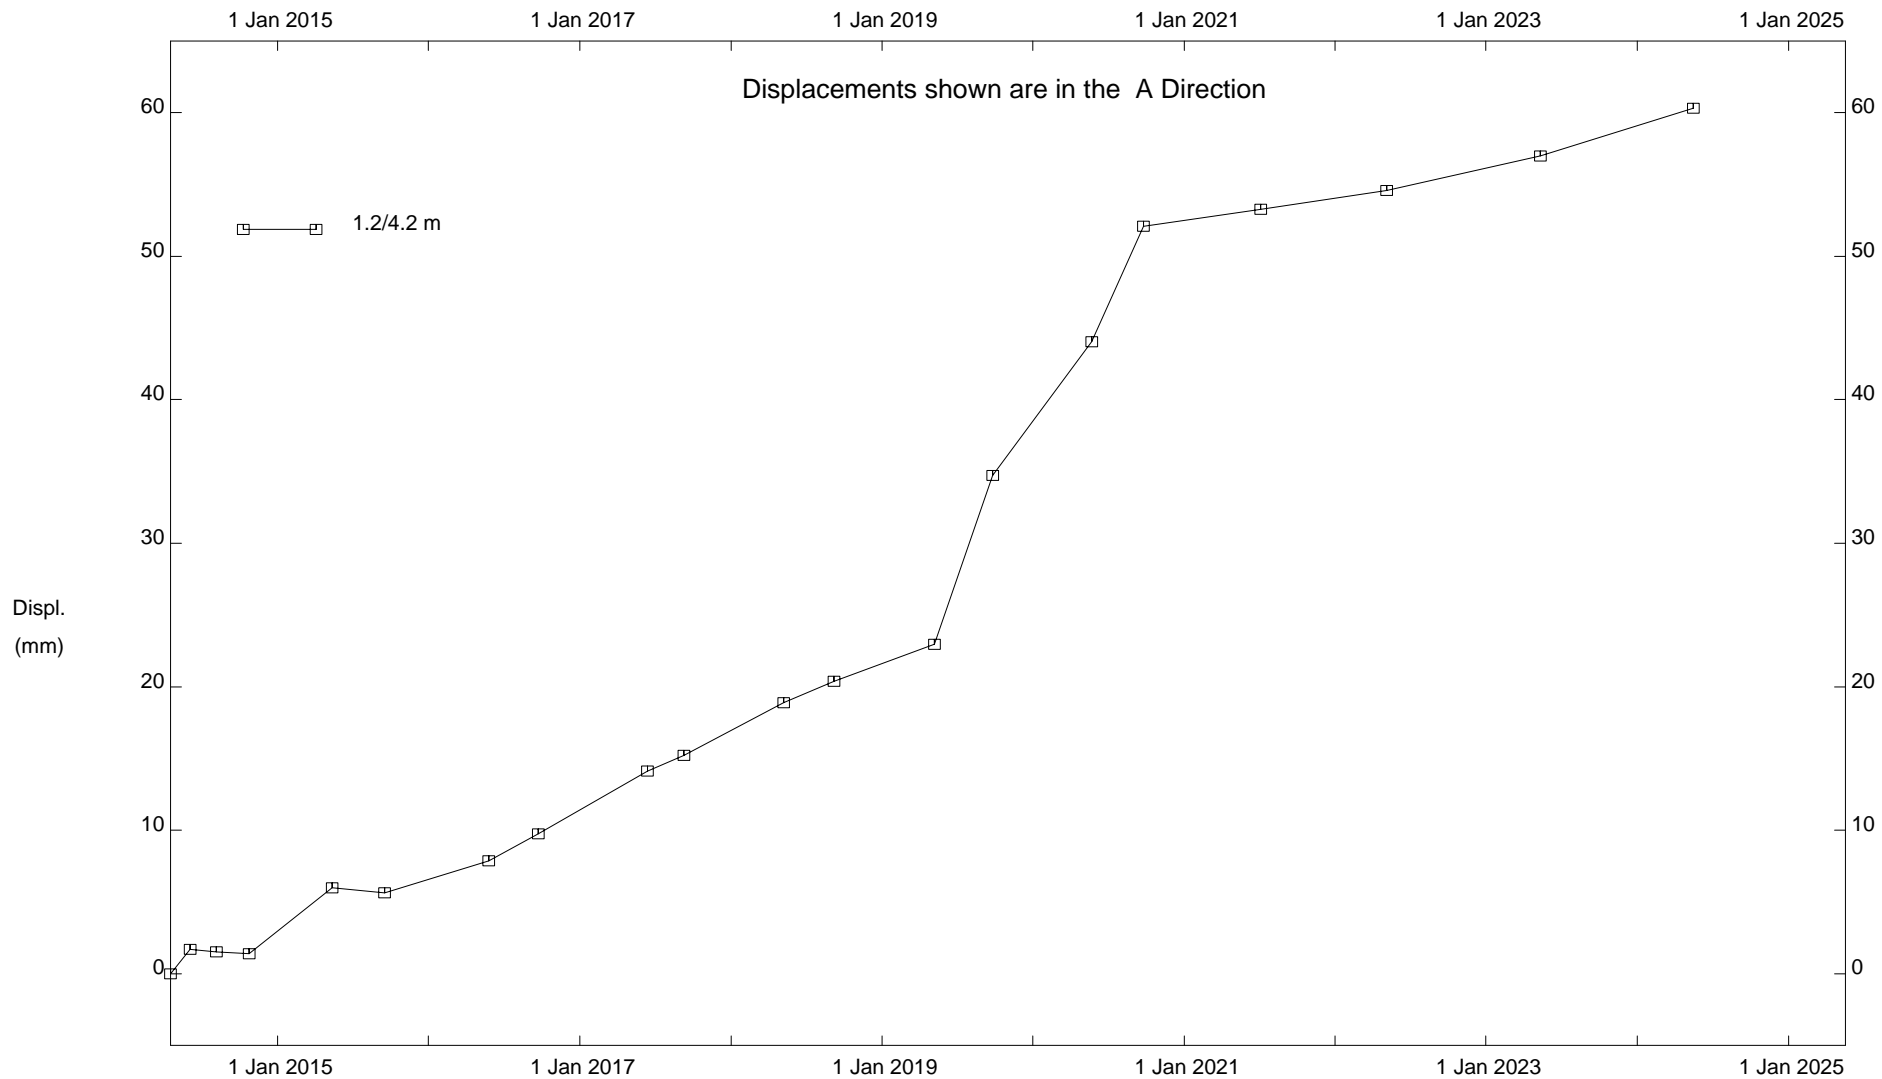
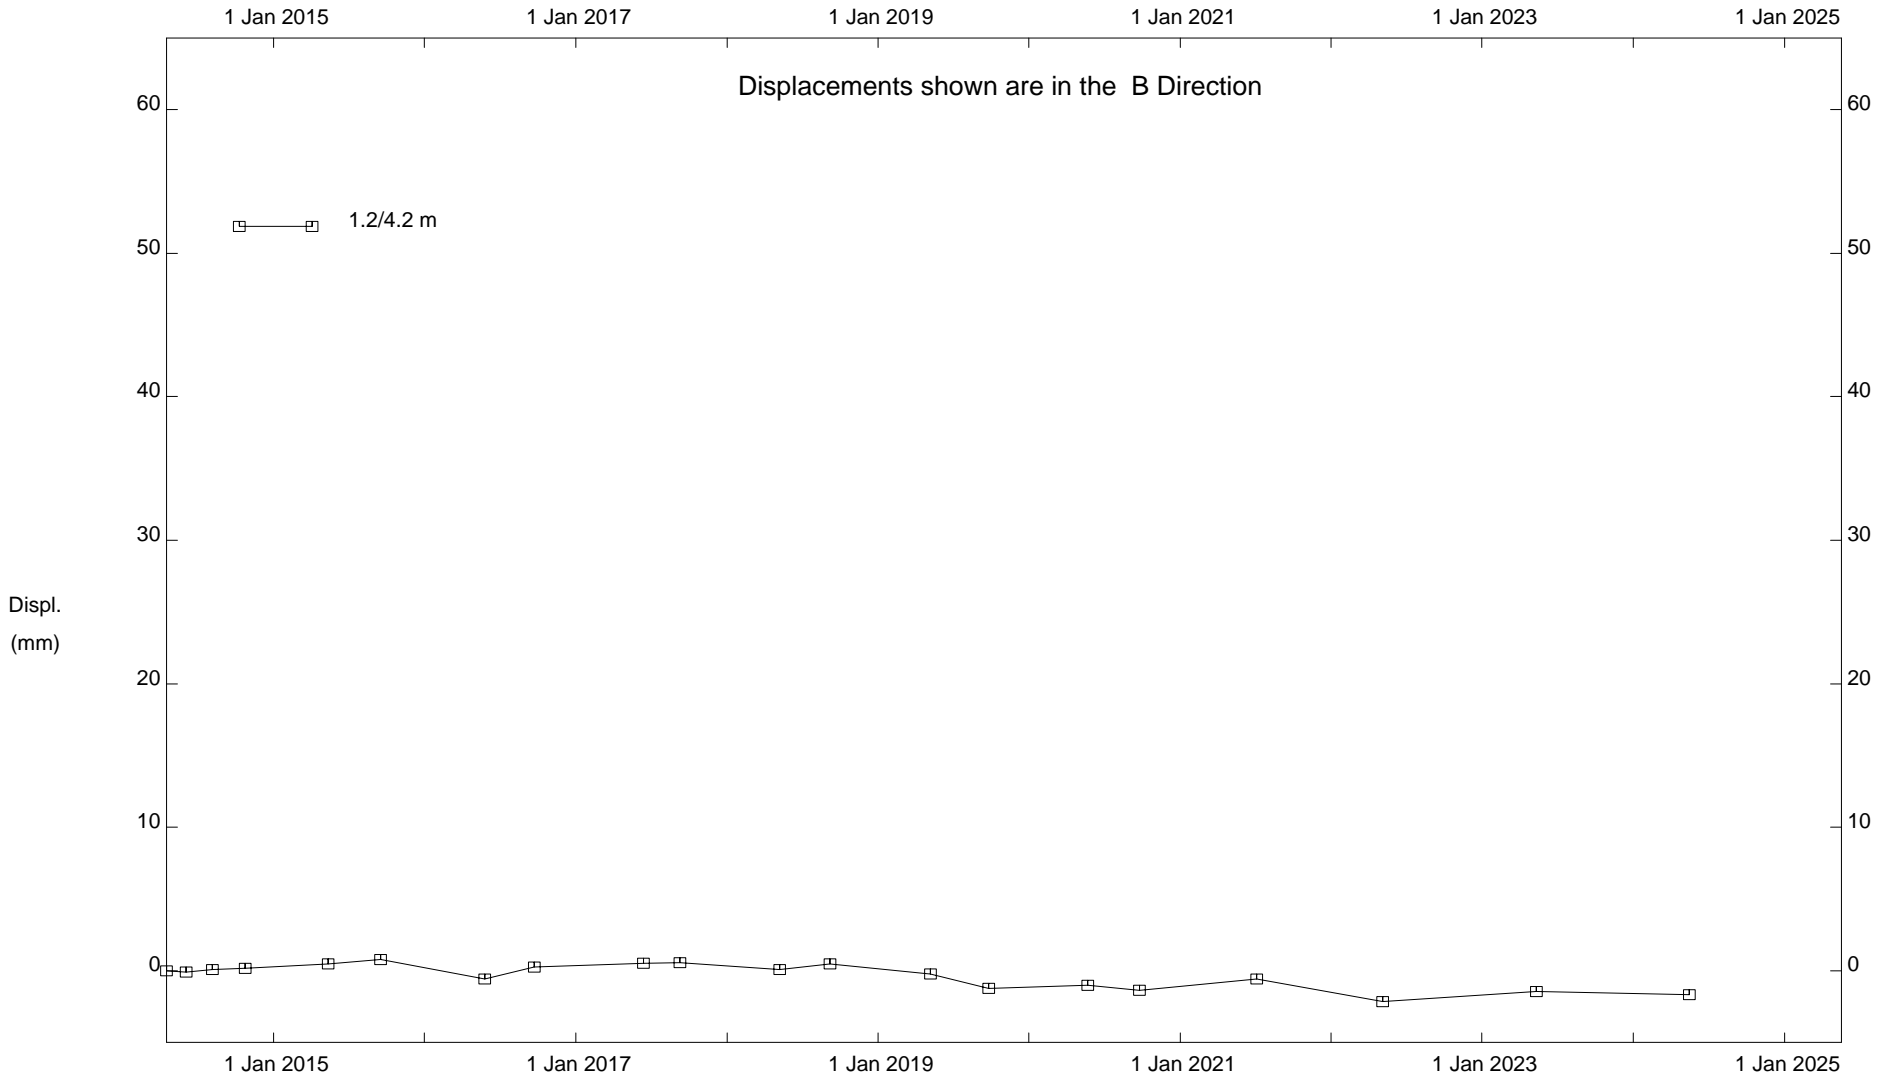
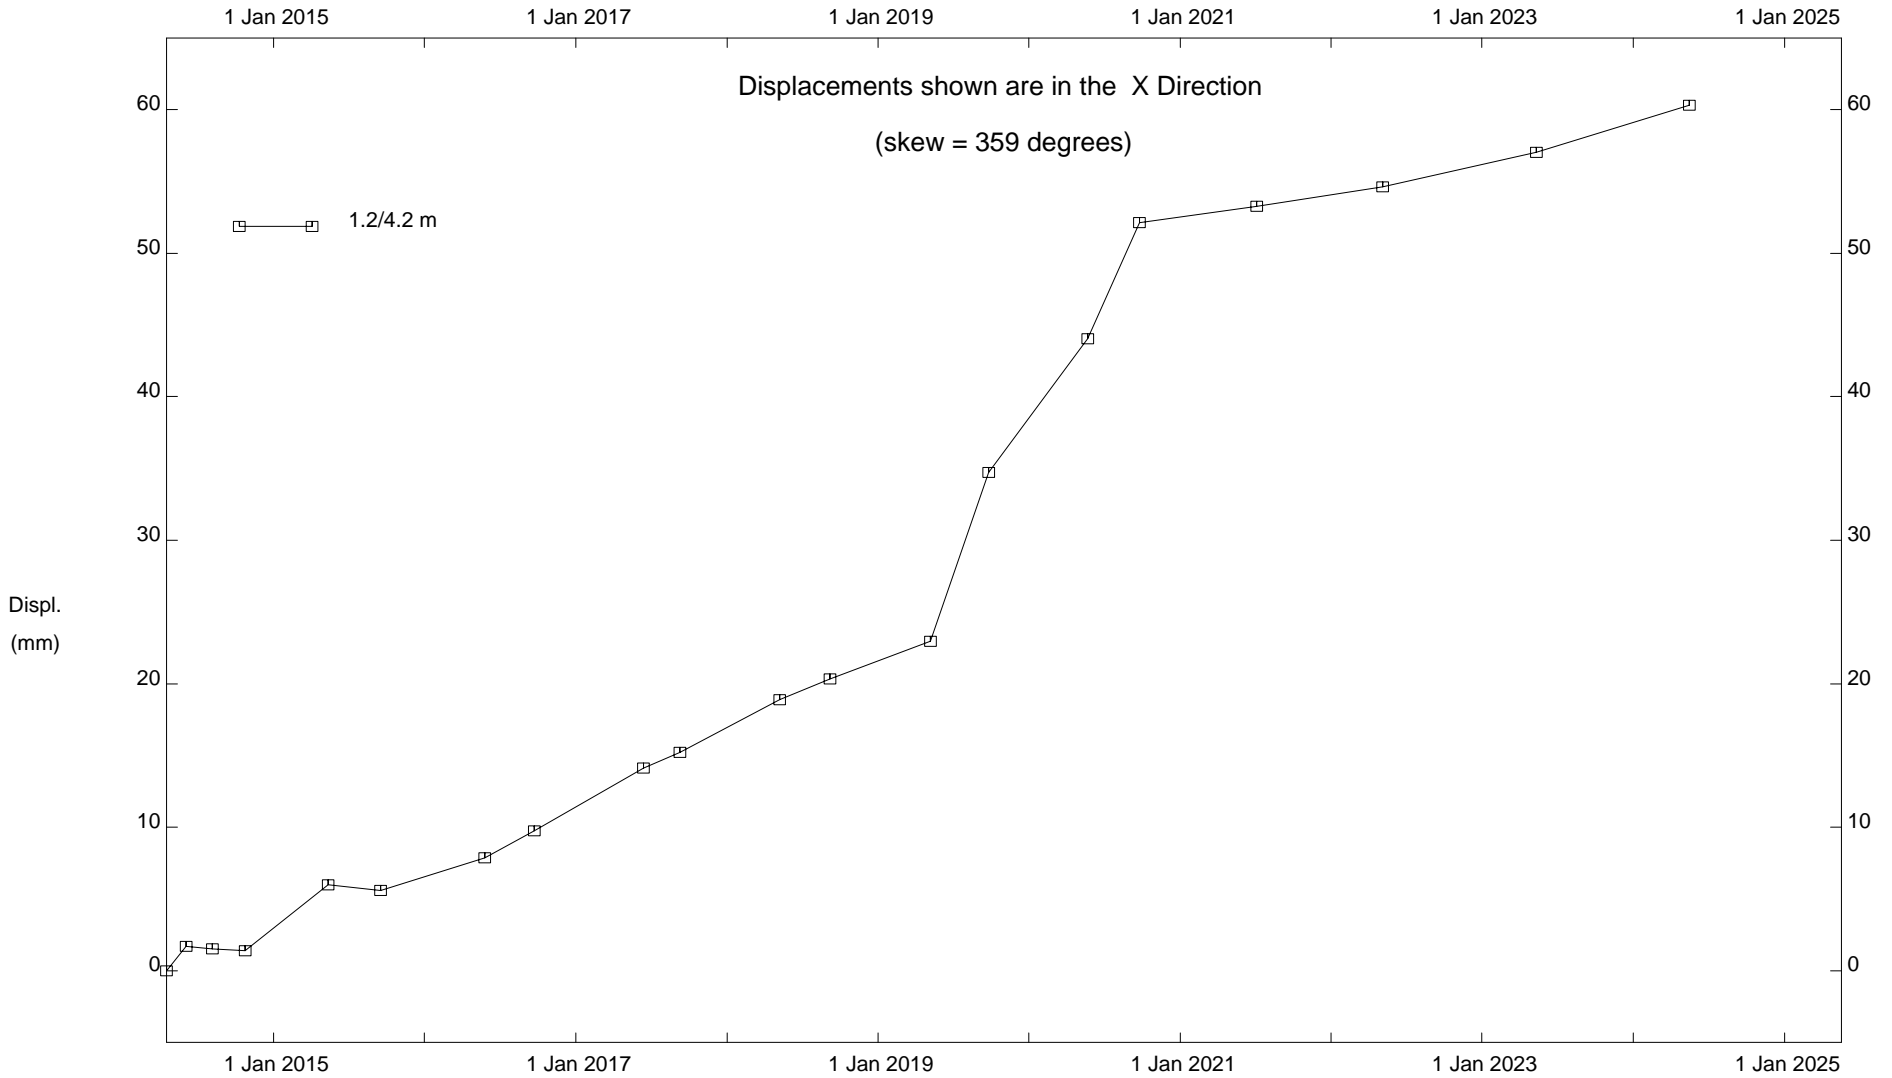
HWY 43:16 Whitecourt East Hill (NC1), Inclinometer SI14-02

SI14-02 has an average rate of movement of about 5 mm/yr since initiation to Spring 2019 at a depth of about 1.2 m to 4.8 m. The rate of movement began increasing in Fall 2019 to a movement rate of about 24 mm/yr during the Fall 2020 reading cycle. The current movement rate is 3 mm/yr with 3 mm of incremental movement observed since the Spring 2023 monitoring cycle.

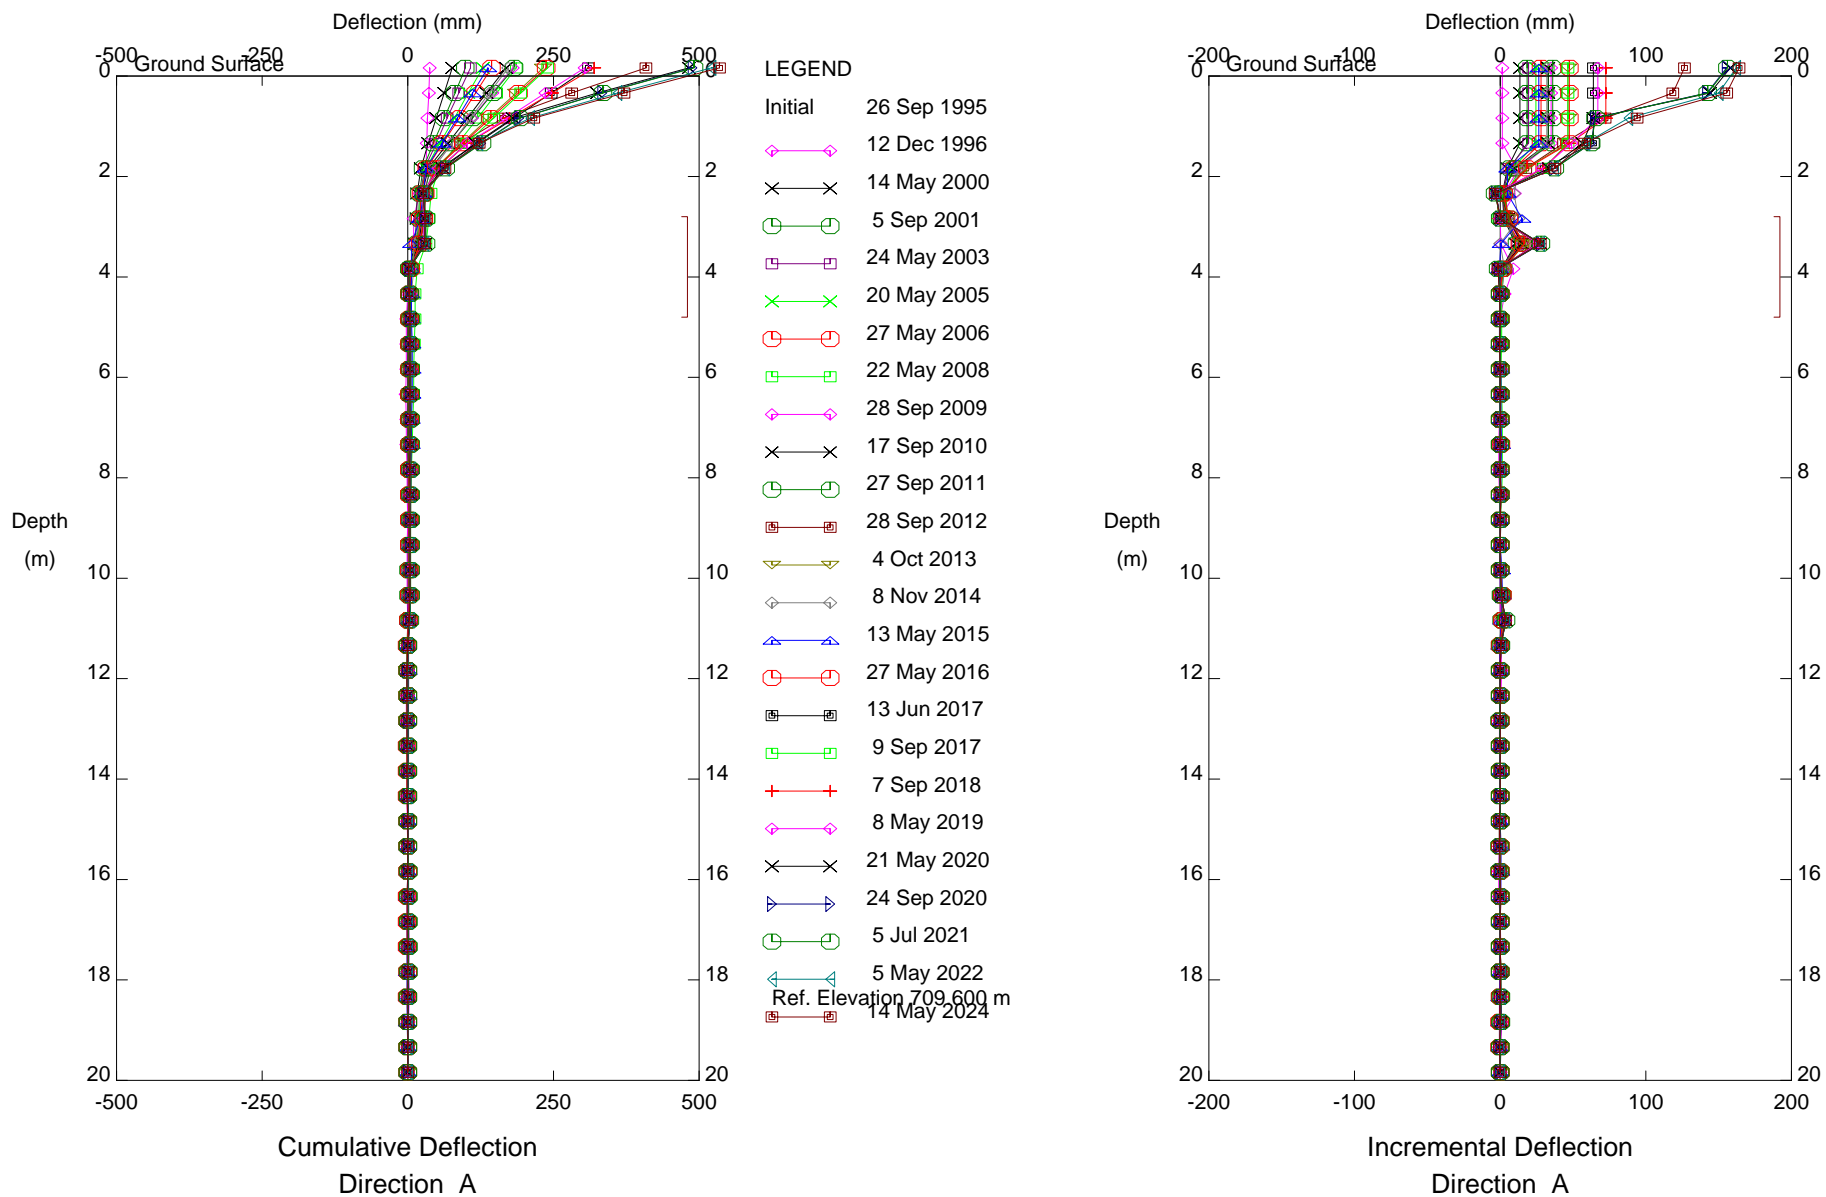
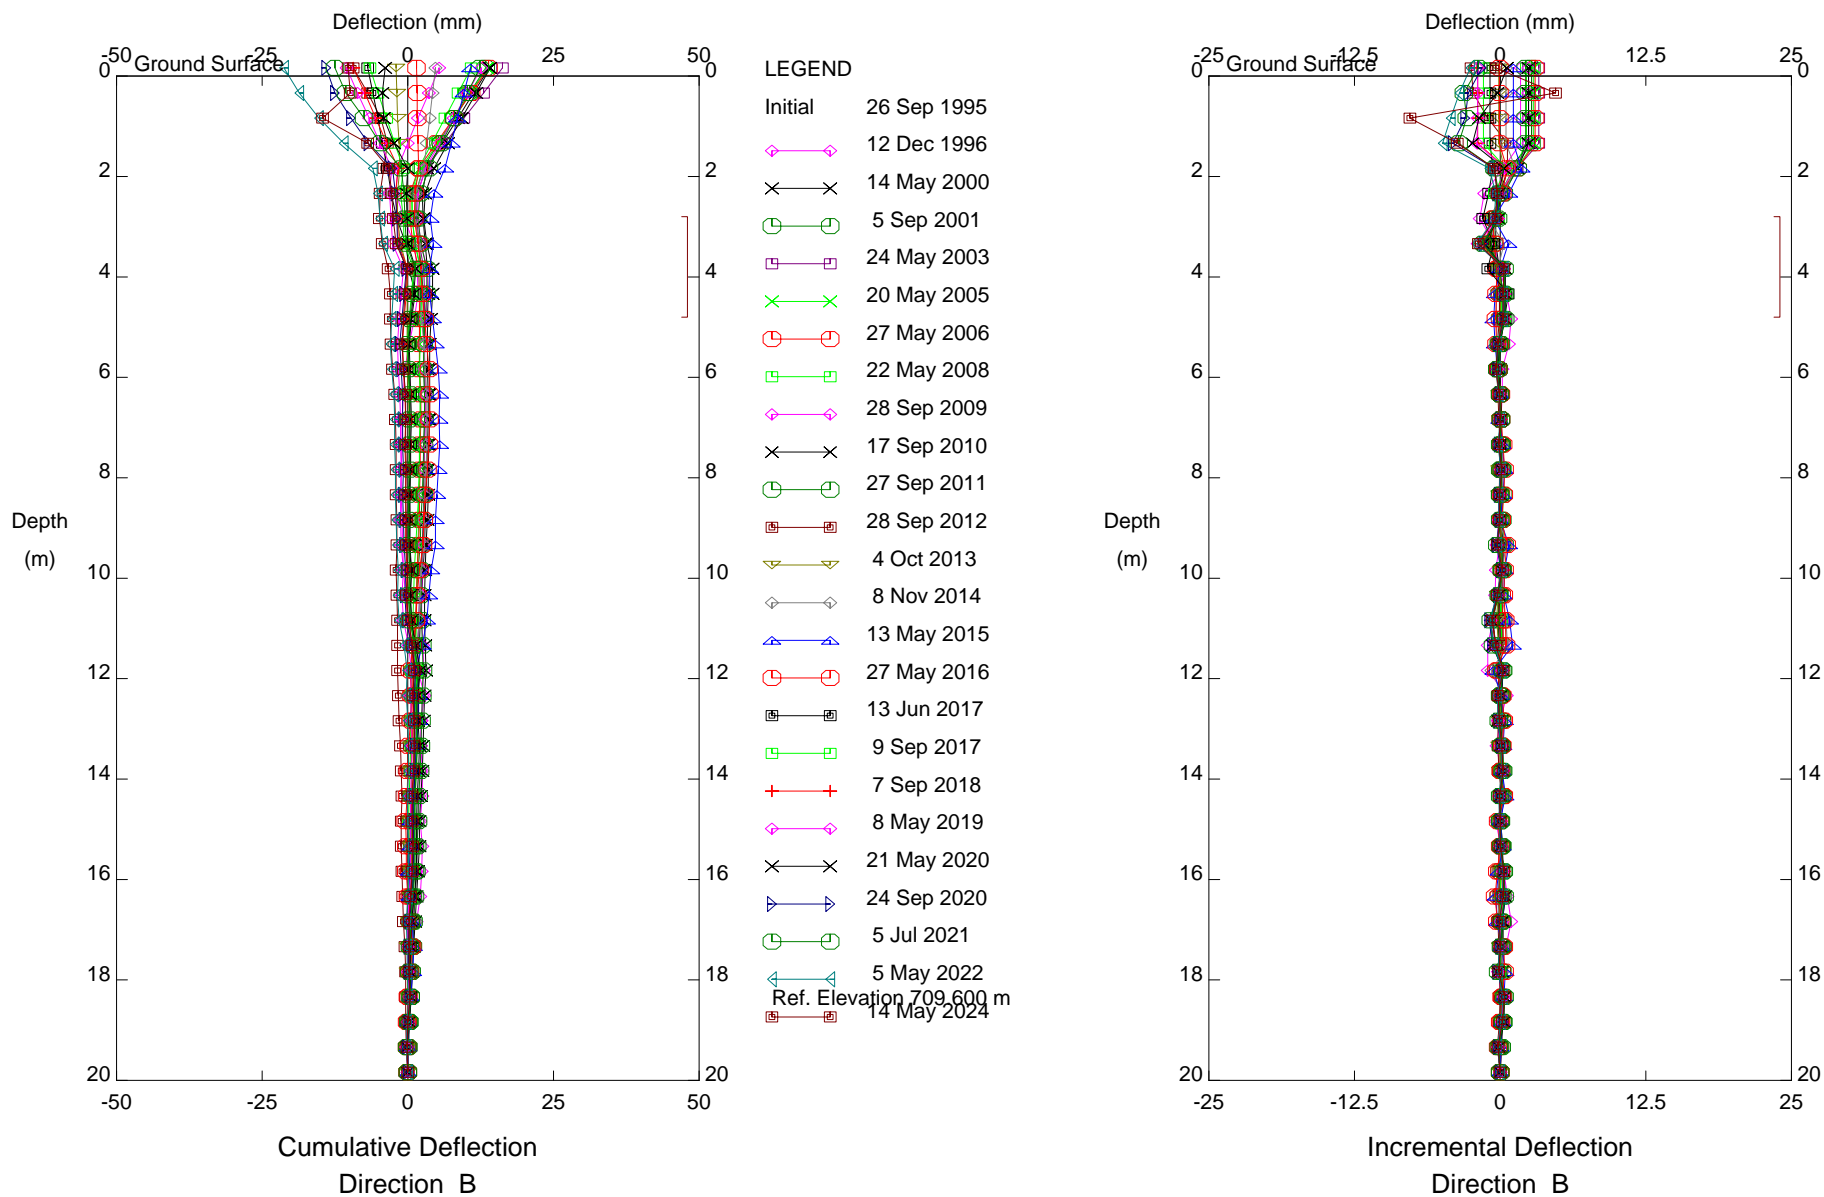
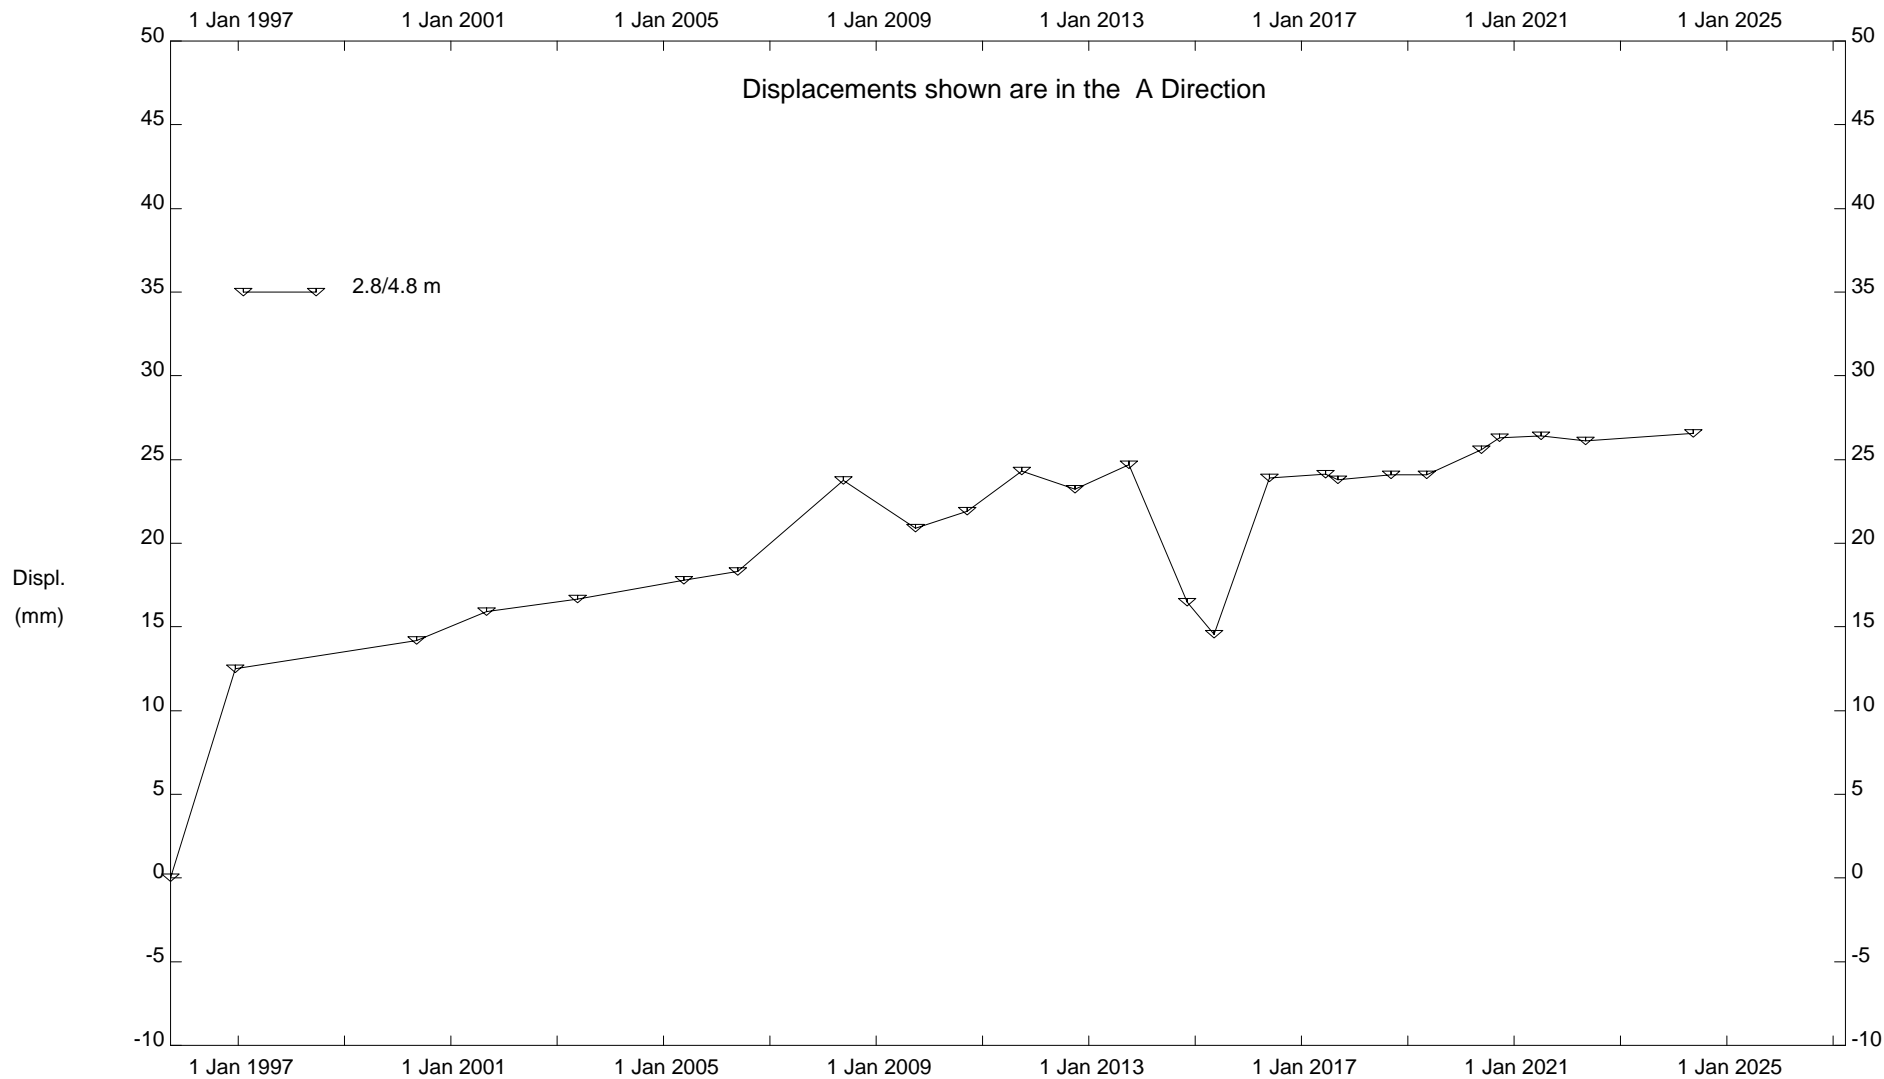
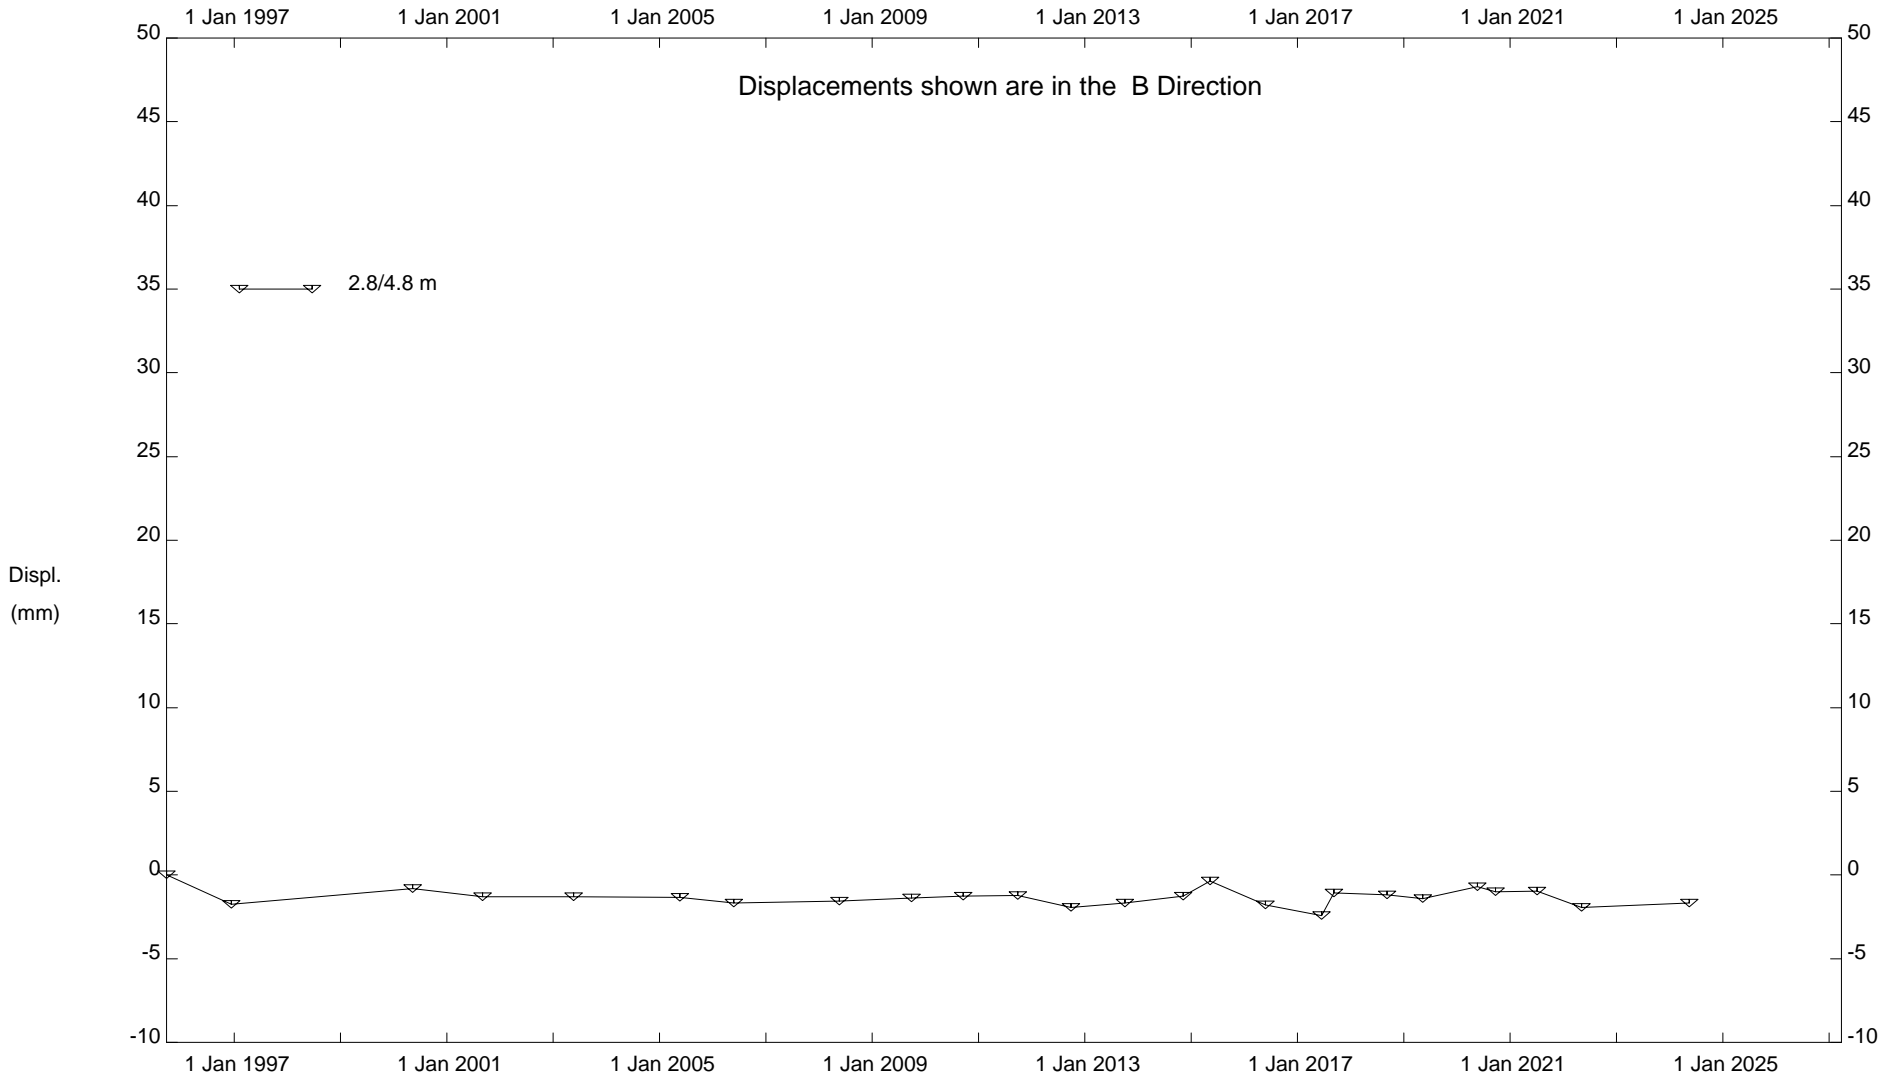
HWY 43:16 Whitecourt East Hill (NC1), Inclinometer SI31
 Alberta Transportation

SI31 is showing creep movement of less than 1 mm/year since 1997 at a shear zone between approximately 2.8 m and 4.8 m. The Spring 2024 readings showed less than 1 mm of incremental movement corresponding to a movement rate of less than 1 mm/year.
