To:	Amy Driessen	From:	Leslie Cho and Xiteng Liu
	Transportation and Economic Corridors		Stantec Consulting Ltd.
File:	123315222	Date:	June 18, 2024

Reference: North Central Region, Edson, Site NC001 - Highway 43:16 Whitecourt East Hill Spring 2024 Instrumentation Monitoring Report

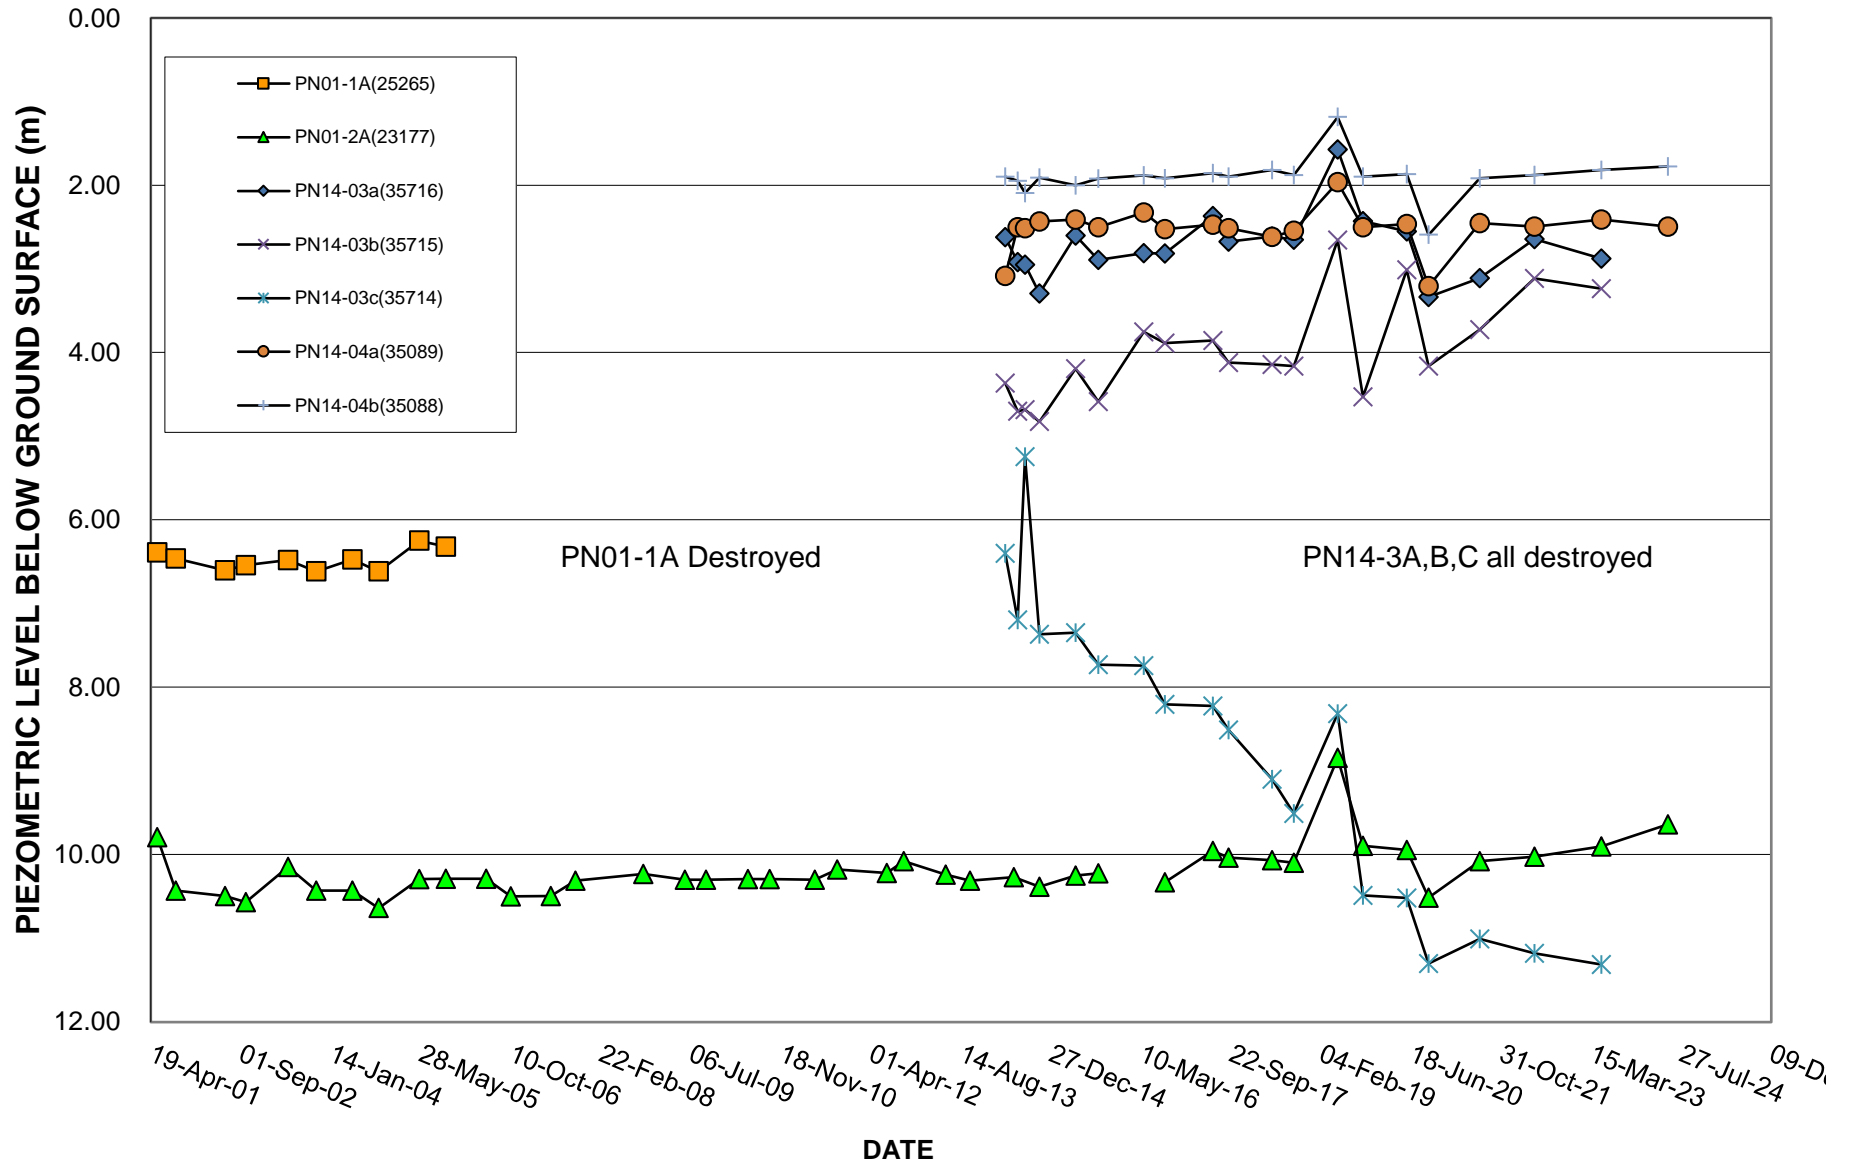
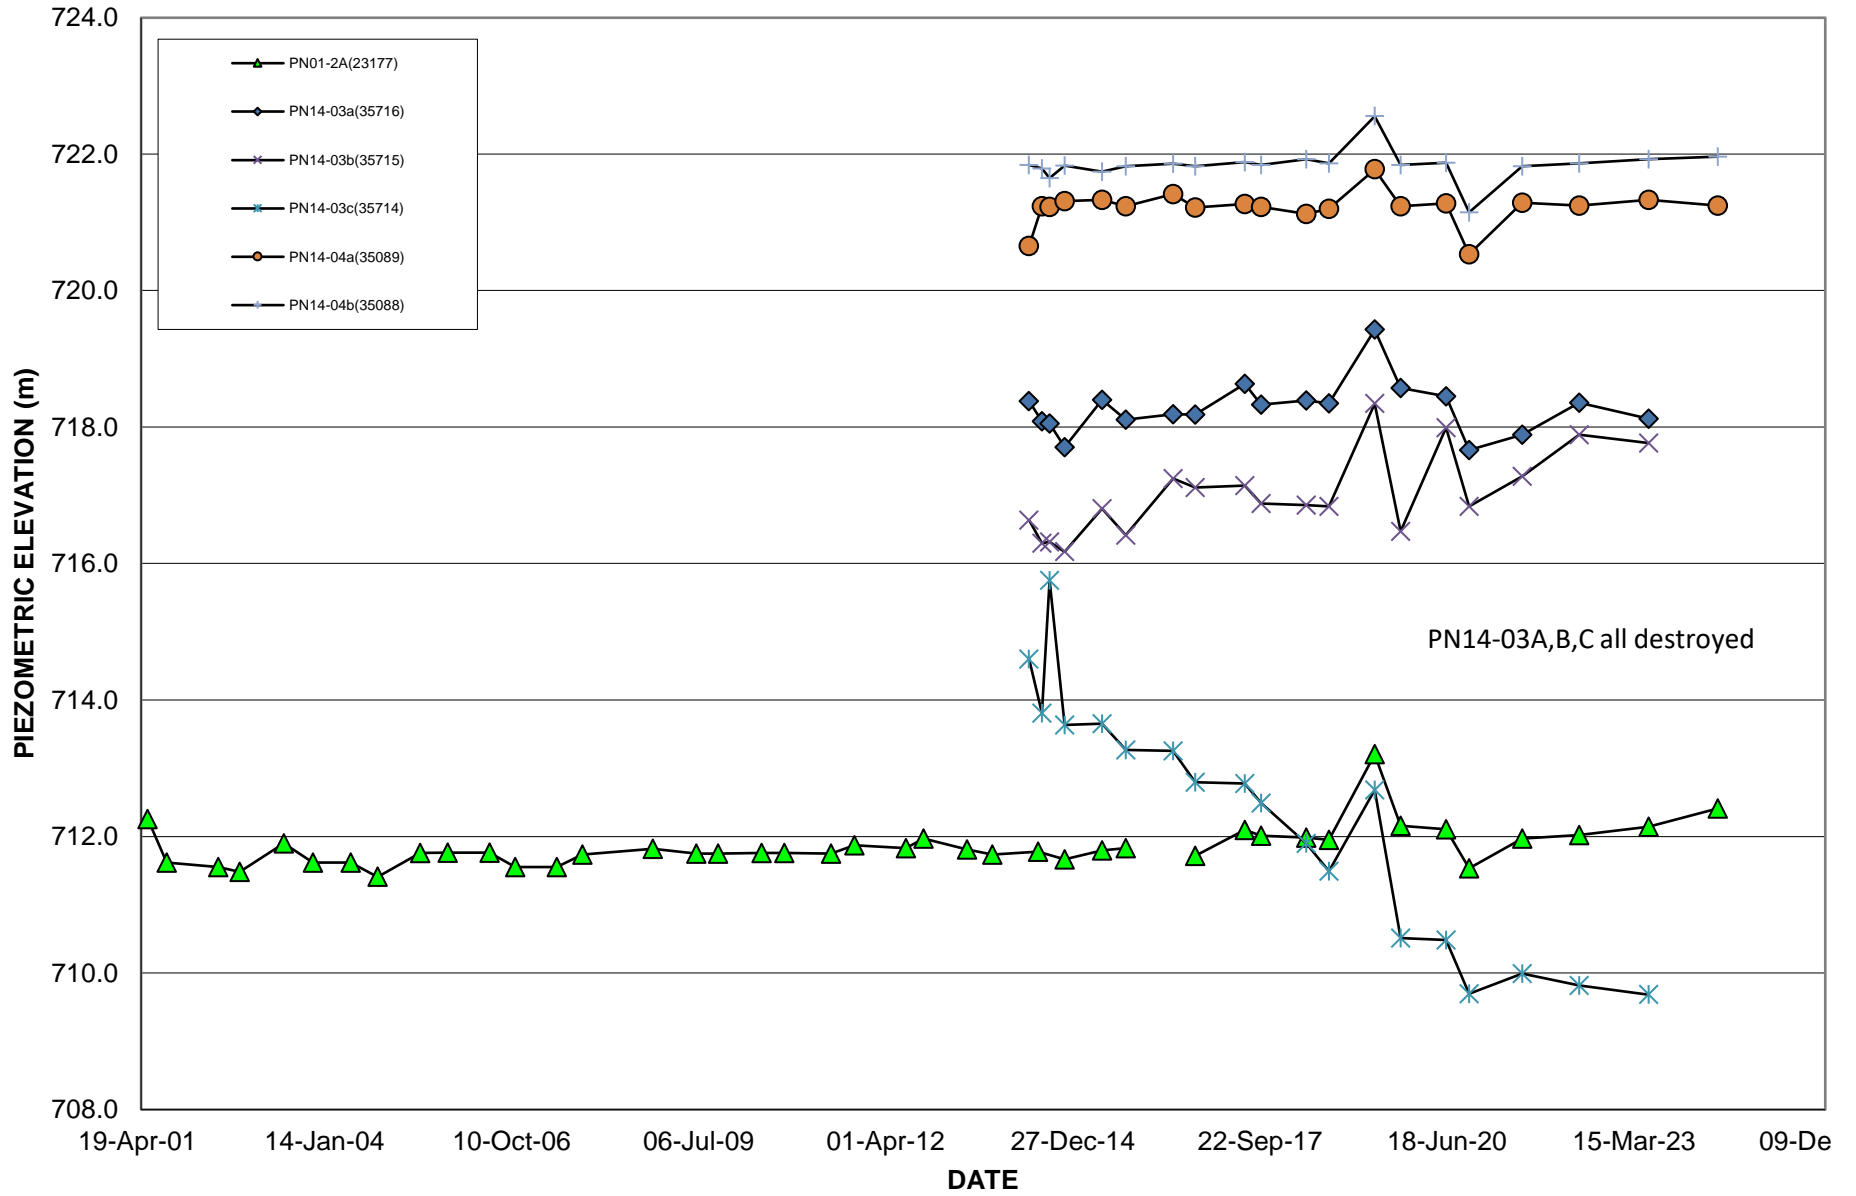
PNEUMATIC PIEZOMETER DATA
NC 1: HWY 43:16 Whitecourt East Hill

Generally, the PNs showed marginal changes in water level since the Spring 2023 reading cycle. The water level in PN01-2A, PN14-04A and PN14-04B changed by approximately 0.2 m, < -0.1 m and < 0.1 m, respectively.

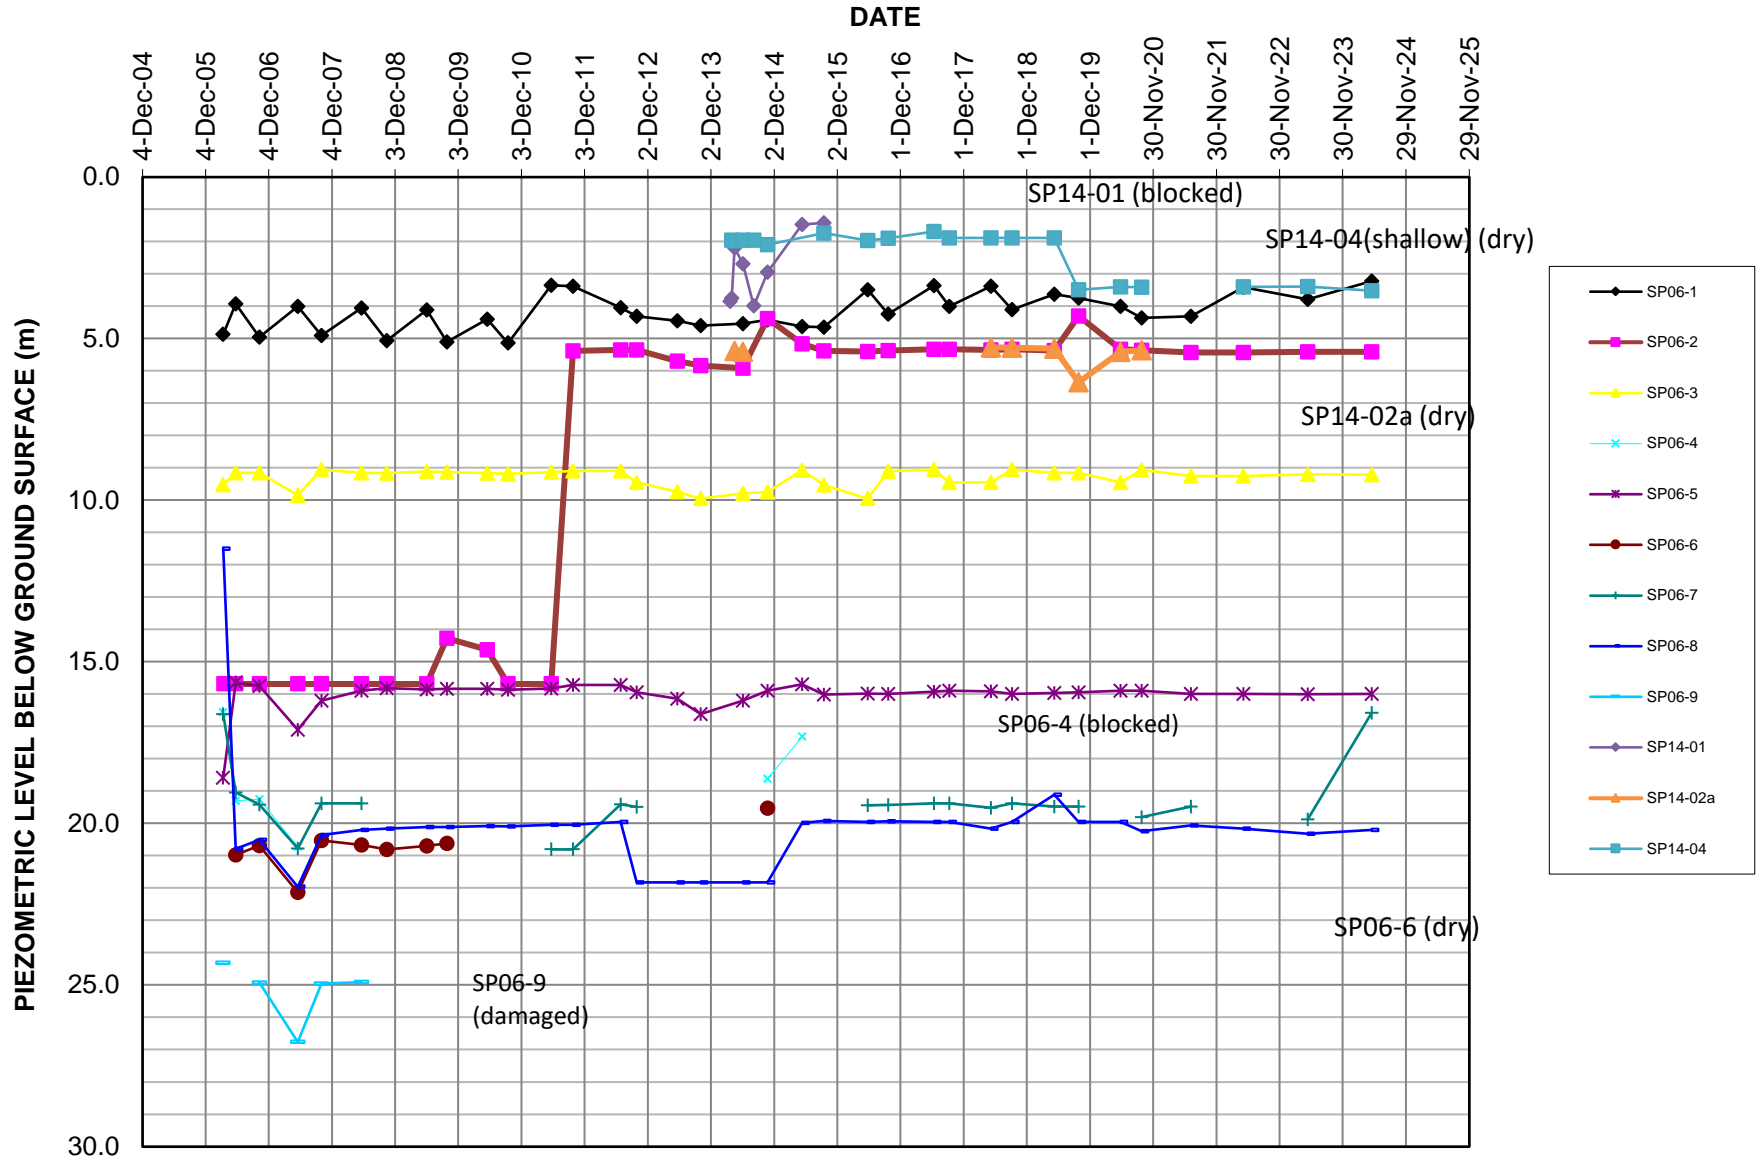
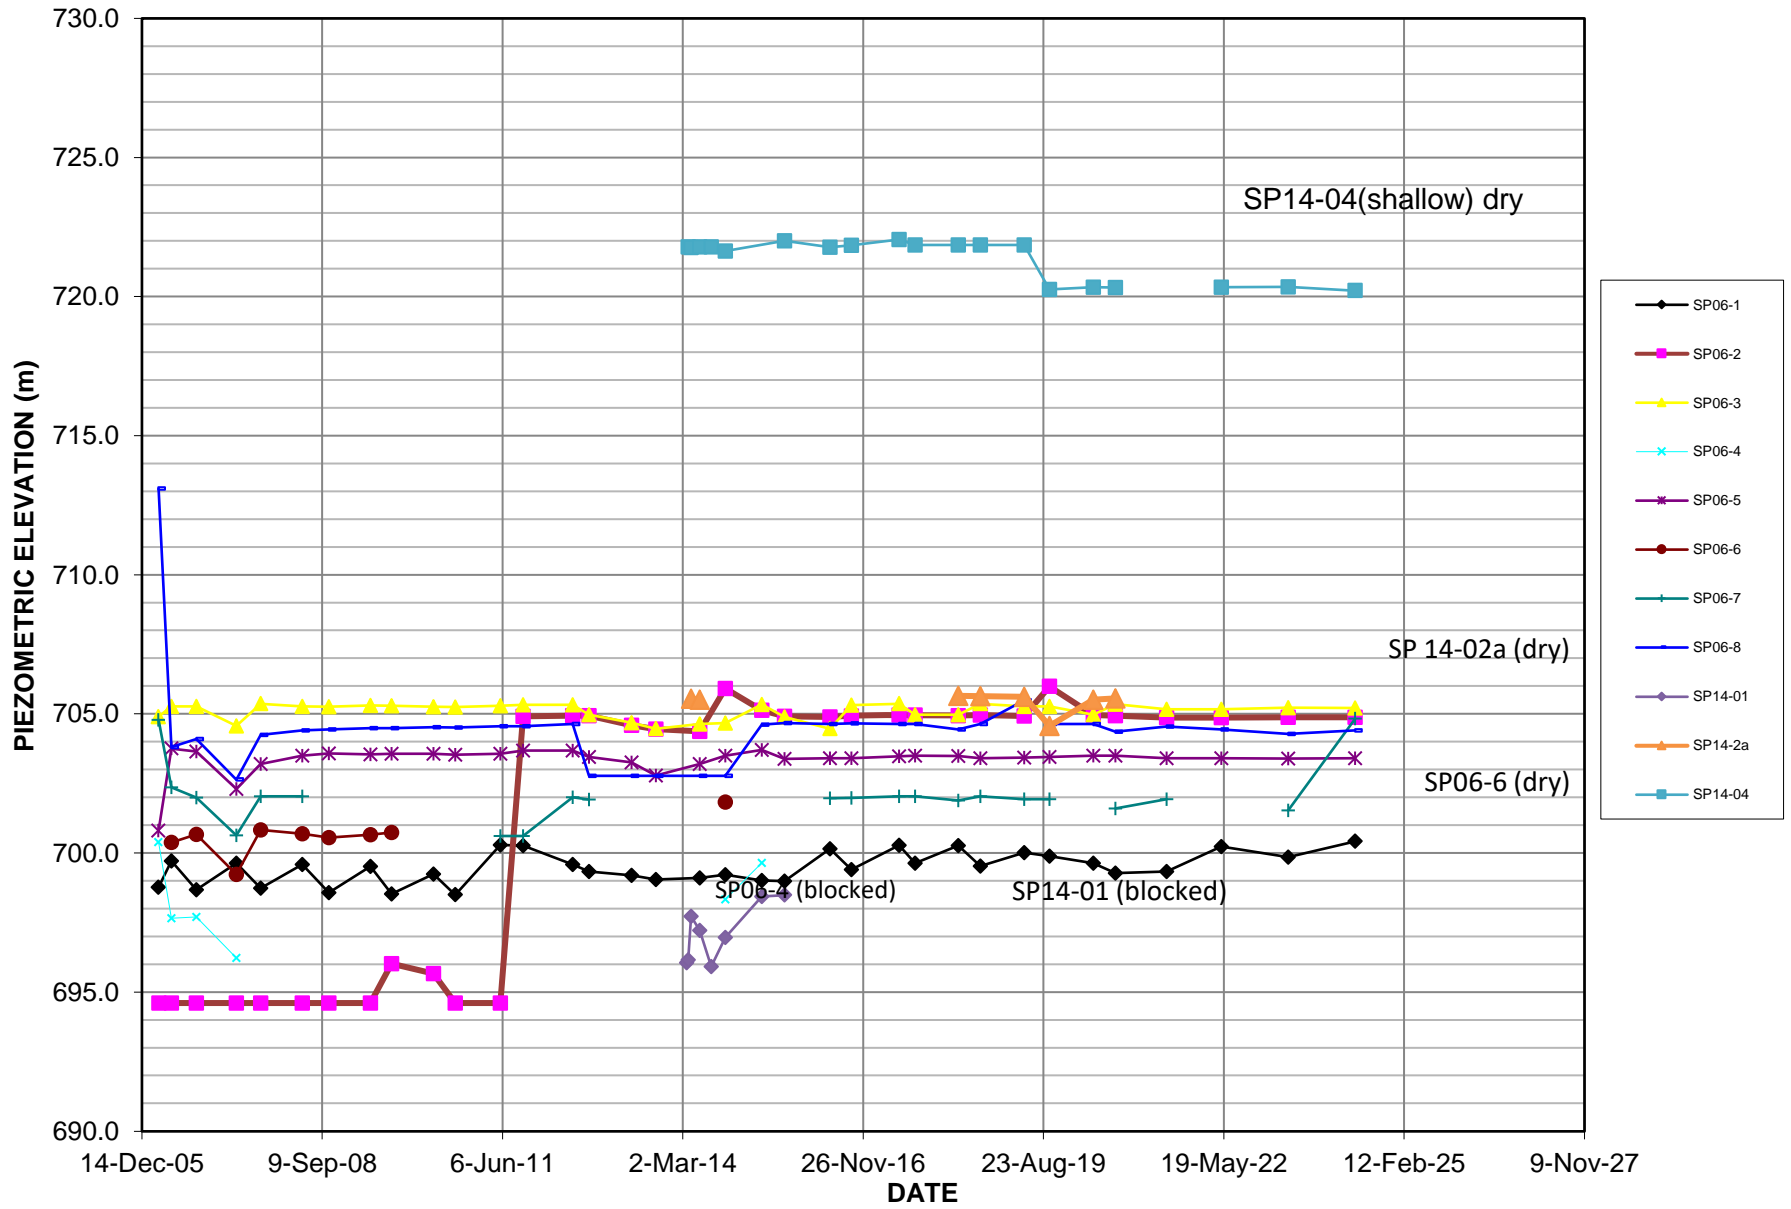
STANDPIPE PIEZOMETER DATA
NC1: HWY 43:16 Whitecourt East Hill

SP06-6, SP14-02A and SP14-04(shallow) were dry during the Spring 2024 reading cycle. The water level in SP06-7 was 19.9 m below ground surface (bgs) during the Spring 2023 reading cycle and was found to rise to 16.6 m bgs in the current reading cycle. Water level in SP06-2, SP06-3, SP06-5, SP06-8 and SP14-04(deep) showed little to no change when compared with the data obtained during the Spring 2023 reading cycle. SP06-1 recorded a 0.6 m increase in water level corresponding to a depth of 3.2 m bgs. Most of the standpipes have little changes since about 2006.

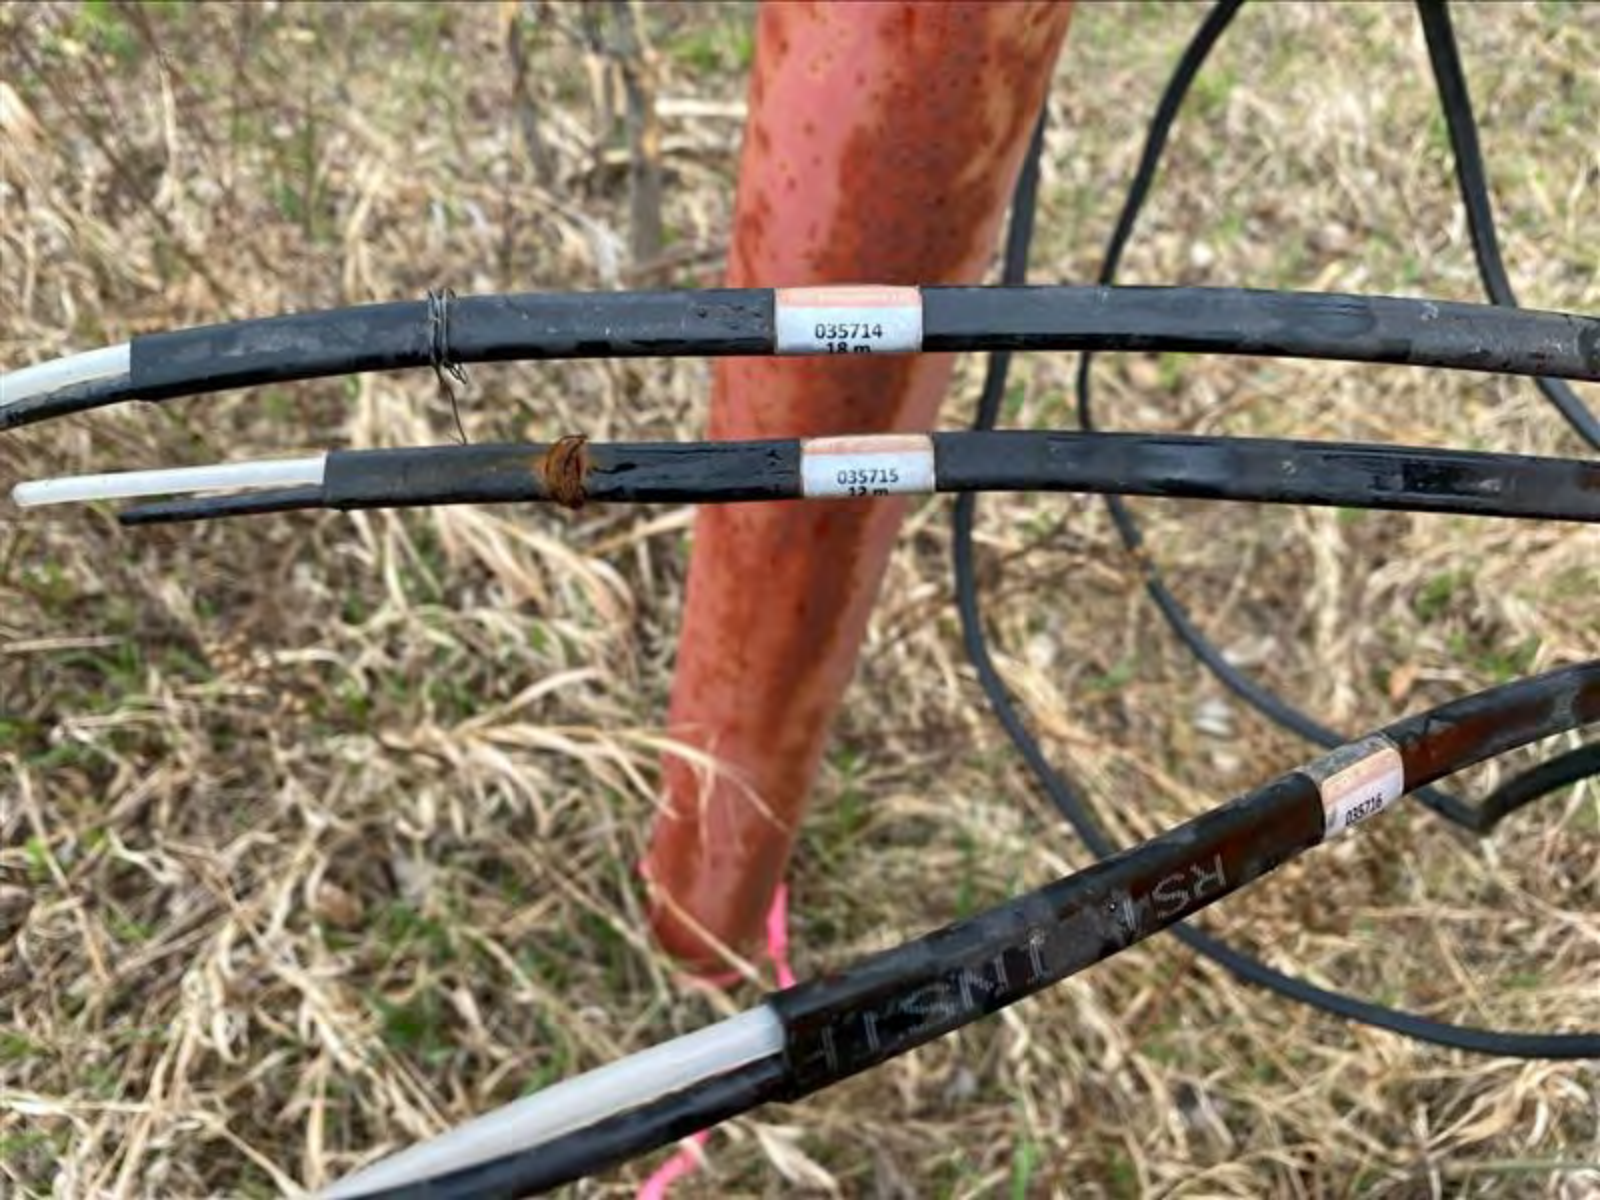
PN14-03A, PN14-03B, and PN14-03C were all found damaged in the Spring 2024 cycle. The tips of the pneumatic piezometers were missing, rendering them unreadable.

The metal connection tips of PN14-03A, PN14-03B, and PN14-03C were sheared at their connections and are currently unreadable.
