GEOHAZARD RISK MANAGEMENT PROGRAM

North Central Region – Edson / Stony Plain Area

2019 Inspection Report

Site Number	Site Name		Hwy	km
NC59	Little Paddle River Slide		43:16	41.4
Legal Land Description	SW 31-57-8-W5M			
UTM Coordinates (NAD 83)	Zone 11U	N5981523	E619300	
Operational Site Instrumentation	Slope Inclinometers		3	
	Pneumatic Piezometers		4	
	Vibrating Wire Piezometers		0	
	Standpipe Piezometers		0	
Date of Last Instrumentation Readings	May 8, 2019

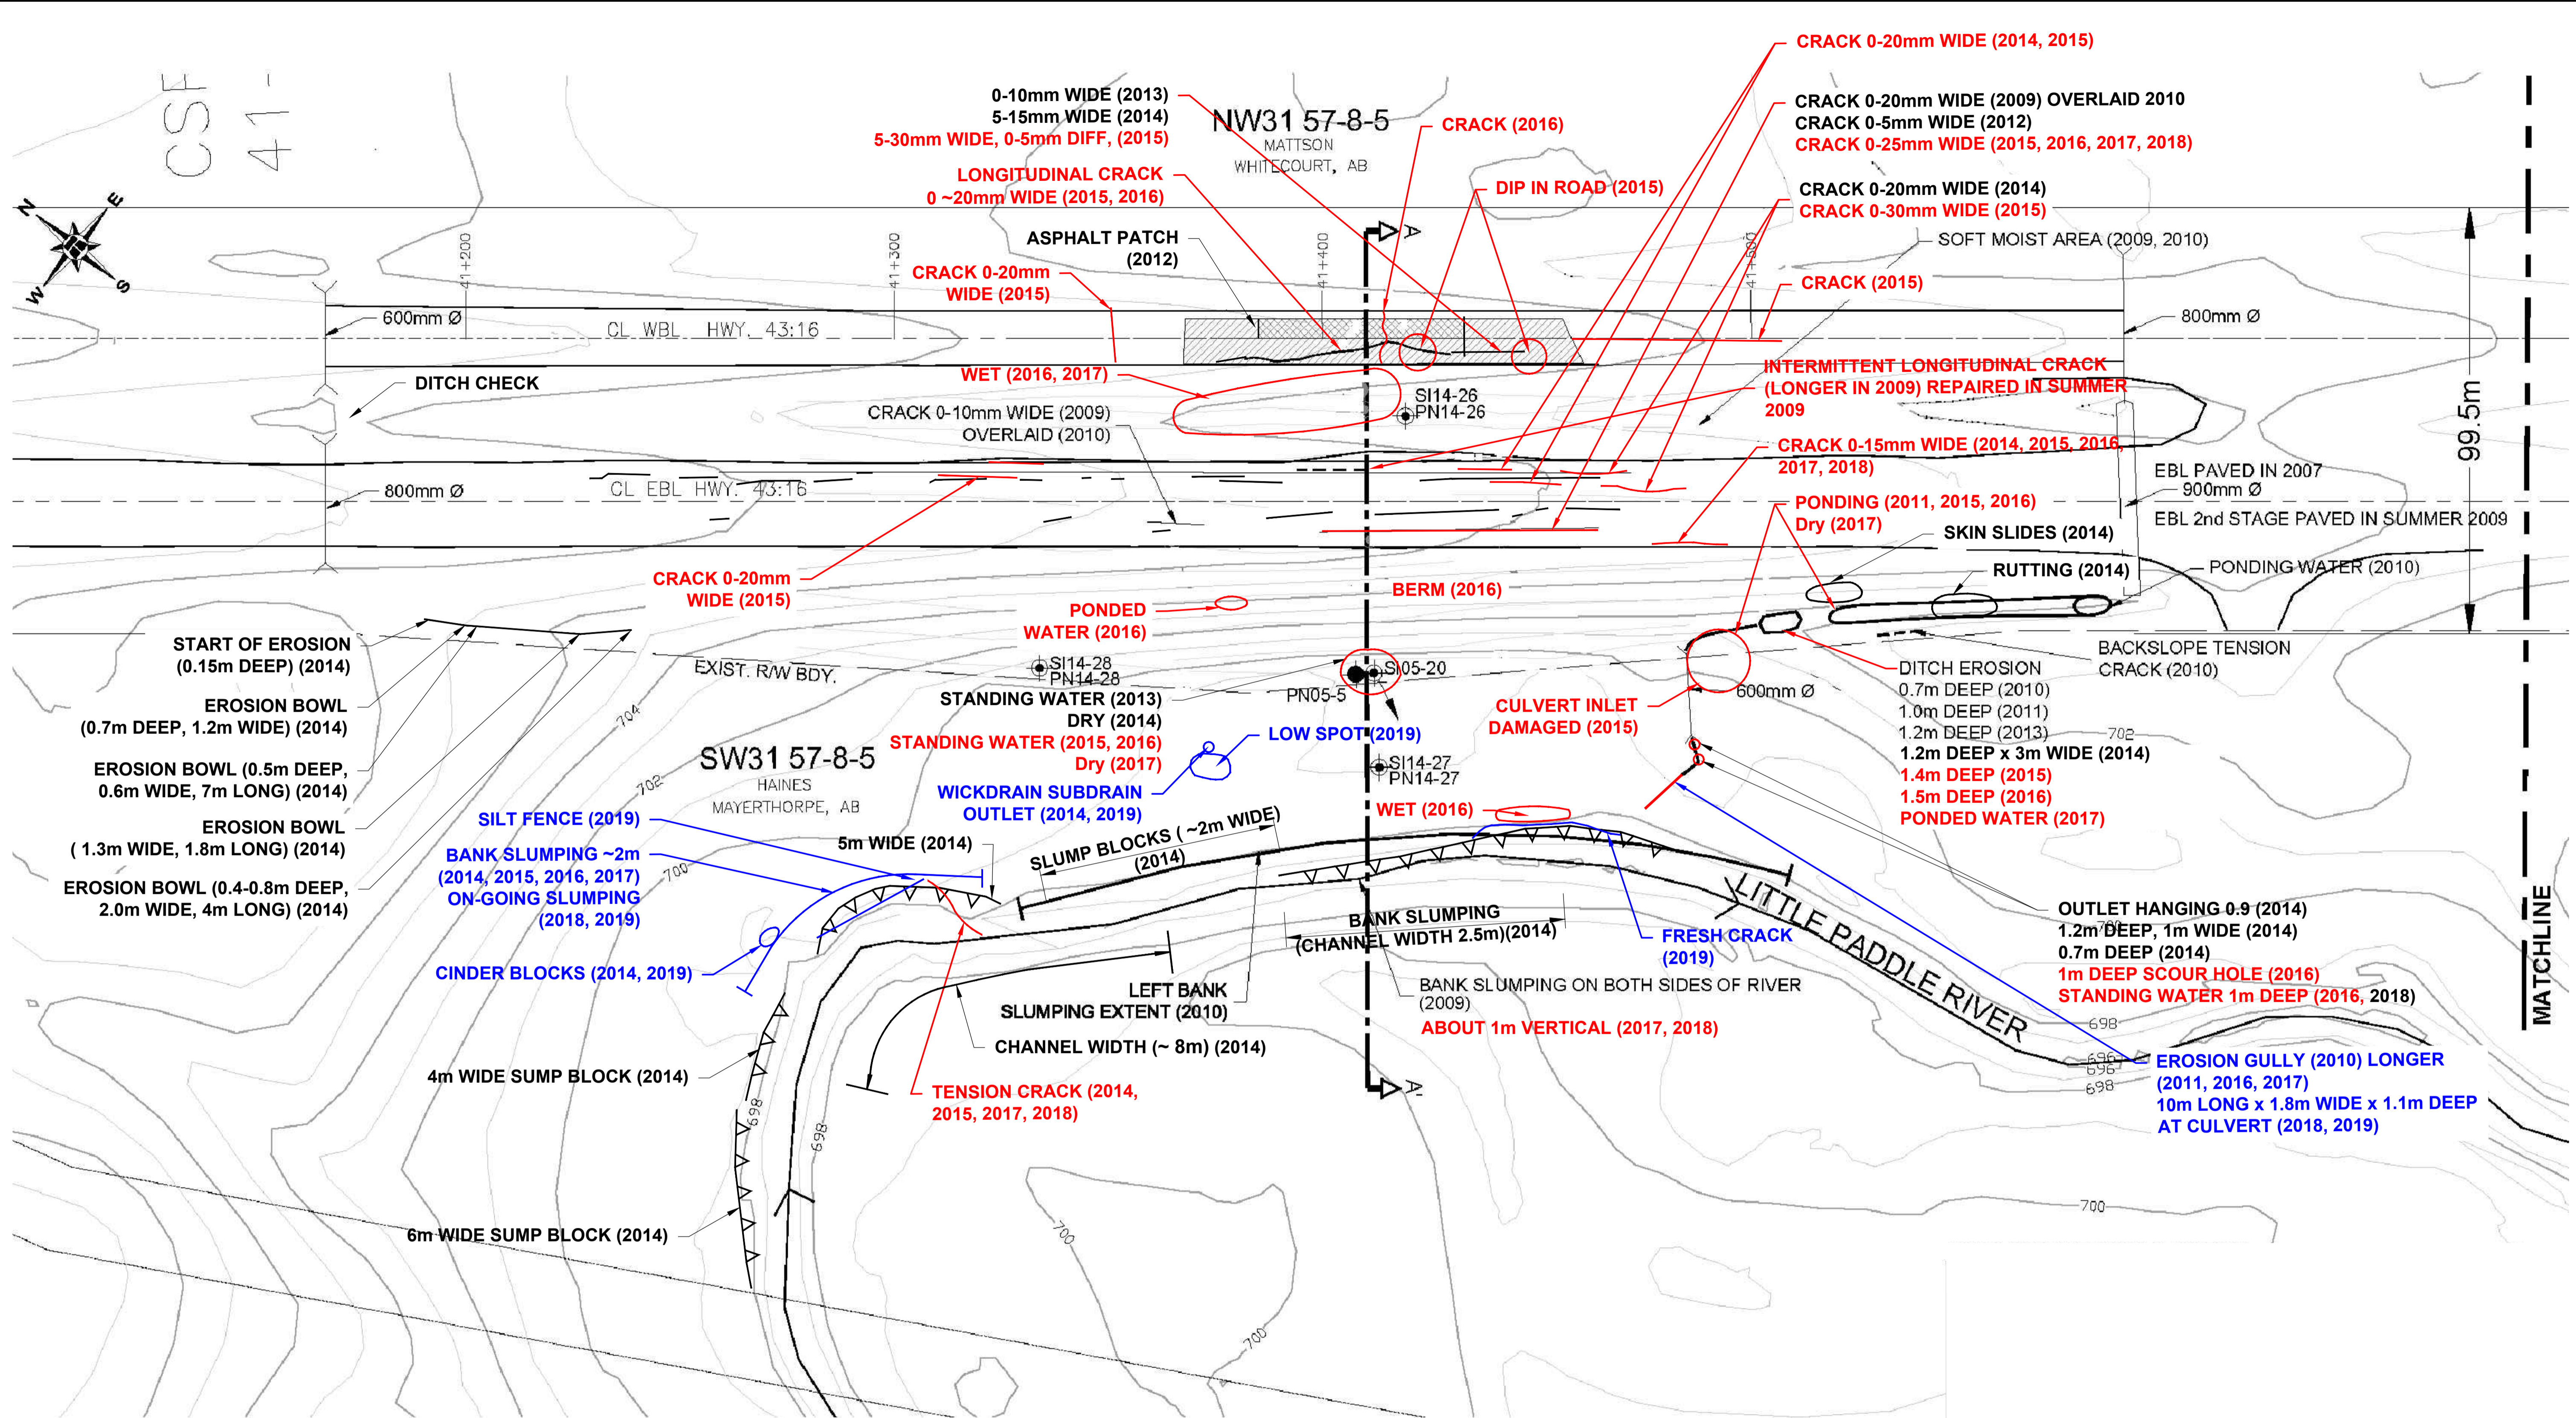
STANTEC CONSULTING	
		400-10220 103 AVENUE NW EDMONTON, ALBERTA, CANADA T5J 0K4	
ALBERTA TRANSPORTATION GEOHAZARD MONITORING PROGRAM NC59 LITTLE PADDLE RIVER MAIN SLIDE SITE PLAN			
DRAWN WW / MK	CHECK XL	APPROVE LC	
DATE 16 JUL 2019	SCALE AS SHOWN	PROJECT # 123312435	
FIGURE - 1			-

Discussion	<p>Per AT's direction, the bridge site was not visited during this inspection. As such the current report will be focused on the Main Slide Site shown in Figure 1. Figure 2 showing the Bridge Site is based on 2018 observations.</p> <p>Pavement cracking was observed on both the eastbound and westbound lanes. No obviously new cracks were observed.</p> <p>A 10 m long by 1.8 m wide by 1.1 m deep erosion gully was observed in 2018 at the outlet of the 600 mm diameter culvert southeast of S105-20. During the current inspection, the gully was found to be full of water and slow flowing as shown in Photos 1 and 2.</p> <p>There appears to be continual riverbank erosion with new scarps and ongoing slumping as shown in Photos 3 to 6.</p>
-------------------	---

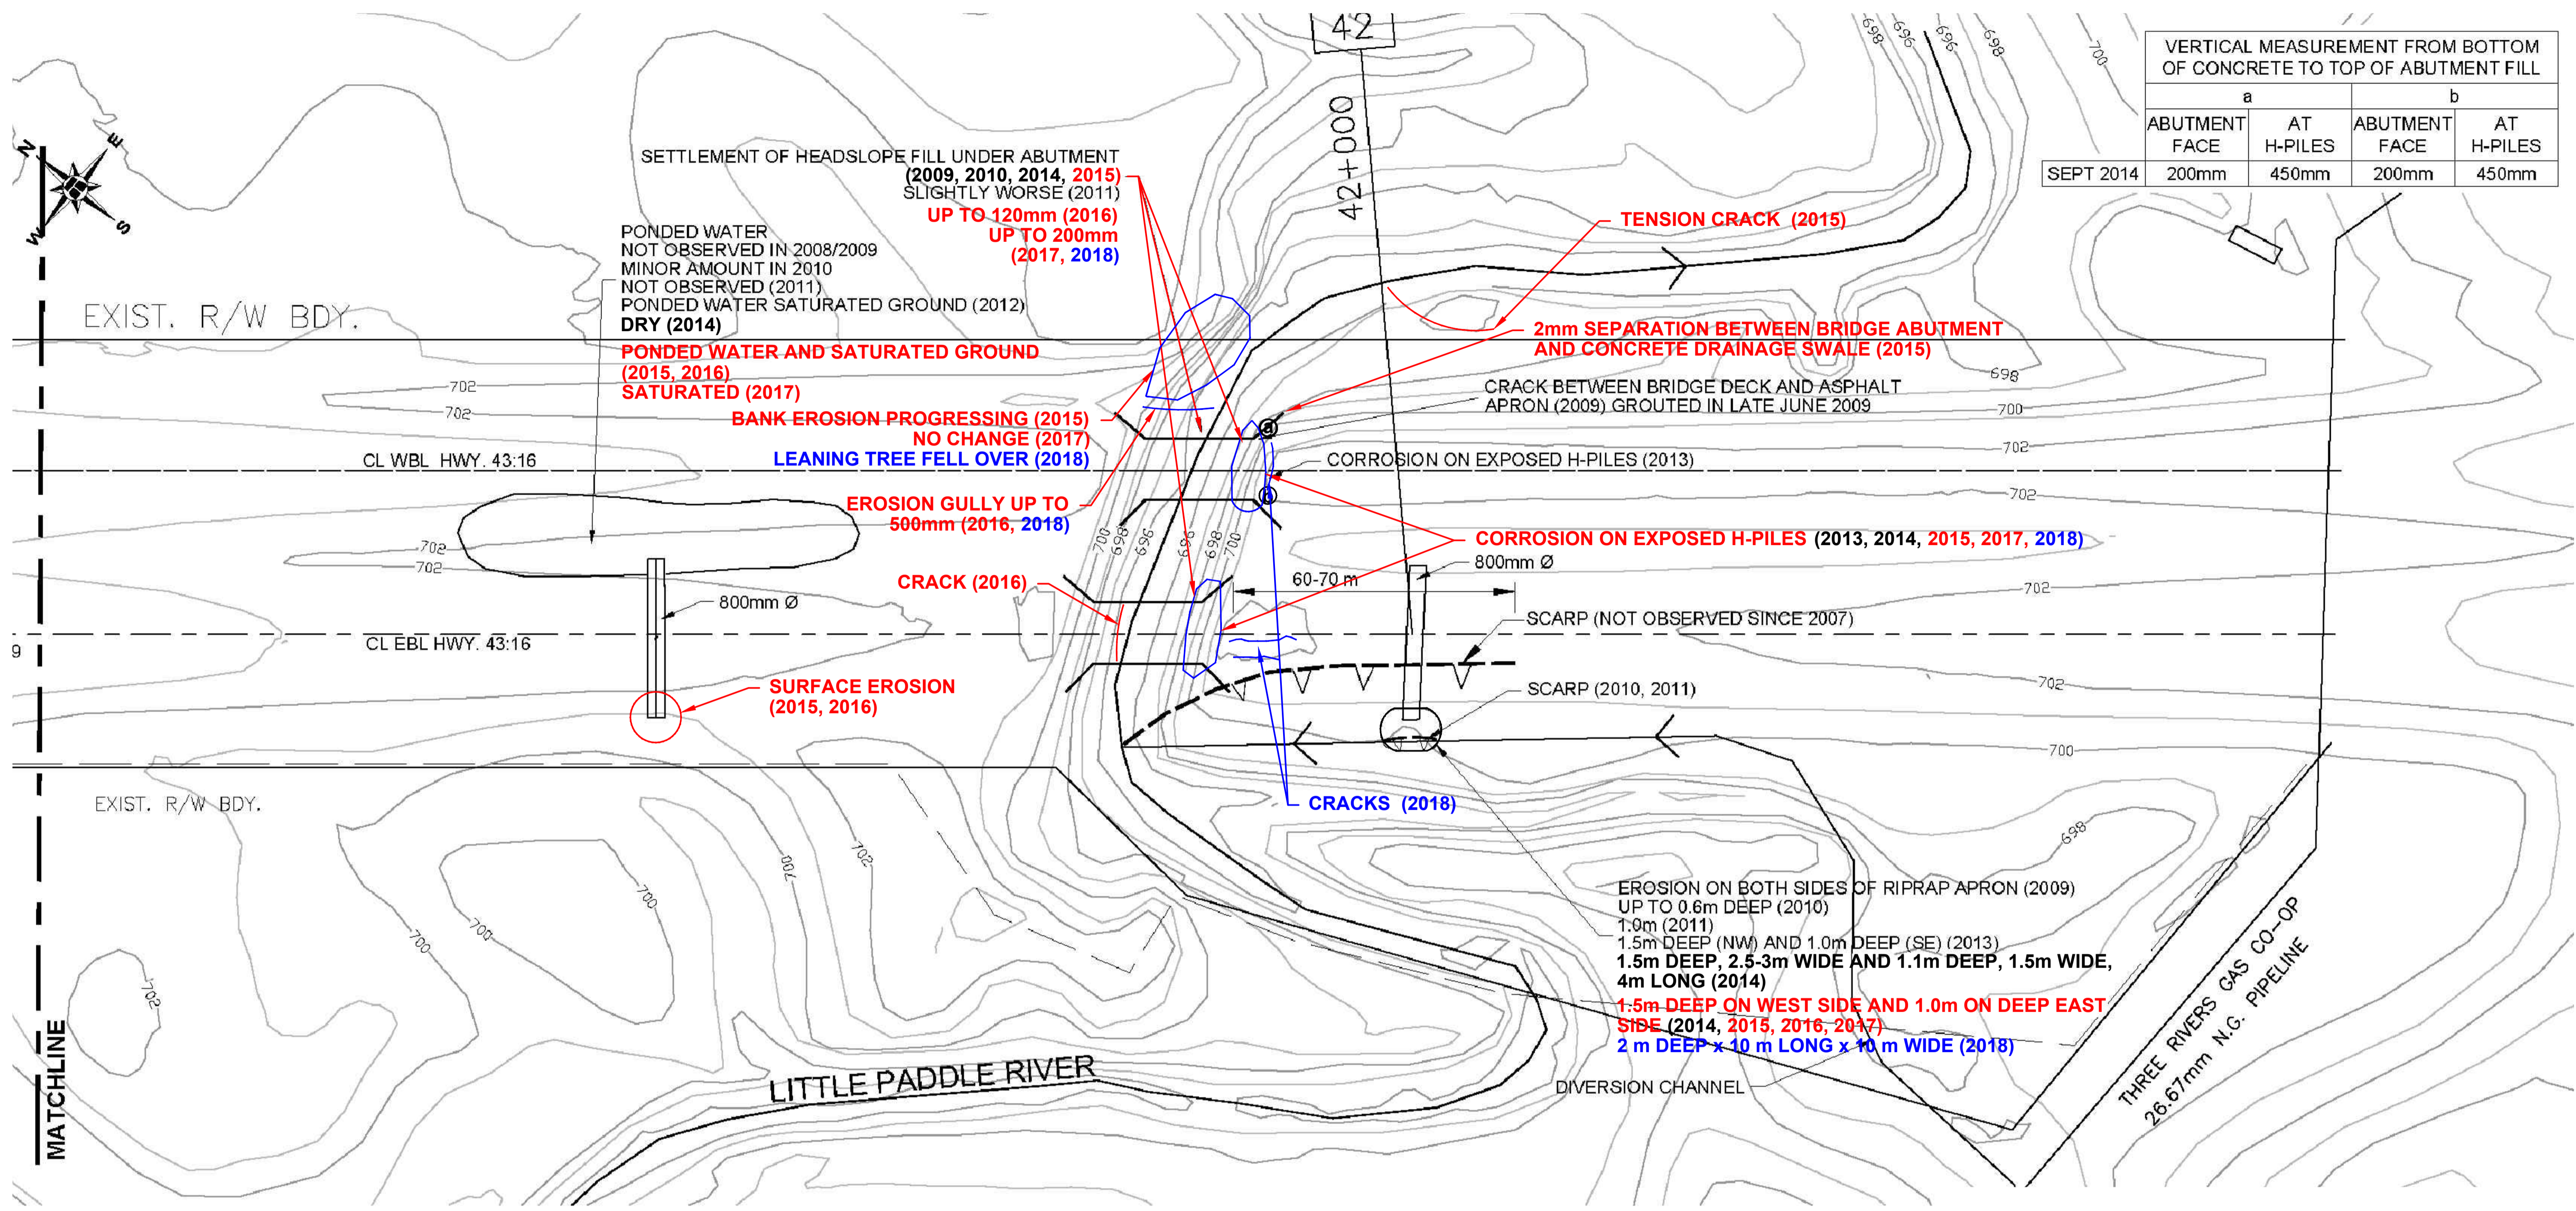
STANTEC CONSULTING	
		10160-112 STREET EDMONTON ALBERTA CANADA	
ALBERTA TRANSPORTATION GEOHAZARD MONITORING PROGRAM NC59 LITTLE PADDLE RIVER BRIDGE SITE PLAN			
DRAWN WW / MK	CHECK XL	APPROVE LC	
DATE 14 AUG. 2018	SCALE AS SHOWN	PROJECT # 123312435	
FIGURE - 2			-

VERTICAL MEASUREMENT FROM BOTTOM OF CONCRETE TO TOP OF ABUTMENT FILL				
	a		b	
ABUTMENT FACE	AT H-PILES	ABUTMENT FACE	AT H-PILES	
SEPT 2014	200mm	450mm	200mm	450mm

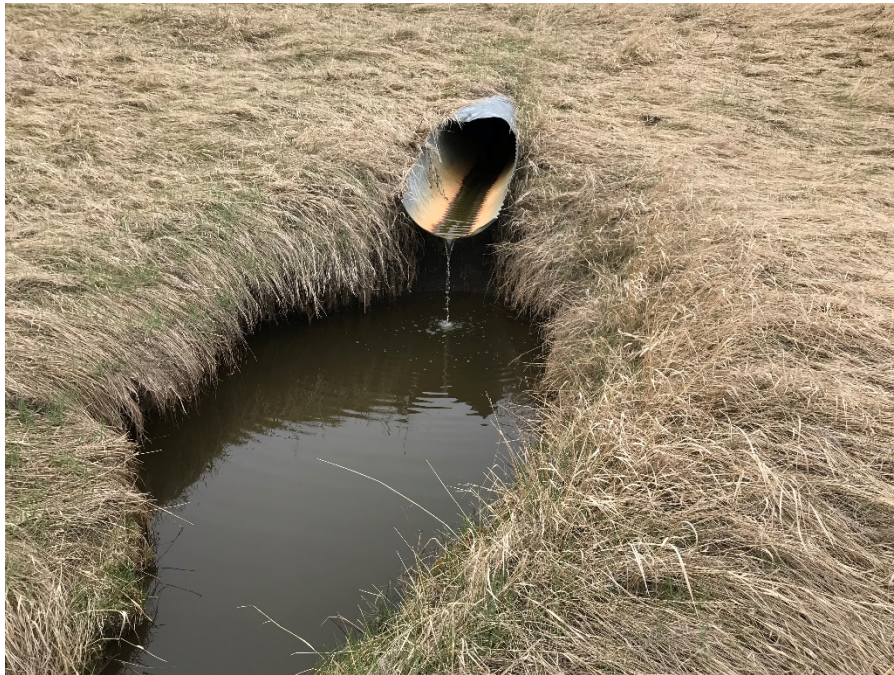
<input checked="" type="checkbox"/> Erosion	- Erosion on both banks of the Little Paddle River - Erosion/scouring at culvert outlet southeast of S114-27	<input type="checkbox"/> Yes	<input checked="" type="checkbox"/> No
<input type="checkbox"/> Seepage		<input type="checkbox"/> Yes	<input type="checkbox"/> No
<input type="checkbox"/> Other		<input type="checkbox"/> Yes	<input type="checkbox"/> No

Photo 1: Eroded channel at culvert outlet southwest of SI14-27 filled with water. Looking northeast.

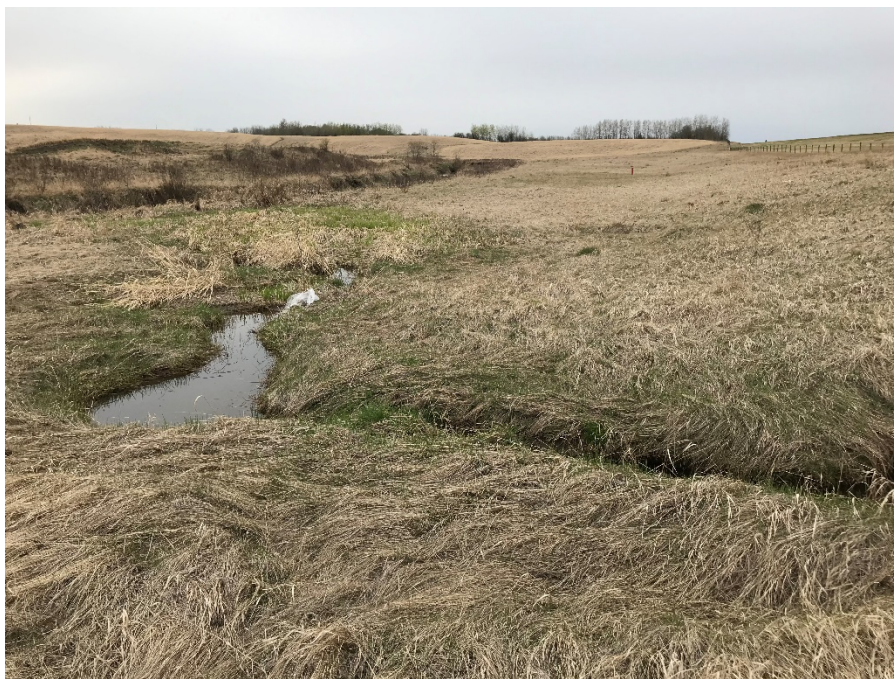
Photo 2: Eroded channel at culvert outlet southwest of SI14-27 filled with water. Looking west.

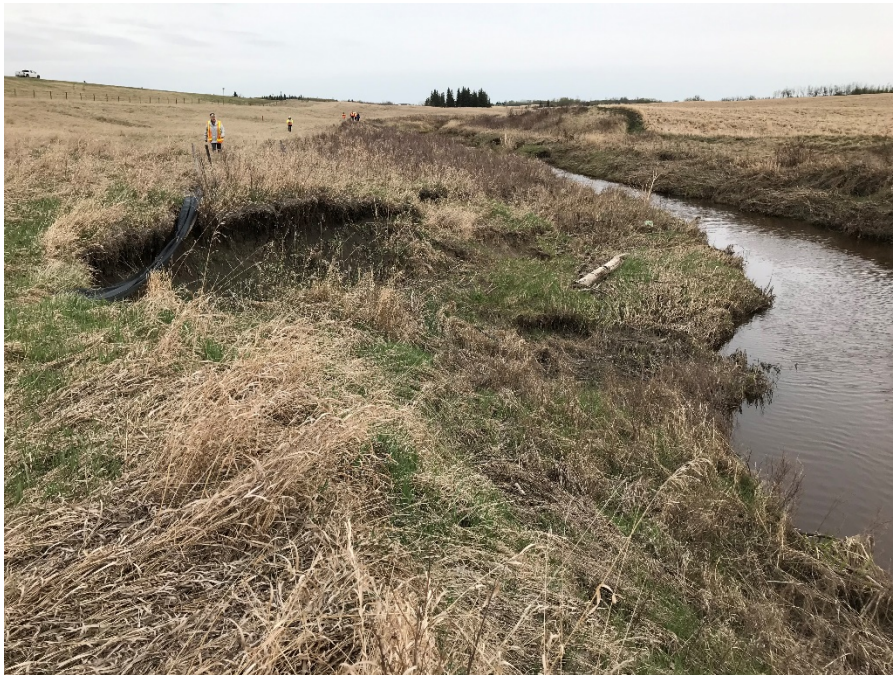
Photo 3: Retrogressing scarp along well vegetated slope and banks. Looking southeast.

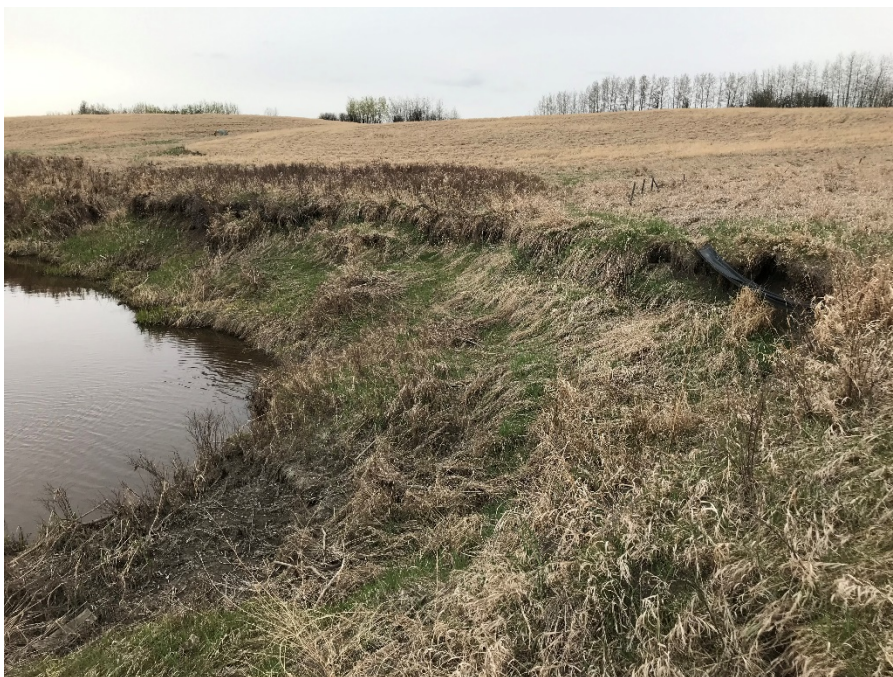
Photo 4: Well vegetated banks and slopes at the northwest bend in the river. Looking northwest.

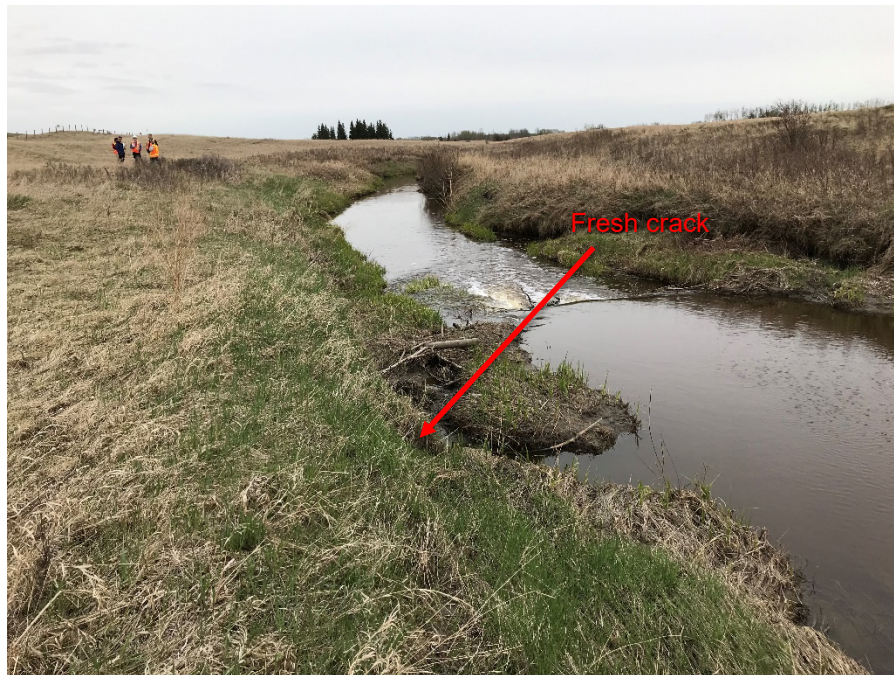
Photo 5: Slumping along southeast meander. Some fresh cracks visible. Looking southeast.

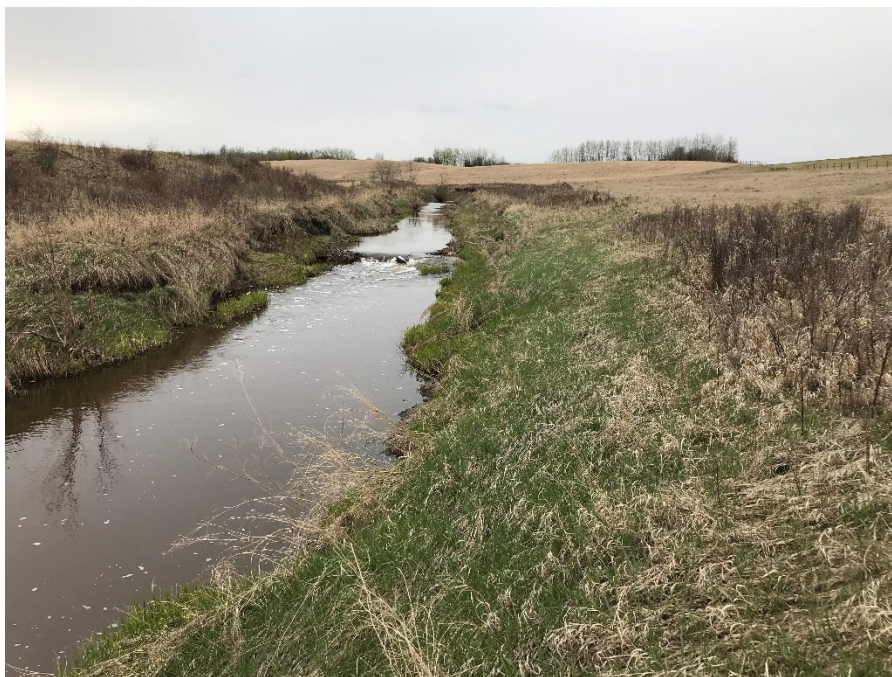
Photo 6: River bank erosion and slumping along. Looking northwest.

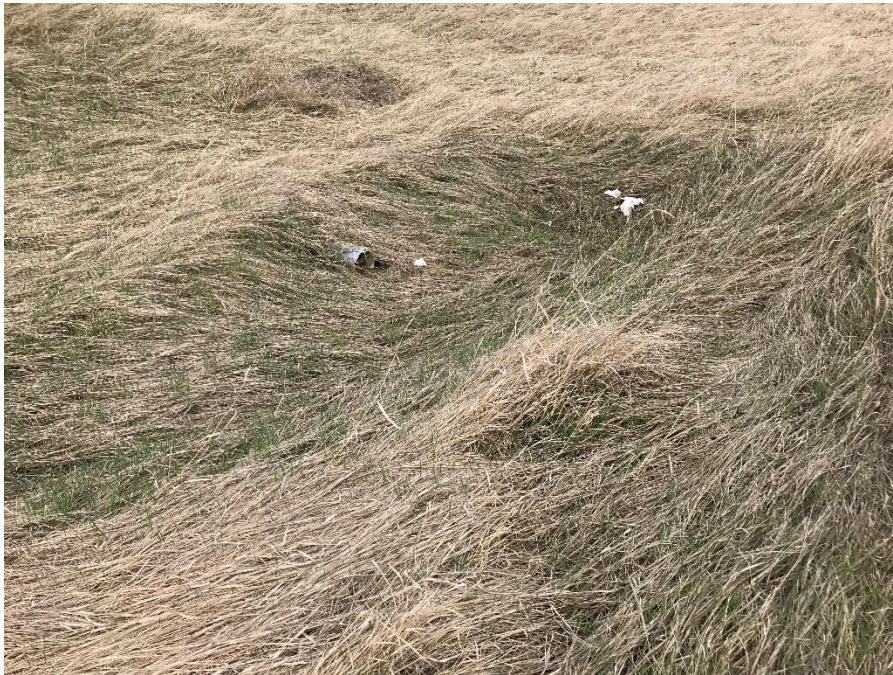
Photo 7: Low spot at subdrain outlet. No water observed at outlet.
Looking southeast.
