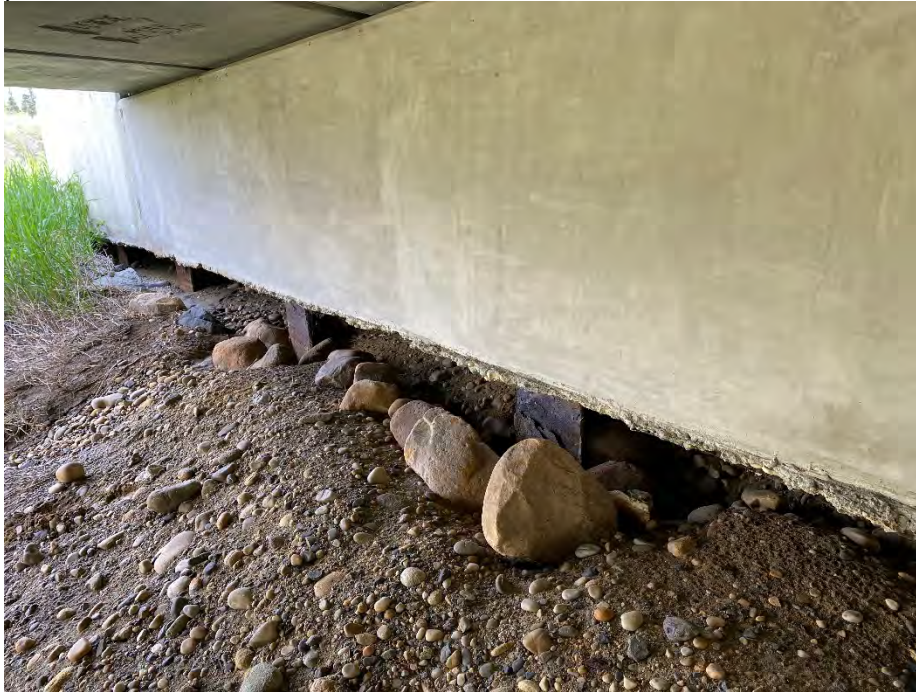
Photo 3: Corrosion on exposed H-piles under south abutment of westbound bridge. Looking east.

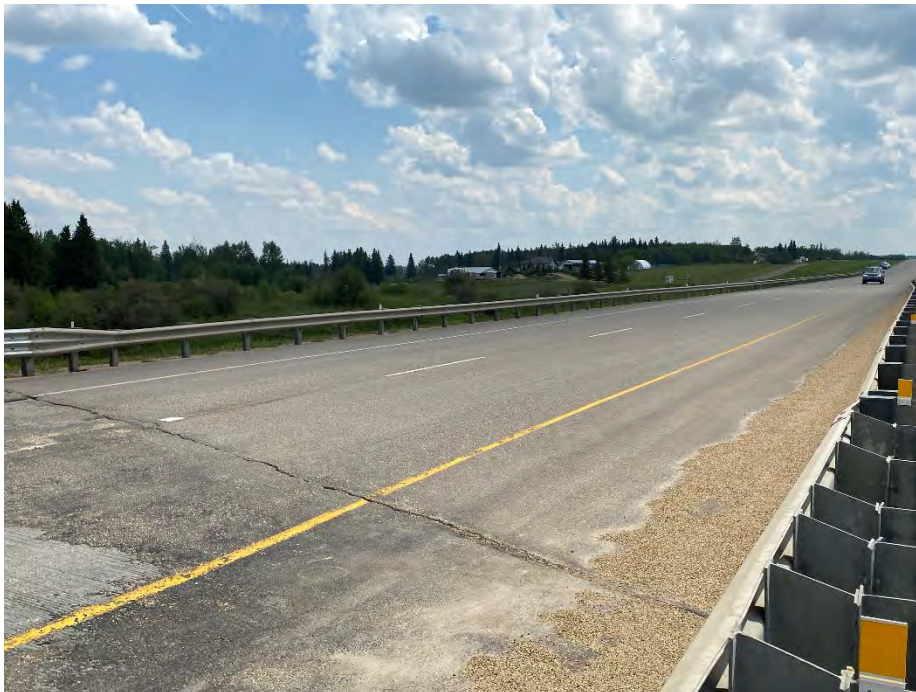
Photo 4: Pavement surface of the westbound bridge on Highway 43. Looking northwest.

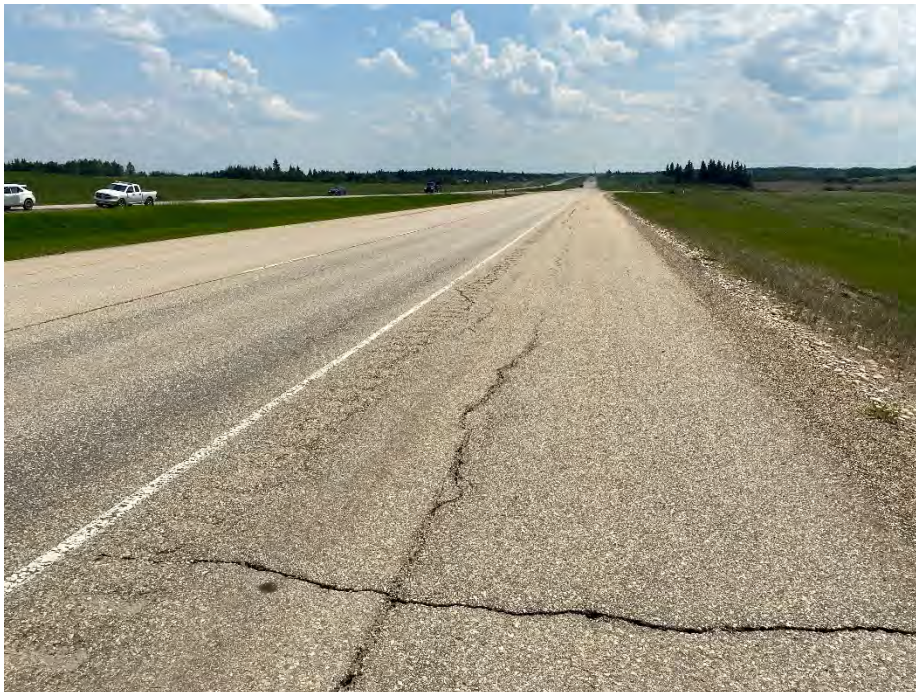
Photo 6: Pavement cracks, southwest of SI14-26. Looking southeast.

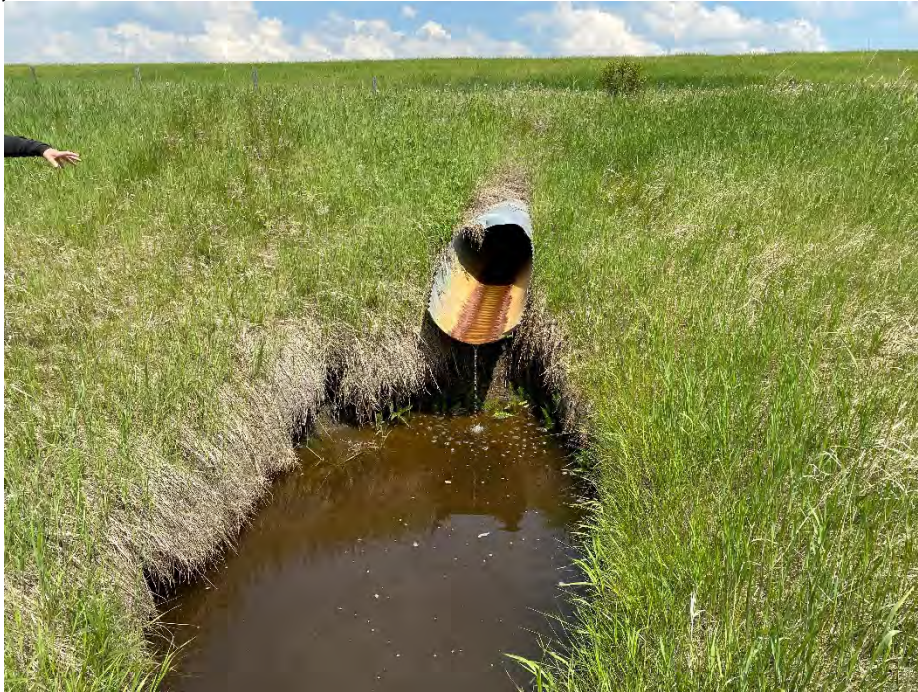
Photo 7: Eroded channel at culvert outlet southeast of SI14-27 filled with water. Looking northeast.

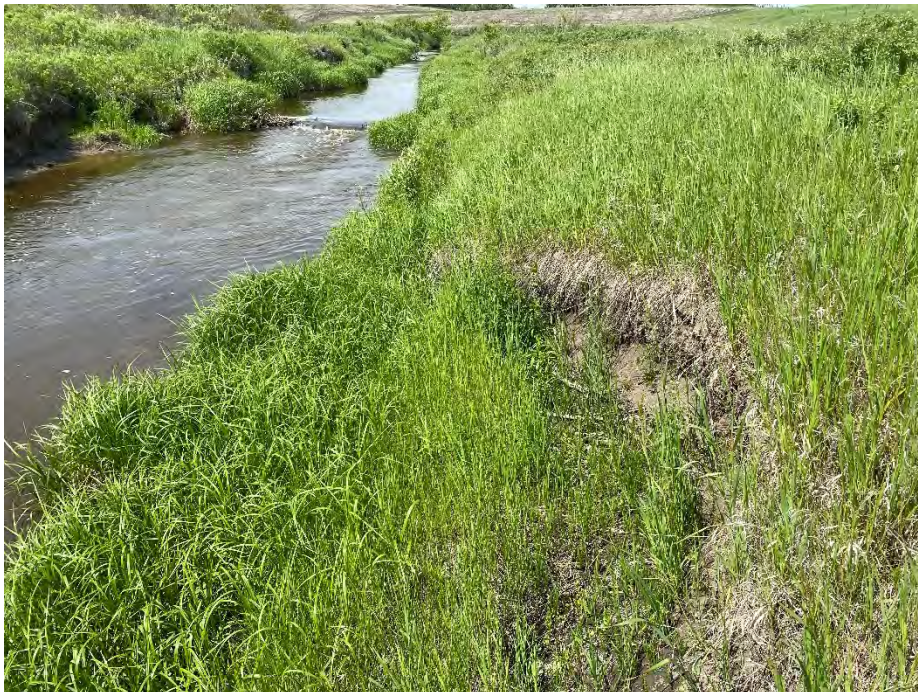
Photo 8: Slumping of crack noticed during last inspection south from SI14-27. Looking northwest.

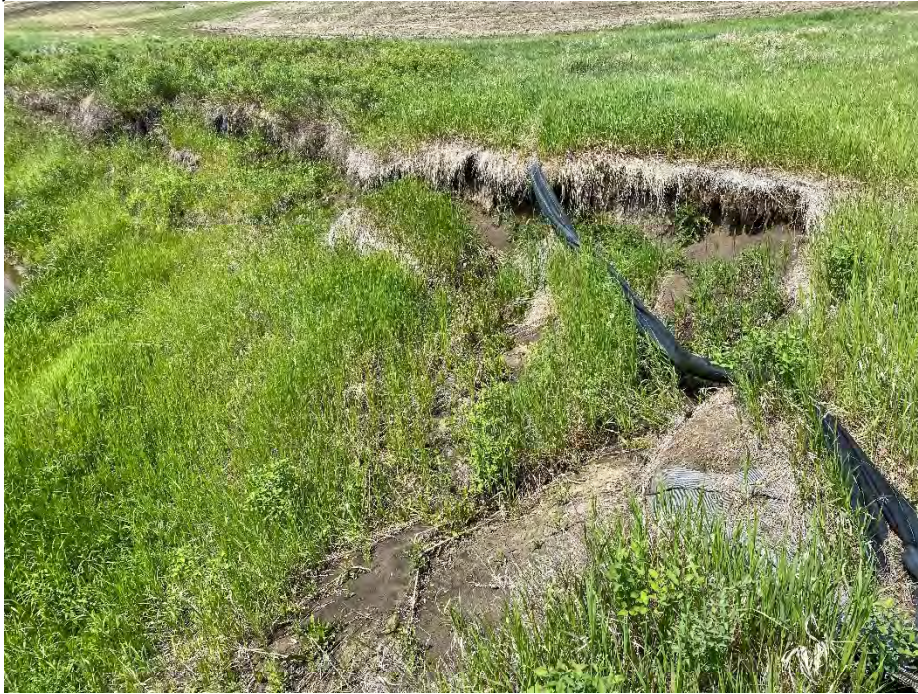
Photo 9: Slumping of slopes at the northwest bend in the river. Looking northwest.
