ALBERTA TRANSPORTATION LANDSLIDE RISK ASSESSMENT

SECTION A: GEOTECHNICAL FILE REVIEW

SITE NC80: FICKLE LAKE ROAD SLIDE

LEGAL LOCATION:	SE 24-51-19-W4M
NEAREST LANDMARK:	2.2 km NORTH OF FICKLE LAKE ROAD
Highway Control Section:	HWY 47:06, km 39.6
Date of Initial Observation:	2012
Date of Last Inspection:	2017
Last Inspected By:	Stantec Consulting Inc.
Instruments Installed:	2 Slope Inclinerometers (2013), 2 Pneumatic Piezometer (2013), 1 Standpipe Piezometer (2013)
Instruments Operational:	1 Slope Inclinerometer (2013), 2 Pneumatic Piezometer (2013)
Risk Assessment:	$PF(9) \cdot CF(6) = RL (54)$
Last Updated:	September 2017 – Stantec Consulting Ltd.

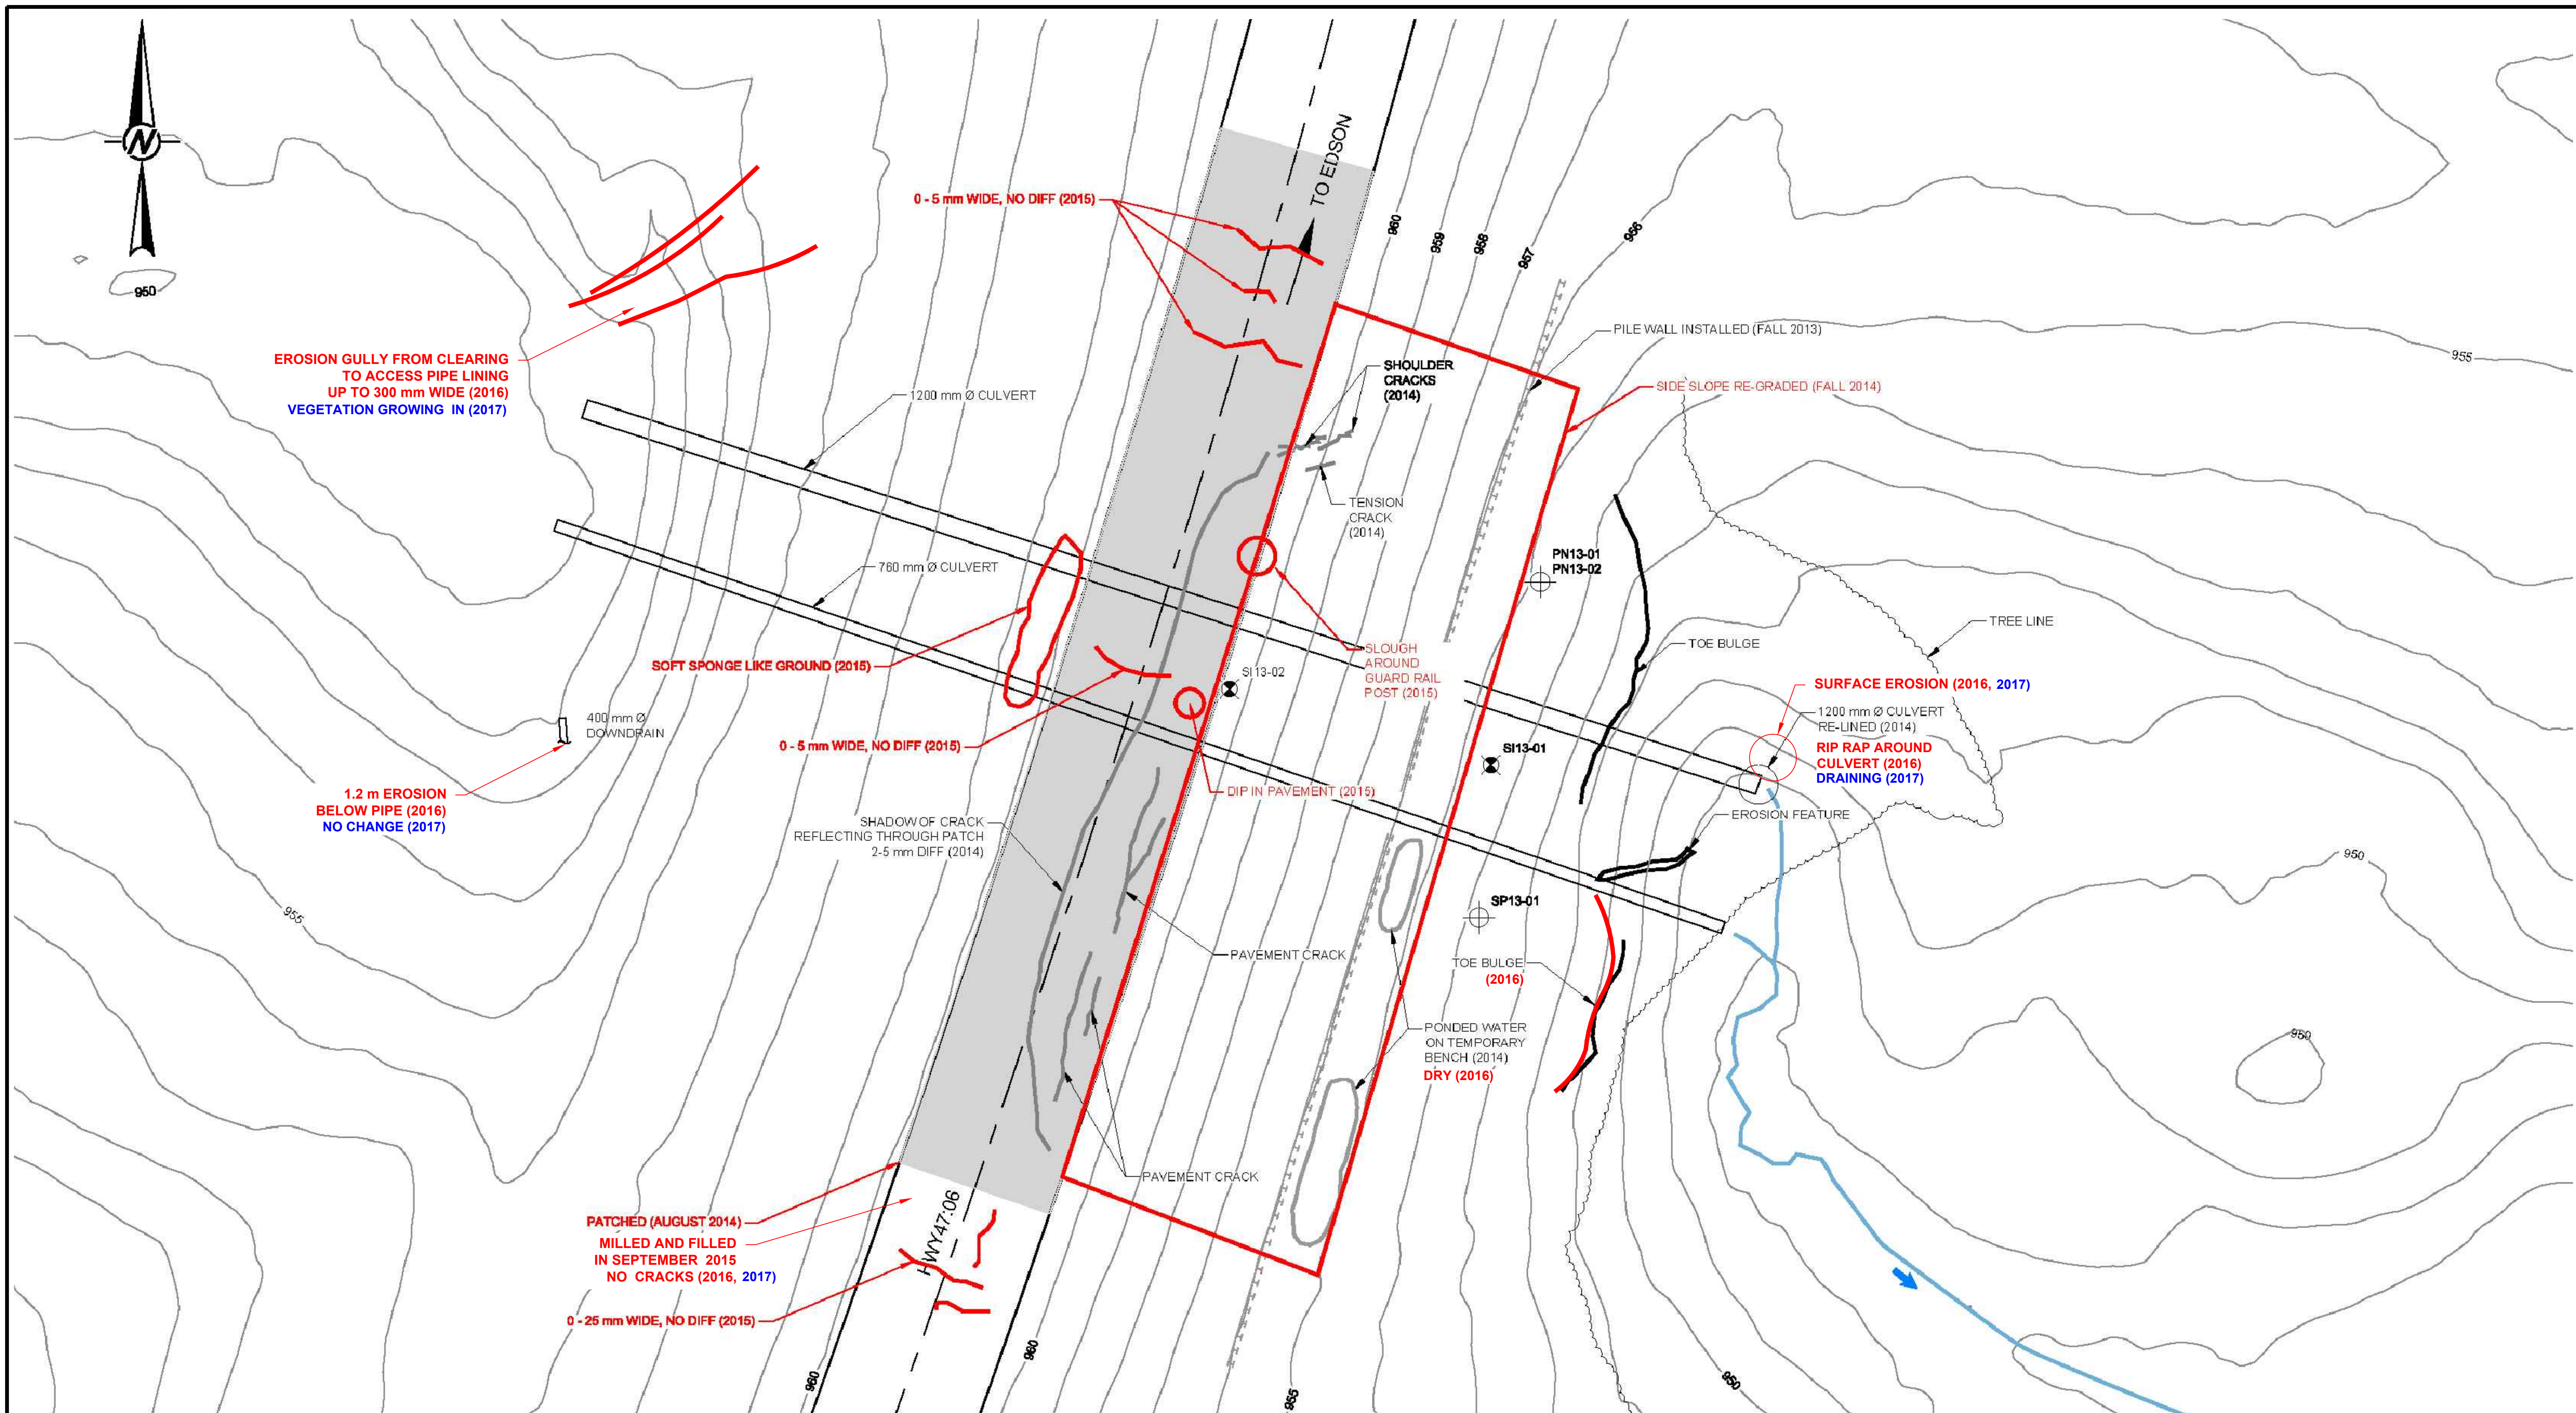
FIGURE - 1

Two slope inclinometers, one pneumatic piezometer, and one standpipe piezometer were installed at the site to monitor ground movements and groundwater levels. The location of these instruments is shown on **Figure 1**.
