<b>SITE NUMBER AND NAME:</b> NC080 – Fickle Creek Slide	<b>HIGHWAY AND KM:</b> 47:06, km 39.608	<b>PREVIOUS INSPECTION:</b> May 26, 2020	<b>CURRENT INSPECTION:</b> July 15, 2021
<b>LEGAL DESCRIPTION:</b> SE-24-51-19-W5	<b>NAD83 COORDINATES:</b> UTM11U 5918635N, 522484E		<b>RISK ASSESSMENT:</b> PF: 5 CF: 6 Total: 30
<b>AVERAGE ANNUAL DAILY TRAFFIC (AADT):</b> 180 (2020)		<b>CONTRACTOR MAINTENANCE AREA (CMA):</b> 508

2021 Site Inspection Photos at NC080

ALBERTA TRANSPORTATION  
GEOHAZARD MONITORING PROGRAM  
NC80 FICKLE CREEK SLIDE  
SITE PLAN

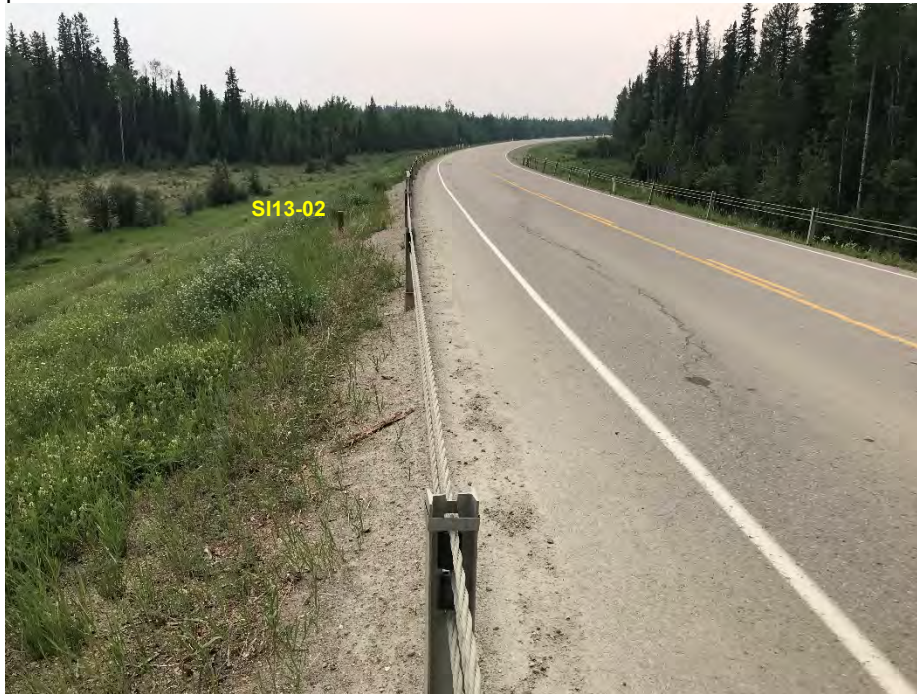
<b>COMMENTS</b>
<ul style="list-style-type: none"> <li>• The pavement cracking (Photos 1 and 2) appeared to be similar to the 2020 inspection and generally consisted of: <ul style="list-style-type: none"> <li>– Approximately 40 m long curvilinear crack along NBL.</li> <li>– 25 mm dip to the southeast in the south third of the curvilinear crack.</li> </ul> </li> <li>• Potential hairline cracks were observed on the outside of the guardrail of the NBL near the south limit of the overlay.</li> </ul>

**Photo 1:** Arched crack near SI13-02. Looking southwest.

- All pavement cracks should be sealed to reduce surface water infiltration into the slide mass. Mill and fill or patching may also be completed to improve the rideability of the highway (i.e. smoothen dips and repair cracks)

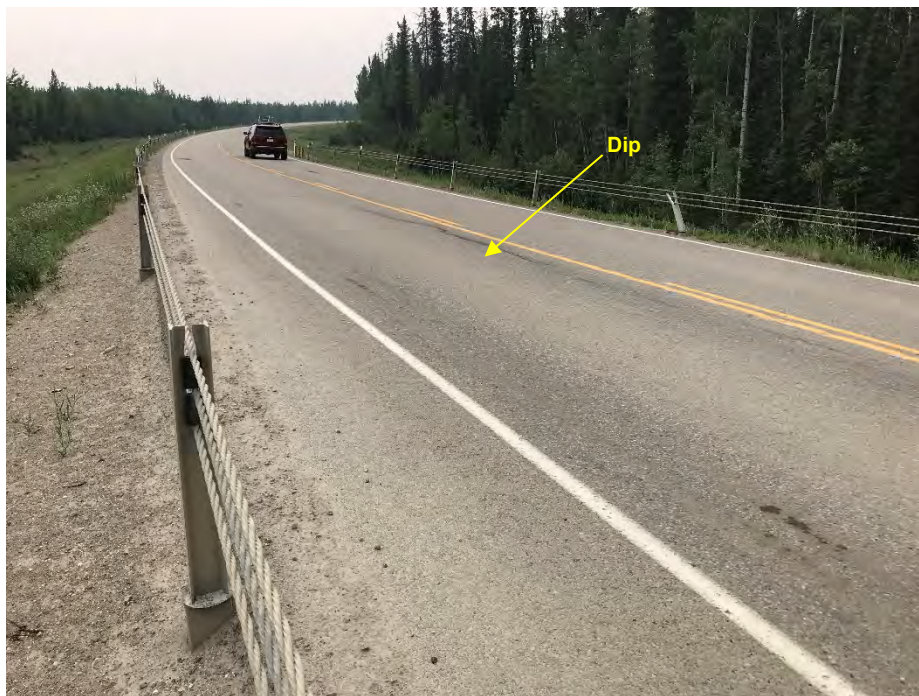
**Photo 2:** Pavement dip near south end of overlay. Looking southwest.

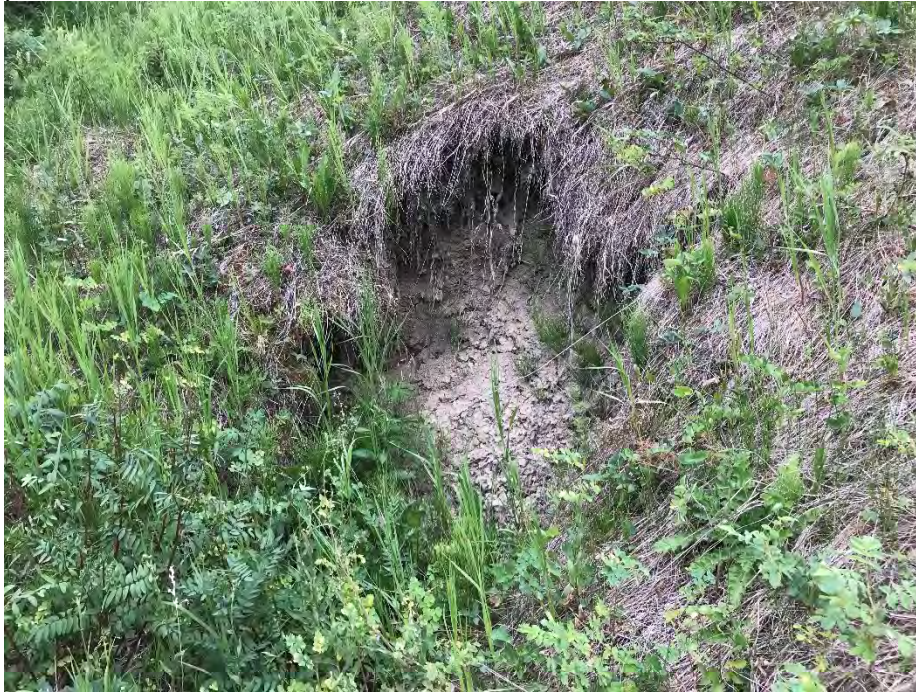
- SI13-01 showed less than 1 mm of incremental movement corresponding to a movement rate of less than 1 mm/year since the Fall 2020 readings. This SI is installed downslope of the pile wall and may not be indicative of movement upslope of the wall.
- No change was observed to the scour hole above the 760 mm diameter culvert and remains about 1.2 m wide and deep (Photo 3).
- The erosion at the outlet of the 1200 mm dia. culvert appears to have worsened (Photo 4). The scarp has receded to about 4 m behind the edge of creek and is about 1.2 m deep.
- A 1.2 m deep scour hole exists at the 400 mm diameter down drain.
- A smaller erosion gully upslope from the erosion gully north of the 1200 mm dia. culvert inlet was observed (Photo 5). The smaller erosion gully was about 500 mm wide and 450 mm deep and extended to about 2 m short of the north tree line (Photo 6).

**Photo 3:** Scour hole above 760 mm diameter culvert. Looking west.

- The scour hole above the 760 mm diameter culvert outlet should be backfilled and reseeded.
- The site should continue to be inspected every two years with the next visit in 2023.

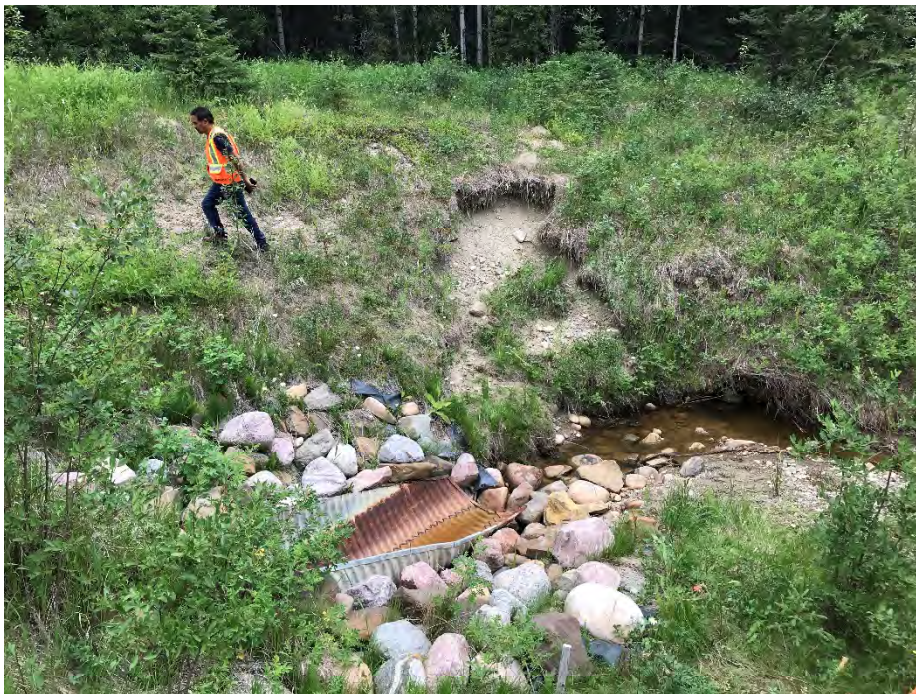
**Photo 4:** Slump/erosion at outlet of 1200 mm diameter culvert. Looking east.

- Riprap can be placed along the creek at the outlet of the 1200 mm dia. culvert to reduce toe erosion of the slump. This slump should be backfilled and reseeded.

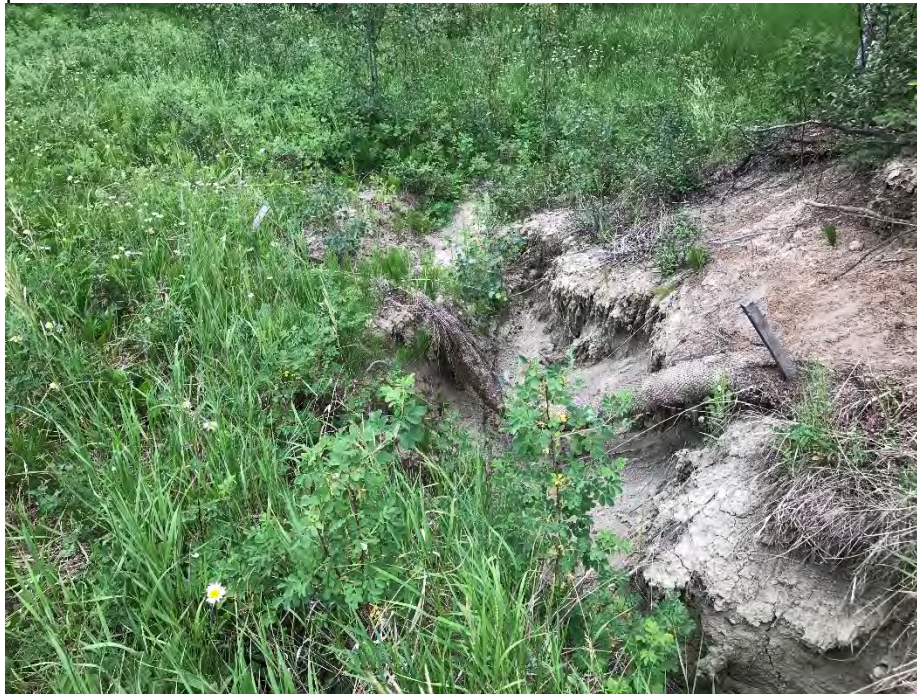
**Photo 5:** Erosion gully north of 1200 mm diameter culvert inlet. Looking southwest.

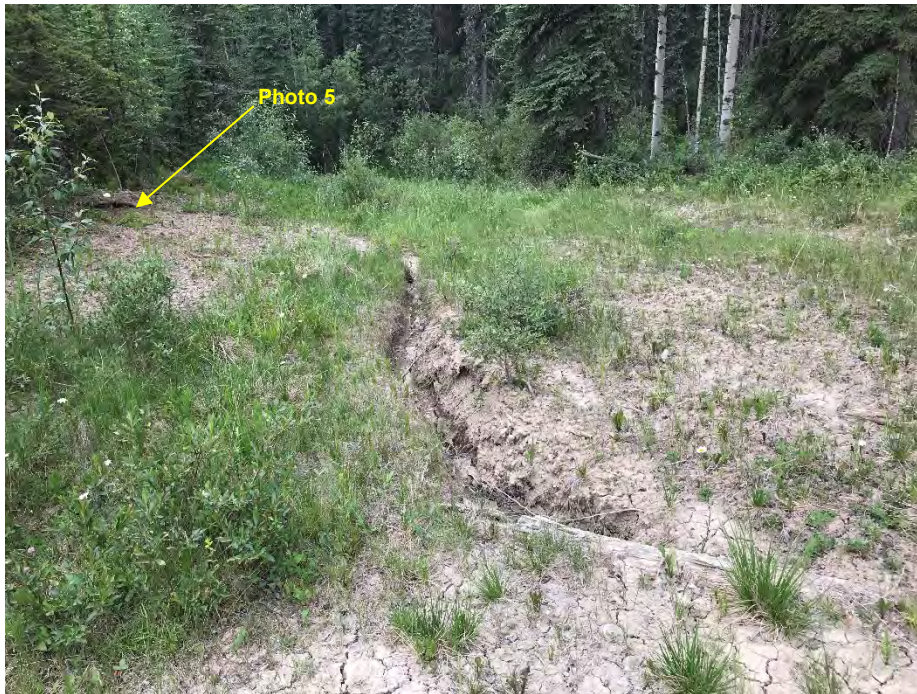
**Photo 6:** New erosion gully leading to old gully shown in Photo 5. Looking southwest.
