SITE NUMBER AND NAME: NC080 – Fickle Creek Slide	HIGHWAY AND KM: 47:06, km 39.608	PREVIOUS INSPECTION: July 15, 2021	CURRENT INSPECTION: June 17, 2022
LEGAL DESCRIPTION: SE-24-51-19-W5	NAD83 COORDINATES: UTM11U 5918635N, 522484E		RISK ASSESSMENT: PF: 7 CF: 7 Total: 49
AVERAGE ANNUAL DAILY TRAFFIC (AADT): 1,060 (2021)		CONTRACTOR MAINTENANCE AREA (CMA): 508

2022 Site Inspection Photos at NC080

ALBERTA TRANSPORTATION
 GEOHAZARD MONITORING PROGRAM
 NC80 FICKLE CREEK SLIDE
 SITE PLAN

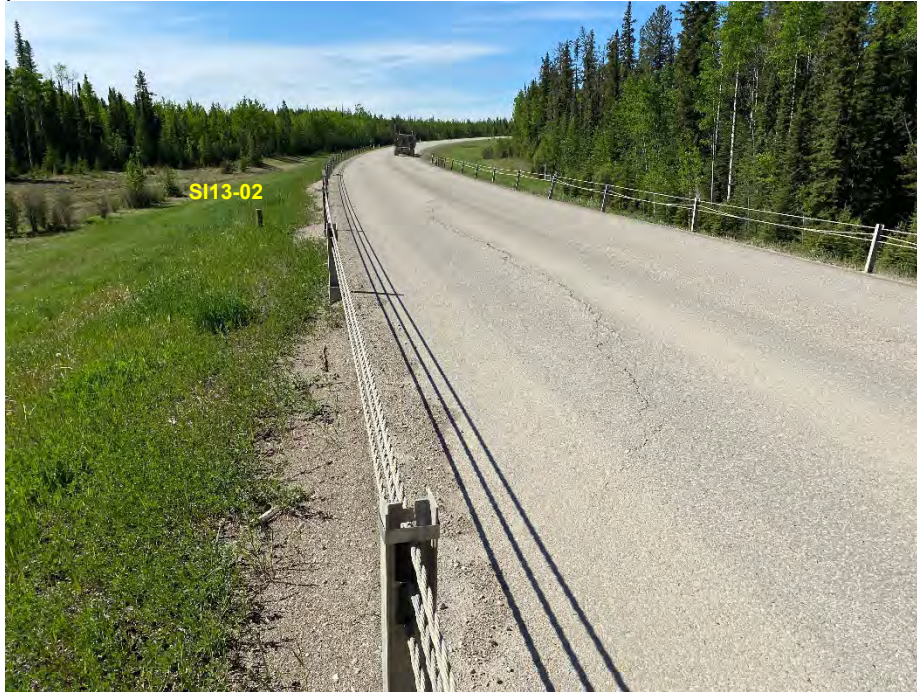
COMMENTS
<ul style="list-style-type: none"> • The pavement cracking (Photos 1 and 2) appeared to be similar to the 2021 inspection and generally consisted of: <ul style="list-style-type: none"> – Approximately 40 m long curvilinear crack along NBL. – Approximately 25 mm dip to the southeast in the south third of the curvilinear crack. The dip was more apparent than during the previous inspection. • During the inspection, multiple trucks drove into oncoming traffic to avoid the dip in the pavement. • The MCI noted that the pavement surface will be seal coated and crack sealing this year. The MCI also informed Stantec that frost heaving was previously observed at the site.

Photo 1: Arched crack near SI13-02. Looking southwest.

- All pavement cracks should be sealed to reduce surface water infiltration into the slide mass. Mill and fill may also be completed to improve the rideability of the highway (i.e. smoothen dips and repair cracks) and to avoid additional loading on the ground surface.

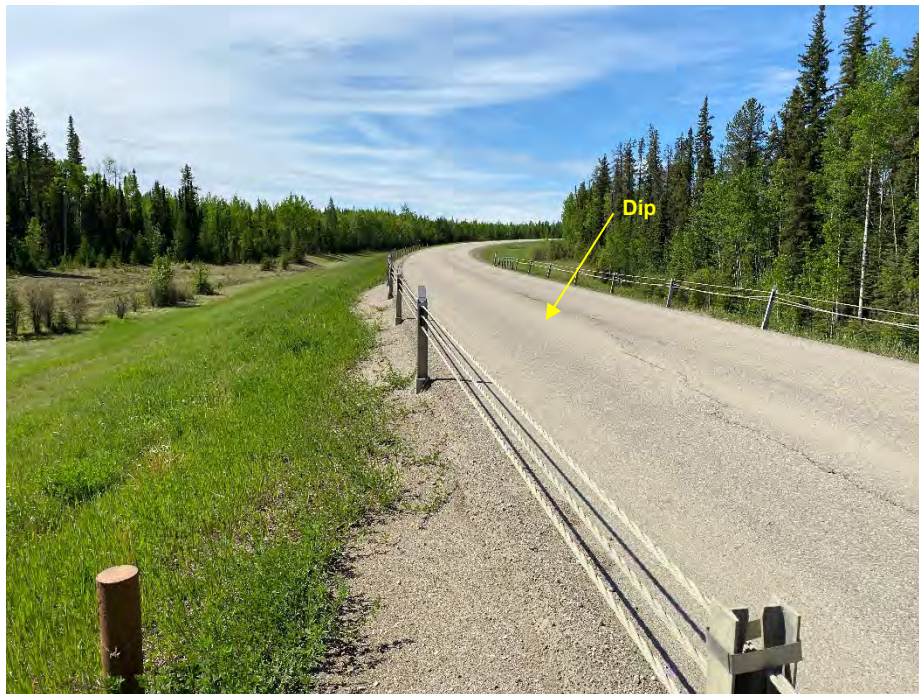
Photo 2: Pavement dip near south end of overlay. Looking southwest.

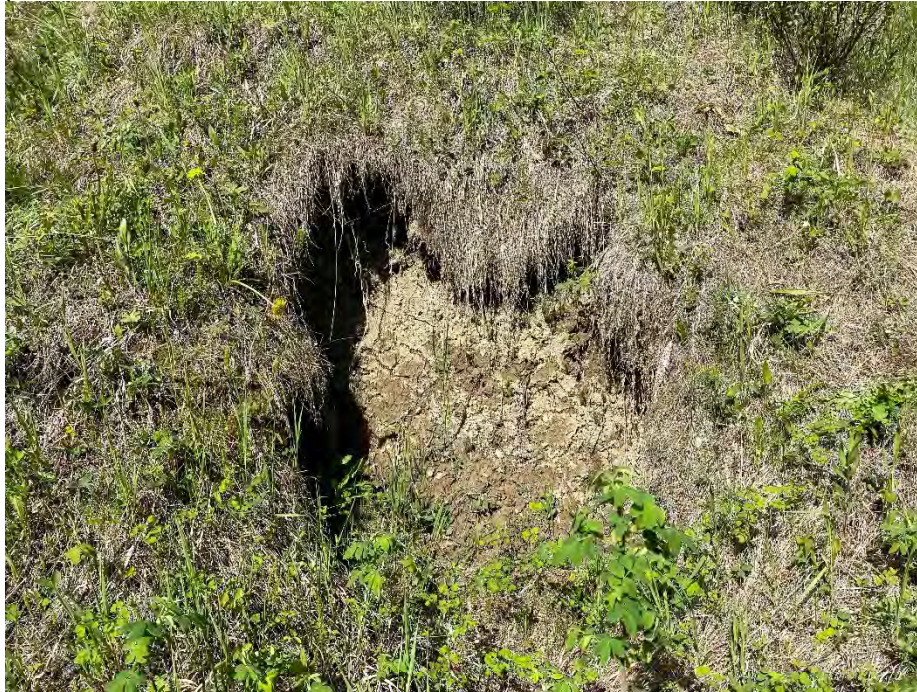
- The scour hole above the 760 mm diameter culvert remains 1.2 m wide. A void was observed below the ground in the scour hole 1 m deep bringing the total depth of scour to 2.2 m (Photo 3).

Photo 3: Scour hole above 760 mm diameter culvert. Looking west.

- The scour hole above the 760 mm diameter culvert outlet should be backfilled and reseeded.
- The 760 mm diameter culvert should be inspected using CCTV to determine if the pipe is broken. A replacement culvert may be required to facilitate creek flow.

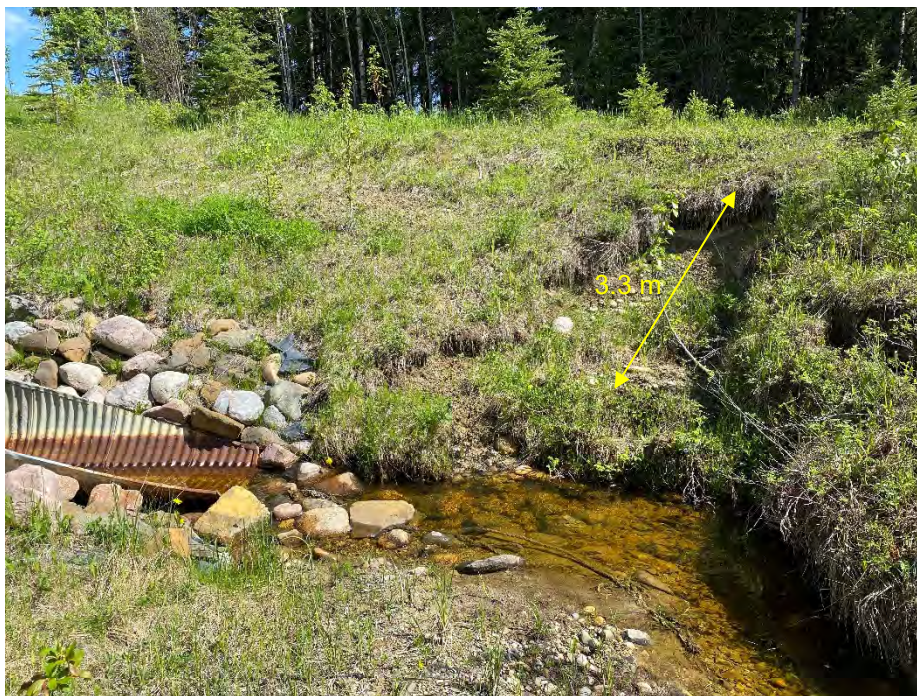
- The erosion near the outlet of the 1200 mm dia. culvert worsened. The scarp has receded to 3.3 m behind the edge of creek and is about 2.2 m wide and 1.2 m deep (Photo 4). Additional erosion was observed to the south of this feature, with minor slumping.

Photo 4: Slump/erosion at outlet of 1200 mm diameter culvert. Looking east.

- Riprap can be placed along the creek at the outlet of the 1200 mm dia. culvert to reduce toe erosion of the slump. This slump should be backfilled and reseeded.

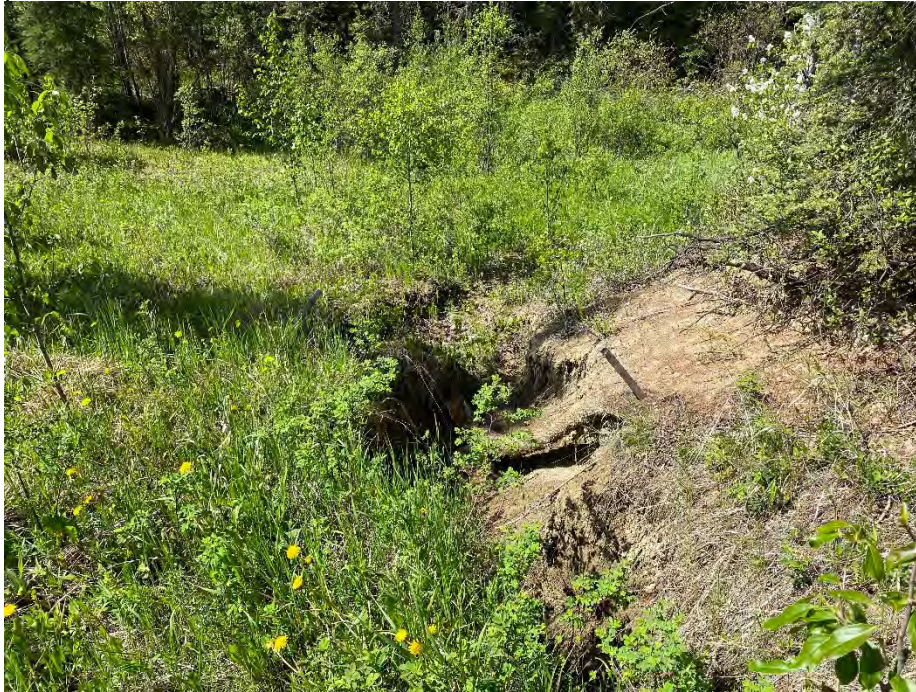
- A smaller erosion gully upslope from the erosion gully north of the 1200 mm dia. culvert inlet was observed. The smaller erosion gully was about 500 mm wide and 450 mm deep and extended to about 2 m short of the north tree line (Photos 5 and 6).

Photo 5: Erosion gully north of 1200 mm diameter culvert inlet. Looking southwest.

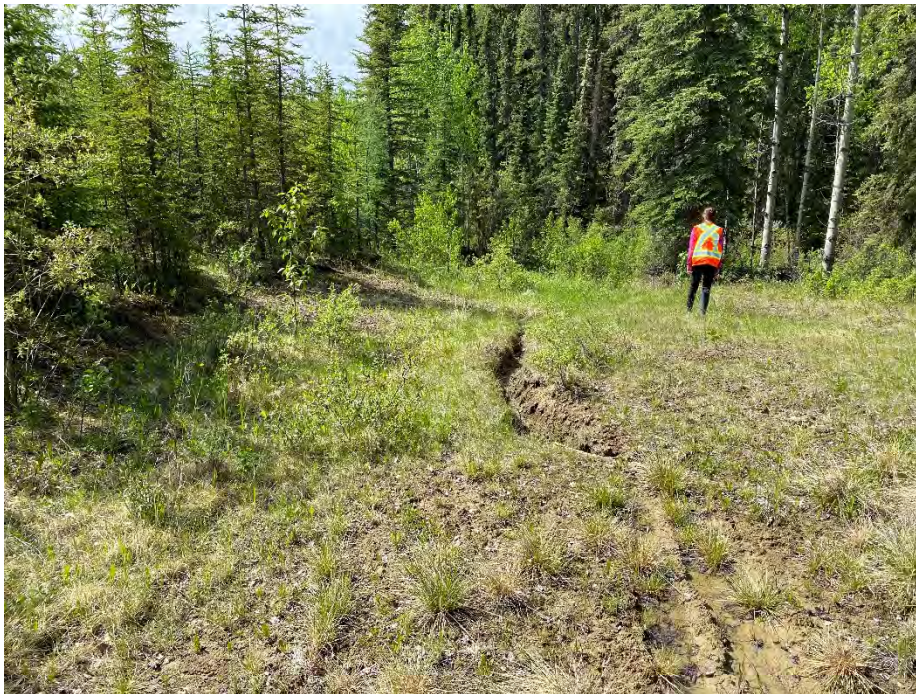
Photo 6: New erosion gully leading to old gully shown in Photo 5. Looking southwest.

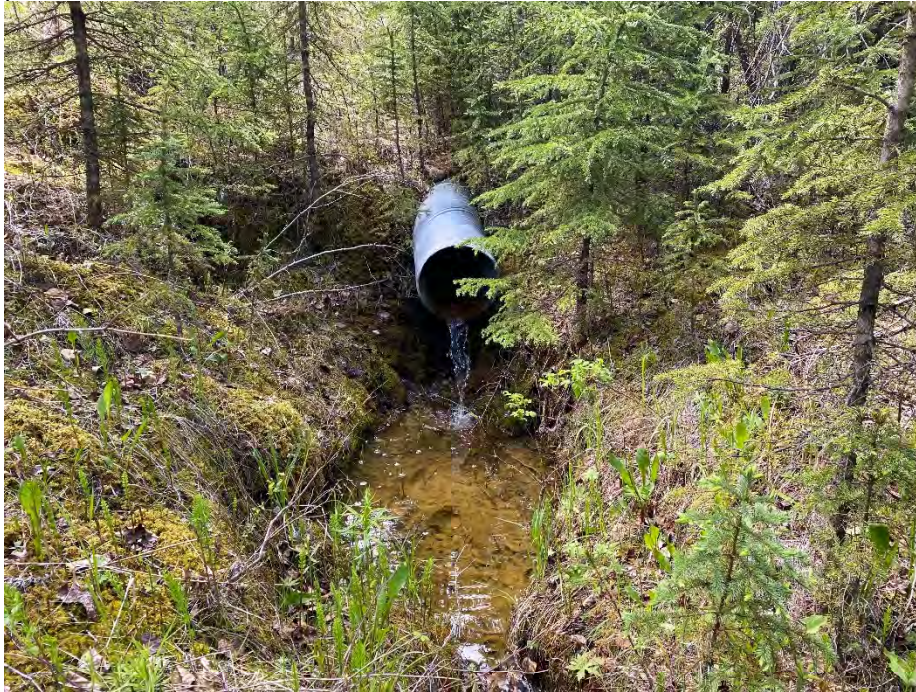
- A 1.2 m deep scour hole exists at the 400 mm diameter down drain and appears unchanged from the 2021 inspection.
- The 760 mm diameter culvert inlet was lifted with water flowing under the culvert. Very slow flow of water was observed at the outlet.

Photo 6: Water flowing under 780 mm diameter culvert. Looking southeast.

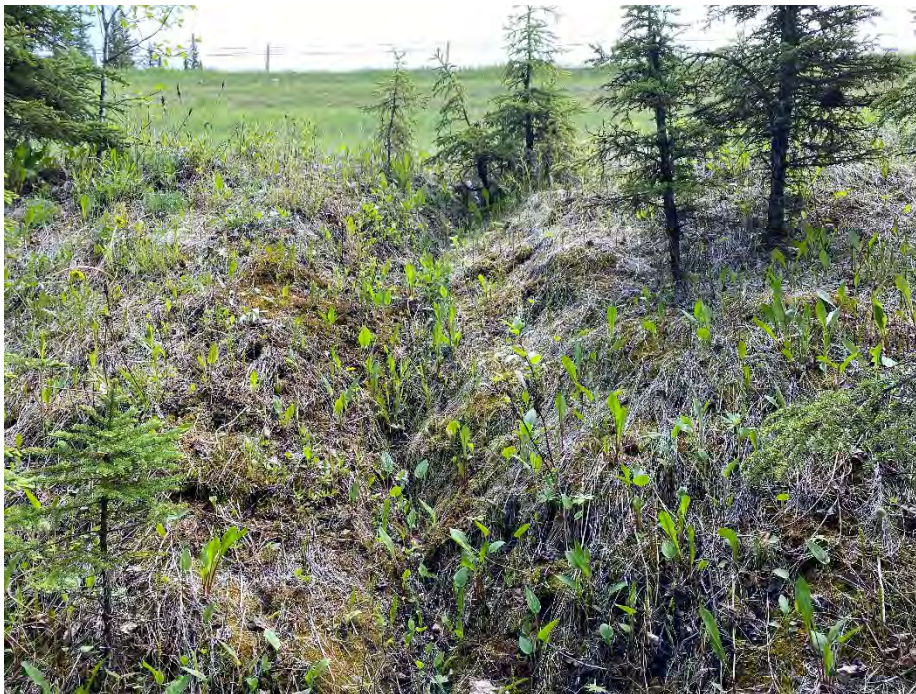
- An erosion gully was observed on the slope between the 400 mm downdrain and the 760 mm diameter culvert outlet. The channel is well vegetated and may not be new (Photo 7).

Photo 7: Vegetated erosion gully on southwest side of highway. Looking east.
