To:	Amy Driessen Alberta Transportation	From:	Leslie Cho and Xiteng Liu Stantec Consulting Ltd.
File:	123315222	Date:	June 2, 2022

**Reference: North Central Region, Edson, Site NC080 - Highway 47:06 Fickle Creek Slide, Spring 2022 Instrumentation Monitoring Report**

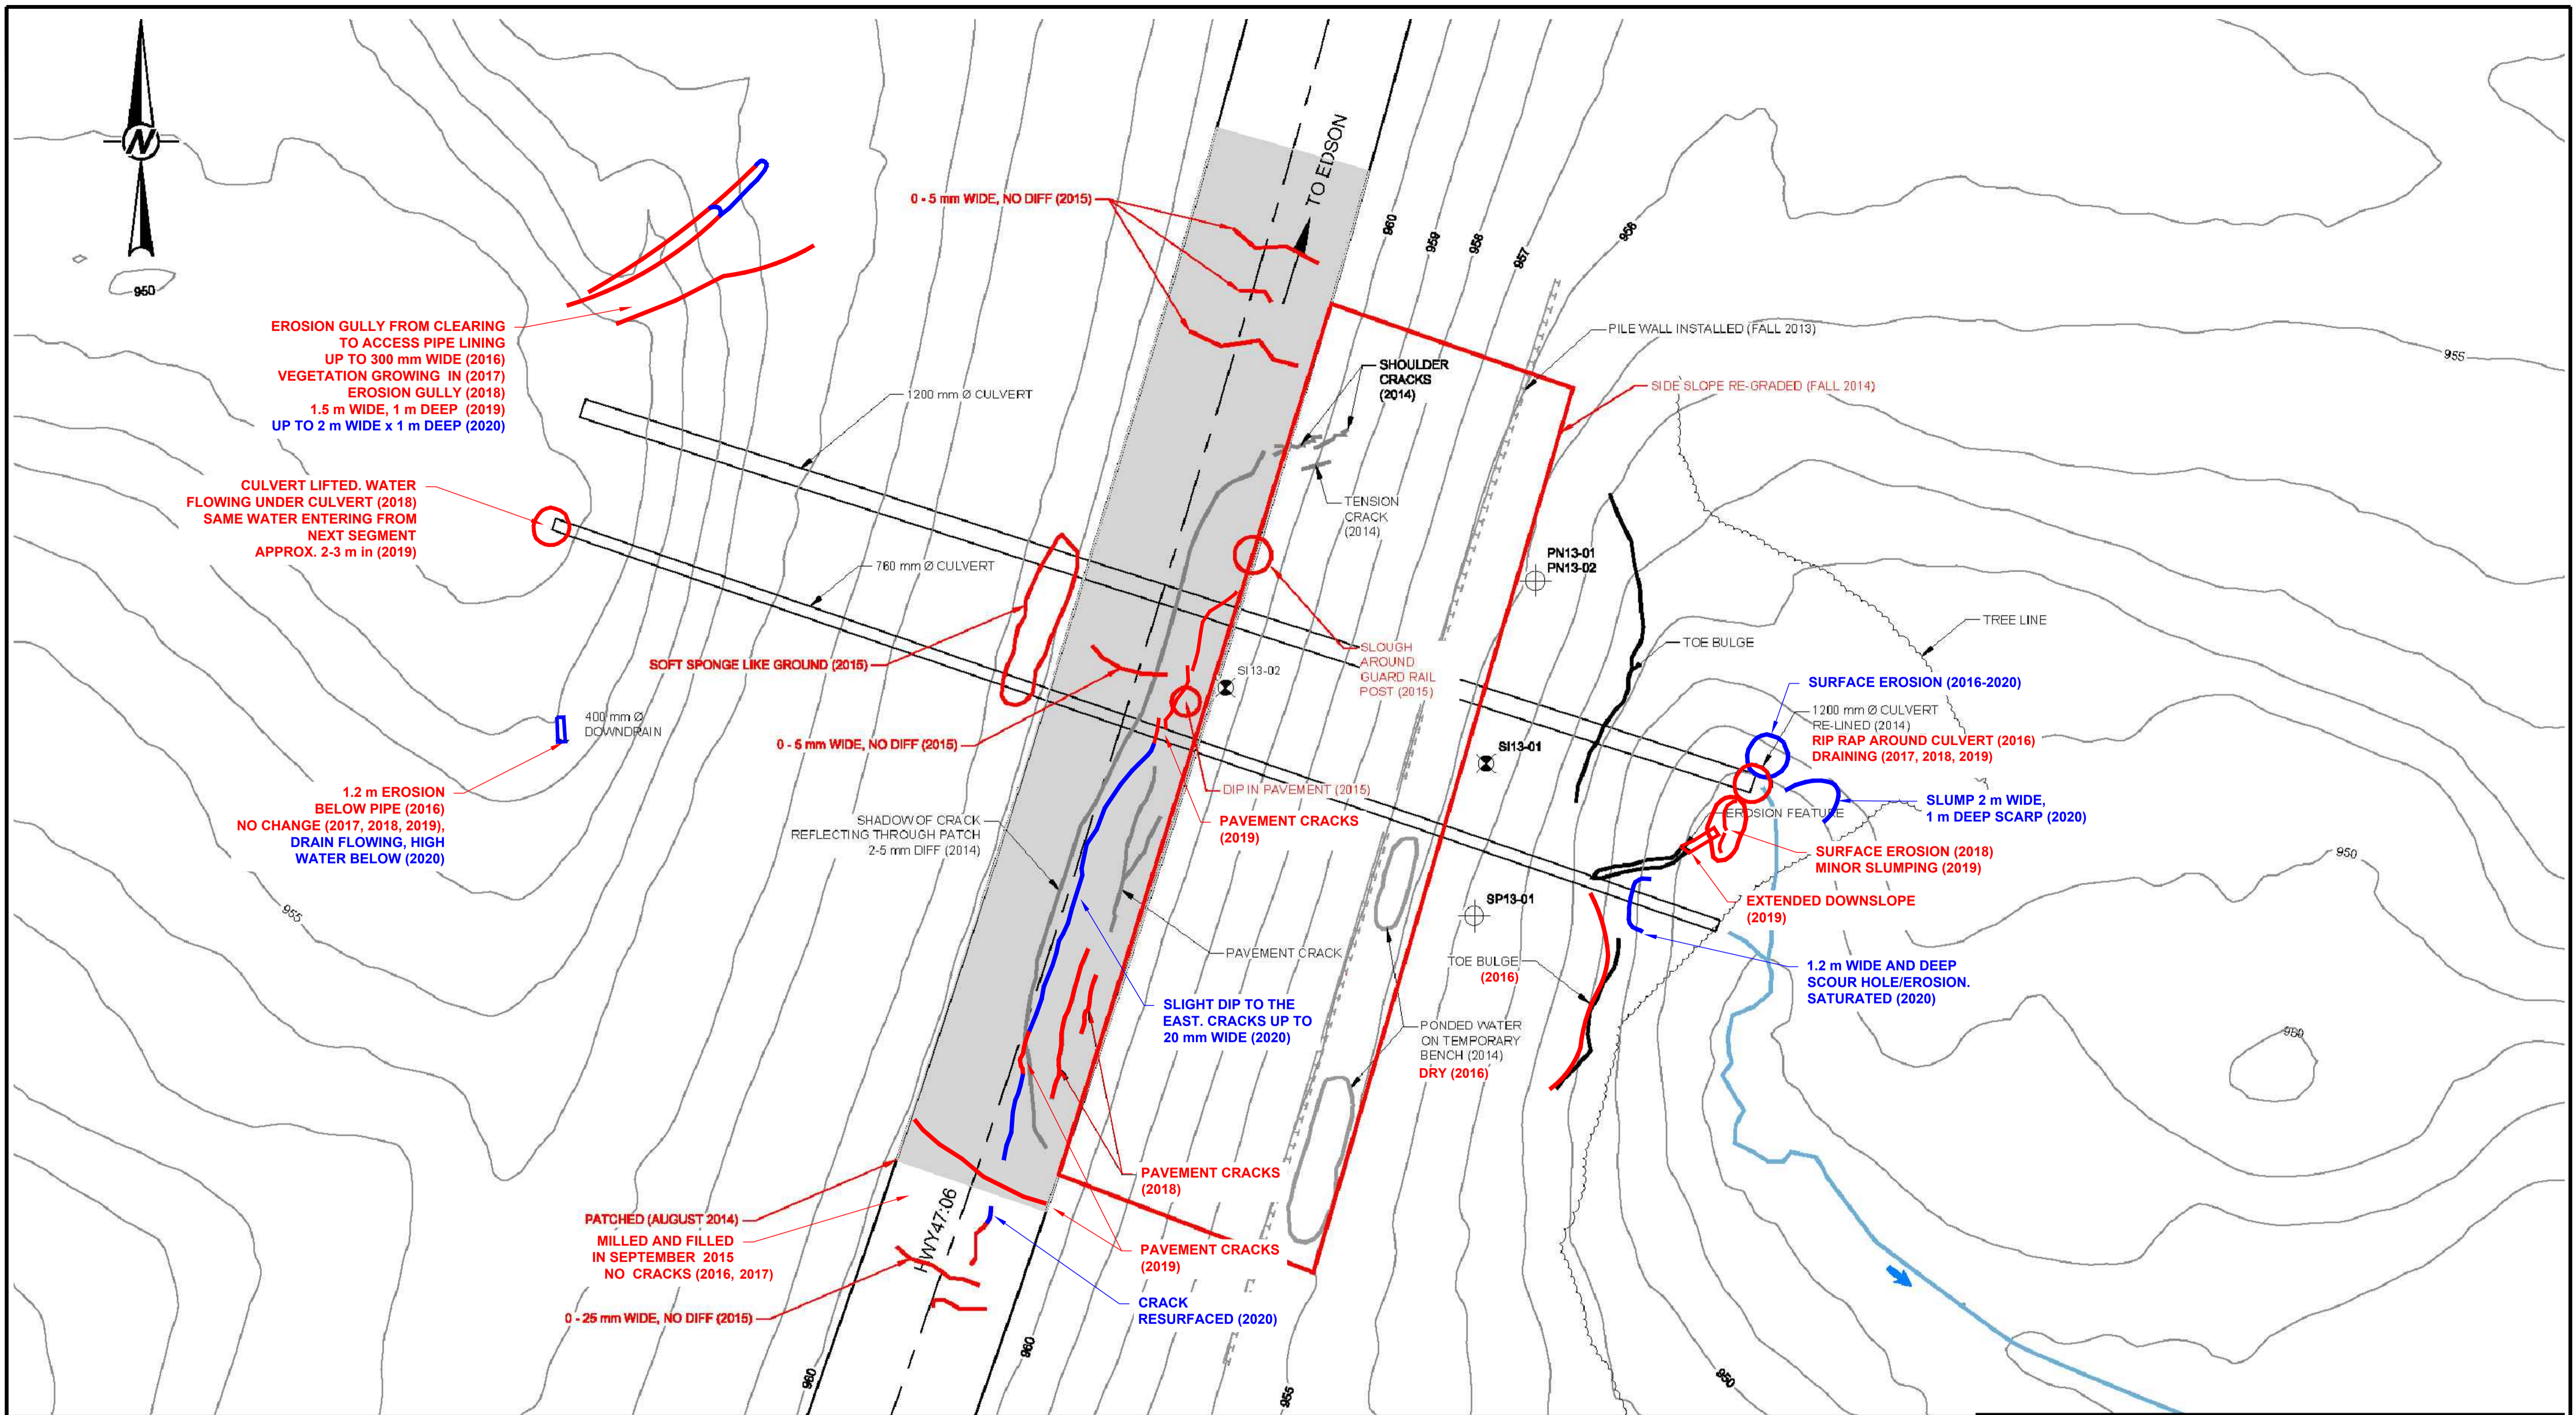
FIGURE - 1

EROSION GULLY FROM CLEARING TO ACCESS PIPE LINING UP TO 300 mm WIDE (2016)  
 VEGETATION GROWING IN (2017)  
 EROSION GULLY (2018)  
 1.5 m WIDE, 1 m DEEP (2019)  
 UP TO 2 m WIDE x 1 m DEEP (2020)

CULVERT LIFTED, WATER FLOWING UNDER CULVERT (2018)  
 SAME WATER ENTERING FROM NEXT SEGMENT APPROX. 2-3 m in (2019)

1.2 m EROSION BELOW PIPE (2016)  
 NO CHANGE (2017, 2018, 2019),  
 DRAIN FLOWING, HIGH WATER BELOW (2020)

SLIGHT DIP TO THE EAST, CRACKS UP TO 20 mm WIDE (2020)

CRACK RESURFACED (2020)

SURFACE EROSION (2016-2020)

1200 mm Ø CULVERT RE-LINED (2014)  
 RIP RAP AROUND CULVERT (2016)  
 DRAINING (2017, 2018, 2019)

SLUMP 2 m WIDE, 1 m DEEP SCARP (2020)

SURFACE EROSION (2018)  
 MINOR SLUMPING (2019)

EXTENDED DOWNSLOPE (2019)

1.2 m WIDE AND DEEP SCOUR HOLE/EROSION. SATURATED (2020)

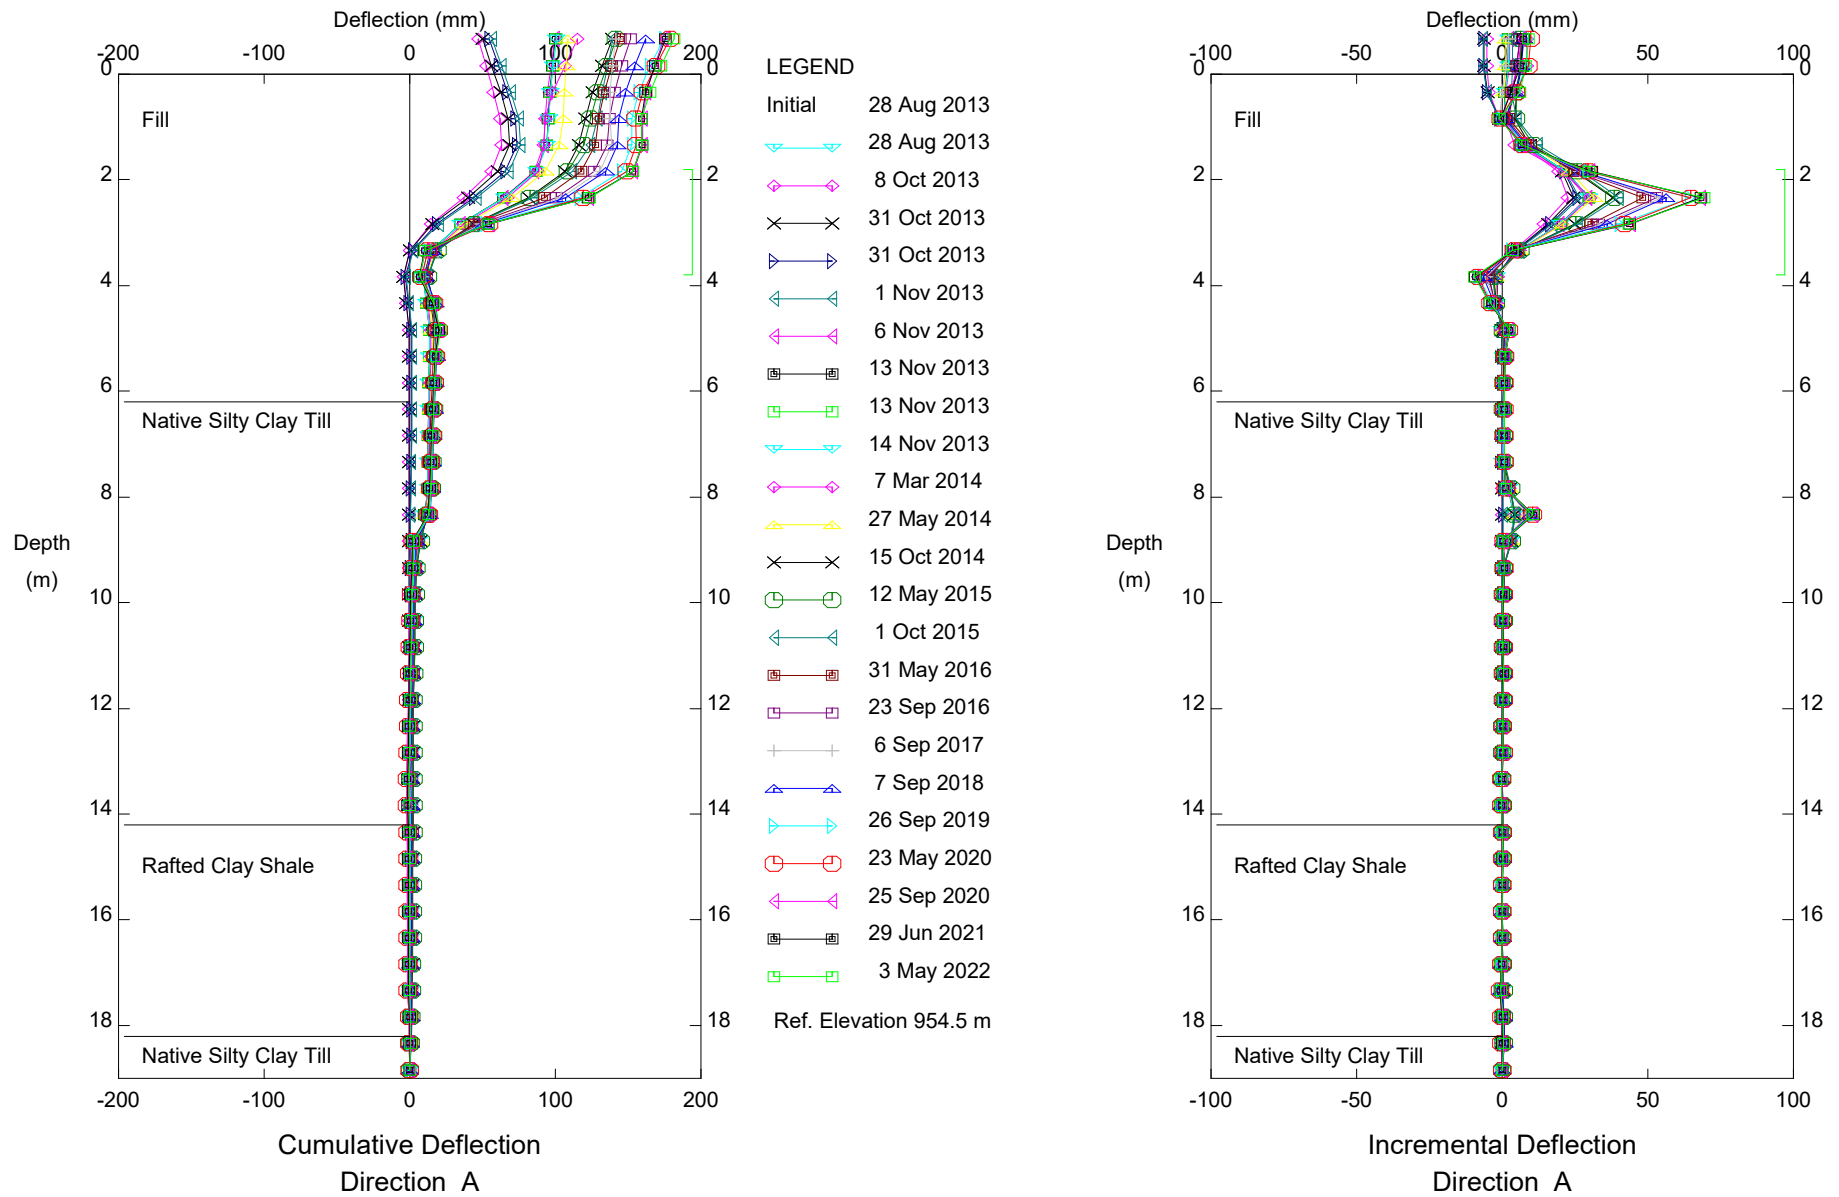
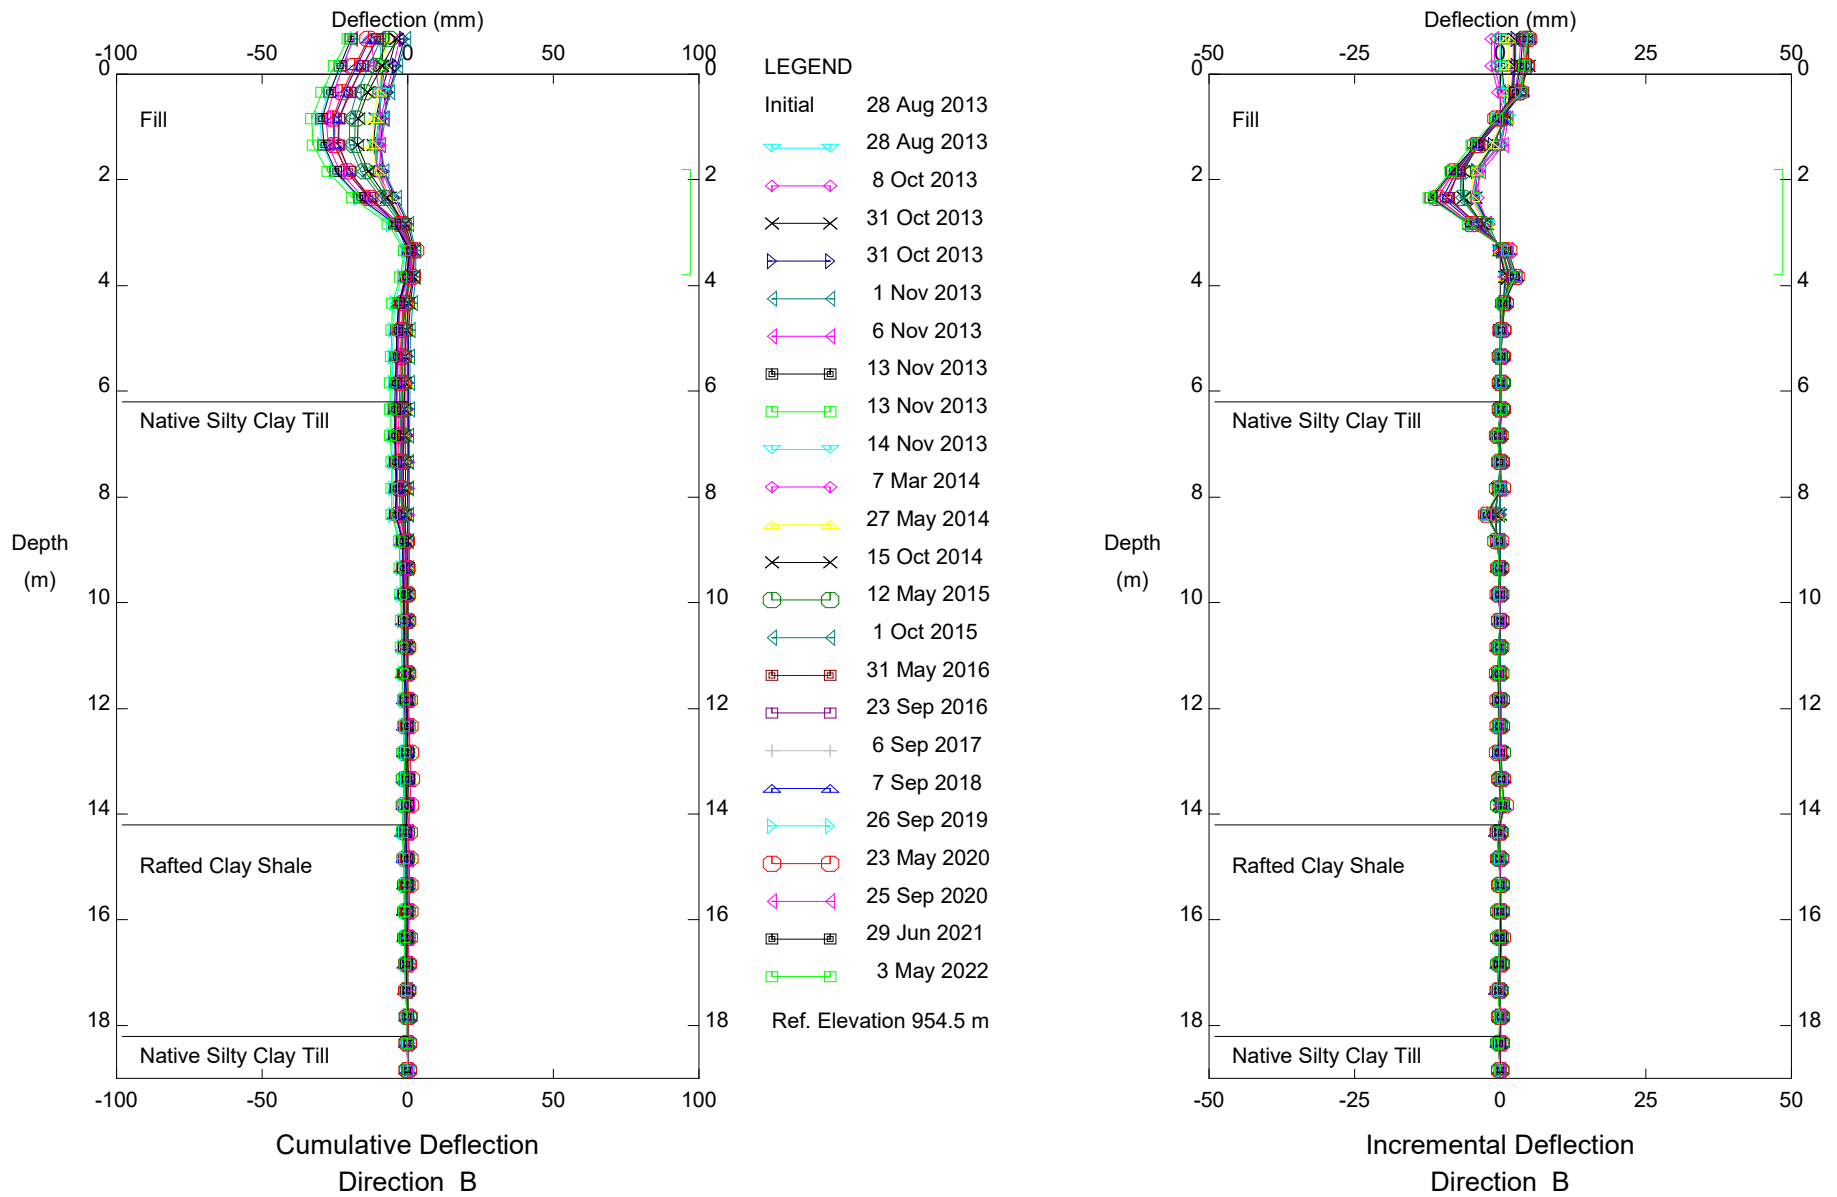
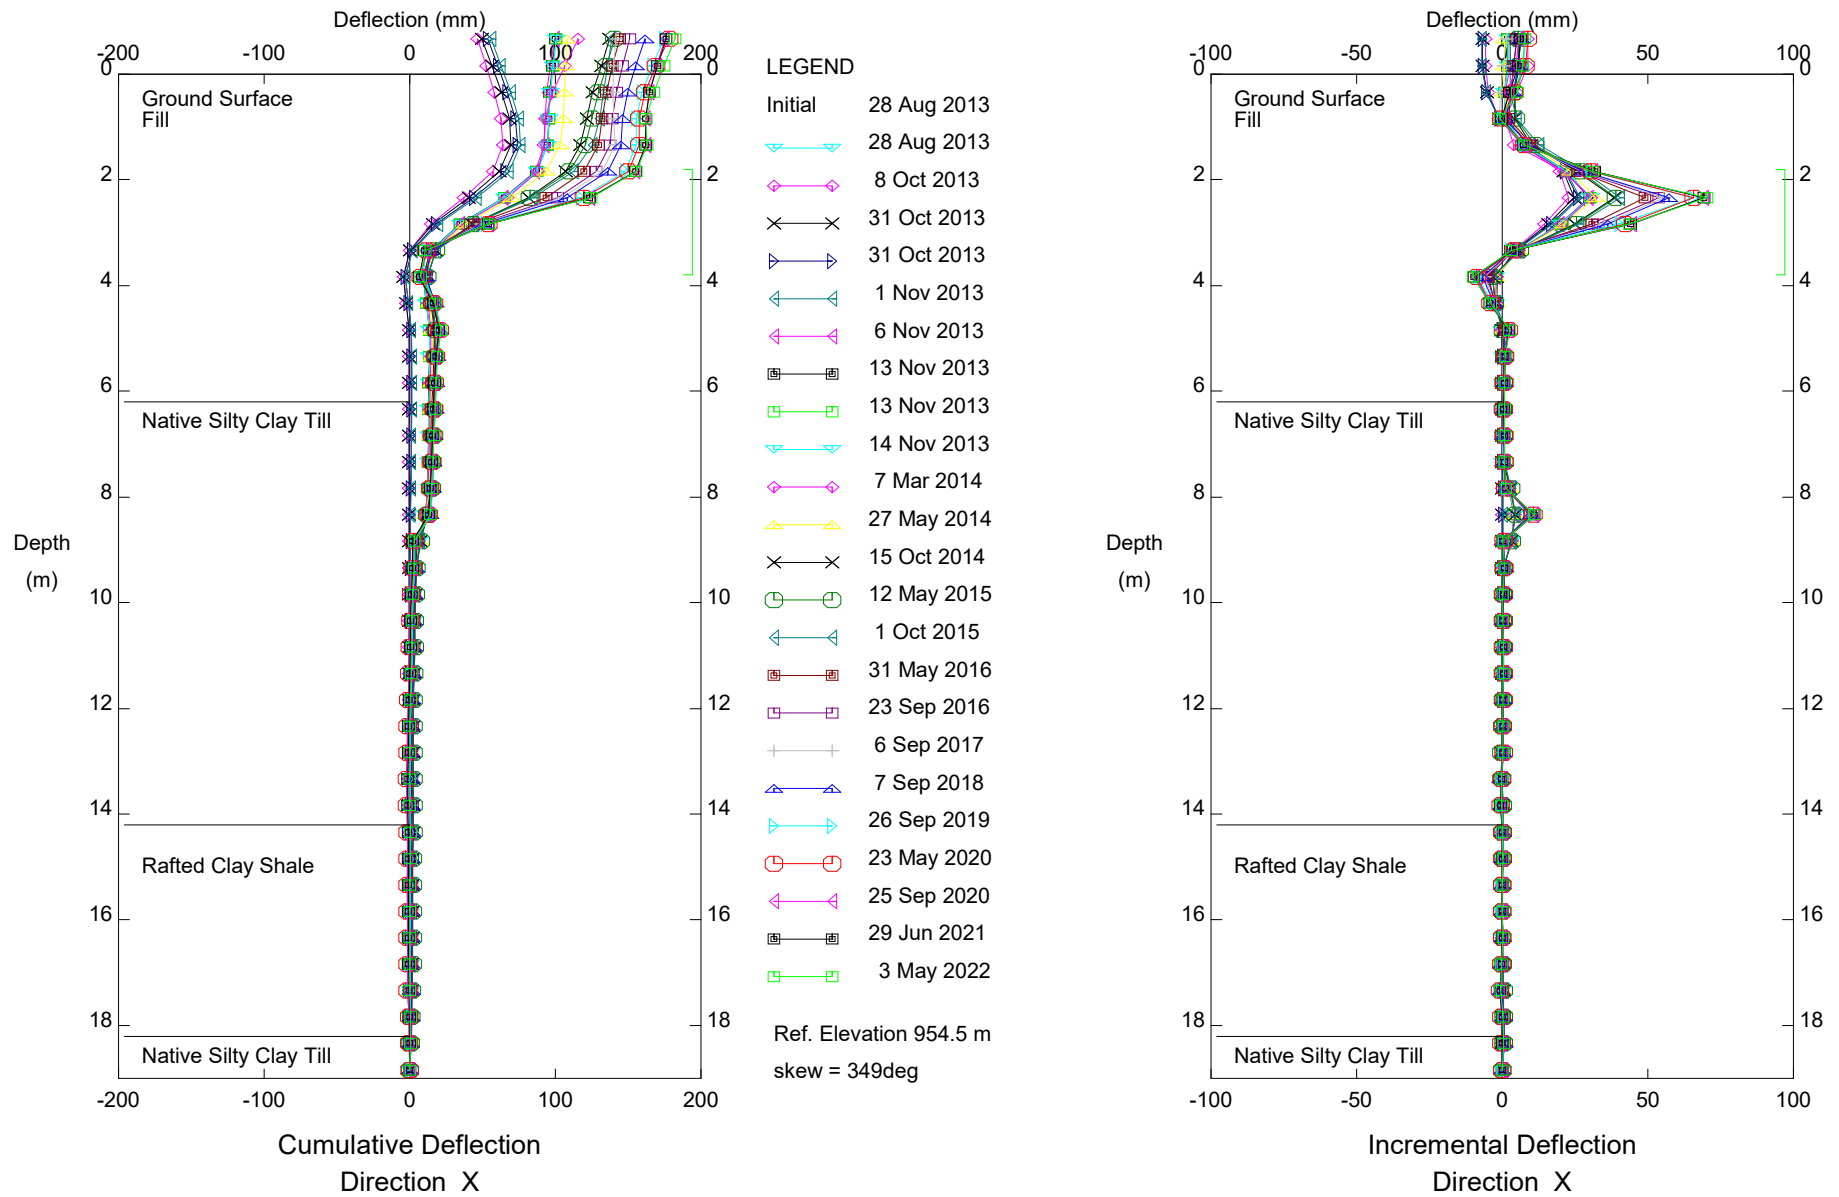
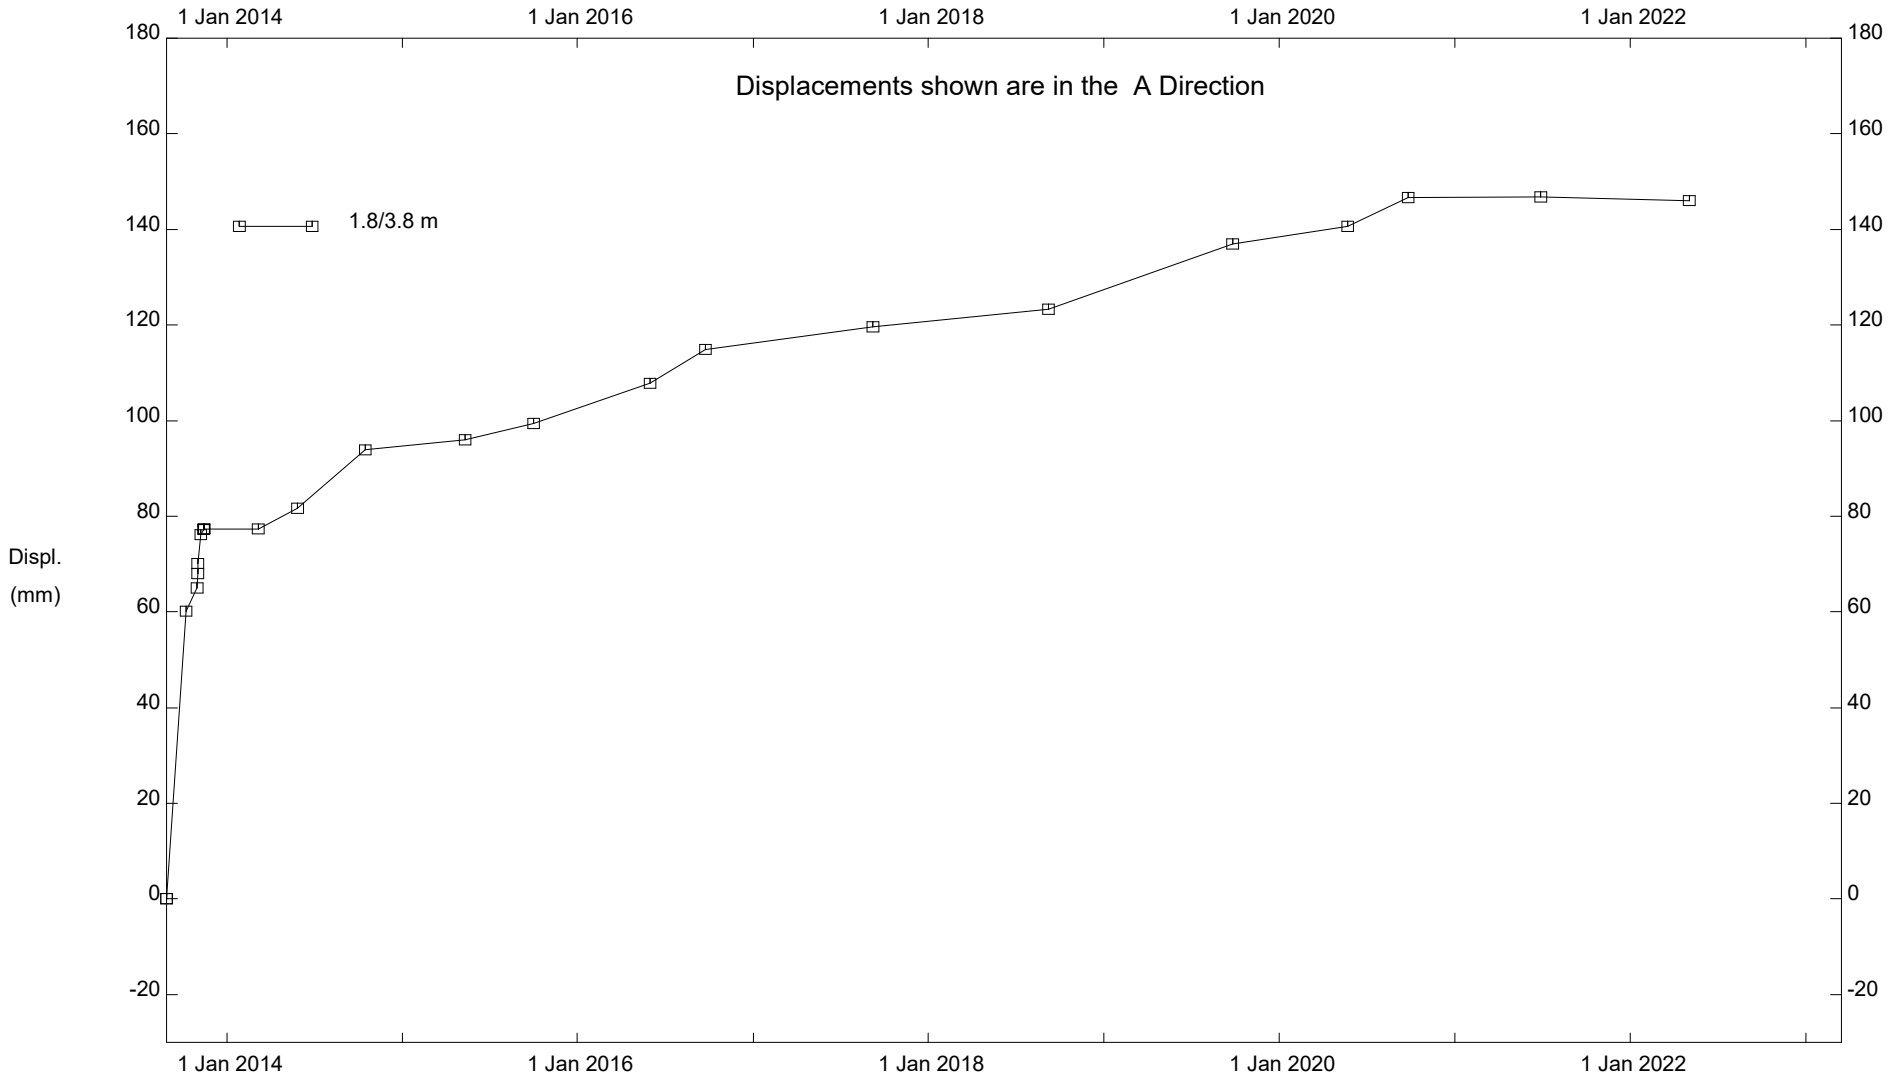
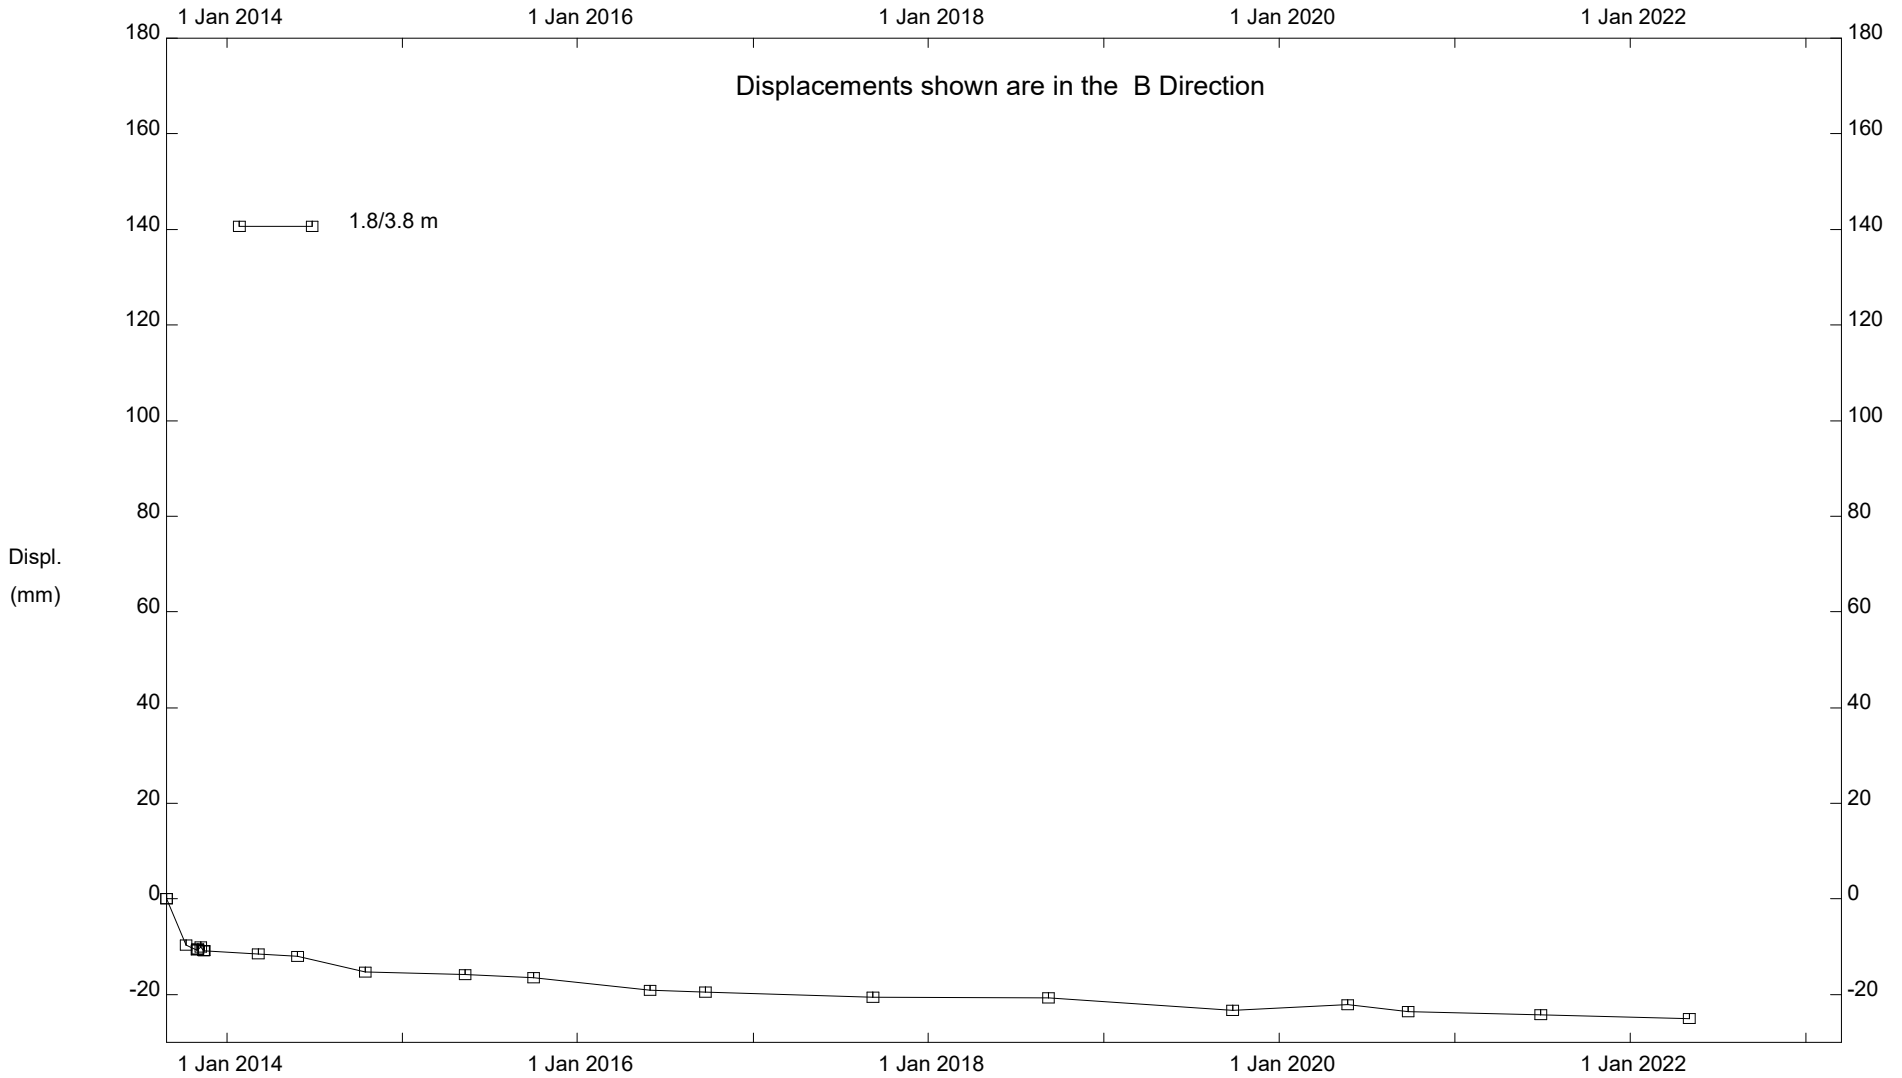
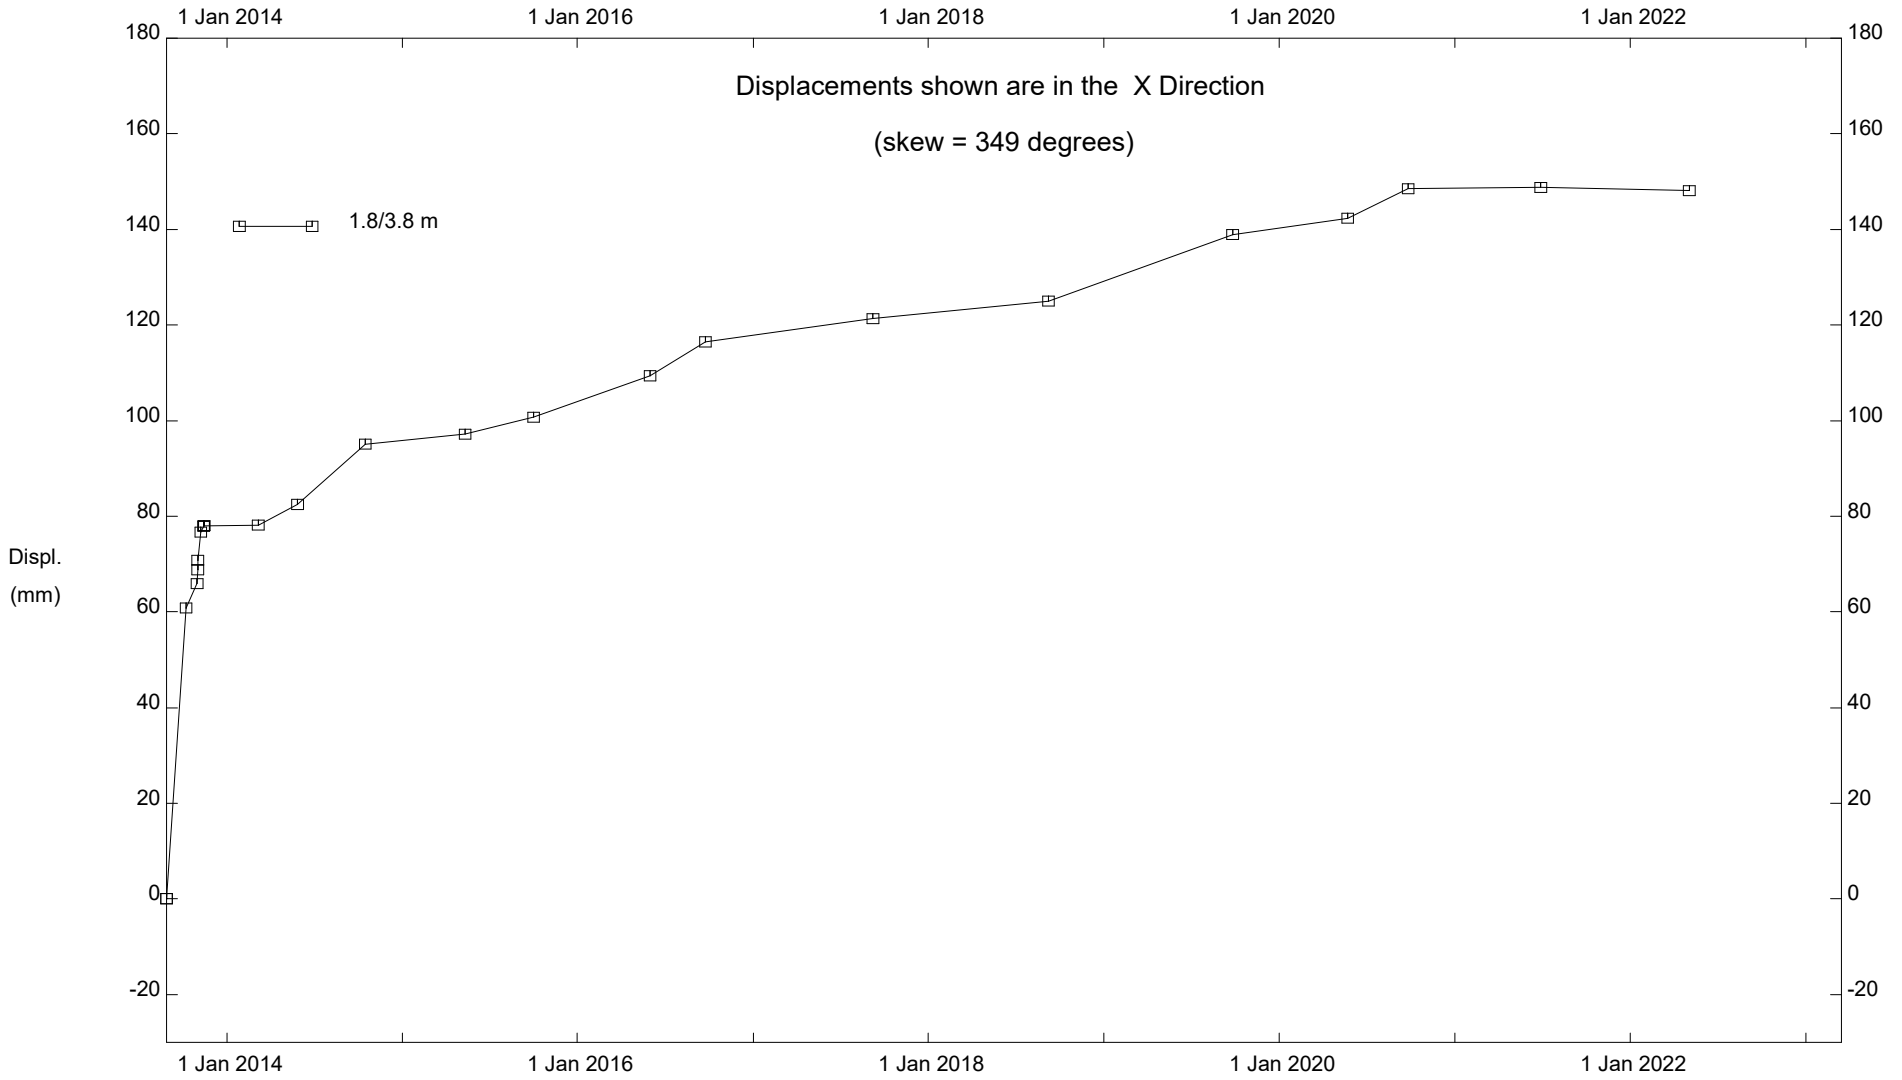
HWY 47:06 Fickle Creek Slide (NC080), Inclinometer SI13-01  
 Alberta Transportation

**SI13-01** had an average movement rate of approximately 8 mm/yr between 1.8 m to 3.8 m depth since the completion of pile wall installation near the end of 2013. The current rate of movement is less than 1 mm/yr which is similar to Spring 2021 readings.

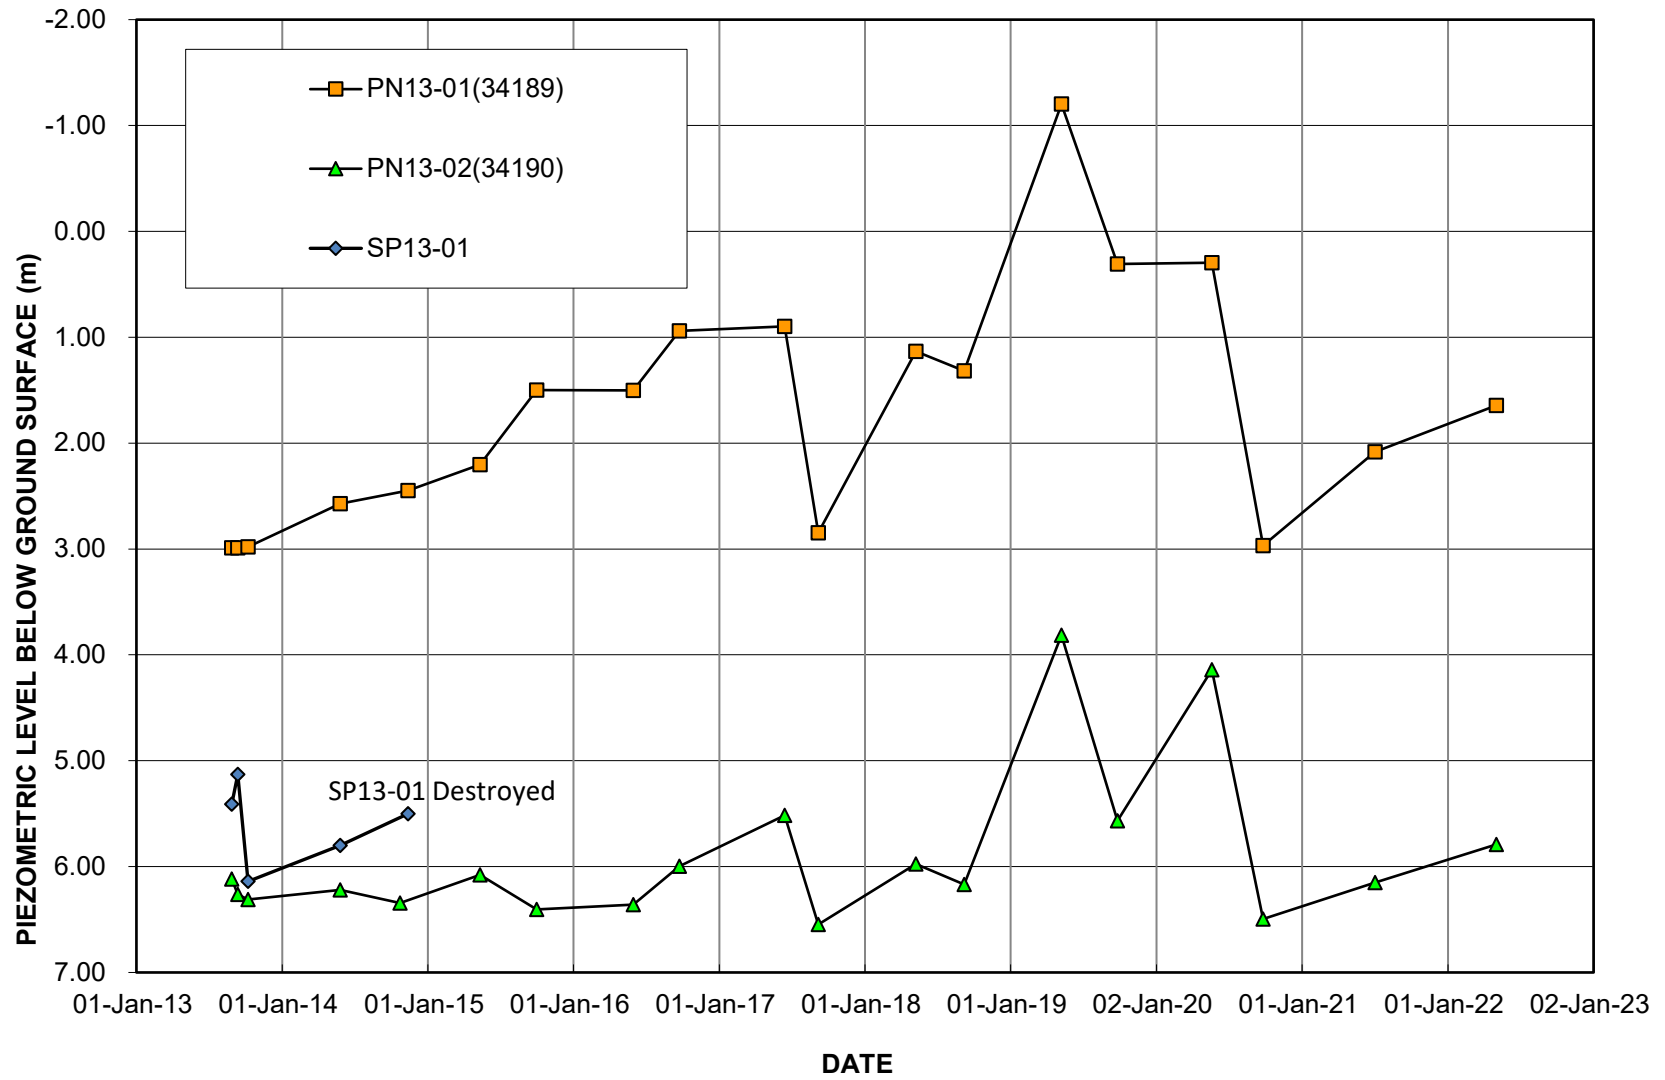
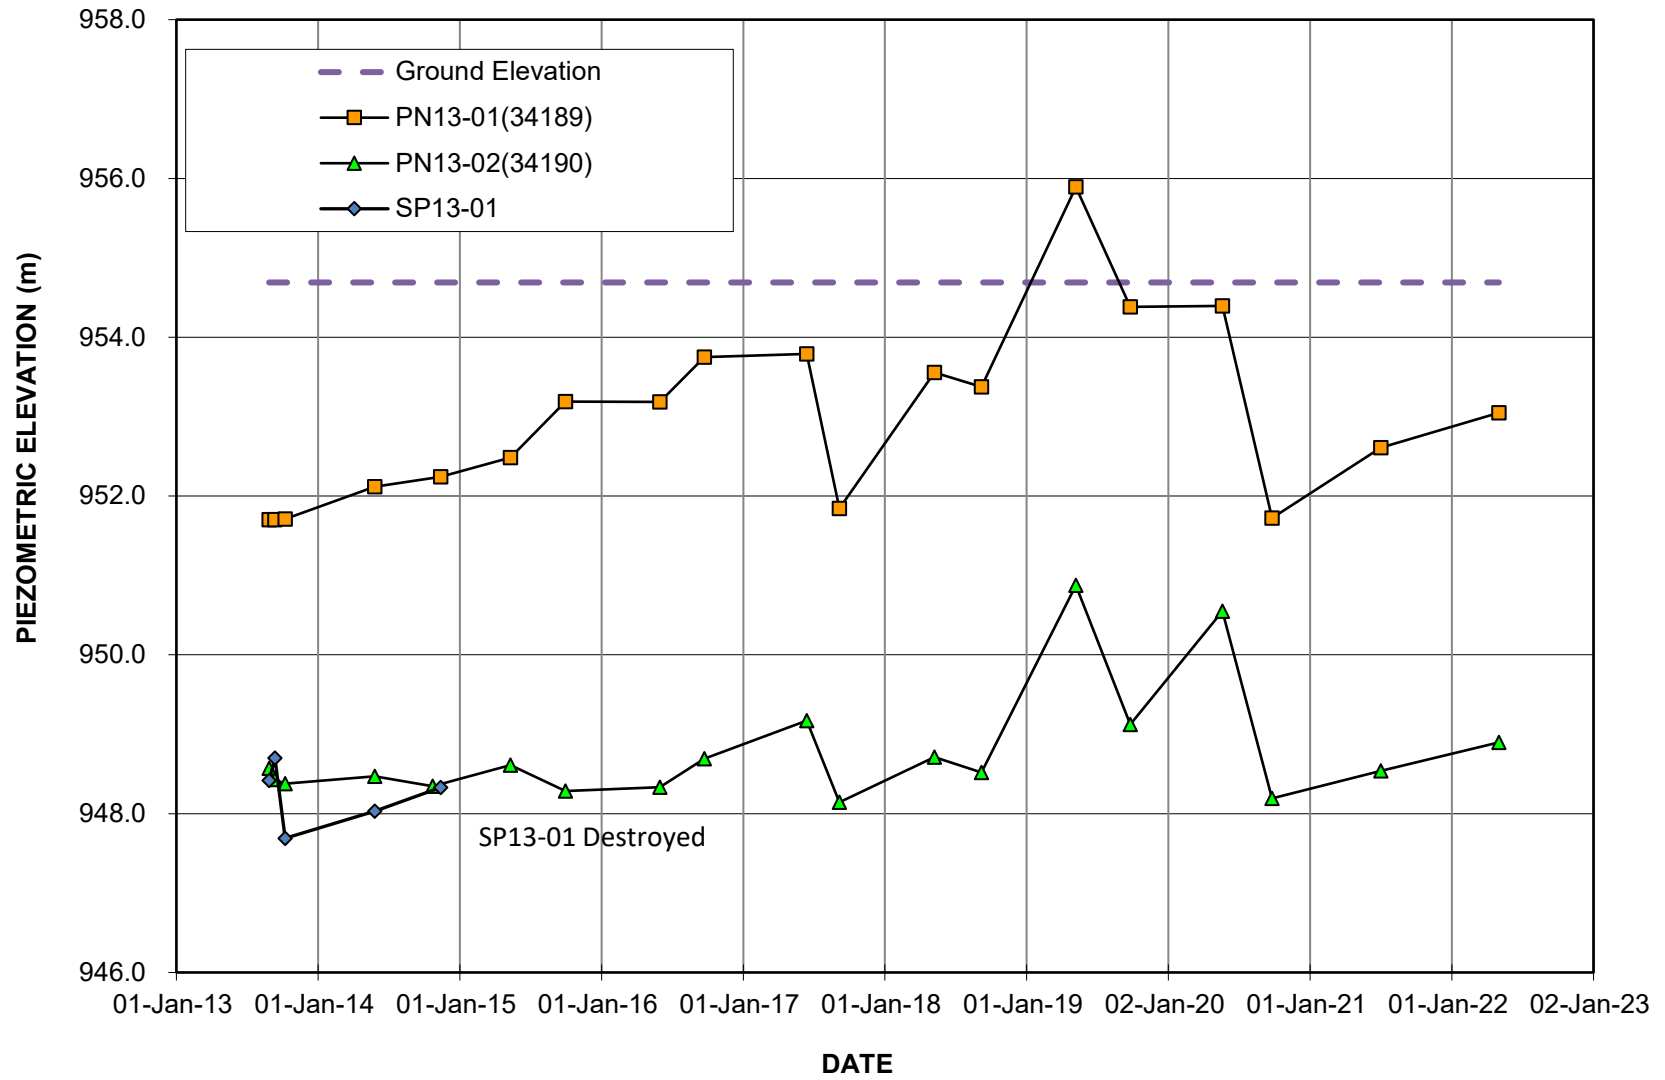
The groundwater level in **PN13-01** increased by 0.5 m compared to the previous Spring 2021 reading. **PN13-02** also showed an increase in piezometric level by 0.3 m. The current piezometric level is at 1.6 m and 5.8 m below ground surface in **PN13-01** and **PN13-02**, respectively.
