SITE NUMBER AND NAME: NC080 – Fickle Creek Slide	HIGHWAY AND KM: 47:06, km 39.608	PREVIOUS INSPECTION: June 17, 2022	CURRENT INSPECTION: June 12, 2024
LEGAL DESCRIPTION: SE-24-51-19-W5	NAD83 COORDINATES: UTM11U 5918635N, 522484E		RISK ASSESSMENT: PF: 7 CF: 7 Total: 49
AVERAGE ANNUAL DAILY TRAFFIC (AADT): 1,200 (2023)		CONTRACTOR MAINTENANCE AREA (CMA): 508

NORTH CENTRAL REGION GRMP
EDSON / STONY PLAIN
SITE INSPECTION FORM

Client/Project
Transportation and Economic Corridors
Geohazard Monitoring Program
NC80 Fickle Creek Slide

2024 Site Inspection Photos at NC080

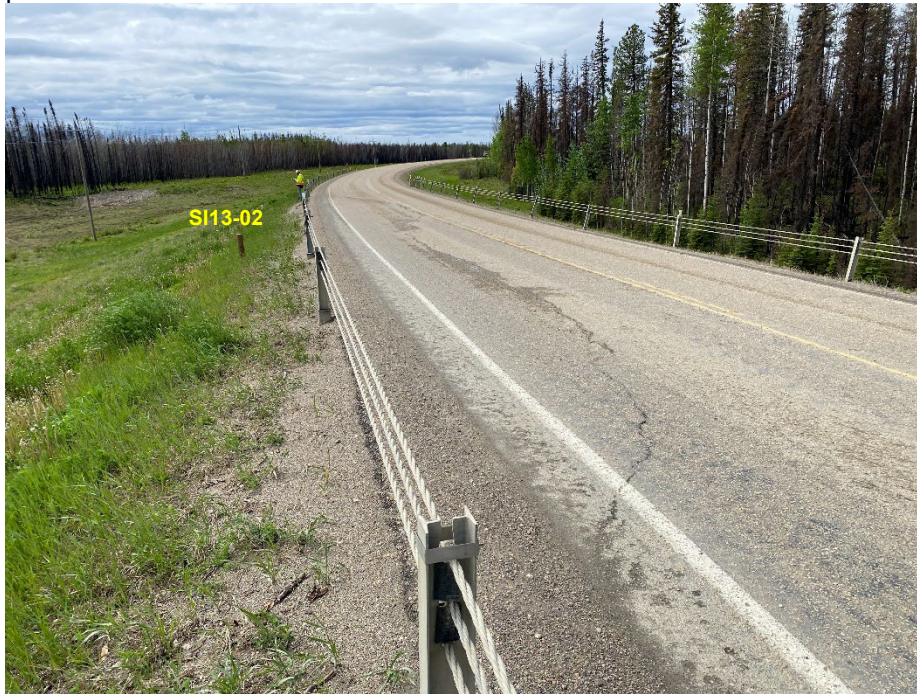
COMMENTS
<ul style="list-style-type: none"> • The pavement cracking (Photos 1 and 2) appeared to be similar to the 2022 inspection and generally consisted of: <ul style="list-style-type: none"> – Approximately 40 m long curvilinear crack along NBL. – Approximately 25 mm dip to the southeast in the south third of the curvilinear crack. The dip was similar to what was observed during the 2022 inspection. • The scour hole above the 760 mm diameter culvert remains 1.2 m wide. A void was observed below the ground in the scour hole 1.1 m deep bringing the total depth of scour to 2.3 m. The void has progressed to expose a 90 mm wide separation in the culvert and flow through the culvert can be seen (Photo 3).

Photo 1: Arched crack near SI13-02. Looking southwest.

- All pavement cracks should be sealed to reduce surface water infiltration into the slide mass. Mill and fill may also be completed to improve the rideability of the highway (i.e. smoothen dips and repair cracks) and to avoid additional loading on the ground surface.

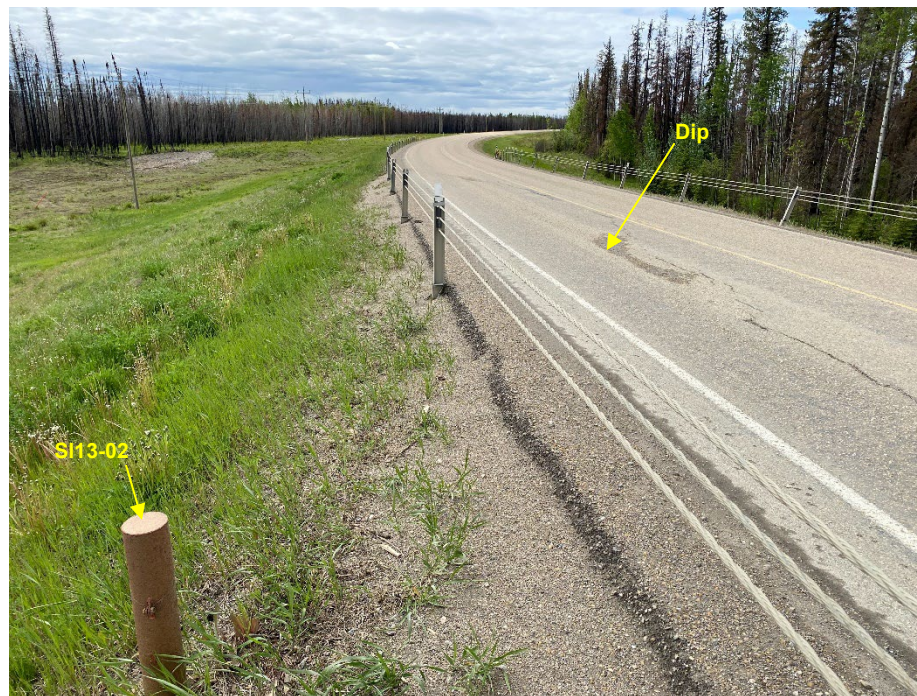
Photo 2: Pavement dip near south end of overlay. Looking southwest.

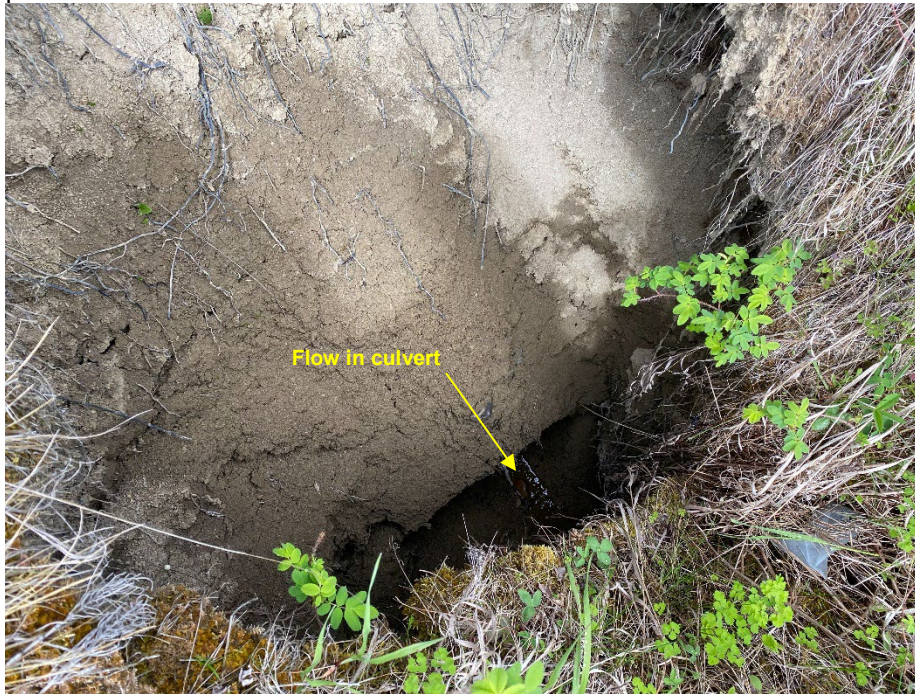
Photo 3: Scour hole exposing 90 mm separation in 760 mm diameter culvert. Looking west.

- The scour hole above the 760 mm diameter culvert outlet should be backfilled and reseeded, after repairing the separation in the culvert.
- The 760 mm diameter culvert should be inspected using CCTV to determine if the pipe is broken. A replacement culvert may be required to facilitate creek flow.

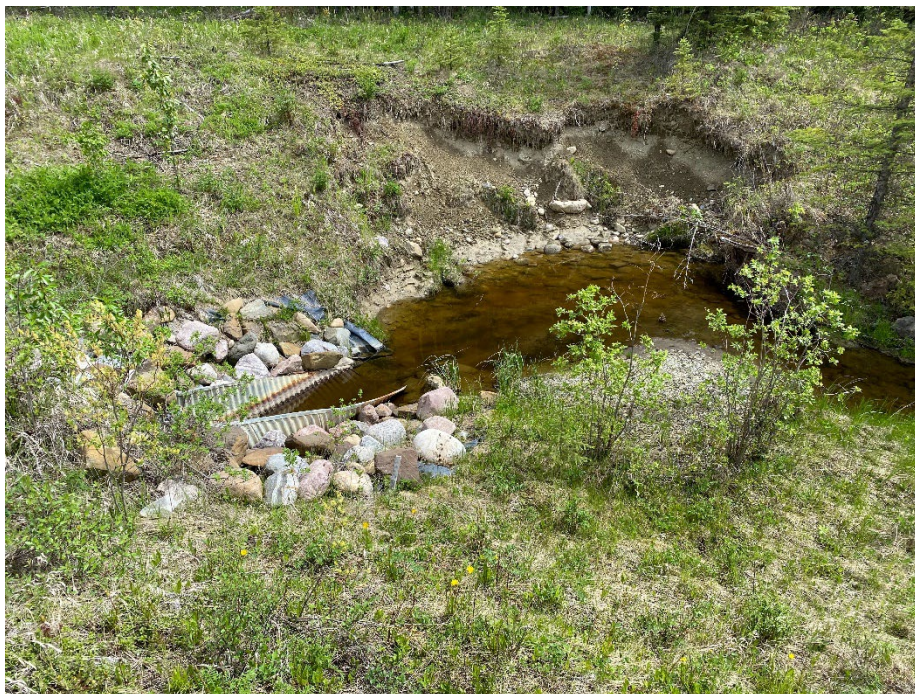
- The erosion near the outlet of the 1200 mm dia. culvert progressed. The scarp has receded to 4.2 m behind the edge of creek and is about 8 m wide and 1.2 m deep (Photo 4).

Photo 4: Retrogressing slump/erosion at outlet of 1200 mm diameter culvert. Looking east.

- Riprap can be placed along the creek at the outlet of the 1200 mm dia. culvert to reduce toe erosion of the slump. This slump should be backfilled and reseeded.

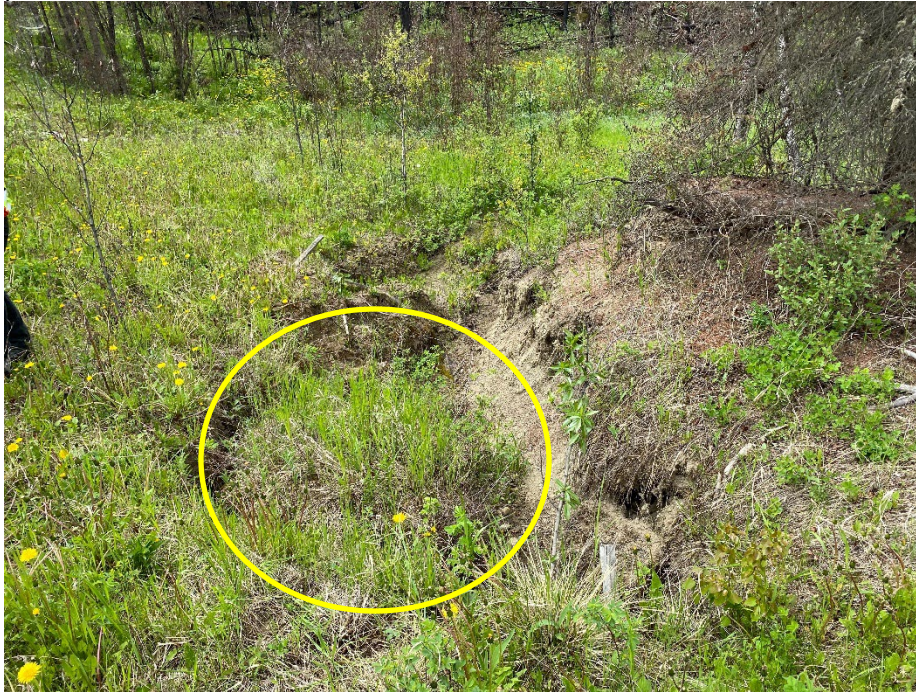
- The erosion gully north of the 1200 mm dia. culvert inlet was observed to be a similar width and depth (up to 2 m wide and 1 m deep) as previous inspections, however a portion of the slope on the west side has slid into the gully (Photo 5).

Photo 5: Erosion gully north of 1200 mm diameter culvert inlet. Portion of slope has slid into gully. Looking southwest.

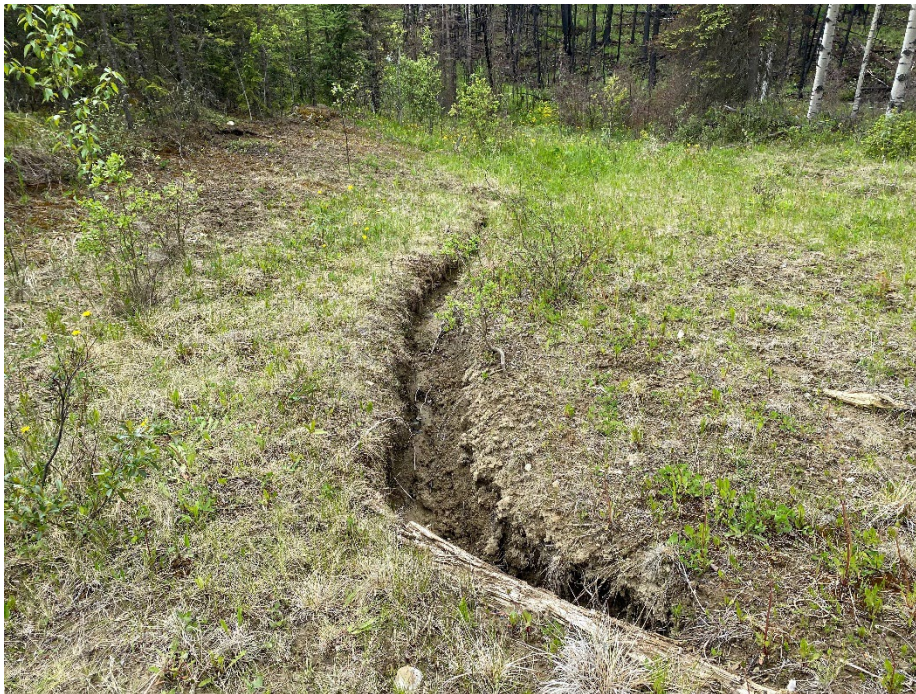
- The smaller erosion gully upslope from the erosion gully north of the 1200 mm dia. culvert inlet was observed to be in a similar condition to the previous inspection in 2022. The smaller erosion gully was about 500 mm wide and 450 mm deep and extended to about 2 m short of the north tree line (Photo 6).

Photo 6: Erosion gully leading to old gully shown in Photo 5. Looking southwest.

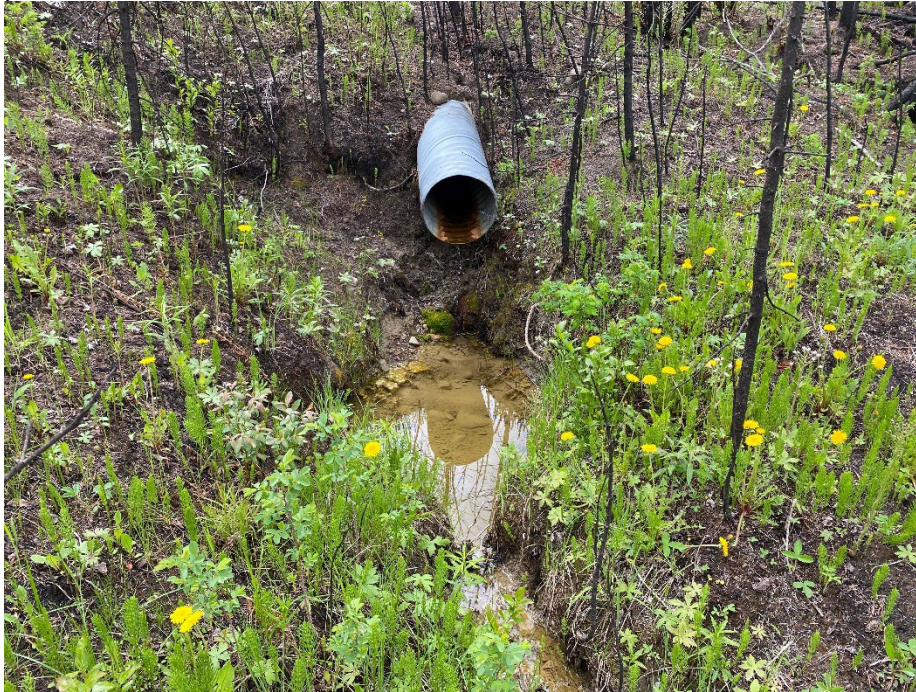
- A 1.2 m deep scour hole exists at the 400 mm diameter down drain and appears unchanged from the 2021 and 2022 inspections. Water was trickling from the down drain at the time of the inspection (Photo 7). A new erosion gully is developing between the 400 mm down drain and the 760 mm diameter culvert outlet.

Photo 7: Outlet of 400 mm down drain. Looking south

- Riprap or gravel can be placed at the down drain to reduce scouring. If left unchecked, the erosional scour may remove additional material and trigger a slope failure on the west side of the highway.

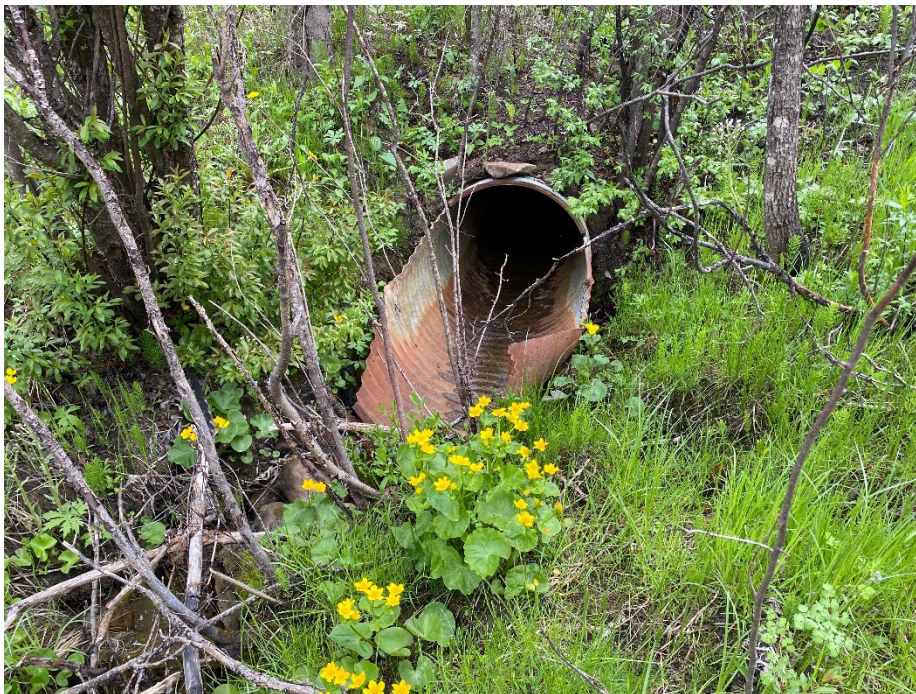
- The 760 mm diameter culvert inlet was lifted with water flowing under the culvert. The condition appears similar to the previous inspection in 2022 (Photo 8).

Photo 8: Outlet of 760 mm culvert. Looking southeast.

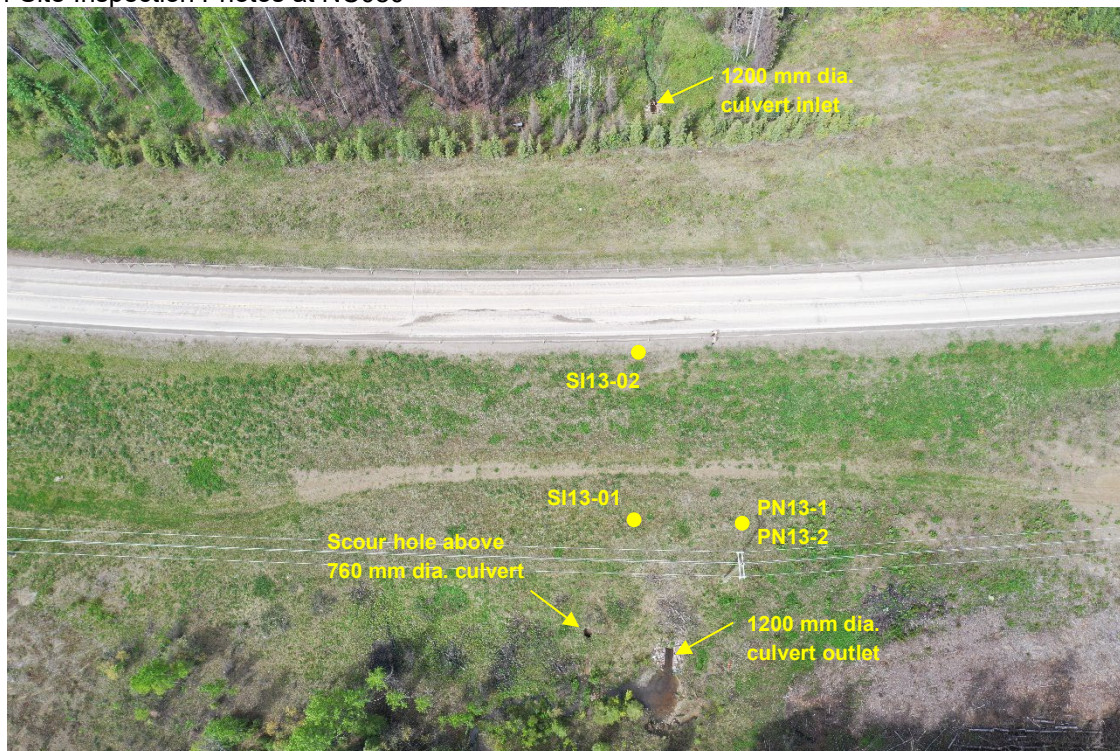
Photo 9: Overview of site. Photo taken by drone, looking northwest.

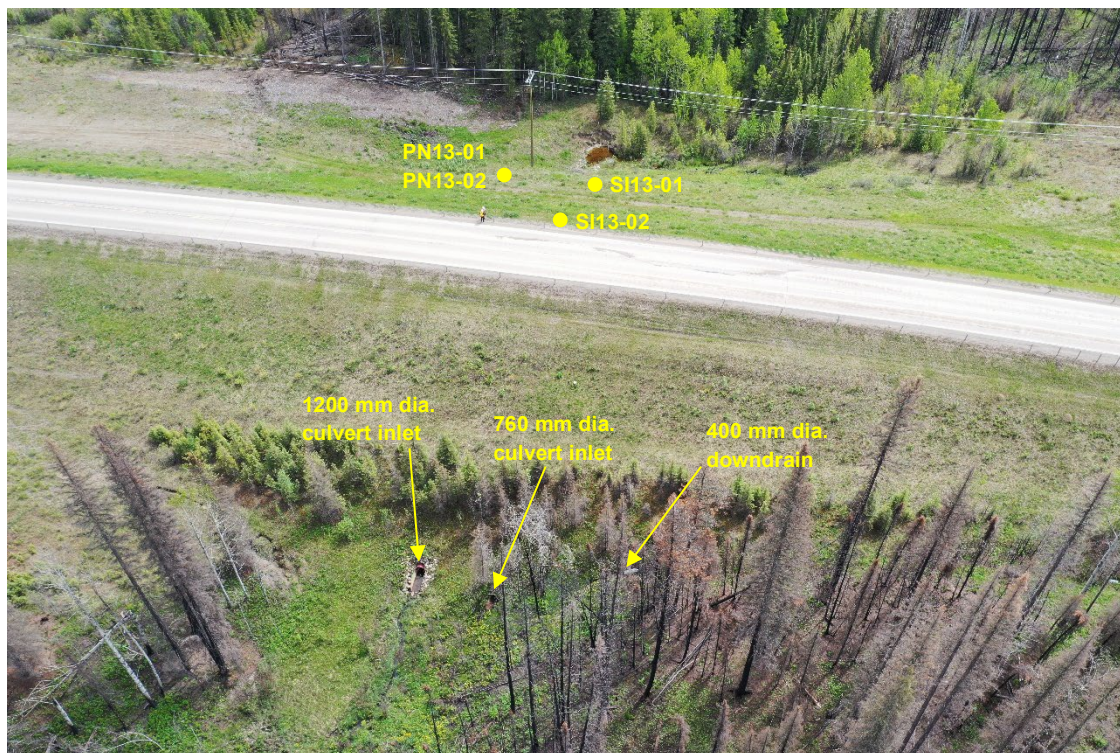
Photo 10: Overview of west side of site. Photo taken by drone, looking east.
