SITE NUMBER AND NAME: NC081 – Evansburg Slide	HIGHWAY AND KM: 16A:08, km 8.230	PREVIOUS INSPECTION: May 25, 2020	CURRENT INSPECTION: July 14, 2021
LEGAL DESCRIPTION: SW 30-53-07-W5M	NAD83 COORDINATES: UTM11U 5941007N, 630586E		RISK ASSESSMENT: PF: 11 CF: 6 Total: 66
AVERAGE ANNUAL DAILY TRAFFIC (AADT): 790 (2020)		CONTRACTOR MAINTENANCE AREA (CMA): 508

NORTH CENTRAL REGION GRMP
EDSON / STONY PLAIN
SITE INSPECTION FORM

2021 Site Inspection Photos at NC081

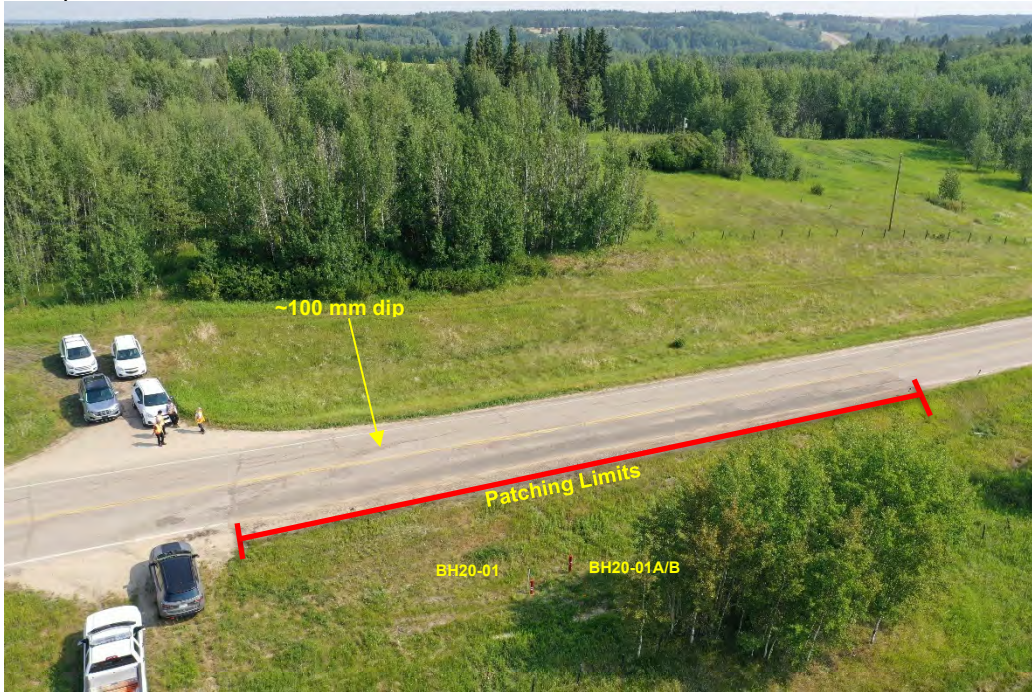
COMMENTS
<ul style="list-style-type: none"> Cracks were reported by the MCI to be about 100 mm wide in the Fall of 2020. An 8 to 10 tonne patch was placed in October to improve the road rideability. An approximately 100 mm dip in pavement was observed on the westbound lane (WBL). The SI installed in BH20-01 recorded about 12 mm of incremental movement at a depth of about 2 m since October 2020 suggesting the landslide is at the clay fill and native clay interface. The SI installed in BH20-02 also showed movement at a depth of about 2 m in the native clay. This movement appears to be localized to the observed toe bulge feature. The piezometers showed a decrease in water level ranging from 1.0 m to 2.0 m. Water levels range from 3.0 m to 4.3 m below ground surface. An exposed Telus cable was observed between the two groups of trees near the fence line. Previously, this cable was observed to be submerged below standing water. However, no water was observed during the current inspection. This may be related to the overall decrease in water level at the site. New erosion channels were observed upslope from the exposed cable.

Photo 1: Pavement cracking along Highway 16A. Looking north.

- This site is currently scheduled for remedial construction. The tender closed in mid-July 2021. Remediation includes constructing a driven steel pile wall (HP 310x110) followed by reconstruction of the highway. No additional remediation/maintenance will be required.
- Site inspections should continue to be completed annually.
- Instrumentation monitoring should continue to be completed semi-annually.

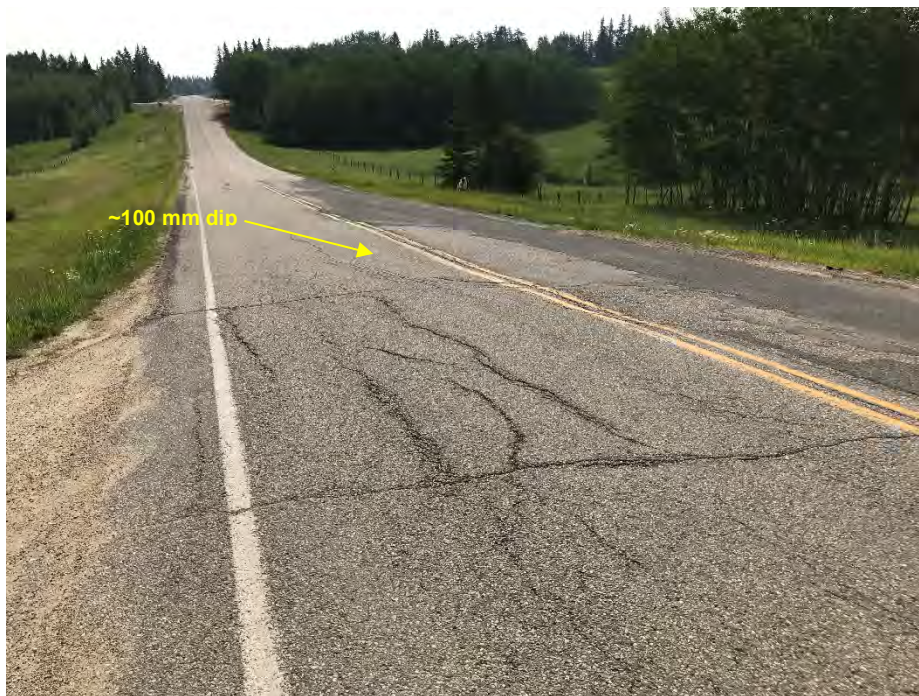
Photo 2: Pavement cracking along Highway 16A. Patch placed on eastbound lane. Looking north.

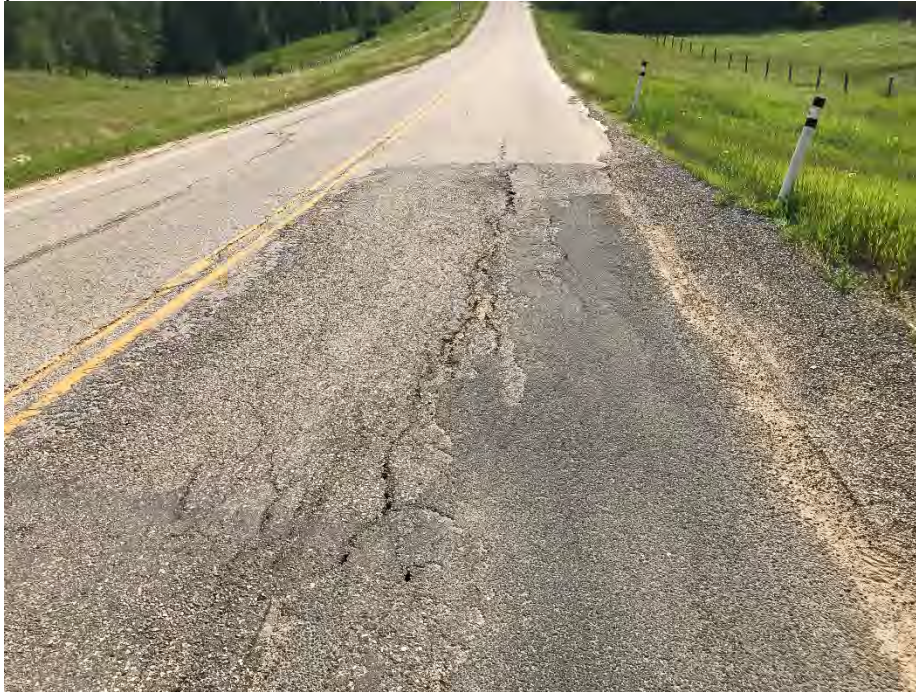
Photo 3: Pavement cracks at east limits of patch. Looking east.

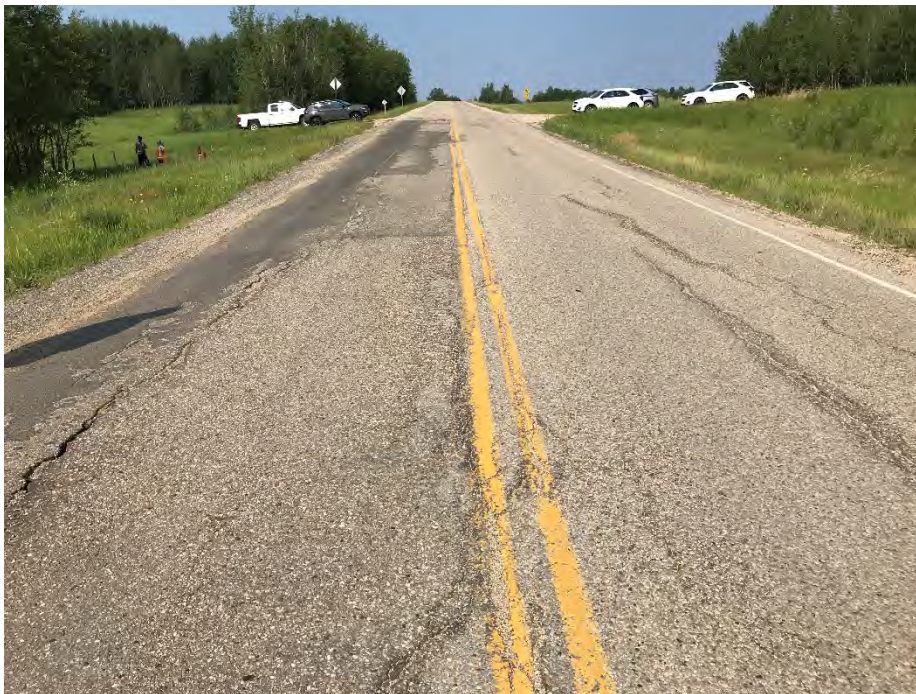
Photo 4: Pavement cracks at east limits of patch. Looking west.

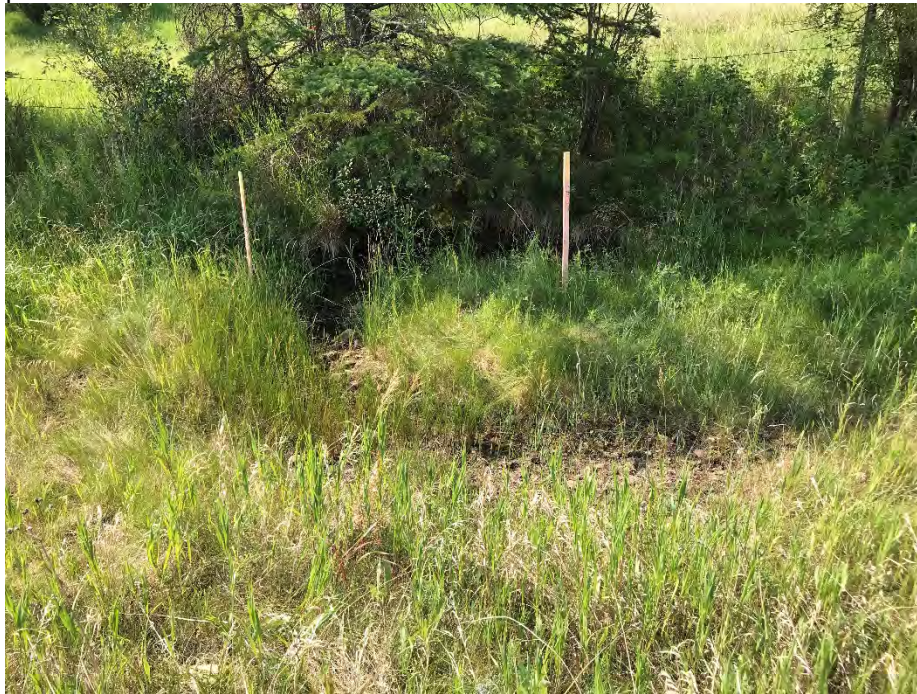
Photo 5: Erosion upslope from exposed Telus cable. Looking south.

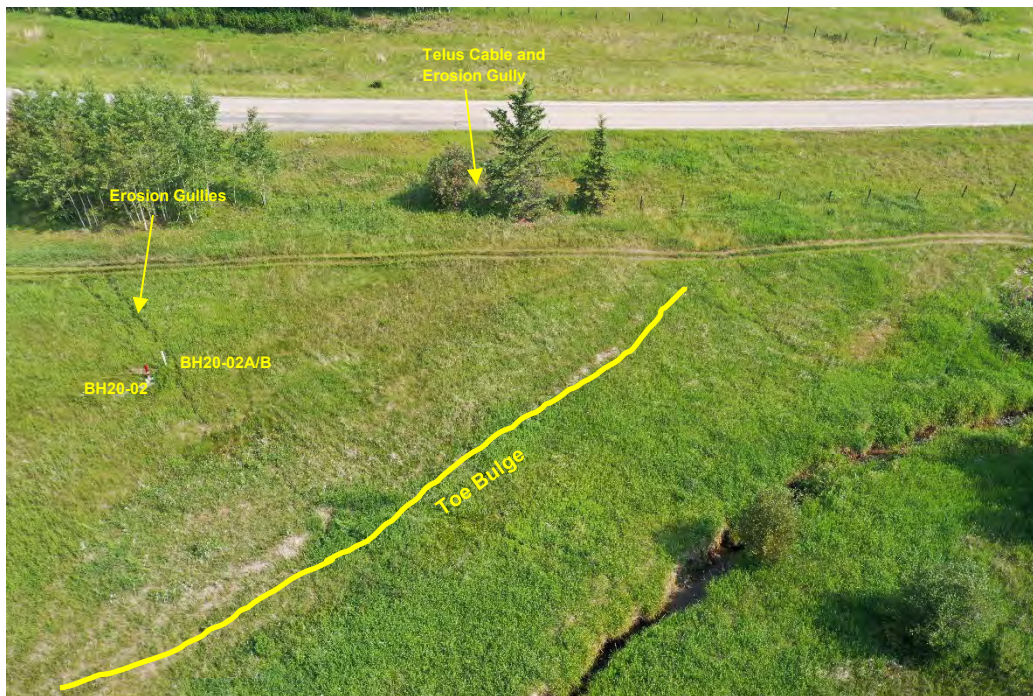
- The culvert (BF71355) is in good condition and does not appear to be affected by the landslide.
- The erosion channel near BH20-02 was mostly vegetated and appears unchanged.
- No apparent change to the toe bulge was observed.
- The south slope was very well vegetated at the time of inspection and may have obscured some landslide features.

Photo 6: Toe bulge. Looking northeast.
