<b>SITE NUMBER AND NAME:</b> NC081 – Evansburg Slide	<b>HIGHWAY AND KM:</b> 16A:08, km 8.230	<b>PREVIOUS INSPECTION:</b> July 14, 2021	<b>CURRENT INSPECTION:</b> June 16, 2022
<b>LEGAL DESCRIPTION:</b> SW 30-53-07-W5M	<b>NAD83 COORDINATES:</b> UTM11U 5941007N, 630586E		<b>RISK ASSESSMENT:</b> PF: 3 CF: 3 Total: 9
<b>AVERAGE ANNUAL DAILY TRAFFIC (AADT):</b> 850 (2021)		<b>CONTRACTOR MAINTENANCE AREA (CMA):</b> 508

2022 Site Inspection Photos at NC081

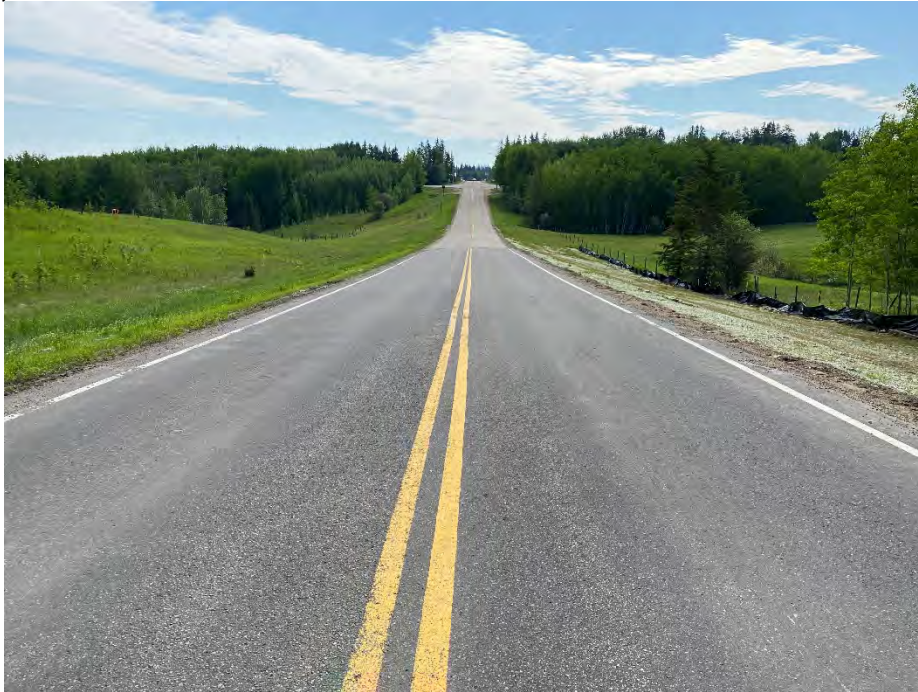
**Photo 1:** Pavement and embankment repair along Highway 16A. Looking east.

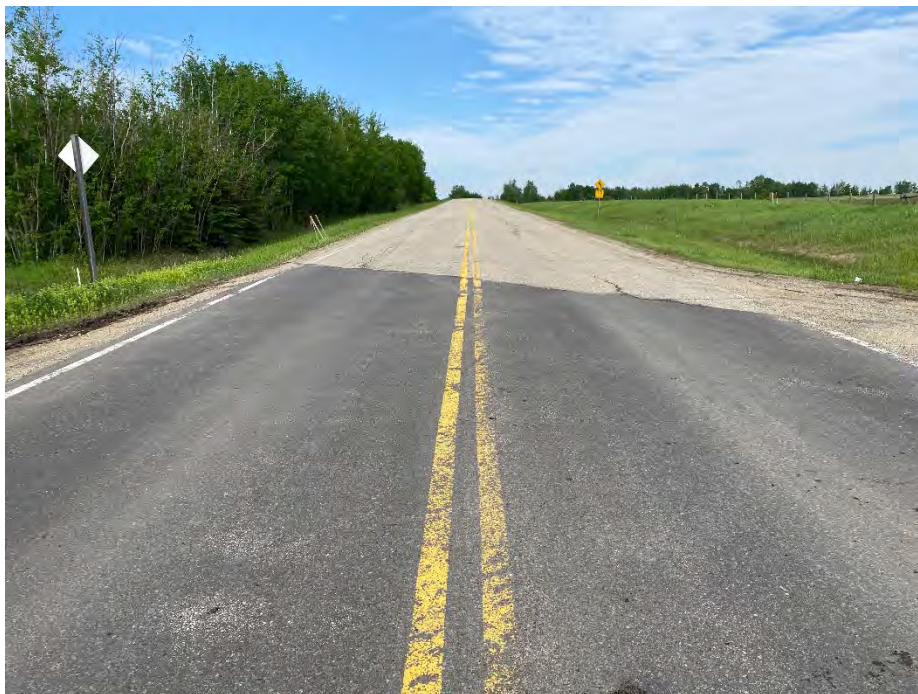
**Photo 2:** Pavement repair along Highway 16A. Looking west.

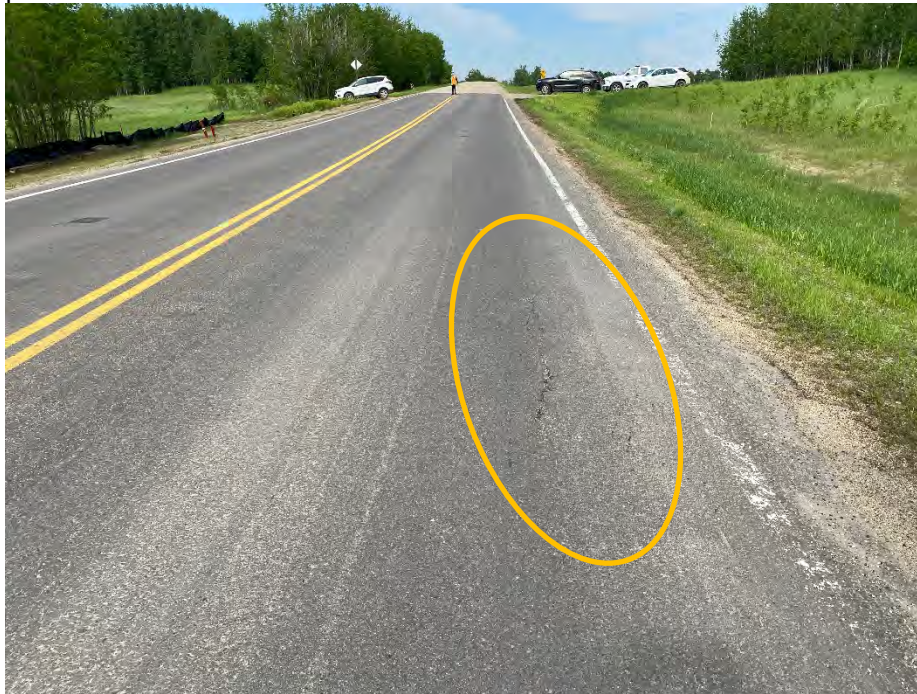
<b>COMMENTS</b>
<ul style="list-style-type: none"> <li>Construction of a driven steel pile wall (HP 310x110) followed by reconstruction of Highway 16A was completed in Fall 2021.</li> <li>Pavement cracks approximately 3 mm to 5 mm wide and 250 mm long were observed in the west bound lane's northern wheel path.</li> <li>SI21-01 and SI21-02 are installed within the pile wall. Small deflections were observed at the pile top which is likely due to loading and deflection of the pile wall. BH20-02 is installed in the bulging area on the south slope near the creek and indicates on-going movement. Piezometric levels range from about 2 m to 4 m below ground surface and are approximately at creek elevation.</li> <li>Saturated ground and erosion were noted at both ends of the culvert crossing the property access road at the southwest corner of the project extents (Photos 5 and 6).</li> <li>The ground around the flush mount installed for SI21-01 and SI21-02 has settled. This is likely due to less compaction around the inclinometers by the Contractors to avoid damage to the instrument.</li> <li>The north and south embankment slopes appear to be in good condition post-construction (Photos 4 and 7).</li> </ul>

**Photo 3:** Pavement cracking in westbound lane. Looking west.

- Pavement cracks should be monitored by the MCI and sealed to prevent water infiltration into the embankment and pavement structure.
- The following items should be addressed as part of construction warranty:
  - Reseeding the south embankment.
  - Regrading the ground around SI21-01 and SI21-02.
  - Removal of the silt fence along the south property's fence line.
- The MCI should continue to monitor the culverts on a regular basis to ensure they are free flowing, to reduce surface water penetration of the embankment and pavement structure.
- The site inspection frequency can be reduced given a pile wall was recently installed. An inspection frequency of once per contract cycle is recommended.
- Instrumentation monitoring should continue to be completed twice annually in the spring and fall.

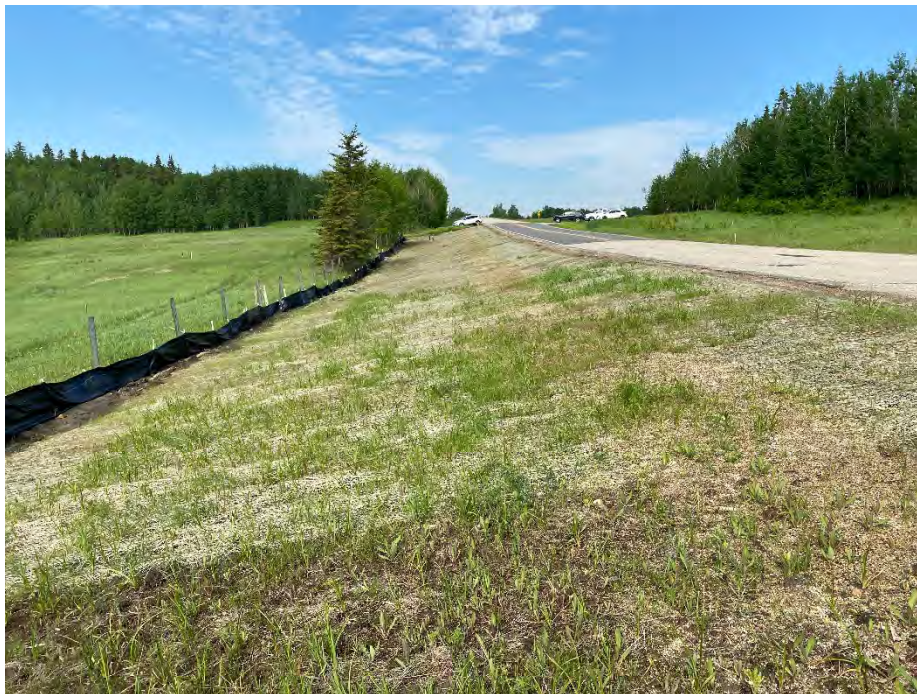
**Photo 4:** South embankment. Looking west.

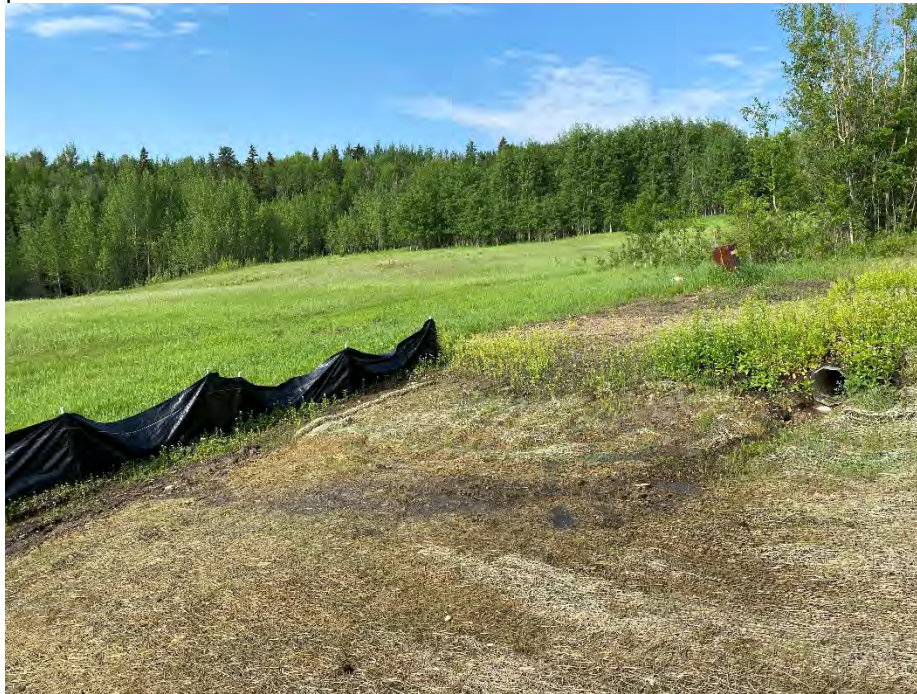
ITEM	CONDITIONS EXIST		DESCRIPTION AND LOCATION	NOTICEABLE CHANGE FROM LAST INSPECTION	
	YES	NO		YES	NO
Pavement Distress		X	Pavement was recently repaired.		X
Slope Movement	X		SI21-01 and 02 show small movements at the pile top. Bulging on south slope near creek.		X
Erosion	X		Erosion noted at the inlet and outlet of the culvert across the south field access road.	X	
Seepage		X			X
Bridge/Culvert Distress		X			X

**Photo 5:** Wet ground and erosion at east end of culvert across property access road. Looking southwest.

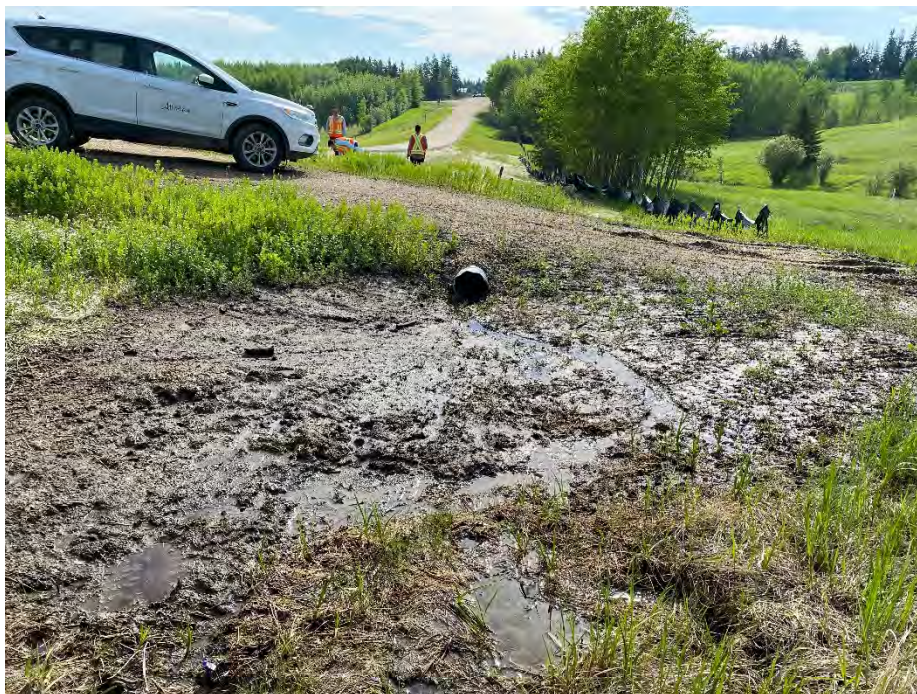
**Photo 6:** Wet ground and erosion at west end of culvert across property access road. Looking east.

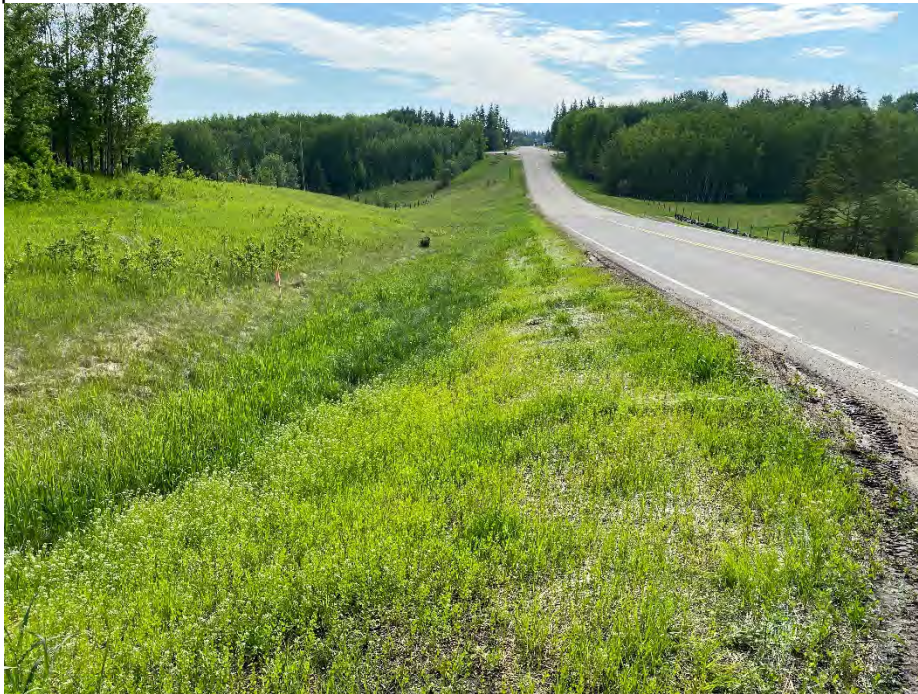
**Photo 7:** Ditch on north side of Highway 16A. Looking east.

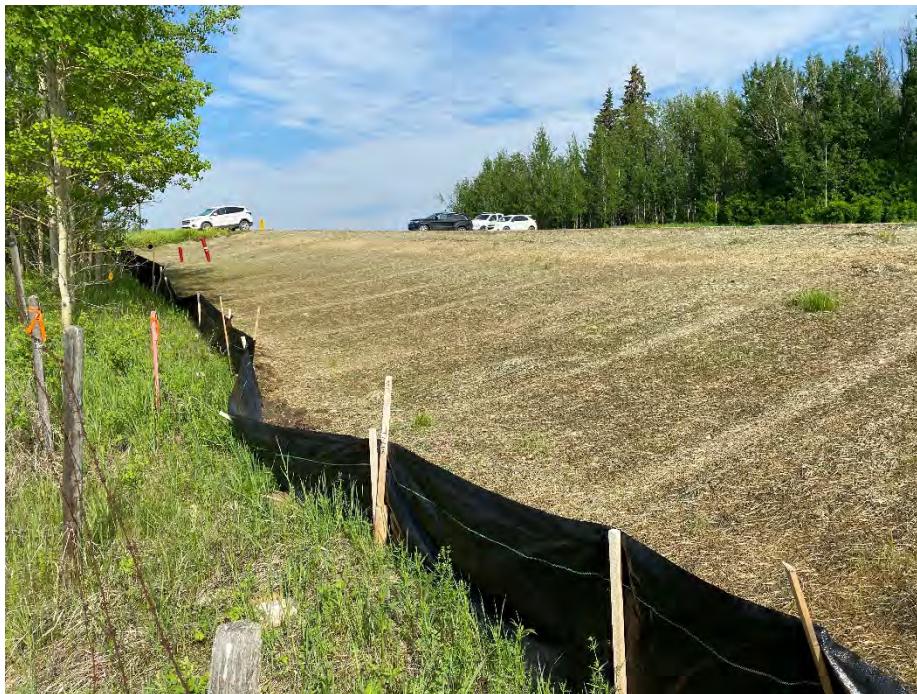
- The exposed Telus cable was not observed between the two groups of trees near the south fence line during this inspection. No erosion or standing water was observed at this location (Photo 8).
- The erosion matting is visible with little vegetation on the repaired portion of the south embankment. Silt fence remains in place along the fence on the south embankment.
- The culvert (BF71355) is in good condition and does not appear to have been affected by the landslide or construction.
- The erosion channel near BH20-02 was mostly vegetated and appears unchanged.
- The south slope beyond the tree line was very well vegetated at the time of inspection and may have obscured some landslide features.

**Photo 8:** Upslope from previous location of exposed Telus cable. Looking northwest.
