| SITE NUMBER AND NAME: NC081 – Evansburg Slide | HIGHWAY AND KM: 16A:08, km 8.230 | PREVIOUS INSPECTION: June 16, 2022 | CURRENT INSPECTION: June 13, 2024 |

| PRIMARY SITE ISSUE: Shallow slope failure on south side of highway. | |

2024 Site Inspection Photos at NC081

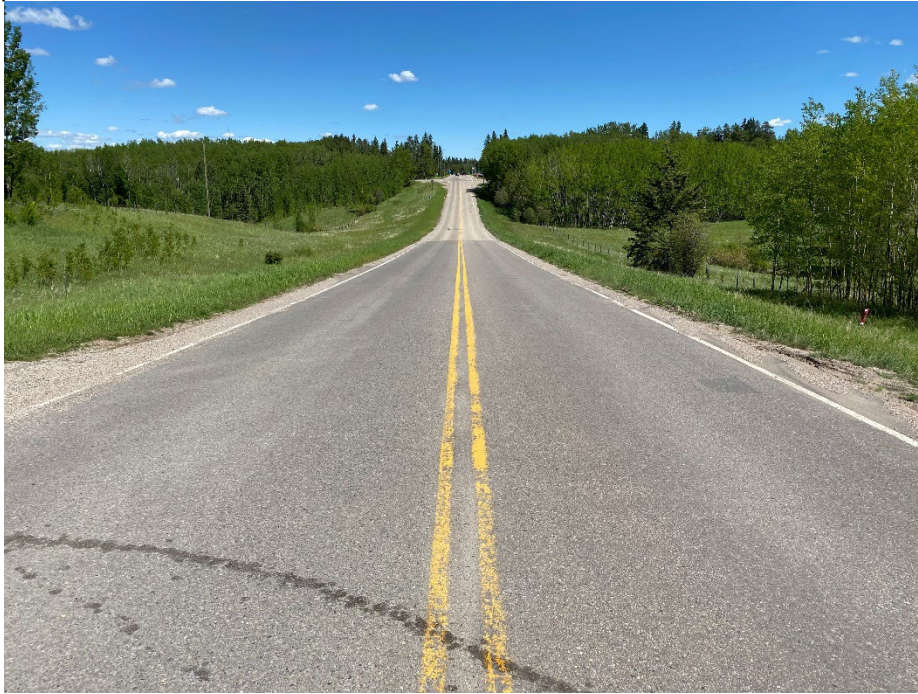
| <ul style="list-style-type: none"> Pavement cracks approximately 3 mm to 5 mm wide and 250 mm long were observed in the westbound lane's northern wheel path, and appear similar to the 2022 inspection. The repaired pavement appears in good condition (Photo 1) Pavement cracking was observed on either side of the 2021 repair zone (Photos 2 & 3) SI21-01 and SI21-02 are installed within the pile wall. Small deflections were observed at the pile top which is likely due to loading and deflection of the pile wall. BH20-02 is installed in the bulging area on the south slope near the creek and indicates little change since 2023. Piezometric levels range from 2.1 m to 4.3 m below ground surface and are approximately at creek elevation, similar to previous years. Erosion was noted at the west end of the culvert crossing the property access road at the southwest corner of the project extents (Photo 4). The east end of the culvert has become vegetated and the erosion and saturated ground observed in 2022 was not present during this inspection. The ground around the flush mount installed for SI21-01 and SI21-02 is settled, similar to the condition in 2022. This is likely due to less compaction around the inclinometers by the Contractors to avoid damage to the instrument. |

Photo 1: Pavement and embankment repair along Highway 16A. Looking east.

- Pavement cracks should be monitored by the MCI and sealed to prevent water infiltration into the embankment and pavement structure.
- The ground crack along the fence line should be regraded to prevent water infiltration into the embankment.
- The MCI should continue to monitor the culverts on a regular basis to ensure they are free flowing to reduce surface water penetration of the embankment and pavement structure.
- The site inspection frequency can be reduced given installation of the pile wall and re-vegetation of the slopes. An inspection frequency of once per contract cycle is recommended.
- Instrumentation monitoring should continue to be completed twice annually in the spring and fall.

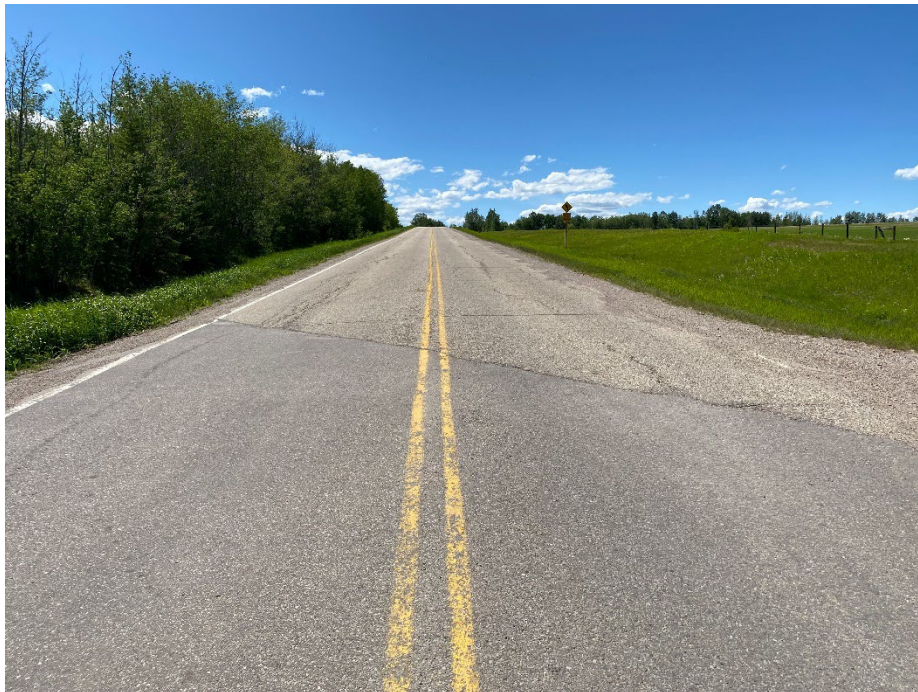
Photo 2: Pavement repair along Highway 16A. Looking west.

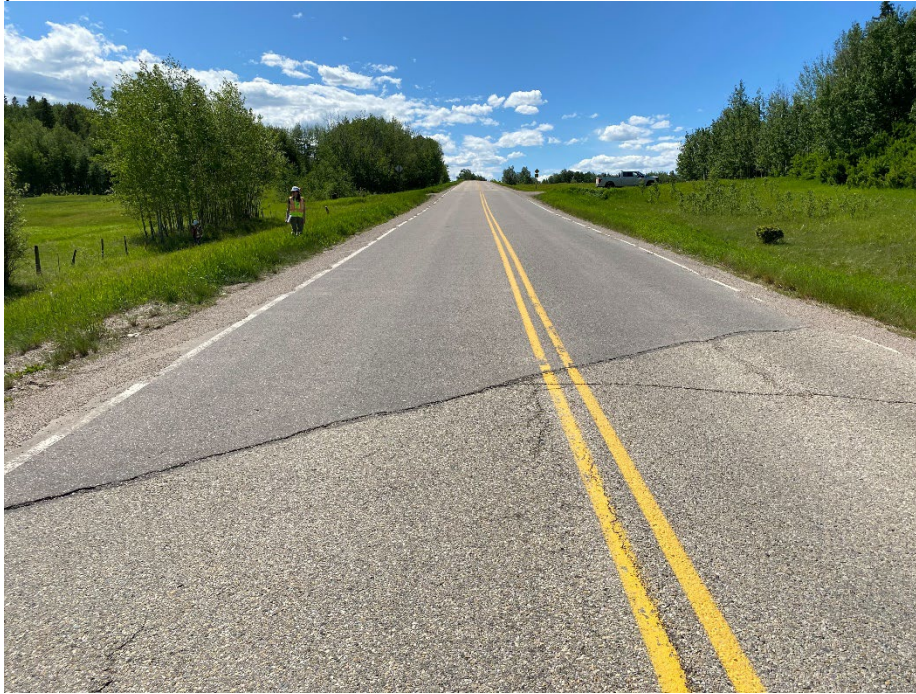
Photo 3: East end of repair zone. Looking west.

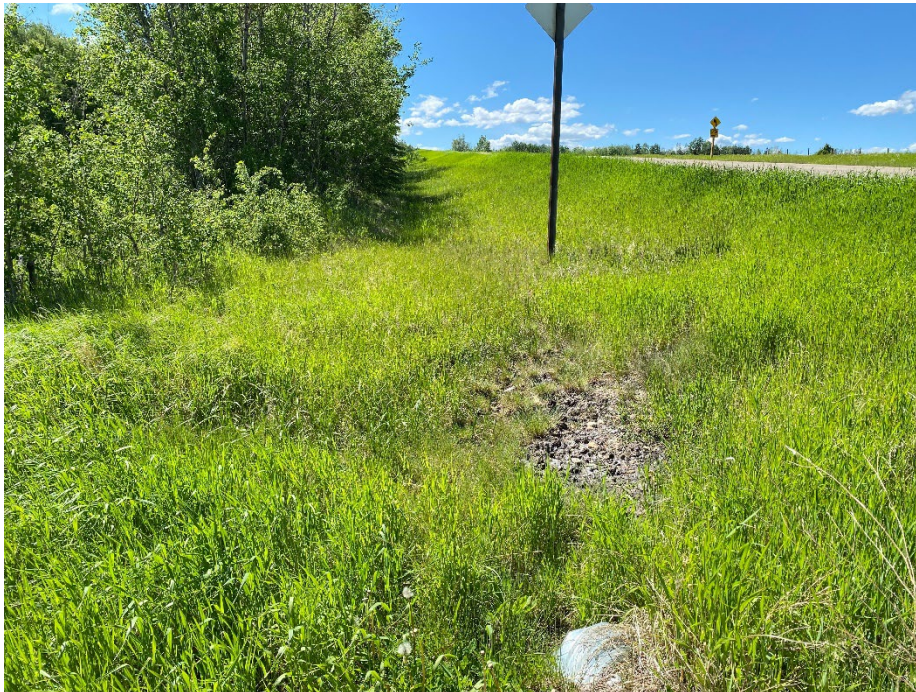
| ITEM | CONDITIONS EXIST | | DESCRIPTION AND LOCATION | NOTICEABLE CHANGE FROM LAST INSPECTION | |
|---|---|---|--|--|---|
| Erosion | X | | Erosion noted at the inlet and outlet of the culvert across the south field access road. | | X |

Photo 4: Erosion at west end of culvert across property access road. Looking west.

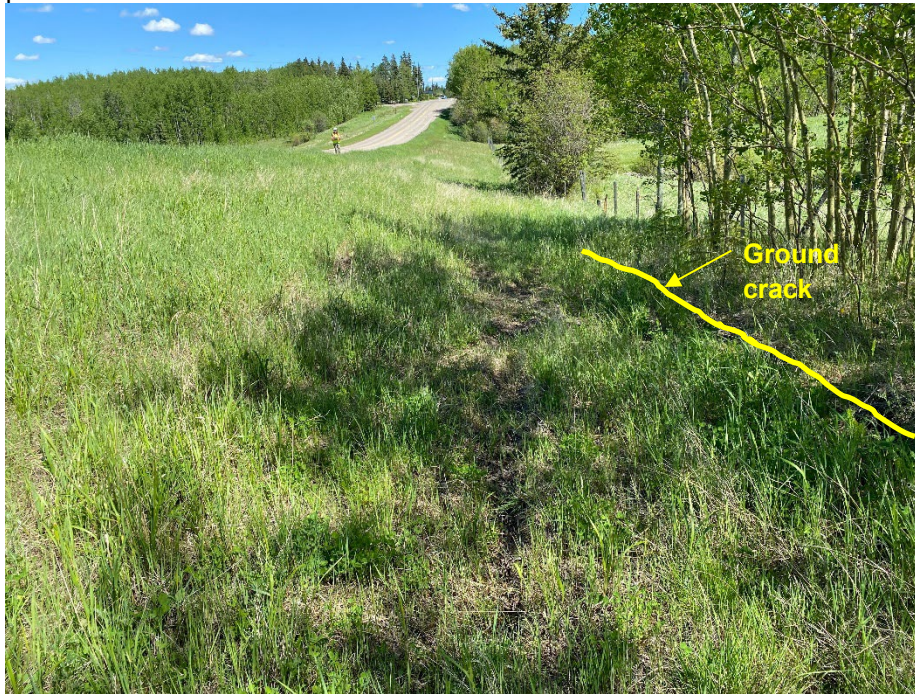
- The south ditch was observed to be dry and well vegetated. A ground crack, approximately 8 m long and 60 mm wide was observed near the south fence line (Photos 5 & 6). This crack may be due to removal of the silt fencing that was observed in 2022.
- The culvert (BF71355) is in good condition and does not appear to have been affected by the landslide or construction (Photos 7 & 8).
- The erosion channel near BH20-02 was mostly vegetated and appears unchanged since 2022.
- The south slope beyond the tree line was very well vegetated at the time of inspection and may have obscured some landslide features.

Photo 5: South ditch, looking east. Ground crack visible near fence line, possibly due to removal of silt fence.

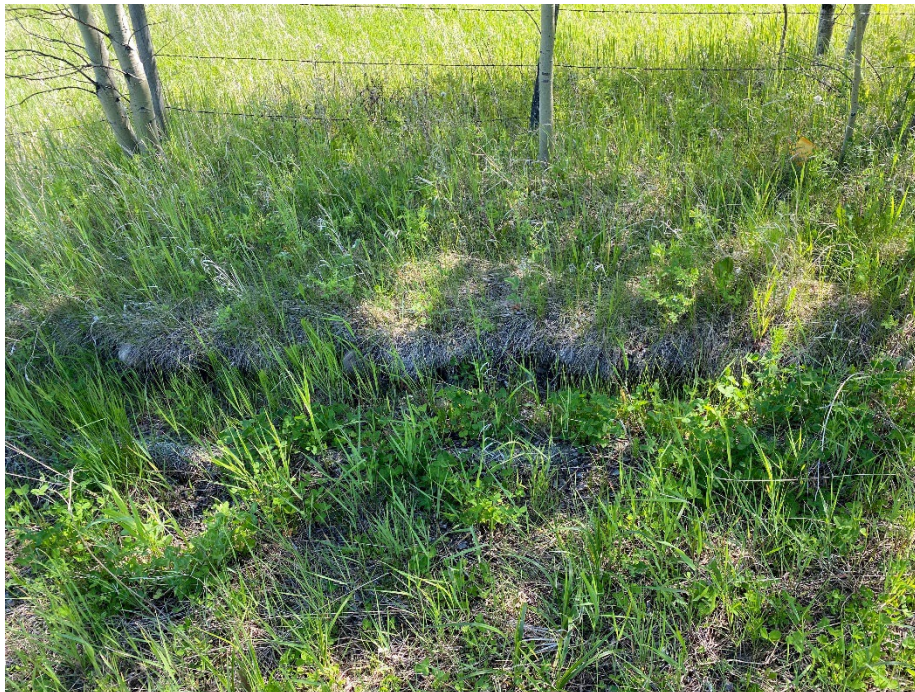
Photo 6: Possible ground crack in south ditch near fence line. Looking south.

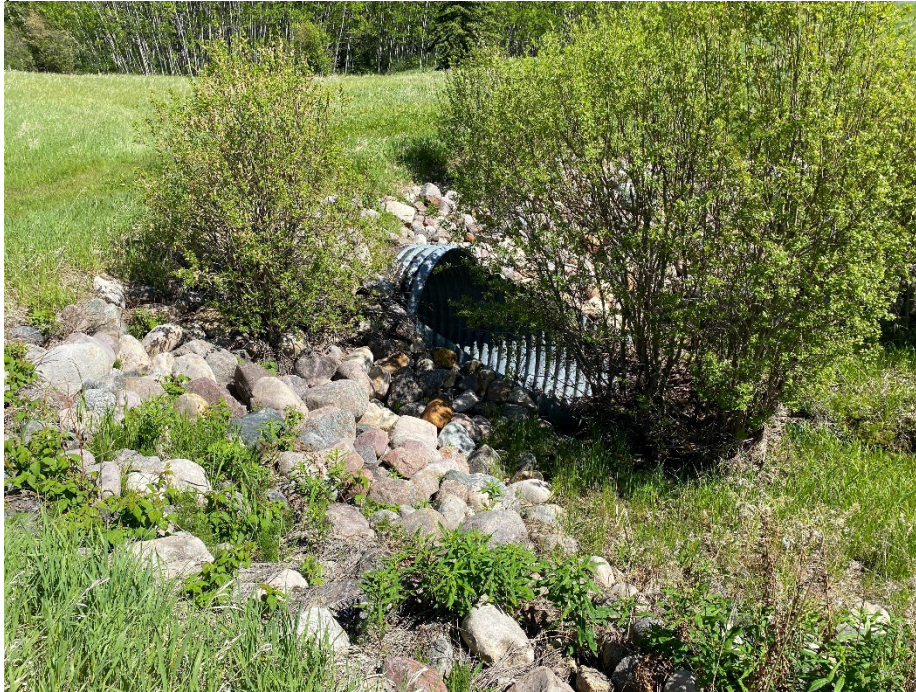
Photo 7: Culvert on south side of highway. Looking southeast.

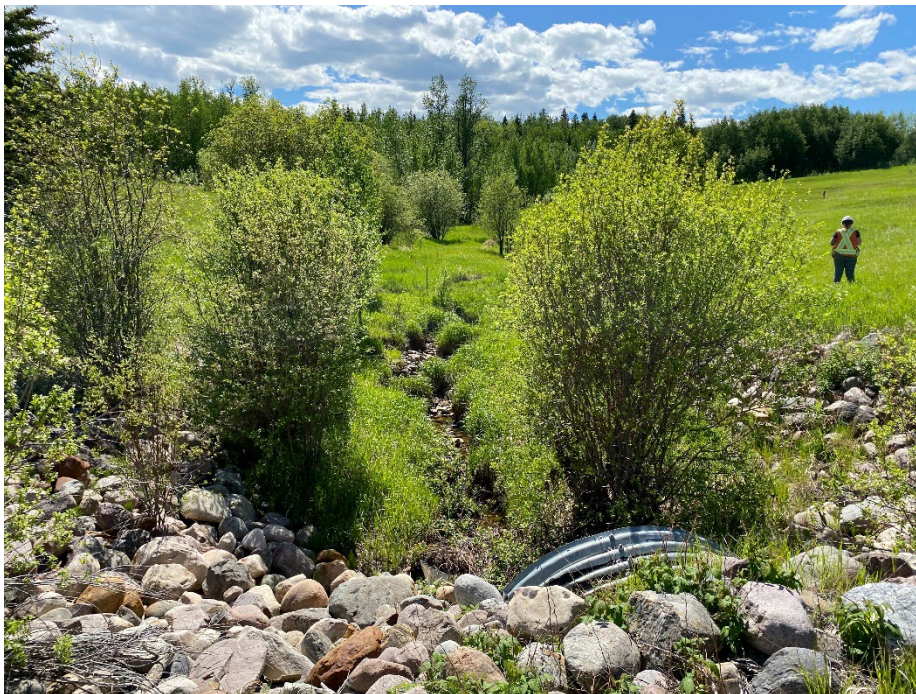
Photo 8: Looking down channel beyond culvert outlet on south side of highway. Facing southwest.
