## GEOHAZARD RISK MANAGEMENT PROGRAM

### North Central Region – Edson / Stony Plain Area

#### 2020 Inspection Report

Site Number	Site Name	Hwy	km
NC13	Cattlepass West	633:02	0.8
Legal Land Description	NW 29-53-6-W5M		
UTM Coordinates (NAD 83)	Zone 11N	N5942619	E642207
Operational Site Instrumentation	Slope Inclinometers	3	
	Pneumatic Piezometers	0	
	Vibrating Wire Piezometers	3	
	Standpipe Piezometers	-	
Date of Last Instrumentation Readings	May 20, 2020

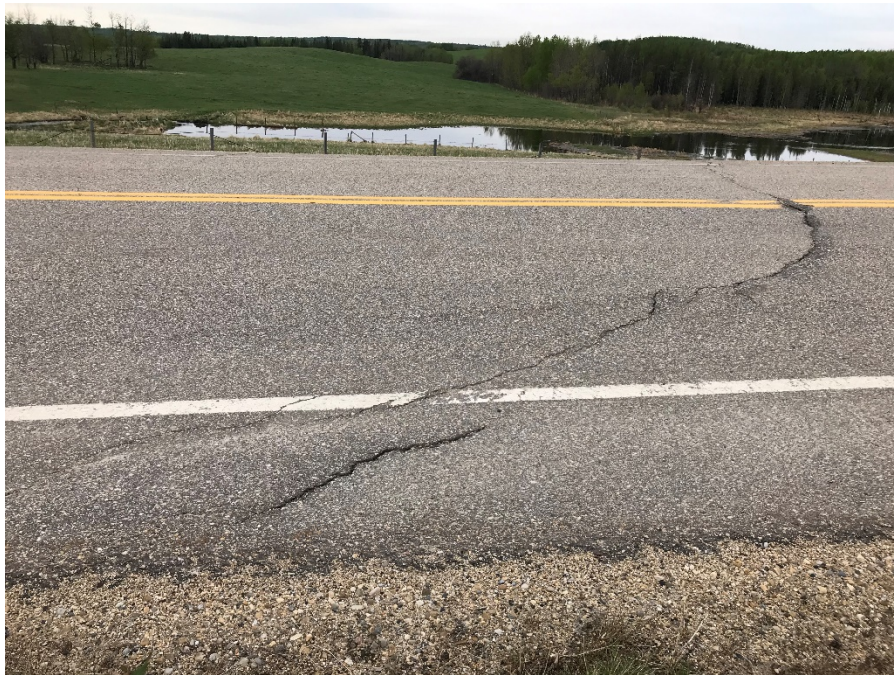
<b>Discussion</b>	<p>Highway 633 was last overlaid in October 2013. The crack patterns have since reflected through the overlay as shown in Photos 1 to 5. The circular crack west of SI05-1 increased its vertical difference to about 15 mm to 20 mm. The crack northeast of SI05-1 appeared to have a deeper dip in the pavement.</p> <p>The overall highway embankments are shown in Photos 6 and 7. No obvious signs of slope instability on the embankment slope were observed.</p> <p>The seepage observed in 2015 along the toe of the berm near the riprap was not observed during this inspection. The water level in the pond to the south appeared to be similar to the 2019 inspection as shown in Photo 8.</p>
<b>Assessment</b>	<p>The SI readings shows signs of creep movement, especially in BH17-02. Together with the development of new pavement cracks suggests that slope movement is ongoing.</p> <p>The overall pore water pressures at the site remains high with a trend of increasing pore pressures. The Spring 2020 instrumentation reading showed pore pressures as high as 0.2 m below ground surface. Artesian conditions were observed prior to remediation in 2011.</p>

**Photo 1:** Circular crack approximately 40 m west of SI05-1. Looking south

<b>Recommendations</b>	<p>Short term recommendations include sealing any new cracks to reduce surface water infiltration into the slope.</p> <p>The culverts and drains at the site should be inspected on a regular basis to reduce the risk of pore pressures building up in the berm and slope and to confirm functionality.</p> <p>Since the site is preloaded, a grade reduction to improve slope performance may be considered. Alternatively, lightweight fill may be considered to reduce the overall driving force on the embankment.</p> <p>Site inspections should be completed annually. Instrumentation monitoring should continue to be collected semi-annually.</p>
------------------------	---

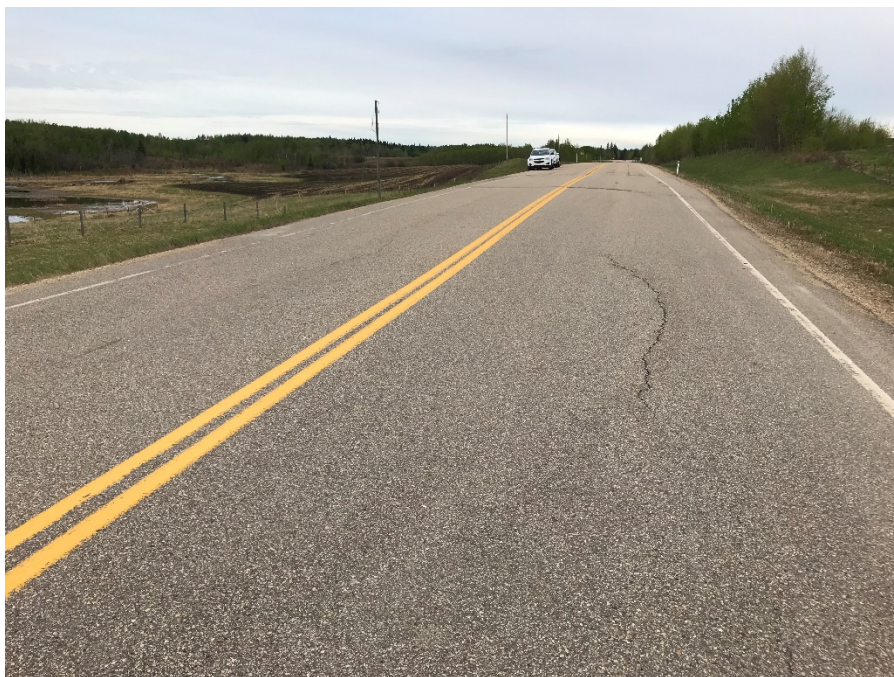
**Photo 2:** Semi-circular pavement crack about 10 m east of Photo 1. Looking west.

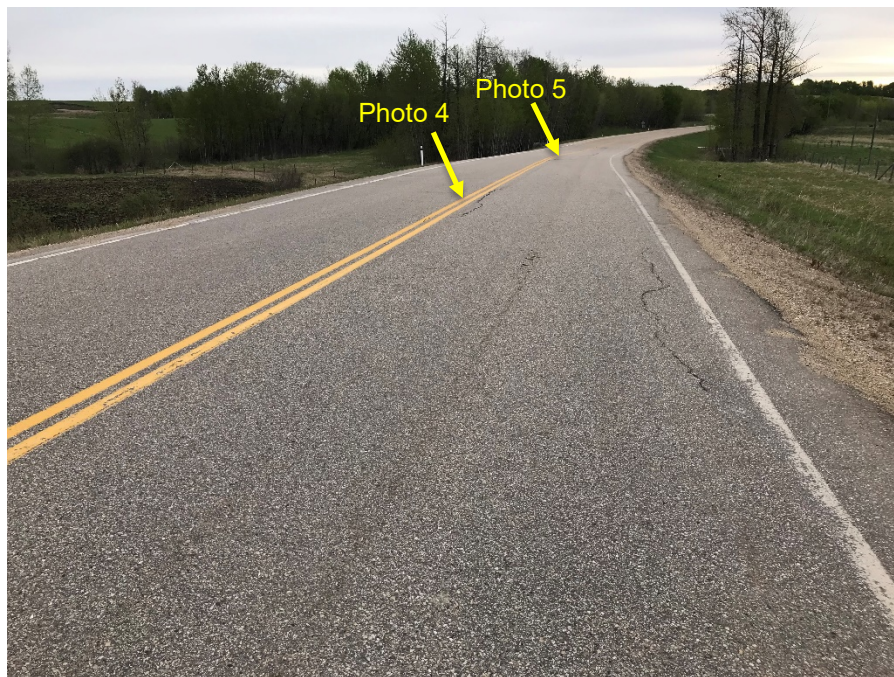
**Photo 3:** Crack on shoulder north of S105-1 unchanged. Looking east.

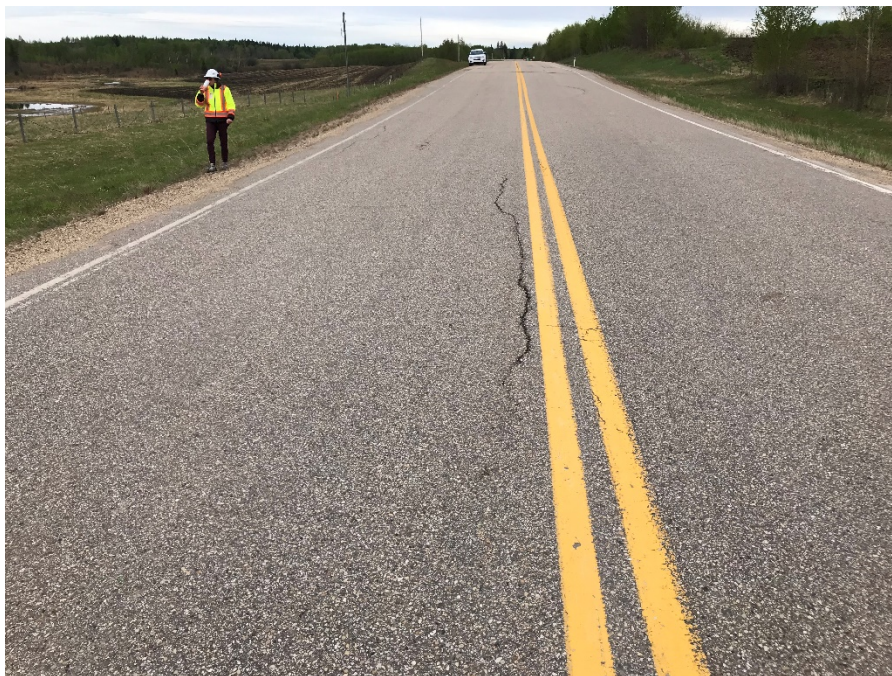
**Photo 4:** Cracking on eastbound lane northwest of BH17-01 Looking west.

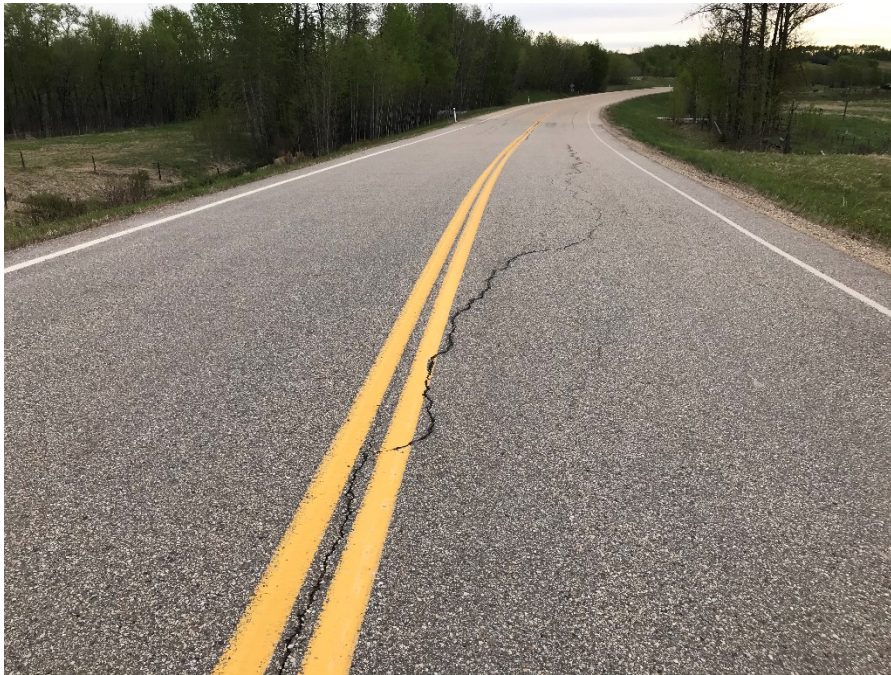
**Photo 5:** Semi-circular crack along C/L and eastbound lane north of BH17-01 Looking west.

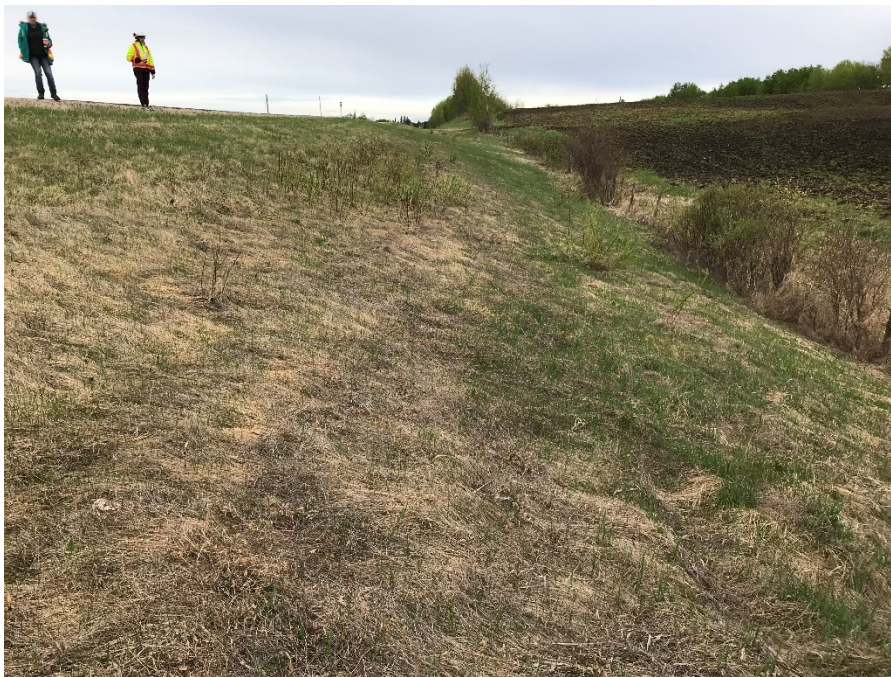
**Photo 6:** Overall view of north side of highway embankment. Looking west.

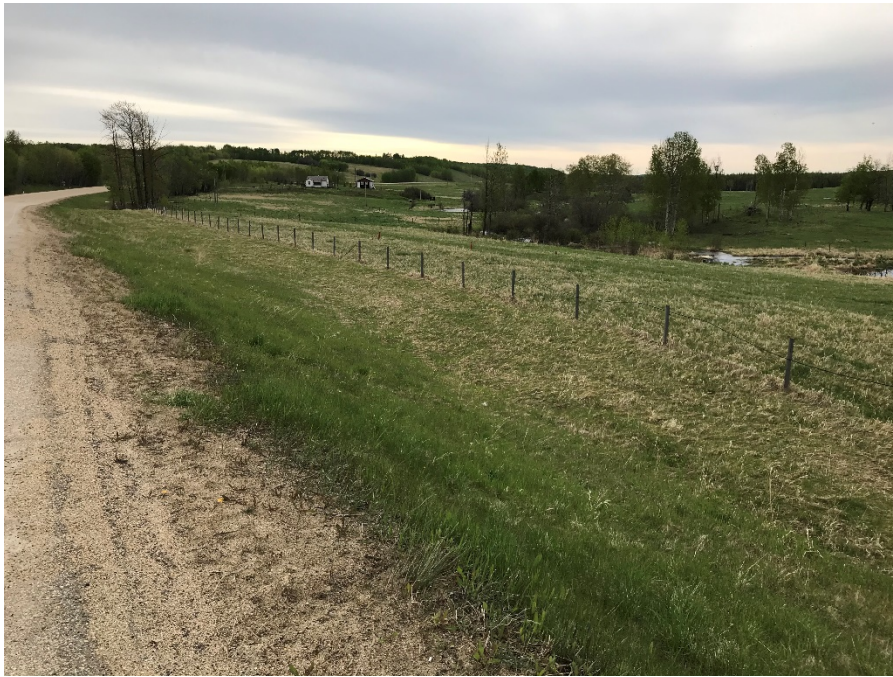
**Photo 7:** Overall view of south side of highway embankment. Looking east.

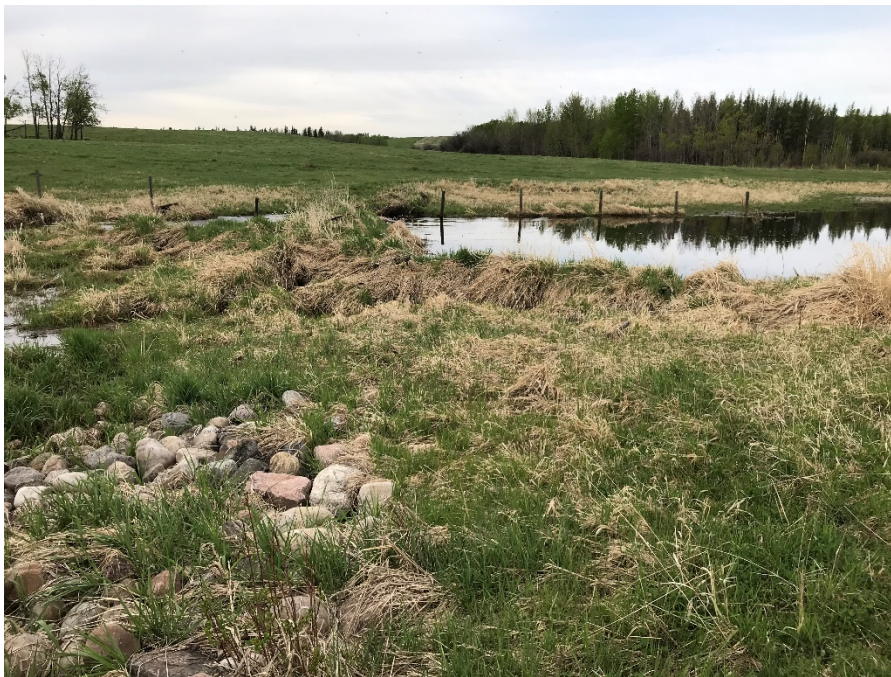
**Photo 8:** Pond at toe of slope. Looking south.
