**NORTH CENTRAL REGION GRMP  
EDSON / STONY PLAIN  
SITE INSPECTION FORM**

<b>SITE NUMBER AND NAME:</b> NC013 – Cattlepass West	<b>HIGHWAY AND KM:</b> 633:02, km 0.780	<b>PREVIOUS INSPECTION:</b> May 25, 2020	<b>CURRENT INSPECTION:</b> June 15, 2022
<b>LEGAL DESCRIPTION:</b> NW 29-53-6-W5M	<b>NAD83 COORDINATES:</b> UTM11U 5942619N, 642207E		<b>RISK ASSESSMENT:</b> PF: 10 CF: 4 Total: 40
<b>AVERAGE ANNUAL DAILY TRAFFIC (AADT):</b> 490 (2021)		<b>CONTRACTOR MAINTENANCE AREA (CMA):</b> 509

2022 Site Inspection Photos at NC013

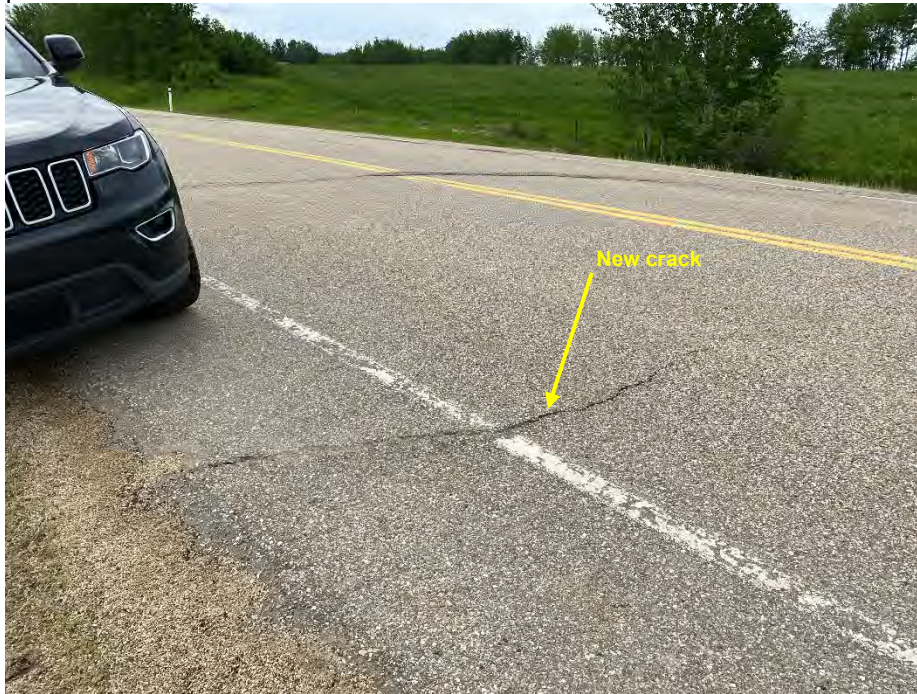
<b>COMMENTS</b>
<ul style="list-style-type: none"> <li>Pavement crack patterns are reflecting through the overlay. The circular crack west of SI05-1 maintained its vertical difference at about 15 mm to 20 mm. Additional cracking noted since last inspection in 2020 (see Figure 1).</li> <li>The SI readings show signs of creep movement. SI05-1 is showing a current rate of movement of 1 to 2 mm/year while the other SIs show a rate of movement less than 1 mm/ year.</li> <li>The slope on the north side of Highway 633 appears to be bulging near the toe north of BH17-01. A small dip was noticed to the northeast of SI05-1.</li> <li>The overall porewater pressures at site remain high, however the last two readings (Fall 2021 &amp; Spring 2022) have shown a decrease. Artesian conditions were observed prior to remediation in 2011.</li> <li>An area of ponding water was observed to the west of SI05-1.</li> <li>The water level in the pond to the south of the toe berm appeared similar to the levels observed during the 2020 inspection.</li> </ul>

**Photo 1:** Circular crack approximately 40 m west of SI05-1 and new crack forming in EBL. Looking northwest.

<b>RECOMMENDATIONS</b>
<ul style="list-style-type: none"> <li>Pavement cracks should be sealed to reduce surface water infiltration into the embankment. Additional pavement patches are not recommended since it is considered an additional driving force on the</li> </ul>

embankment. Mill and fill could be completed to address the vertical displacement until remediation is completed.

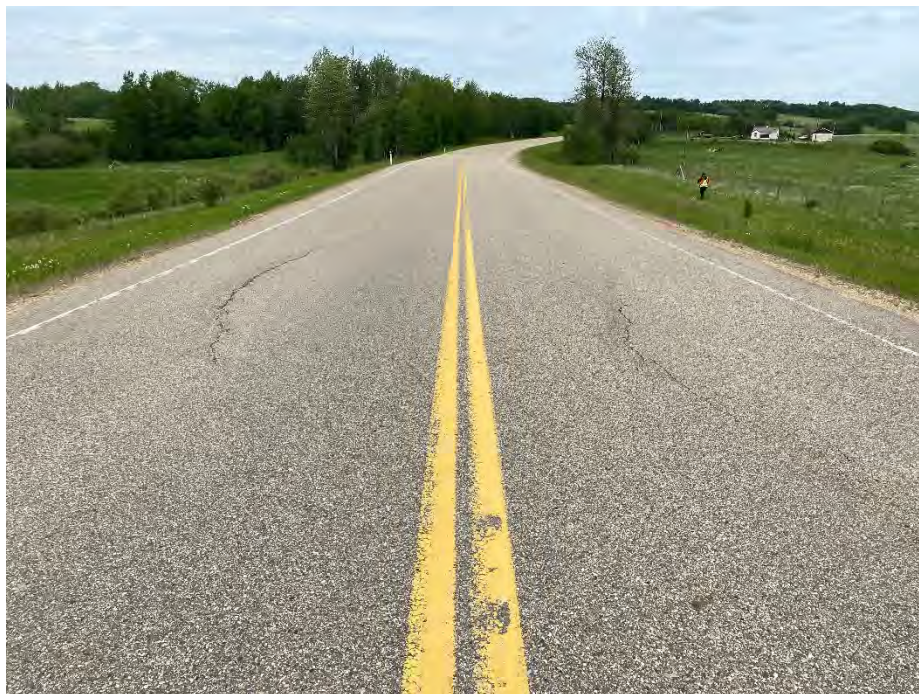
**Photo 2:** Semi-circular pavement cracks about 10 m east of Photo 1. Looking northeast.

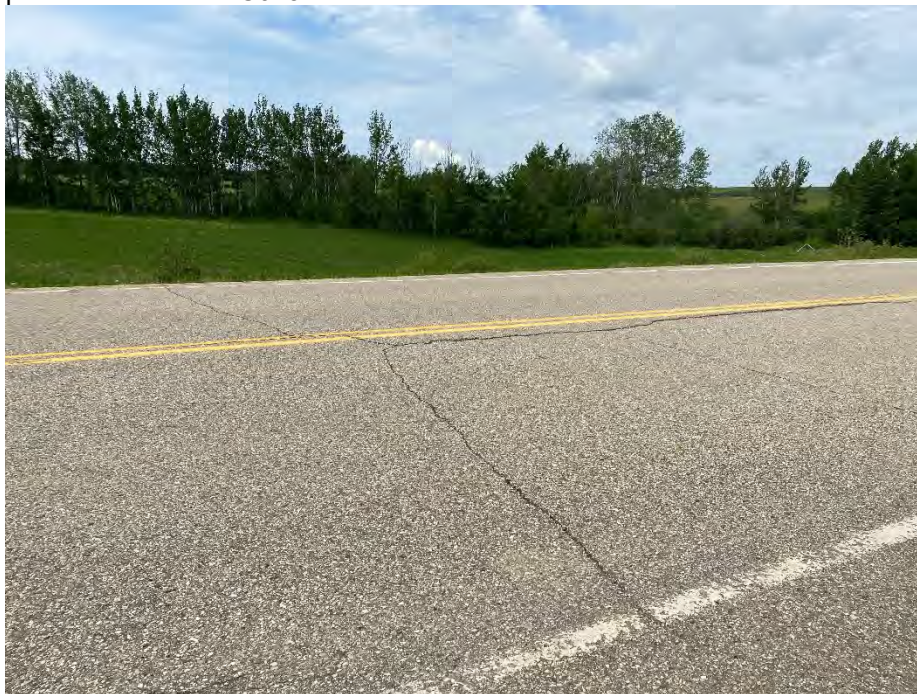
**Photo 3:** Pavement cracking approximately 15 m east from SI05-1. Looking north.

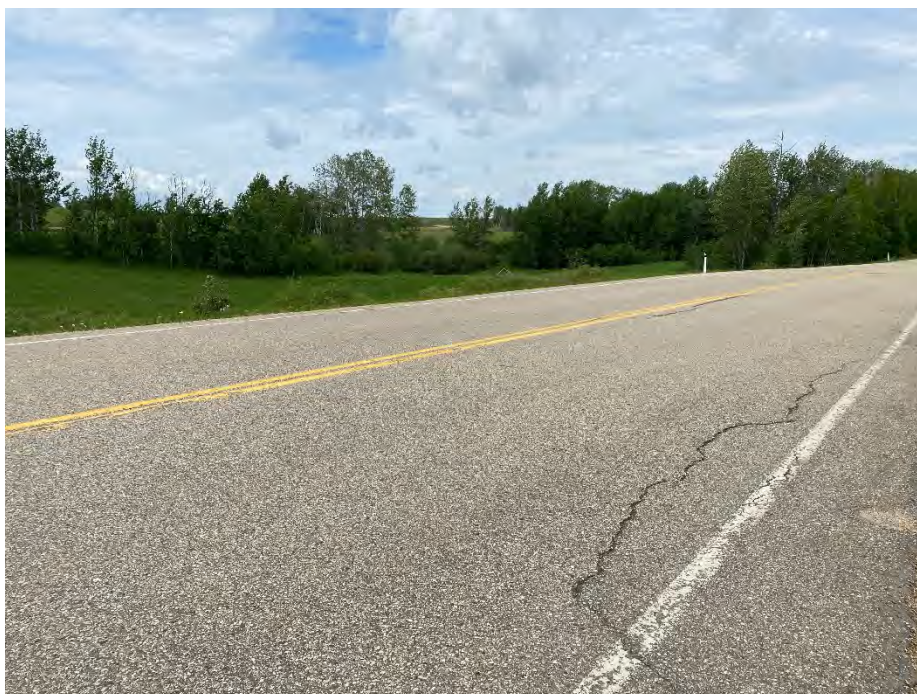
**Photo 4:** Crack on shoulder north of SI05-1. Looking northeast.

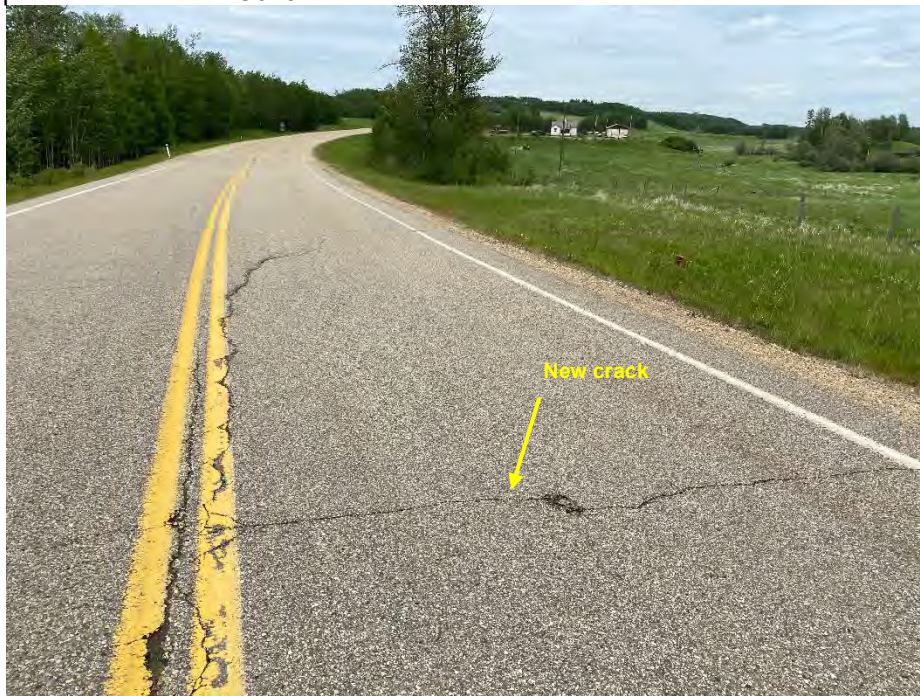
**Photo 5:** Semi-circular crack along C/L and EBL lane north of BH17-01. New transverse cracking. Looking east.

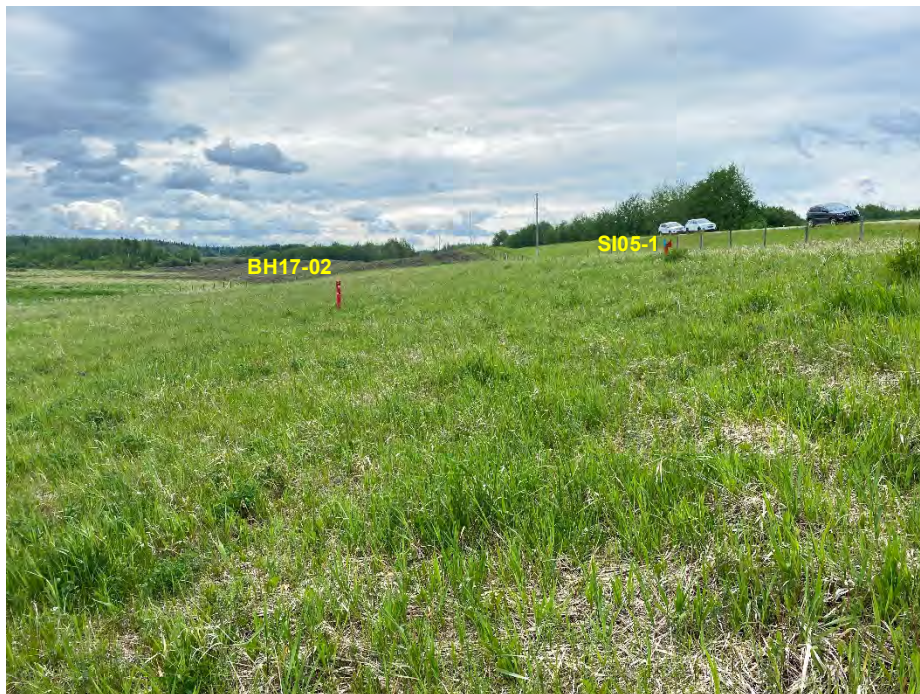
**Photo 6:** South toe berm. Looking west.

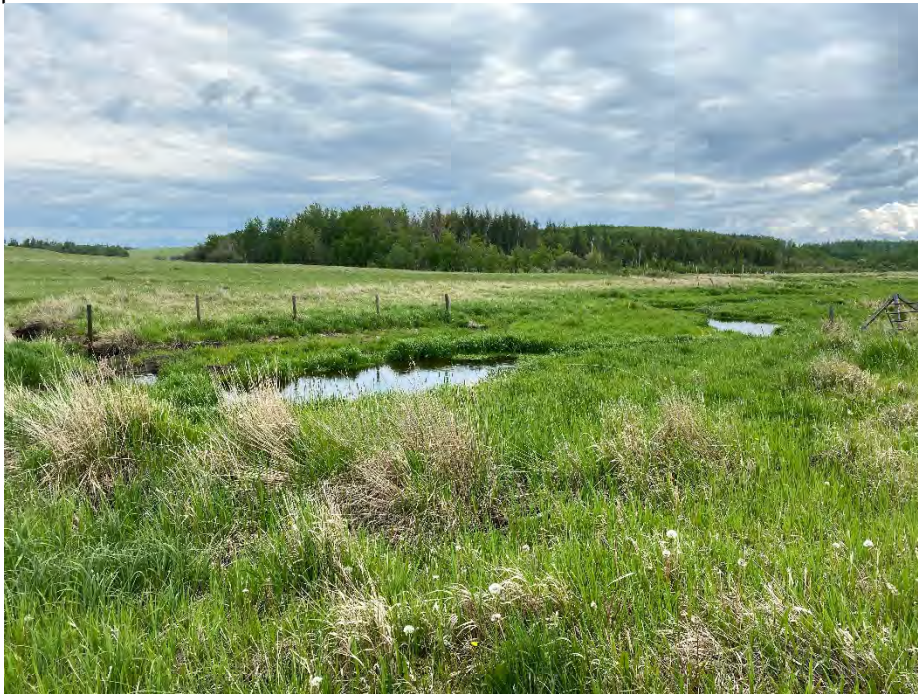
**Photo 7:** Ponding water at toe of slope. Looking southwest.

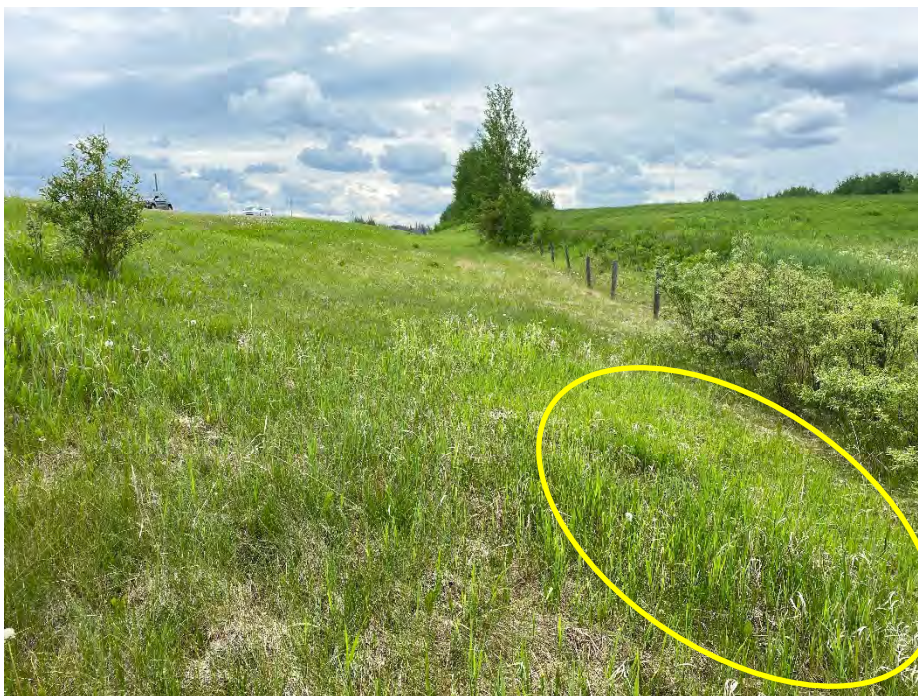
**Photo 8:** Slumping in north ditch, north from BH17-01. Looking southwest.
