To:	Amy Driessen Alberta Transportation	From:	Leslie Cho and Carrie Murray Stantec Consulting Ltd.
File:	123315222	Date:	June 12, 2022

**Reference: North Central Region, Edson, Site NC013 - Highway 633:02 Cattlepass West, Spring 2022 Instrumentation Monitoring Report**

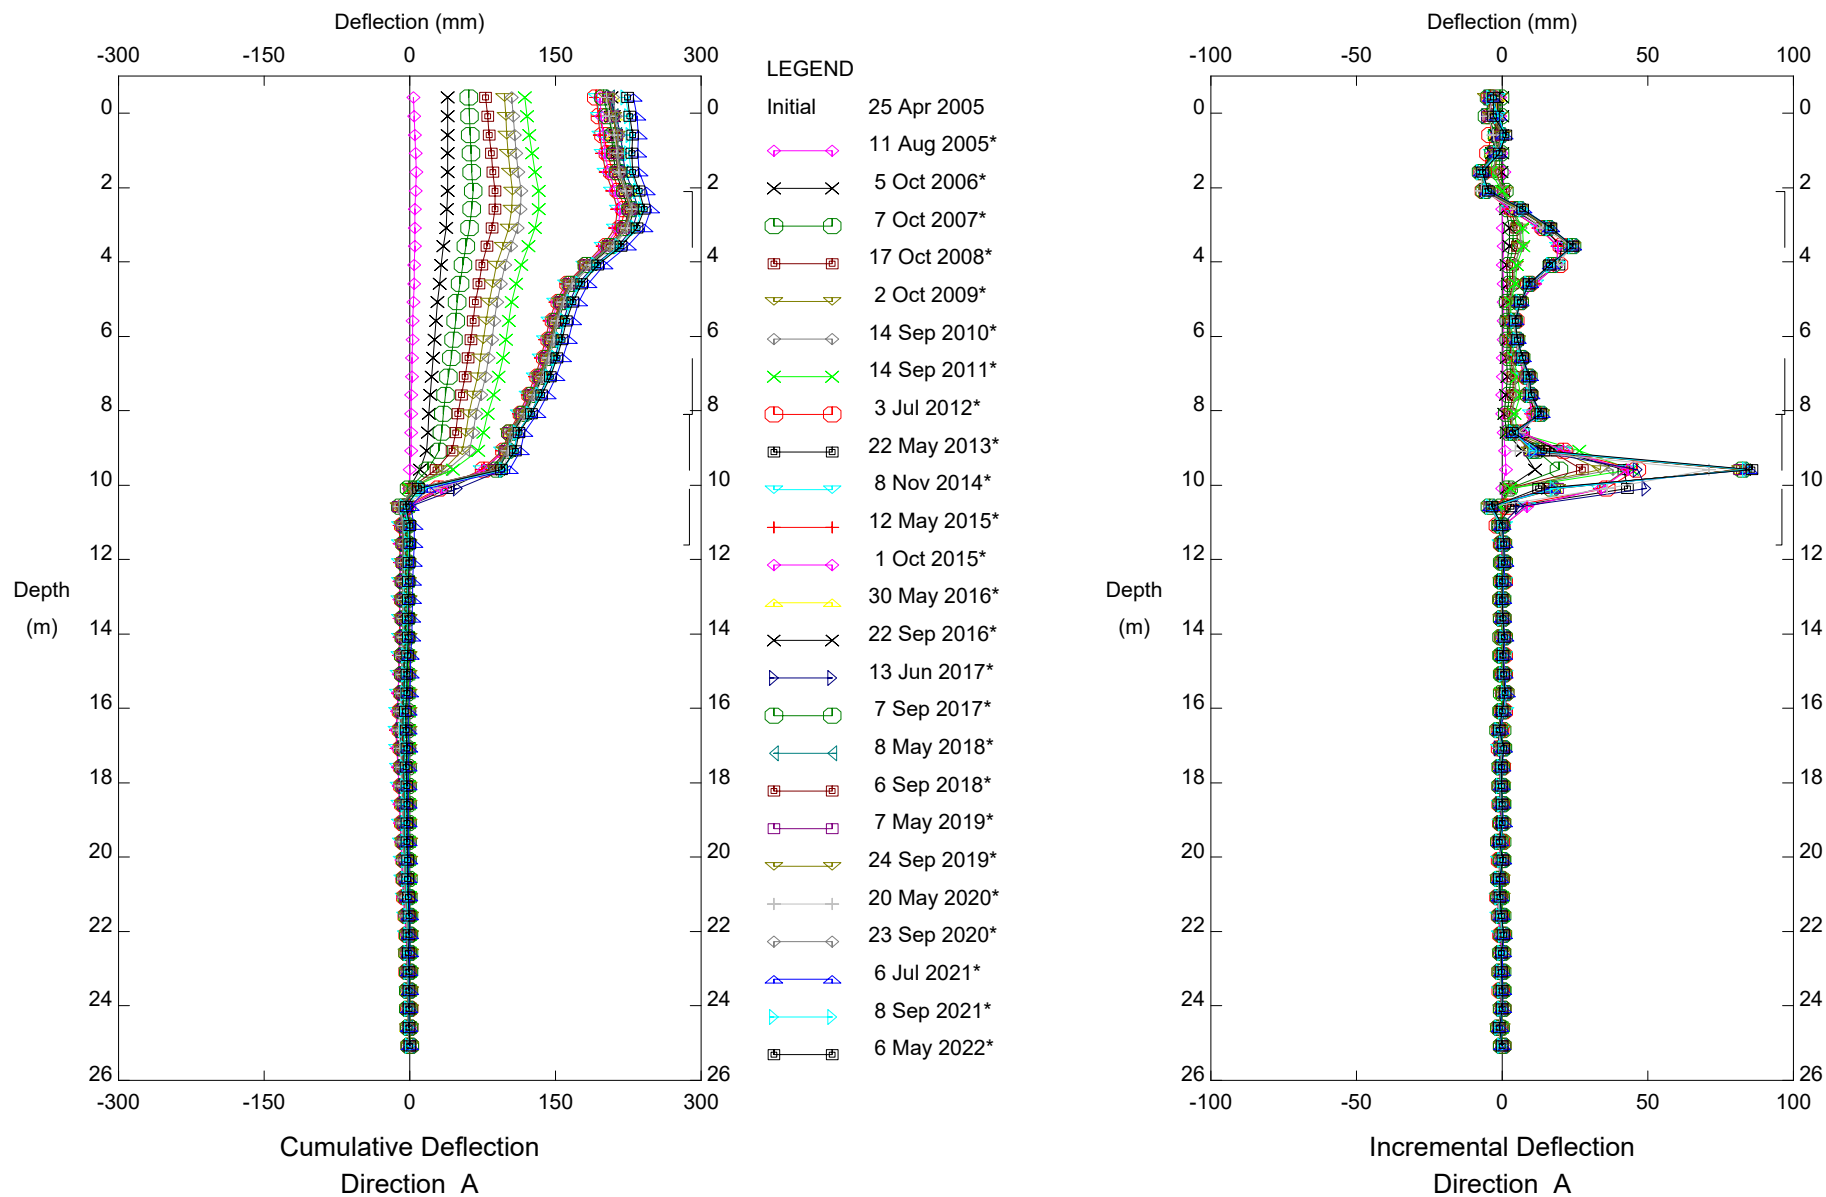
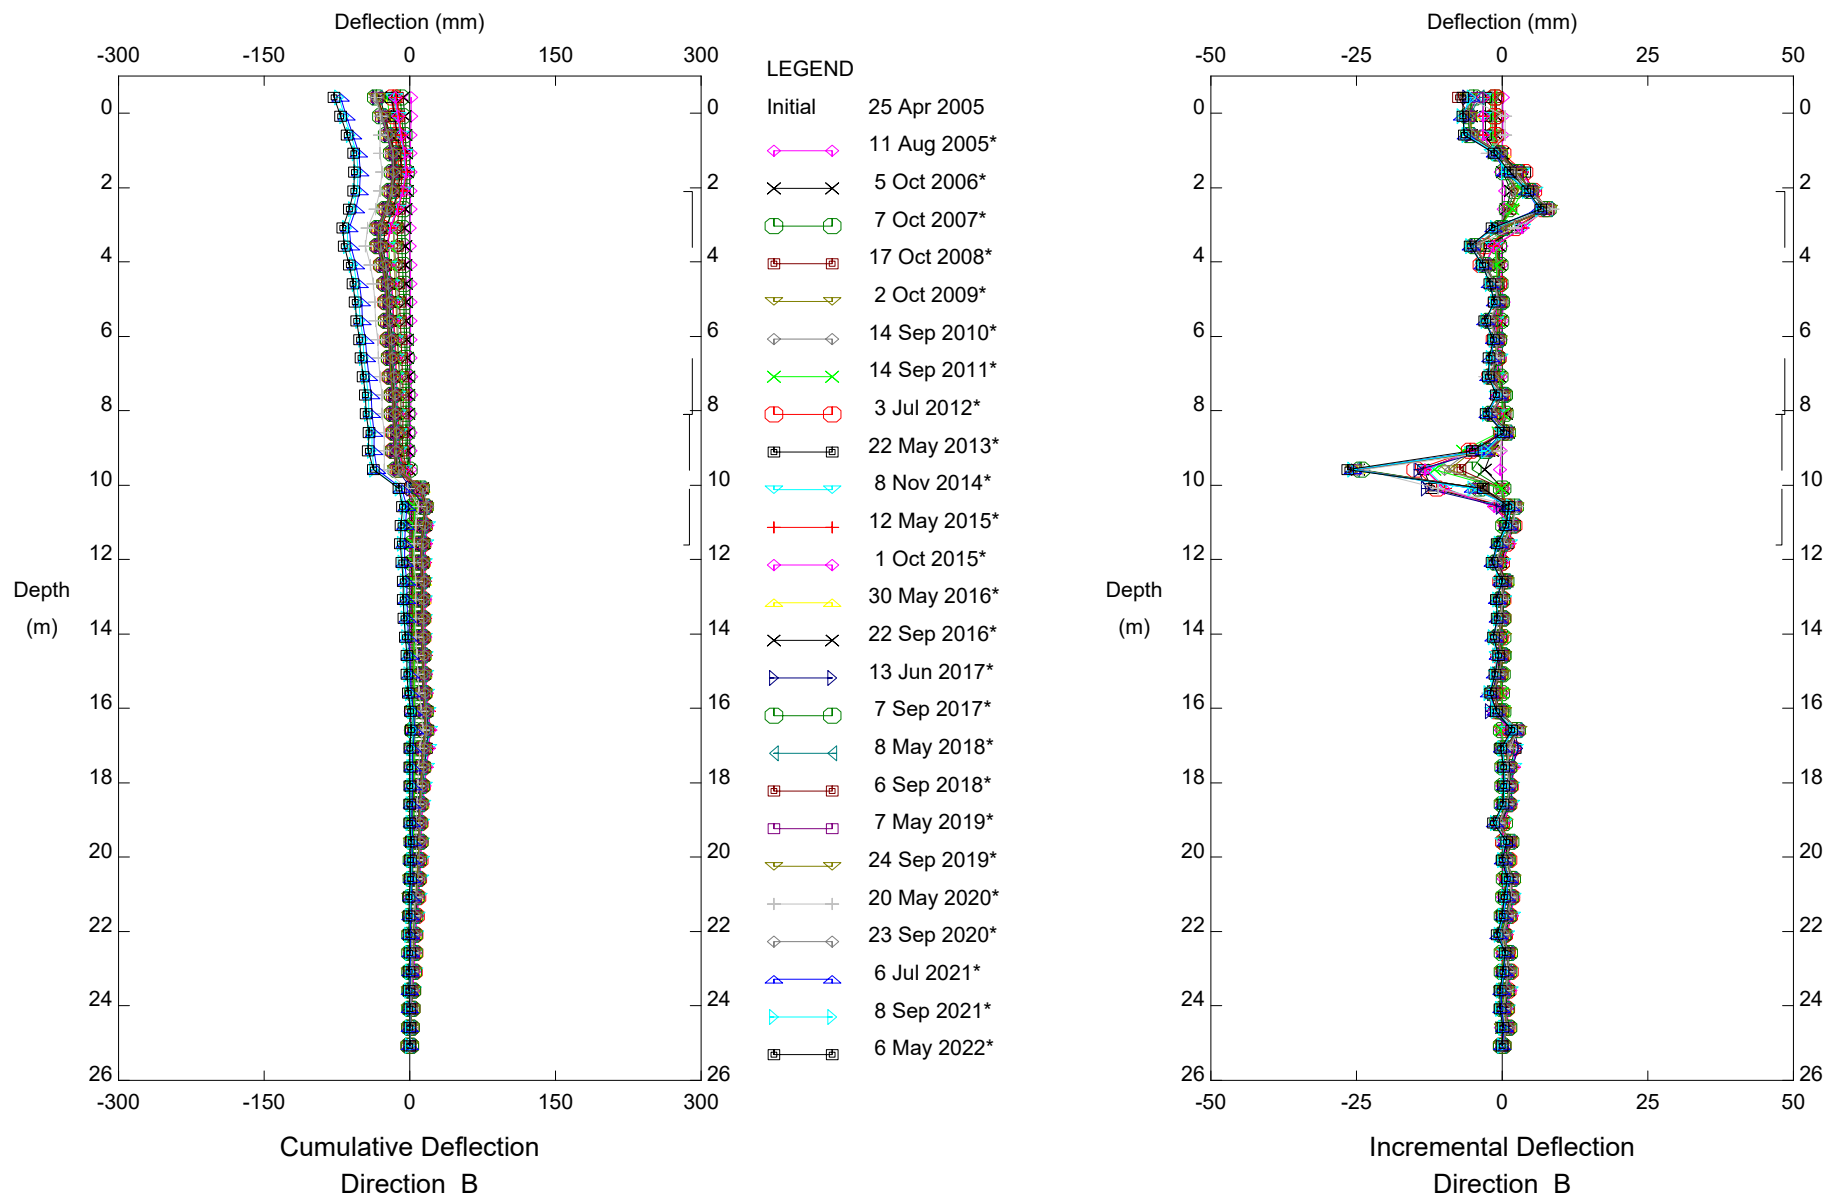
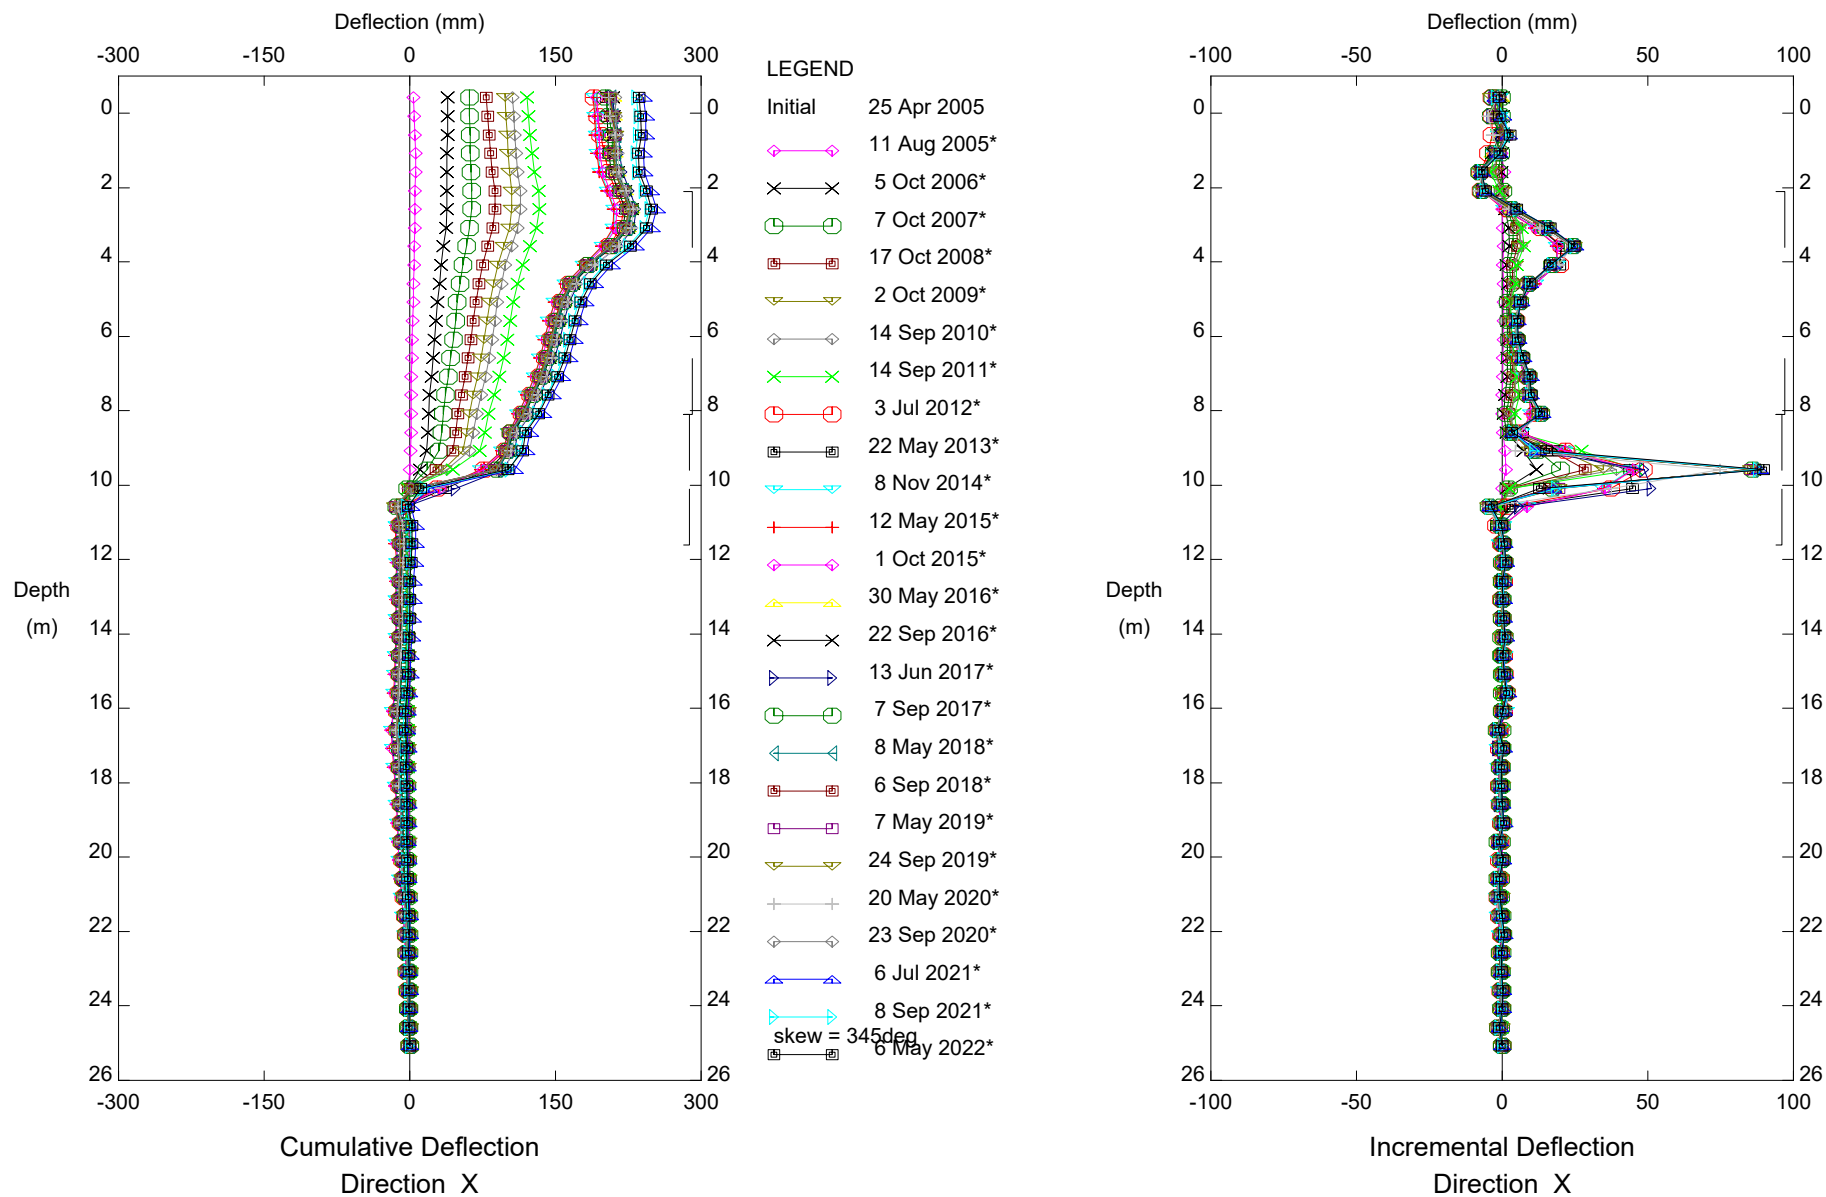
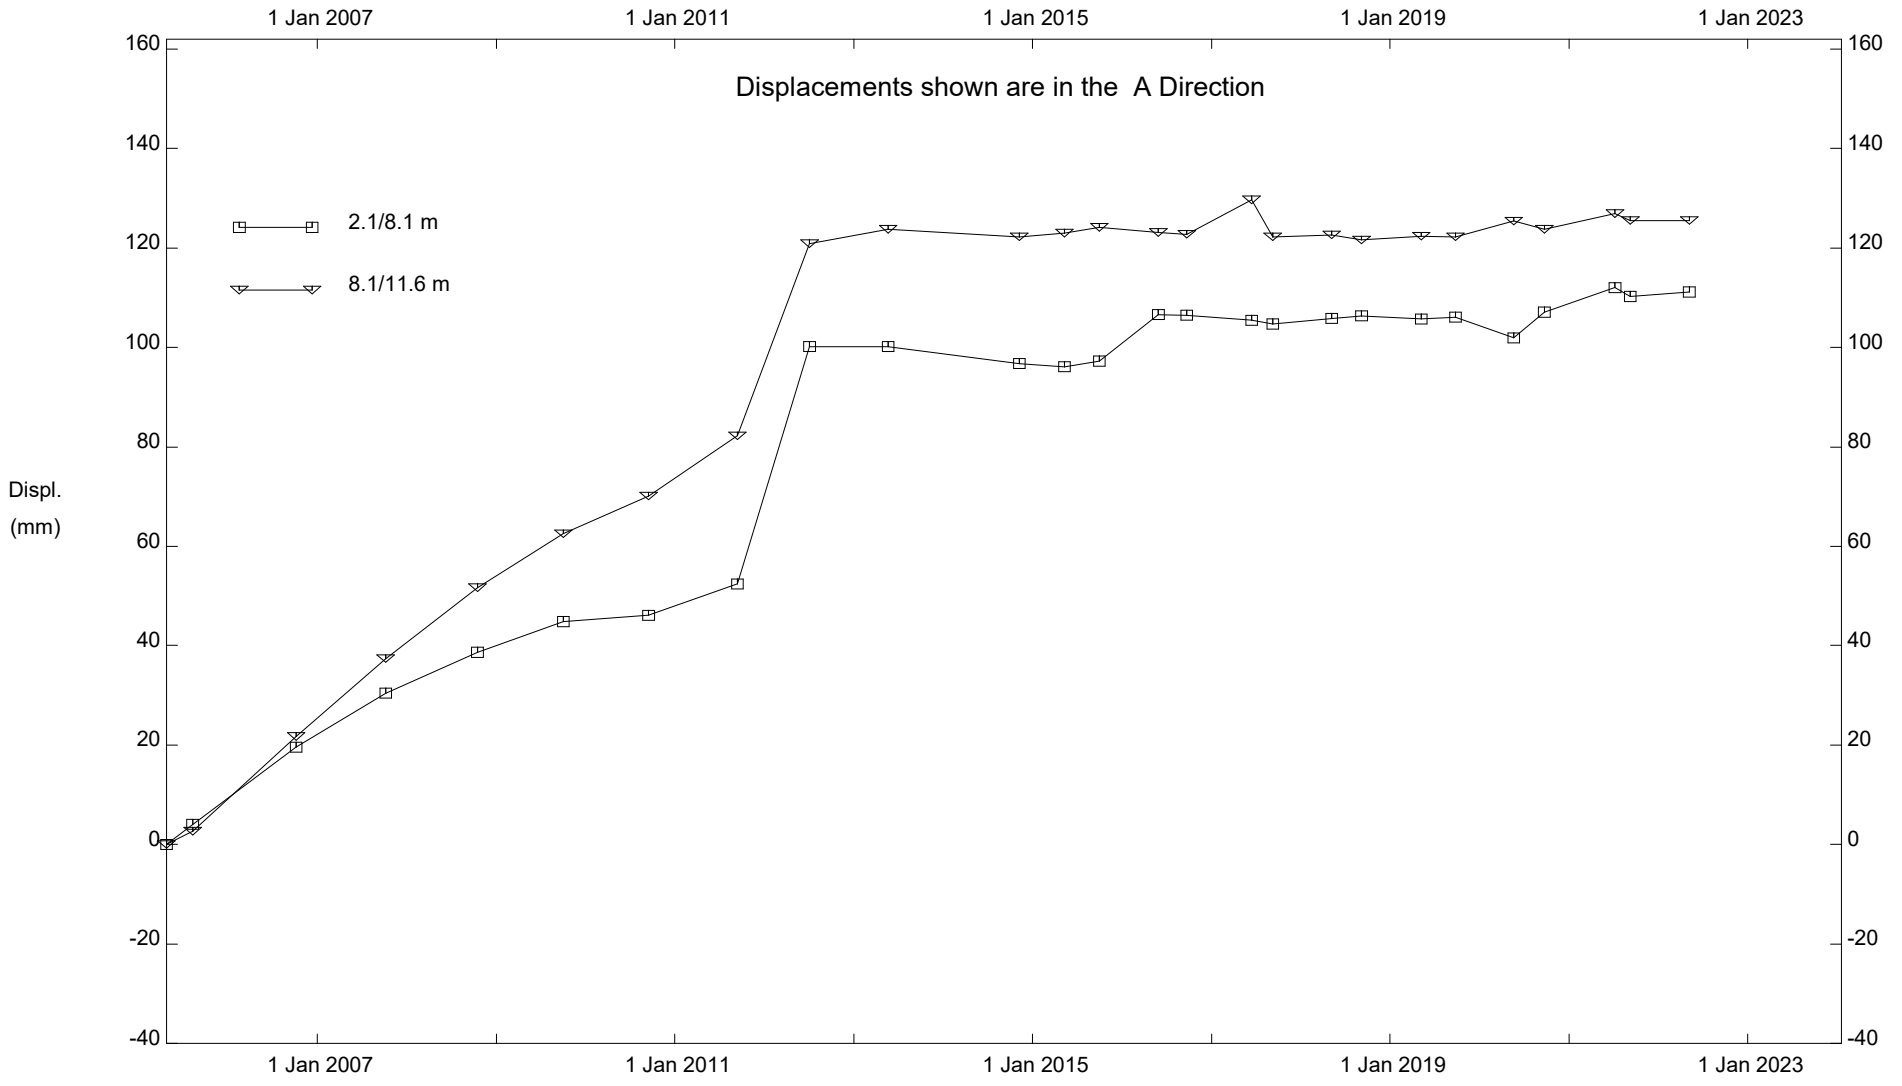
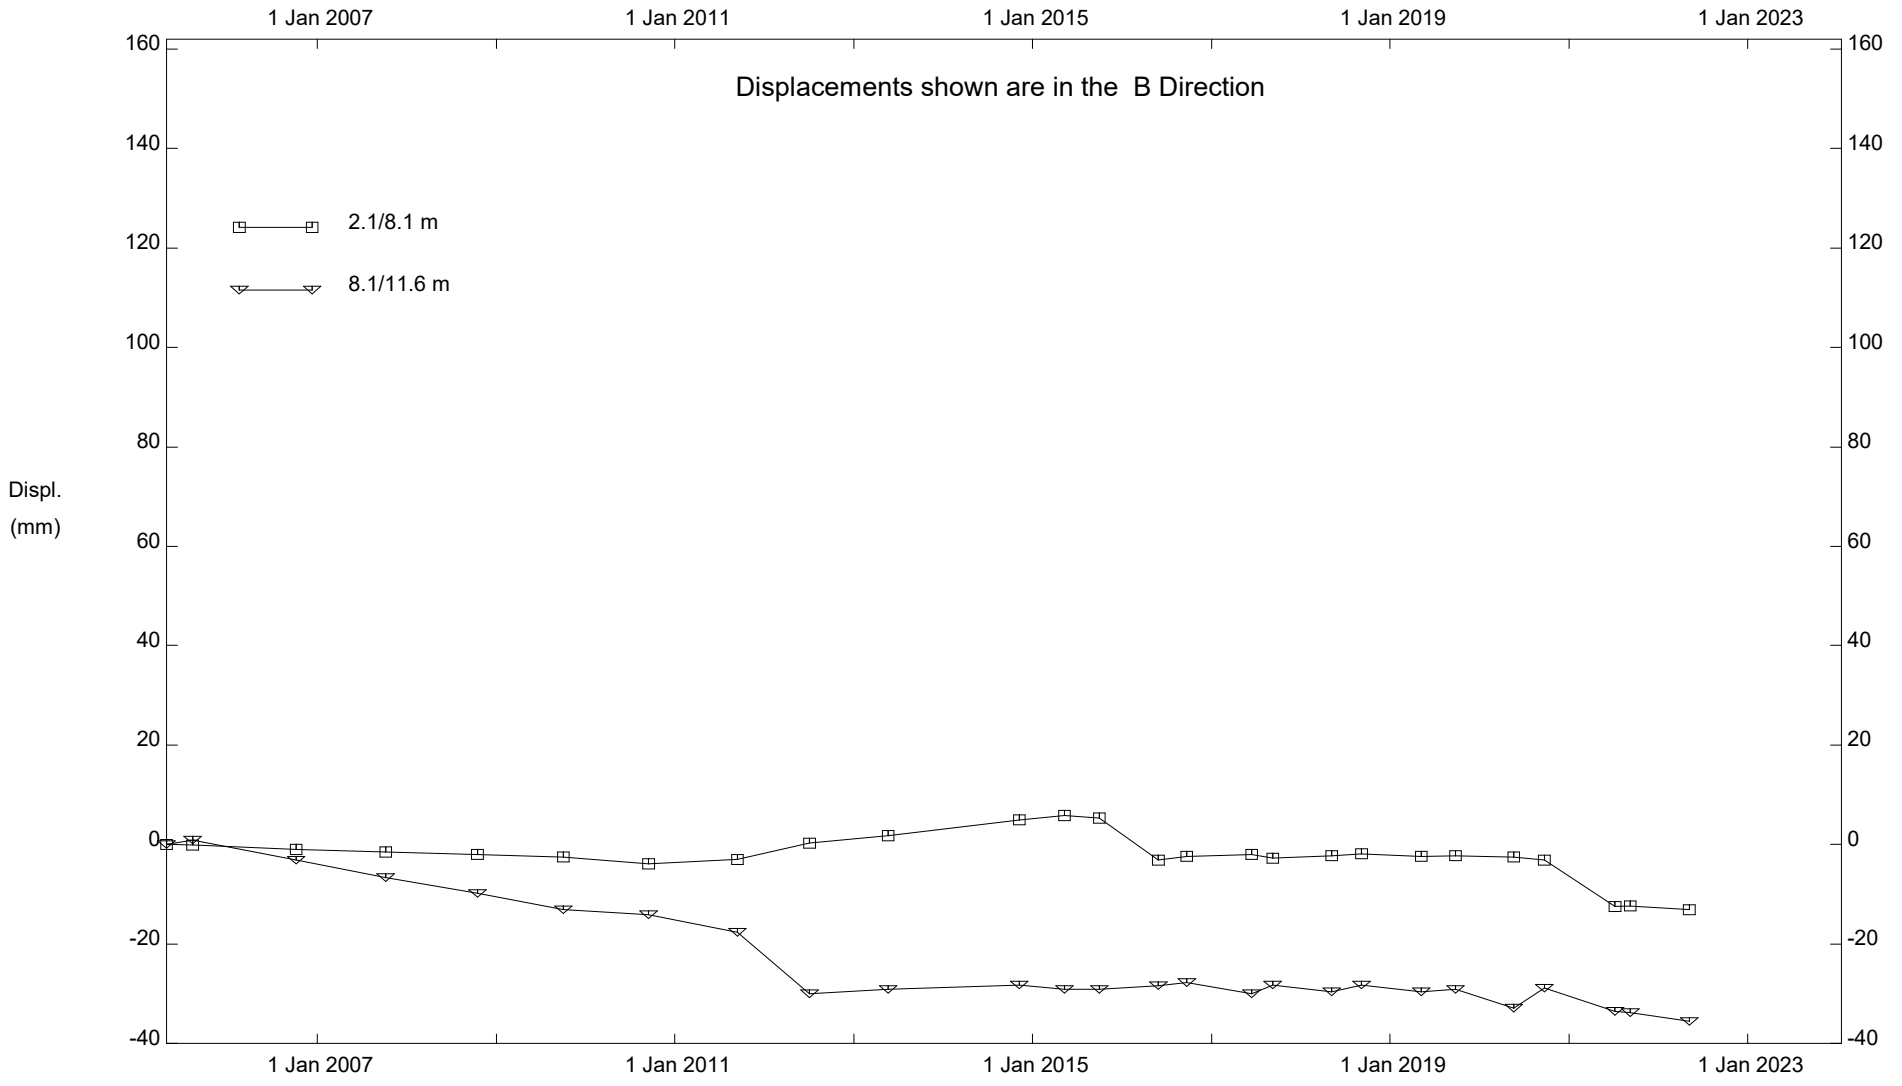
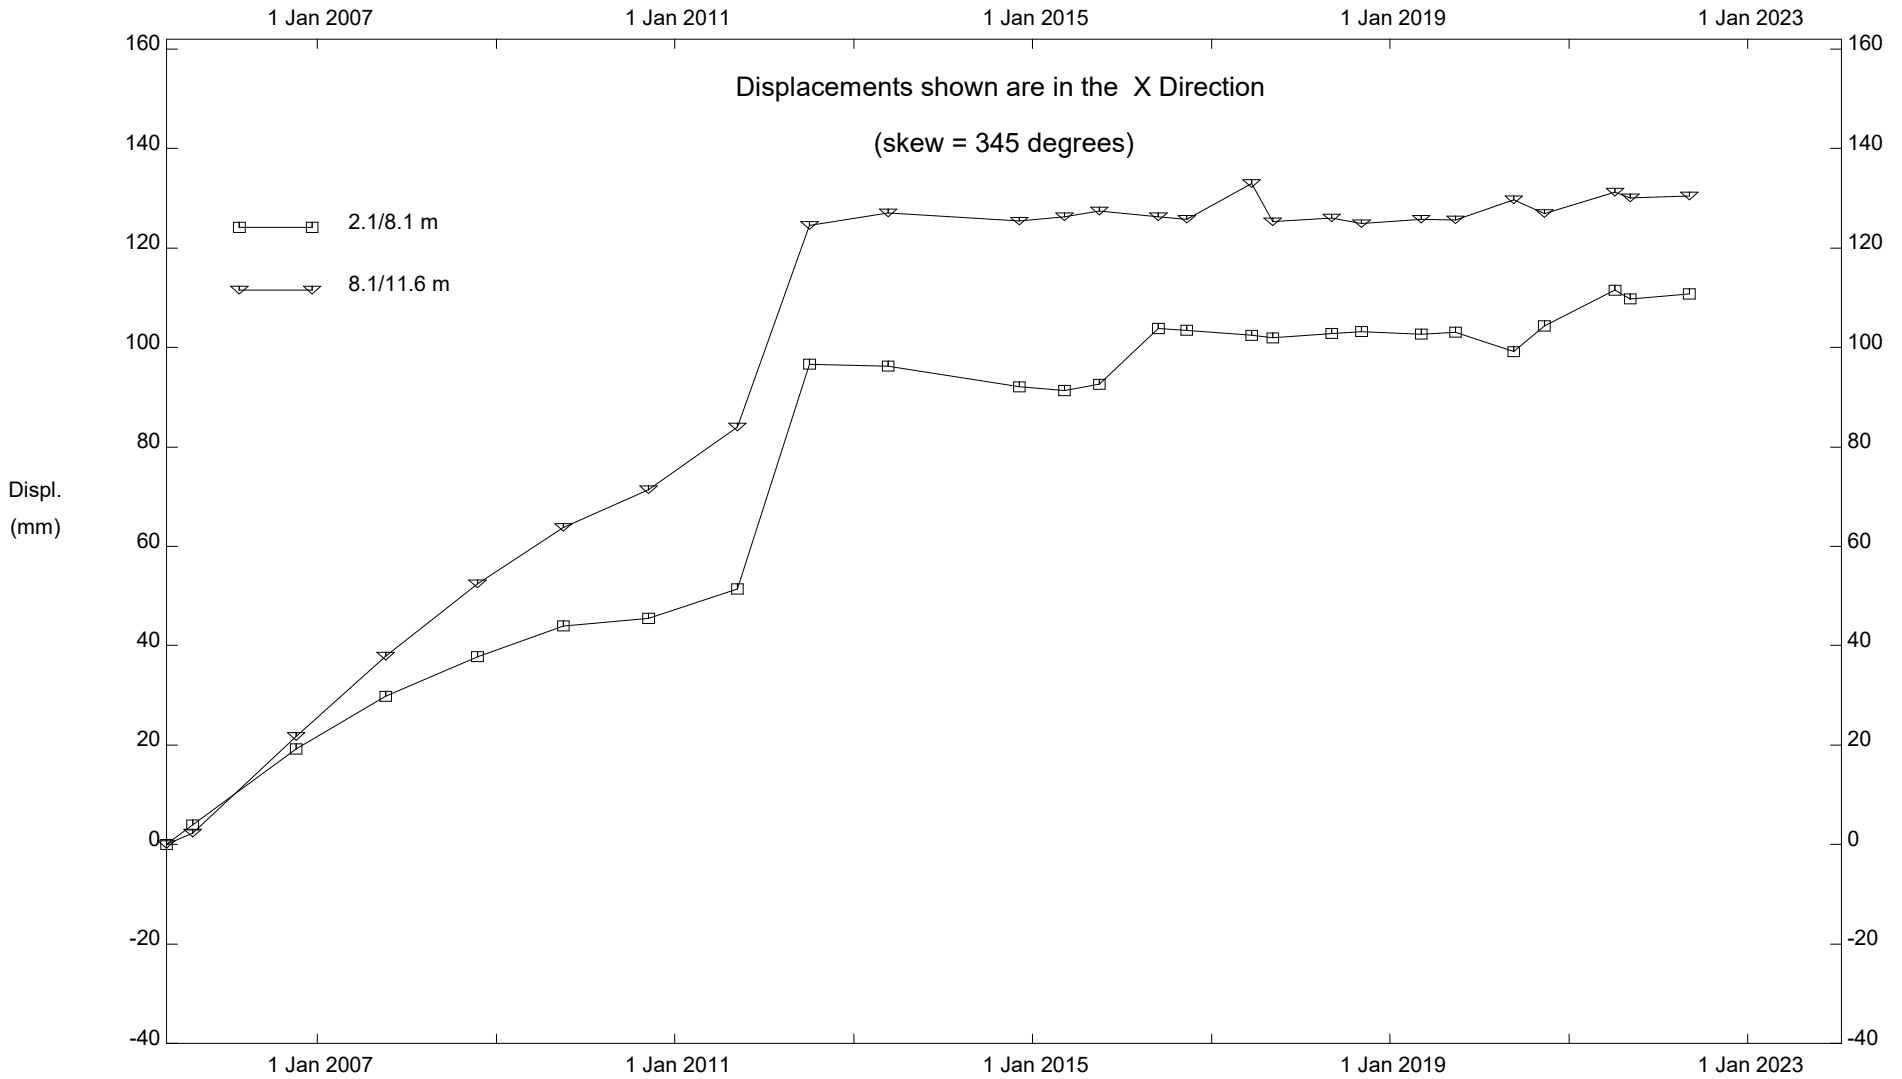
HWY 633:02 Cattlepass West (NC13), Inclinometer SI05-1  
 Alberta Transportation

**SI05-1** has two movement zones being monitored. An increase in movement of 1 mm or less was observed in both movement zones since the Fall 2021 readings.

Although SI05-1 and SI17-01 can still be monitored, the SI casing should be extended to approximately 1 m above ground and protected with a steel casing to protect against further damage rendering this repair unfeasible.

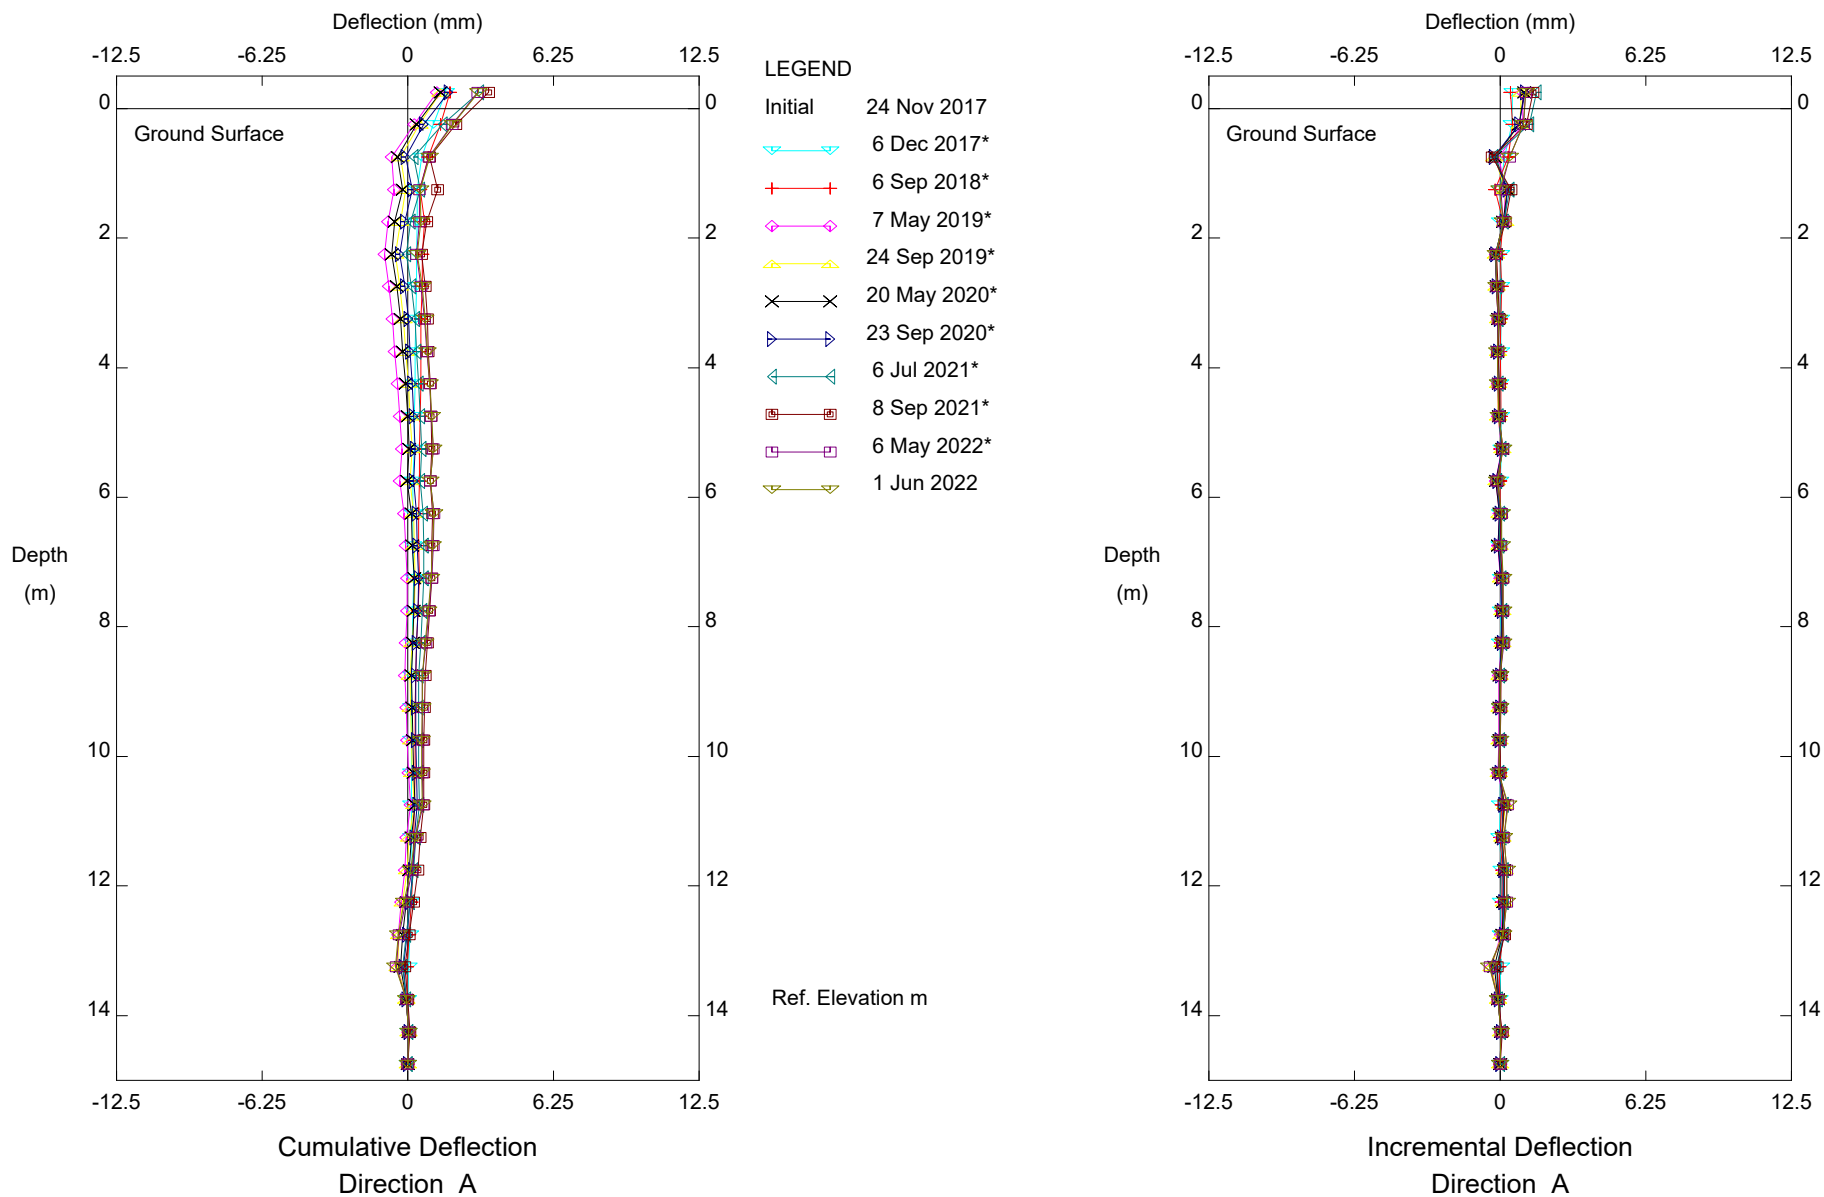
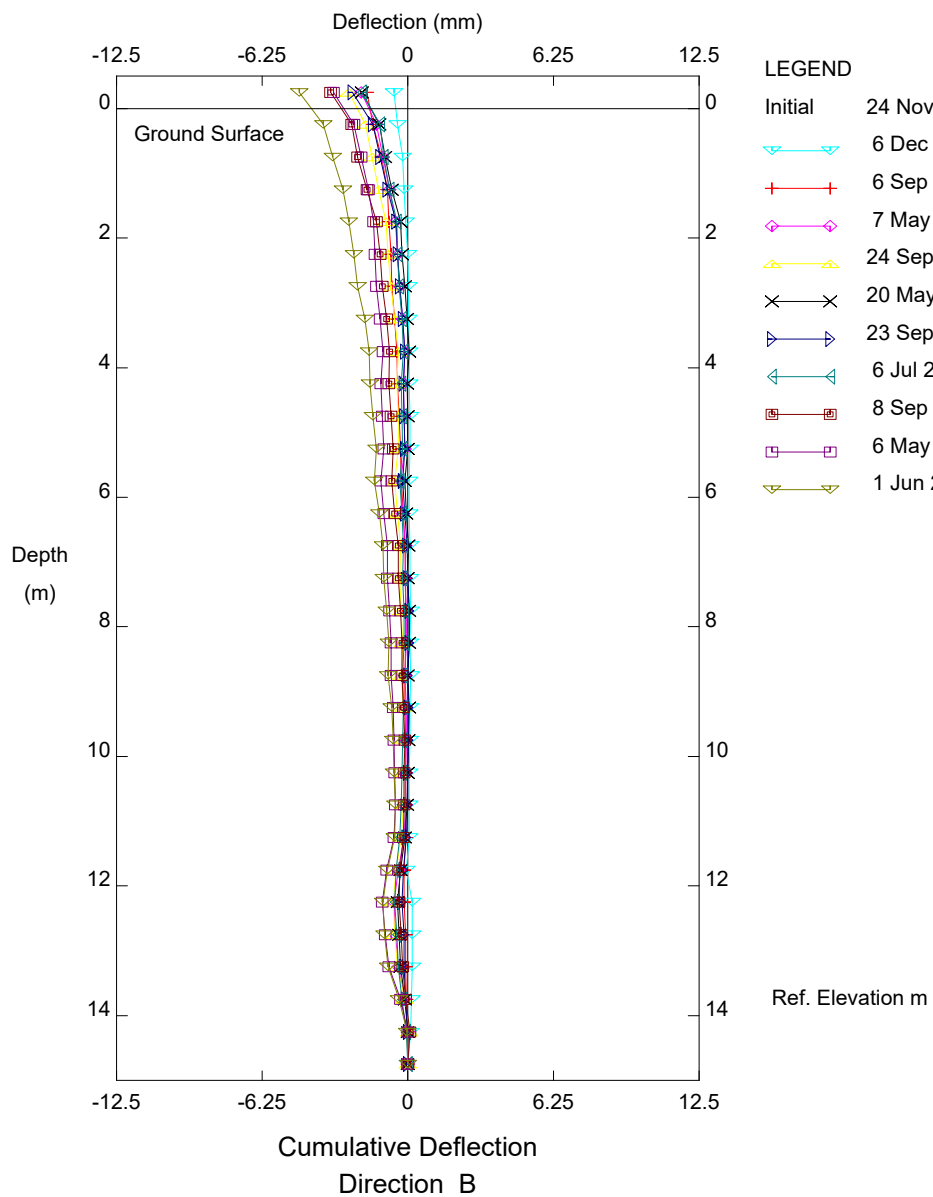
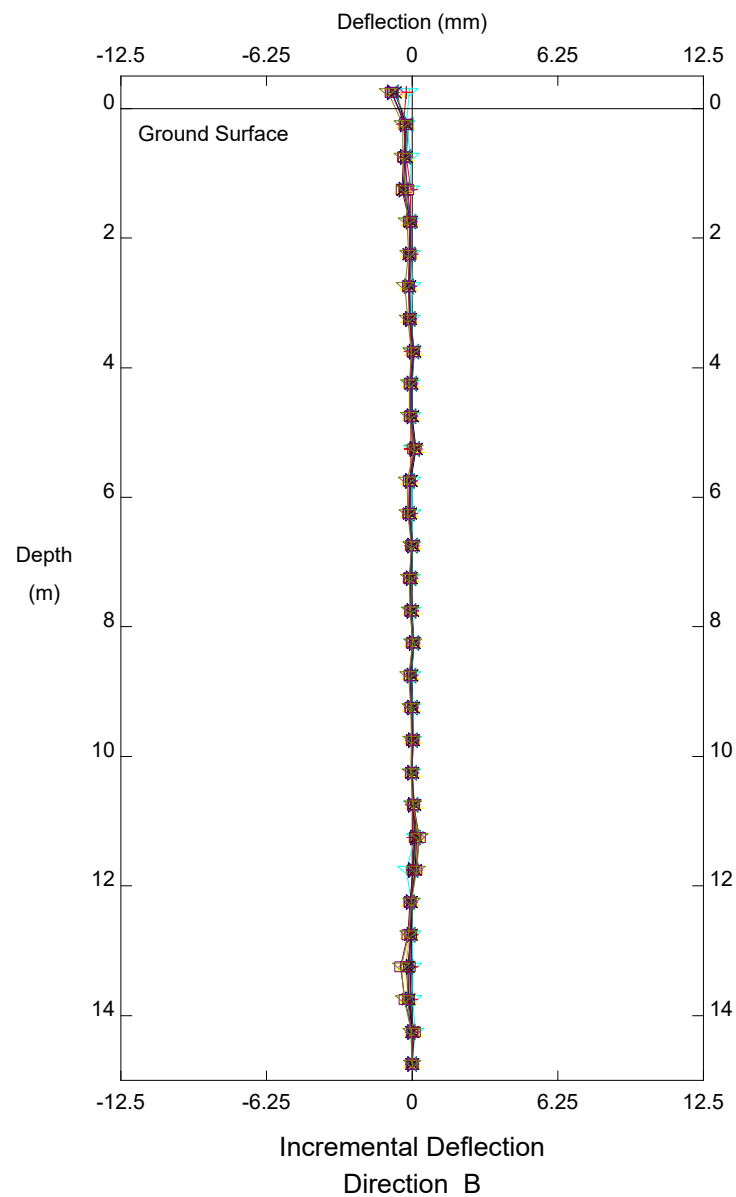
NC13, Inclinometer SI17-01

No discernable zone of movement has been recorded in **SI17-01** to date.
