To:	Amy Driessen Alberta Transportation	From:	Leslie Cho and Carrie Murray Stantec Consulting Ltd.
File:	123315222	Date:	June 12, 2022

**Reference: North Central Region, Edson, Site NC013 - Highway 633:02 Cattlepass West, Spring 2022 Instrumentation Monitoring Report**

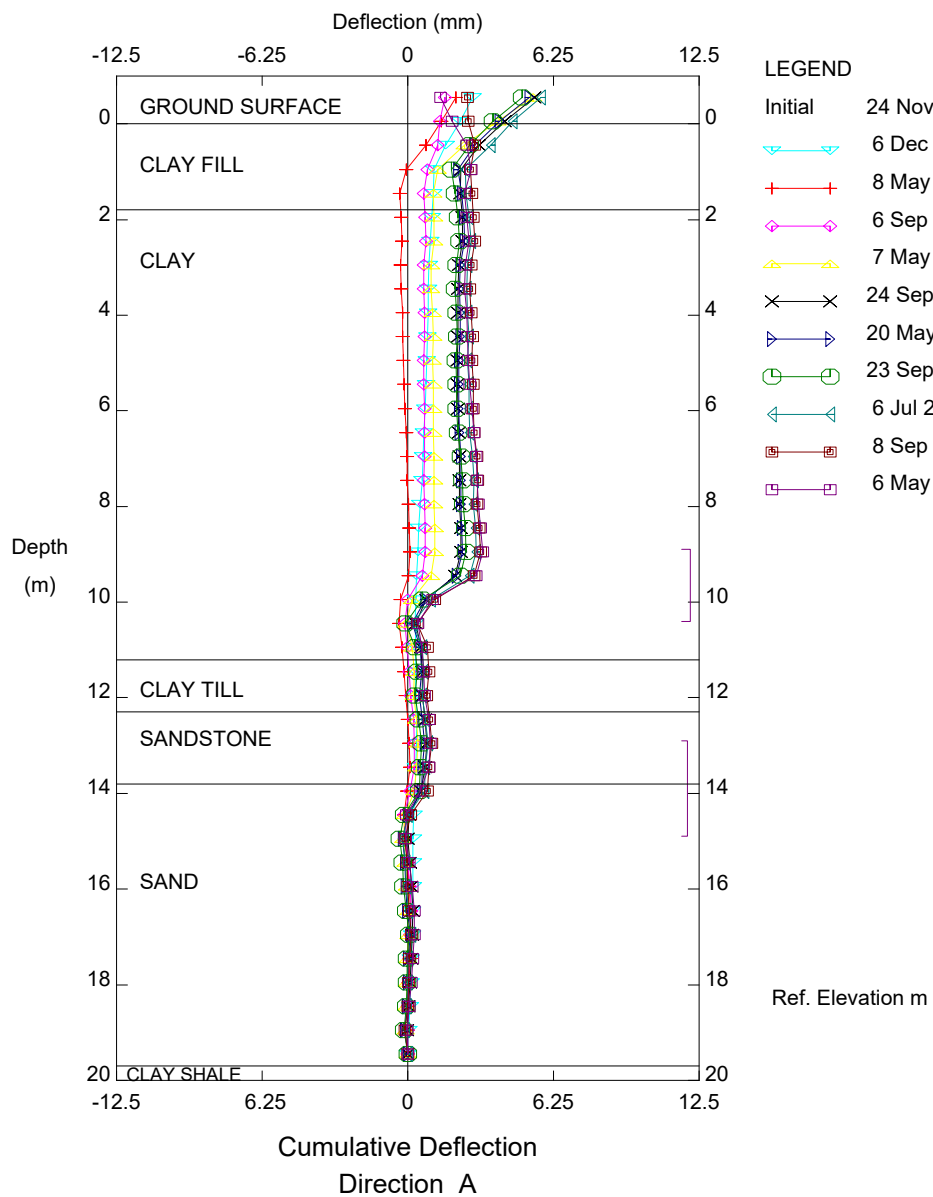
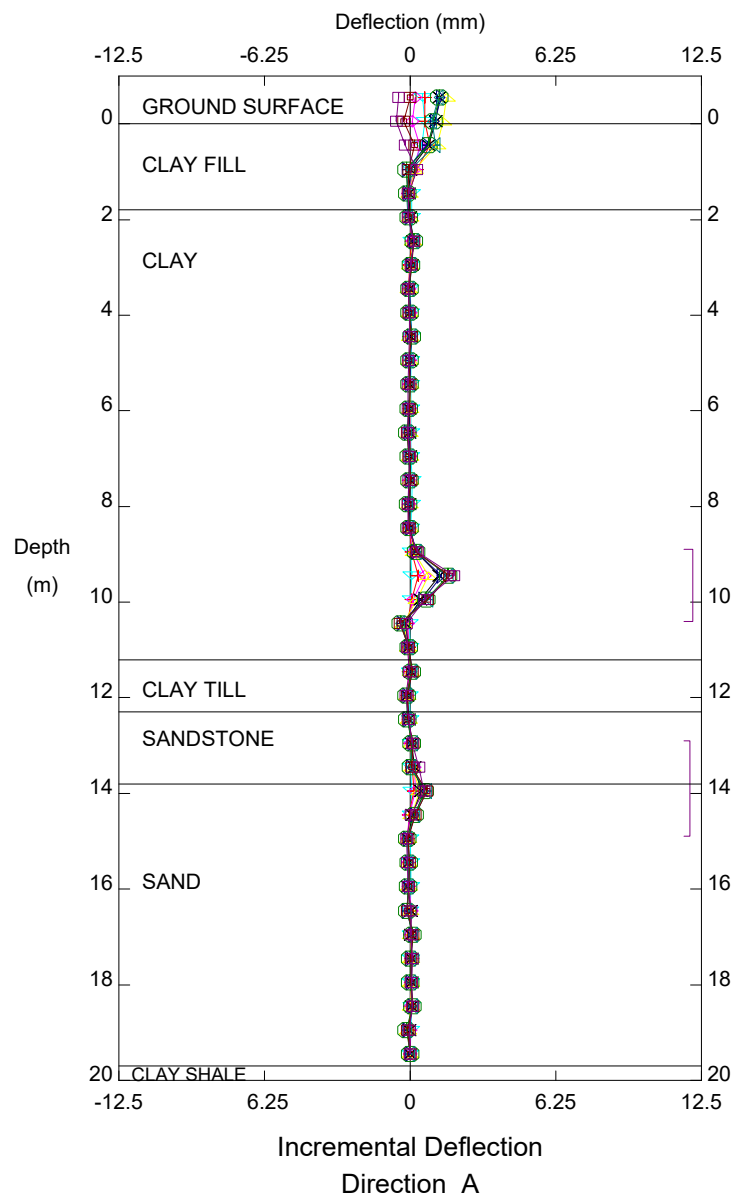
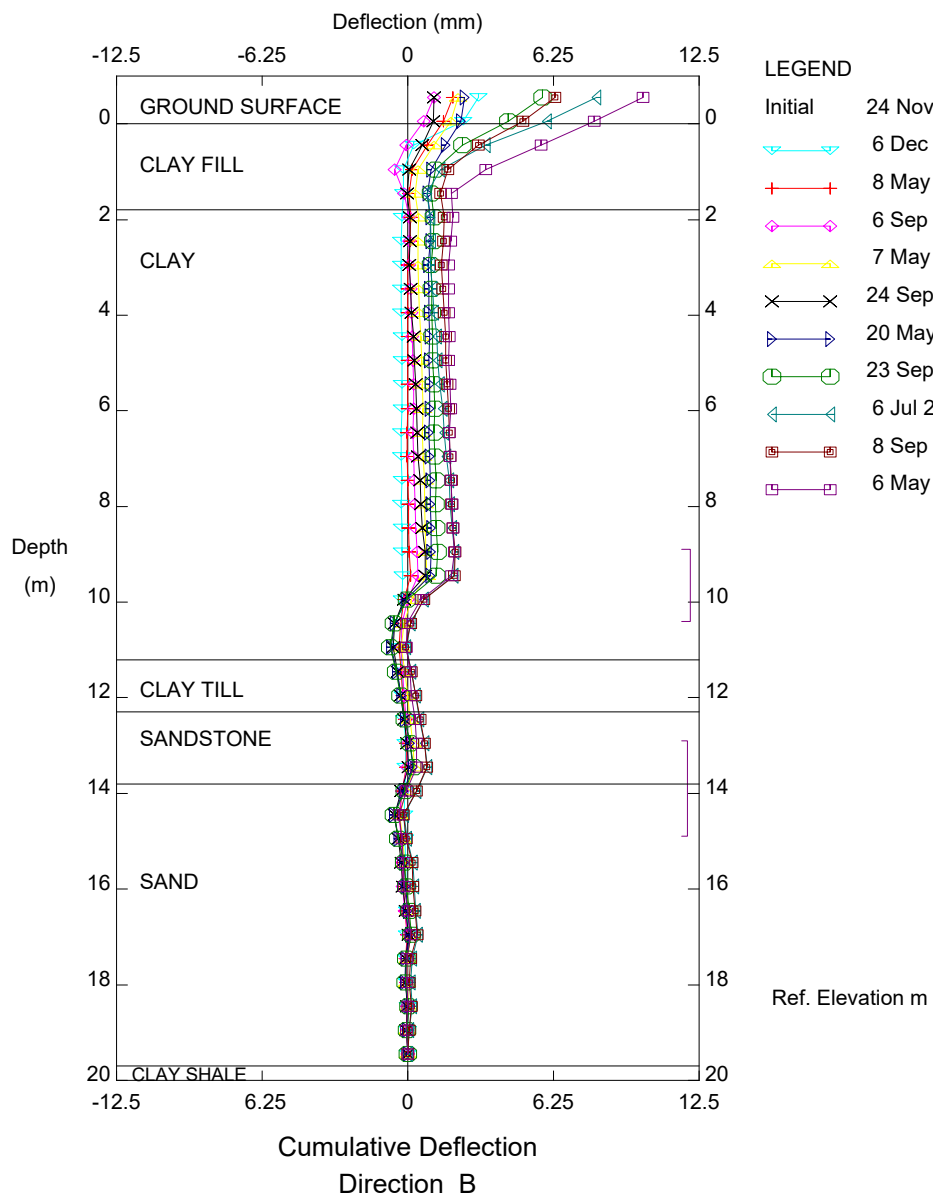
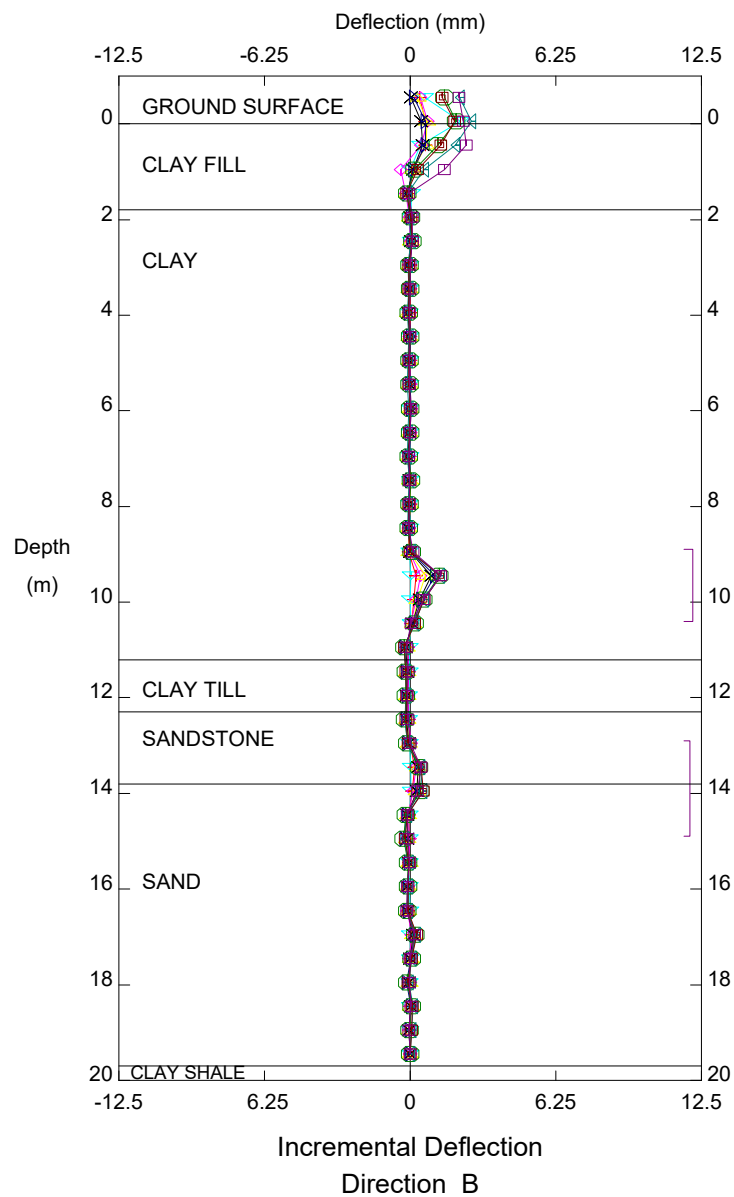
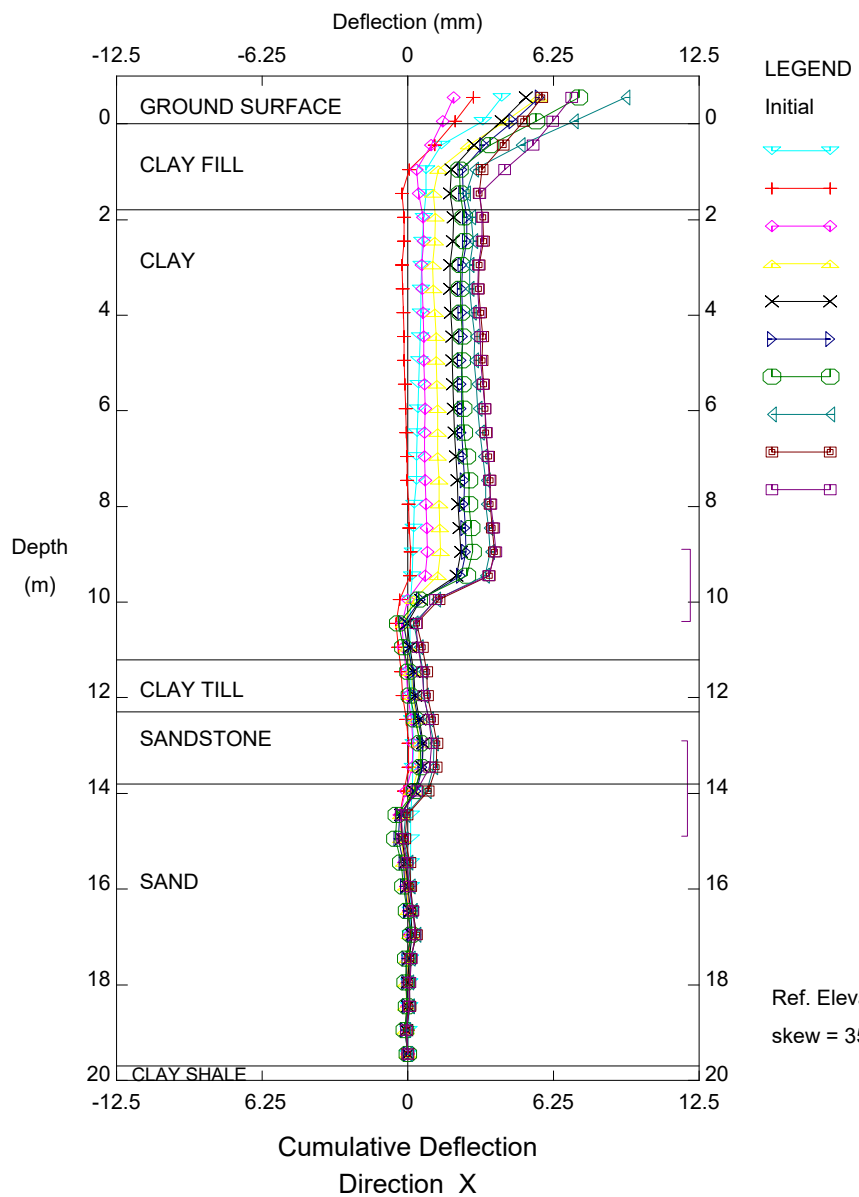
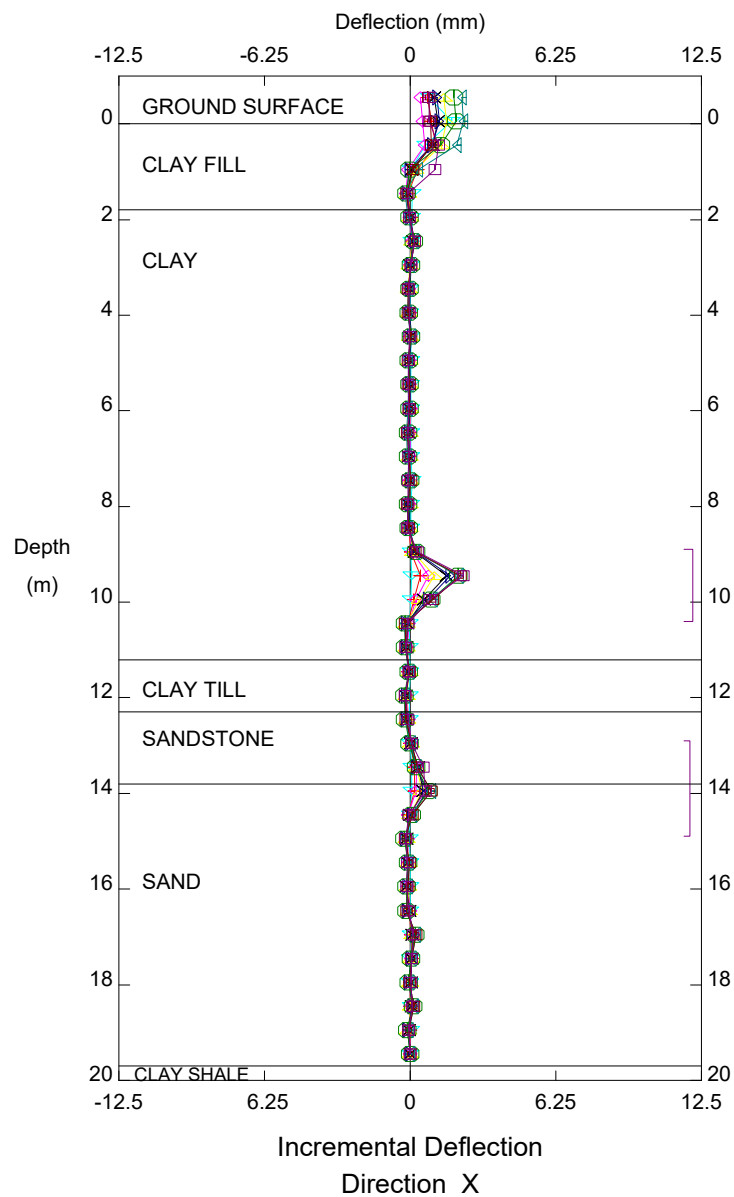
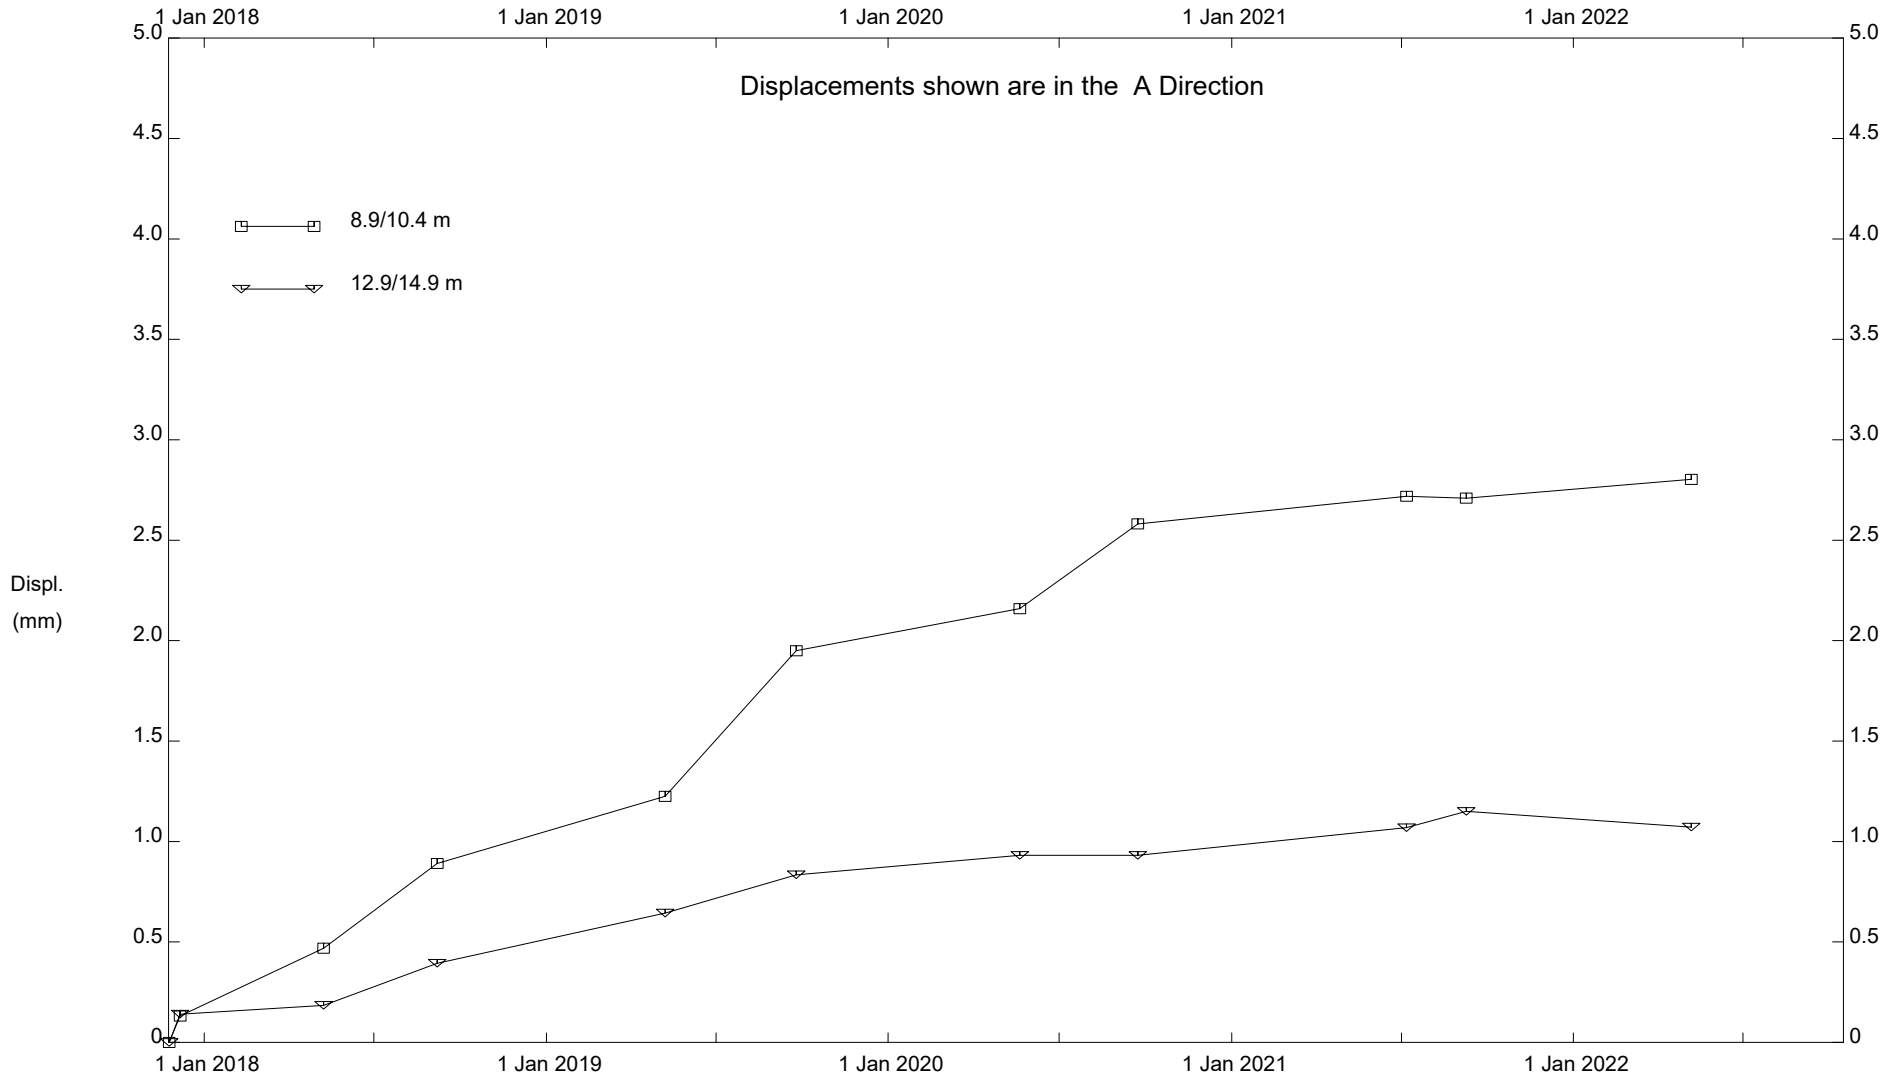
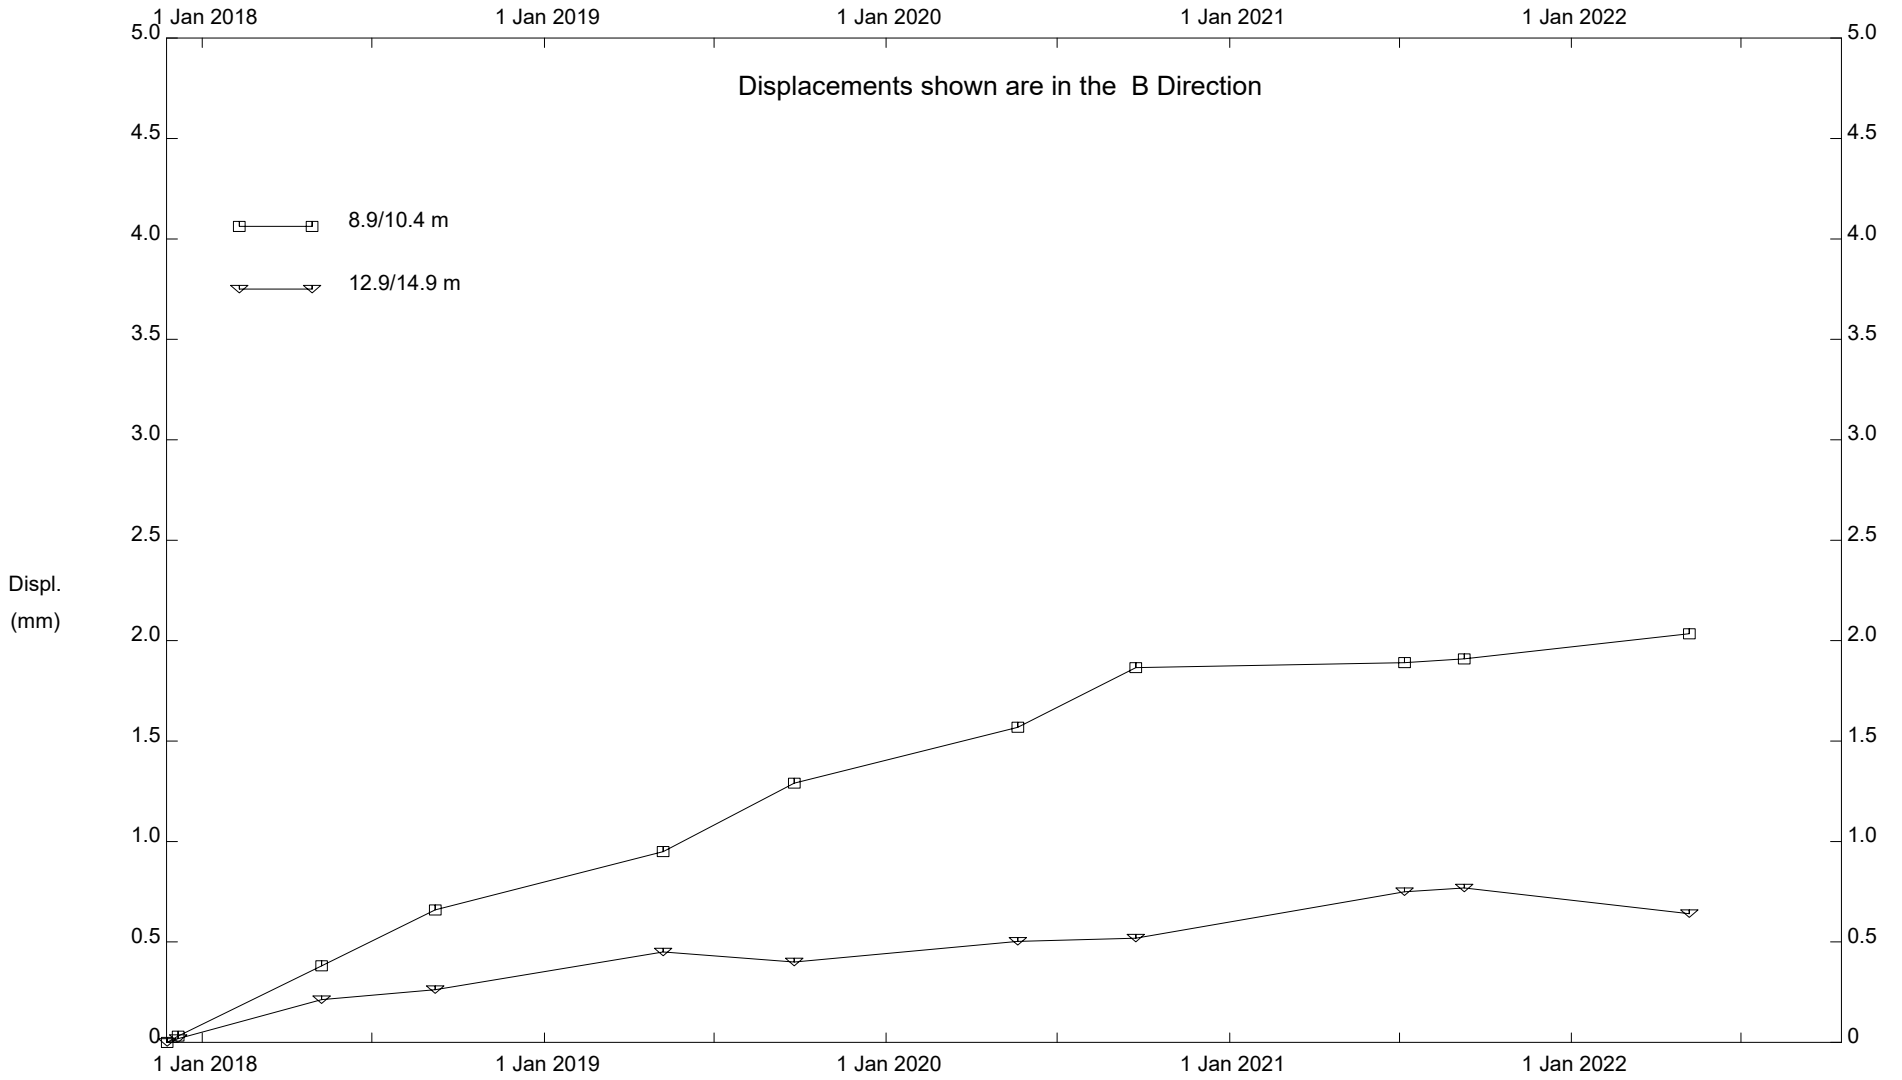
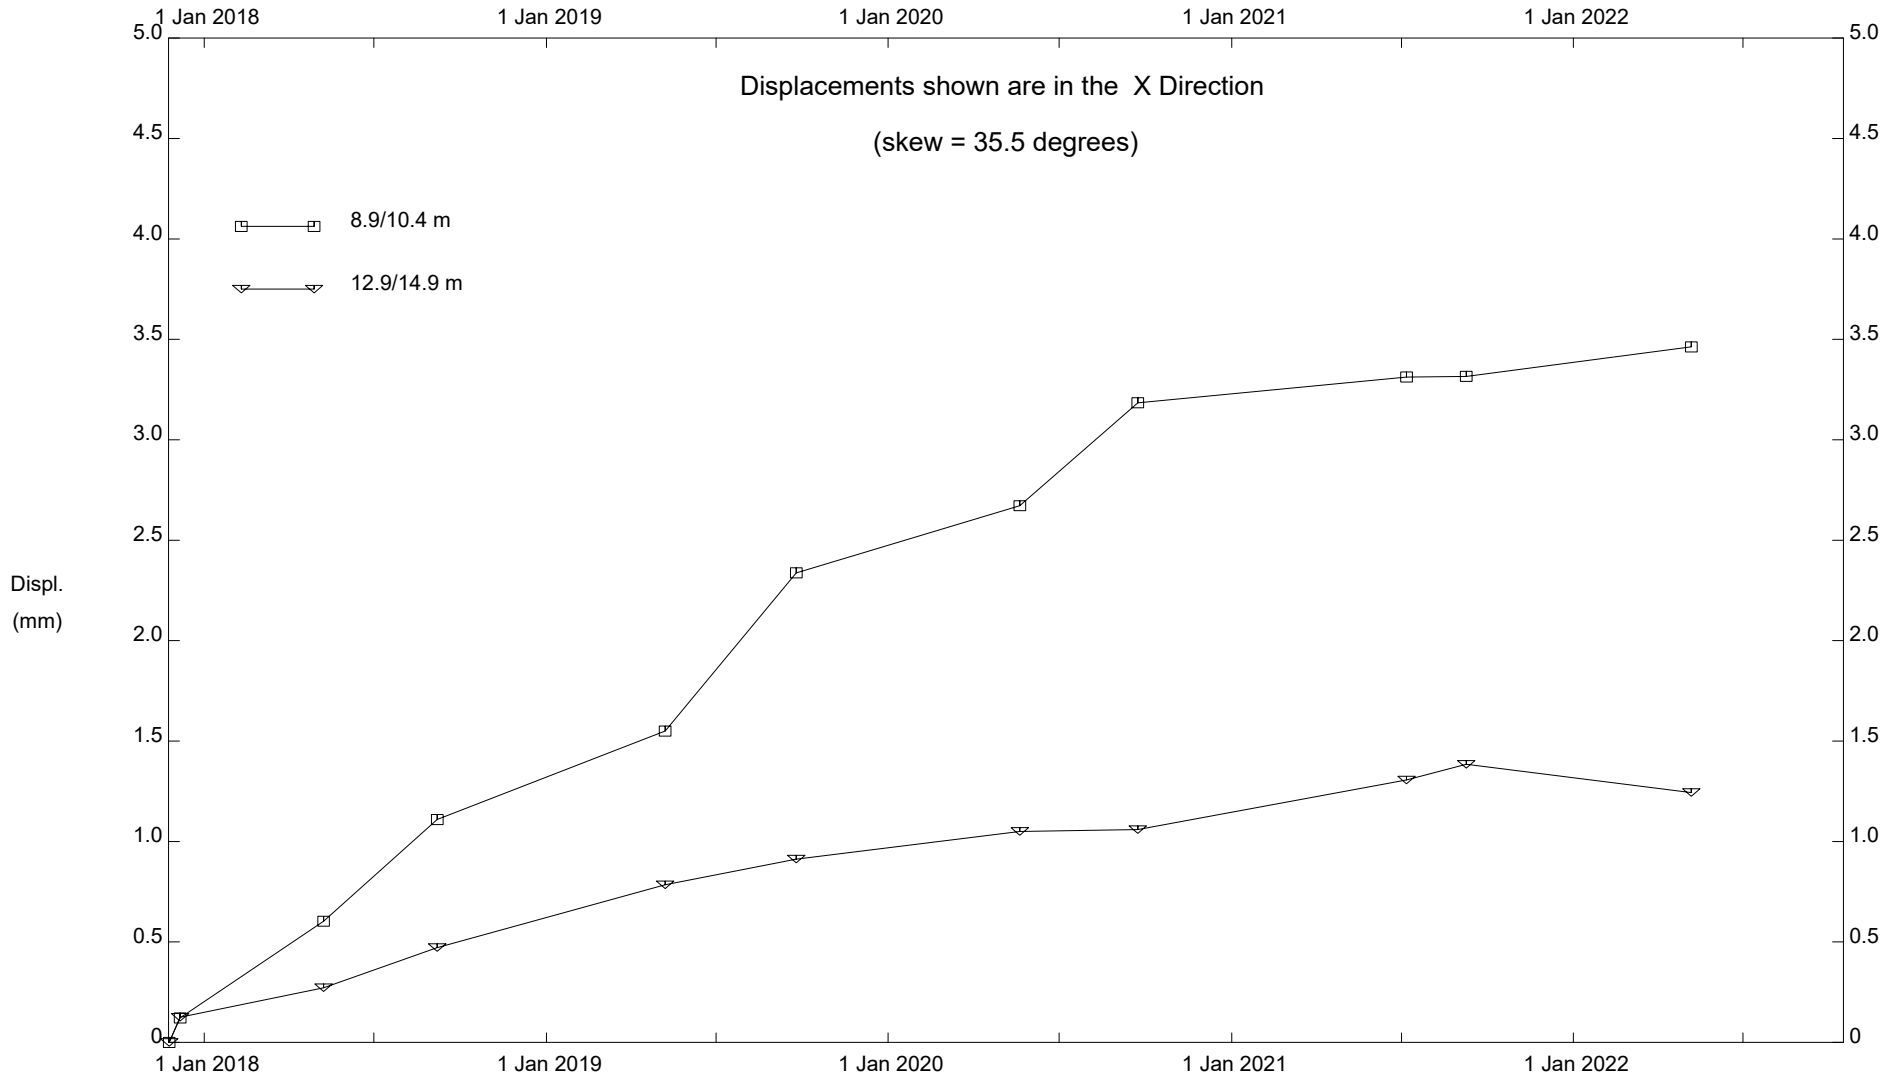
NC13, Inclinometer SI17-02

**SI17-02** has two movement zones being monitored, the upper movement zone from 8.9 m to 10.4 m appears to be creeping at a rate of less than 1 mm/yr since initialization in 2017. The current rate of movement for the lower movement zone from 12.9 m to 14.9 m depth was also observed to be less than 1 mm/yr. The upper movement zone has a total cumulative movement of about 3 mm. The lower movement zone has a total cumulative movement of about 1 mm.

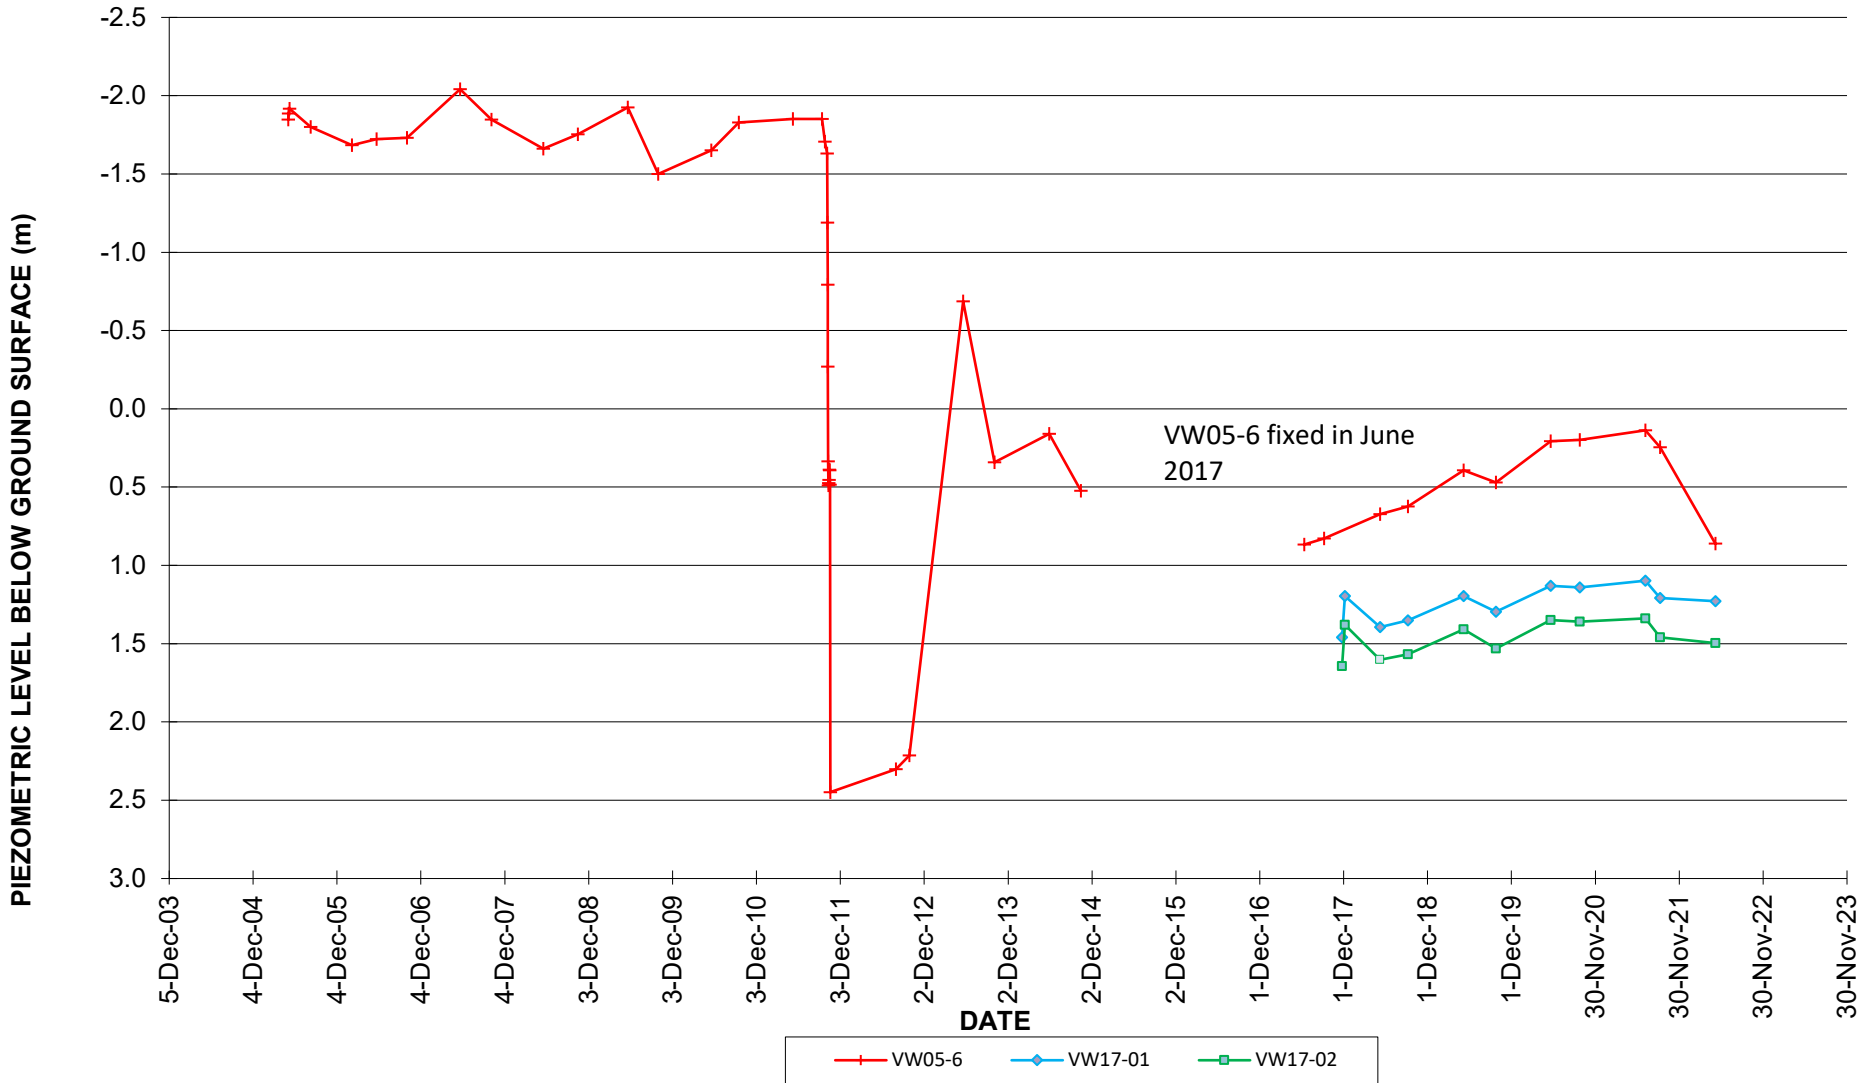
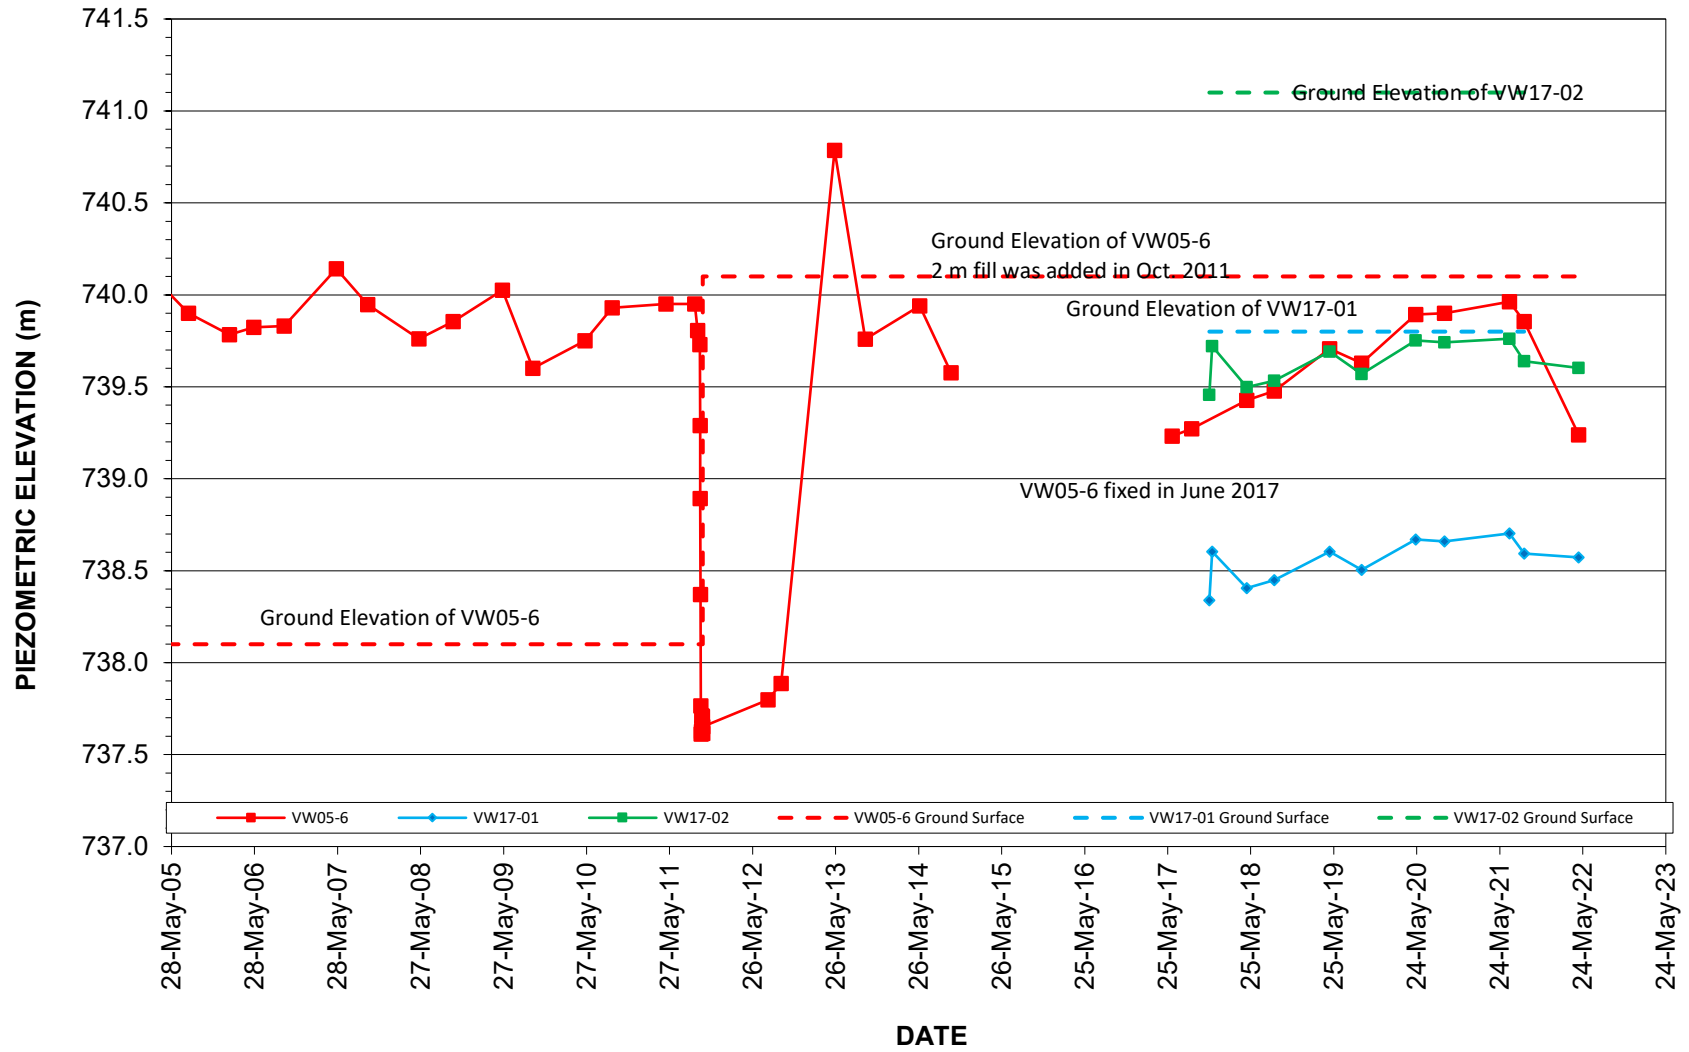
### PIEZOMETER DATA NC13: HWY633:02, Cattlepass West

Little to no change in groundwater levels was observed in VW17-01 and VW17-02 with water levels at 1.2 m below ground surface (bgs) and 1.5 m bgs, respectively. VW05-6 decreased by 0.7 m compared to the Fall 2021 readings. The groundwater level readings show a general trend of increasing water levels since installation in 2017.

**VW05-6** showed artesian groundwater levels prior to construction in 2011 and is currently about 0.9 m below ground surface (bgs).

**VW17-01** and **VW17-02** show a current piezometric level of 1.2 m and 1.5 m bgs, respectively.
