To:	Amy Driessen	From:	Leslie Cho and Xiteng Liu
	Transportation and Economic Corridors		Stantec Consulting Ltd.
File:	123315222	Date:	October 18, 2024

**Reference: North Central Region, Edson, Site NC013 - Highway 633:02 Cattlepass West, Fall 2024 Instrumentation Monitoring Report**

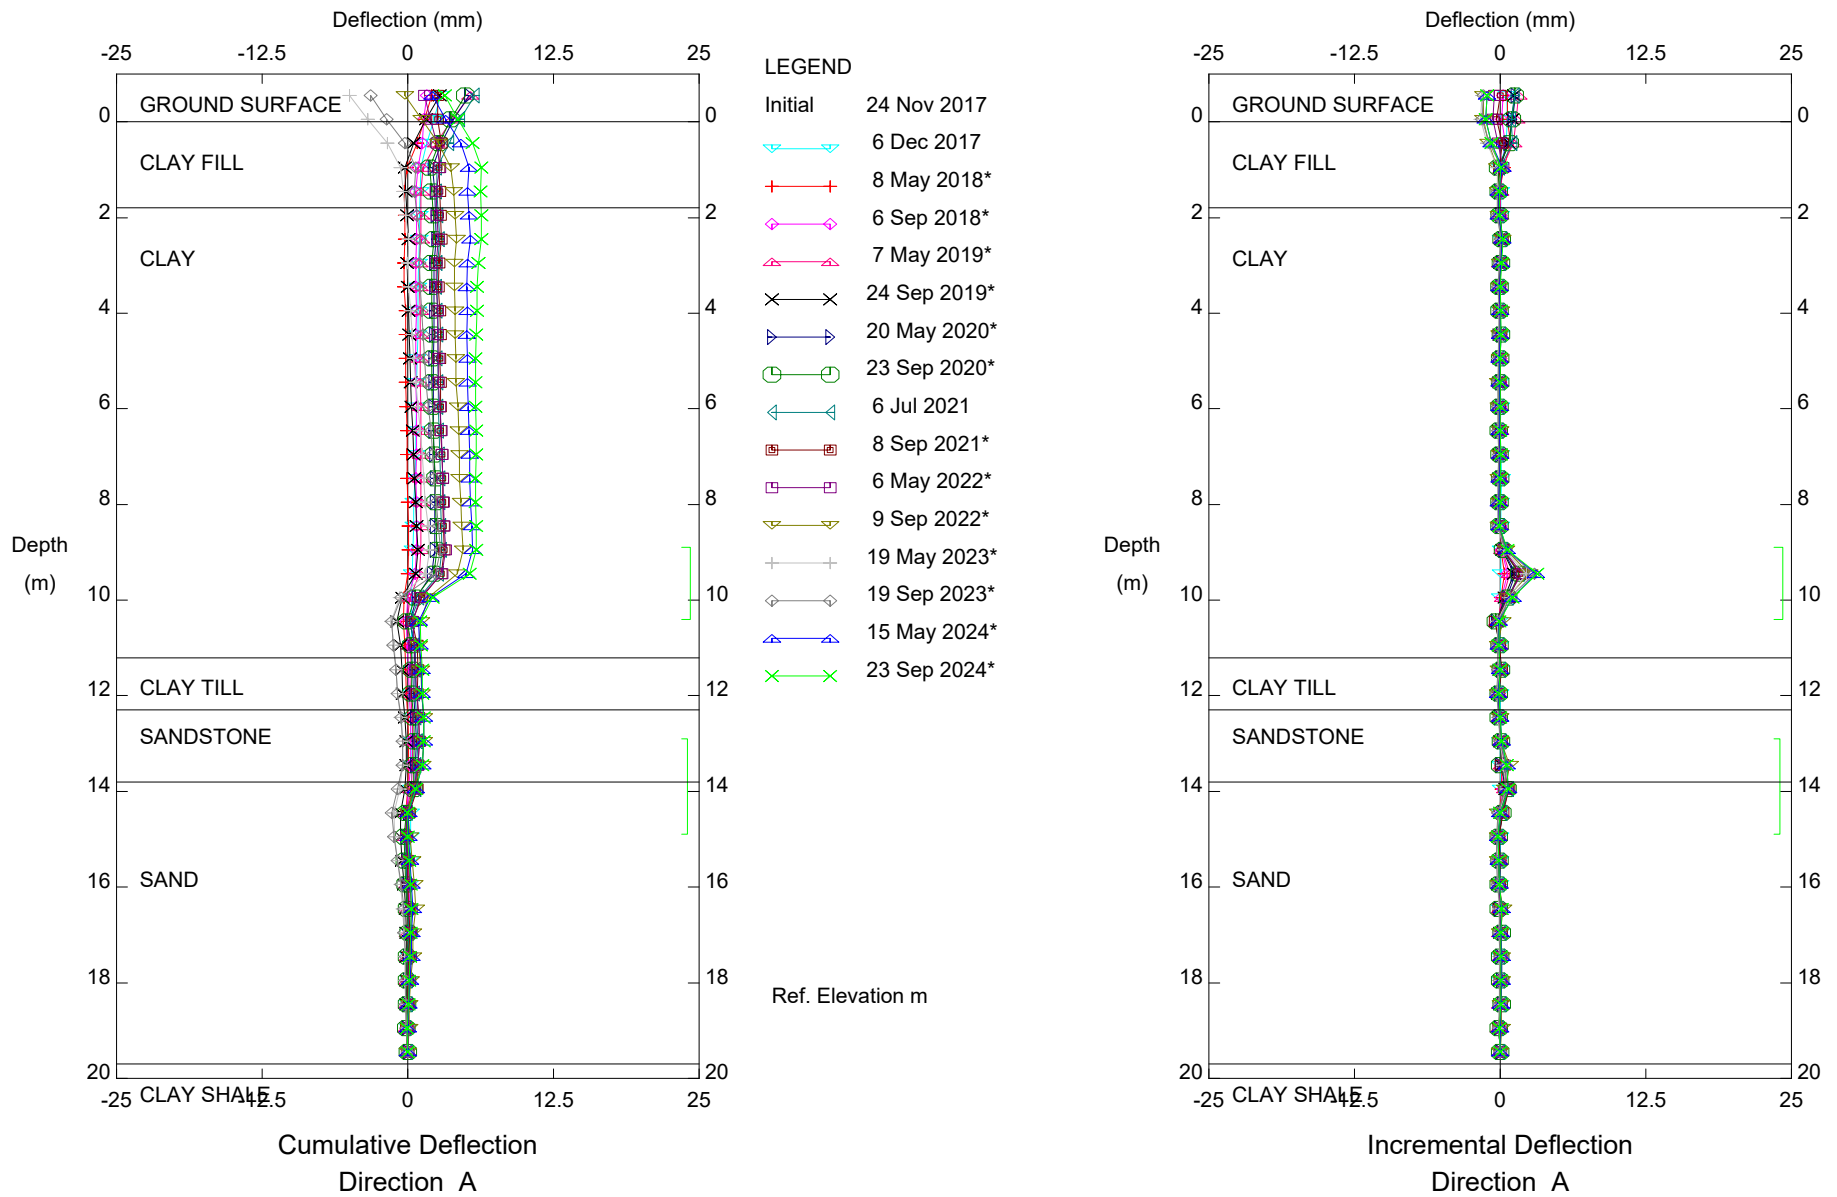
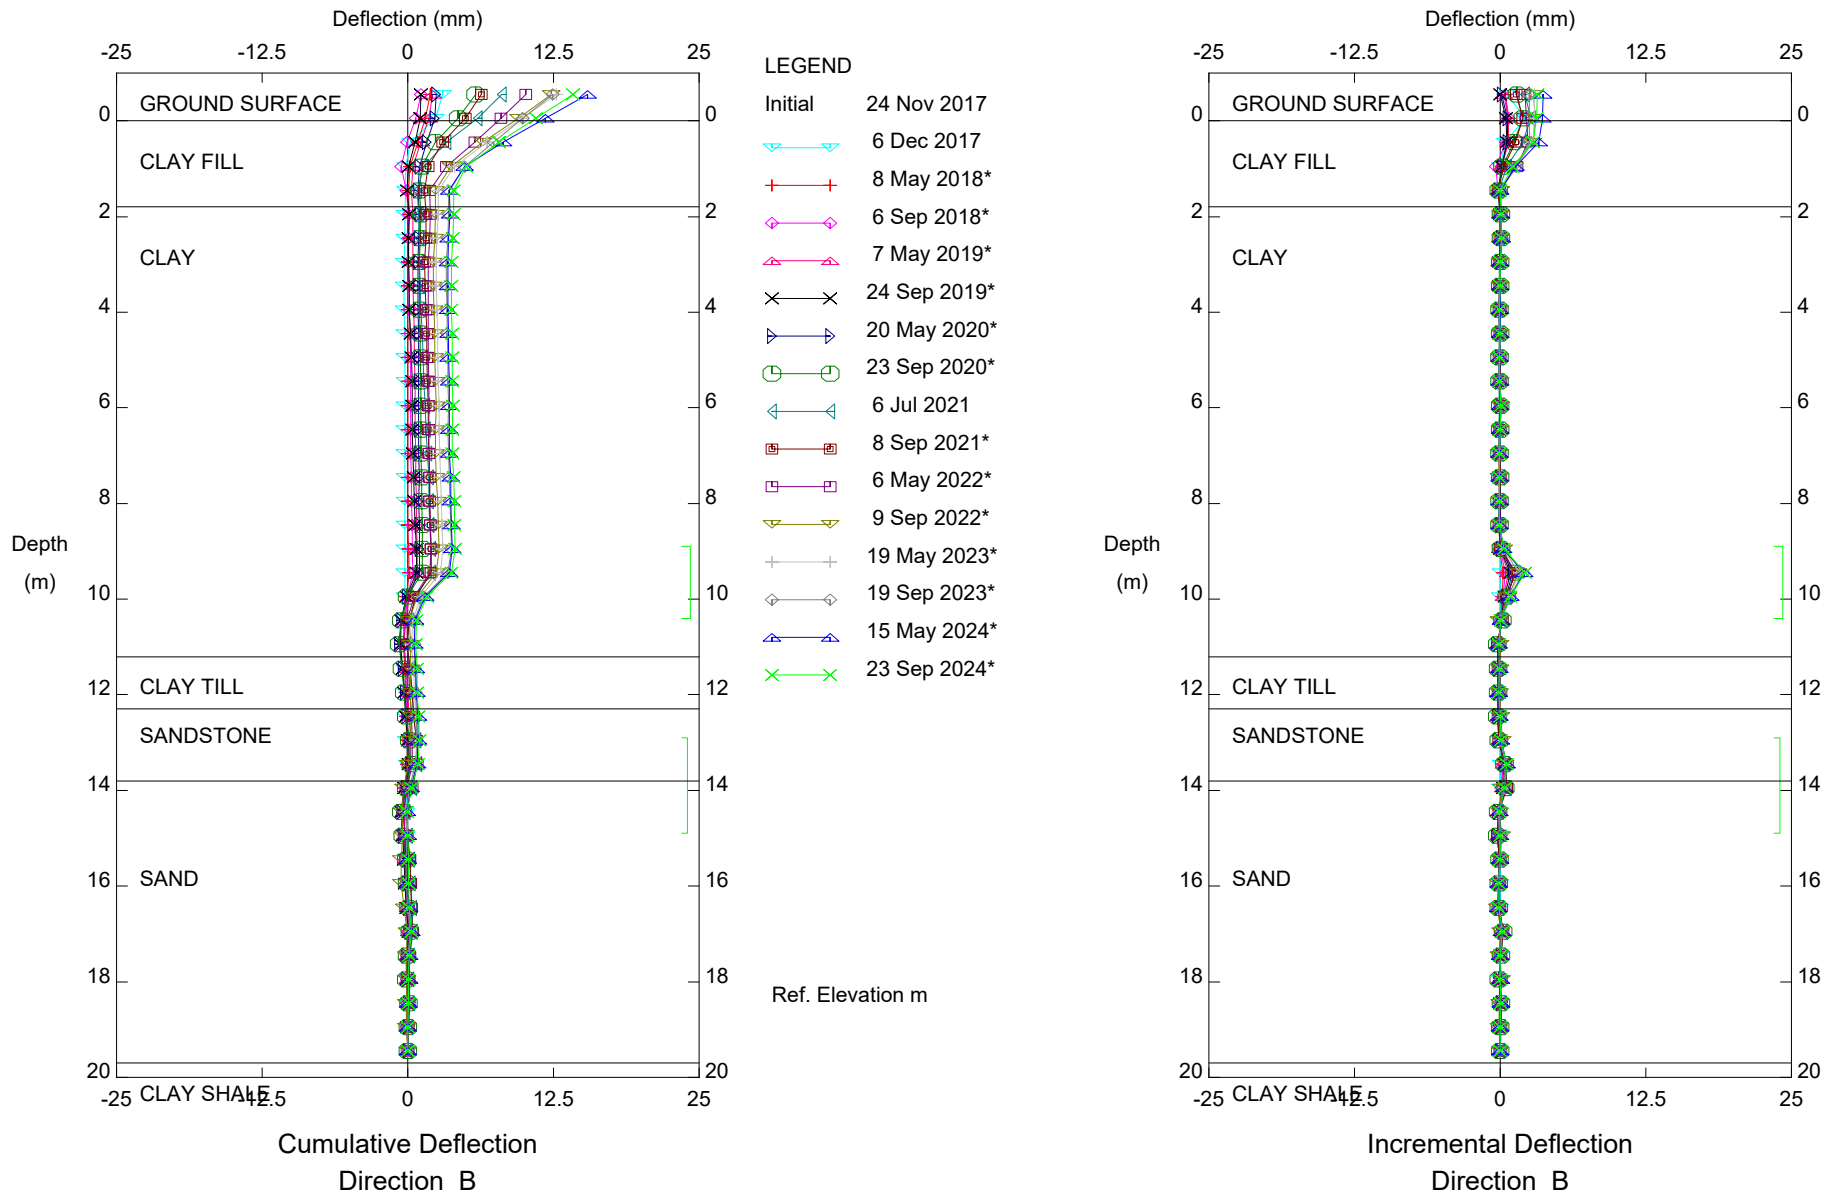
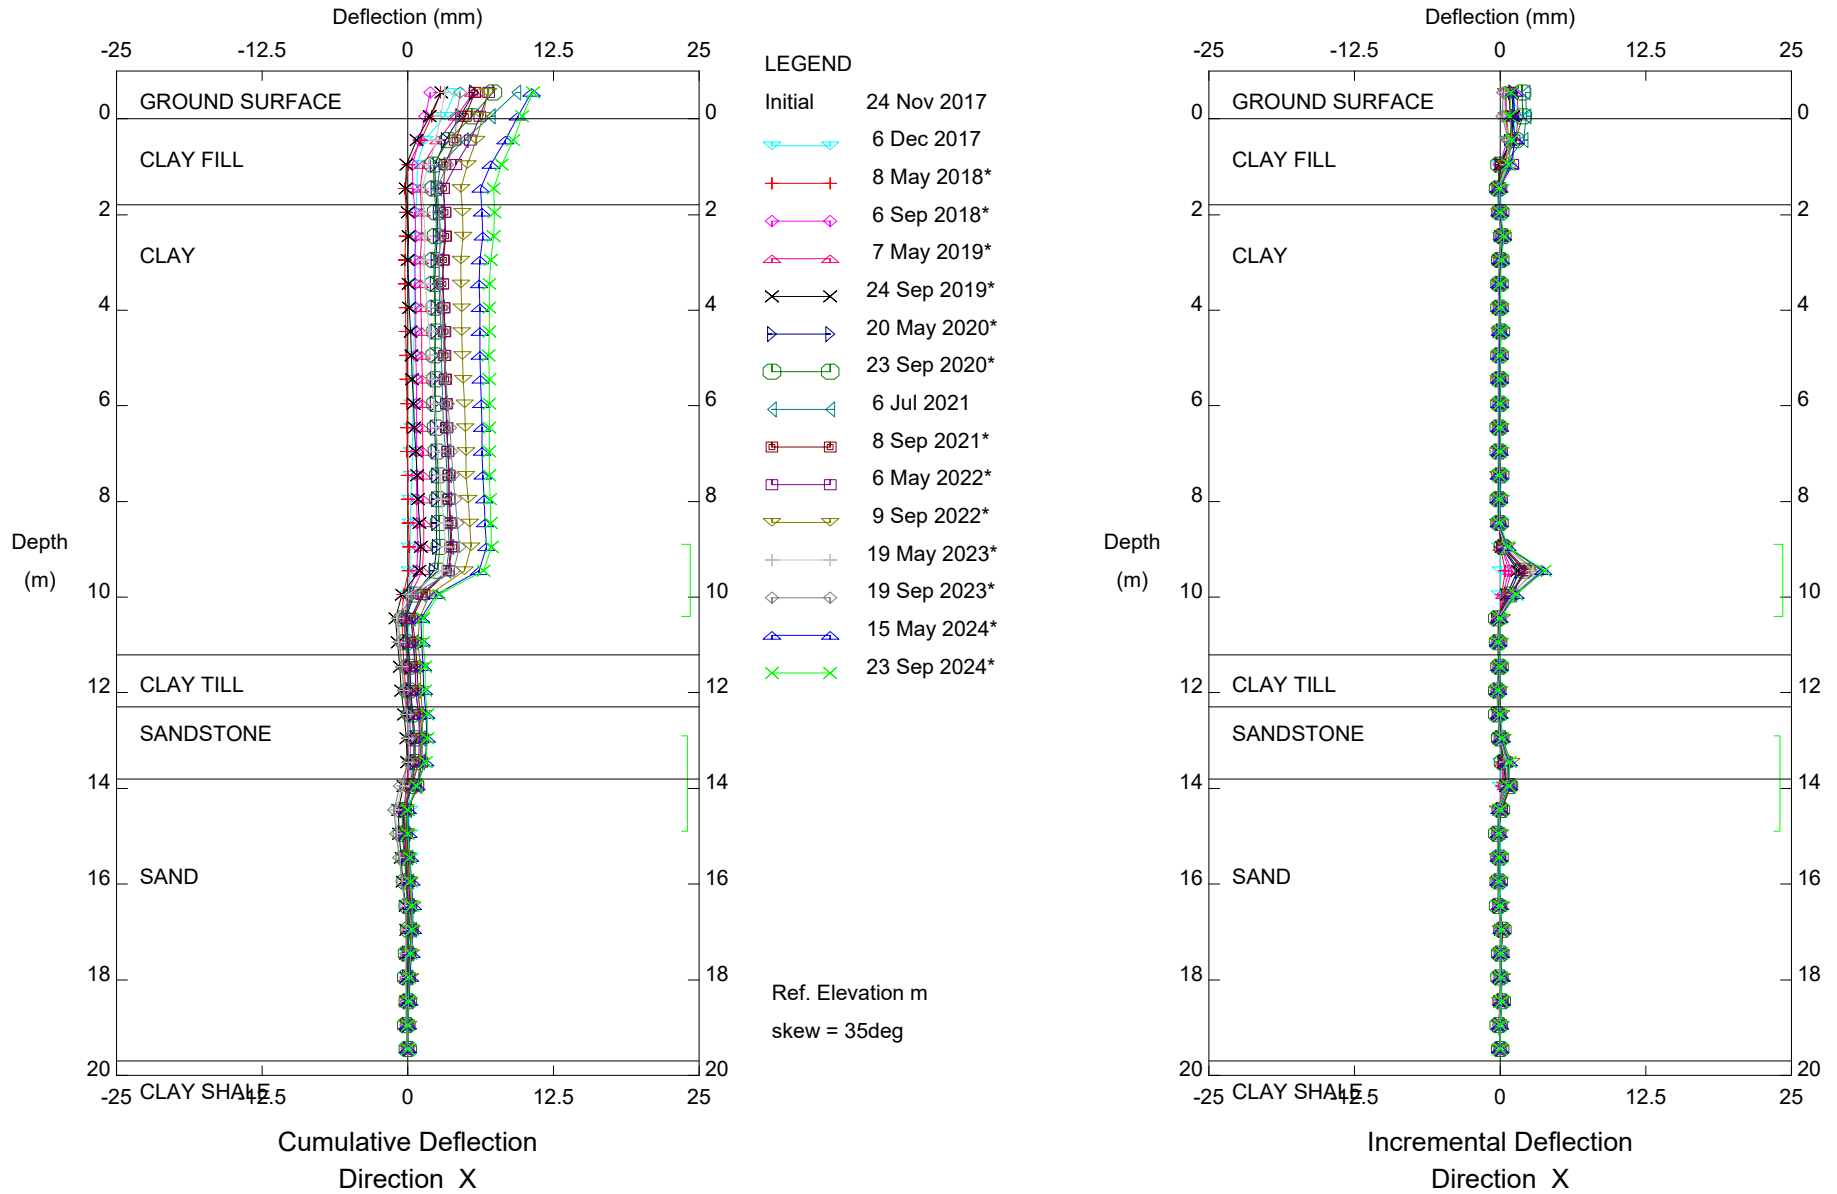
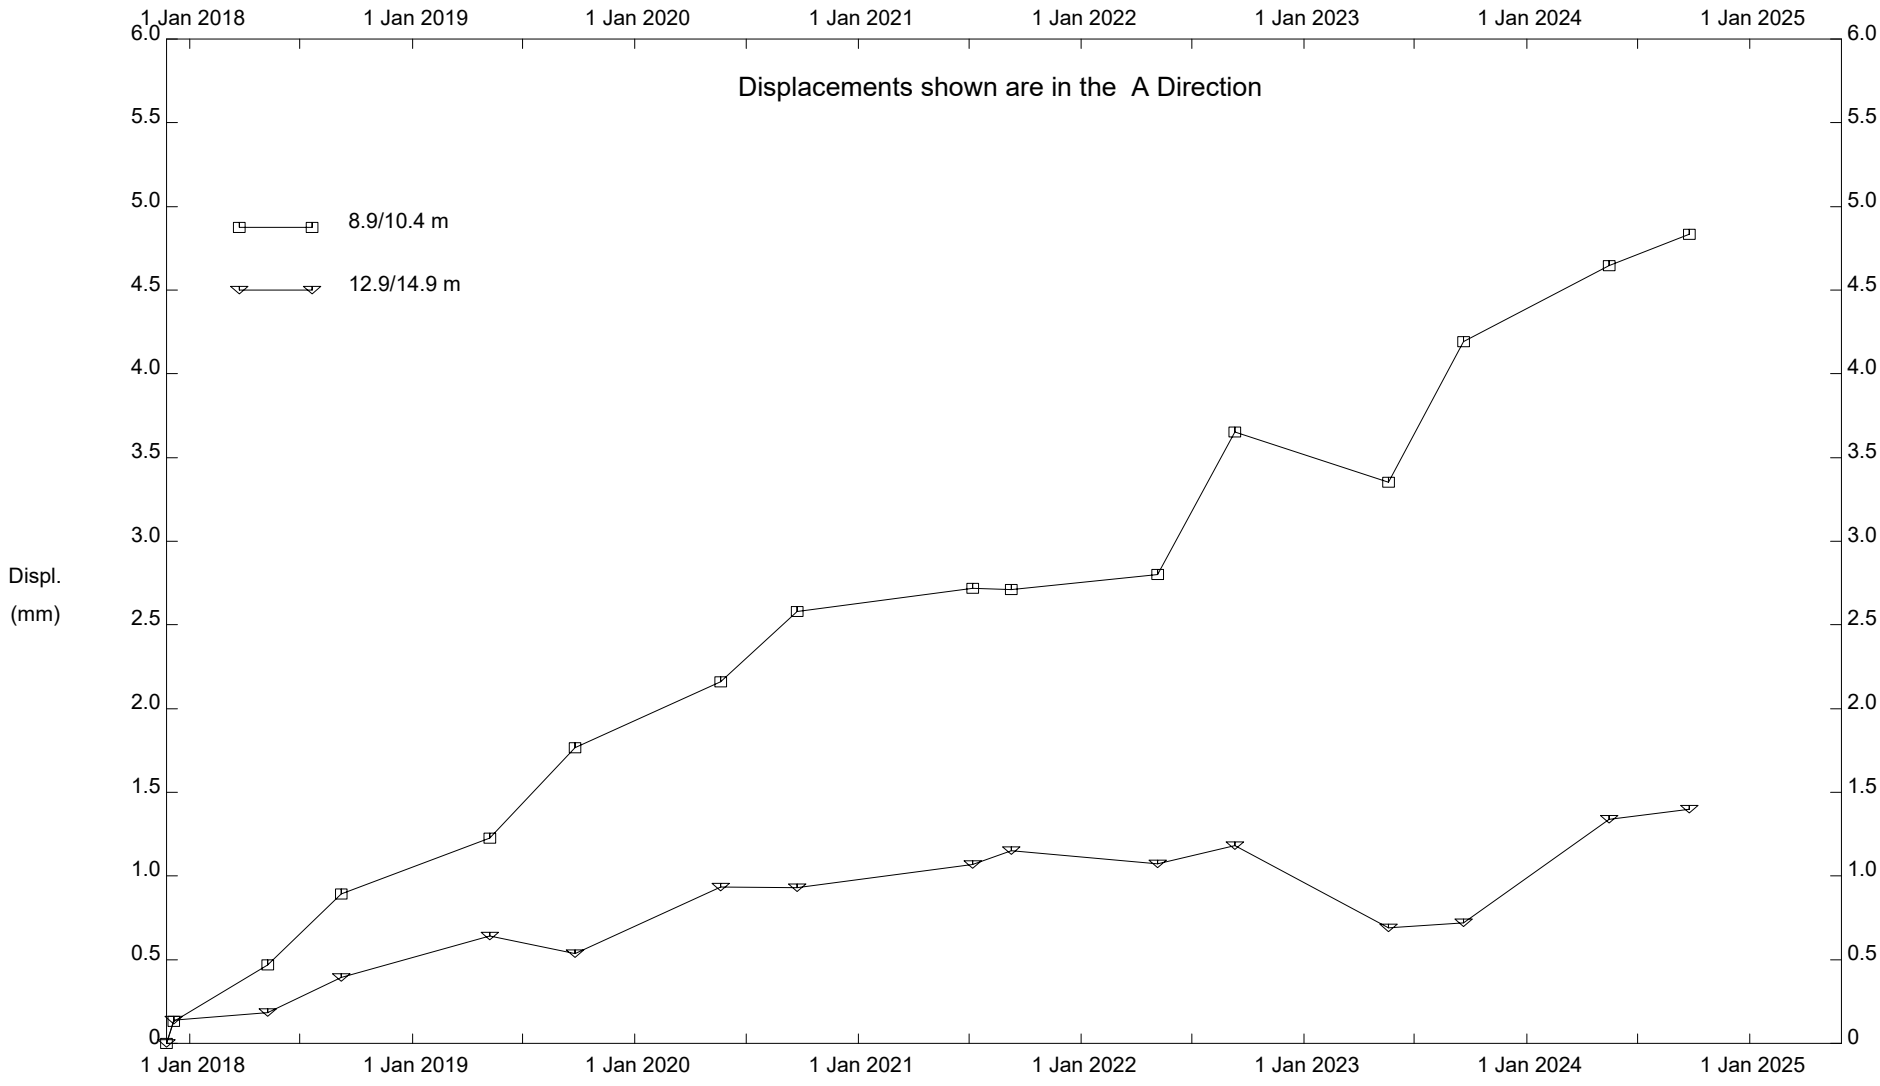
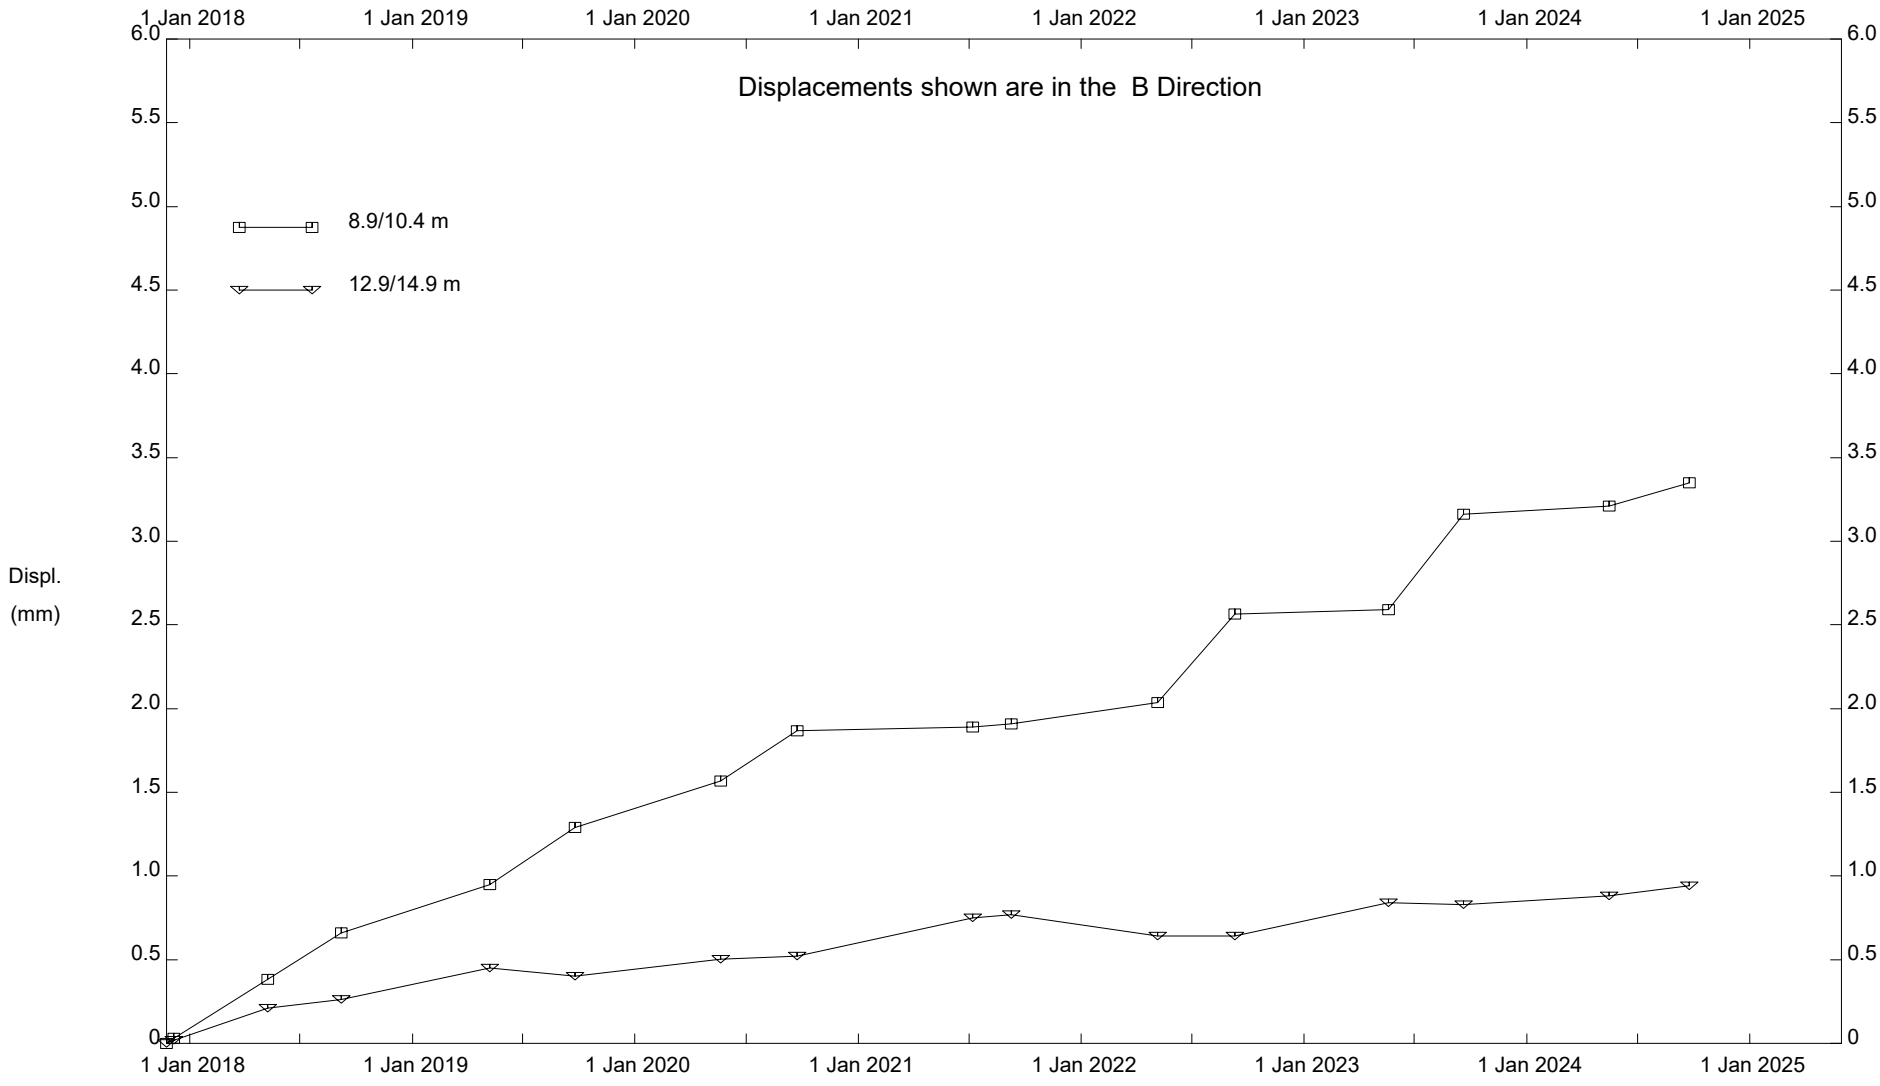
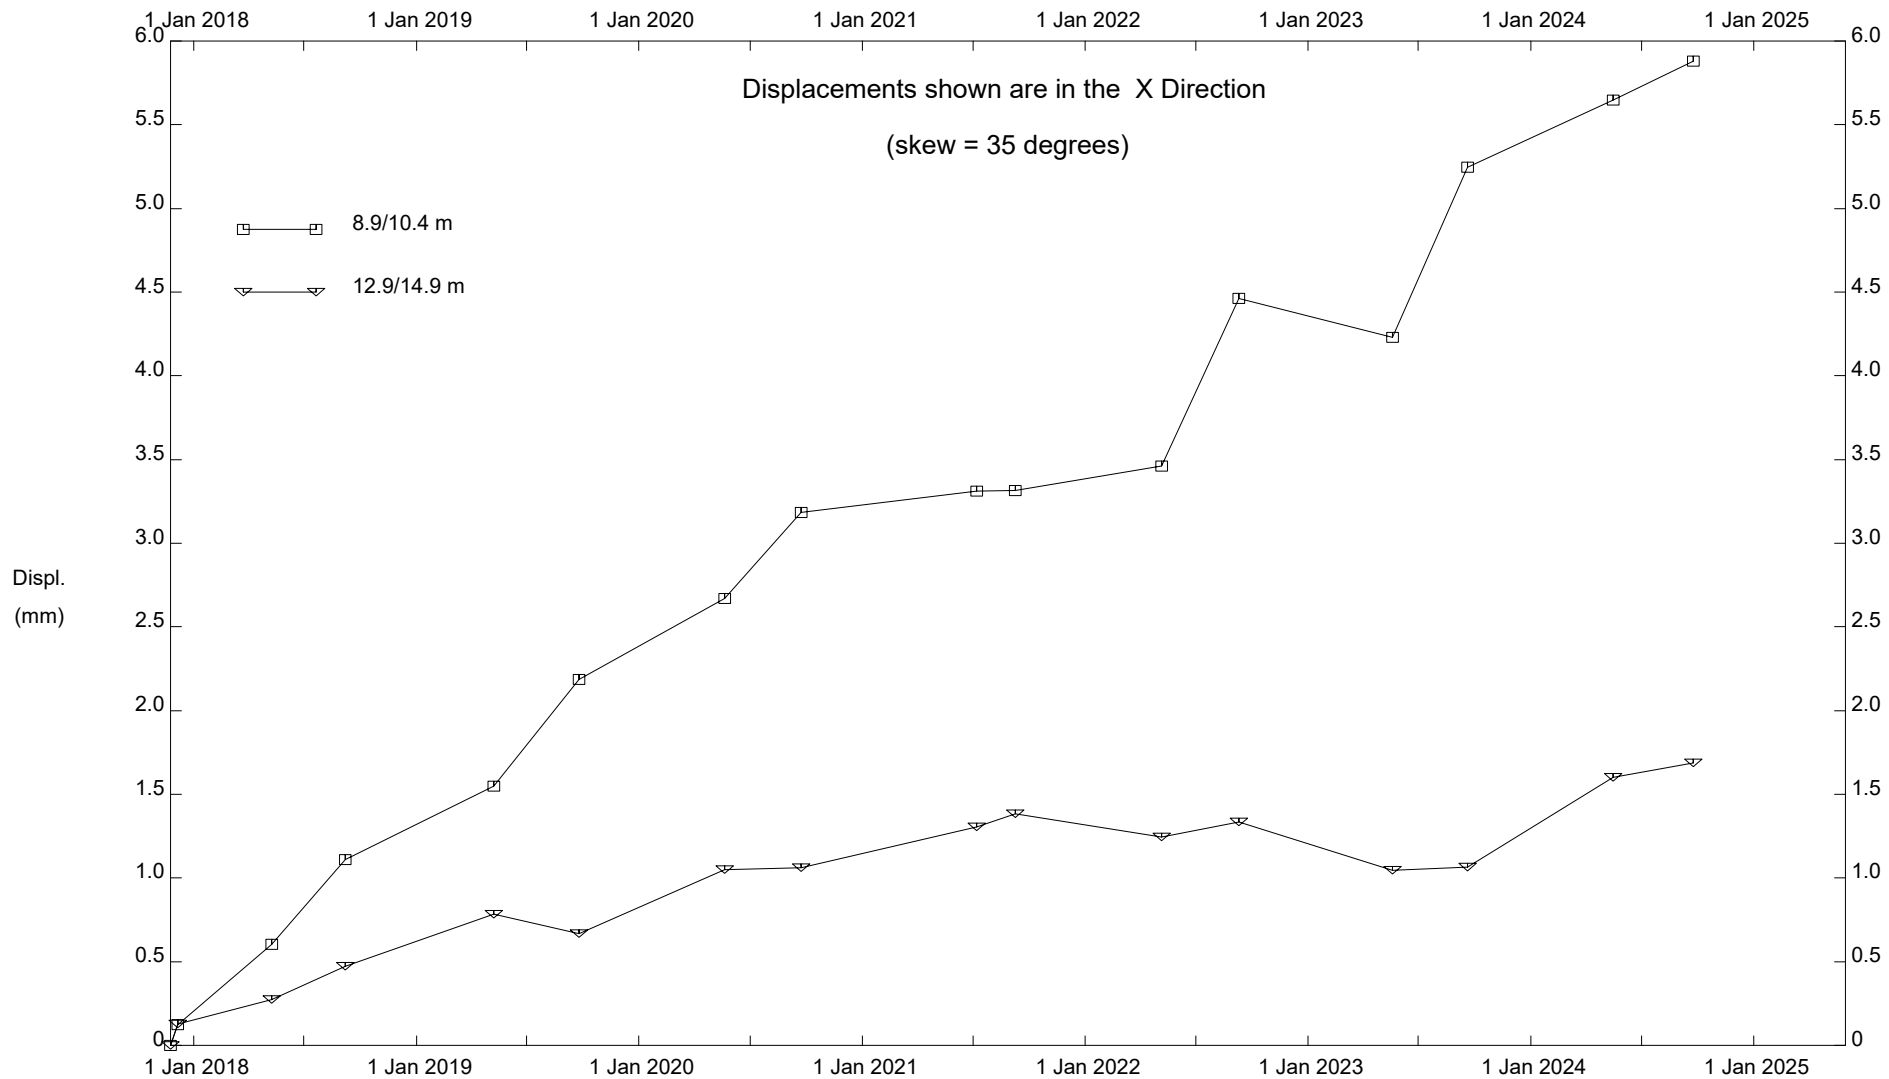
NC13, Inclinometer SI17-02

No new zones of movement were observed in the one operational SI during the Fall 2024 reading cycle.

SI17-02 has two movement zones being monitored, the upper movement zone is at 8.9 m to 10.4 m and the lower movement zone is at 12.9 to 14.9 m. The cumulative movement in each zone is 6 mm and 2 mm, respectively. The current rate of movement for both zones is less than or equal to 1 mm/yr.

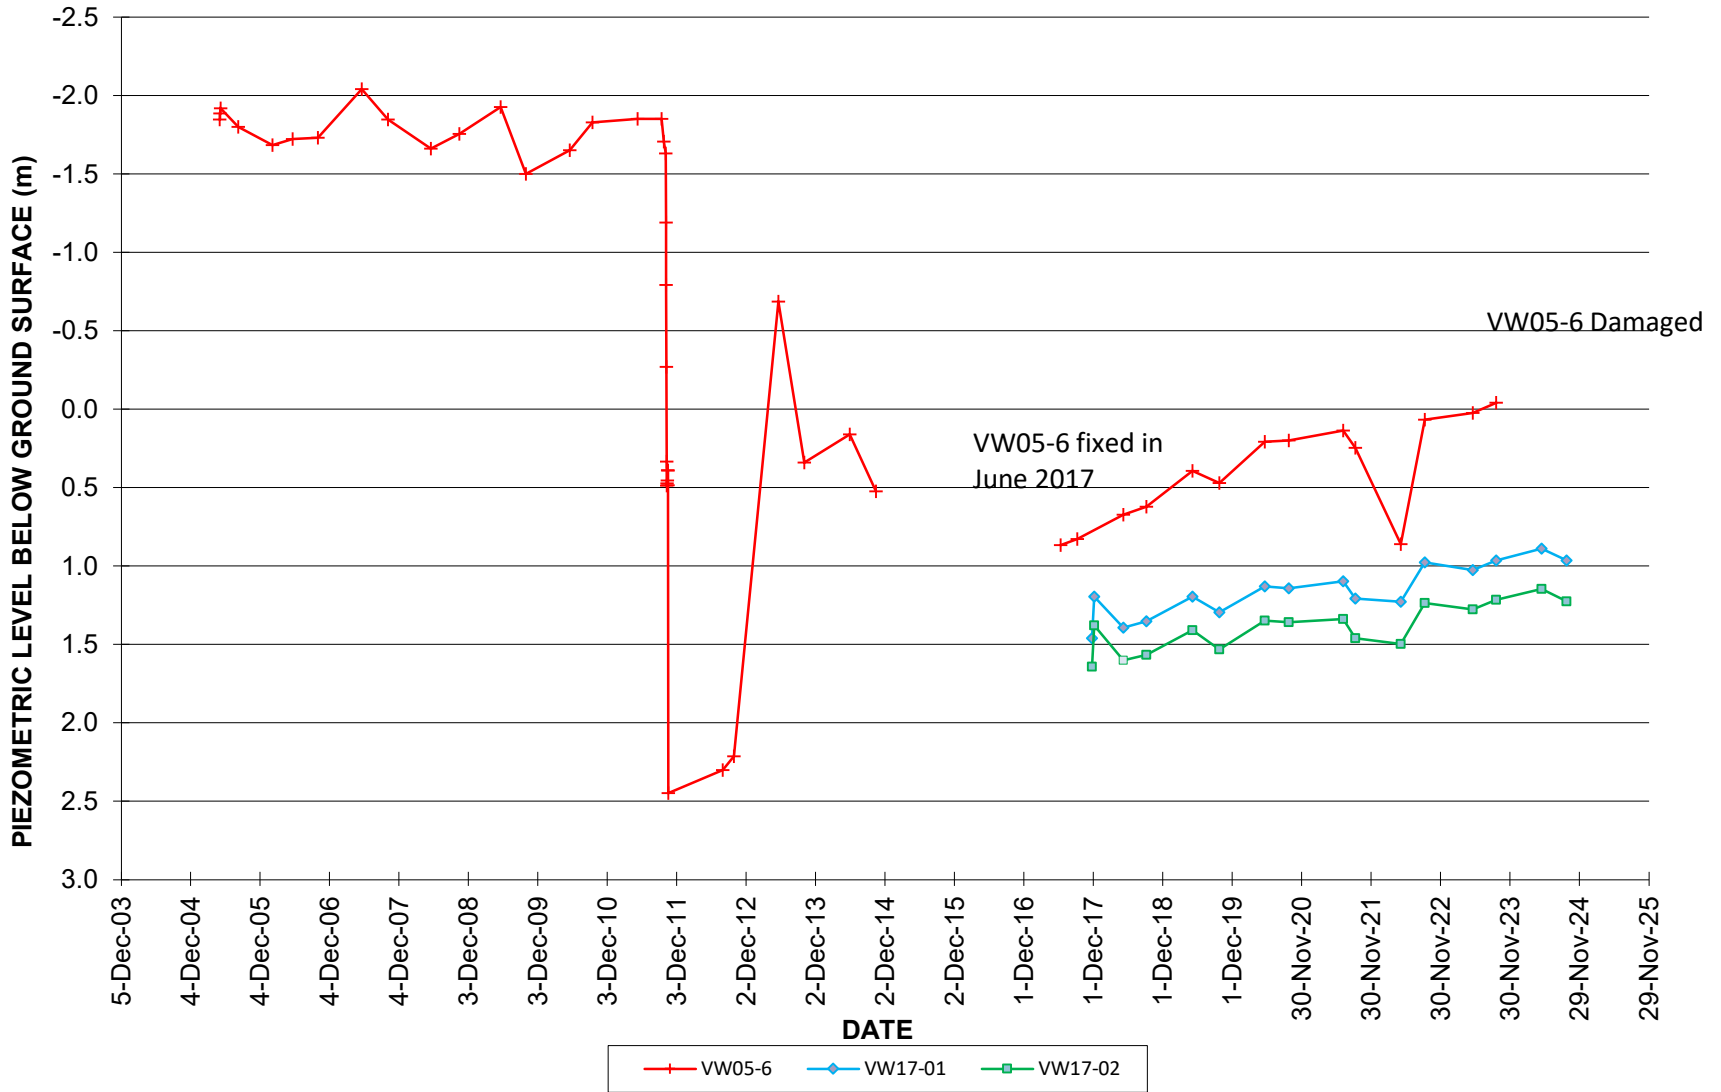
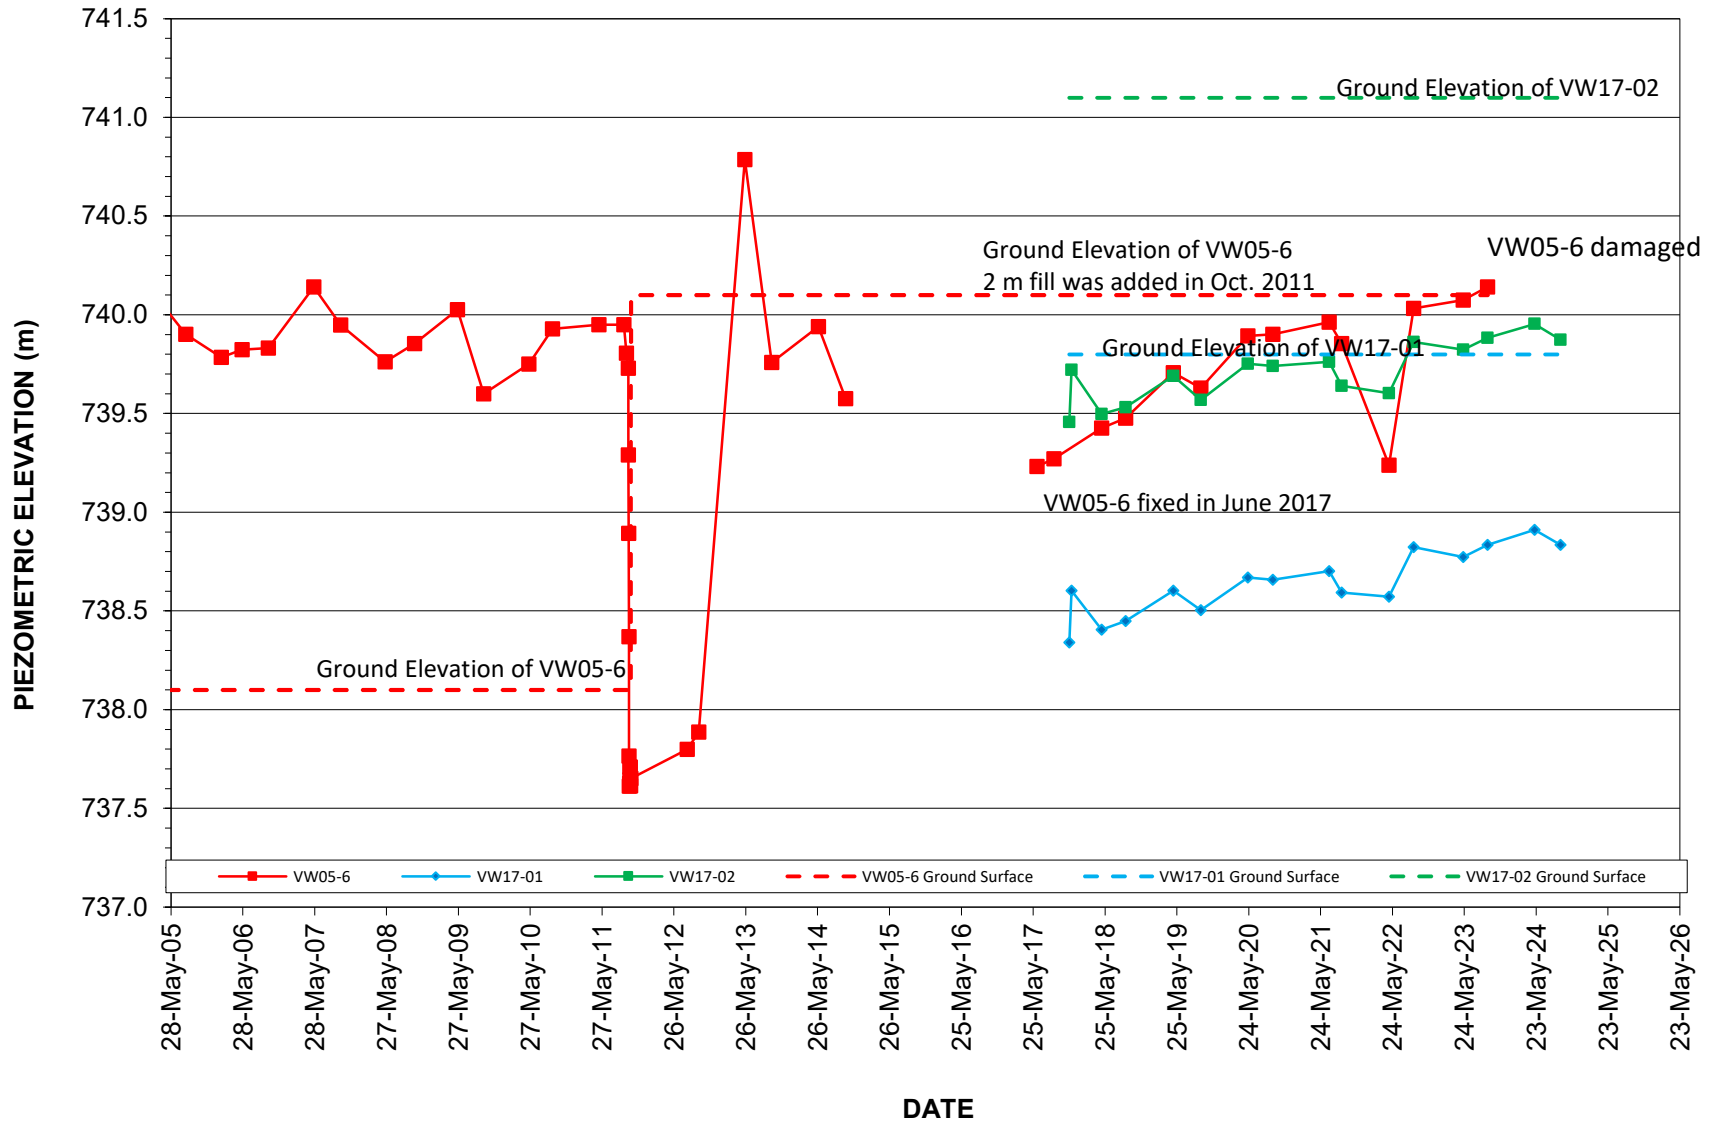
### PIEZOMETER DATA NC13: HWY633:02, Cattlepass West

Water level in VW17-01 and VW17-02 both decreased by about 0.1 m from their historic maximum piezometric elevations. VW17-01 and VW17-02 showed a current piezometric level of 0.9 m and 1.1 m bgs, respectively.
