SITE NUMBER AND NAME: NC013 – Cattlepass West	HIGHWAY AND KM: 633:02, km 0.780	PREVIOUS INSPECTION: June 15, 2022	CURRENT INSPECTION: June 11, 2024
LEGAL DESCRIPTION: NW 29-53-6-W5M	NAD83 COORDINATES: UTM11U 5942619N, 642207E		RISK ASSESSMENT: PF: 10 CF: 4 Total: 40
AVERAGE ANNUAL DAILY TRAFFIC (AADT): 460 (2023)		CONTRACTOR MAINTENANCE AREA (CMA): 509

2024 Site Inspection Photos at NC013

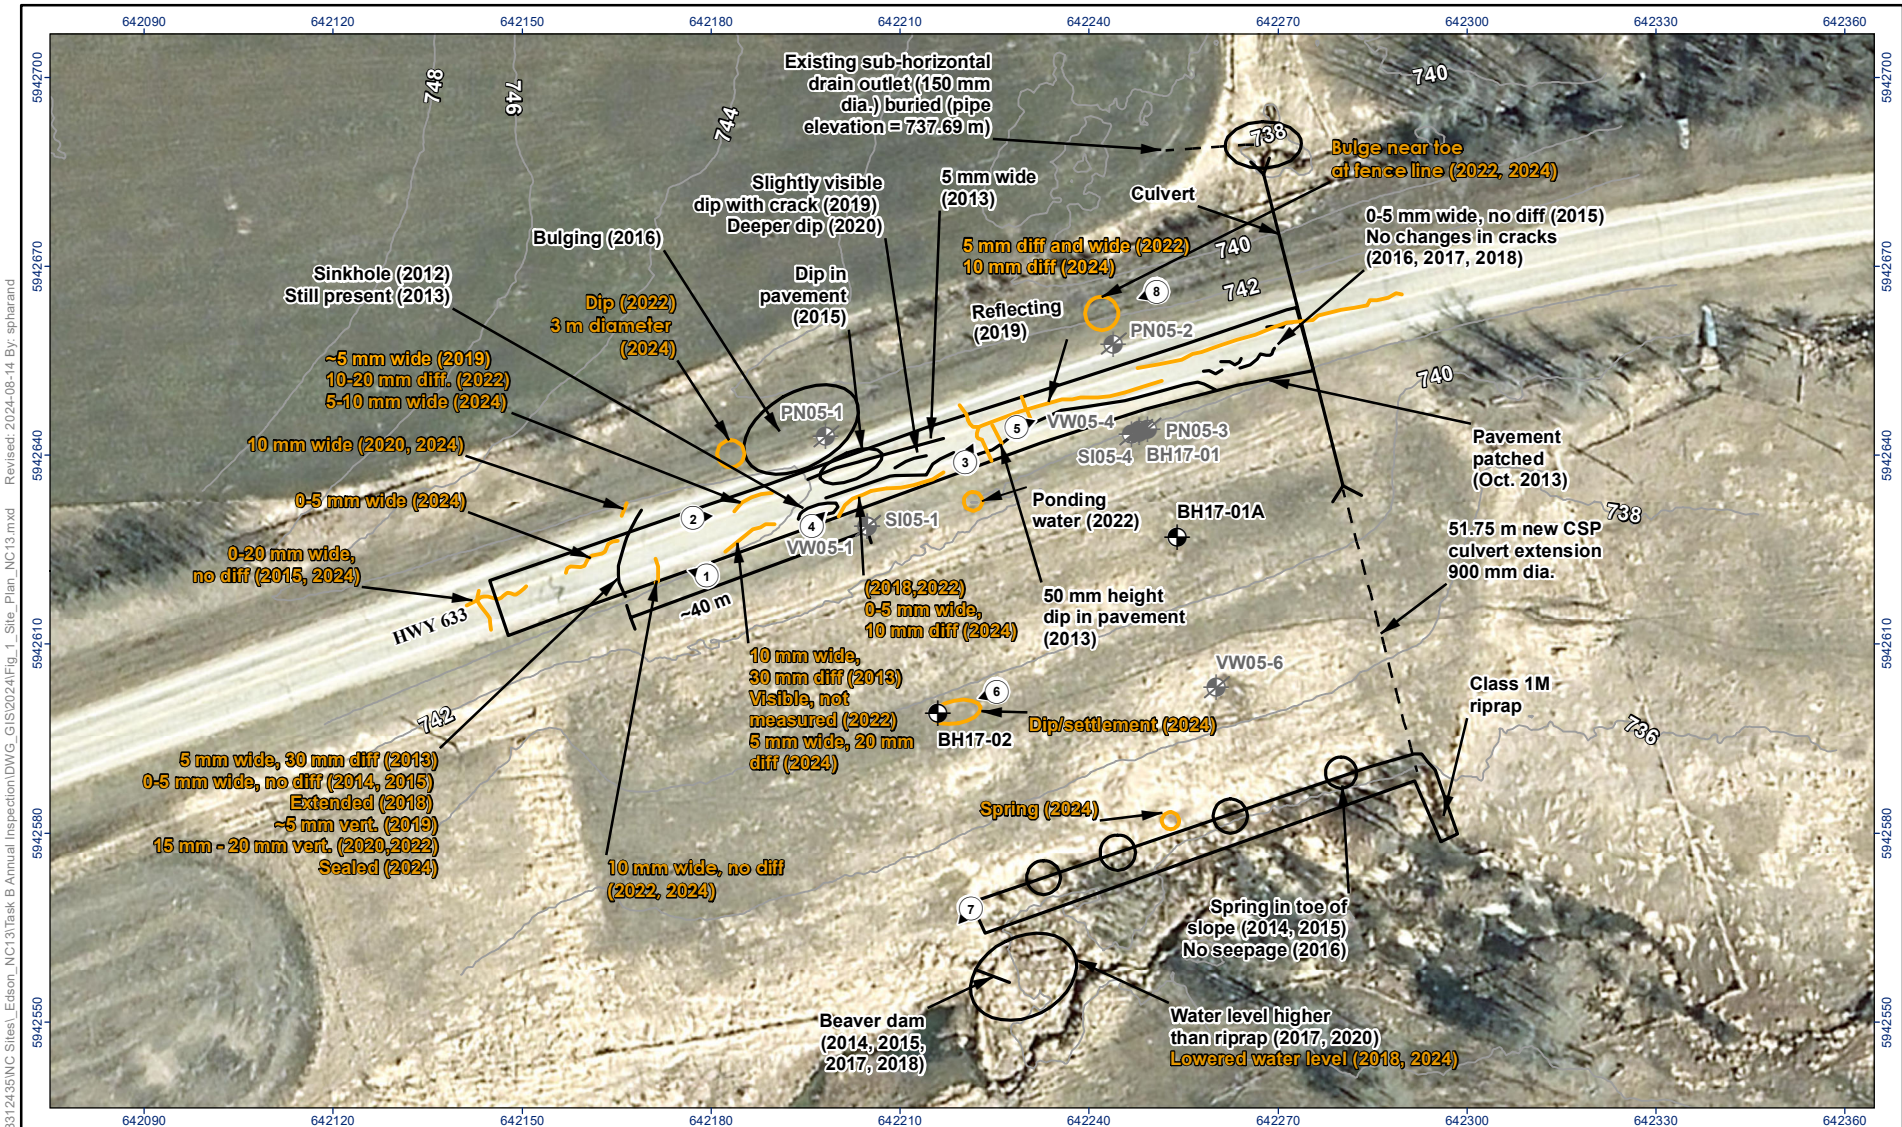
ITEM	CONDITION EXISTS		DESCRIPTION AND LOCATION	NOTICEABLE CHANGE FROM LAST INSPECTION	
	YES	NO		YES	NO
Pavement Distress	X		Pavement cracking along Highway 633	X	
Slope Movement	X		Increased pavement cracks, SI readings show signs of creep movement	X	
Erosion		X			X
Seepage	X		A spring was observed near the toe of the south embankment.	X	
Bridge/Culvert Distress		X			X

COMMENTS
<ul style="list-style-type: none"> The circular crack west of SI05-1 has been sealed since the previous inspection in 2022 (Photo 1). The crack to the northwest of SI05-1 has maintained its vertical difference of about 20 mm. The crack to the east of SI05-1 was observed to have a vertical difference of about 10 mm and has lengthened since the 2022 inspection (Photo 2). Additional pavement cracks with no vertical difference are present (Photos 3, 4 and 5). An approximately 3 m diameter ground depression was observed around BH17-02 (Photo 6). The bulge in the slope near the toe north of BH17-01 does not visually appear to have grown since the previous inspection in 2022. The slope on the north side of Highway 633 appears to be bulging near the toe north of BH17-01 (Photo 8). A spring was observed during the 2024 inspection, near the middle of the length of riprap placed at the toe of the southern embankment. This spring was not observed during previous site inspections. The water level in the pond to the south of the toe berm appeared slightly lower than the level observed during the 2022 inspection (Photo 7). The SI reading shows signs of creep movement. SI17-02 is showing a current rate of movement less than 1 mm /year. All other SIs on the site have been damaged and could not be read.

- The overall porewater pressures at site remain high and have continued to increase since 2017. VW17-01 and VW17-02 are currently at its highest recorded porewater pressure since initiation in 2017. Artesian conditions were observed prior to remediation in 2011 in VW05-6; however, VW05-6 was found damaged in Spring 2024.
- Due to the continued creep measured in the SI, and the loss of instruments due to shearing, the Probability Factor for the site remains at 10. The Consequence Factor has also been kept at 4 as partial closure of the road or significant detours would be the result of a slide occurrence.

- Pavement cracks should be sealed to reduce surface water infiltration into the embankment. Additional pavement patches are not recommended since it is considered an additional driving force on the embankment. Mill and fill could be completed to address the vertical displacement until remediation is completed. Any fill placed, either soil or asphalt, should result in no net addition of loads.

- The culverts and drains at the site should be inspected regularly to reduce the risk of pore pressures building up in the berm and slope, and to confirm functionality.

- Since the site is preloaded, a grade reduction to improve slope performance may be considered. The high-level cost for grade reduction is \$400,000 to \$700,000 excluding engineering costs. Alternatively, lightweight fill may be considered to reduce the overall driving force on the embankment, with a high-level cost of \$1.5 to \$2.3 Million excluding engineering costs.

- Site inspections should continue every 2 years.
- Instrumentation readings should continue to be read semi-annually.

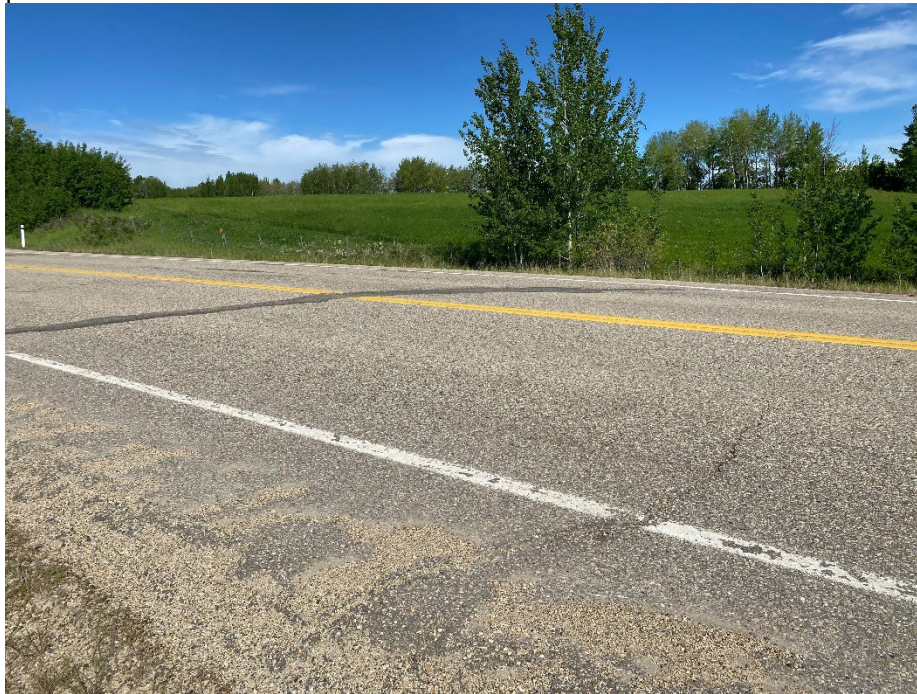
Photo 1: Sealed circular crack approximately 40 m west of SI05-1 and smaller circular crack in EBL. Looking northwest.

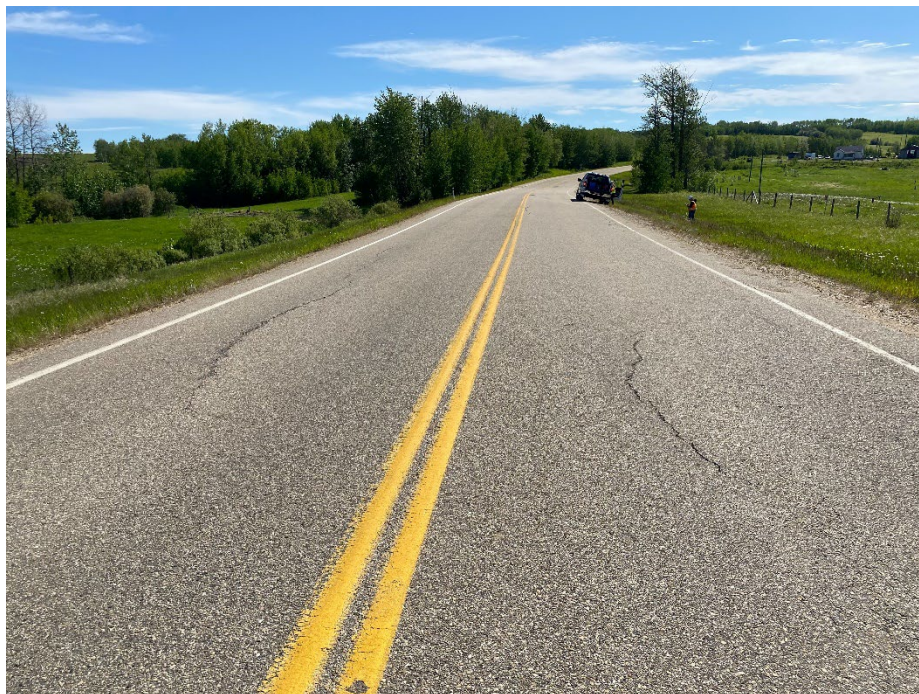
Photo 2: Semi-circular pavement cracks about 10 m east of Photo 1. Looking northeast.

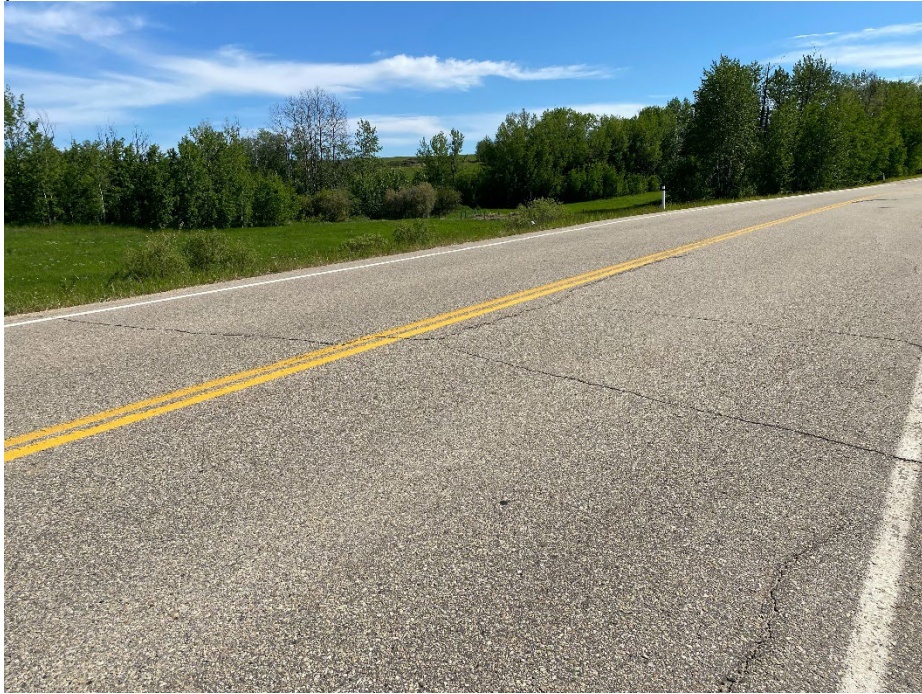
Photo 3: Pavement cracking approximately 15 m east from SI05-1. Looking north.

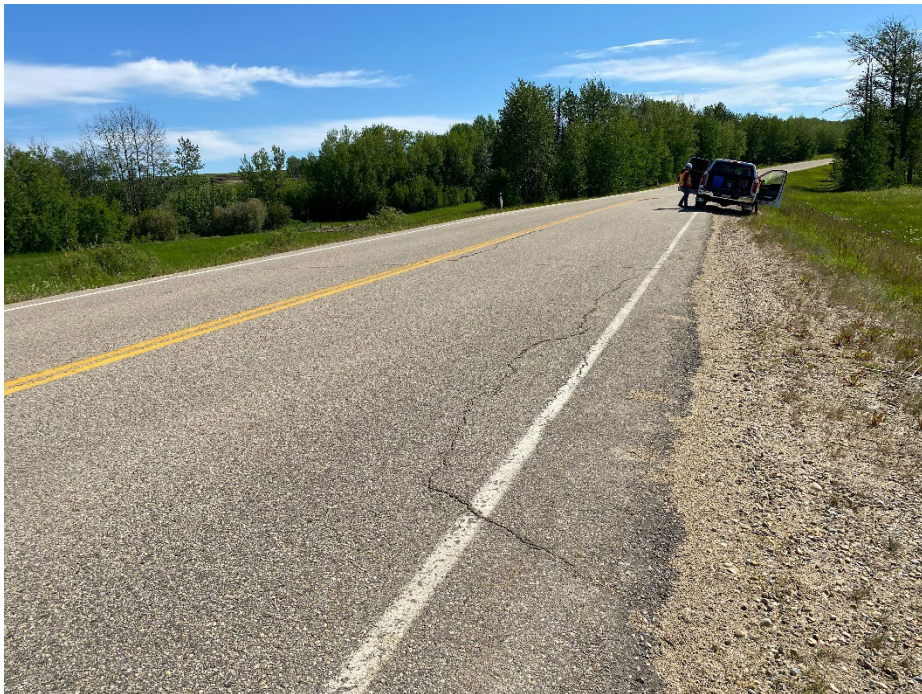
Photo 4: Crack on shoulder north of SI05-1. Looking northeast.

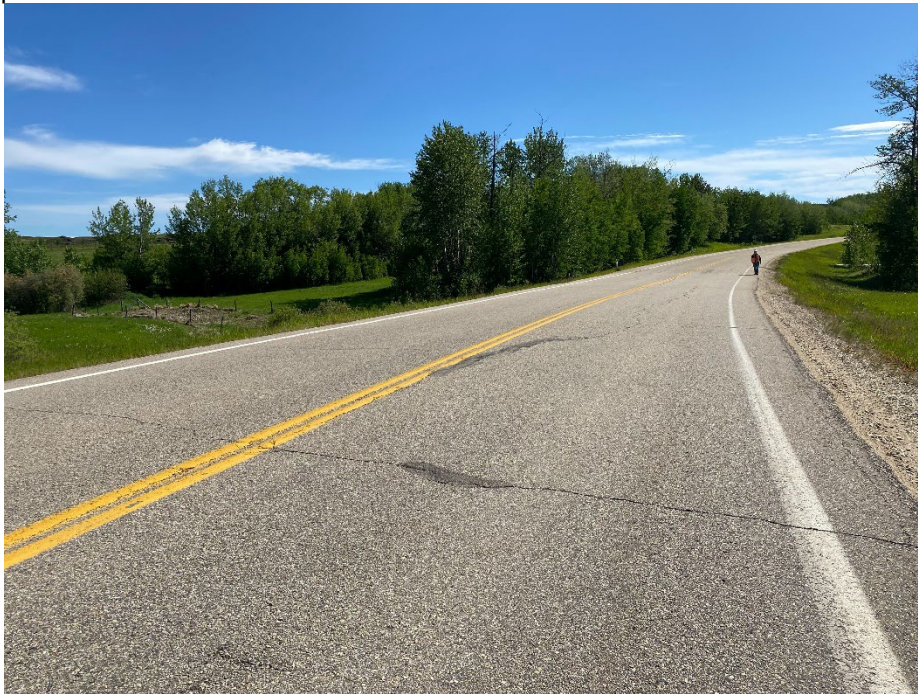
Photo 5: Semi-circular crack along C/L and EBL lane north of BH17-01. Transverse cracking. Looking east.

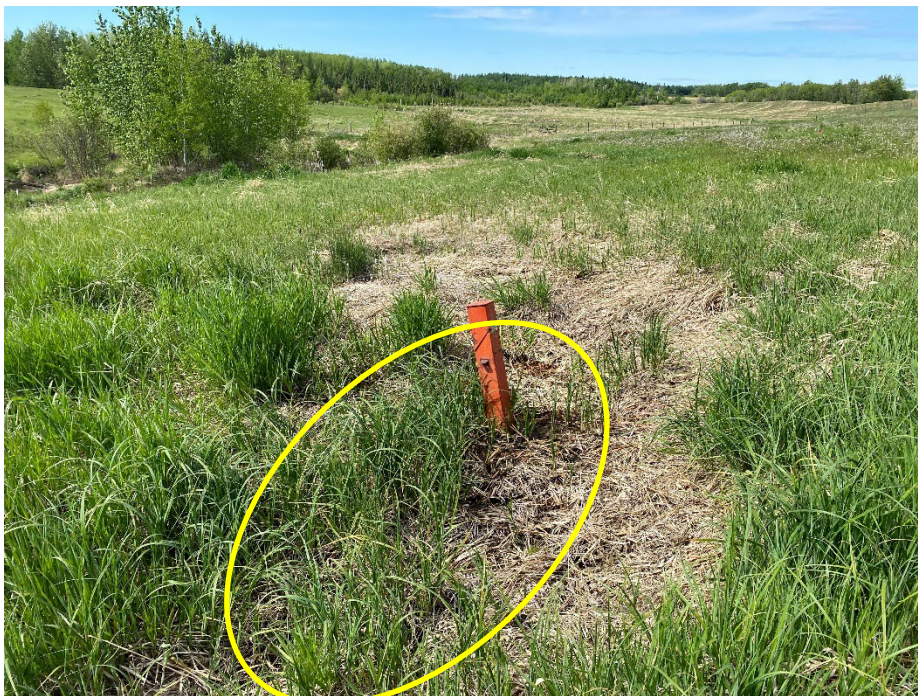
Photo 6: Settlement around BH17-02 on the south embankment. Looking west.

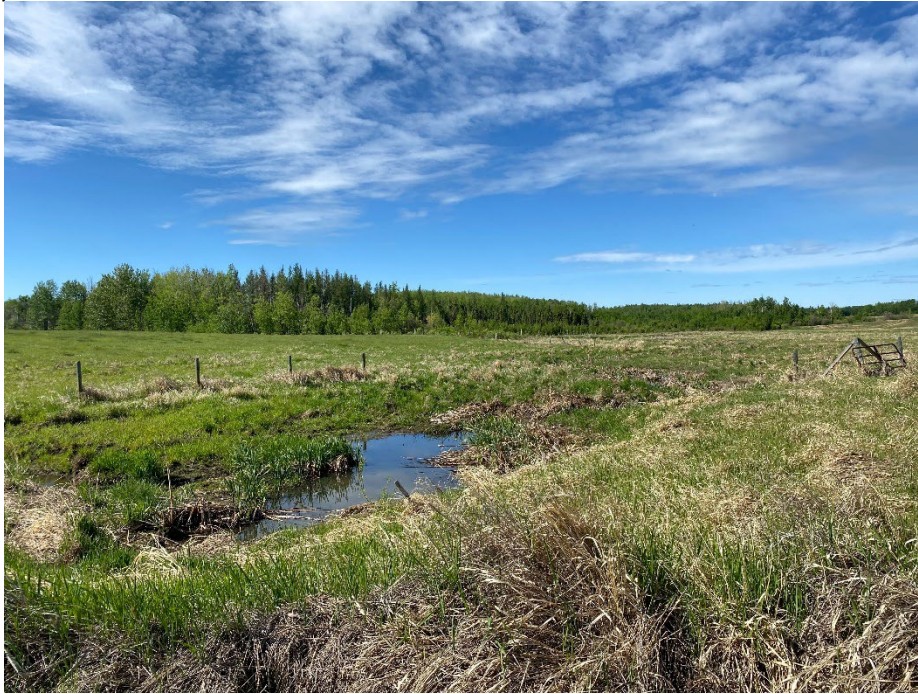
Photo 7: Ponding water at toe of slope. Looking southwest.

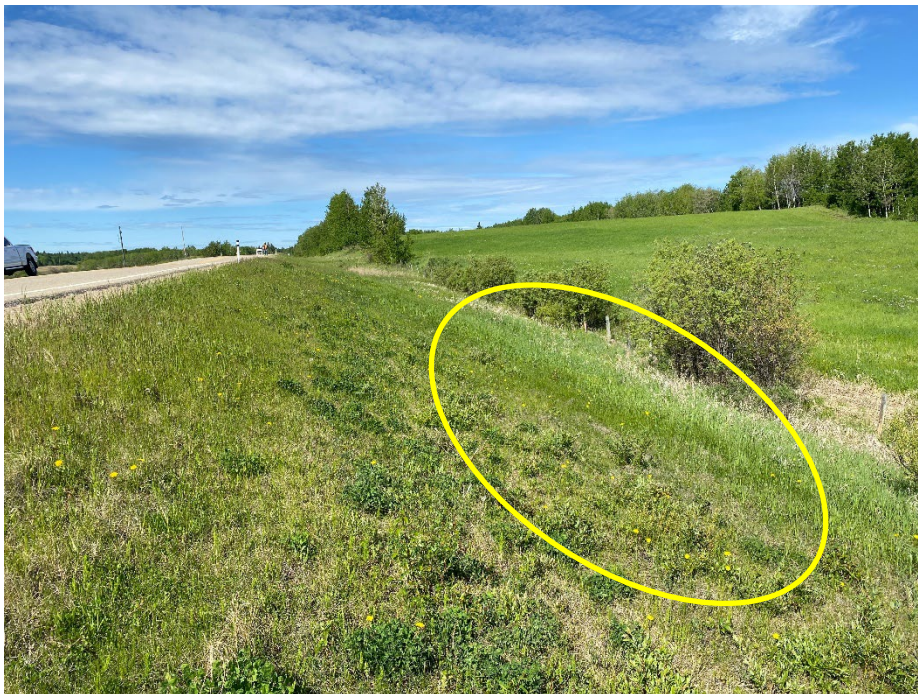
Photo 8: Slumping in north ditch, north from BH17-01. Looking southwest.
