To:	Amy Driessen	From:	Leslie Cho and Xiteng Liu
	Transportation and Economic Corridors		Stantec Consulting Ltd.
File:	123315222	Date:	June 18, 2024

**Reference: North Central Region, Edson, Site NC013 - Highway 633:02 Cattlepass West, Spring 2024 Instrumentation Monitoring Report**

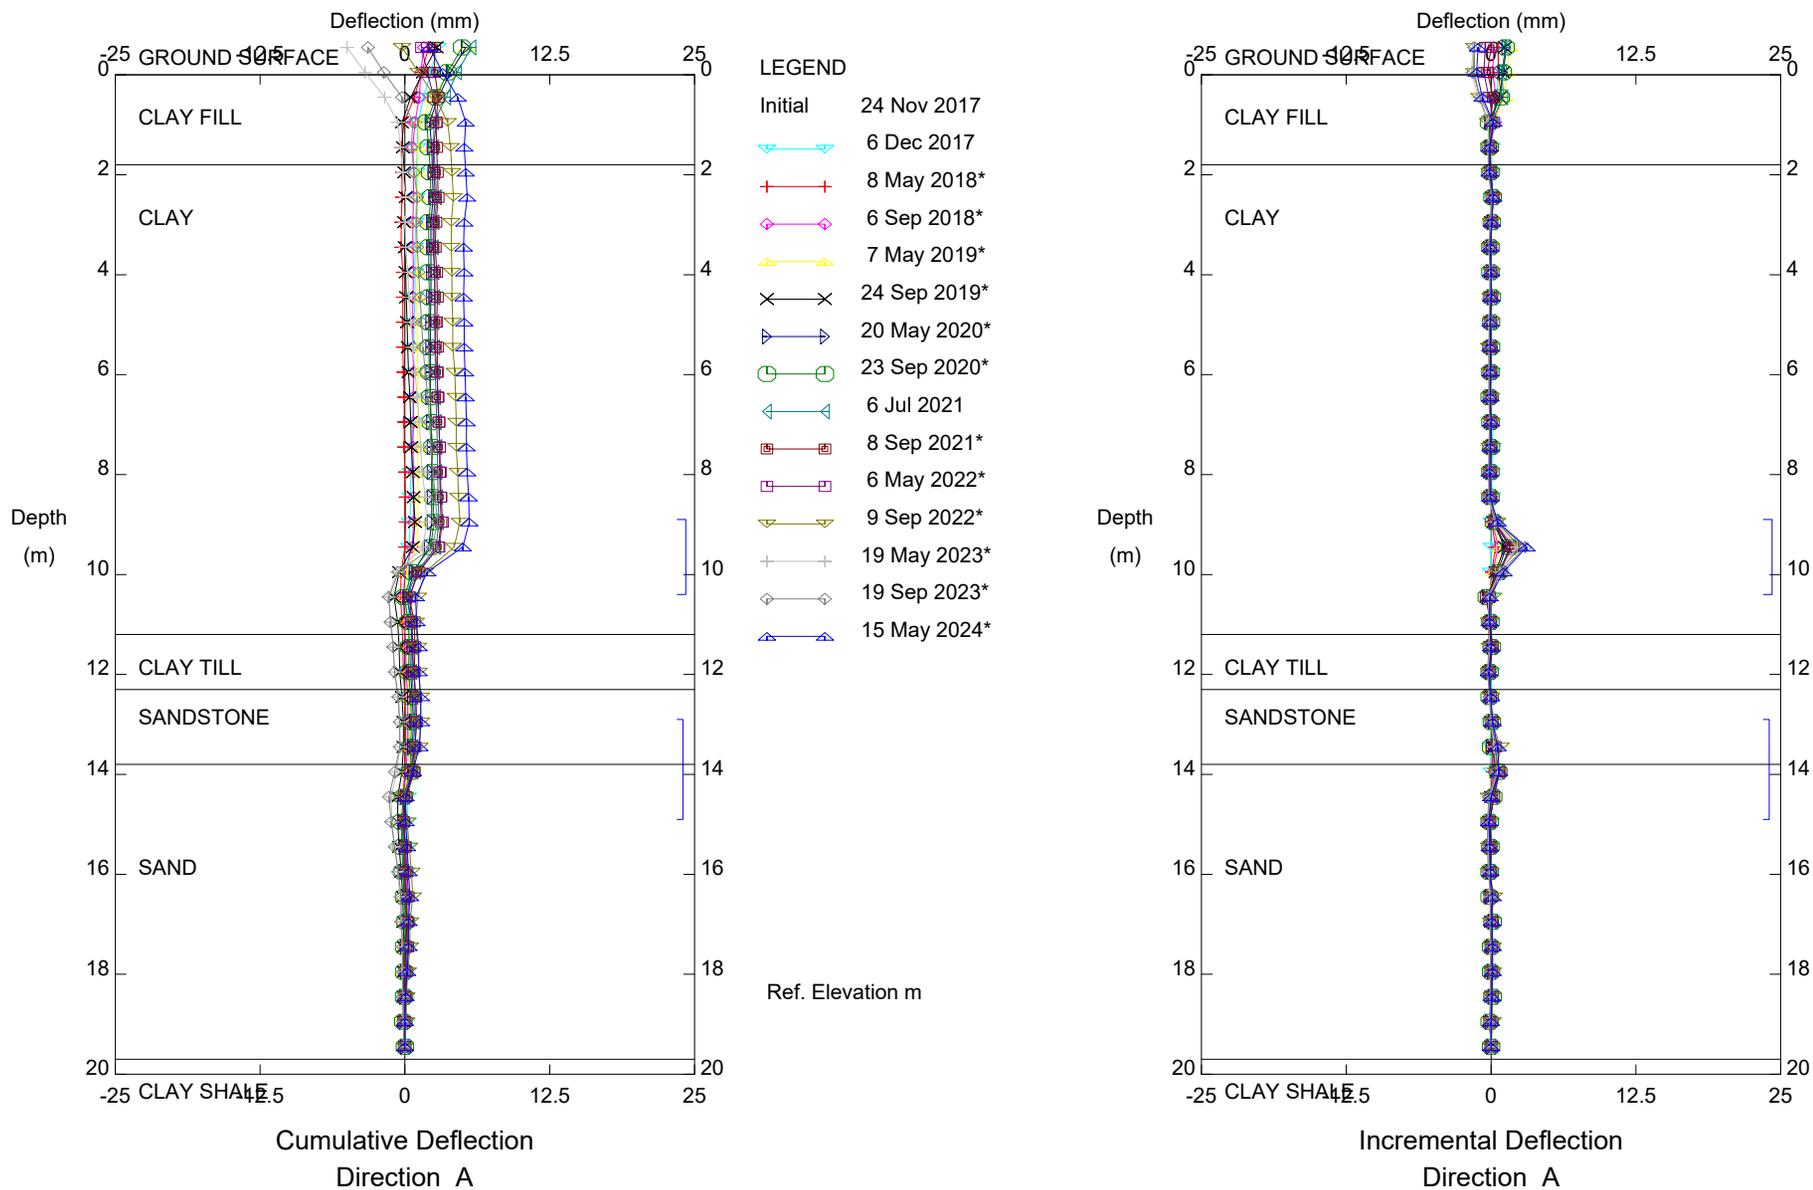
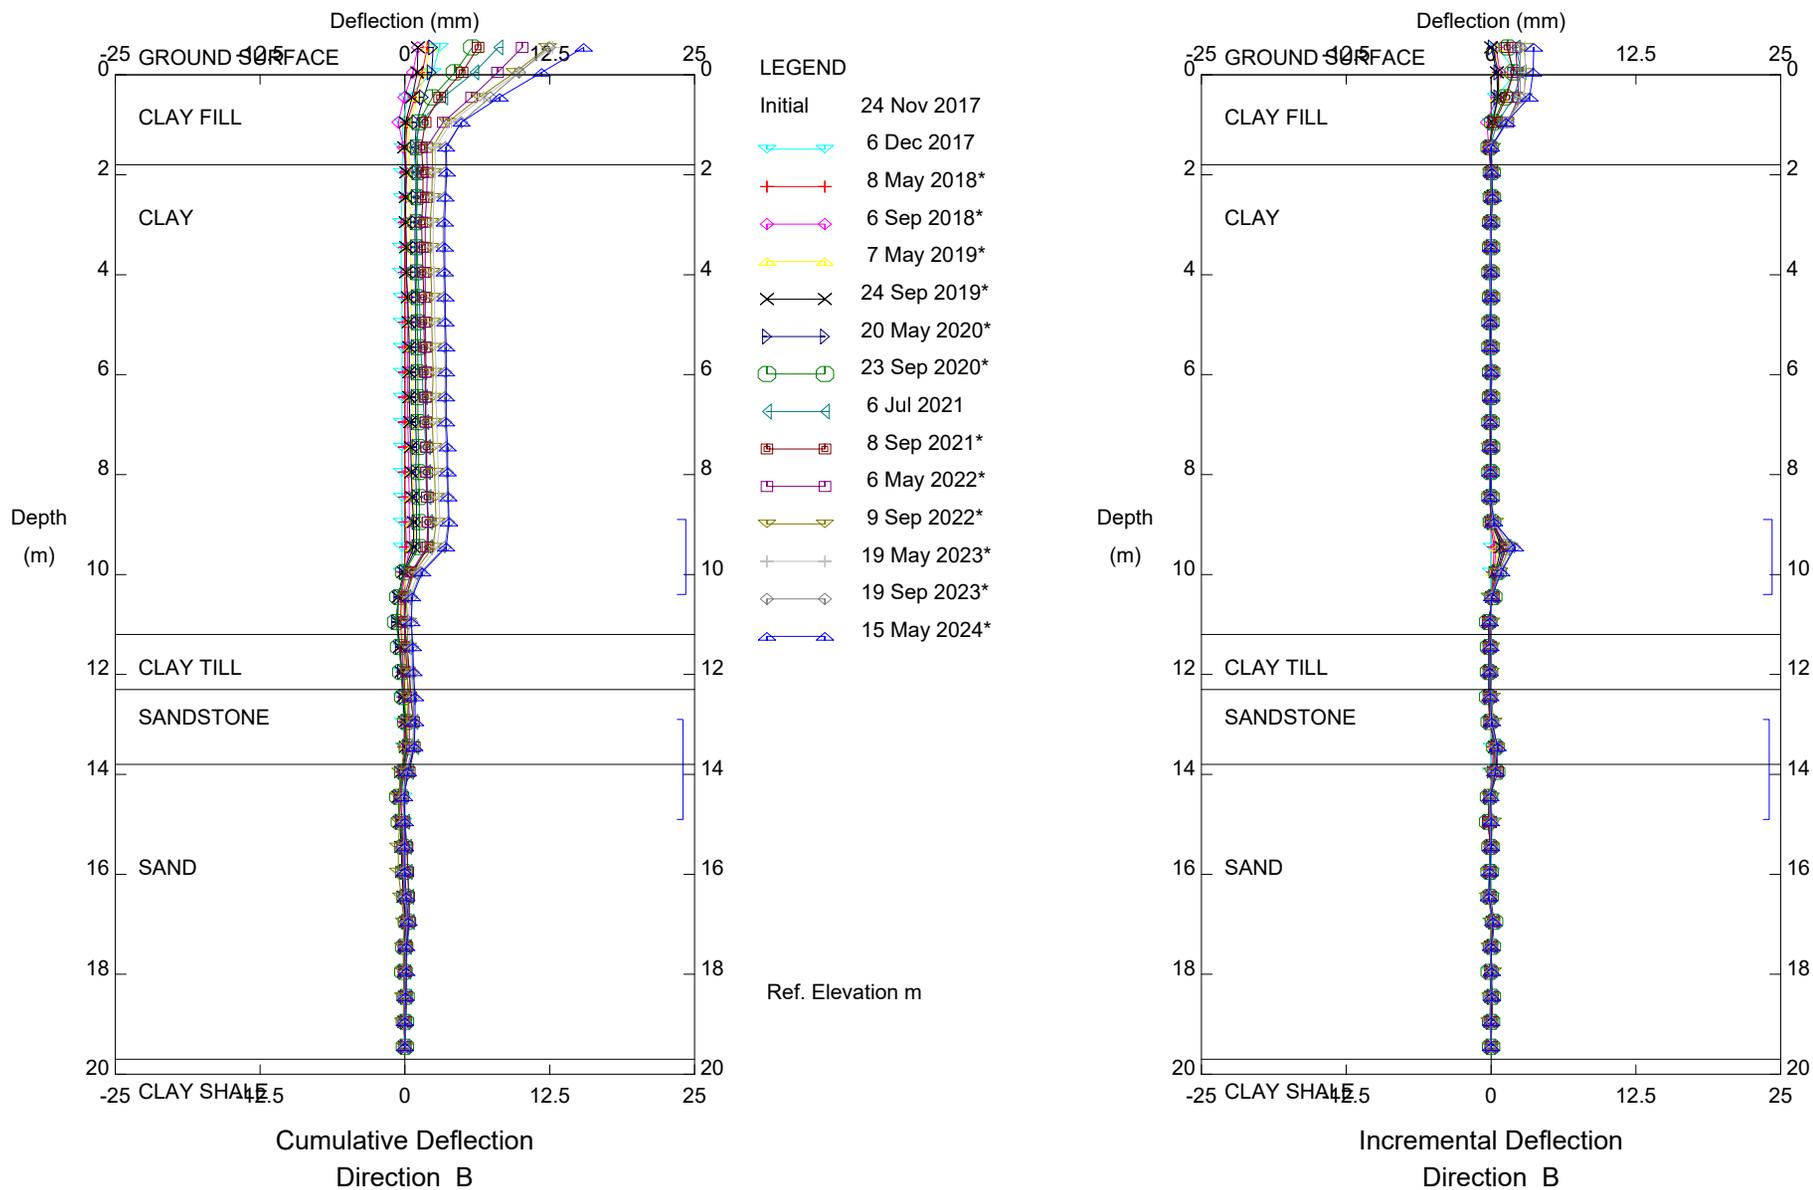
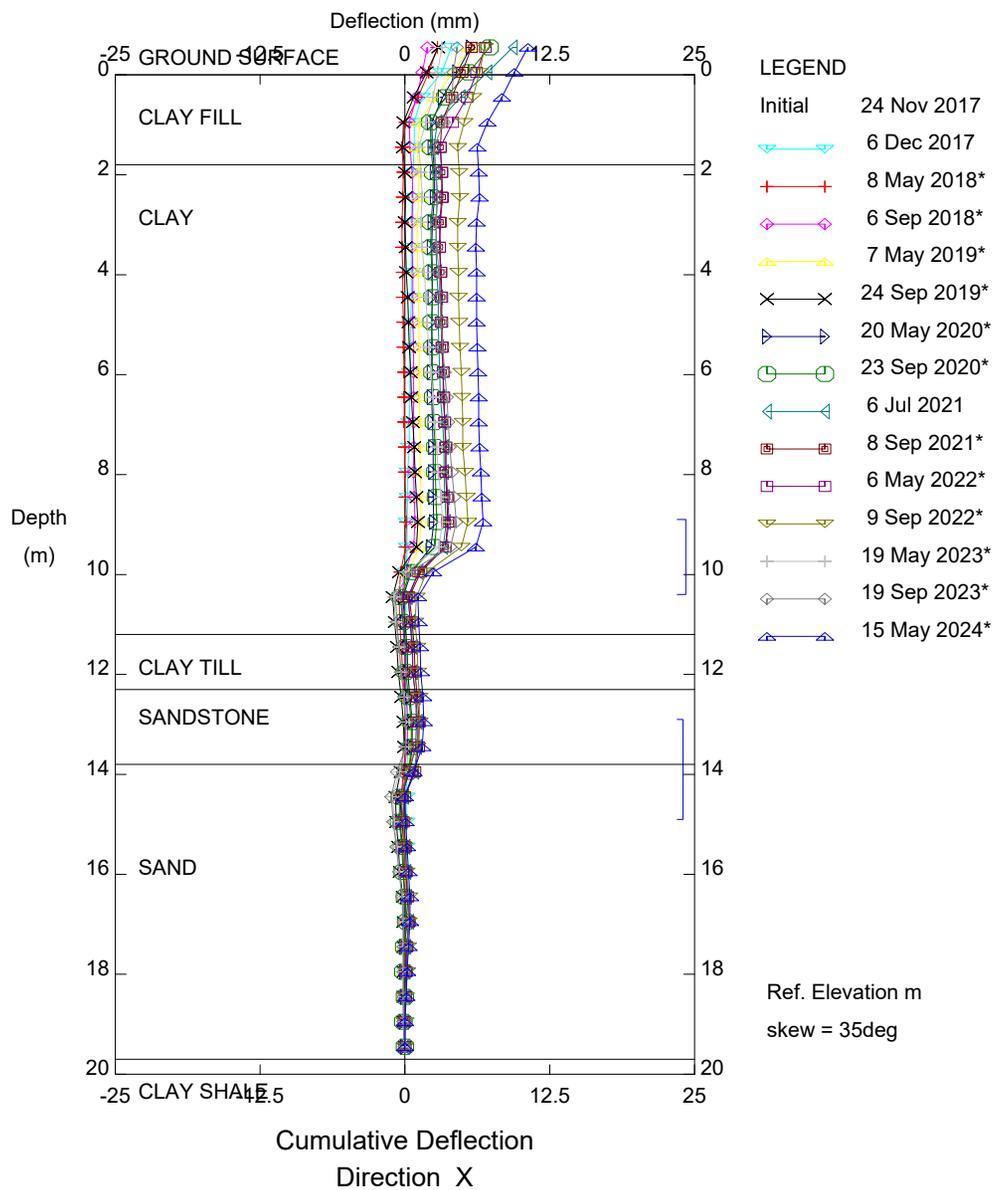
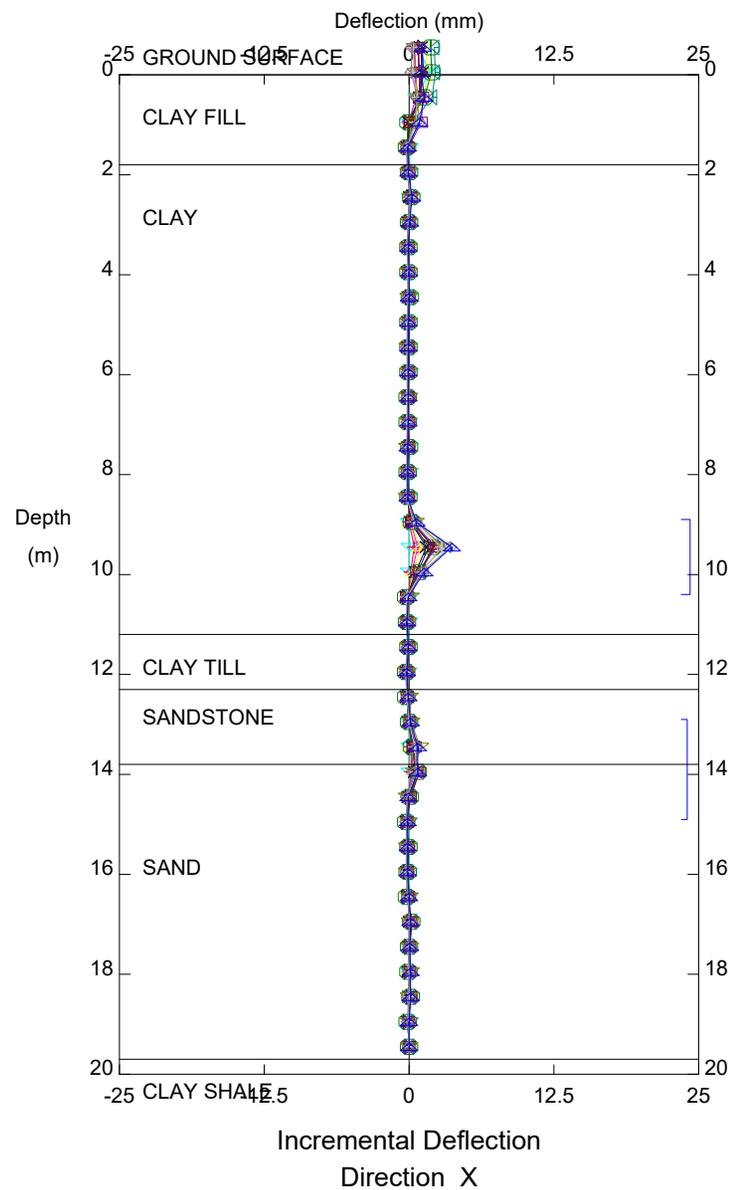
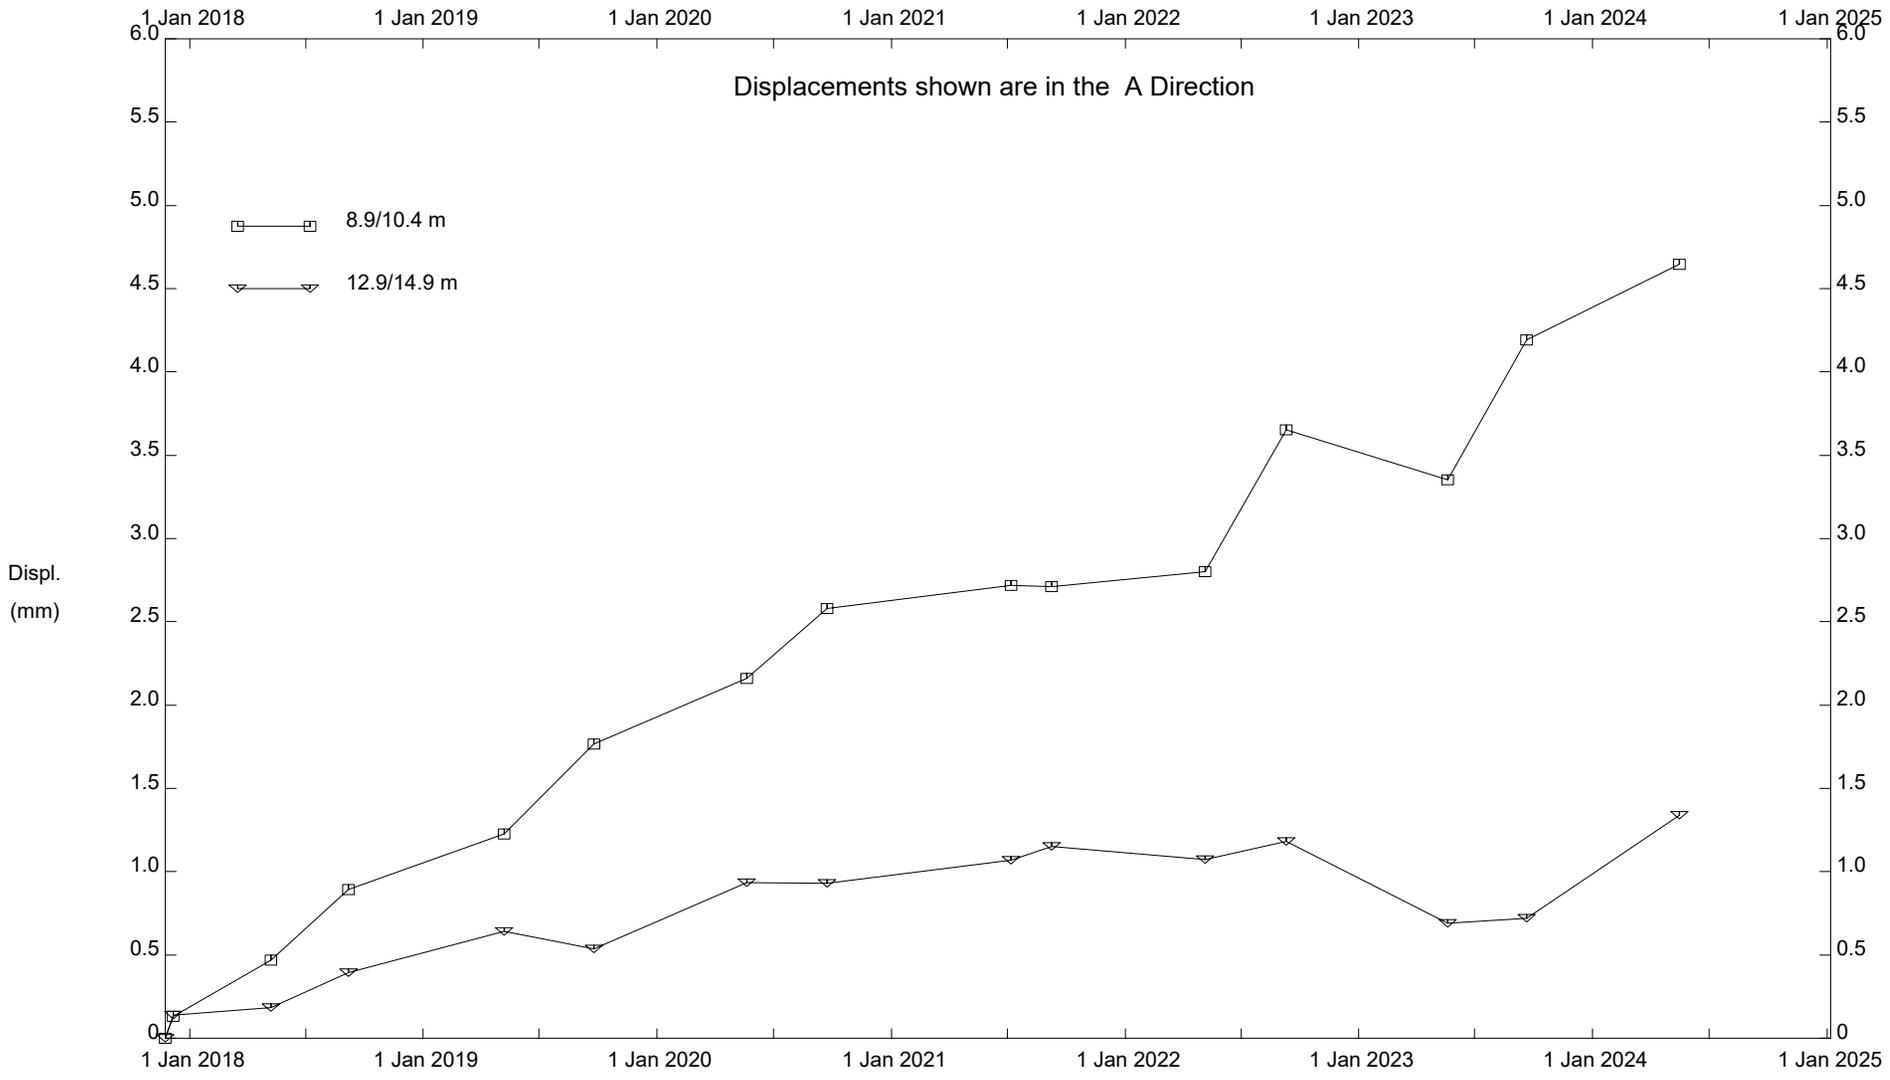
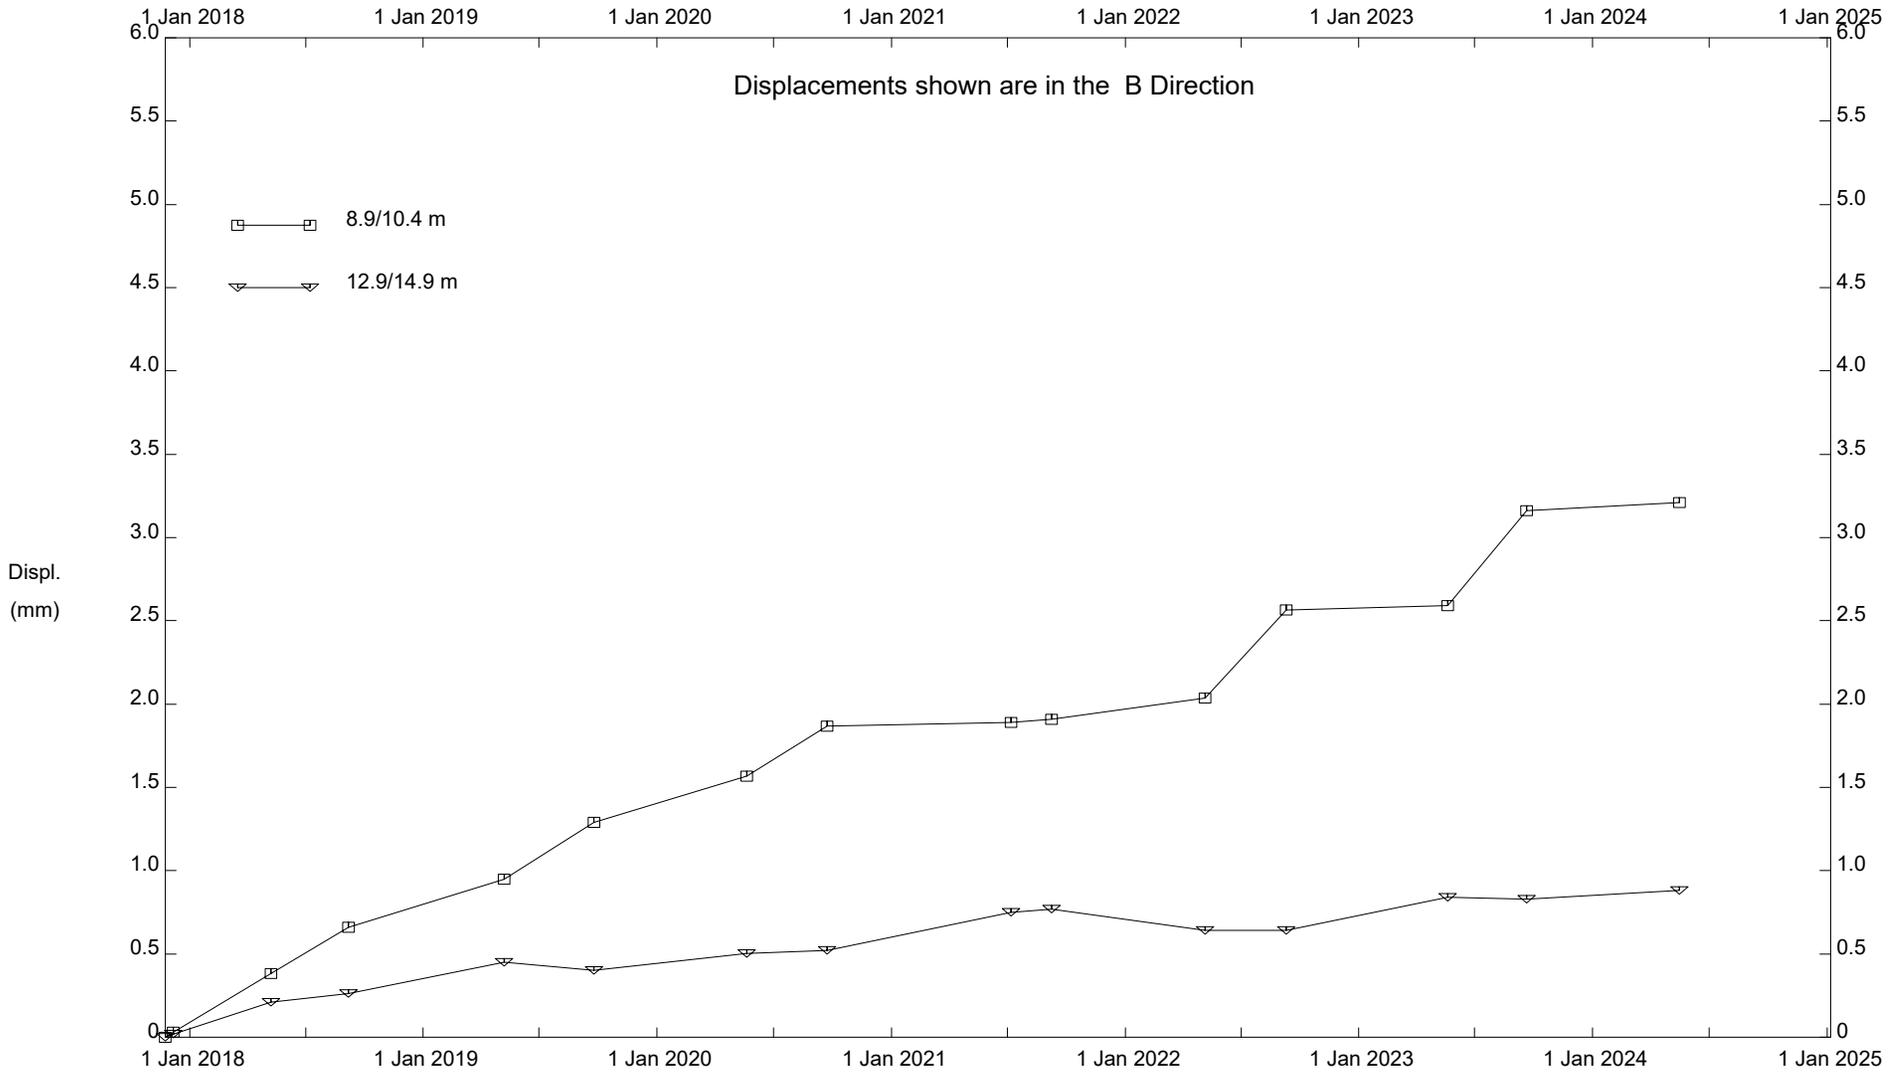
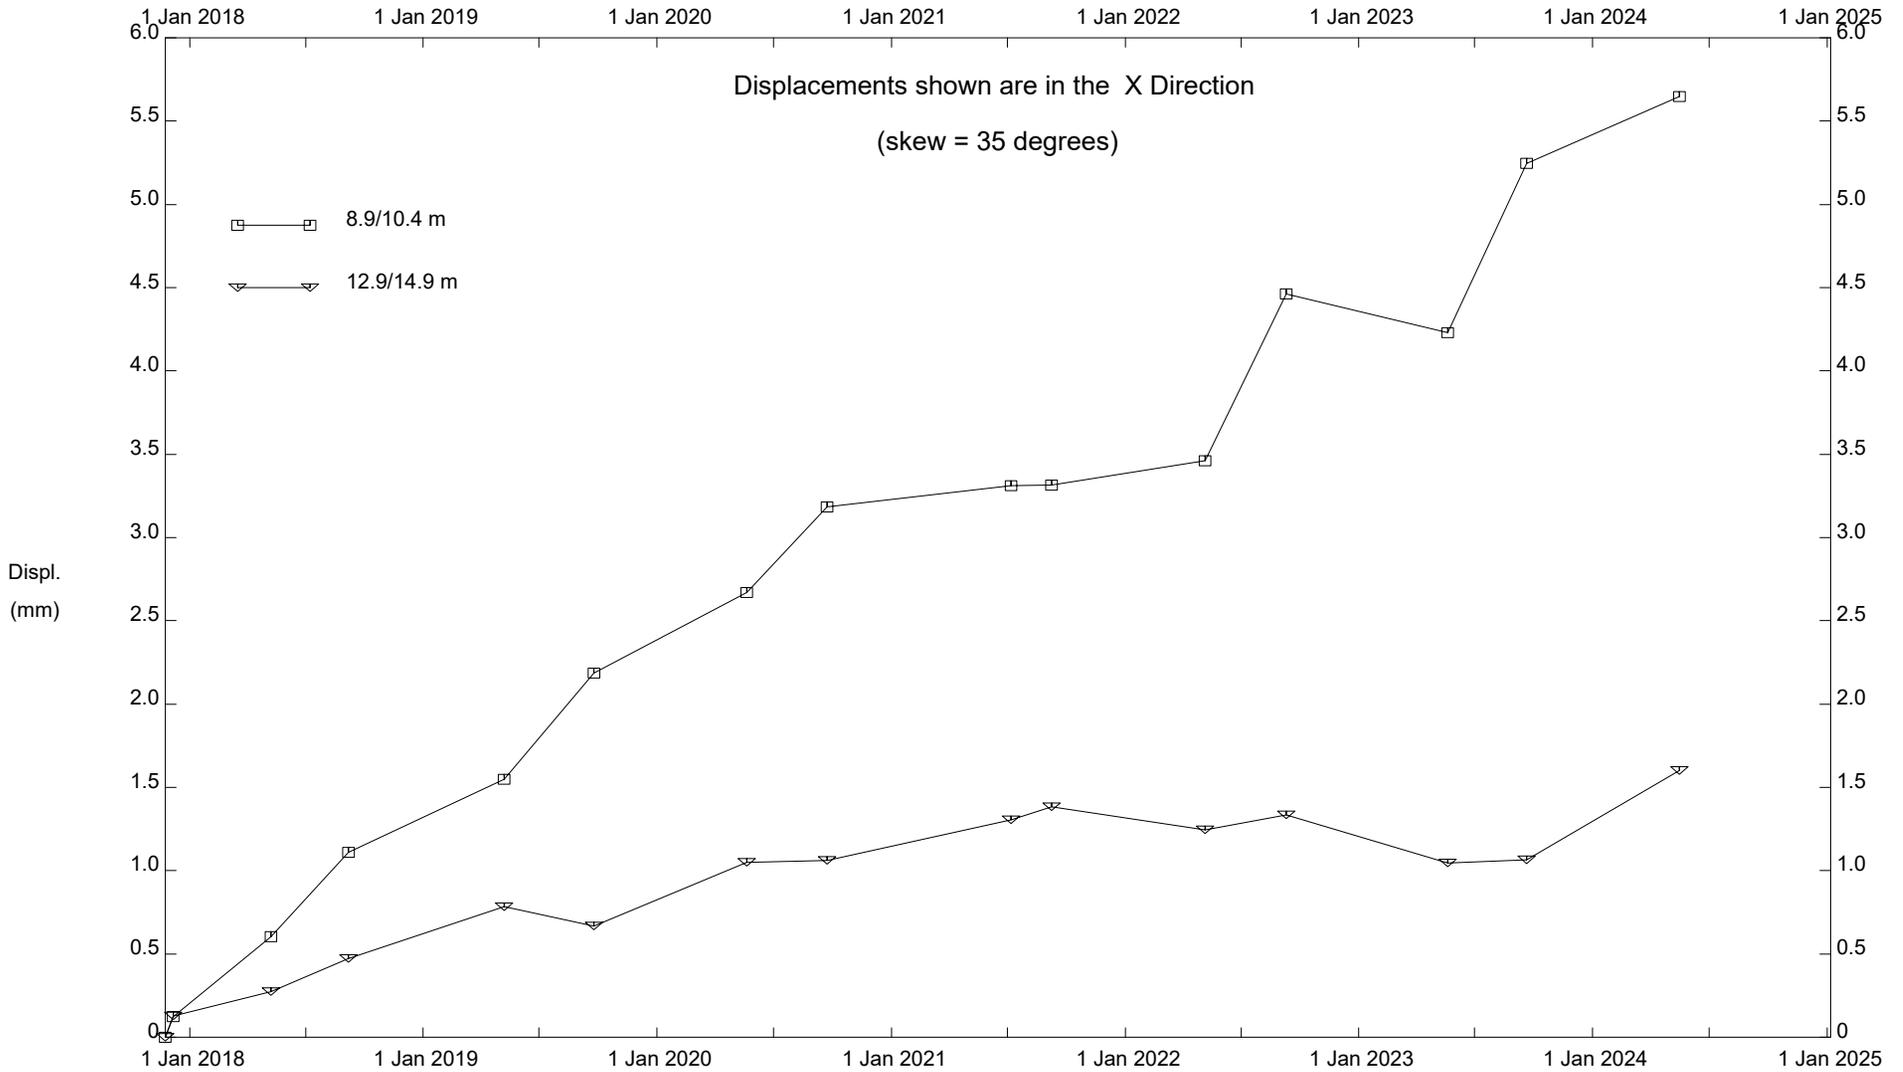
NC13, Inclinator SI17-02

SI17-02 has two movement zones being monitored, the upper movement zone is at 8.9 m to 10.4 m and the lower movement zone is at 12.9 to 14.9 m. The cumulative movement in each zone is 6 mm and 2 mm, respectively. The current rate of movement for both zones is less than or equal to 1 mm/yr.

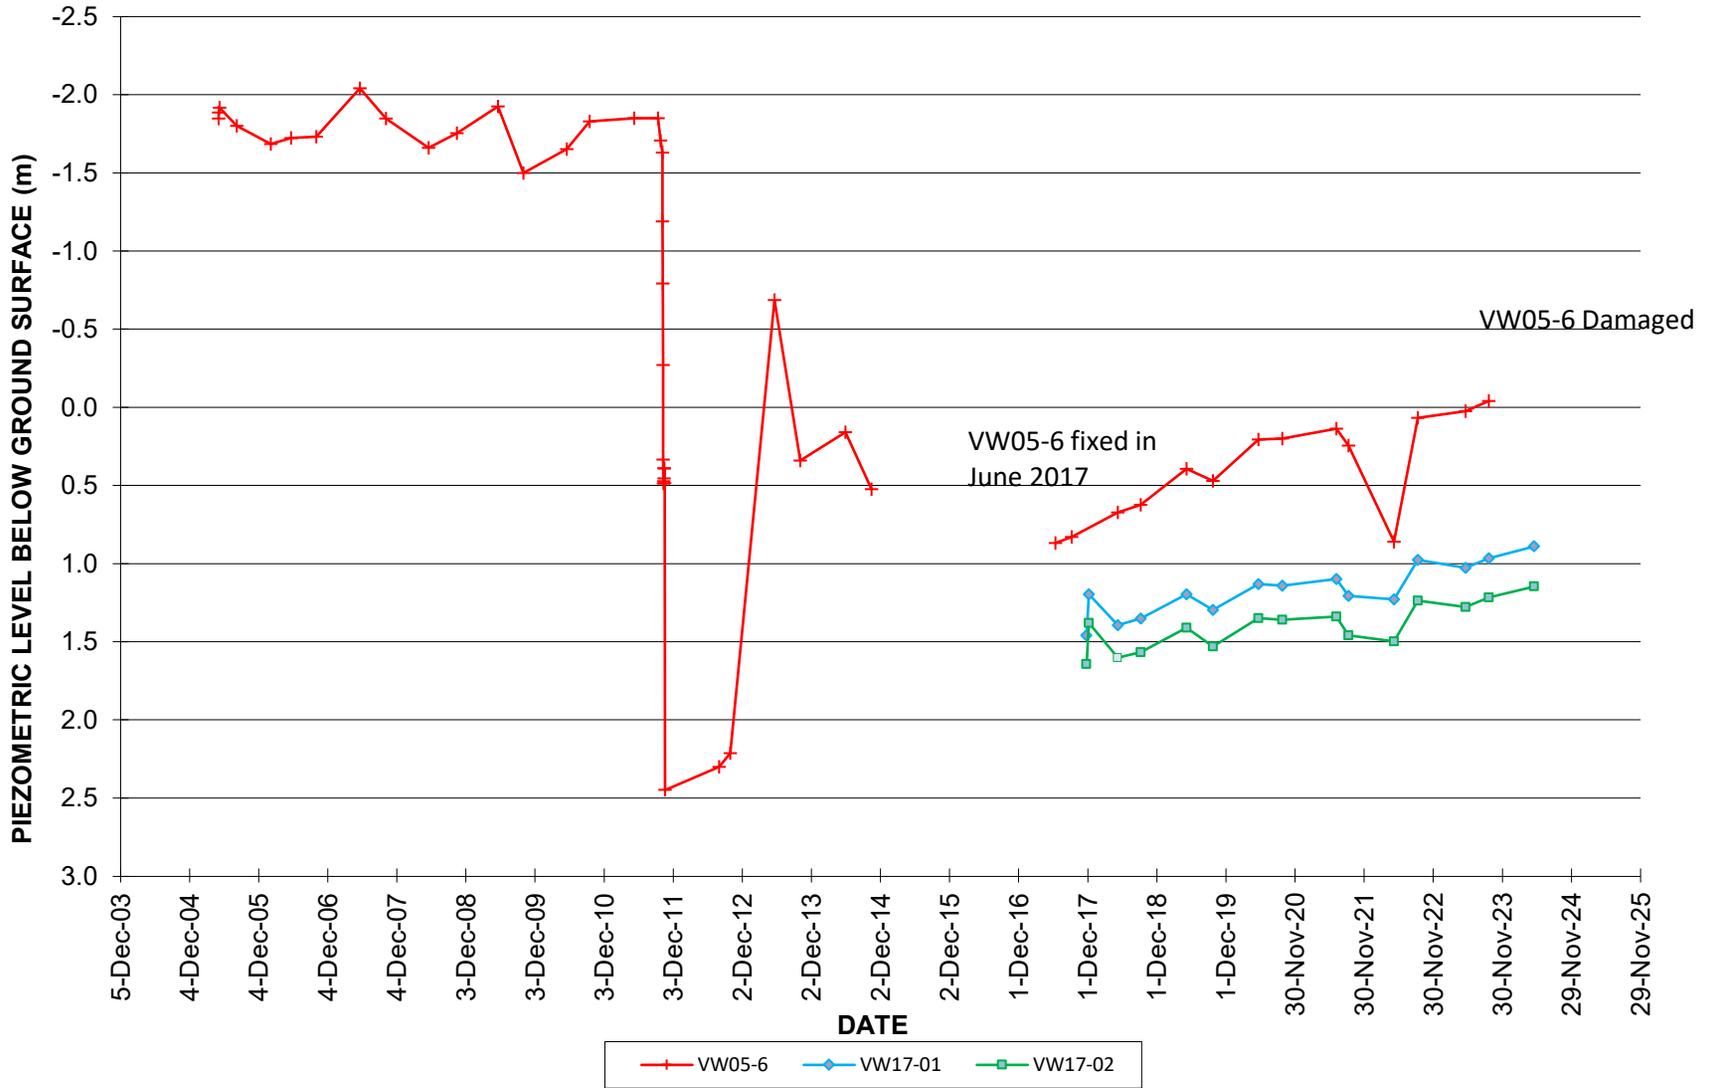
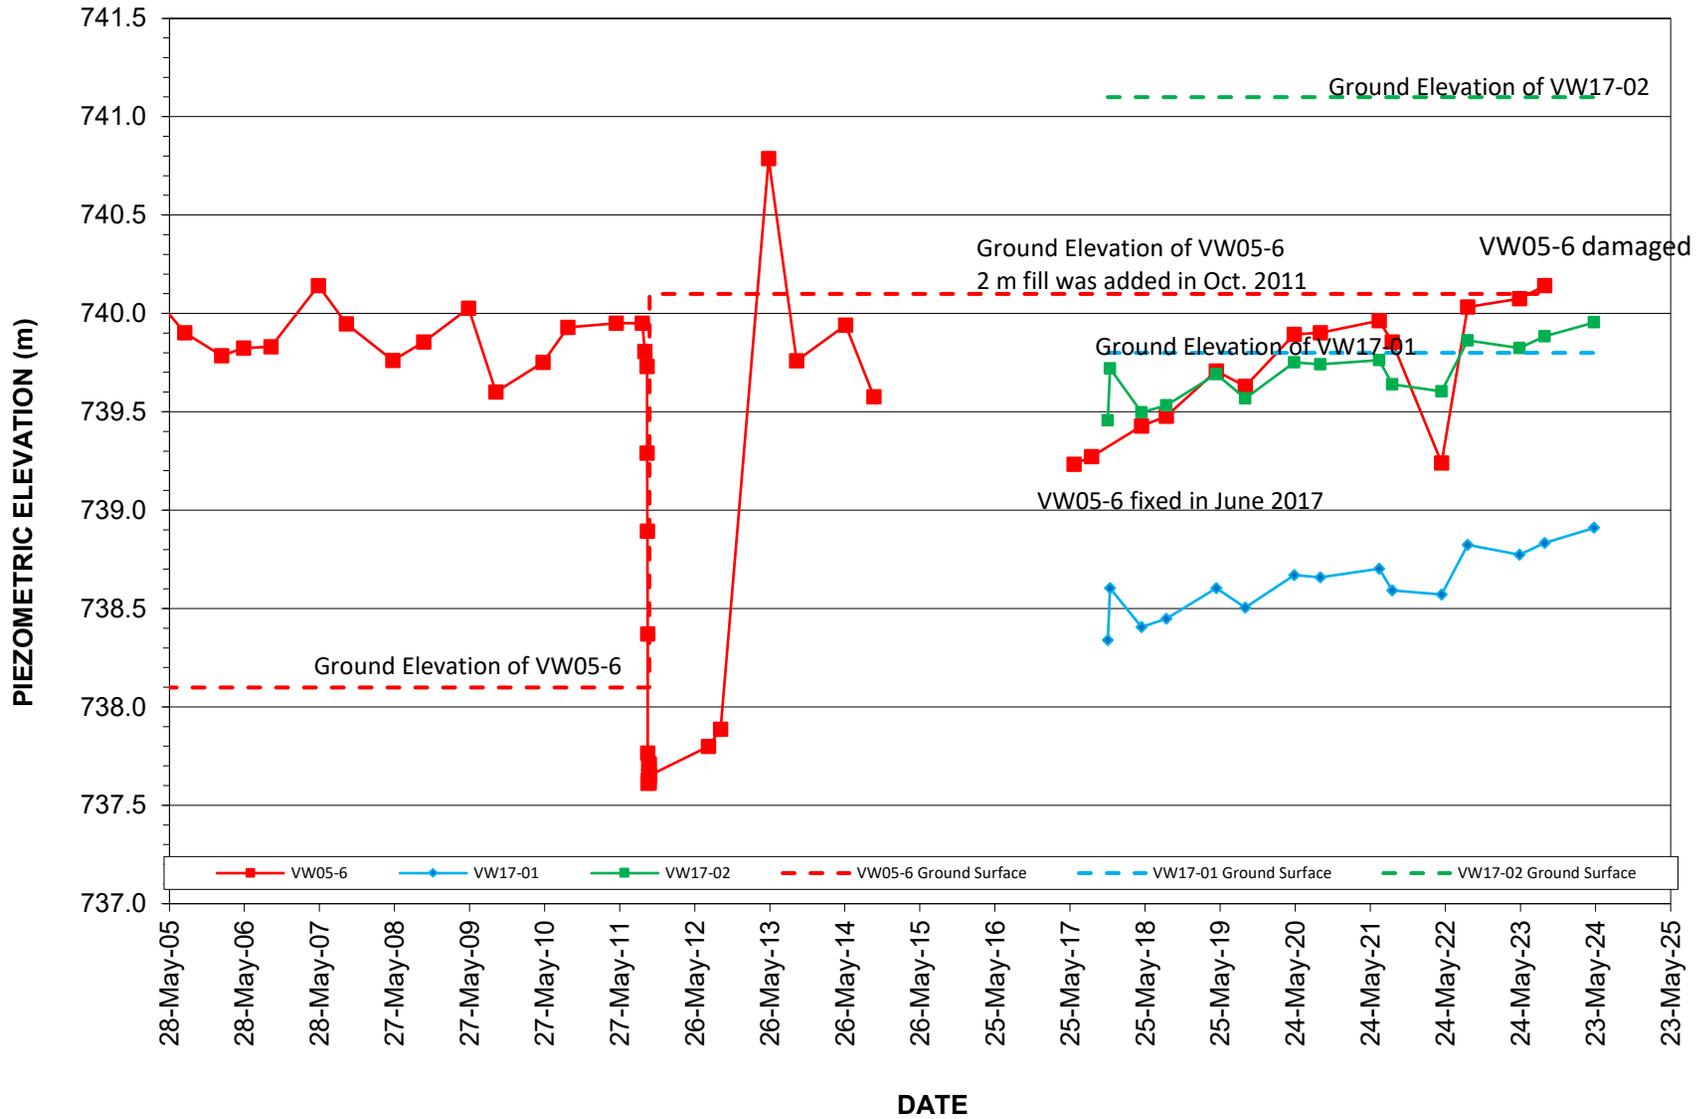
### PIEZOMETER DATA NC13: HWY633:02, Cattlepass West

Water level in VW17-01 and VW17-02 both increased by about 0.1 m. VW17-01 and VW17-02 showed a current piezometric level of 0.9 m and 1.1 m bgs, respectively, marking their highest water levels to date.
