## GEOHAZARD RISK MANAGEMENT PROGRAM

### North Central Region – Edson / Stony Plain Area

#### 2020 Inspection Report

Site Number	Site Name	Hwy	km
NC44	Cattlepass East	633:02	1.5
Legal Land Description	NW 29-53-6-W5M		
UTM Coordinates (NAD 83)	Zone 11N	N5942545	E642834
Operational Site Instrumentation	Slope Inclinometers	2	
	Pneumatic Piezometers	1	
	Vibrating Wire Piezometers	2	
	Standpipe Piezometers	0	
Date of Last Instrumentation Readings	May 20, 2020

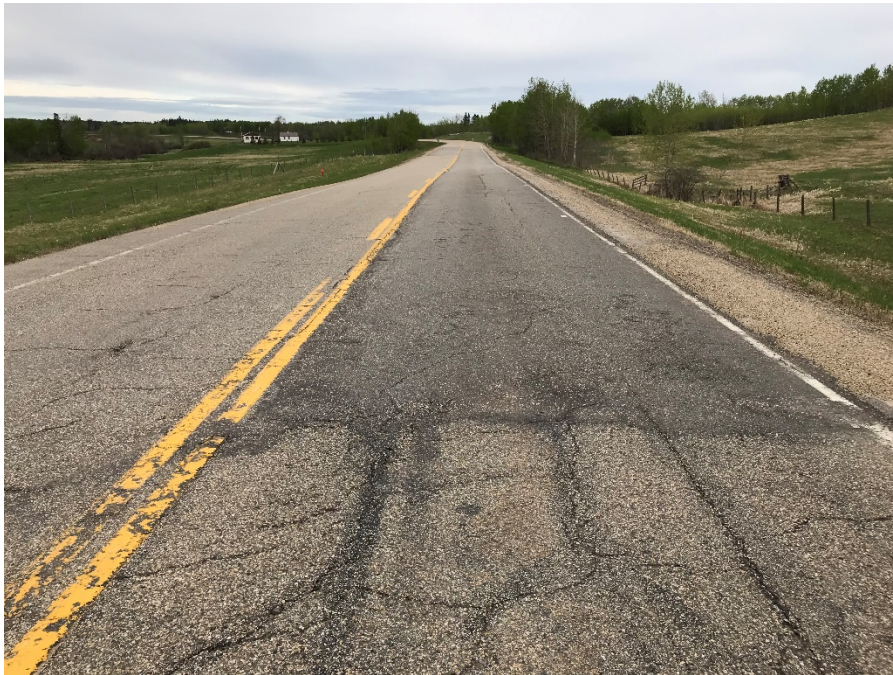
<b>Discussion</b>	<p>The westbound lane and parts of the eastbound lane on Highway 633 was last overlaid in mid-June 2017. The cracking pattern on the highway appeared mostly similar to the previous inspection as shown in Photos 1 to 4. A new crack had developed upslope from BH17-01 and SI05-7 and is shown in Photo 3. Potential toe bulging was observed downslope from this crack as shown in Photo 5.</p> <p>Standing water was observed at both ends of the culvert as shown in Photos 6 and 7. There appears to be little grade for water to drain from the culvert outlet.</p> <p>The berm was grass covered with no visible signs of distress observed.</p> <p>Erosion is ongoing in the north ditch as shown in Photo 8.</p>
<b>Assessment</b>	<p>Pore water pressures at this site remain high with PN05-8 showing artesian conditions at 0.1 m above ground surface. A general trend of increasing pore pressures can be seen since about 2011.</p> <p>Reflection of the cracks through the overlay in previous years suggests that slope movement is ongoing. This is further evidenced by increased movement recorded in SI17-01 at a depth of about 10 m below ground surface. On-going movement may be due to the high pore pressures at the site. A possible source of water infiltration into the slope is through the erosion channel on the north ditch. The ponded water on both ends of the culvert may also be allowing water to infiltrate the slope.</p>

**Photo 1:** Pavement cracks at east limits of 2017 patch. Looking west.

<b>Recommendations</b>	<p>Short term recommendations include sealing of any cracks to reduce surface water infiltration into the slope and pavement structure. The culverts at the site should be inspected on a regular basis to reduce the risk of pore pressures building up in the berm and slope and to maintain functionality. Grading may be considered at the culvert inlet to reduce the amount of ponded water. The erosion gully in the north ditch should be repaired to reduce seepage of water into the slope and under the highway.</p> <p>Long term recommendations may consist of lowering the overall highway grade to reduce the driving force on the slope. Alternatively, reconstruction of the highway using lightweight fill may also help reduce the driving force on the slope.</p> <p>Site inspections should be completed annually. Instrumentation monitoring should be completed semi-annually.</p>
------------------------	---

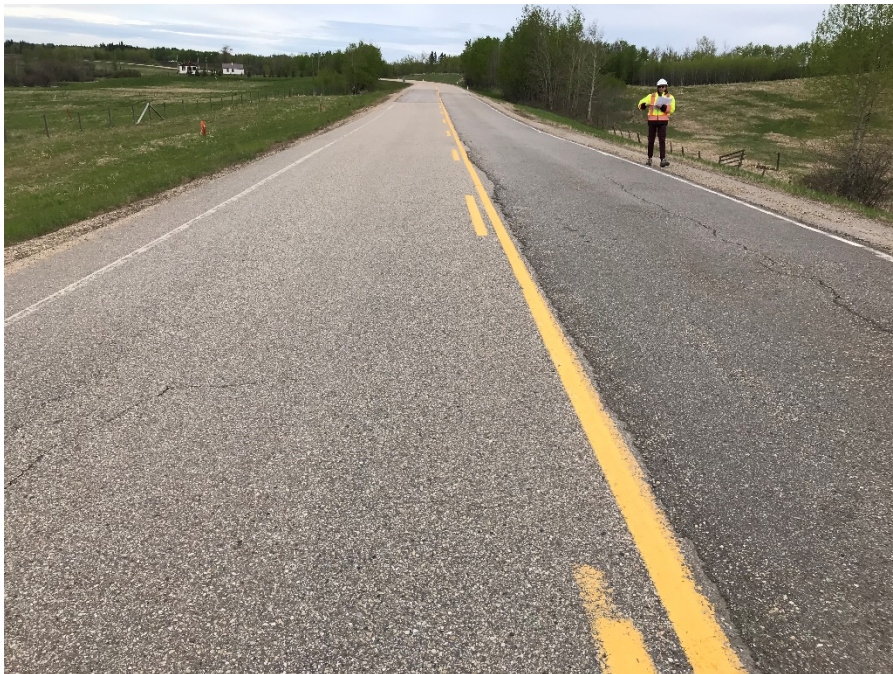
**Photo 2:** Pavement cracks along Highway 633. Looking west.

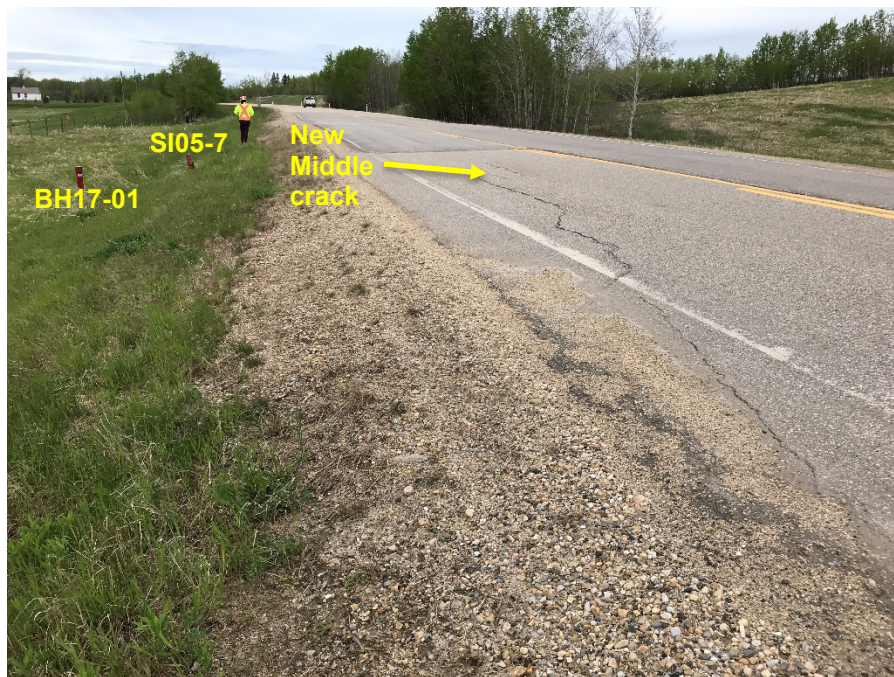
**Photo 3:** Pavement cracks along Highway 633. Looking west.

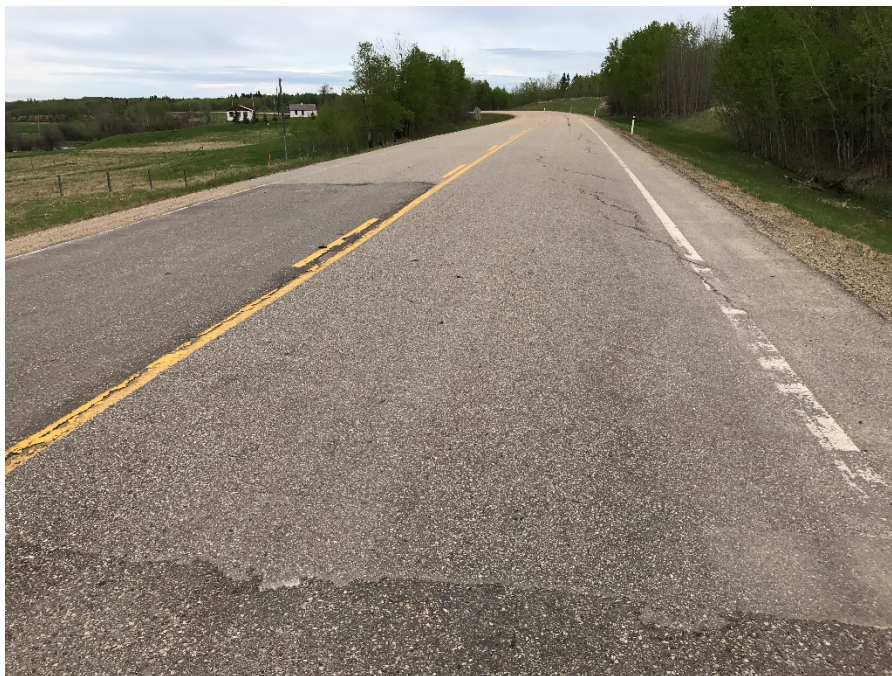
**Photo 4:** Pavement cracks at west limits of 2017 patch. Looking west.

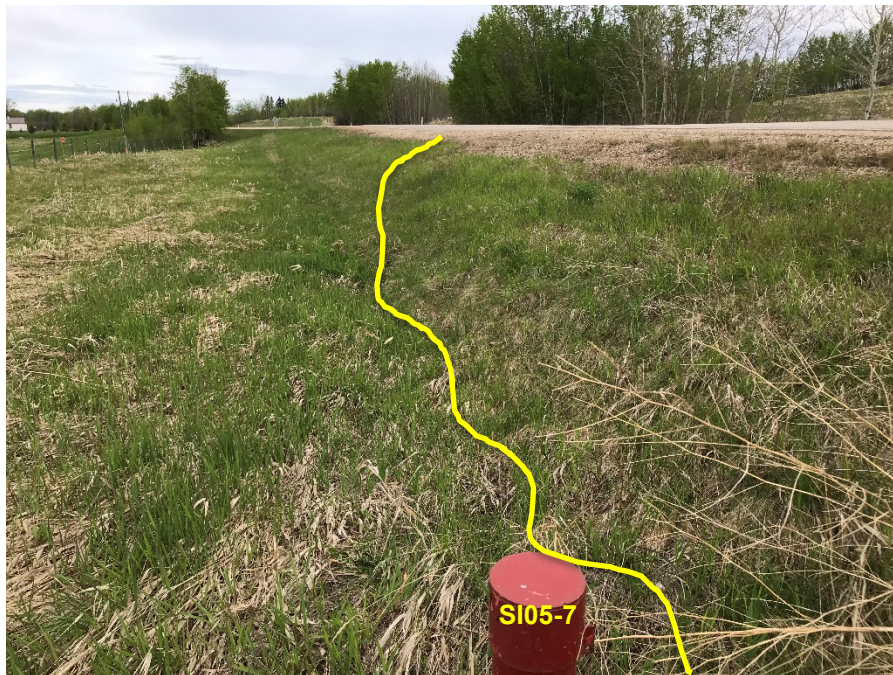
**Photo 5:** Potential bulging near SI05-7. Looking west.

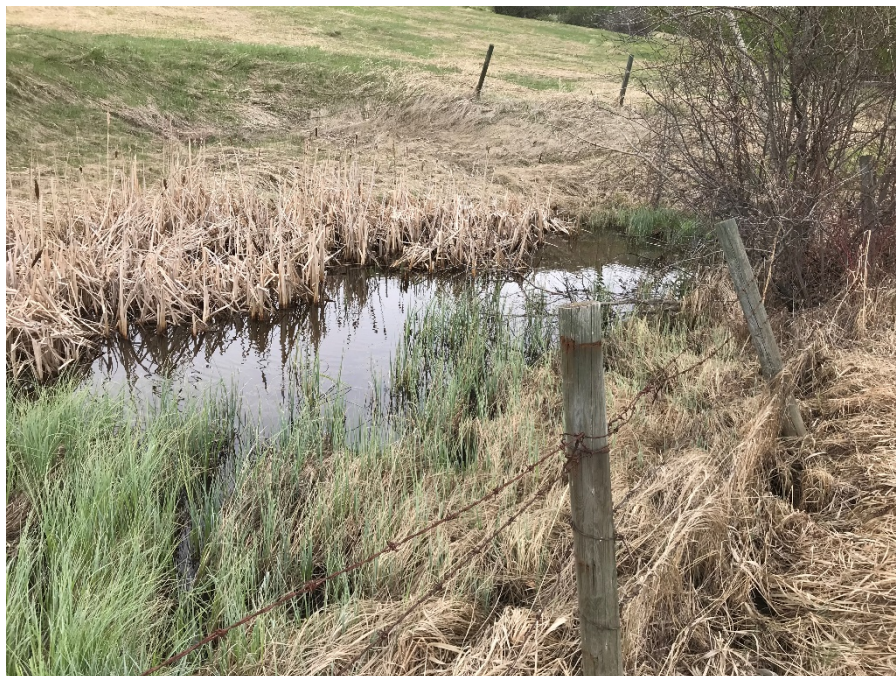
**Photo 6:** Ponded water at culvert inlet in the north. Looking northeast.

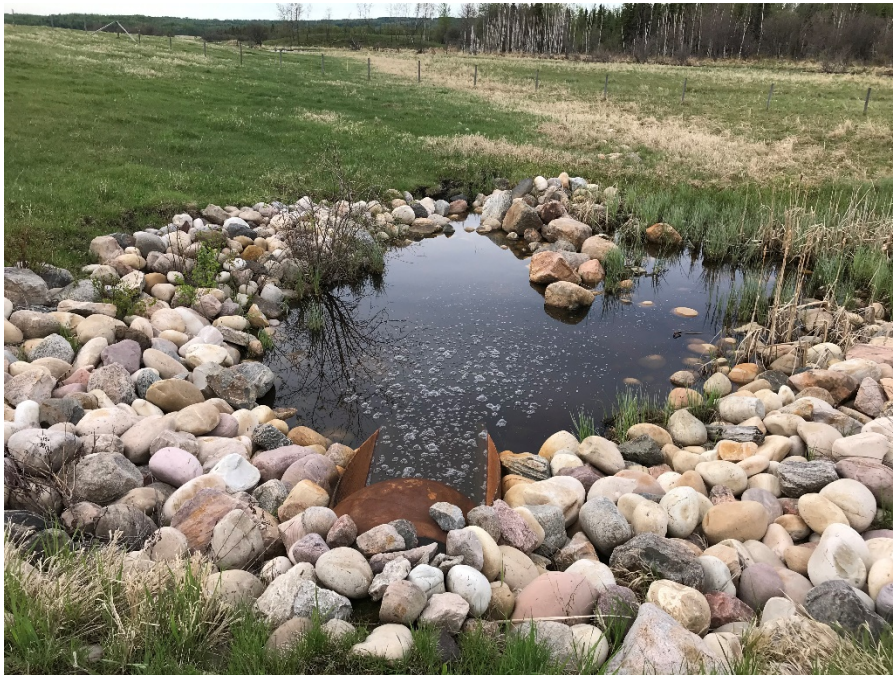
**Photo 7:** Ponded water at culvert outlet in the south. Looking south.

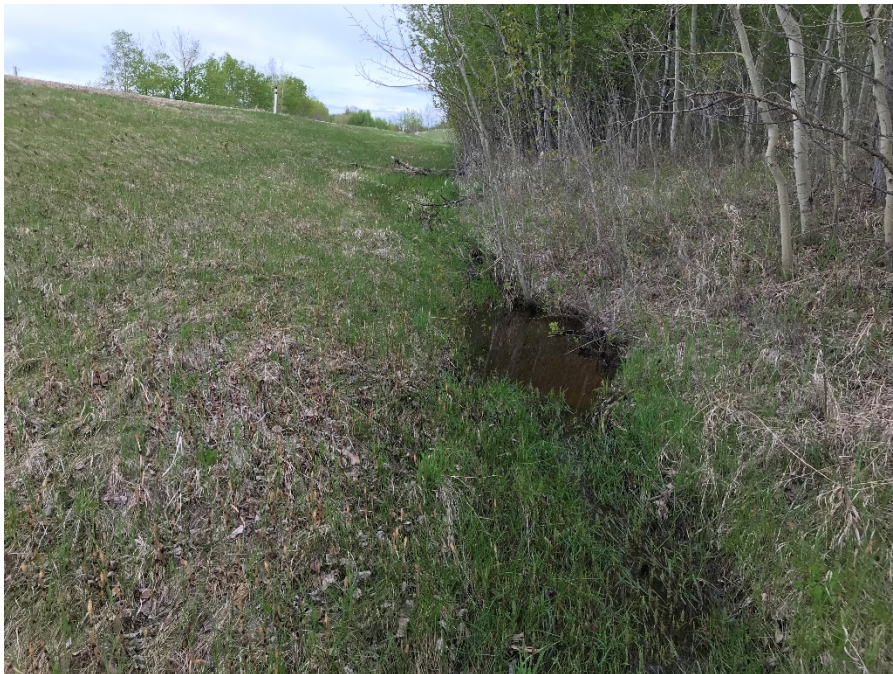
**Photo 8:** Erosion gully along north ditch of Highway 633. Looking west.
