SITE NUMBER AND NAME: NC044 – Cattlepass East	HIGHWAY AND KM: 633:02, km 1.434	PREVIOUS INSPECTION: May 25, 2020	CURRENT INSPECTION: June 15, 2022
LEGAL DESCRIPTION: NW 29-53-6-W5M	NAD83 COORDINATES: UTM11U 5942545N, 642834E		RISK ASSESSMENT: PF: 9 CF: 4 Total: 36
AVERAGE ANNUAL DAILY TRAFFIC (AADT): 410 (2021)		CONTRACTOR MAINTENANCE AREA (CMA): 509

2022 Site Inspection Photos at NC044

Client/Project: Alberta Transportation
 Geohazard Monitoring Program
 NC44 Cattle Pass East

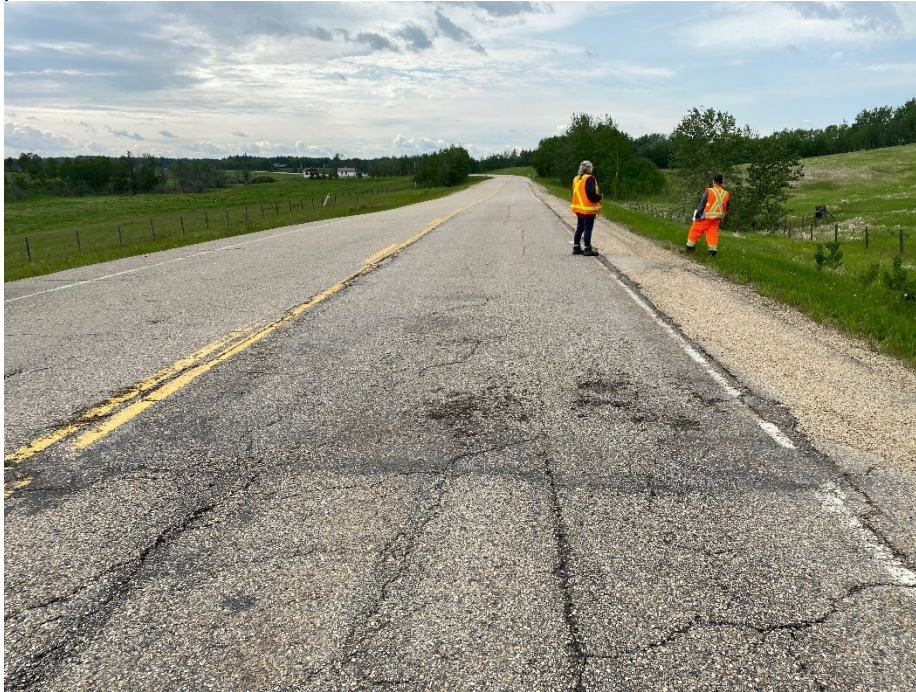
COMMENTS
<ul style="list-style-type: none"> The cracking pattern on the highway appeared mostly similar to the previous inspection as shown in Photos 1 to 4. A new crack had developed upslope from BH17-01 and SI05-7 and is shown in Photo 3. Potential toe bulging was observed downslope from the new crack as shown in Photo 5. SI17-01 shows continued movement at a rate of about 2 mm/yr between 6 m and 10 m depth. SI17-02 shows creep between 12 and 16 m. Ongoing movement may be due to high pore pressures at the site. A possible source of water infiltration into the slope is through the erosion channel on the north ditch. The ponded water on both ends of the culvert may also be infiltrating into the slope. Groundwater levels in PN05-8 and VW17-02 are within 1 m of ground surface while VW17-01 is about 3 m below ground surface. Standing water was observed at both ends of the culvert as shown in Photos 6 and 7. Water appeared to be flowing through the culvert. There appears to be little grade for water to drain from the culvert outlet. The berm was grass covered with no visible signs of distress observed. Erosion is ongoing in the north ditch as shown in Photo 8.

Photo 1: Pavement cracks at east limits of 2017 patch. Looking west.

RECOMMENDATIONS
<ul style="list-style-type: none"> • Short term recommendations include sealing of any cracks to reduce surface water infiltration into the slope and pavement structure. Additional pavement patches are not recommended since it is considered an additional driving force on the embankment. Mill and fill could also be completed such that the final pavement elevation is not higher than the existing elevation. • The MCI should continue to inspect the culverts on site on a regular basis to reduce the risk of pore pressures building up in the berm and slope and to maintain functionality. • Grading may be considered at the culvert inlet to reduce the amount of ponded water. However, grading works would likely occur outside of AT's right-of-way. • The erosion gully in the north ditch should be repaired to reduce seepage of water into the slope and under the highway. • Long-term remediation may consist of lowering the overall highway grade to reduce the driving force on the slope. The high-level cost of grade reduction is \$1.8 Million minus engineering costs. Alternatively, reconstruction of the highway using lightweight fill may also help reduce the driving force on the slope. The high-level cost for reconstruction using lightweight fill is \$6.0 Million. • Site inspections frequency should remain at every two years with instrumentation monitoring completed annually in the spring.

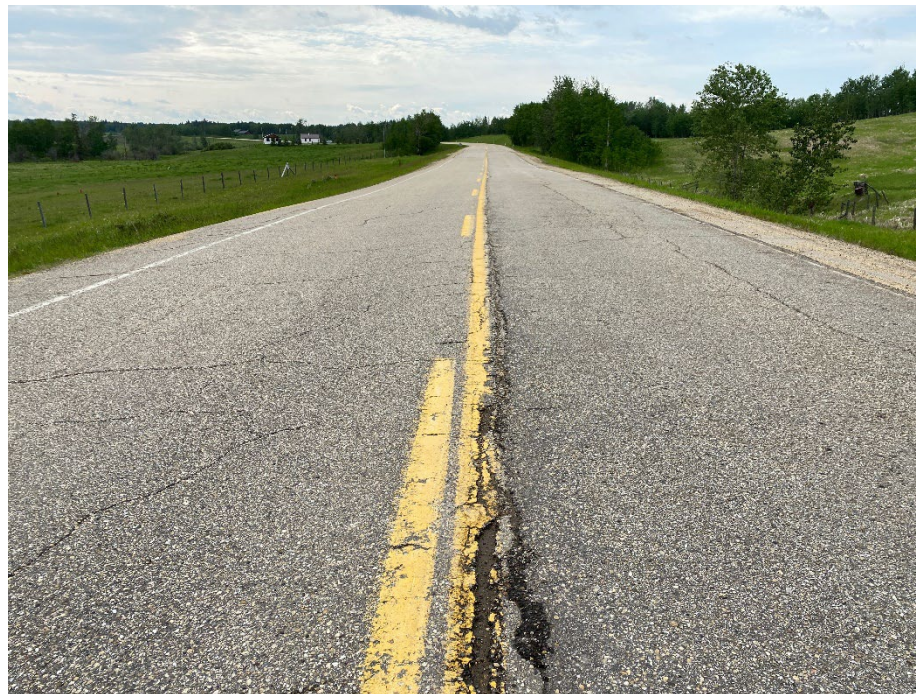
Photo 2: Pavement cracks along Highway 633. Looking west.

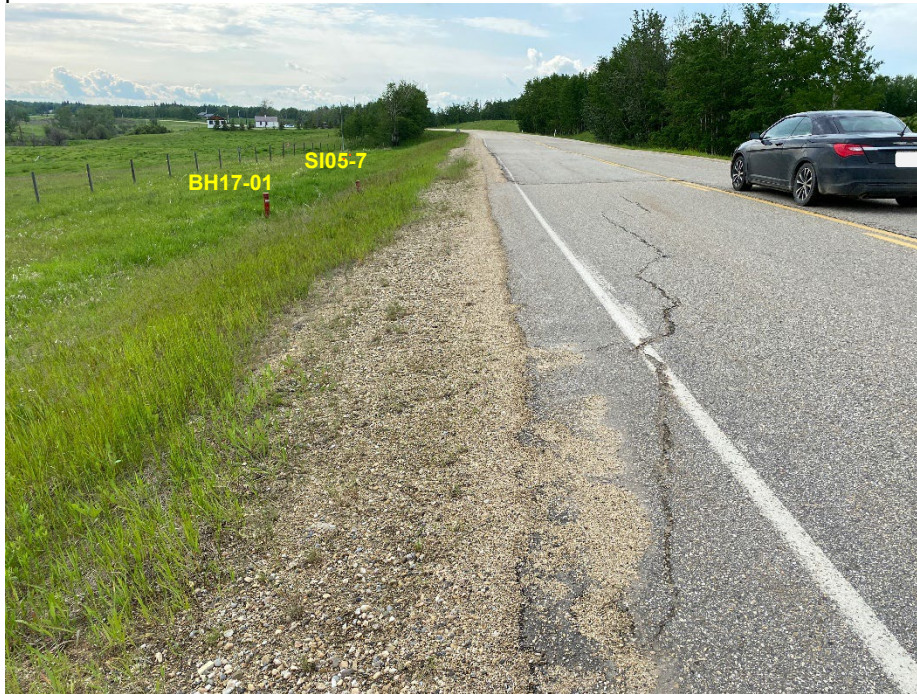
Photo 3: Pavement cracks along Highway 633. Looking west.

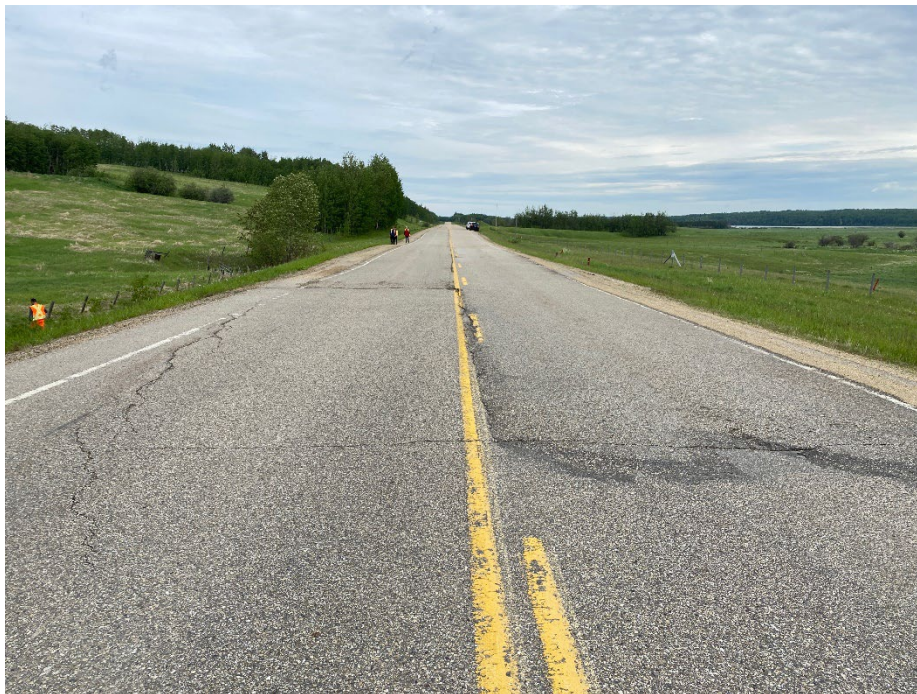
Photo 4: Pavement cracks at west limits of 2017 patch. Looking east.

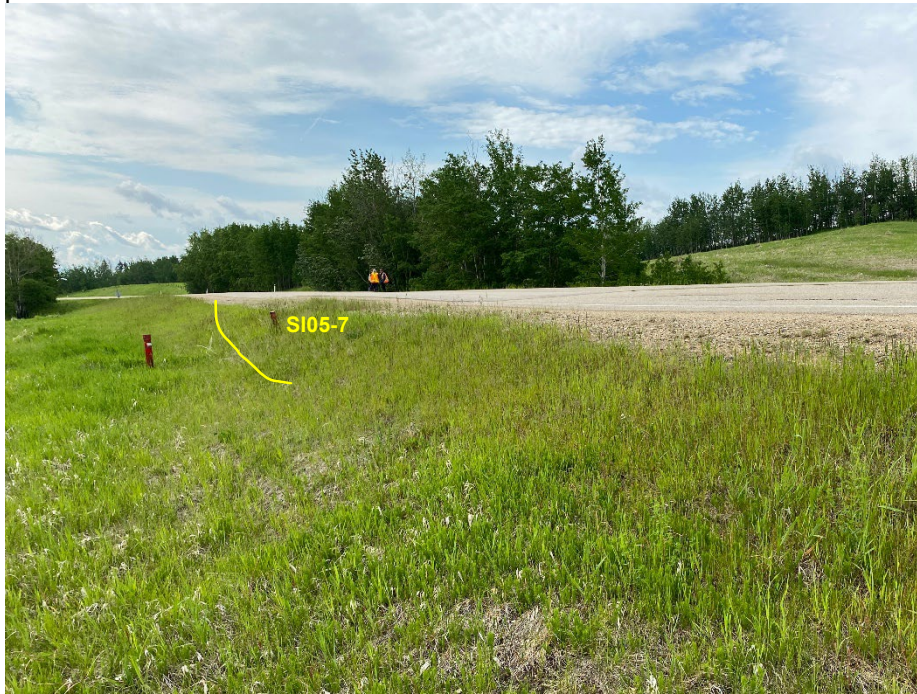
Photo 5: Potential bulging near SI05-7. Looking northwest.

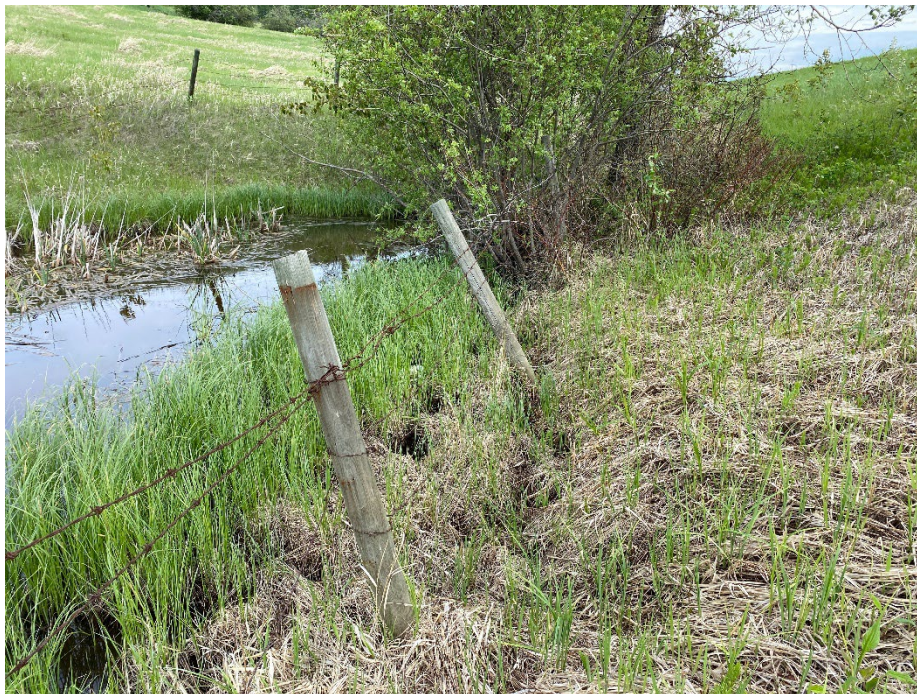
Photo 6: Ponded water at culvert inlet in the north. Looking northeast.

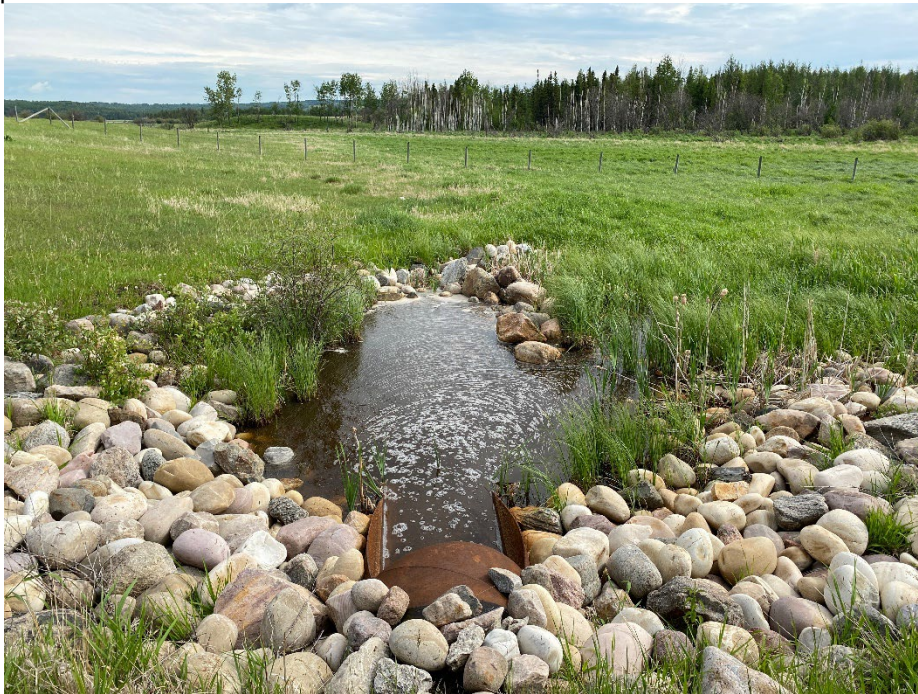
Photo 7: Ponded water at culvert inlet in the south. Looking south.

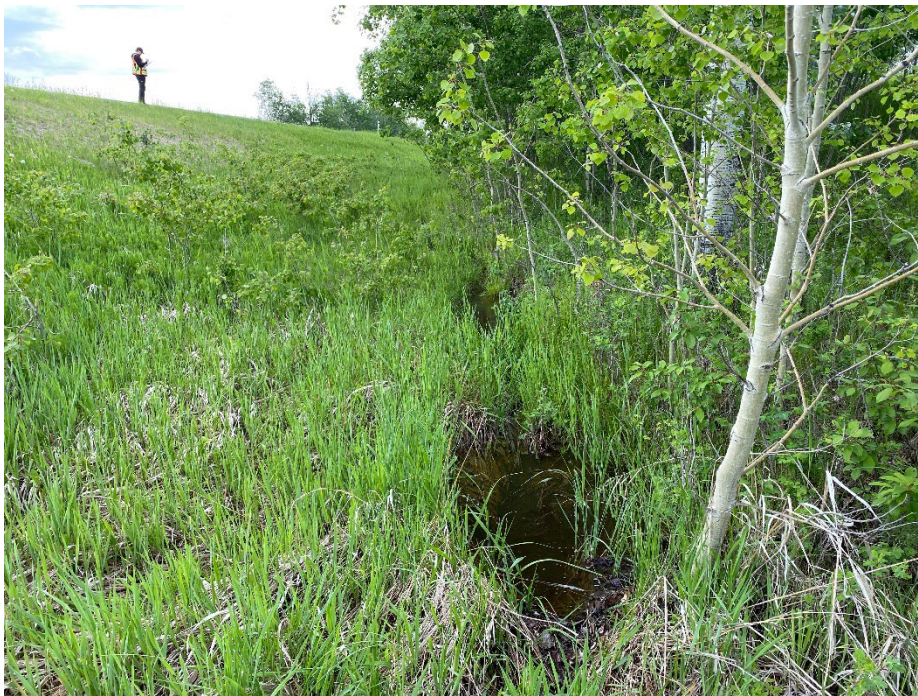
Photo 8: Erosion gully along north ditch of Highway 633. Looking southwest.
