SITE NUMBER AND NAME: NC044 – Cattlepass East	HIGHWAY AND KM: 633:02, km 1.434	PREVIOUS INSPECTION: June 15, 2022	CURRENT INSPECTION: June 11, 2024
LEGAL DESCRIPTION: NW 29-53-6-W5M	NAD83 COORDINATES: UTM11U 5942545N, 642834E		RISK ASSESSMENT: PF: 9 CF: 4 Total: 36
AVERAGE ANNUAL DAILY TRAFFIC (AADT): 460 (2023)		CONTRACTOR MAINTENANCE AREA (CMA): 509

2024 Site Inspection Photos at NC044

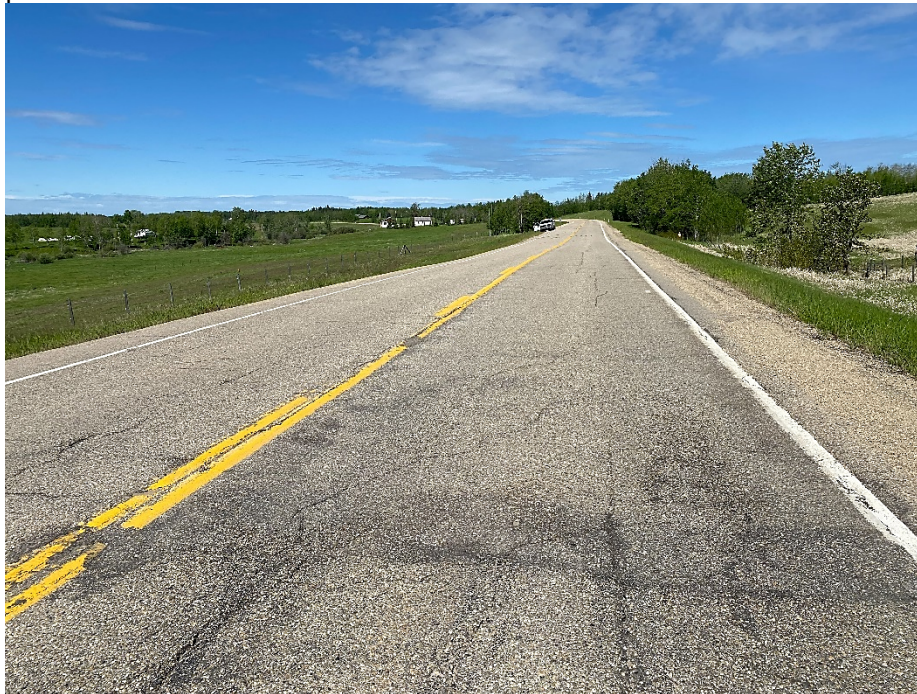
COMMENTS
<ul style="list-style-type: none"> The cracking pattern on the highway appeared to have progressed since the previous inspection. Further cracks are reflecting through the pavement patches and a new crack, 0-15 mm wide, was observed near the west end of the 2013 patch (Photos 1 to 4). The curved crack in the east bound lane near SI17-01 has been sealed (Photo 2). Map pavement cracking is present on the east side of the site. A road sign warning of the bumps ahead was observed to be placed at the far west side of the site, for east bound traffic. Multiple sets of tire marks were observed within both lanes, which may be due to vehicles suddenly braking after traveling over the bumps (Photo 3). The potential toe bulging observed near SI05-7 (which has sheared) appears to still be present (Photo 5) with little to no change observed. SI17-01 shows continued movement at a rate of about 2 mm/yr between 6 m and 10 m depth. SI17-02 shows an incremental movement of 3 mm between 10 m and 13 m depth since the last reading in Spring 2023 with a

Photo 1: Pavement cracks at east limits of 2017 patch. Looking west.

- Short term recommendations include sealing of any cracks to reduce surface water infiltration into the slope and pavement structure. Additional pavement patches are not recommended since it is considered an additional driving force on the embankment. Mill and fill could be completed such that the final pavement elevation is not higher than the existing elevation.

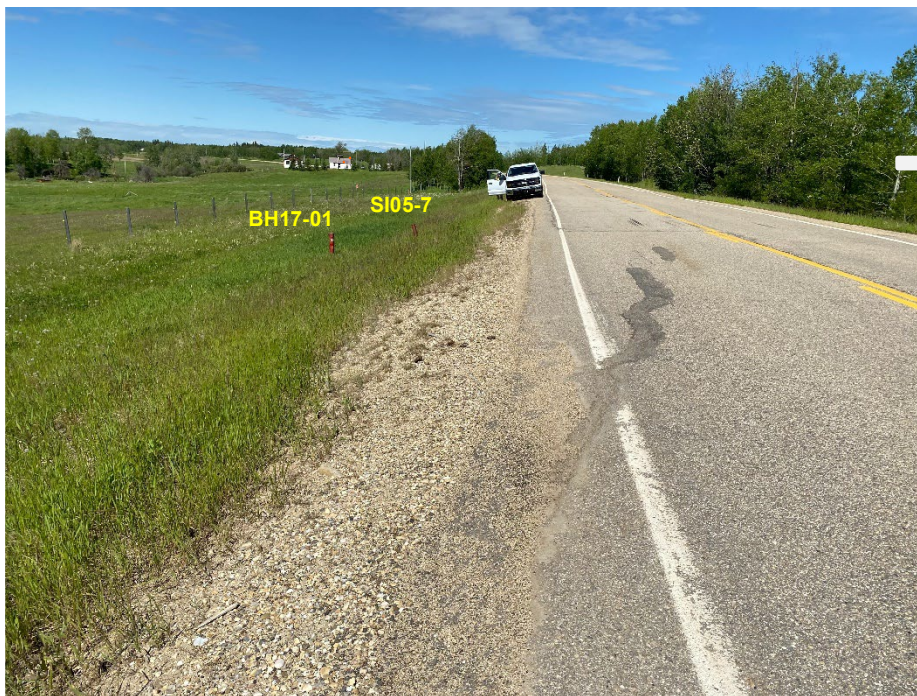
Photo 2: Pavement cracks in EB lane sealed since 2022 inspection. Looking west.

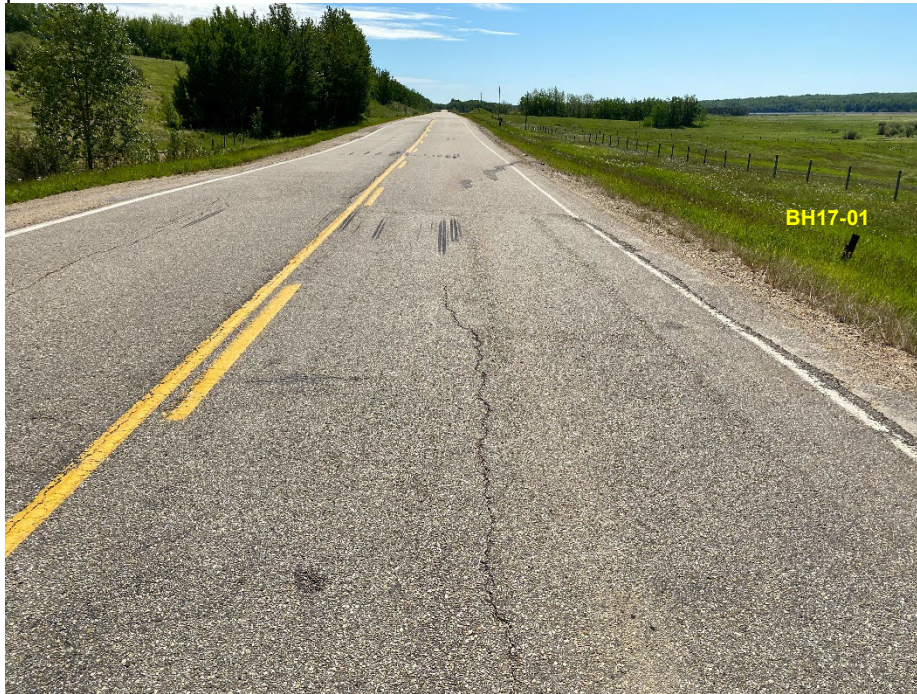
Photo 3: Cracks and skid marks on Highway 633. Looking east.

- Stantec also recommends that a road sign warning of the bumps ahead be installed on the east end of the site, similar to the one installed on the west side.

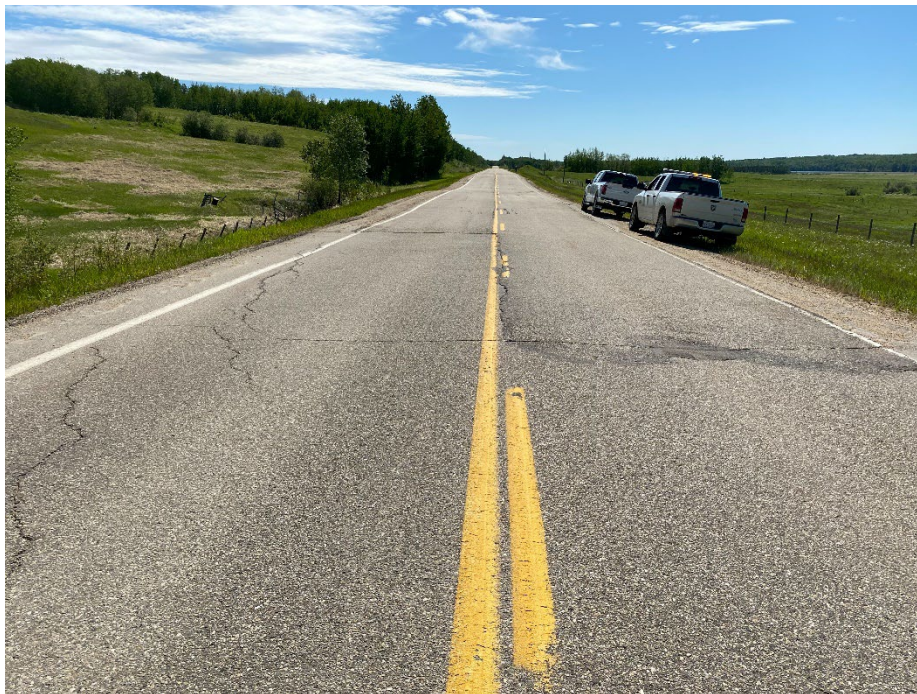
Photo 4: Pavement cracks just before west limits of 2017 patch. Looking east.

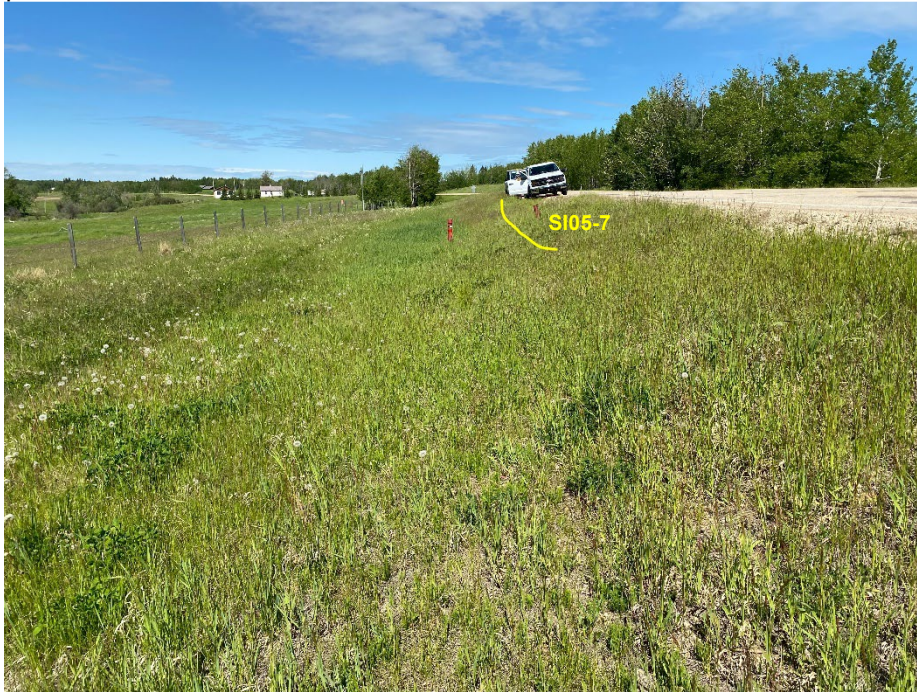
Photo 5: Potential bulging near SI05-7. Looking northwest.

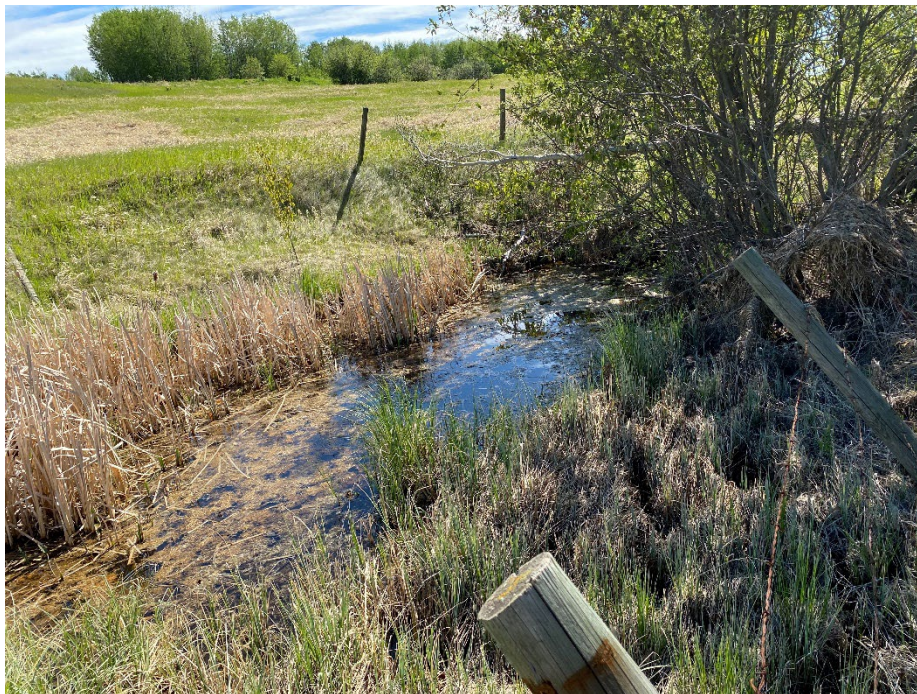
current rate of movement of 3 mm/yr. Ongoing movement may be due to high pore pressures at the site. A possible source of water infiltration into the slope is through the erosion channel on the north ditch. The ponded water on both ends of the culvert may also be infiltrating into the slope.

- The berm was grass covered with no visible signs of distress observed.
- A dip was observed in the south ditch, approximately above the culvert alignment.
- Standing water was observed at both ends of the culvert as shown in Photos 6 and 7. Water appeared to be flowing through the culvert, however, water appears to be very slowly draining from the outlet. The water collected at the outlet appeared still and murky.
- Erosion is ongoing in the north ditch. During the inspection the west end of the erosion channel appeared dry, while the east end appeared to be wet (Photo 8).
- The groundwater level in PN05-8 increased by 0.4 m since the last reading in Spring 2023 and is now within 0.3 m from ground surface. The groundwater level in VW17-02 dropped by 0.1 m, and is now 1.1 m below ground surface, while the groundwater level in VW17-01 rose by 0.1 m but remains 3.3 m below ground surface.

Photo 6: Ponded water at culvert inlet. Looking northeast.

- The MCI should continue to inspect the culverts on site on a regular basis to reduce the risk of pore pressures building up in the berm and slope and to maintain functionality. A CCTV inspection could be conducted to assess the culvert condition.

- Grading may be considered at the culvert inlet to reduce the amount of ponded water. However, grading works would likely occur outside of TEC's right-of-way.

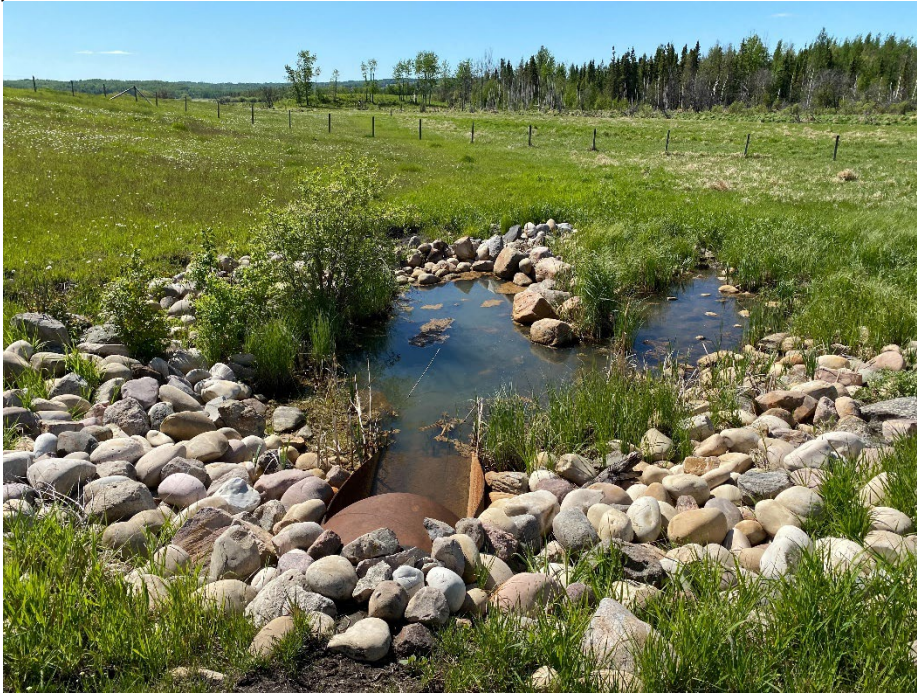
Photo 7: Ponded water at culvert outlet. Looking south.

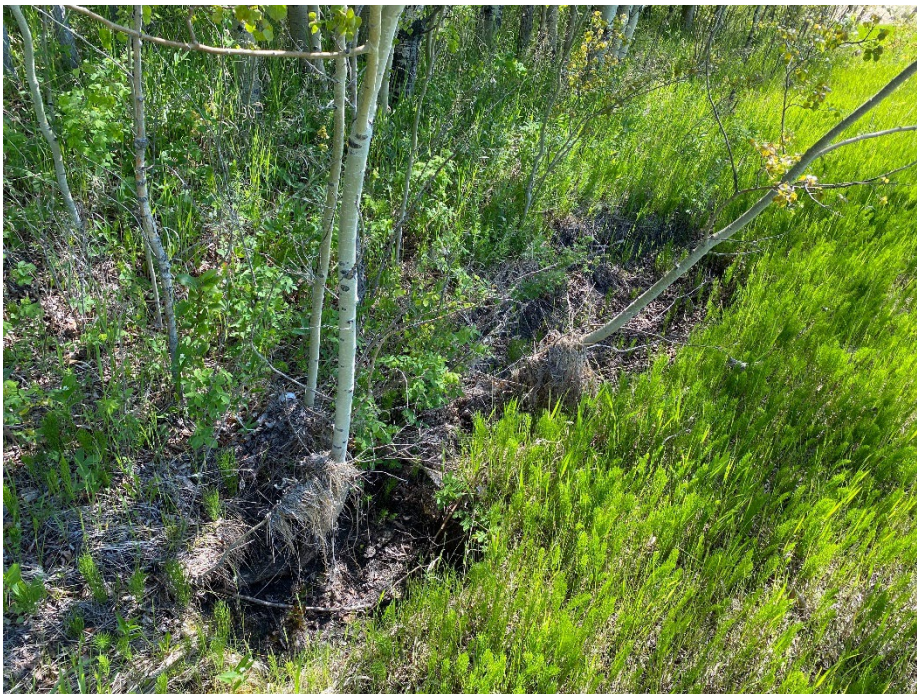
Photo 8: Erosion gully along north ditch of Highway 633. Looking east.

- The erosion gully in the north ditch should be repaired to reduce seepage of water into the slope and under the highway.
- Long-term remediation may consist of lowering the overall highway grade to reduce the driving force on the slope. The high-level cost of grade reduction is \$400,000 to \$700,000 not including engineering costs. Alternatively, reconstruction of the highway using lightweight fill may also help reduce the driving force on the slope. The high-level cost for reconstruction using lightweight fill is \$1.5M to \$2.3M, excluding engineering costs.
