Client/Project: Alberta Transportation Geohazard Monitoring Program
 NC76 Blue Ridge Slide
 123312435

Title: Site Plan

Reference: 2020 Annual Inspection Photographs at NC76 – Blue Ridge Slide
File Number: 123312435

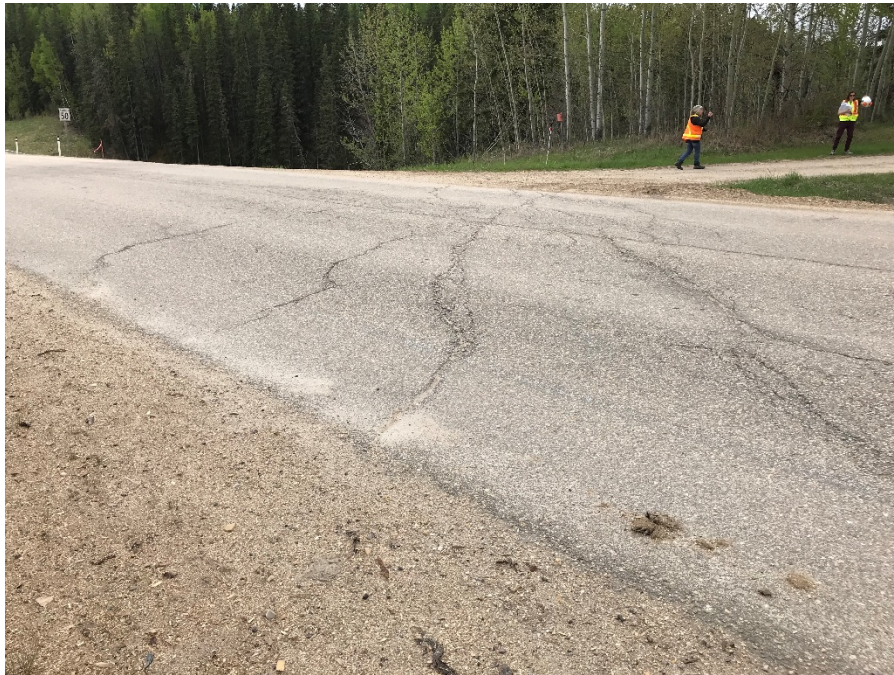
Photo 1: Pavement cracks at north portion of site at access road. Looking southwest.

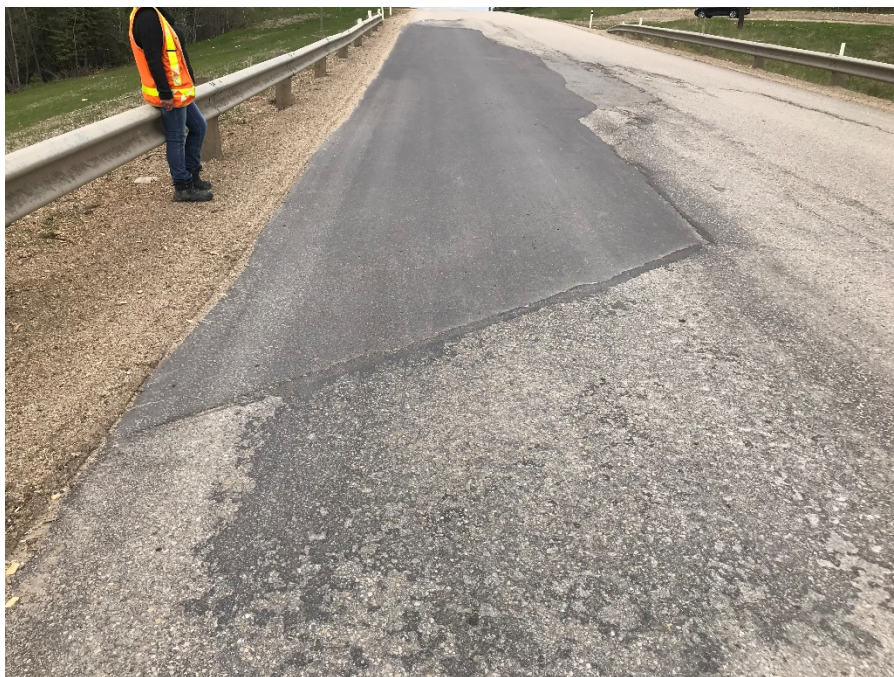
Photo 2: Repaired portion of Highway 658. Looking north.

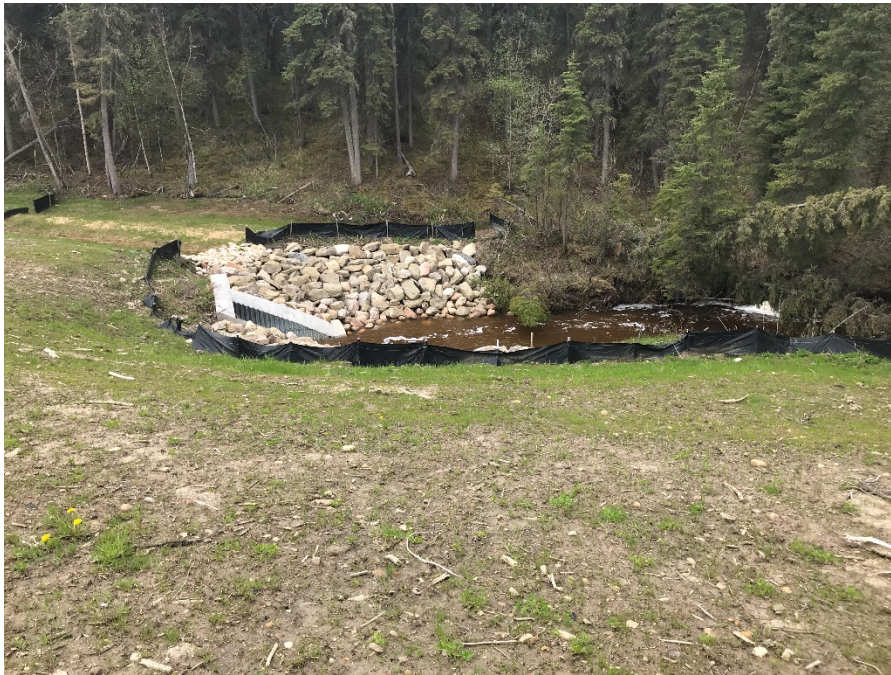
Photo 3: Culvert extended downstream. Looking southwest.

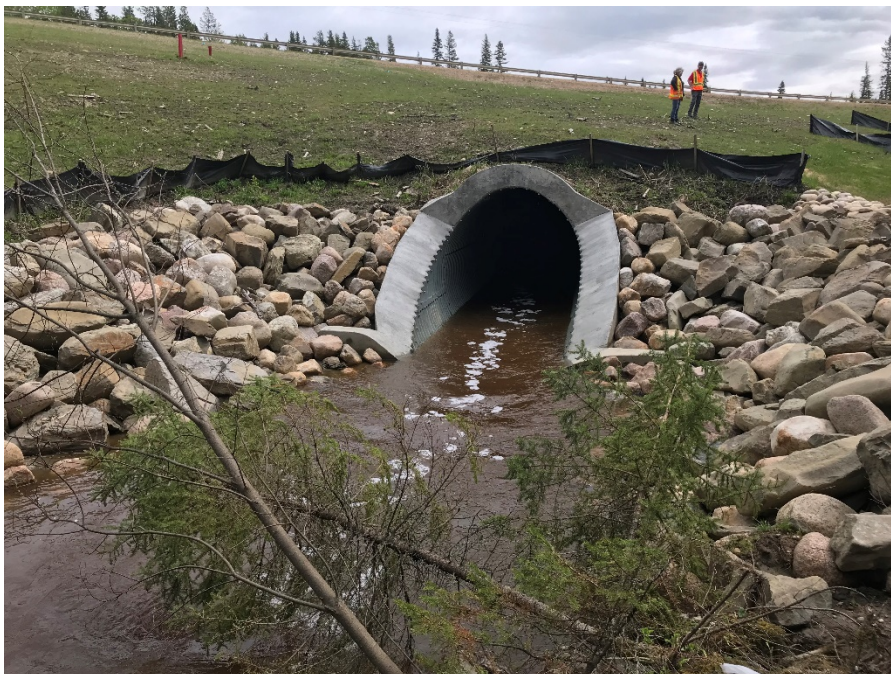
Photo 4: Repaired culvert. Looking southeast.

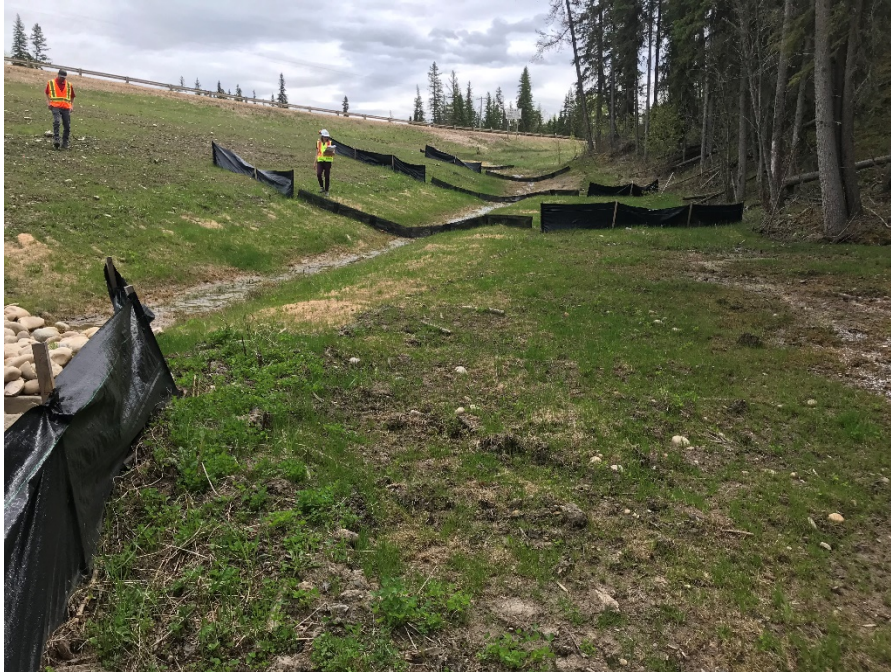
Photo 5: Regraded swale leading to culvert outlet. Looking southeast.

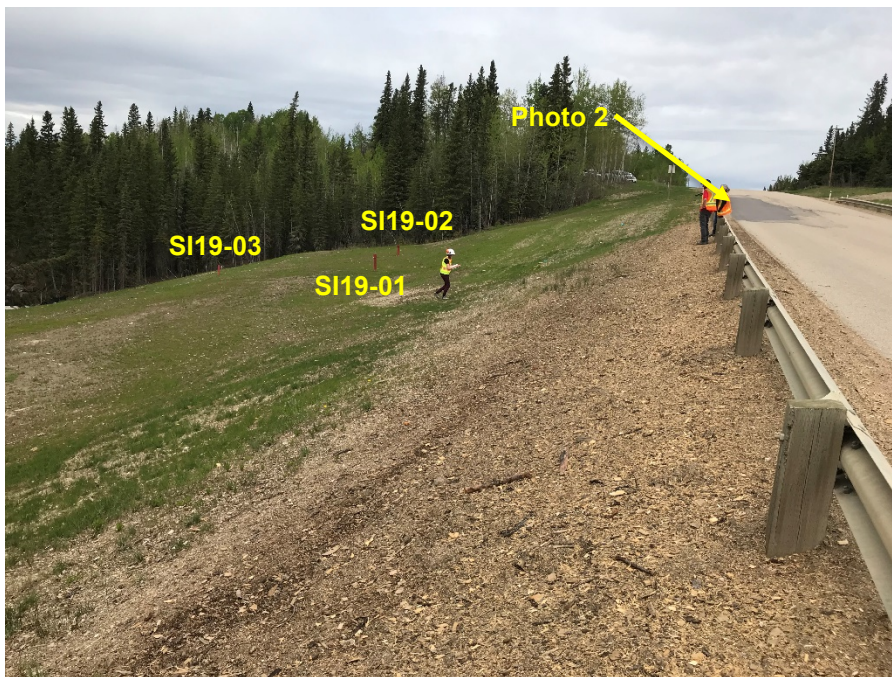
Photo 6: Repaired slope and berm location. Looking north.

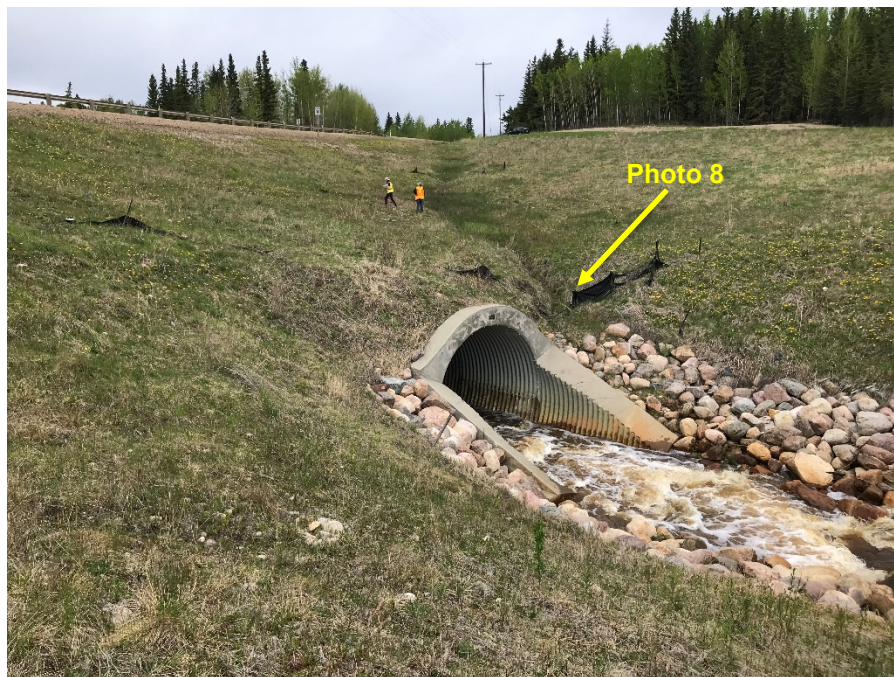
Photo 7: Erosion along drainage ditch to culvert inlet. Looking north.

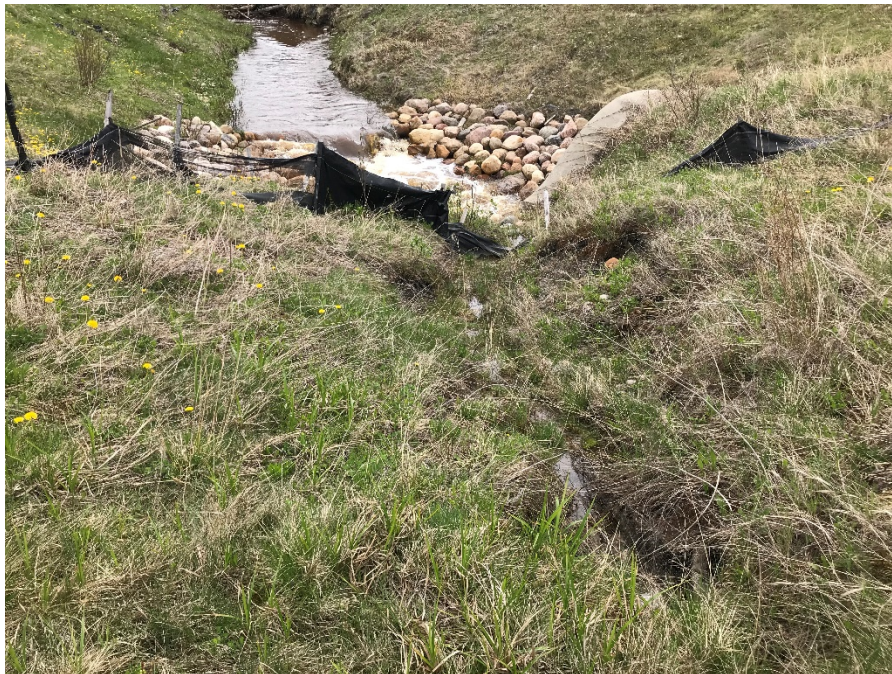
Photo 8: Erosion upslope from culvert inlet. Looking north.

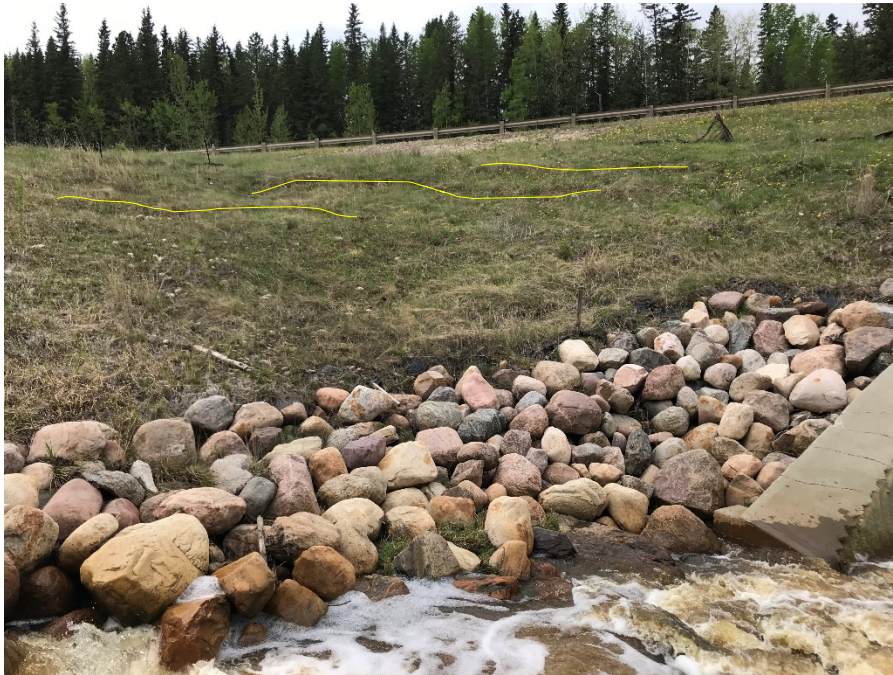
Photo 9: Tension crack developing south of culvert inlet. Looking southwest.
