<b>SITE NUMBER AND NAME:</b> NC076 – Blue Ridge Slide	<b>HIGHWAY AND KM:</b> 658:02, km 7.417	<b>PREVIOUS INSPECTION:</b> May 25, 2020	<b>CURRENT INSPECTION:</b> May 31, 2023
<b>LEGAL DESCRIPTION:</b> SW 25-59-10-W5M and SE 26-59-10-W5M	<b>NAD83 COORDINATES:</b> UTM11U 5999049N, 606082E		<b>RISK ASSESSMENT:</b> PF: 4 CF: 6 Total: 24
<b>AVERAGE ANNUAL DAILY TRAFFIC (AADT):</b> 870 (2022)		<b>CONTRACTOR MAINTENANCE AREA (CMA):</b> 508

2023 Site Inspection Photos at NC076

Client/Project: Transportation and Economic Corridors, Geohazard Monitoring Program, NC76 Blue Ridge Slide  
 123315222

Title: Site Plan

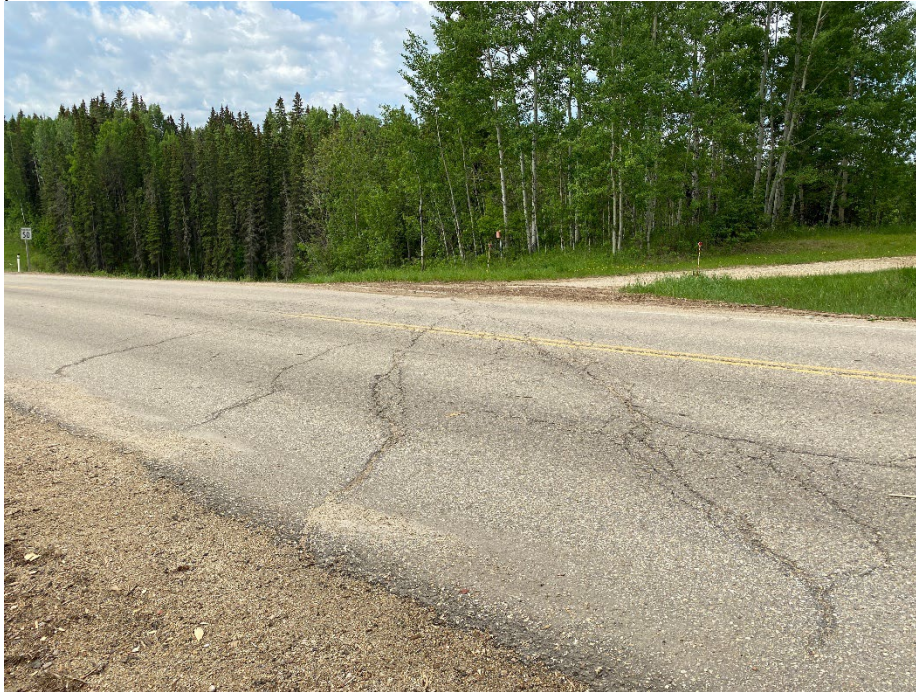
<b>COMMENTS</b>
<ul style="list-style-type: none"> <li>Pavement cracking at the entrance to the residence at the north site limits appears unchanged since 2018 (Photo 1).</li> <li>The pavement was patched across both lanes from the north end of the guardrail to approximately 125 m south. Cracks have begun to develop within the repaired area and are forming a semi-circle within the SBL upslope from SI19-01 and SI19-02 (Photo 2).</li> <li>The subdrains at the culvert outlet were not observed and are likely grown over with vegetation.</li> <li>The extended portion of the culvert outlet appears to be in good condition (Photo 3).</li> <li>Gullyng with ponded water was observed in the swale next to the tree line on the west slope, south from the culvert outlet (Photo 4).</li> </ul>

**Photo 1:** Pavement cracks at north portion of site at road to residence. Looking southwest.

- Pavement cracks should be sealed to reduce surface water infiltration into the embankment.
- Regrading of the drainage ditches along the east and west embankment slopes could be completed.
- Site inspections should continue to be completed once per contract cycle.
- Instrument monitoring should continue to be completed annually in the spring.

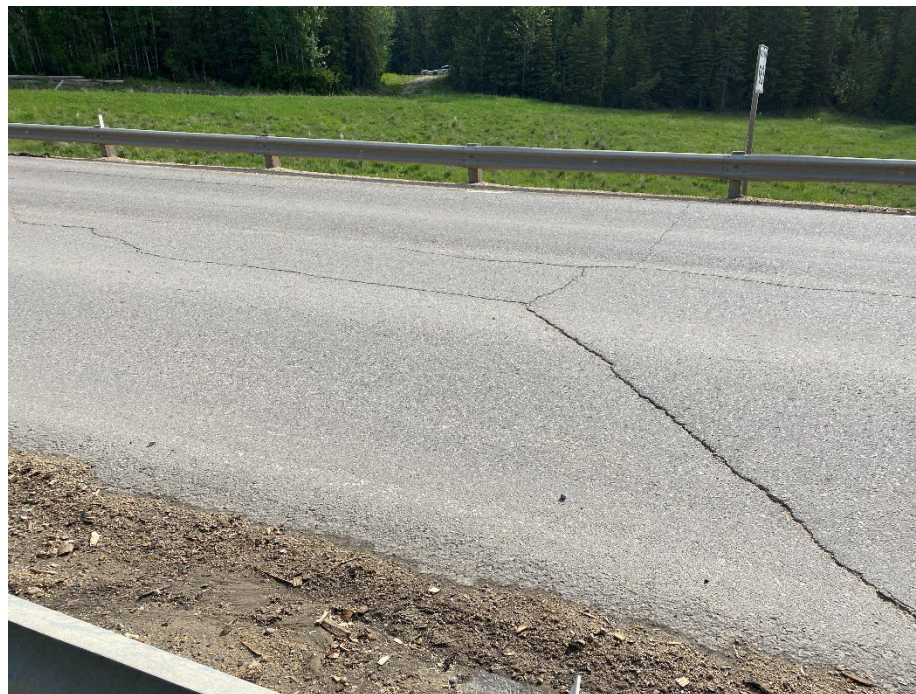
**Photo 2:** Pavement cracks upslope from SI19-01. Looking northeast.

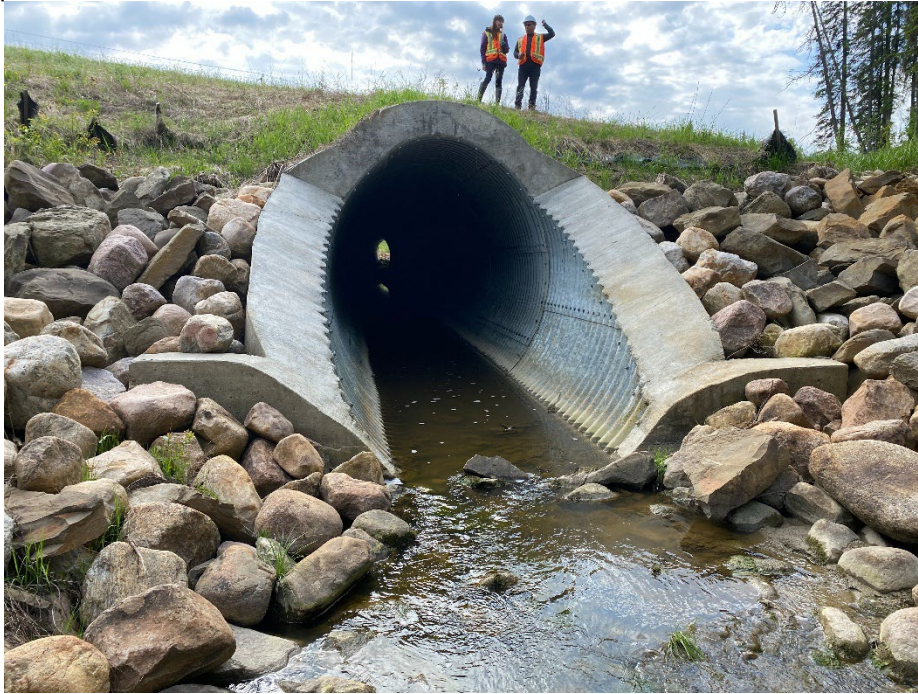
**Photo 3:** Culvert outlet, looking southeast.

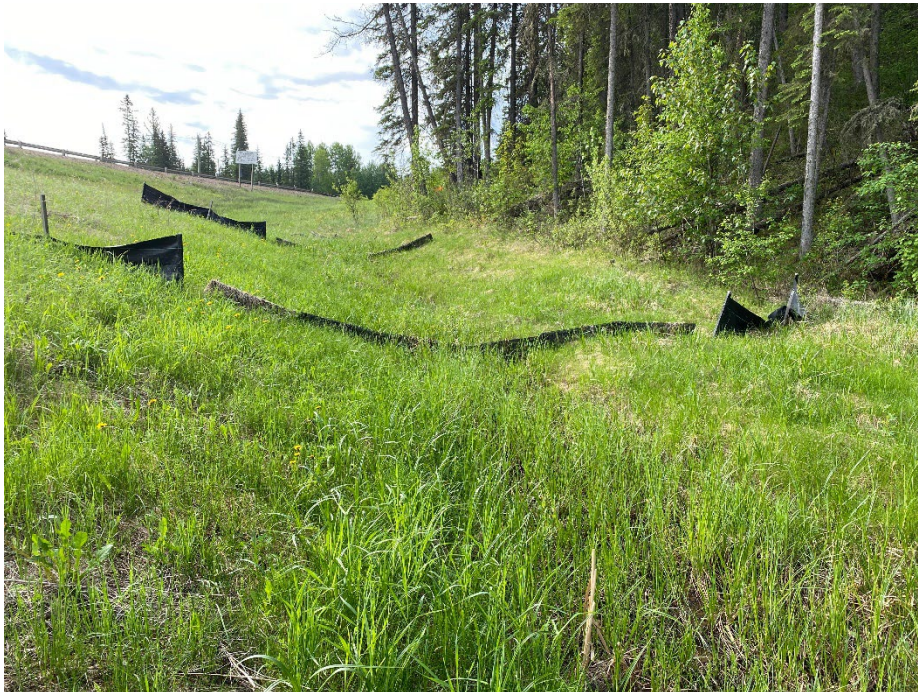
**Photo 4:** Gullying and ponded water present through swale leading to culvert outlet. Looking southeast.

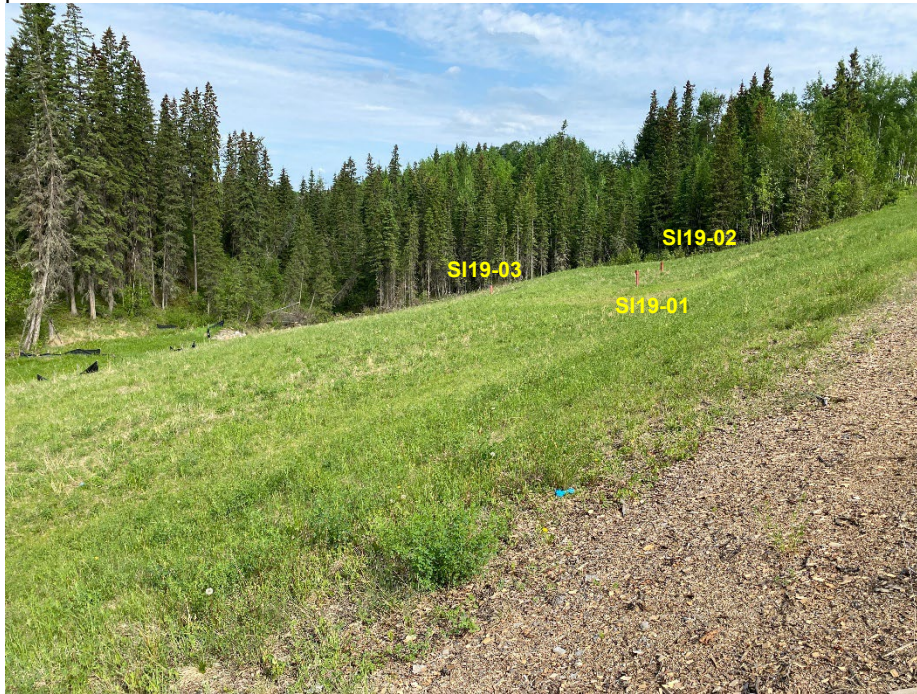
**Photo 5:** Repaired slope and berm location. Looking northwest.

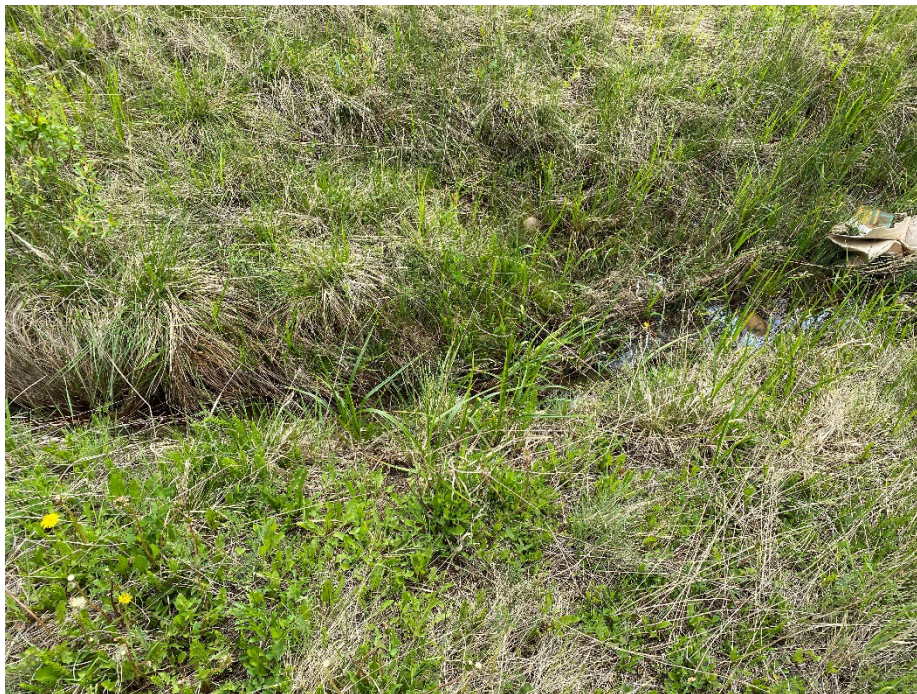
- Erosion gullies up to 1.2 m deep and 2.3 m wide were observed on the east side of the highway leading to the culvert inlet (Photos 6 and 7).
- Erosion gullies up to 0.4 m wide were observed on the east side of the highway, starting at the pavement's edge near the culvert inlet.
- Skin slides were observed on the slope to the south of the culvert inlet but appear to be establishing vegetation cover (Photo 8).
- SI19-01 and SI19-02 currently have a movement rate of less than 1 mm/yr with cumulative movement of less than 1 mm since 2019. However, SI19-03 installed on the lower portion of the embankment slope currently has a movement rate of 1 mm/yr at a depth of about 7 m below ground surface with total cumulative movement of nearly 6 mm.

**Photo 6:** Erosion gully in the east ditch, north from culvert inlet. Looking east.

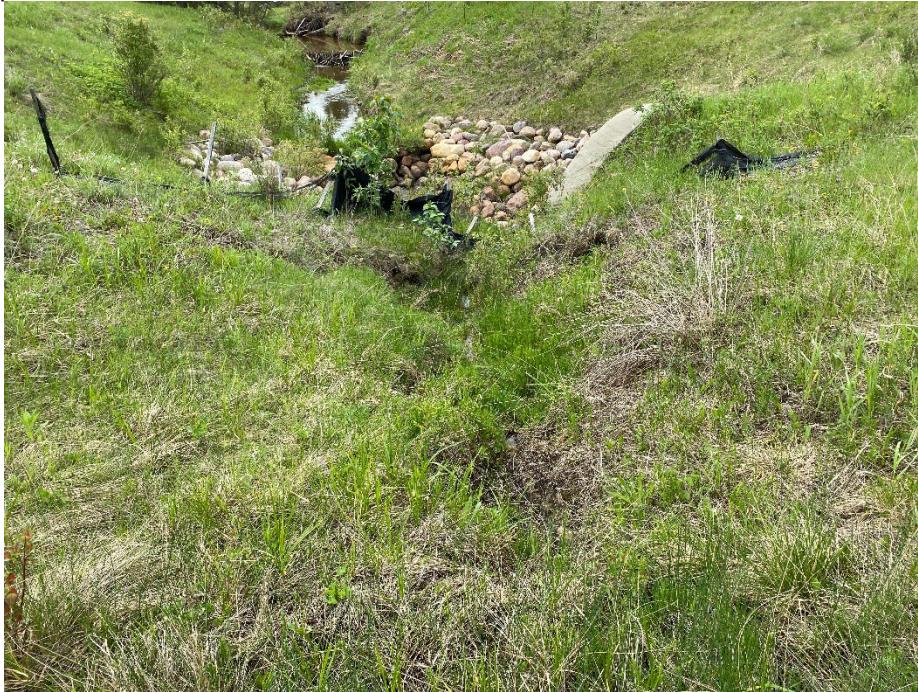
**Photo 7:** Erosion upslope from culvert inlet. Looking north.

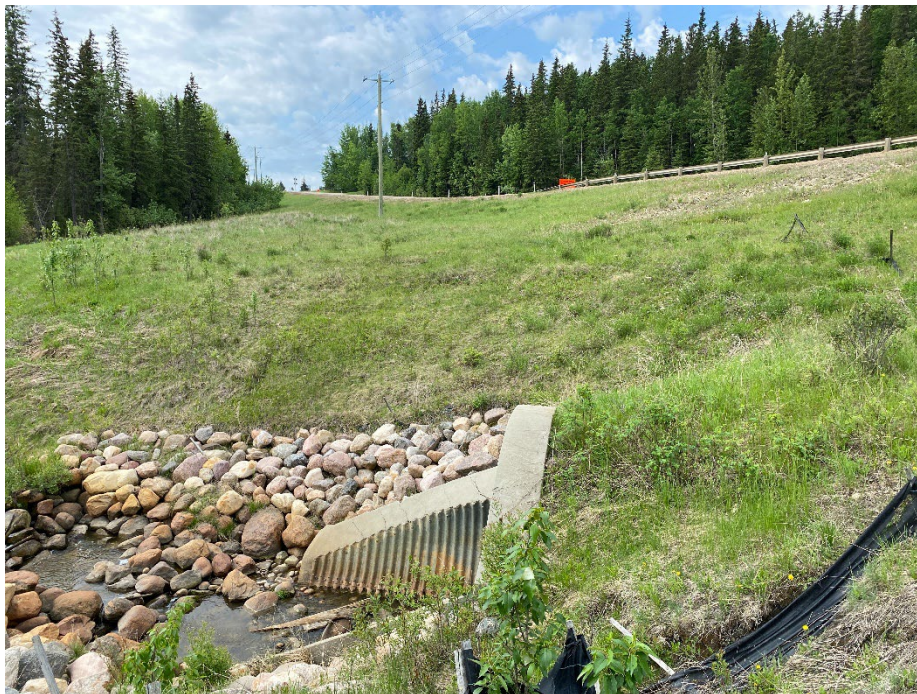
**Photo 8:** Skin slides south of culvert inlet. Looking southwest.
