<b>SITE NUMBER AND NAME:</b> NC098 – Hwy 658 Embankment Slide	<b>HIGHWAY AND KM:</b> 658:02, km 29.900	<b>PREVIOUS INSPECTION:</b> June 14, 2022	<b>CURRENT INSPECTION:</b> June 13, 2024
<b>LEGAL DESCRIPTION:</b> SW 12-61-9-W5M	<b>NAD83 COORDINATES:</b> UTM11U 6013255N, 615954E		<b>RISK ASSESSMENT:</b> PF: 7 CF: 3 Total: 21
<b>AVERAGE ANNUAL DAILY TRAFFIC (AADT):</b> 370 (2023)		<b>CONTRACTOR MAINTENANCE AREA (CMA):</b> 508

<b>SUMMARY OF INSTRUMENTATION:</b> No instrumentation installed at this site. <b>LAST READING DATE:</b> N/A	<b>INSPECTED BY:</b> Stantec: Leslie Cho, Sonja Pharand TEC: Kristen Tappenden, Tim Gernyn
<b>PRIMARY SITE ISSUE:</b> Embankment creep movements towards south of highway causing pavement distress.	
<b>APPROXIMATE DIMENSIONS:</b> Approximately 125 m long (pavement section)	
<b>DATE OF ANY REMEDIAL ACTION:</b> Pavement milled and filled in 2020.

2024 Site Inspection Photos at NC098

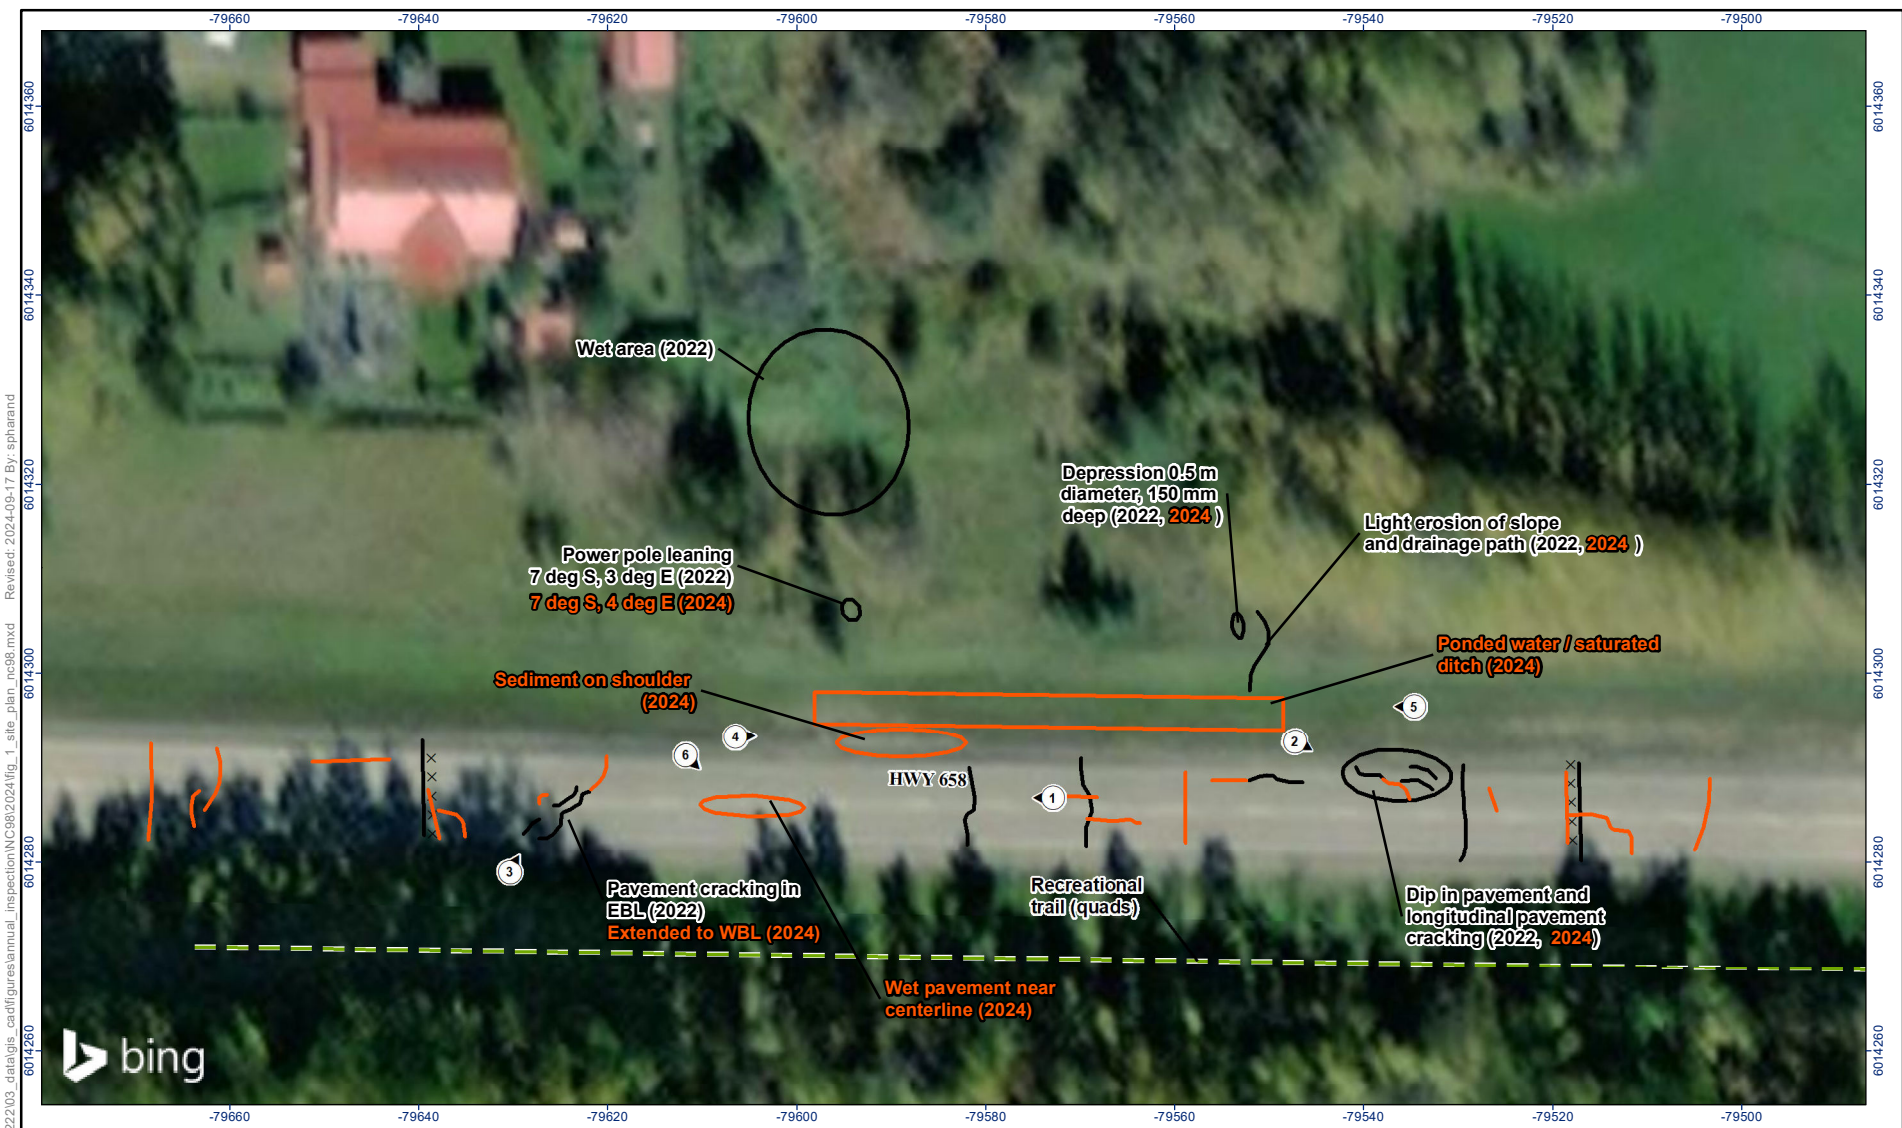
**Figure No.**  
**1**

ITEM	CONDITIONS EXIST		DESCRIPTION AND LOCATION	NOTICEABLE CHANGE FROM LAST INSPECTION	
	YES	NO		YES	NO
Pavement Distress	X		Transverse cracking within patch limits, Semi-circular cracking near east and west patch limits.	X	
Slope Movement	X		Dip in the westbound lane (WBL) near east patch extent. Semi-circular cracking near east and west patch limits.		X
Erosion	X		Minor erosion in the north ditch.	X	
Seepage		X			
Culvert Distress		X

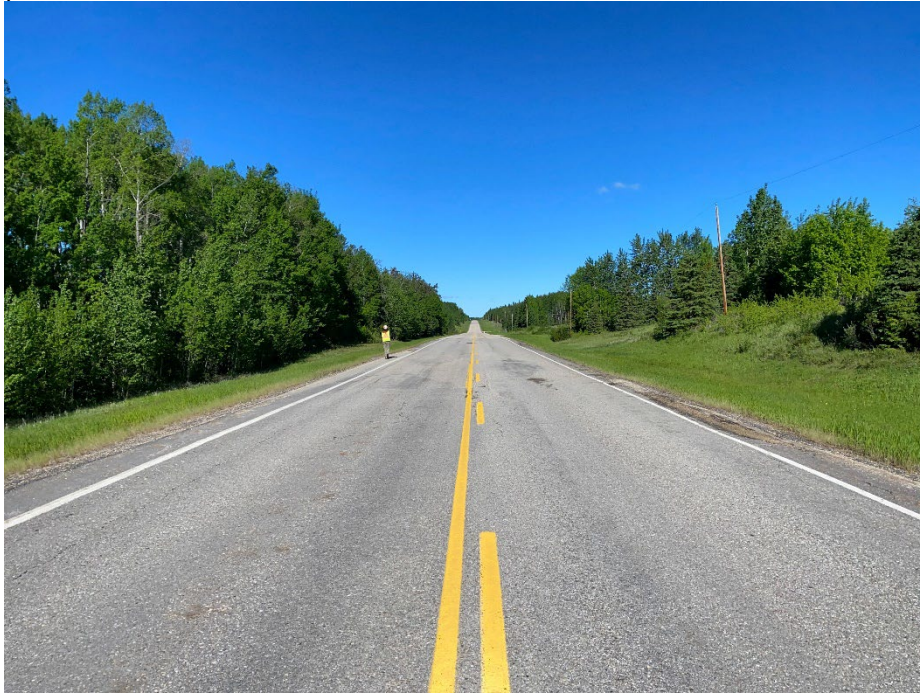
**Photo 1:** Highway 658, looking west.

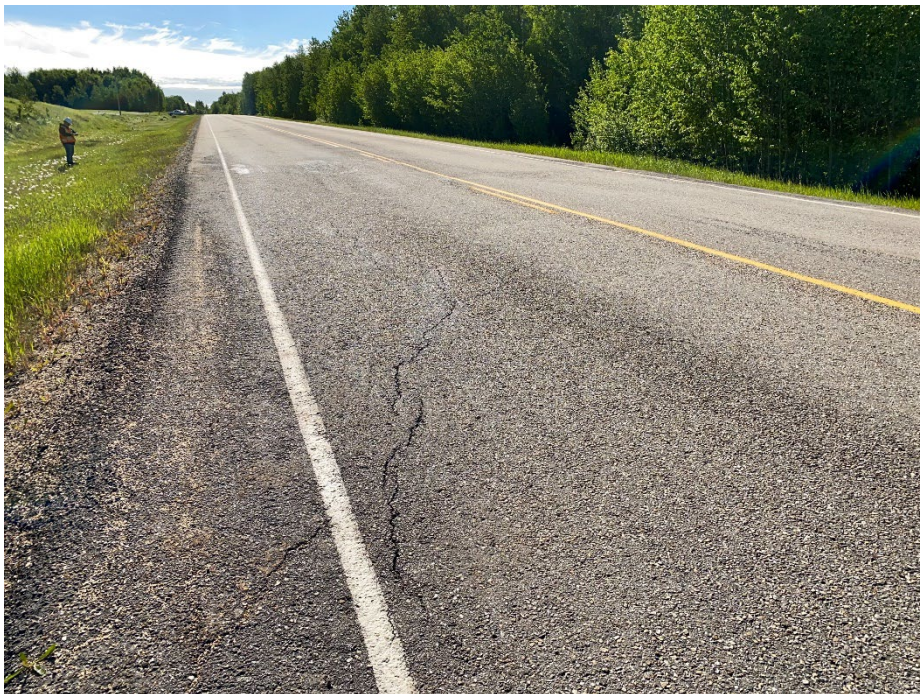
<b>COMMENTS</b>
<ul style="list-style-type: none"> <li>A pavement patch was placed in 2020 within the landslide zone. Pavement cracks have reflected through the patch with semi-circular cracking near the east and west extents. No vertical difference was observed at the crack locations, however the semi-circular cracks have spread, and additional cracking was present compared to the 2022 inspection (Photos 1 to 3).</li> <li>A slight dip on the WBL was observed near the east patch limits (Photo 2).</li> <li>The second power pole east of the private driveway on the north embankment is leaning approximately 7° south and 4° east, similar to the 2022 inspection.</li> <li>A wet area with differing vegetation (grasses) is located northeast of the power pole, at the top of the embankment.</li> <li>A depression approximately 0.5 m in diameter and 0.15 m deep was observed on the embankment slope northwest from where the pavement dips. Light erosion and a drainage path exist to the east of this depression. These elements appear unchanged from the 2022 inspection.</li> <li>Ponded water was observed in a section of the north ditch. Minor erosion and sedimentation was observed closer to the shoulder of the highway (Photo 4 and 5).</li> <li>No rain occurred while on site for the inspection, however a wet spot was observed along the centerline of the highway across from the power pole (Photo 6), suggesting potential high groundwater table.</li> </ul>

**Photo 2:** Pavement cracking in west bound lane. Looking east.

- All pavement cracks should be sealed to reduce surface water infiltration to the landslide mass.
- Additional pavement patches are not recommended since it would represent an additional load on the landslide. Instead, mill and fill should be completed to maintain the pavement cracks. Where mill and fill is planned, the pavement elevation should be equal to or lower than existing such that no net addition of loads is placed on the landslide.

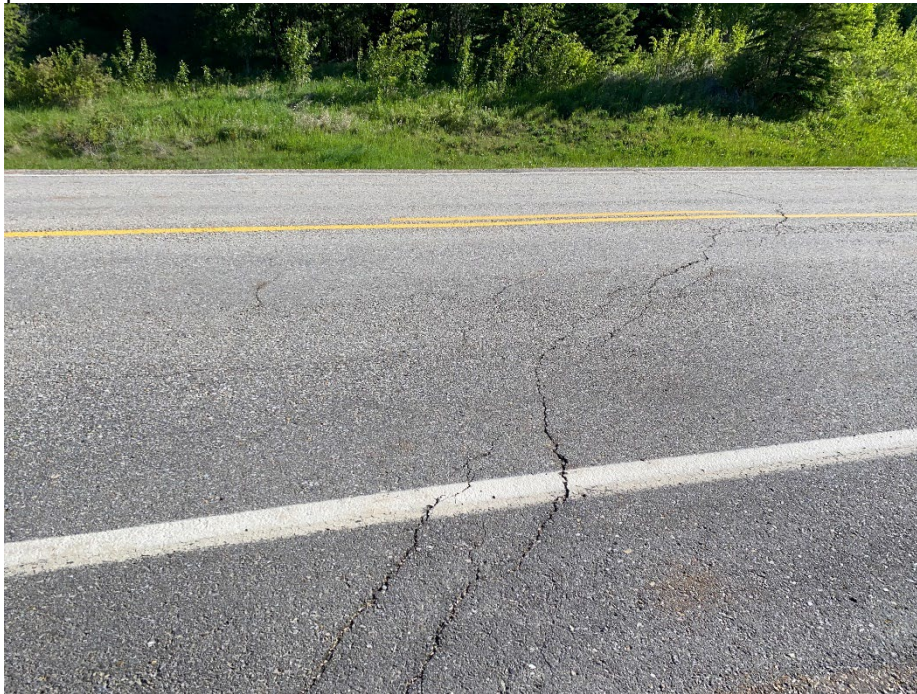
**Photo 3:** Angled pavement cracks across east bound lane. Looking northeast.

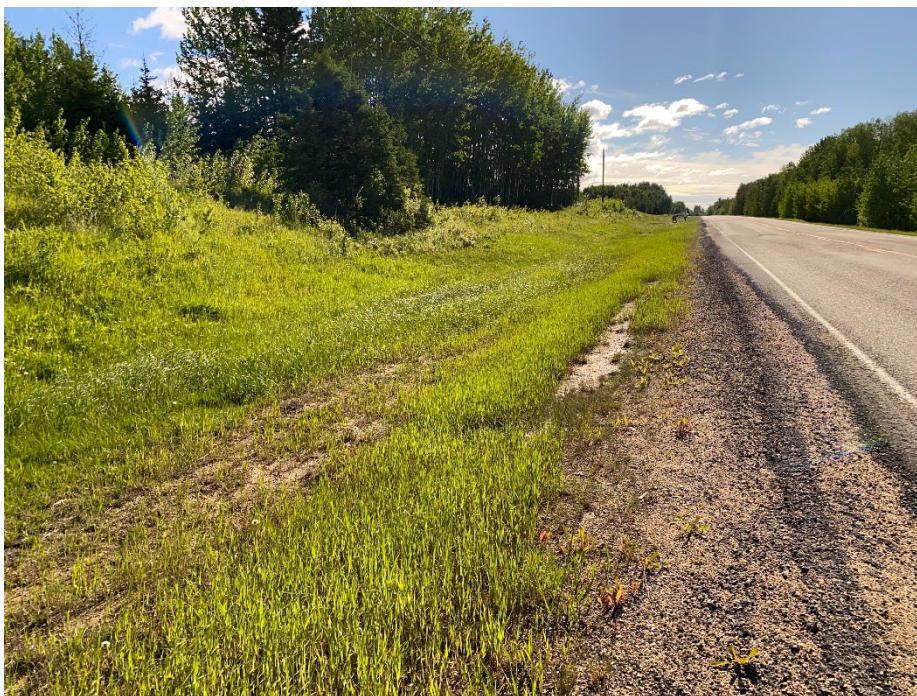
**Photo 4:** Minor erosion and sedimentation in north ditch. Looking east.

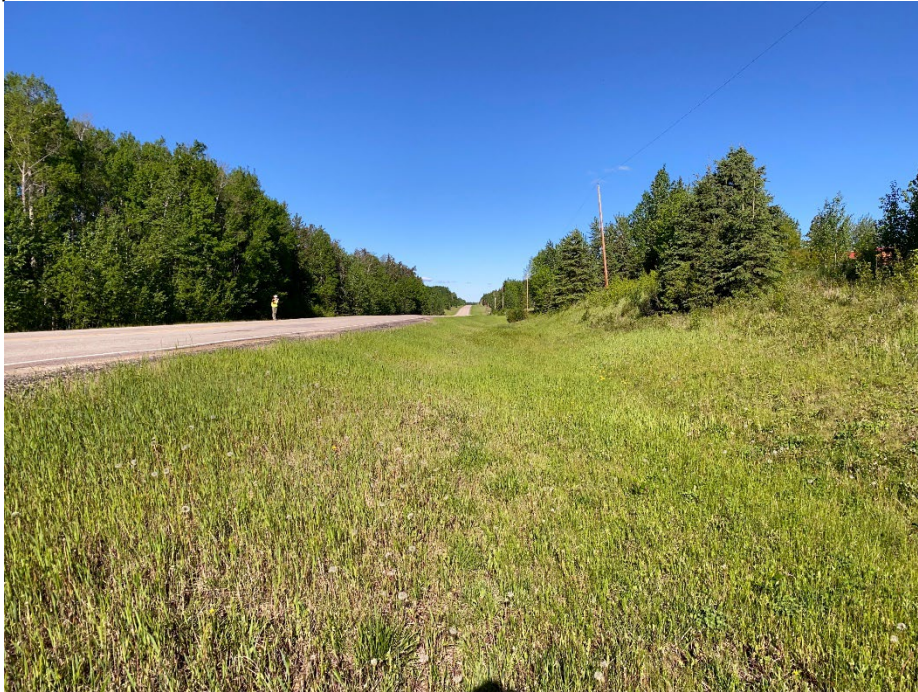
**Photo 5:** Ditch and embankment on north side of highway. Facing west.

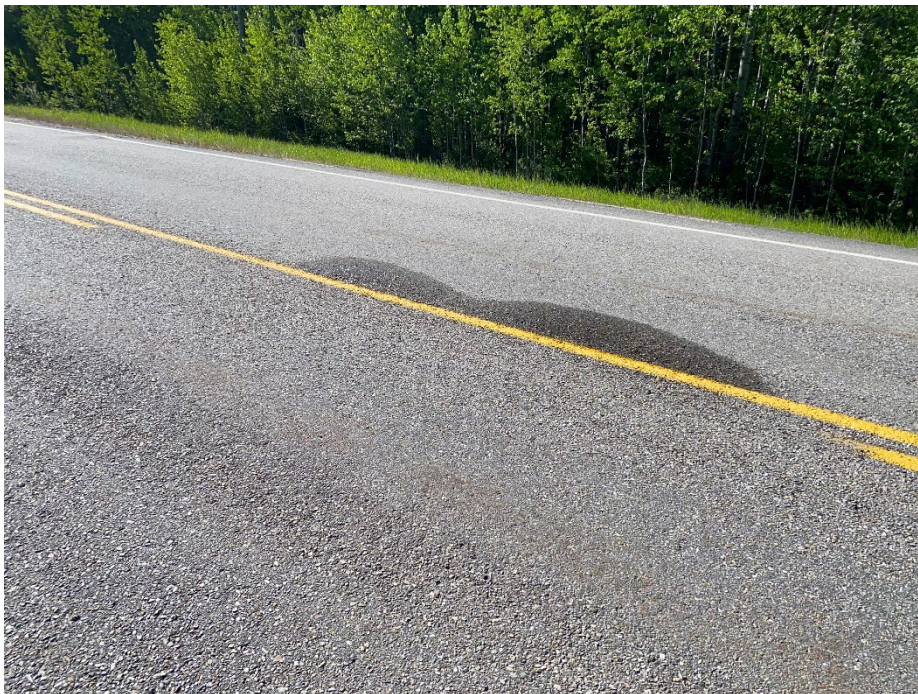
**Photo 6:** Possible seepage near centerline across from power pole. Looking southeast.

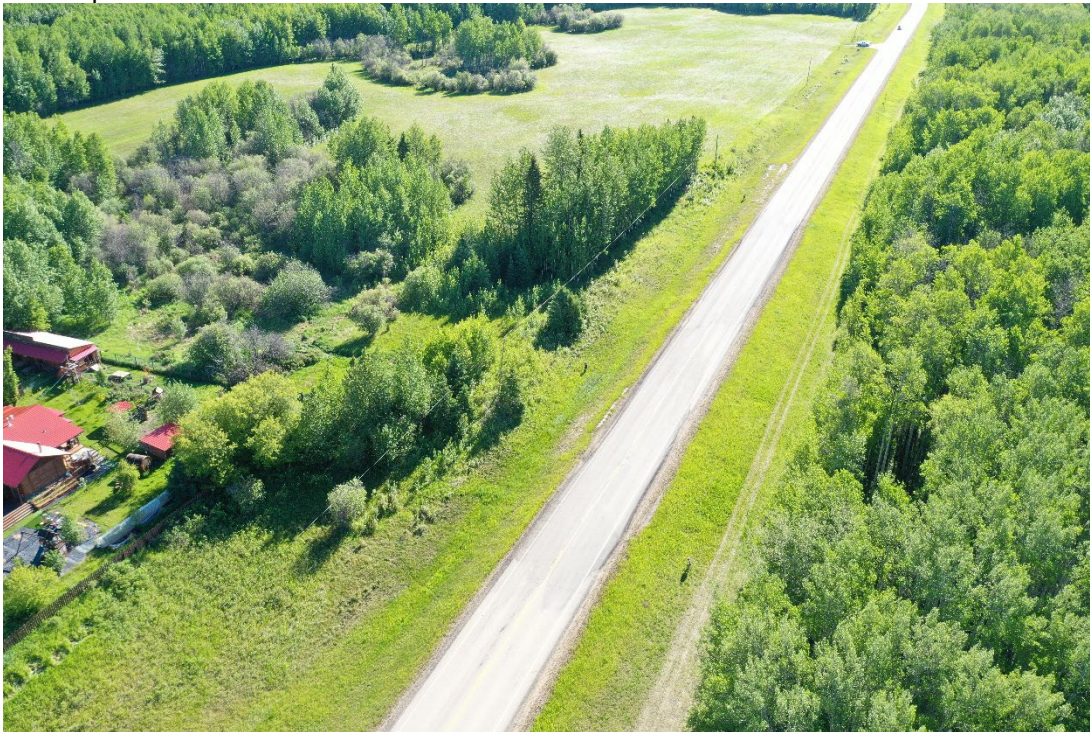
**Photo 7:** Site overview, taken by drone. Looking northeast.

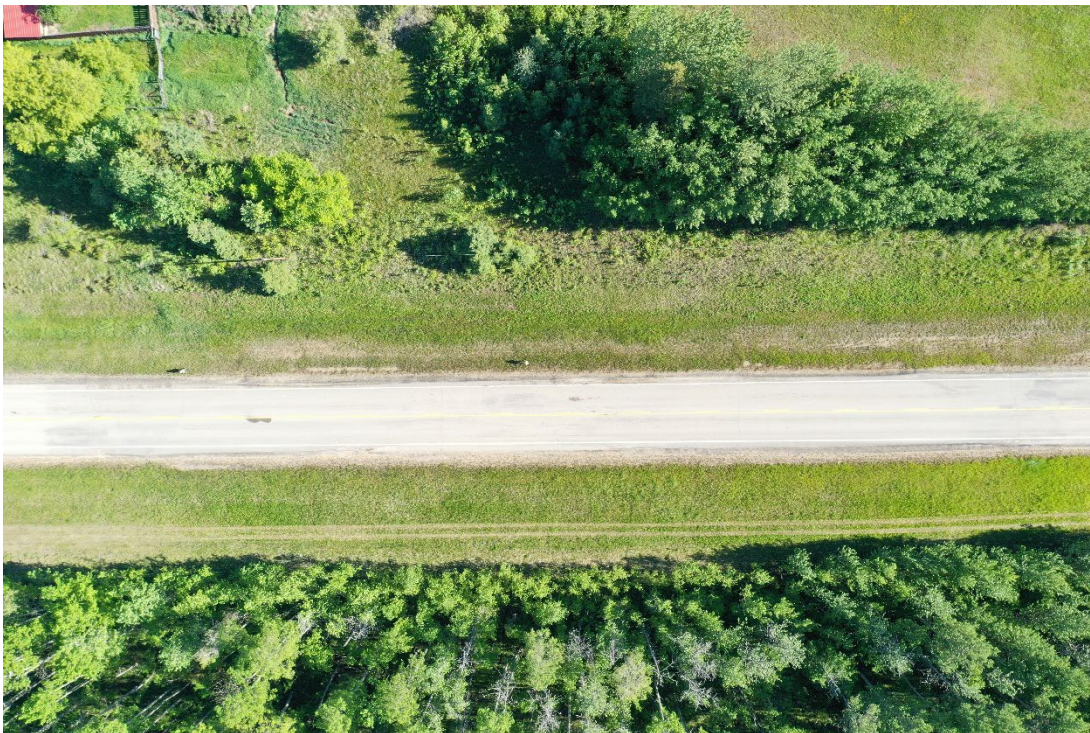
**Photo 8:** Site overview, taken by drone. Looking north.
