SITE NUMBER AND NAME: NC101 – Highway 658 Embankment Fill Slide	HIGHWAY AND KM: 658:02, km 13.382	PREVIOUS INSPECTION: N/A	CURRENT INSPECTION: May 31, 2023
LEGAL DESCRIPTION: NW 11-60-10-W5M	NAD83 COORDINATES: UTM11U 6004423N, 604544E		RISK ASSESSMENT: PF: 5 CF: 2 Total: 10
AVERAGE ANNUAL DAILY TRAFFIC (AADT): 360 (2022)		CONTRACTOR MAINTENANCE AREA (CMA): 508

2023 Site Inspection Photos at NC101

Client/Project: Transportation and Economic Corridors, Geohazard Monitoring Program, Highway 658:02, km 13.382
 123315222

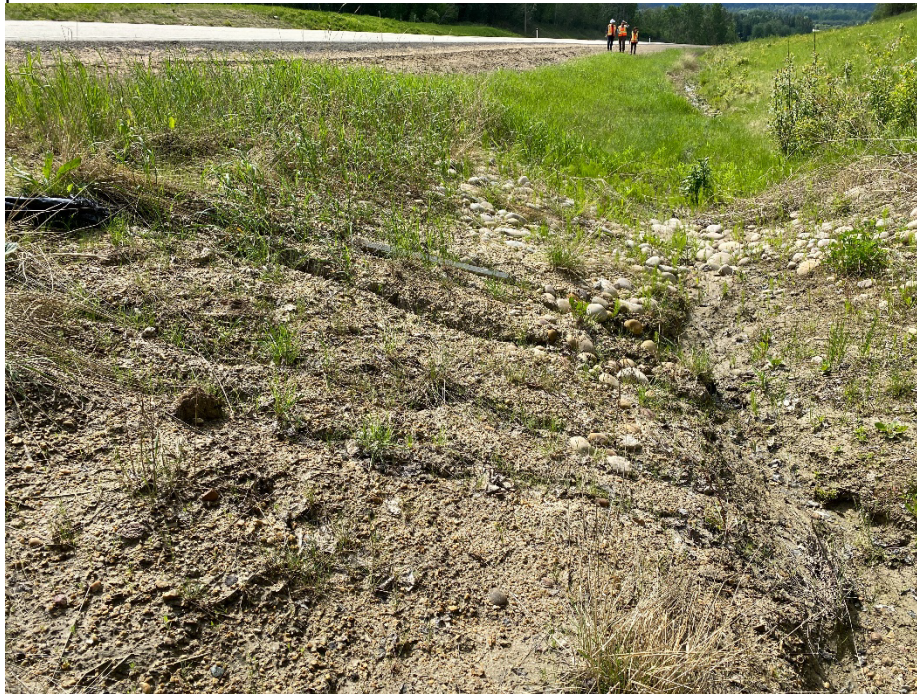
COMMENTS
<ul style="list-style-type: none"> Two small pavement cracks (< 0.5 m in length, 1 mm wide) were observed in the SBL on the south side of the grouted C/L culvert alignment. Remnants of the old ditch block south of the culvert inlet were observed in the west ditch. The material contains some exposed cobbles and is poorly vegetated. Erosion rills have formed from the pavement down into the ditch (Photo 1 and 2). An erosion gully up to 0.9 m wide and 0.5 m deep has formed through the old ditch block area (Photo 1 and 2). Silt fencing was installed on the east side of the old ditch block parallel to the highway likely intended to reduce erosion while vegetation was establishing. The silt fence was observed to be toppled. The west ditch to the north of the old ditch block is well vegetated with no observed erosion or ponding water (Photo 3). Erosion gullyng up to 0.5 m wide continued through the west ditch and extended about 90 m south from the old ditch block location. There was occasional ponding through the west ditch, and exposed cobbles (Photo 4). TEC documentation suggests this ditch was once armoured with cable concrete protection. Staples were observed at regular intervals through the west ditch suggesting alternative forms of erosion protection were installed; however, it was not apparent which erosion control product is currently installed.

Photo 1: Erosion gully through the old ditch block with erosion rills into the ditch. Looking south.

- Pavement cracks should be sealed to reduce surface water infiltration into the embankment.
- Regrading of the west ditch from the old ditch block down to the next culvert inlet location should be performed. Erosion protection (possibly consisting of re-vegetation and/or rock check dams) should also be considered. The estimated cost of installing rock check dams is \$5,000 to \$10,000 excluding engineering.
- No further site visits are recommended.

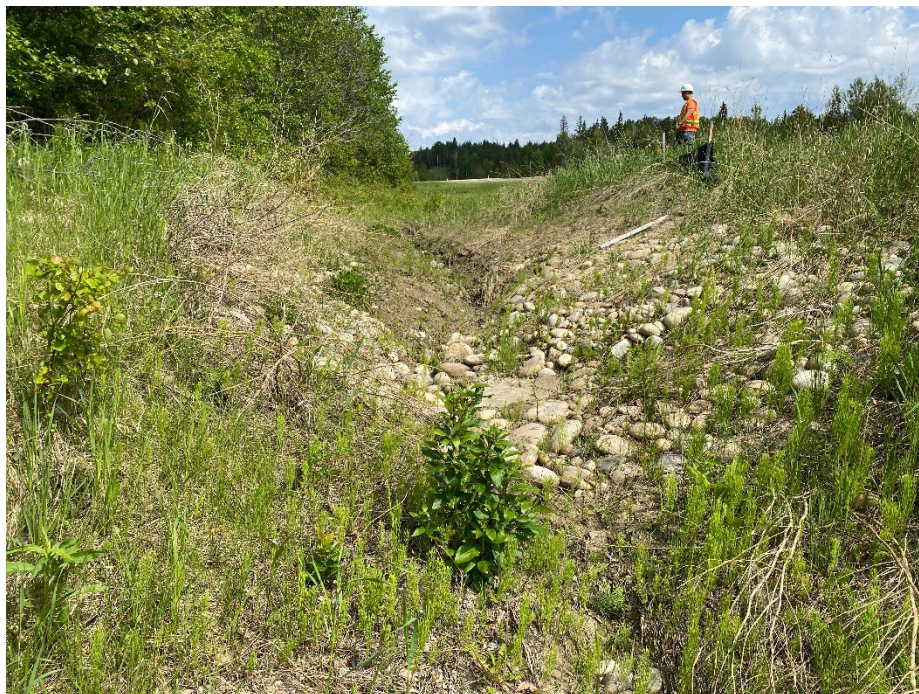
Photo 2: Erosion gully and remnants of old ditch block, looking north.

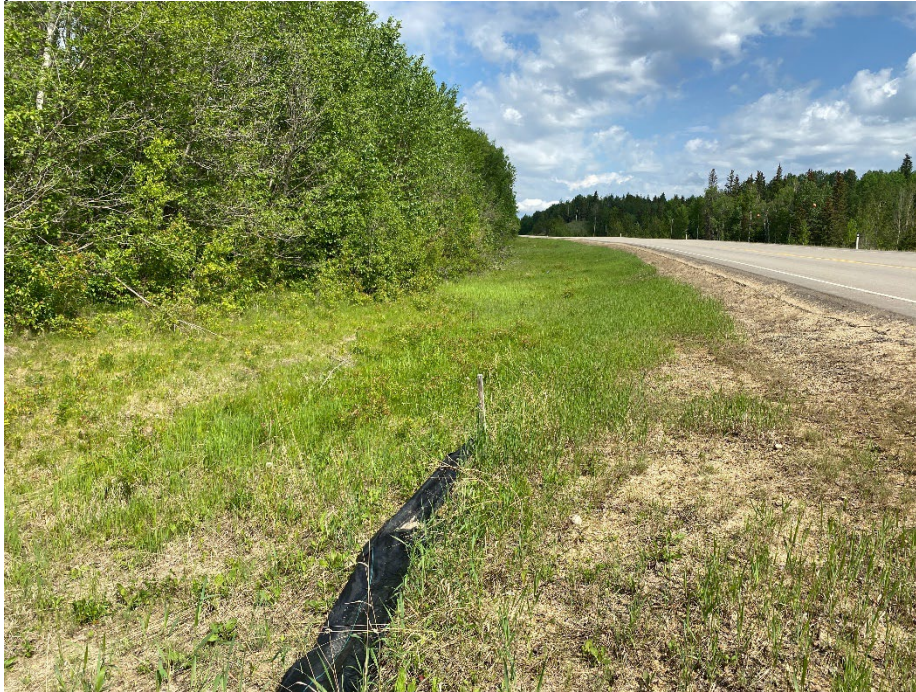
Photo 3: West ditch to the north from the old ditch block. Looking north.

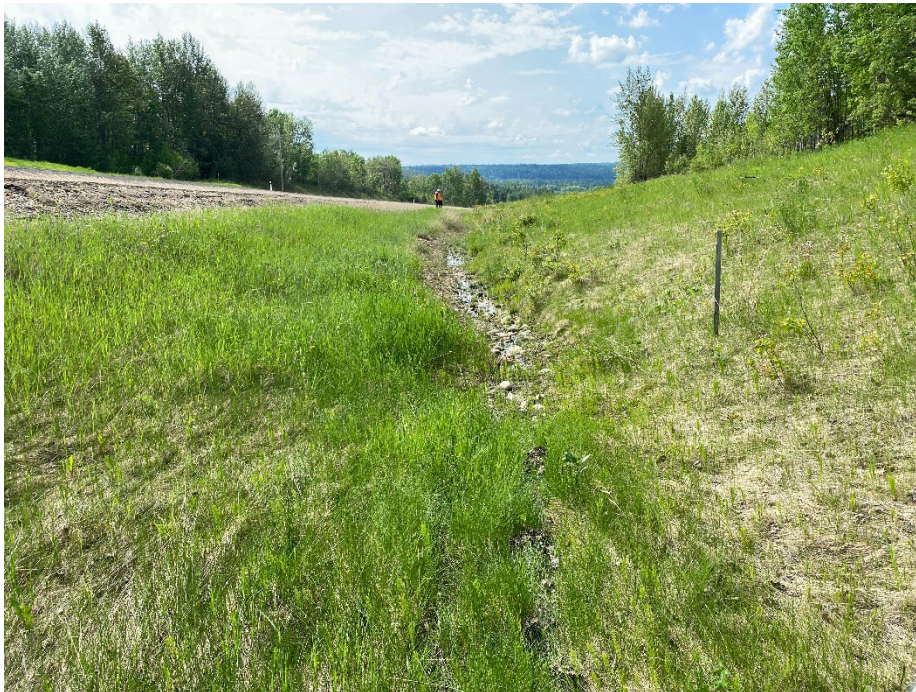
Photo 4: West ditch south from the old ditch block with gulying and exposed cobbles. Looking south.

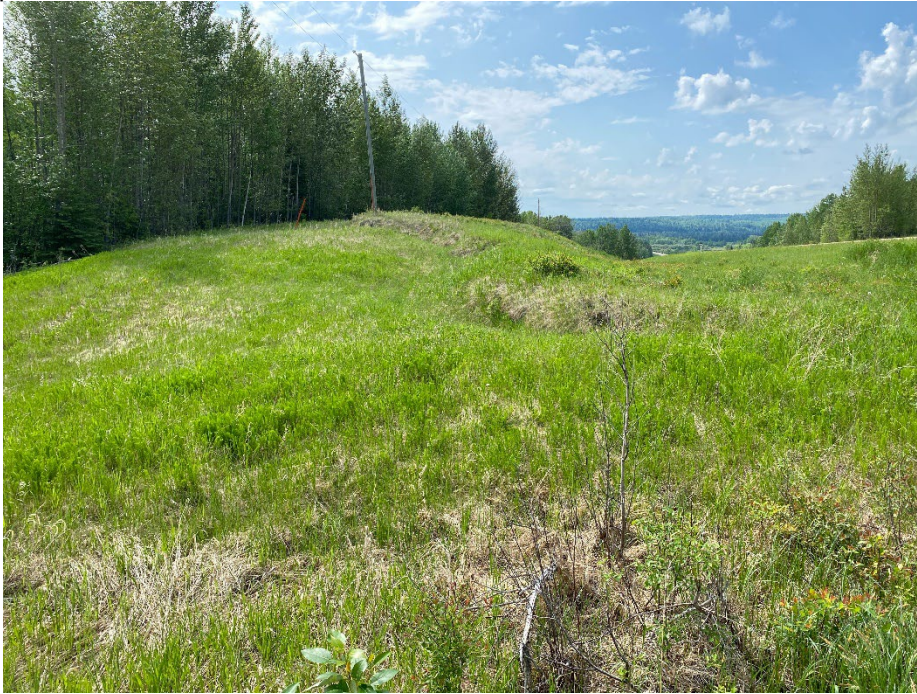
- An old, vegetated landslide exists on the east side of the highway, just south from where the C/L culvert used to outlet (Photo 5).
- The old scarp was up to 1.3 m high and runs from south of the old culvert outlet to a few meters beyond the power pole (Photo 6).
- The scarp is within a meter of the power pole, which appears to be leaning east at approximately 10-15° (Photo 6).

Photo 5: Old landslide east of Highway 658, looking south.

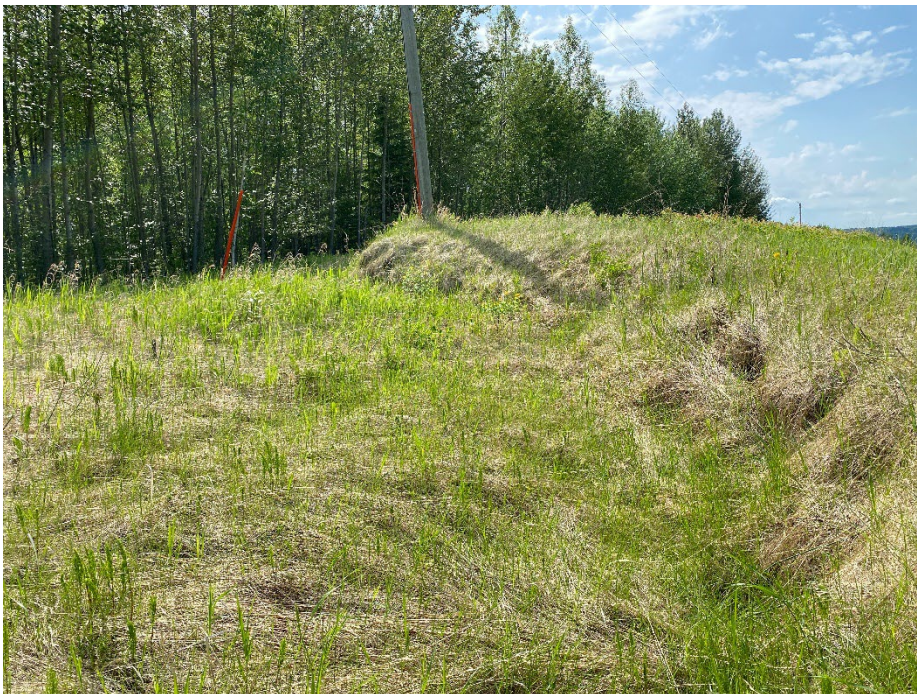
Photo 6: Old scarp and leaning power pole. Looking southeast.
