To:	Amy Driessen Alberta Transportation	From:	Leslie Cho and Carrie Murray Stantec Consulting Ltd.
File:	123315222	Date:	June 12, 2022

Reference: North Central Region, Edson, Site NC044 - Highway 633:02 Cattlepass East, Spring 2022 Instrumentation Monitoring Report

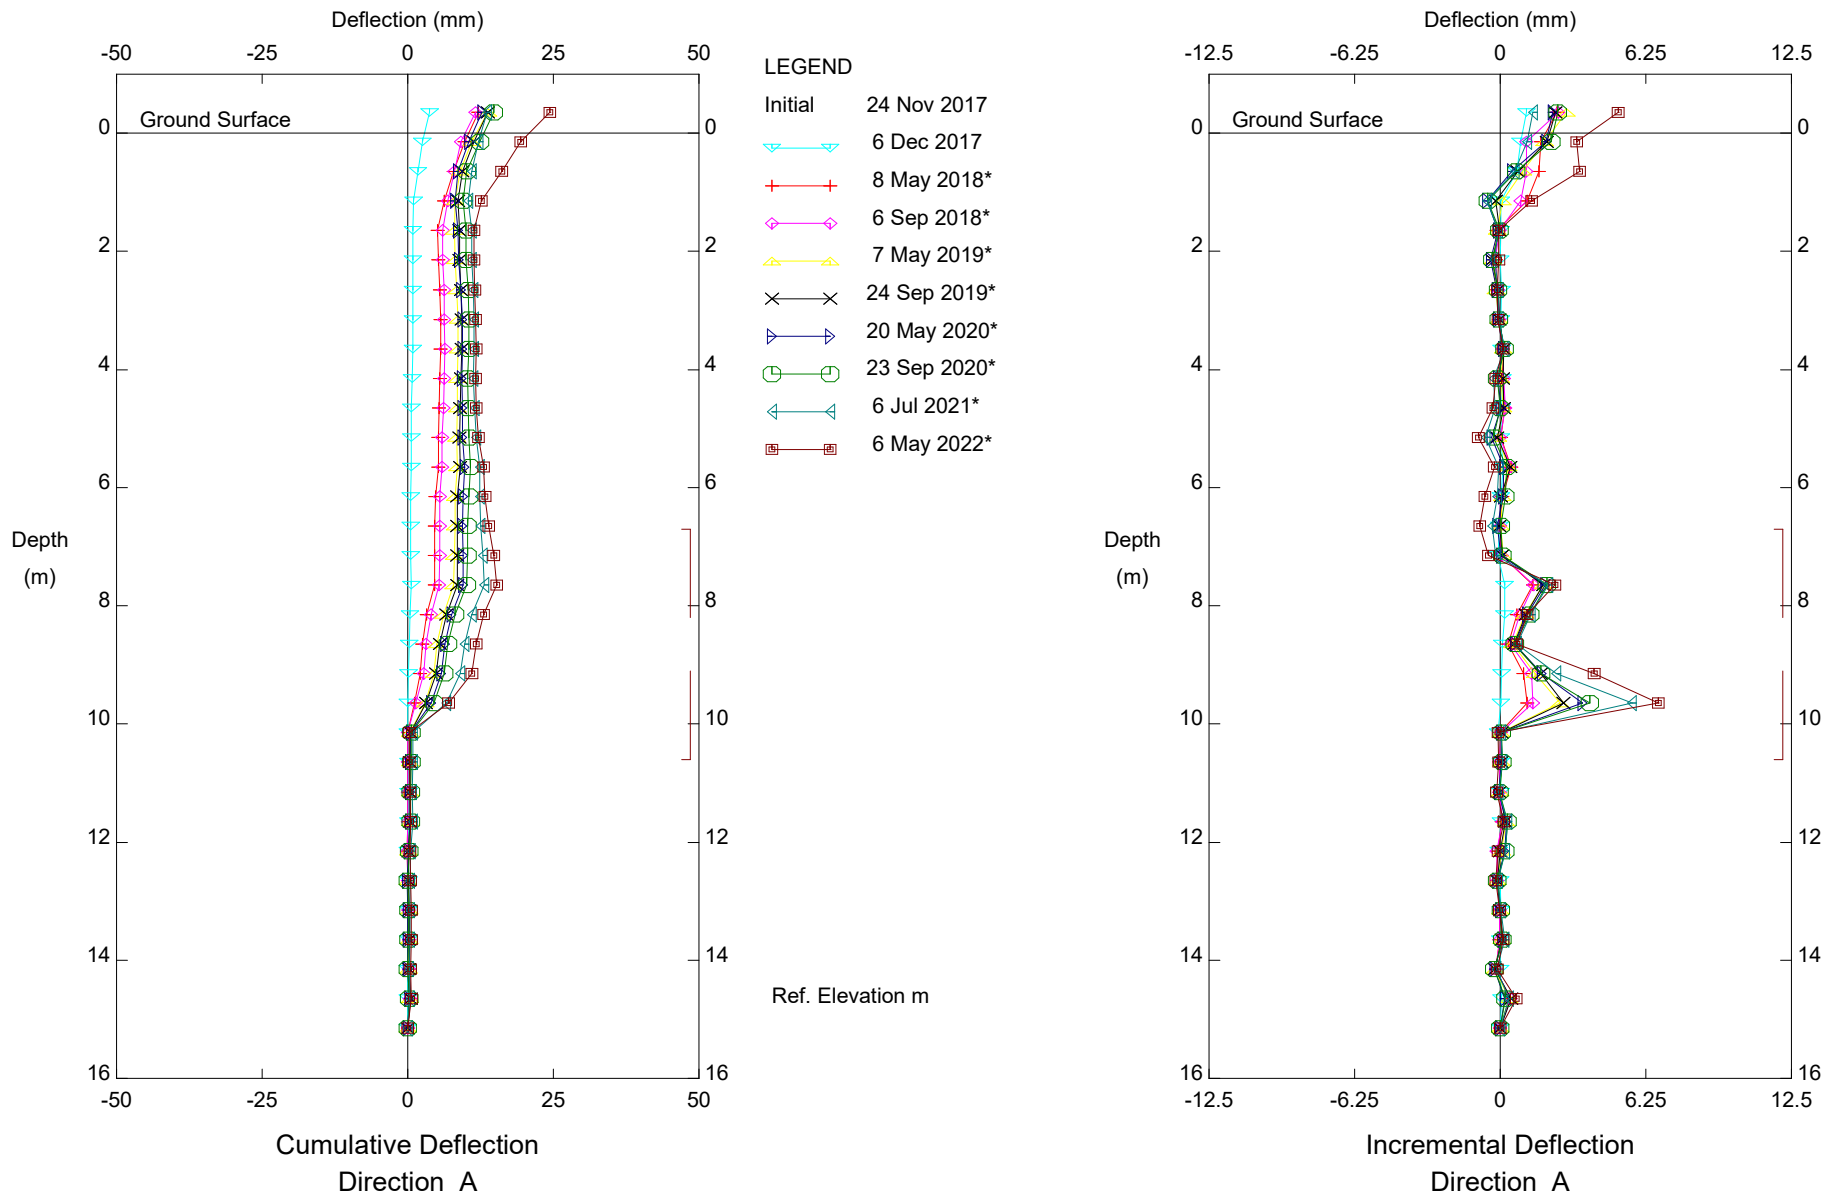
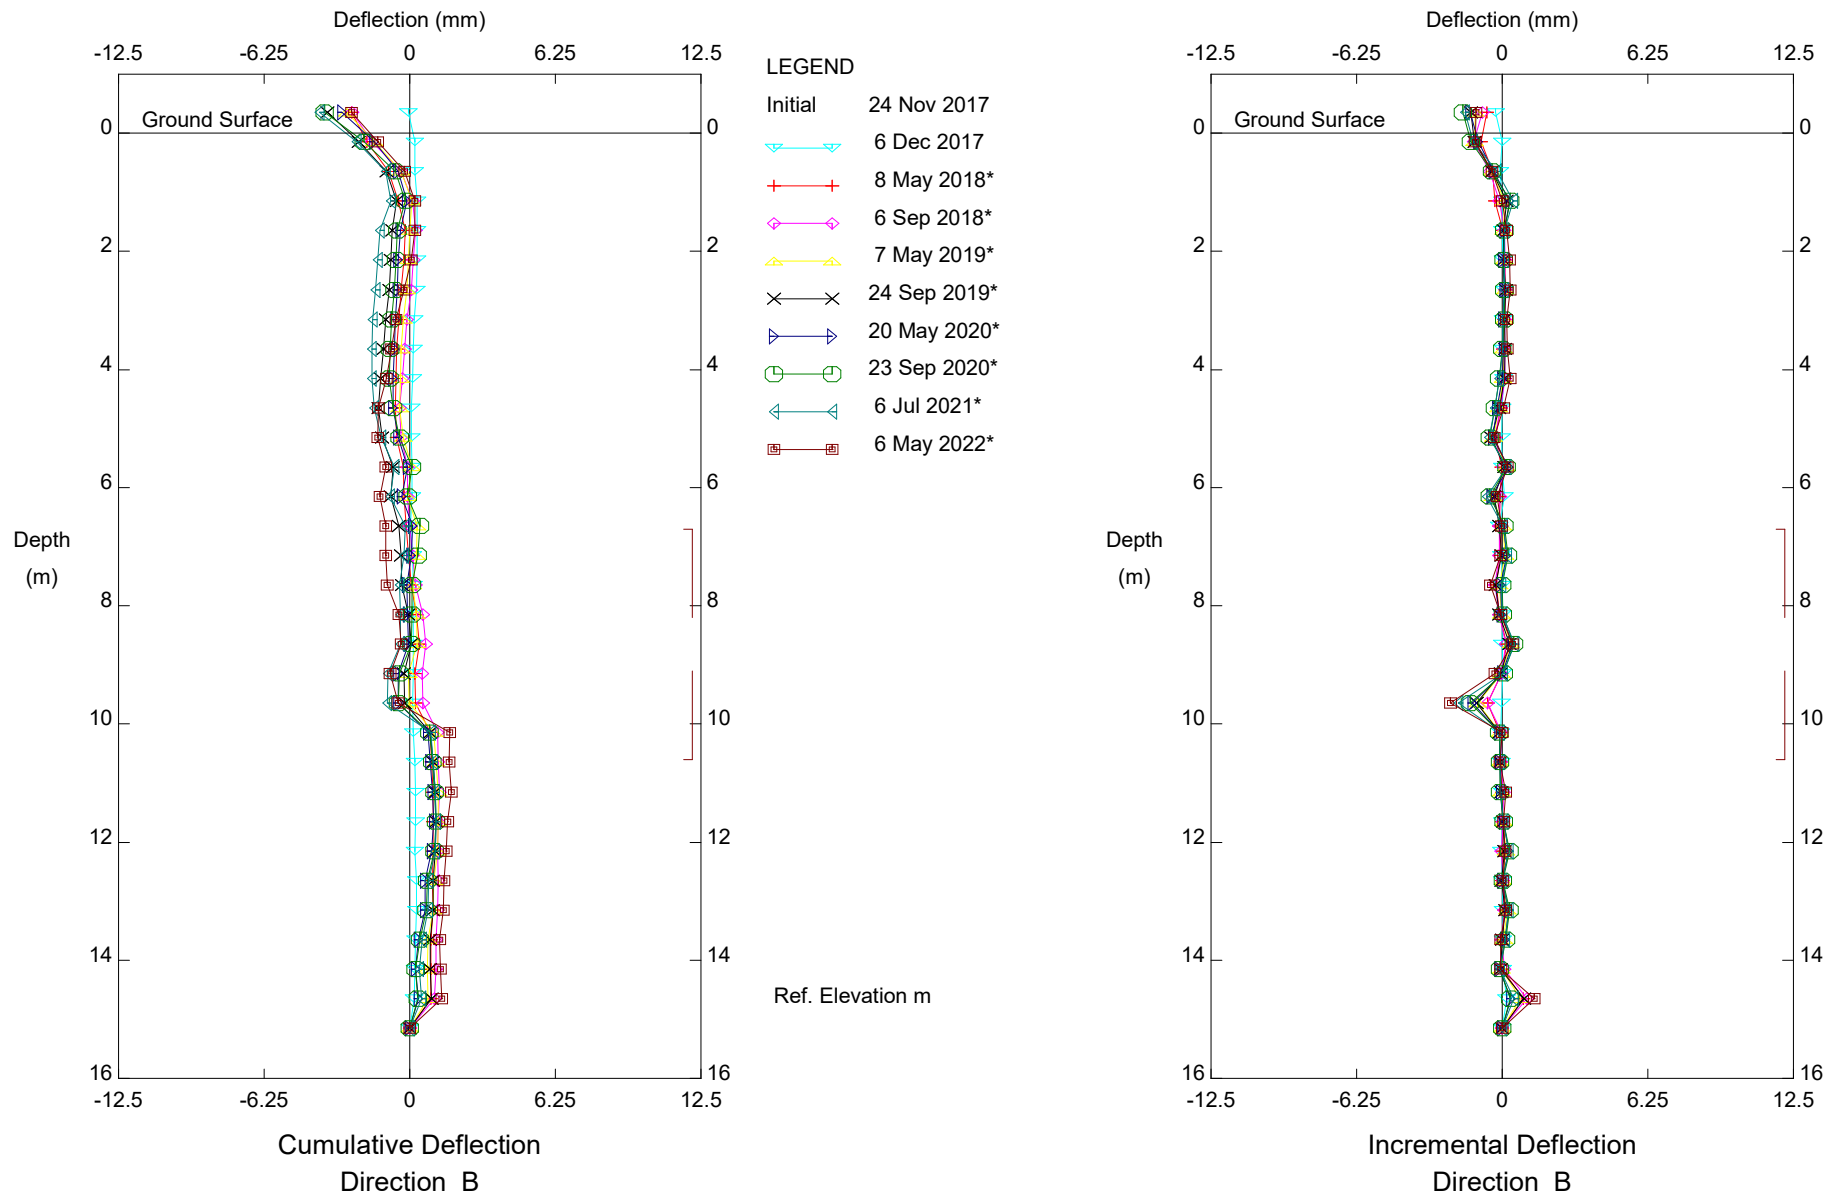
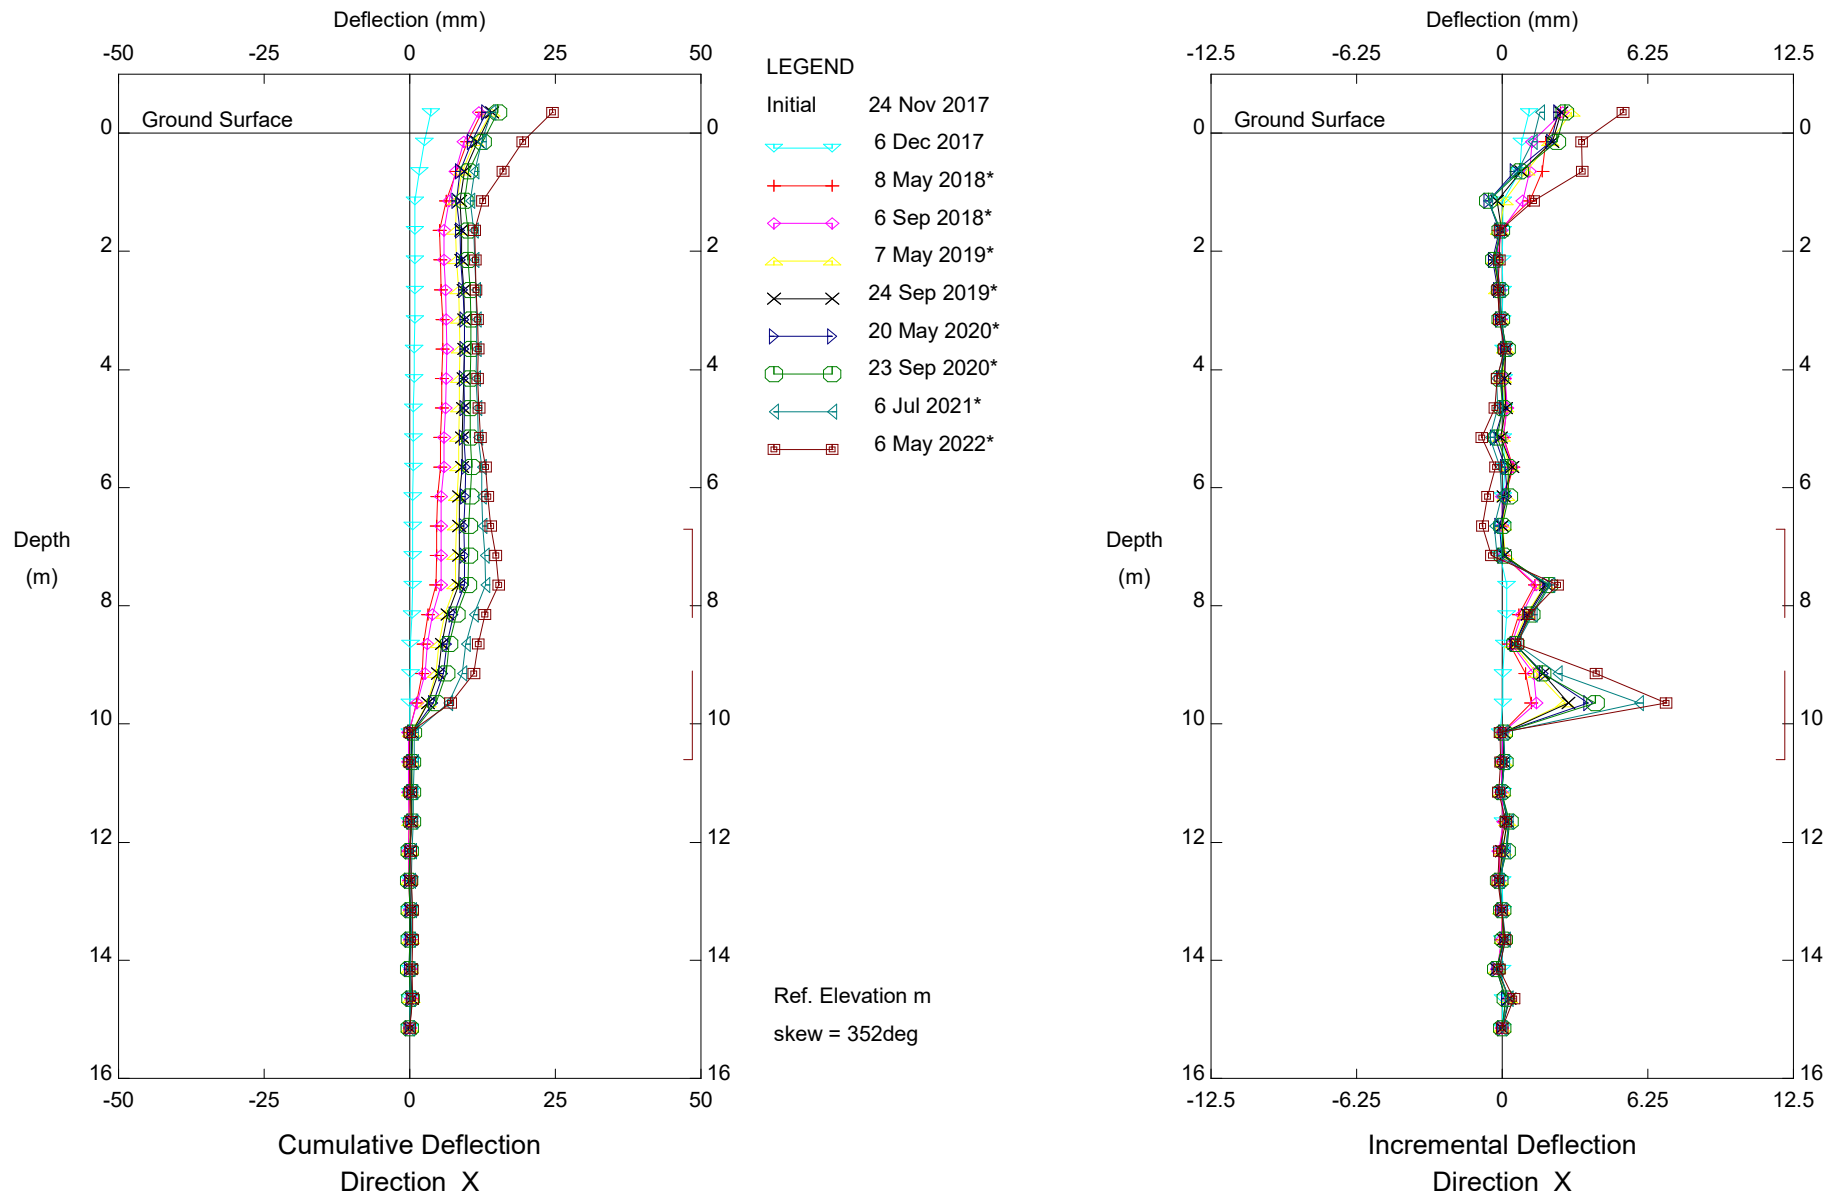
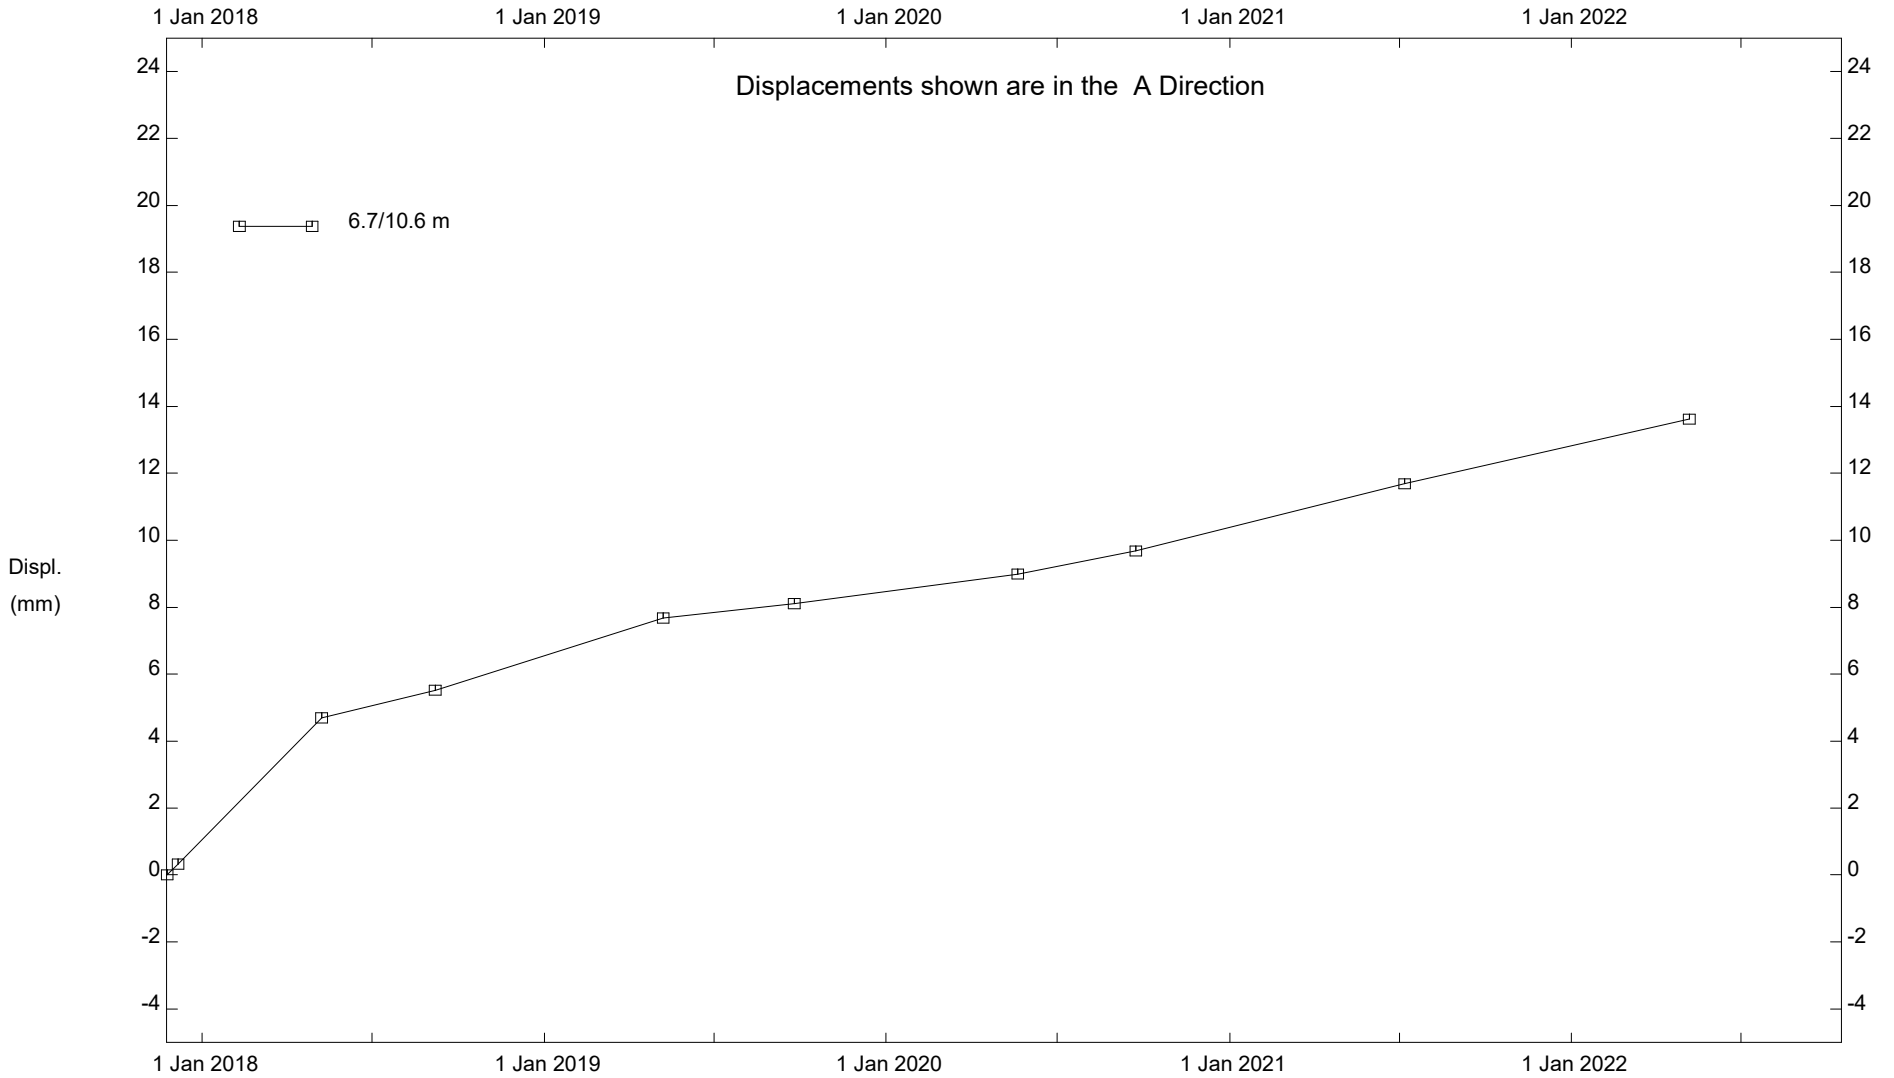
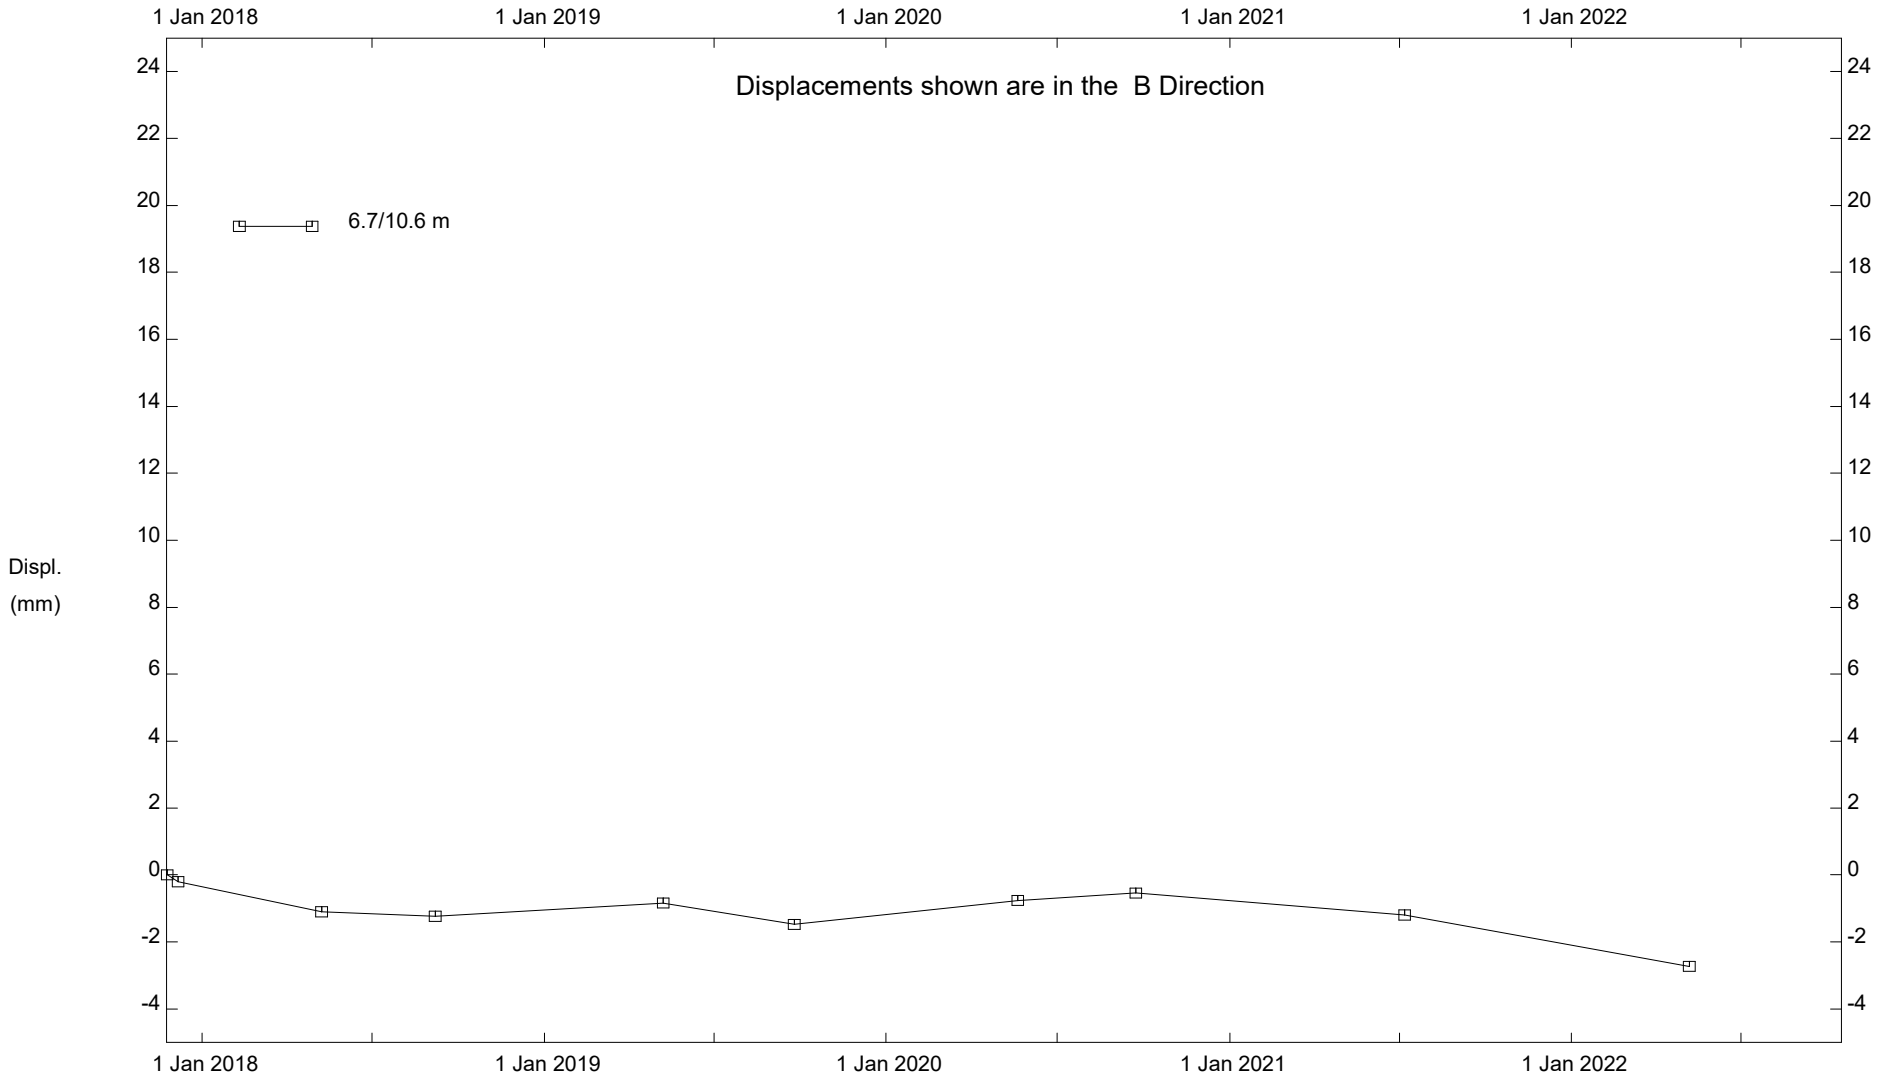
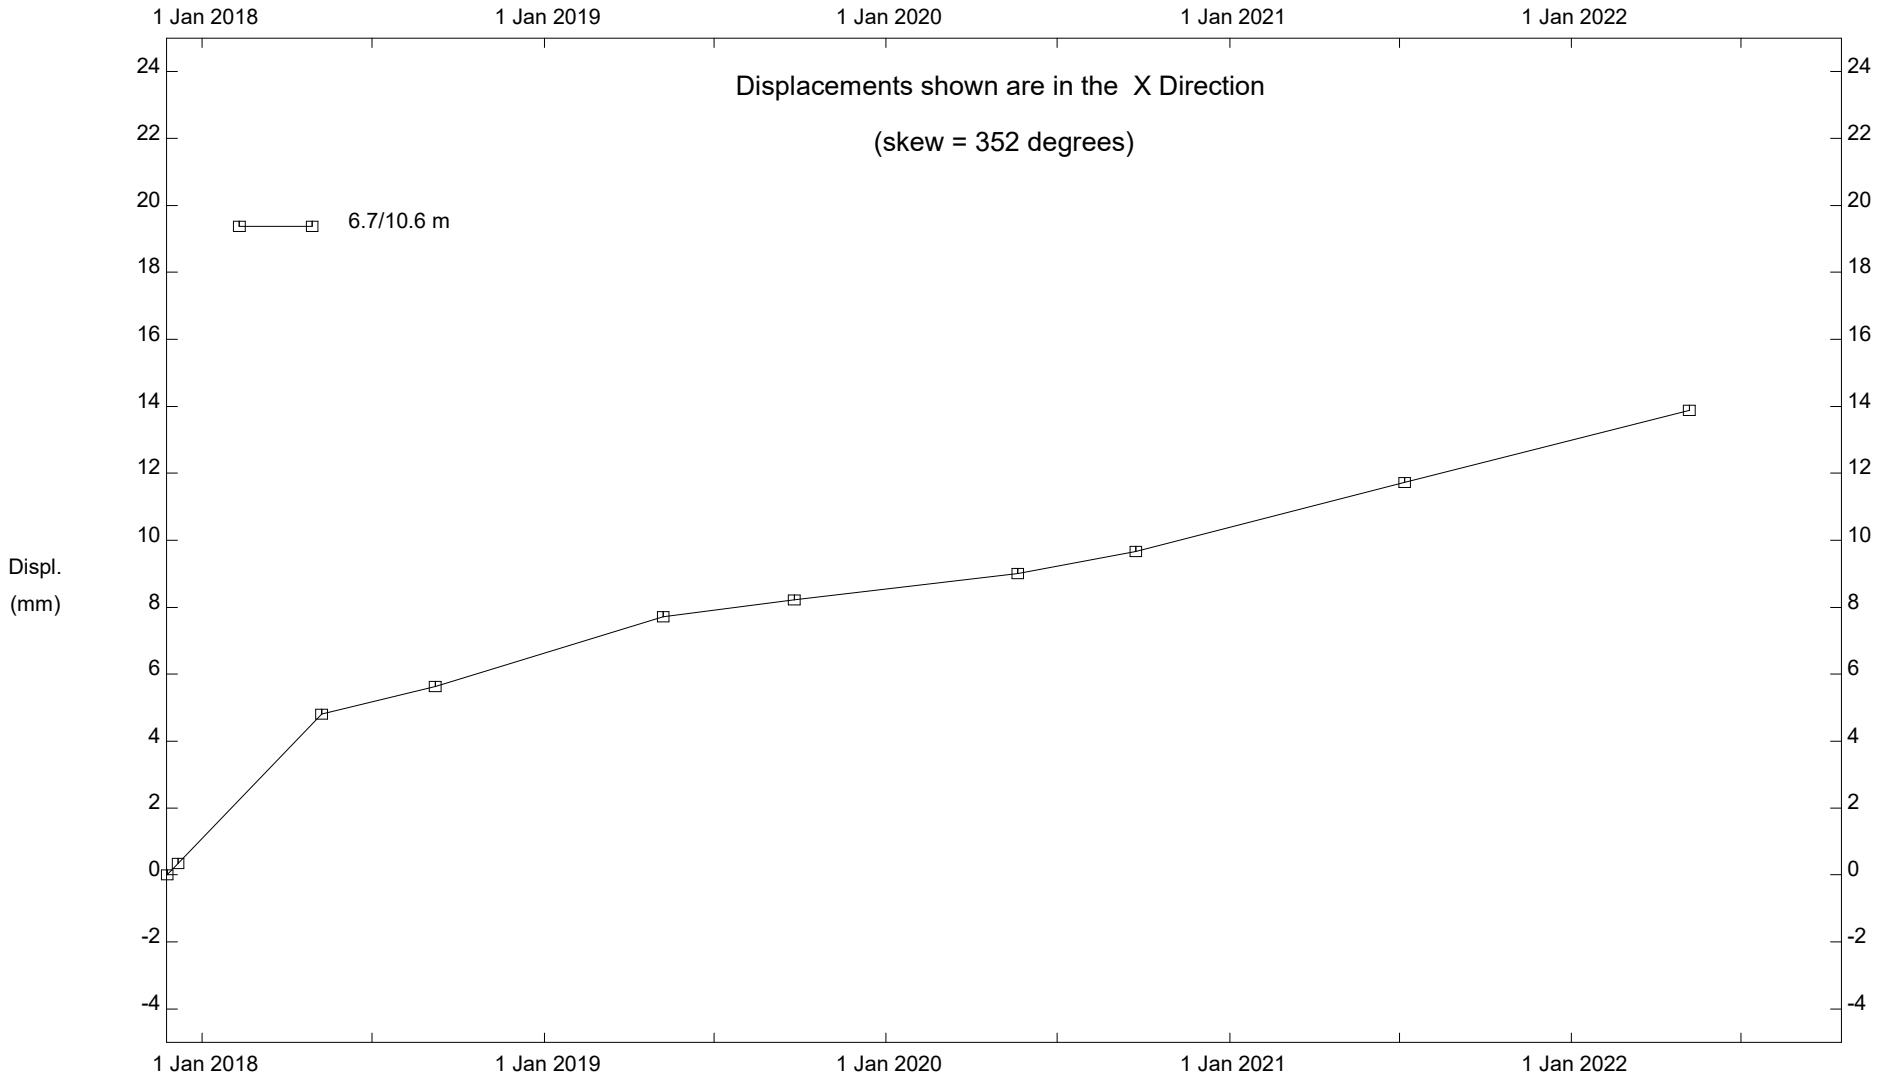
HWY 633:02 Cattlepass East (NC044), Inclinometer SI17-01

SI17-01 has a movement zone at approximately 6.7 m to 10.6 m below ground surface (bgs). During the Spring 2022 reading cycle, 2 mm of incremental movement was recorded corresponding to a current movement rate of 2 mm/yr. The overall movement rate is about 2 mm/yr since Spring 2018.

It is recommended that all instruments be monitored again during the Spring 2023 reading cycle.

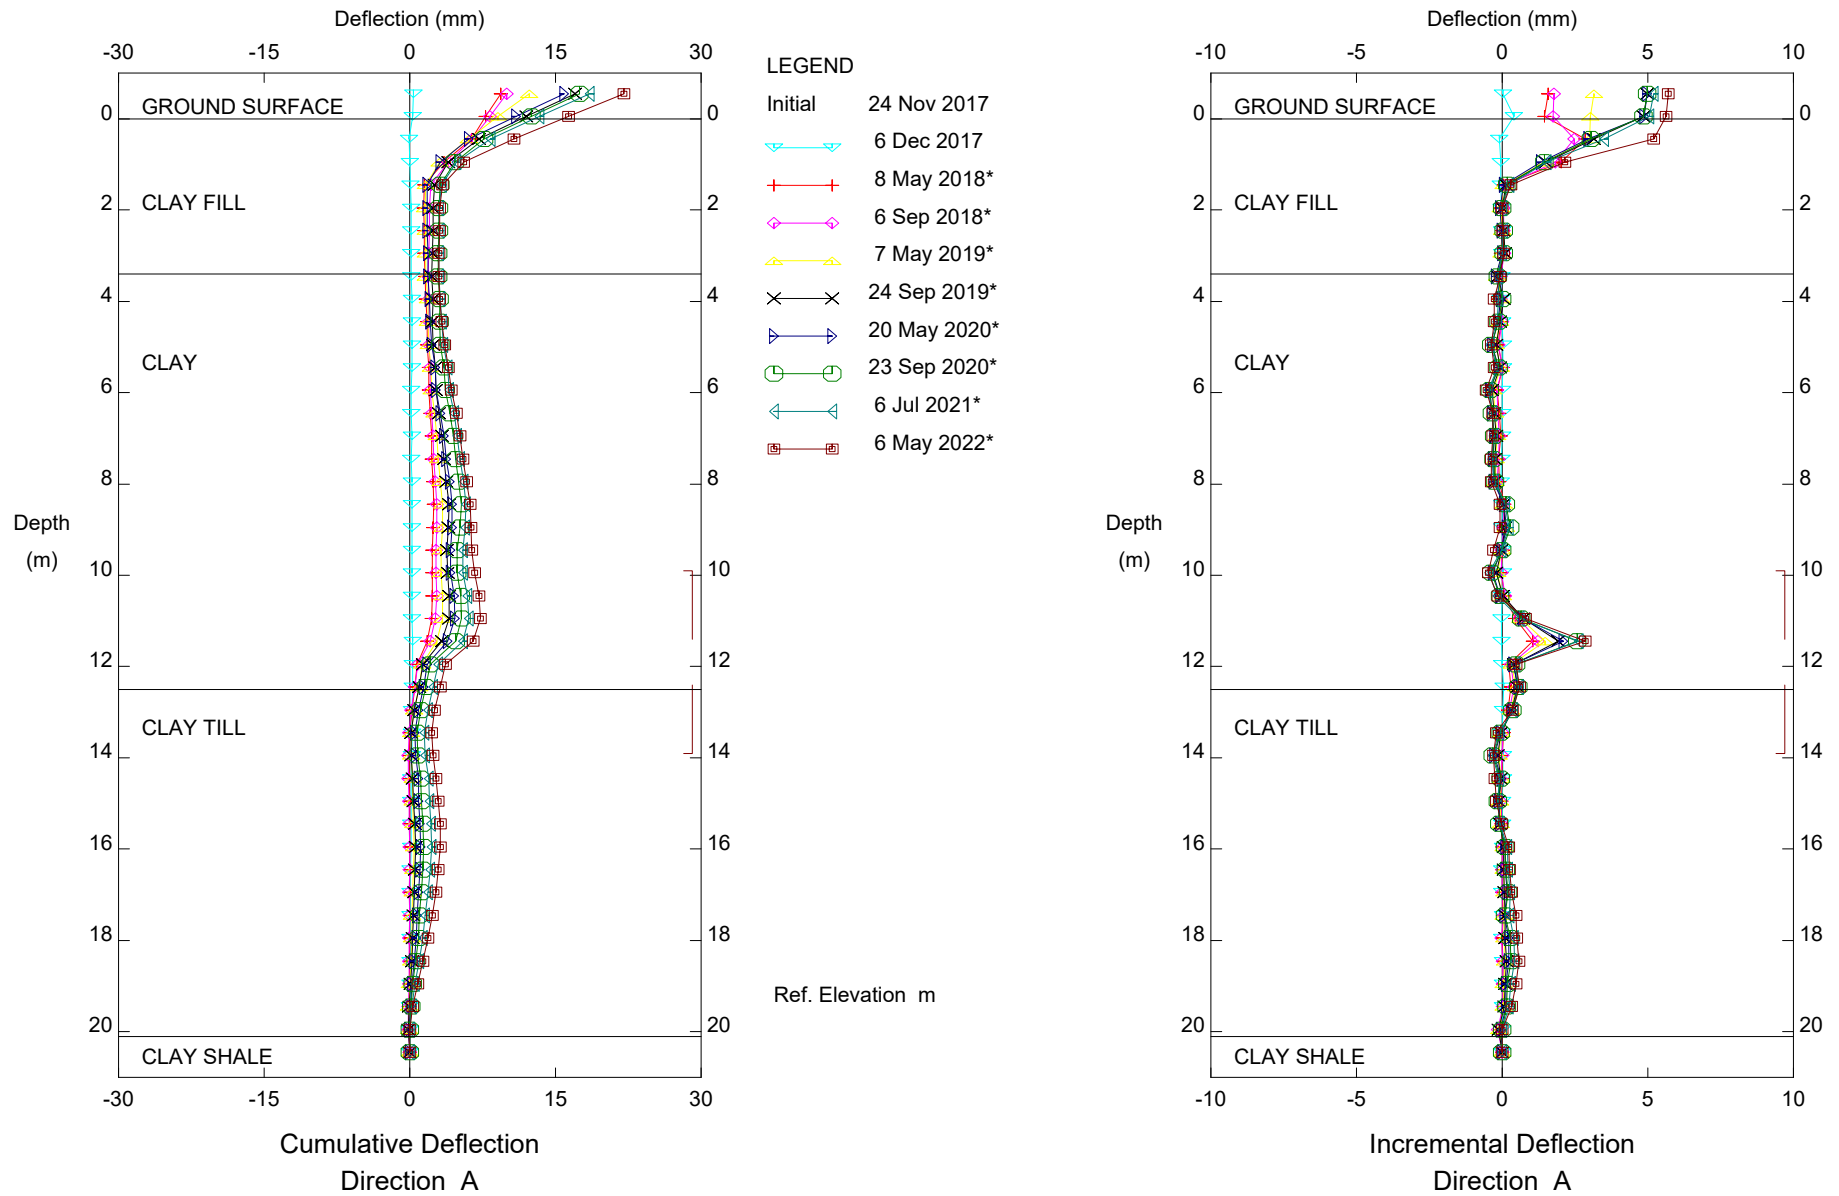
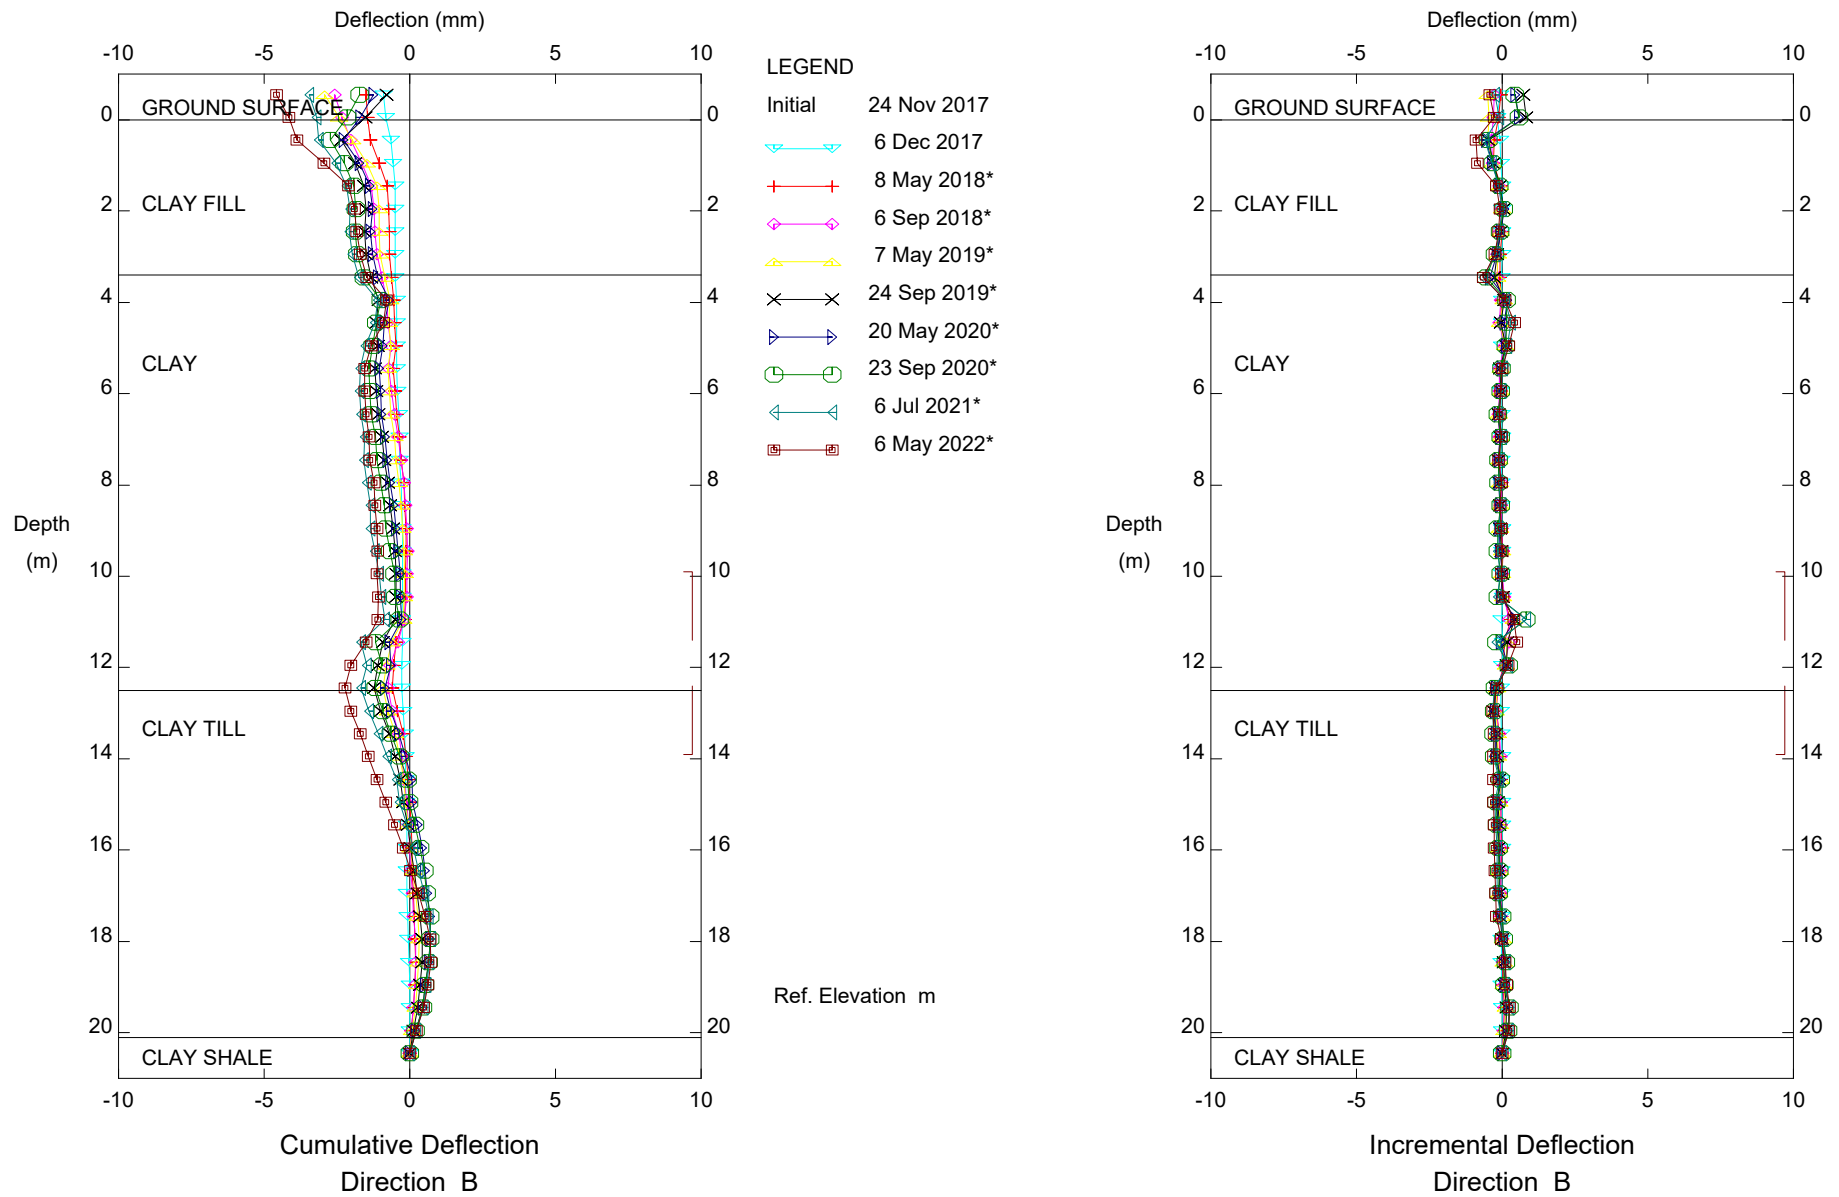
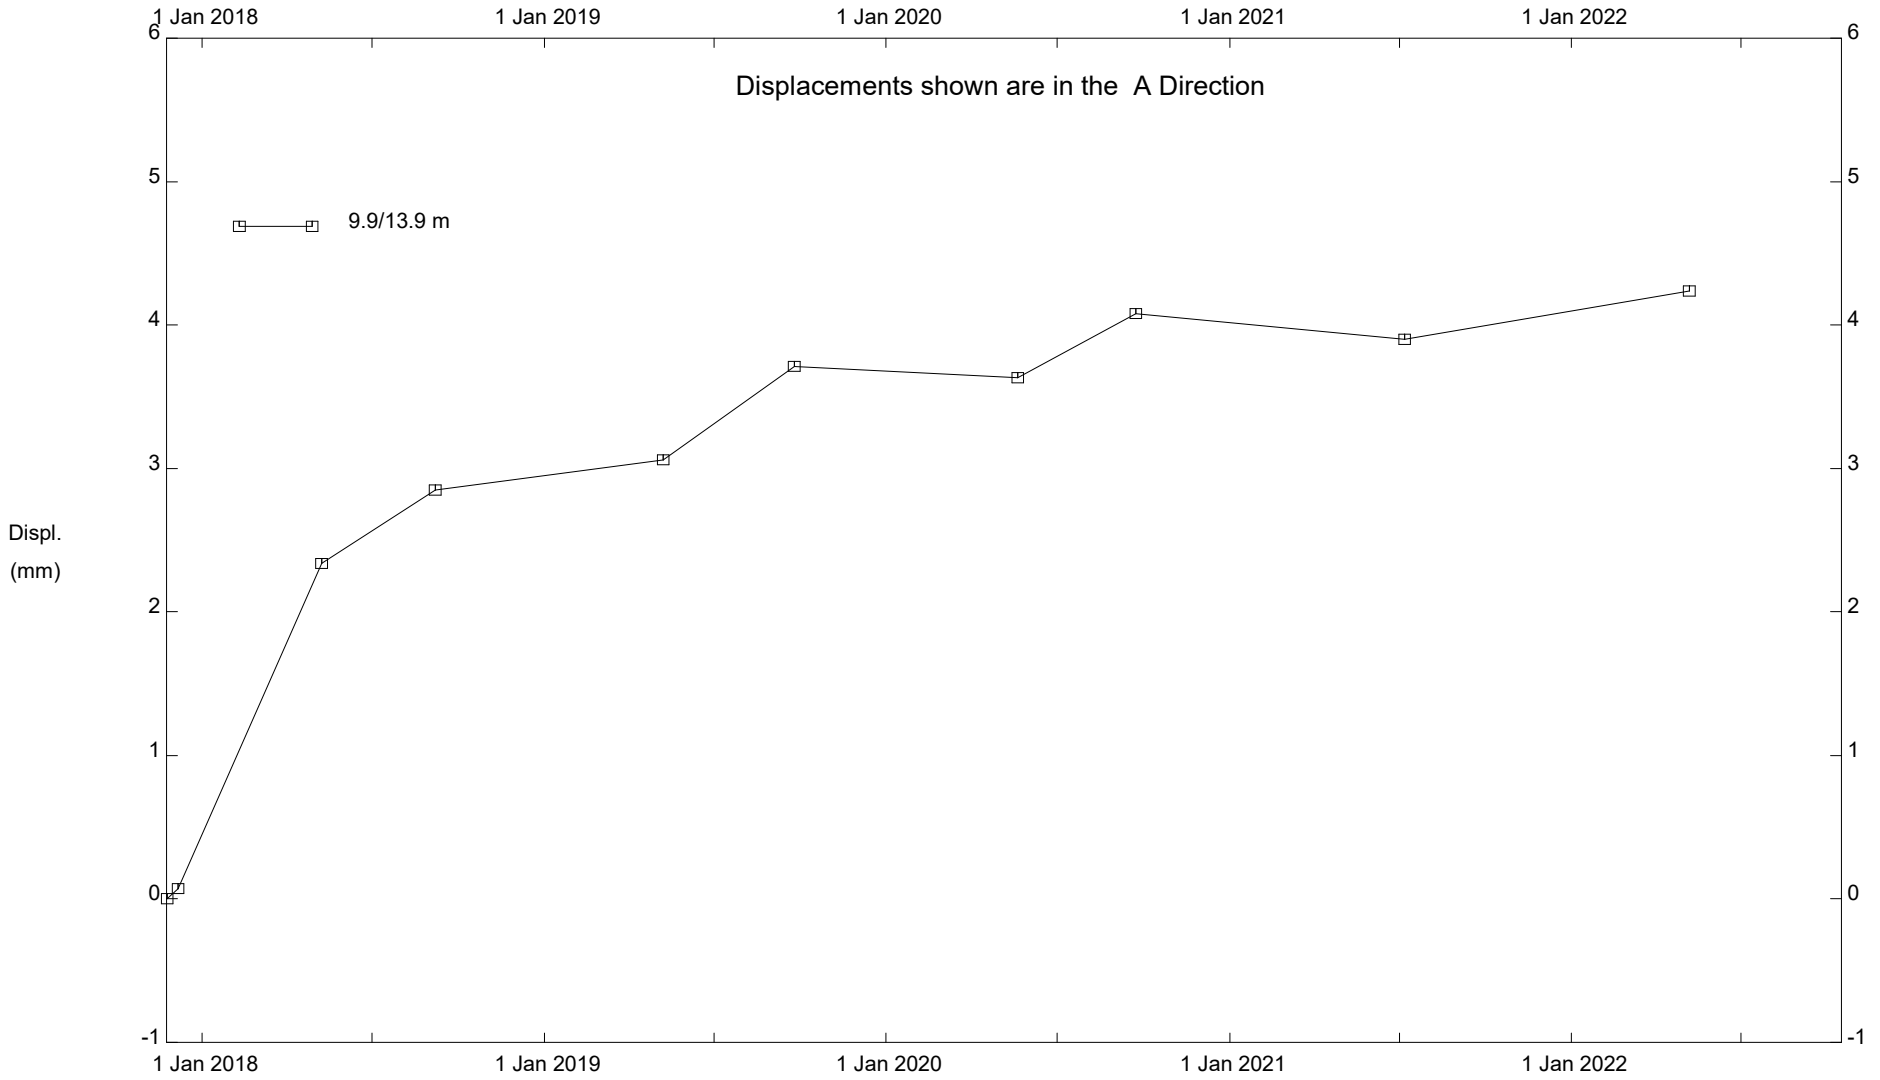
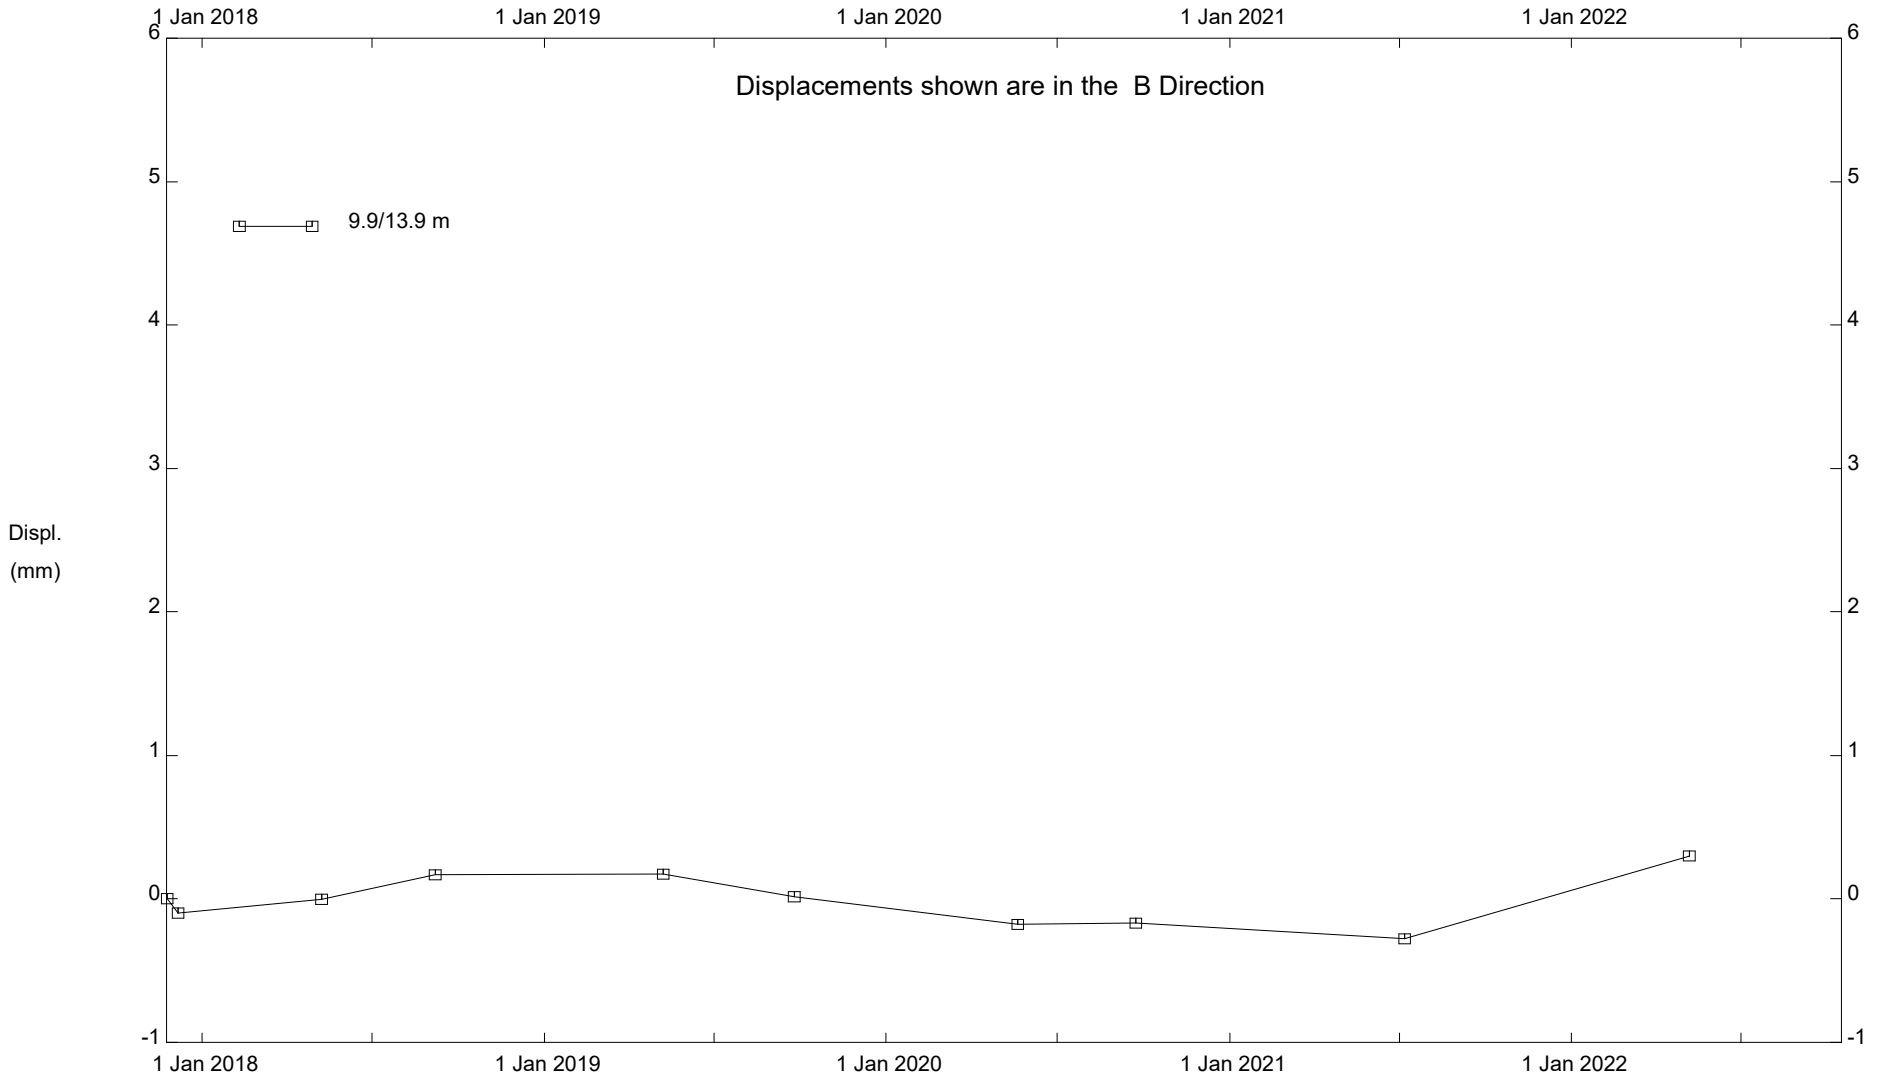
HWY 633:02 Cattlepass East (NC044), Inclinometer SI17-02

SI17-02 has a zone of movement at approximately 11 to 12 m below ground surface (bgs). The current reading shows less than 1 mm movement since the last reading in Spring 2021. There appears to be creep movement at a rate of less than 1 mm/yr since Spring 2018.
