To:	Amy Driessen Alberta Transportation	From:	Leslie Cho and Carrie Murray Stantec Consulting Ltd.
File:	123315222	Date:	June 12, 2022

Reference: North Central Region, Edson, Site NC044 - Highway 633:02 Cattlepass East, Spring 2022 Instrumentation Monitoring Report

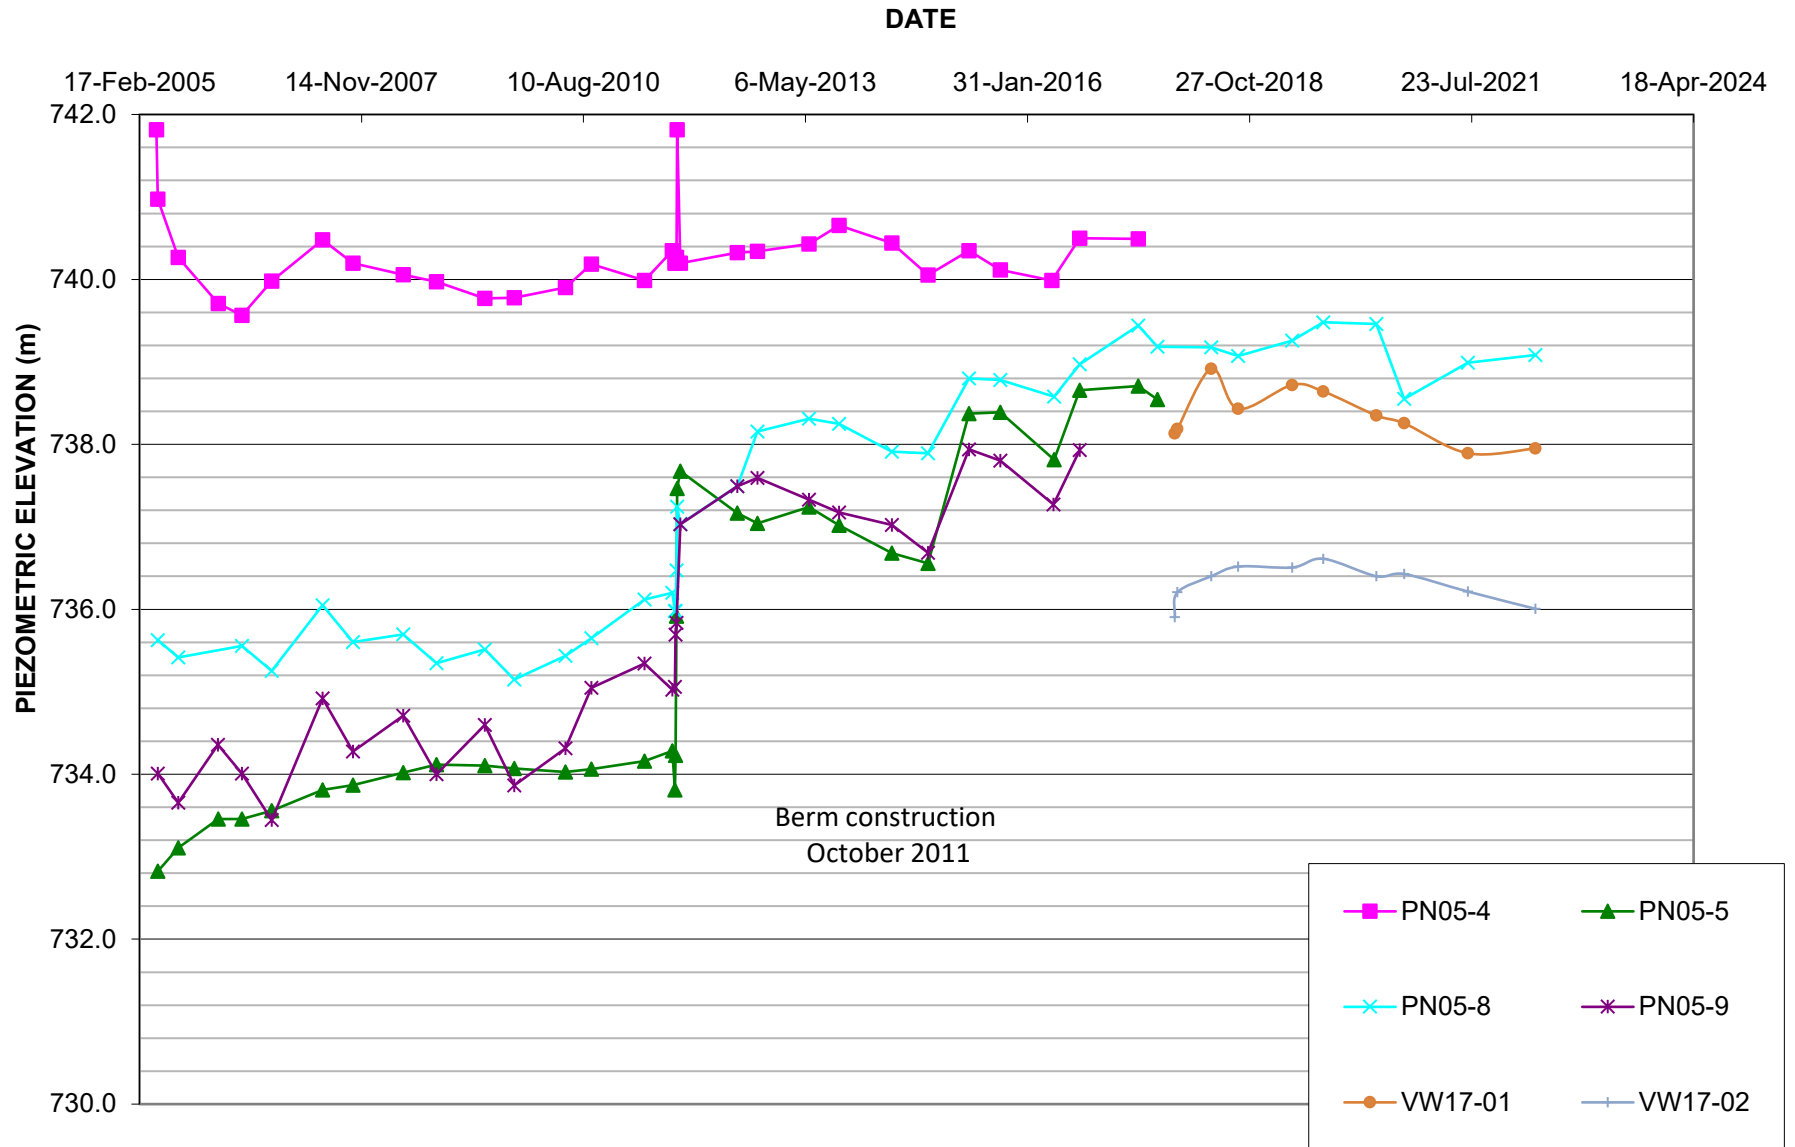
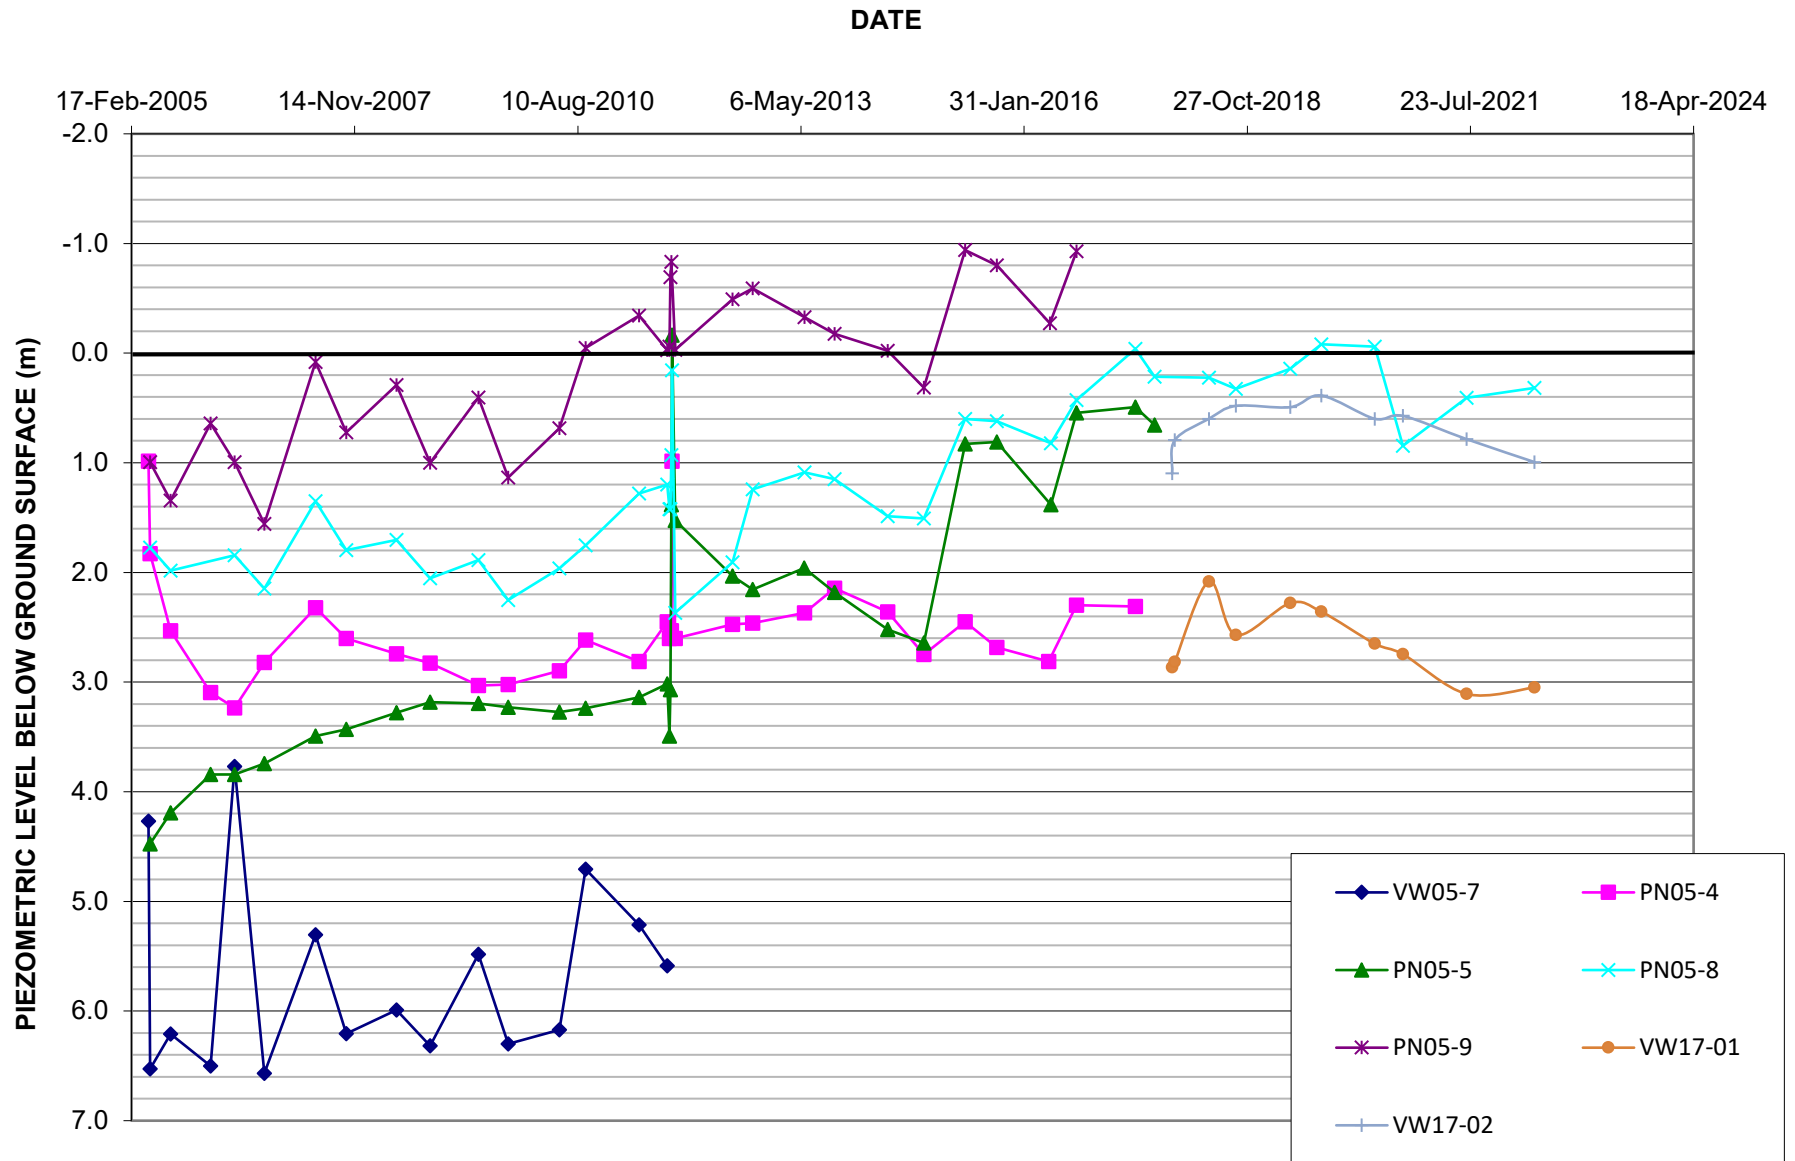
Pneumatic piezometer **PN05-8** showed an increase of 0.1 m in the piezometric level since the Spring 2021 reading cycle. An overall trend of increasing pore pressure has been developing since about 2010.

The piezometric level in **VW17-01** showed an increase of 0.1 m while **VW17-02** showed a decrease of 0.2 m, compared to the Spring 2021 reading cycle.
