SITE NUMBER AND NAME: NC014 – North of Fort Assiniboine	HIGHWAY AND KM: 661:02, km 1.8	PREVIOUS INSPECTION: June 14, 2022	CURRENT INSPECTION: May 31, 2023
LEGAL DESCRIPTION: NW-01-62-06-W5	NAD83 COORDINATES: UTM11U 6023391N, 644779E		RISK ASSESSMENT: PF: 8 CF: 10 Total: 80
AVERAGE ANNUAL DAILY TRAFFIC (AADT): 190 (2022)		CONTRACTOR MAINTENANCE AREA (CMA): 508

2023 Site Inspection Photos at NC014

TRANSPORTATION AND ECONOMIC CORRIDORS
GEOHAZARD MONITORING PROGRAM
NC014-1: HWY 661:02 FORT ASSINIBOINE (km 1.8)
SITE PLAN SHOWING EXISTING FEATURES

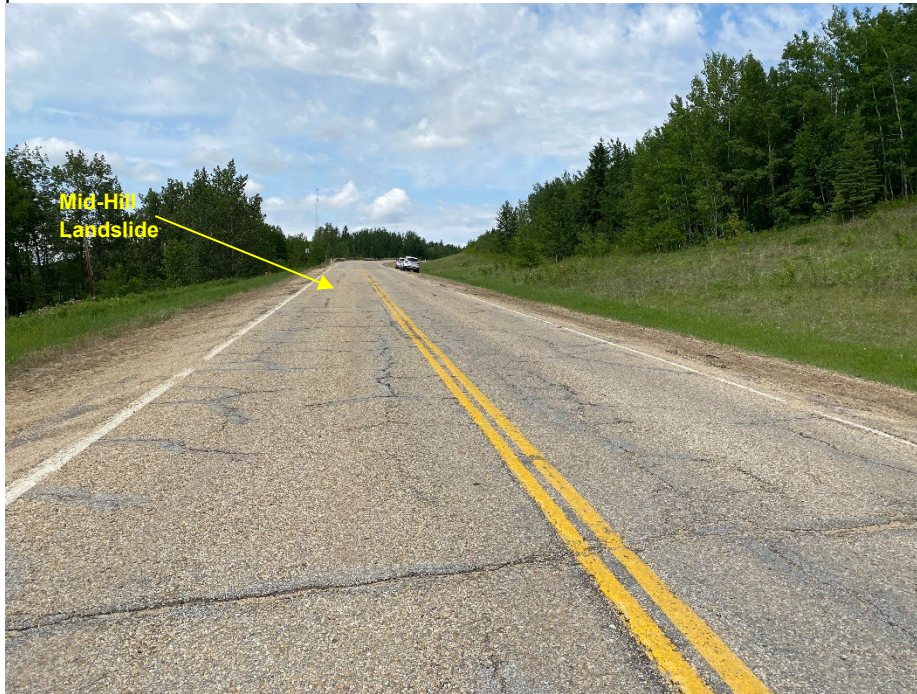
Other	X		Two sinkholes in ravine. Two new sinkholes in east ditch within mid-hill slope section.		X
COMMENTS					
<ul style="list-style-type: none"> • Highway cracking was observed along the mid hill slope and upper slope sections where landslide activity is apparent and in other areas mostly due to traffic use (Photo 1). • The water level in MH#1 was at ground surface. Water from the drainage channel adjacent to the MH appeared to be ponding and flowing into MH#1 (Photo 2). Siltation may be a problem at MH#1. • The mid hill slope section (Photos 3 and 4) had 10 to 50 mm wide reflective cracks. A more apparent dip towards the southwest was observed and is estimated to be about 25 to 50 mm deep. • At the upper slope section (Photo 5), a head scarp and graben were observed downslope of the guardrail. The guardrail also appeared to be slightly sagging and shifting laterally. Pavement cracks upslope from the graben were up to 80 mm wide. A slight dip in the pavement towards the west was also observed. • Both functional SIs are located above the highway backslope and outside the landslide area. Both instruments showed no movement. Readings on these SIs have stopped since land access permissions have not been agreed upon with the private landowner since Spring 2021. • The piezometers show water levels have been relatively consistent with spring 2023 readings ranging from 2.1 m bgs to 26.4 m bgs. A slight trend of increasing water levels seems to be developing in most piezometers since 2006. • Numerous sand outcrops were observed downslope of the upper slope landslide graben. The two small sand outcrops closest to the ravine formed depressions up to 0.5 m deep. • A gully with exposed sand has formed south from the upper slope section near the sand outcrops, down to the bench (Photo 7). • The two sinkholes in the ravine downslope of the highway between the upper and mid slope appear to have increased in size since the 2022 site inspection. The north sinkhole was measured to be 600 mm deep by 1 m in diameter, and the south sinkhole was measured at 400 mm deep by 1 m in diameter (Photo 6). • The sinkhole in the east ditch near the centre section of the corner was not observed and may have been infilled. • Two new sinkholes were observed in the east ditch near the mid-hill landslide area. The northernmost sinkhole was approximately 0.5 m deep, 0.7 m wide and 1.0 m long. The other sinkhole, southeast from the utility box, was measured to be 0.9 m deep, 1.2 m wide and 1.5 m long (Photo 8). • A perforated subdrain was observed at surface along the east ditch. The subdrain was infilled with soil and does not appear functional. The actual alignment and extents of the subdrain is currently unknown. It is possible that the sinkholes in the east ditch are related to the old subdrain. • Several homes exist near the base of the landslide representing a public safety issue along with potential loss of privately owned structures. As such, the Consequence Factor remains at 10.

Photo 1: Pavement cracking southeast of mid-hill landslide. Looking northwest.

RECOMMENDATIONS					
<ul style="list-style-type: none"> • All pavement cracks should be sealed to reduce surface water infiltration into the landslide mass. • All culverts and manholes should be inspected to reduce the risk of water seeping into the slope. This could consist of cleaning and flushing to promote water flow. • The sinkholes should be backfilled and capped with clay to reduce further erosion and surface water infiltration into the slope. • Slope inclinometers within the slide mass are no longer functioning. Slope movement can be monitored by installing replacement inclinometers and/or considering InSAR or LiDAR change detection methods. • Preliminary remediation options may include: <ul style="list-style-type: none"> – Constructing a concrete pile wall from the upper slope section to the mid-hill section, approximately 160 m long. The high-level cost for a concrete pile wall is \$3.1 million to \$4.2 million, excluding engineering. – Reconstructing the highway with lightweight fill such as EPS geofoam or lightweight cellular concrete. The high-level cost for this option is \$730,000 to \$1.1 million excluding engineering. – Installing a new subdrain along the east ditch. The high-level cost for this option is \$400,000 to \$500,000 excluding engineering. – Maintenance, monitoring and surveillance approach: Given the low volume and low speed nature of this highway, it may be preferential for TEC to continue maintaining the highway by placing asphalt patches and sealing cracks as well as maintaining the existing manholes and subdrainage system. This approach carries some risk in that the rate of slope movement can suddenly increase. If this approach is adopted, increased monitoring of the site is recommended consisting of additional slope inclinometers below the

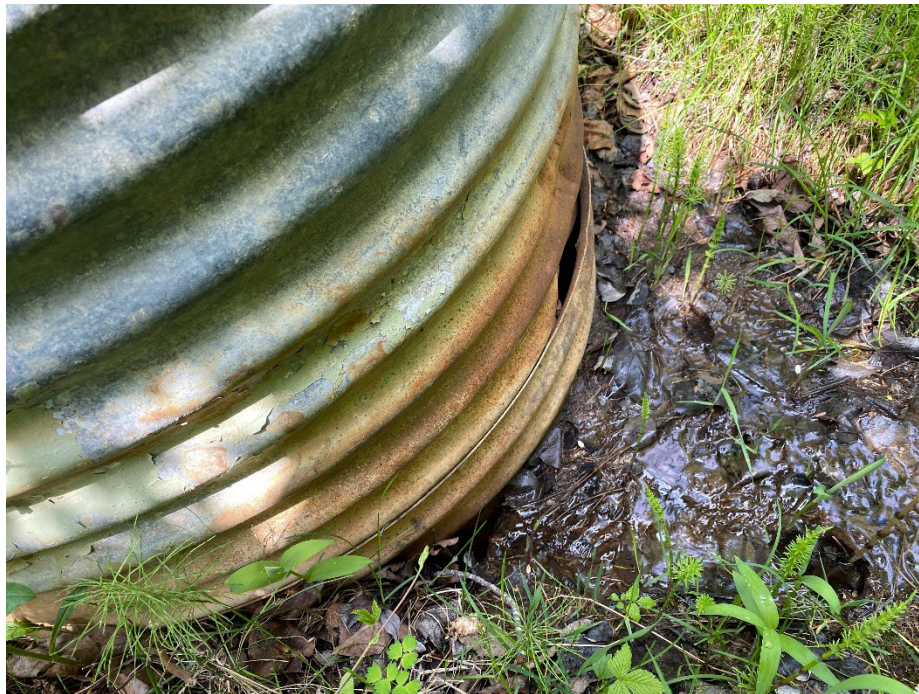
Photo 2: Pooling/flowing water adjacent to MH#1. Water entering culvert at ground surface. Looking northeast.

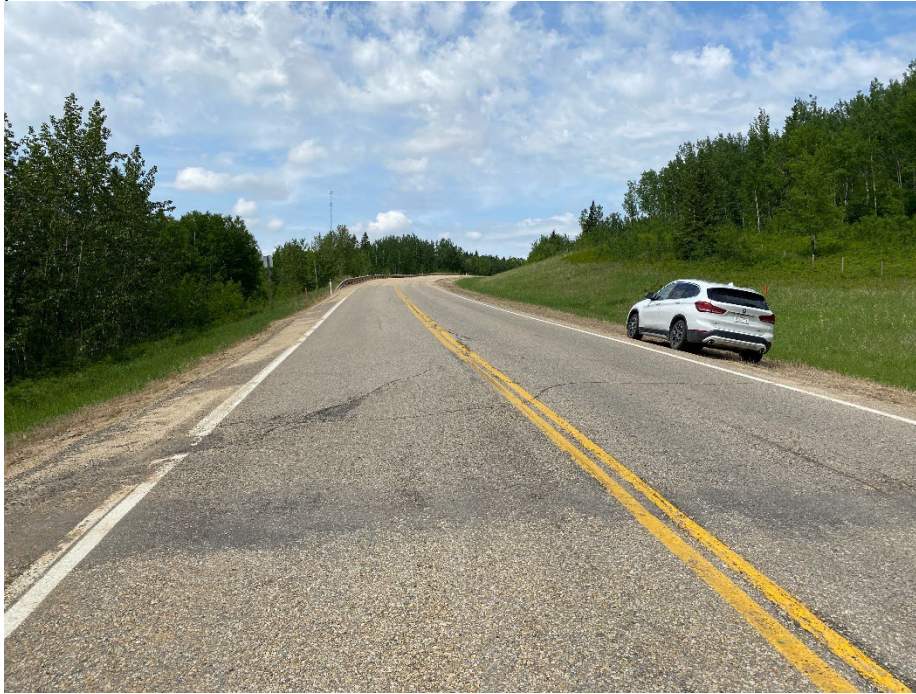
Photo 3: Pavement cracking at south extent of mid-slope landslide. Looking northwest.

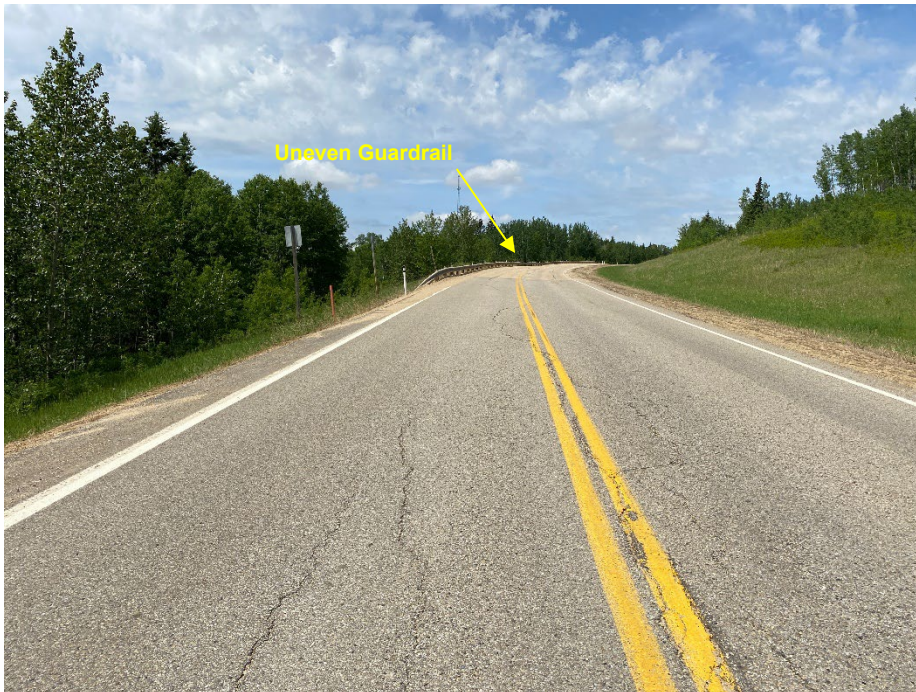
Photo 4: Pavement cracking at mid to north extent of mid-slope landslide. Looking northwest.

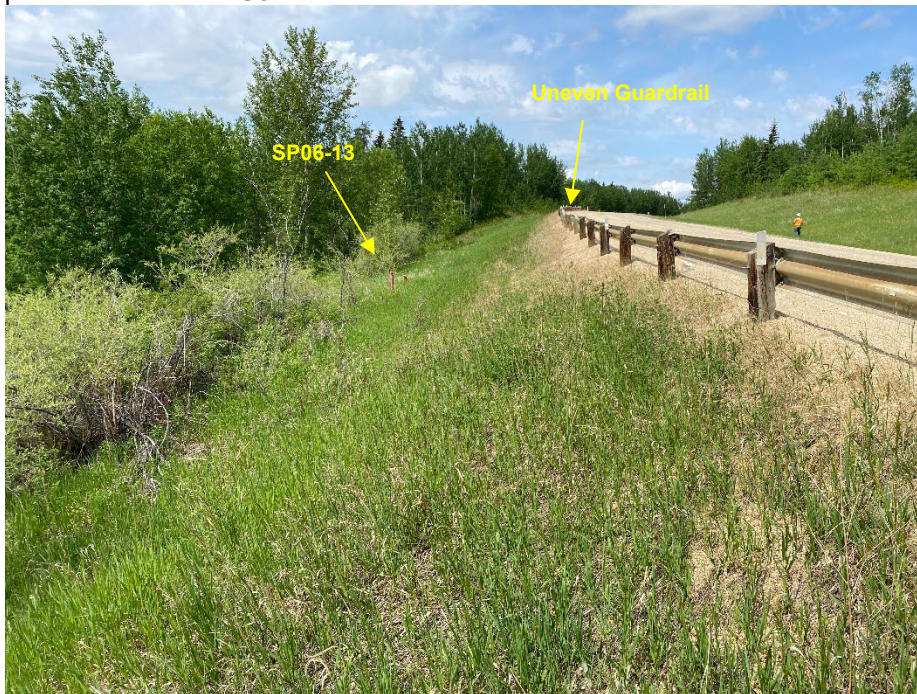
Photo 5: Landslide at uphill section. Looking northwest.

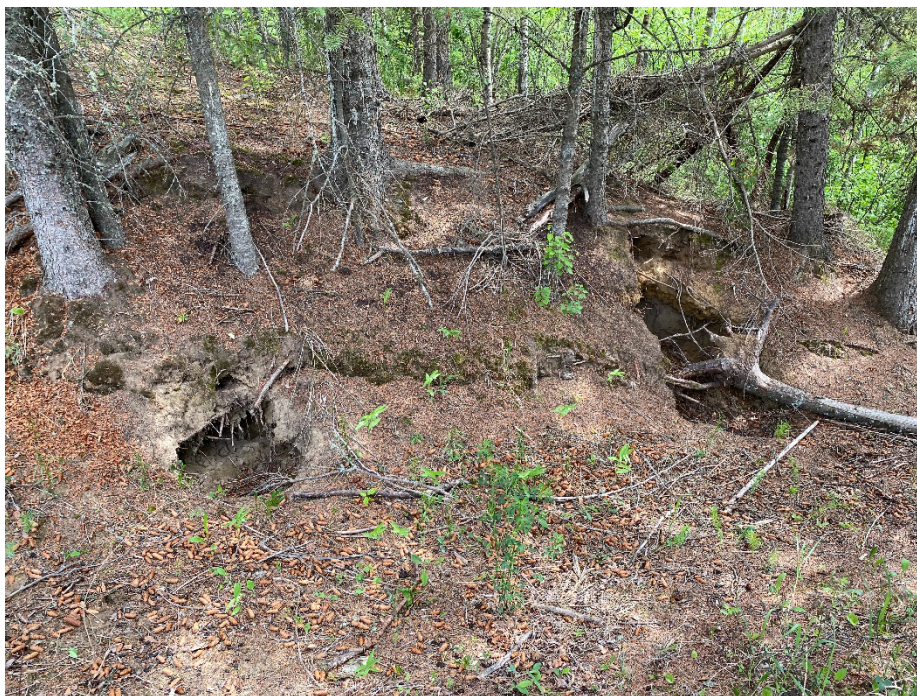
Photo 6: Two sinkholes in ravine. Looking southeast.

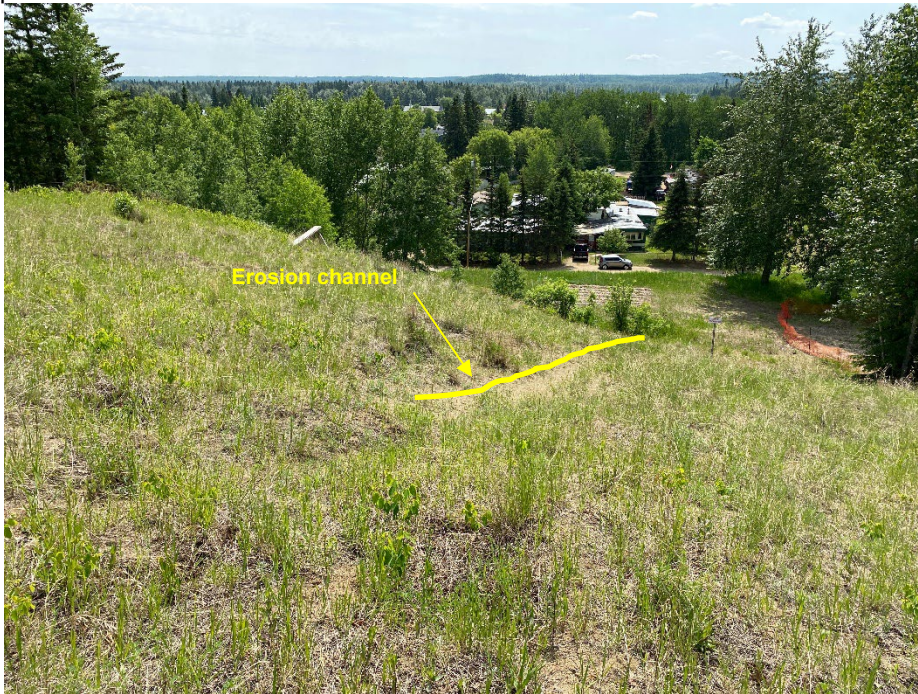
Photo 7: Sand exposed in erosion channel heading downslope to the bench. Looking southwest.

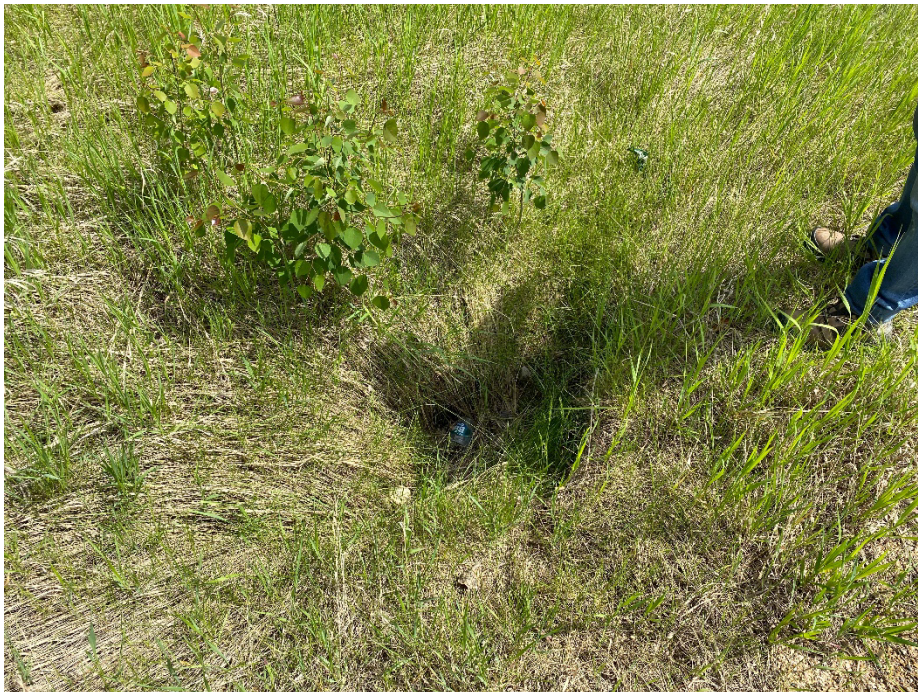
Photo 8: New sinkhole southeast from the utility box in the east ditch near the mid-hill landslide area. Looking northeast.

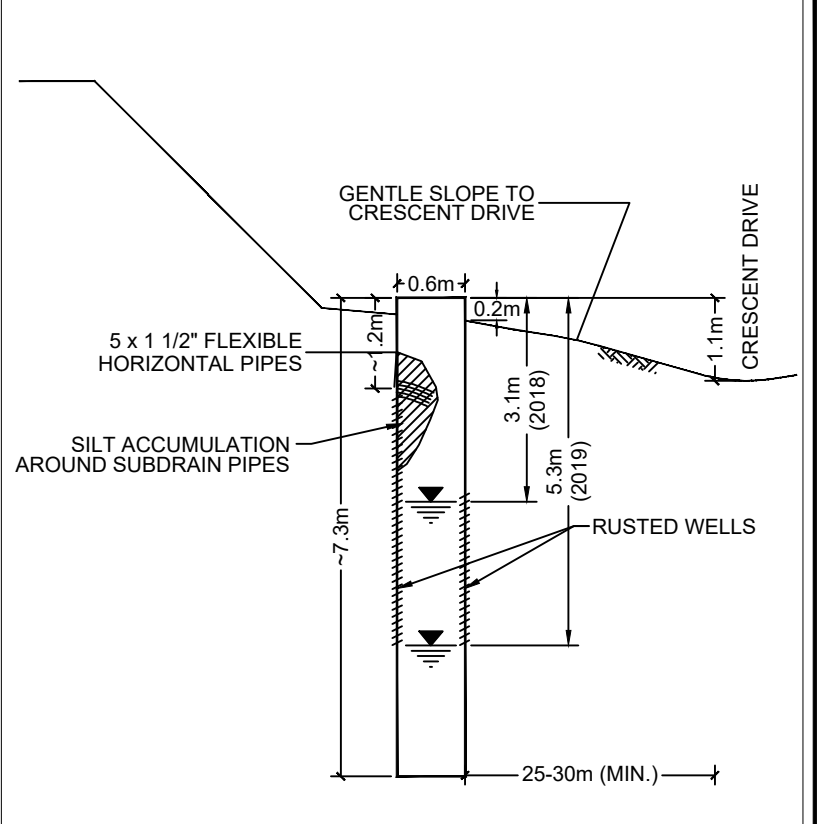
MANHOLE #2 DETAILS (2014)
N.T.S.

- NOTES:**
- MH #2 HAS NO OUTFLOW PIPE - WATER IS LIKELY PERCOLATING INTO GROUND (2015)
 - MINOR FLOW FROM ONE OF SUBHORIZONTAL DRAINS IN 2016
 - ONE OF THE SUBHORIZONTAL DRAINS IS DRIPPING WATER
 - ONE OF THE DRAINS IS FLOWING. MORE WATER NOTED IN 2018
 - STEADY FLOW FROM ONE OF THE DRAINS; HEAVIEST FLOW SINCE OBSERVED
