SITE NUMBER AND NAME: NC014 – North of Fort Assiniboine	HIGHWAY AND KM: 661:02, km 1.8	PREVIOUS INSPECTION: May 31, 2023	CURRENT INSPECTION: June 13, 2024
LEGAL DESCRIPTION: NW-01-62-06-W5	NAD83 COORDINATES: UTM11U 6023391N, 644779E		RISK ASSESSMENT: PF: 8 CF: 10 Total: 80
AVERAGE ANNUAL DAILY TRAFFIC (AADT): 220 (2023)		CONTRACTOR MAINTENANCE AREA (CMA): 508

Client/Project
 Transportation and Economic Corridors
 Geohazard Monitoring Program
 NC014-1: HWY 661:02 Fort Assiniboine (km 1.8)
 123315222

2024 Site Inspection Photos at NC014

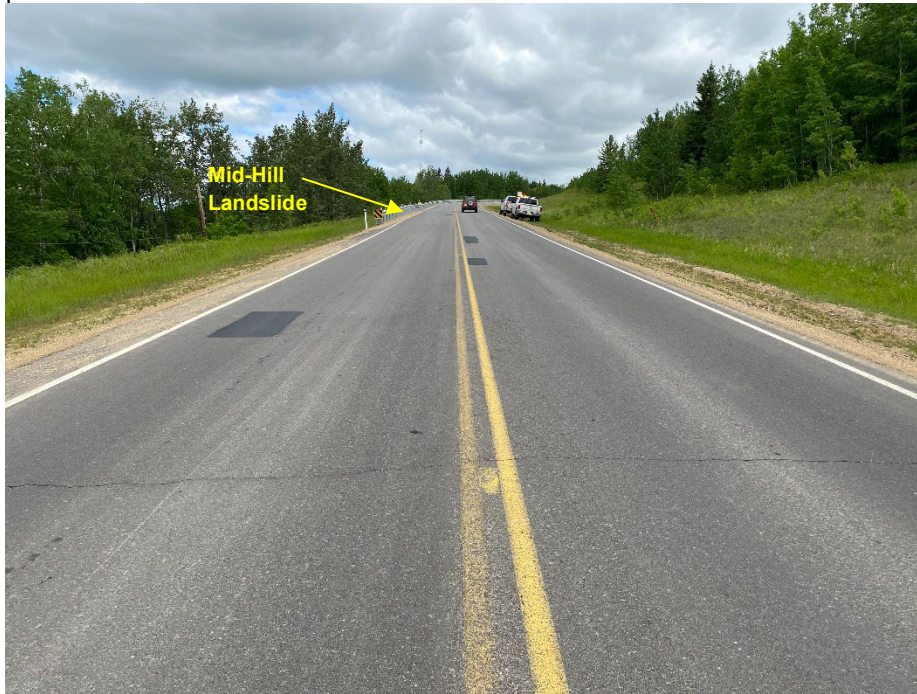
Photo 1: Pavement condition southeast of mid-hill landslide. Looking northwest.

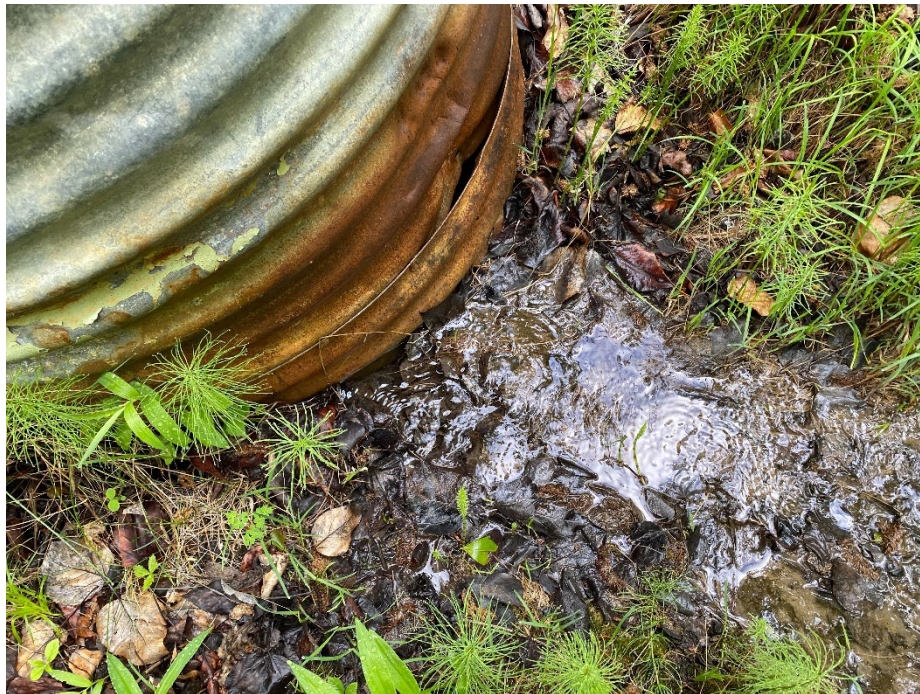
Photo 2: Pooling/flowing water adjacent to MH#1. Water entering culvert at ground surface. Looking northeast.

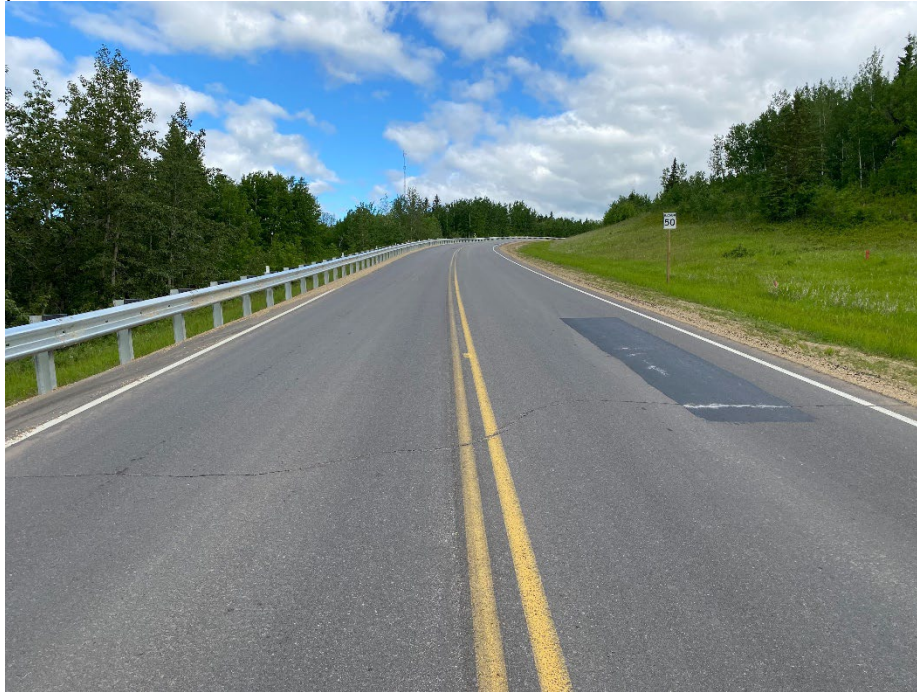
Photo 3: Cracks reflecting through pavement repair at south extent of mid-slope landslide. Looking northwest.

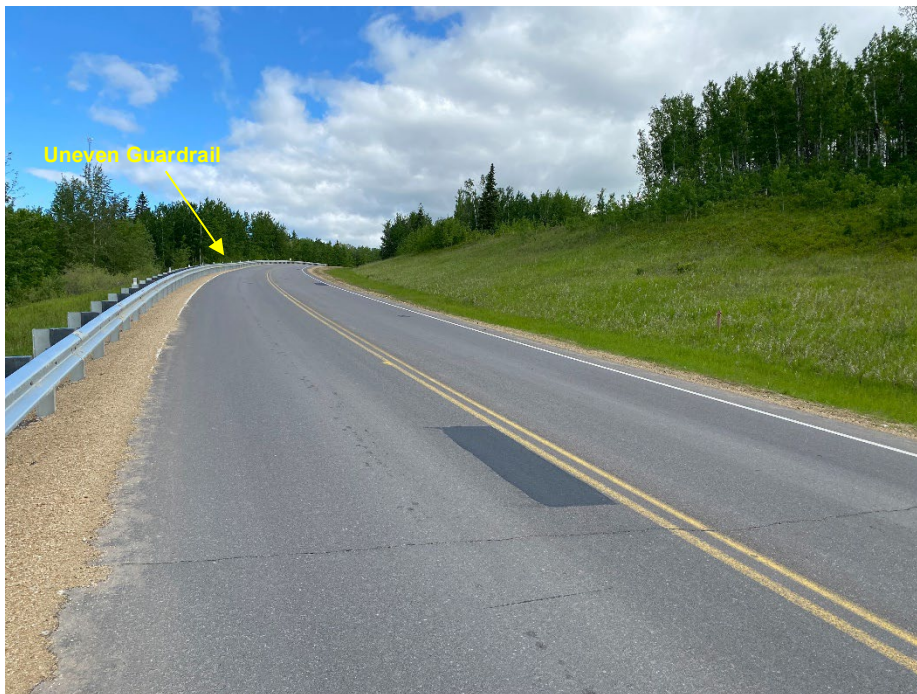
Photo 4: Pavement cracking north of mid-slope landslide. Looking northwest.

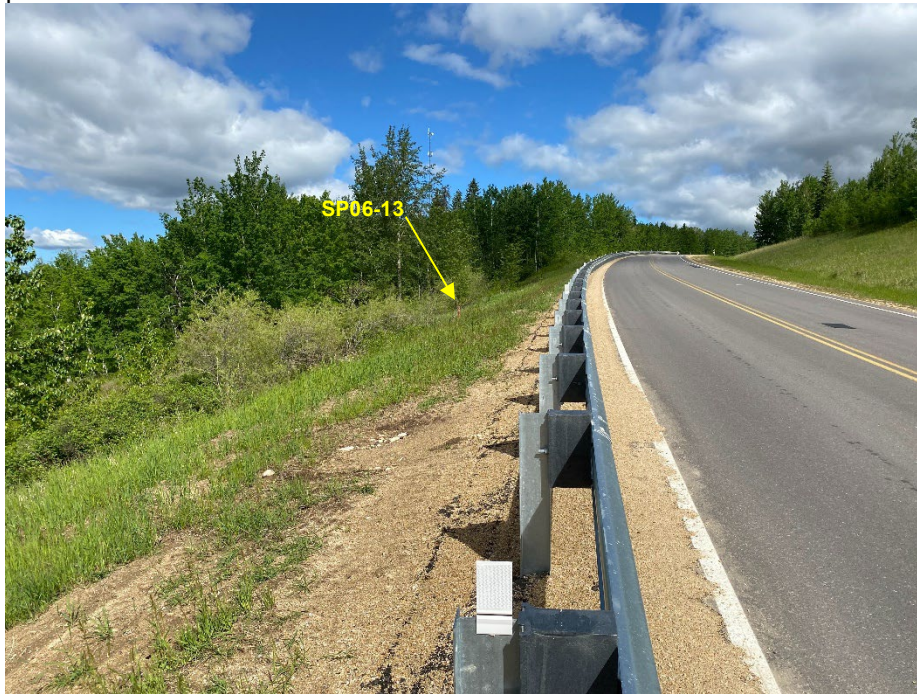
Photo 5: Landslide at uphill section. Looking northwest.

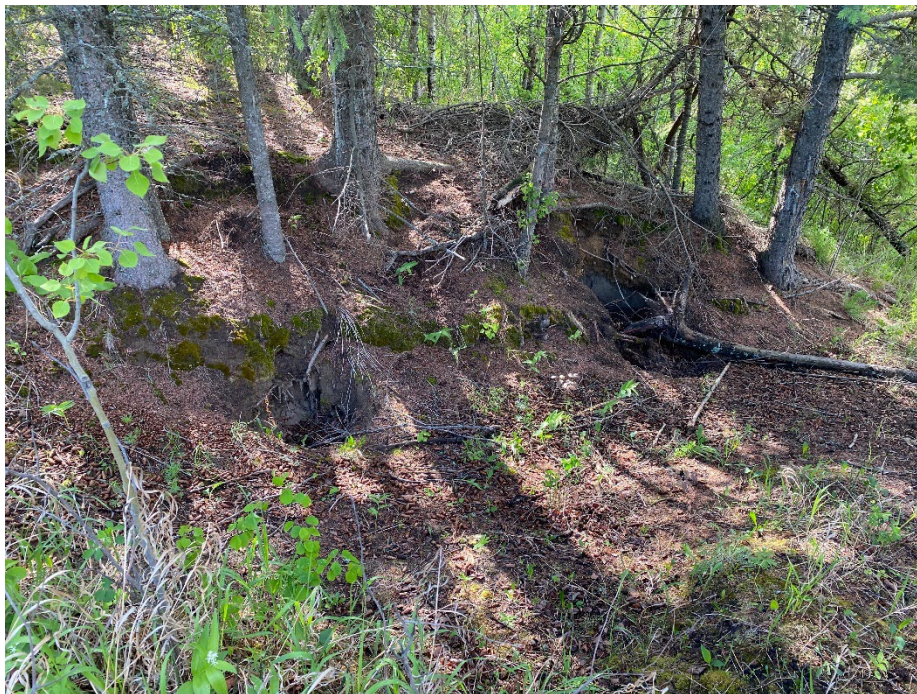
Photo 6: Two sinkholes in ravine. Looking southeast.

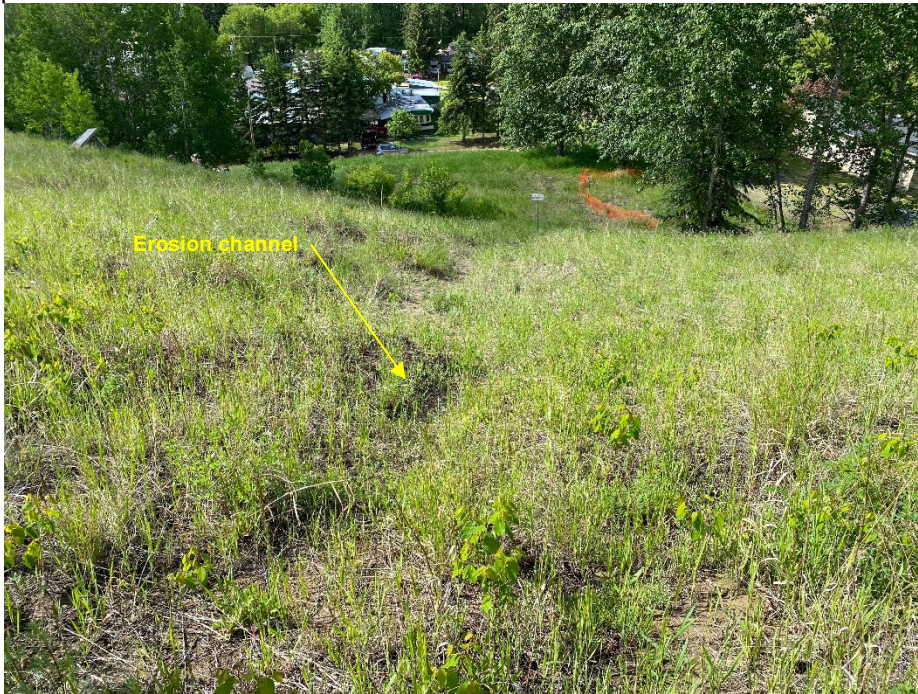
Photo 7: Erosion channel heading downslope to the bench. Looking southwest.

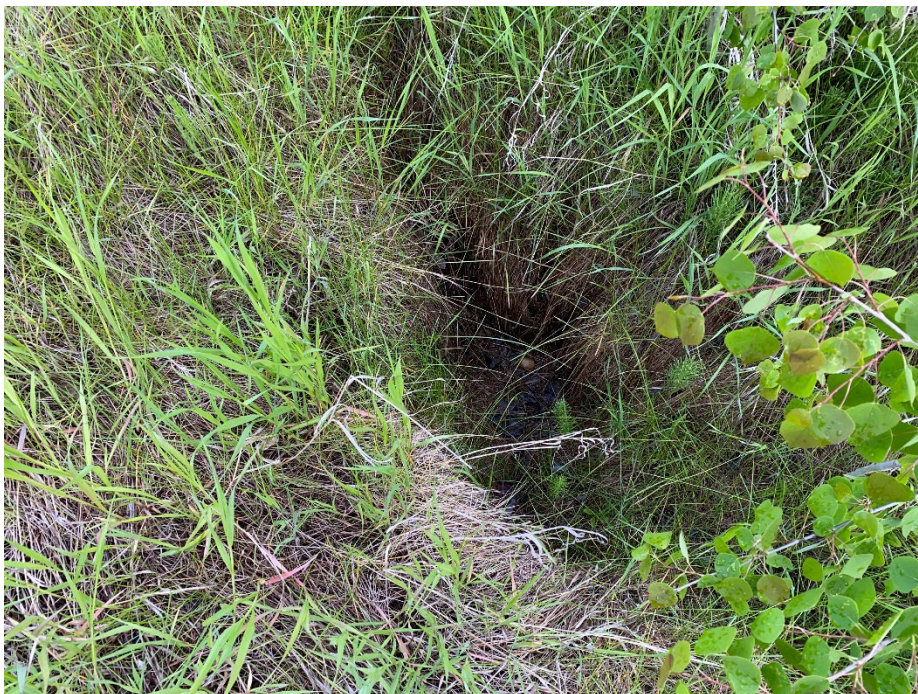
Photo 8: Sinkhole southeast from the utility box in the east ditch near the mid-hill landslide area. Looking north.

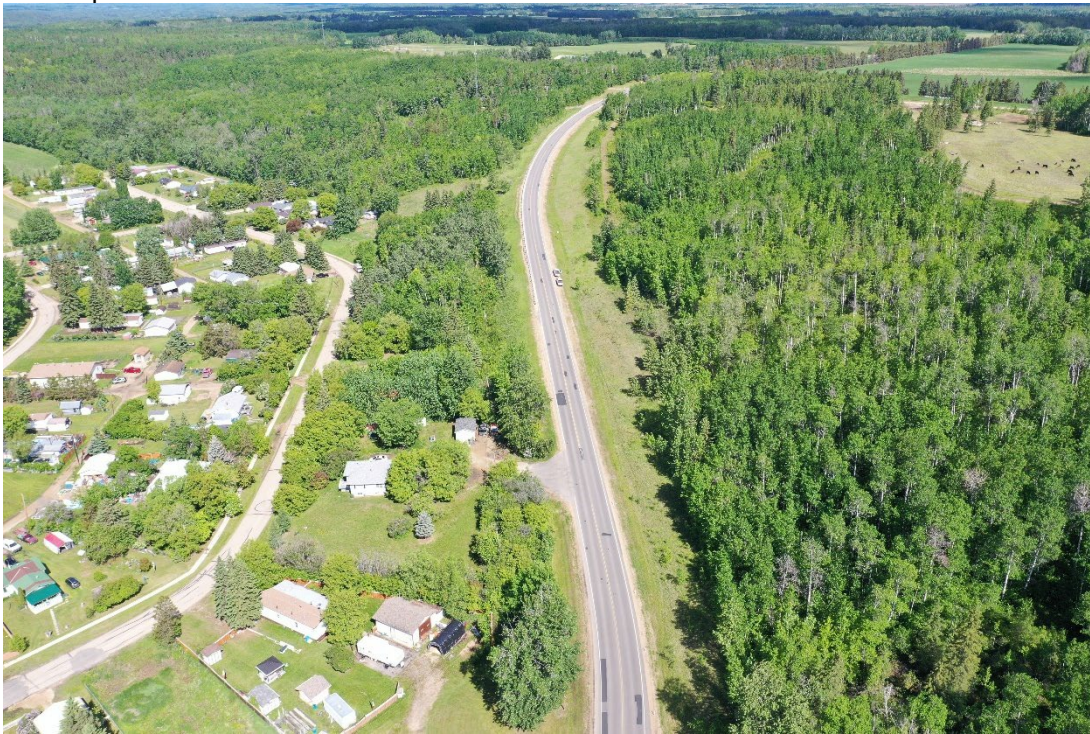
Photo 9: Site overview, taken by drone. Darker pavement patches are deficiency repairs, approx. 2 weeks old at time of photo. Looking northwest.

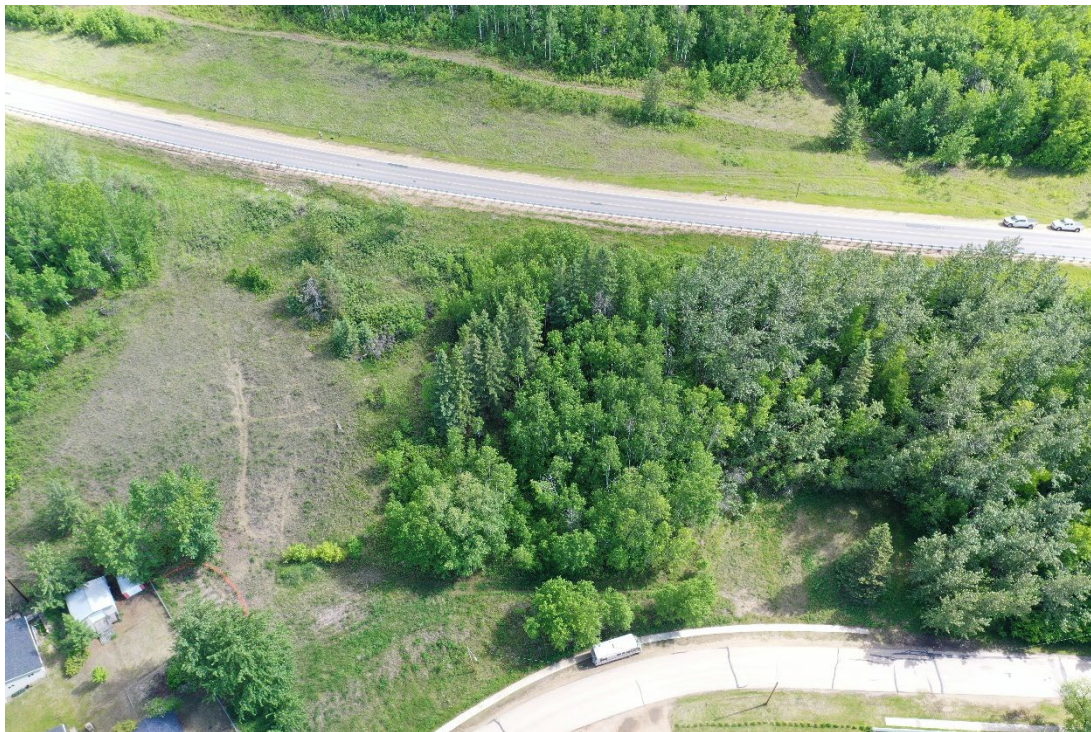
Photo 10: Overview of slide areas on highway embankment. Looking northeast.
