THURBER ENGINEERING LTD.

August 22, 2003

File: 15-16-173

**SH734:22 - EMERGENCY CALL-OUT
DITCH EROSION, NORTH VALLEY SLOPE
BRAZEAU RIVER, ALBERTA**

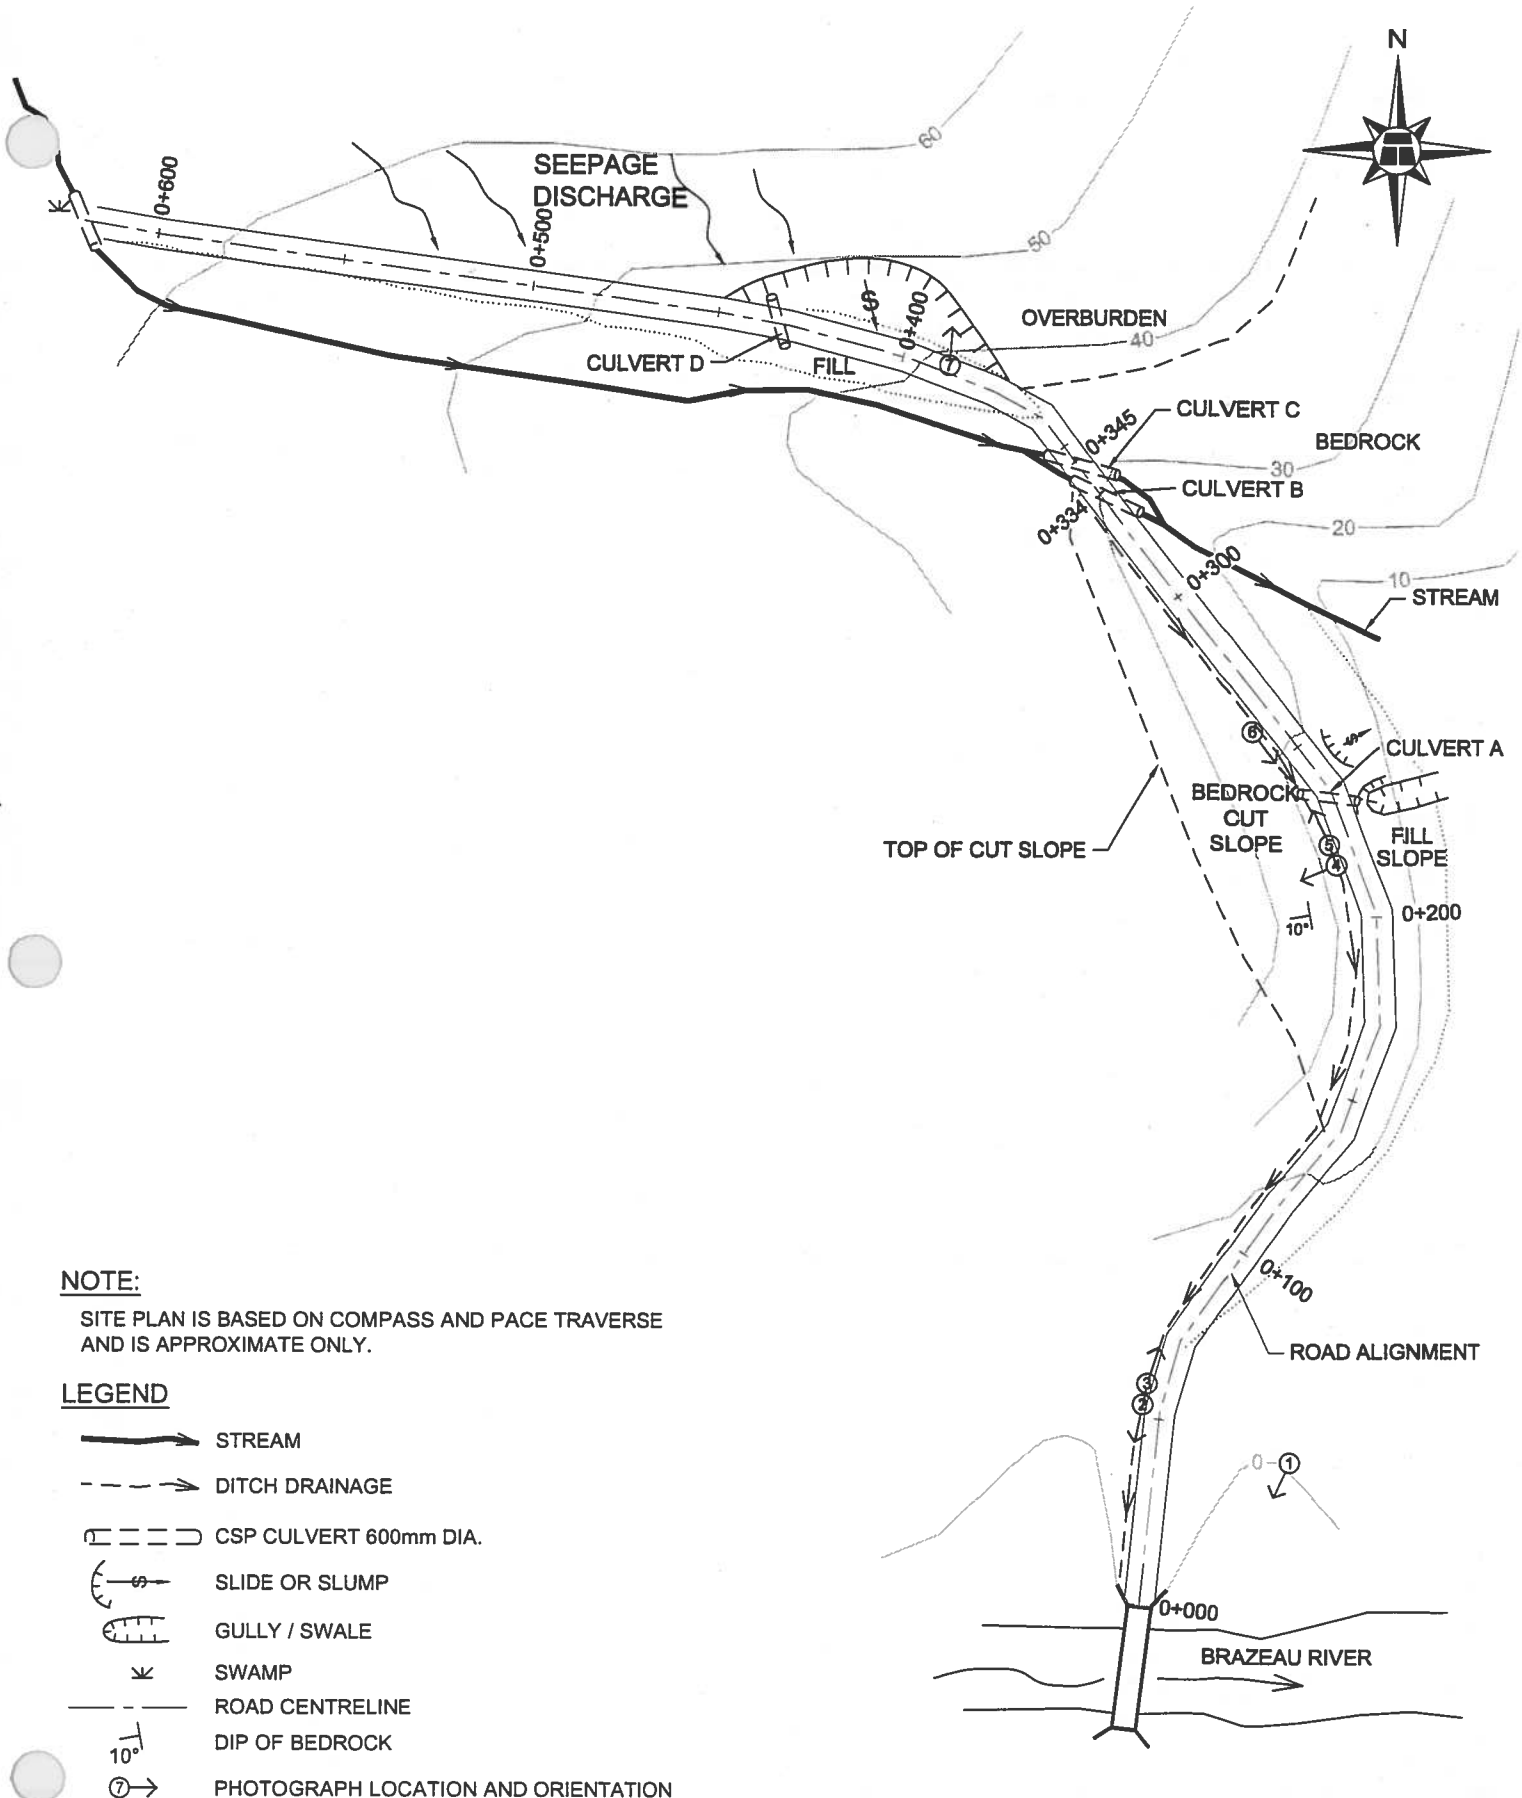
HWY 734:22 EMERGENCY CALL OUT - AUGUST 2003
 FIGURE 1 SITE PLAN AND GEOLOGIC FEATURES

A rough field survey of the road alignment and adjacent slopes was carried out during the filed visit using a compass, hand inclinometer and pacing. Several surficial geologic features and observations were also noted during the survey. The resulting data is summarized in Figure 1. Several photographs were taken during the traverse and selected photographs are attached. The location and orientation of each photograph is shown on Figure 1. Field observations are given in Table 1.

Road Station*	Feature	Comments
0+115	West ditch	Recent lateral erosion of ditch
0+200	Bedrock outcrop	Sandstone, siltstone shale beds, dipping approx. 10° towards 260°, 35 degree cutslope with gravel-sized talus
0+235	Fill slope	Fill slope inclined at 33-36° on the east side, 2-3 m deep gully eroded at Culvert A outlet 2-3 m long tension cracks north of Culvert A Culvert A inlet partially blocked
0+250	Fill slope	6 m wide landslide on fill slope, 0.3 m depression along outside edge of road
0+290	West ditch	Recent lateral erosion, ditch 4m wide (photo 6),.
0+345	Culvert/stream	Some stream flow passing into west ditch
0+400	North Earth Slump	Approximately 70 m wide x 30 m long. Trees rotated back approximately 23 degrees, Seepage discharge along north ditch.

The culverts shown in Figure 1 were 500 or 600 mm diameter corrugated steel pipe with generally 300-400 mm of cover in the traffic lanes. The inlets and some of the outlets had significant damage.

- i) discharging some of the seepage into Culvert D (See Figure 1) and the remaining seepage from the slope should be directed through a subdrain pipe along the north side of the road and discharged downstream of Culverts C & B, or
- ii) alternatively diverting all the seepage discharge from the slope into a subdrain along the north side of the road, and discharging it downstream of culverts C & B, in other words bypassing Culvert D.
