SITE NUMBER AND NAME: NC109 - Highway 734 North of BF77316	LOCATION: On Highway 734, about 200 m north of BF 77316	HIGHWAY: 734:22	KM: 27.257
LEGAL DESCRIPTION: NW-16-45-18-W5	NAD83 COORDINATES: UTM11U 5859050 N, 529722 E		
AVERAGE ANNUAL DAILY TRAFFIC (AADT): 130 (2022)		CONTRACTOR MAINTENANCE AREA (CMA): 508

PRIMARY SITE ISSUE: Washed-out northbound lane (NBL) of highway
APPROXIMATE DIMENSIONS: 15 m long by 3 m wide
<p>SITE BACKGROUND AND HISTORY:</p> <p>A call-out inspection was conducted by Thurber Engineering Ltd. (2003). Background information obtained by Thurber included:</p> <ul style="list-style-type: none"> • Highway 734:22 was first constructed in 1970s as a gravel surfaced road. • Erosion of the west ditch from about 100 m to 350 m north of the bridge has been occurring during periods of high precipitation. Stantec estimates this to be in the same area as the current call-out inspection. • Silt and sediment have been entering the stream downslope of the road and may impact the Brazeau River. • The road fill extending from 100 m to 350 m north of the bridge is steeply inclined and exhibits signs of settlement, shallow soil slides, and gully erosion associated with a cul

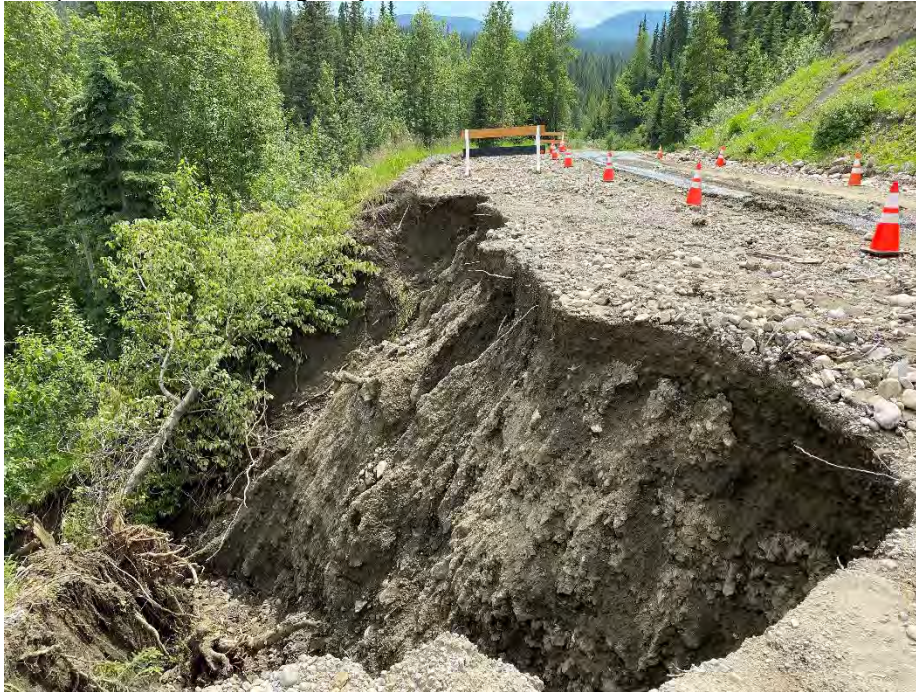
- The NBL of Highway 734 was washed out approximately 200 m north of BF77316 (Photos 1 and 2). The washed-out area was about 15 m long. Approximately 3 m wide of roadway was lost at the north end and 2 m at the south end of the wash-out. At the north end, the wash-out was measured to be about 2.5 m deep while the south end was estimated to be in the order of 4 m to 5 m deep. The downslope (east) side of the wash-out was well-vegetated with mature trees. However, a few trees appeared to be recently knocked over likely due to the wash-out.

- The soil near the wash-out appeared to be silty sandy gravelly glacial till with trace to some clay. Tree roots could be observed within the wash-out (Photos 1 and 2). The soil appeared to be wet in places. Curved mature trees (Photo 10) were also observed along a vertical portion up the mountainside suggesting the surficial soils could include colluvium.

Photo 1: North end of washed-out NBL. Looking south.

- Rebuilding the washed-out portion of the highway using granular fill. Given the sensitivity of the site, it may not be possible to properly compact the granular fill. As such, geoweb could be a potential option to improve the performance of the reconstructed embankment and roadway, reinforce the slope, and allow for permeability. It is likely that a full road closure is required during construction.

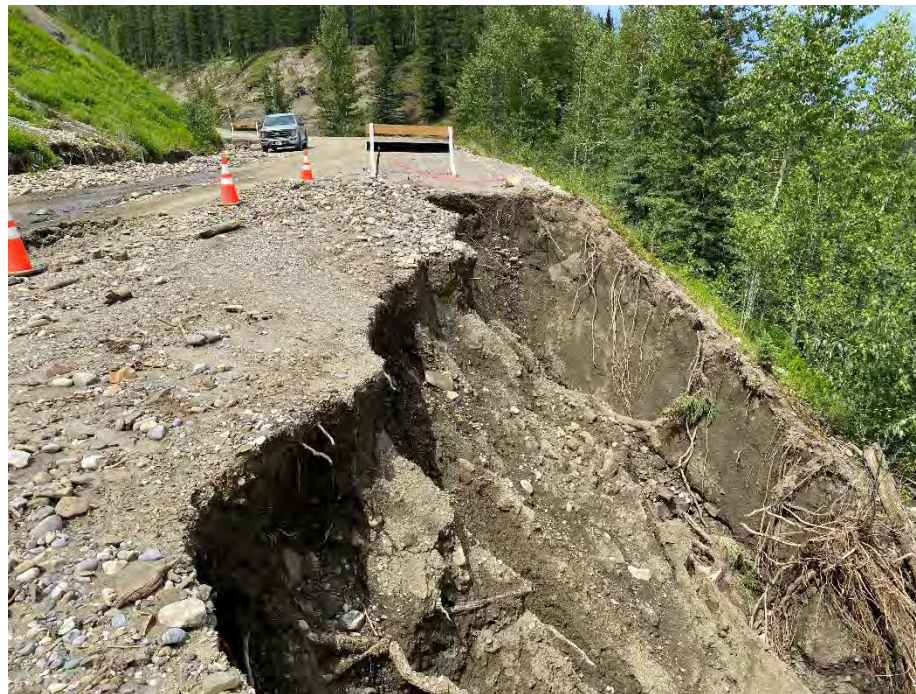
Photo 2: South end of washed-out NBL. Looking north.

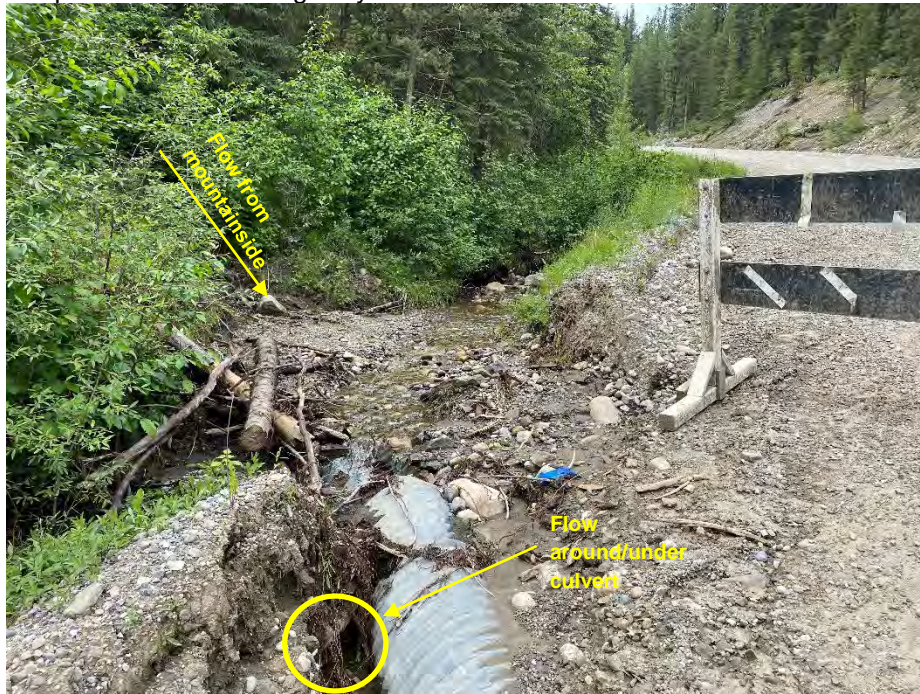
- At approximately 150 m north of the wash-out, significant surface water flow was observed coming from higher up the mountain and within the ditch along the SBL. The two flows joined slightly upstream from the 600 mm dia. culvert (Culvert C). The combined flow becomes divided approximately at the culvert inlet where water can be observed to be going through the culvert and around or under the culvert (Photo 3). No obvious damage was observed inside the wall at the culvert inlet that would suggest water flowing out the side walls. A second 600 mm dia. culvert (Culvert B) was observed about 10 m south of Culvert C. Culvert B was infilled with soil and debris at the inlet and is no longer functional (Photo 5), although a slow drip of water can be observed at the outlet.

Photo 3: Culvert C inlet. Water flow from ditch and from up the mountain. Looking northwest.

- Diverting water flow into Culverts B and C using a small earth berm.
 - Installing a permanent ditch with erosion protection (riprap or half culvert) along the SBL down to the 800 mm dia. culvert near BF77316.

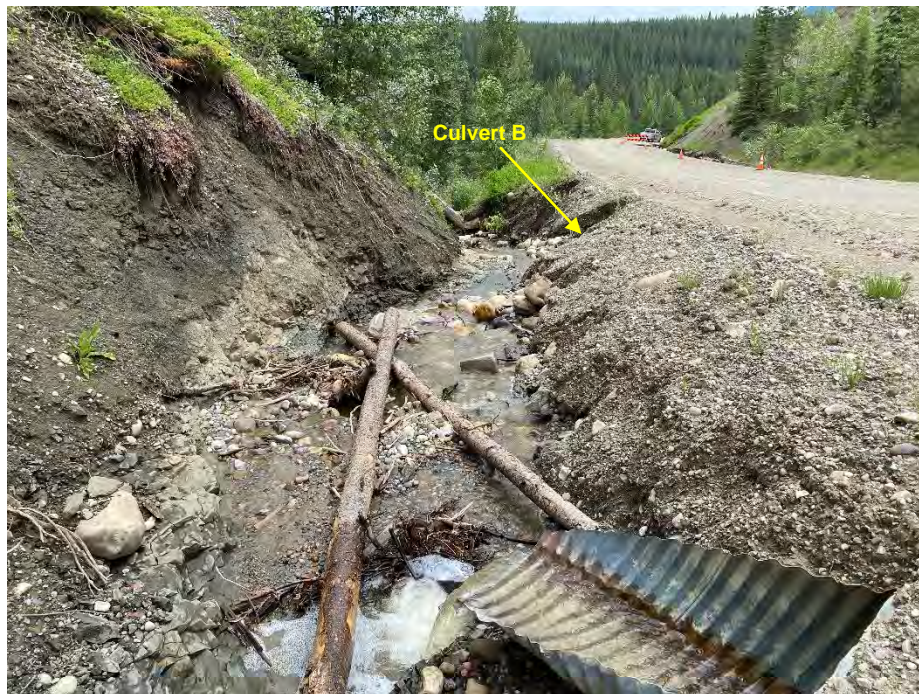
- The ditch flow along the SBL has significantly eroded the highway shoulder (Photos 5 and 6). A continuous erosion channel was observed from Culverts B and C down to about the wash-out area. The erosion channel was up to 4 m wide and 0.8 m deep. The NBL also contained a few localized areas with shoulder erosion (Photos 4, 7, and 8).

Photo 4: Culvert C discharging water to eroded NBL ditch. Looking southeast.

- Erosion channels along the NBL shoulder should be repaired by backfilling with similar soils to reinstate the road width and placing riprap at eroded locations for erosion protection.

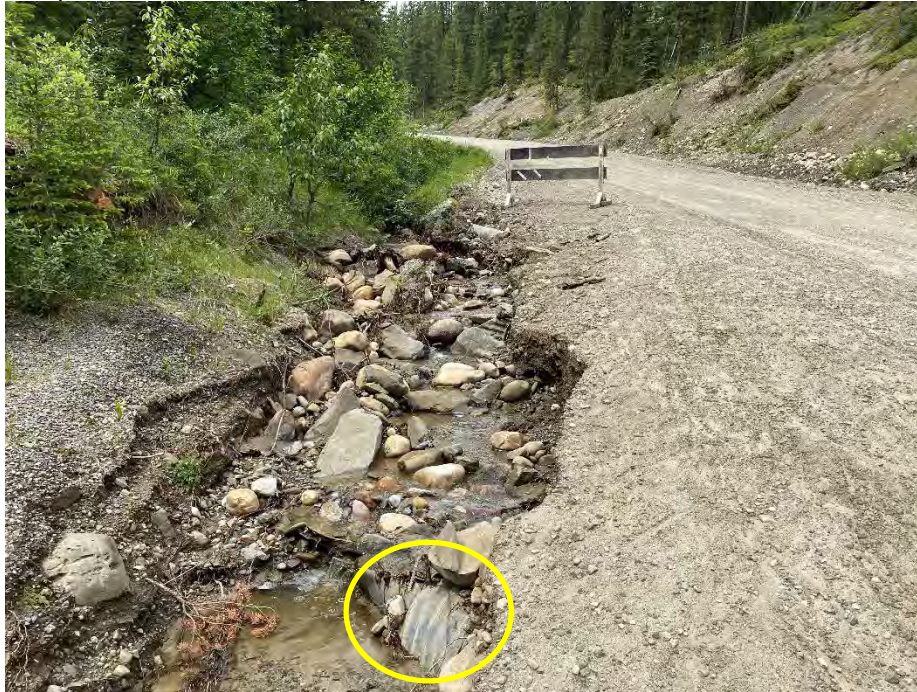
Photo 5: Culvert C buried at inlet. Severe erosion along west edge of SBL. Looking northwest.

- All culverts should be inspected to maintain functionality. Damaged culverts should be replaced. The hole in the 450 mm dia. culvert should be repaired or covered to enhance motorist safety.

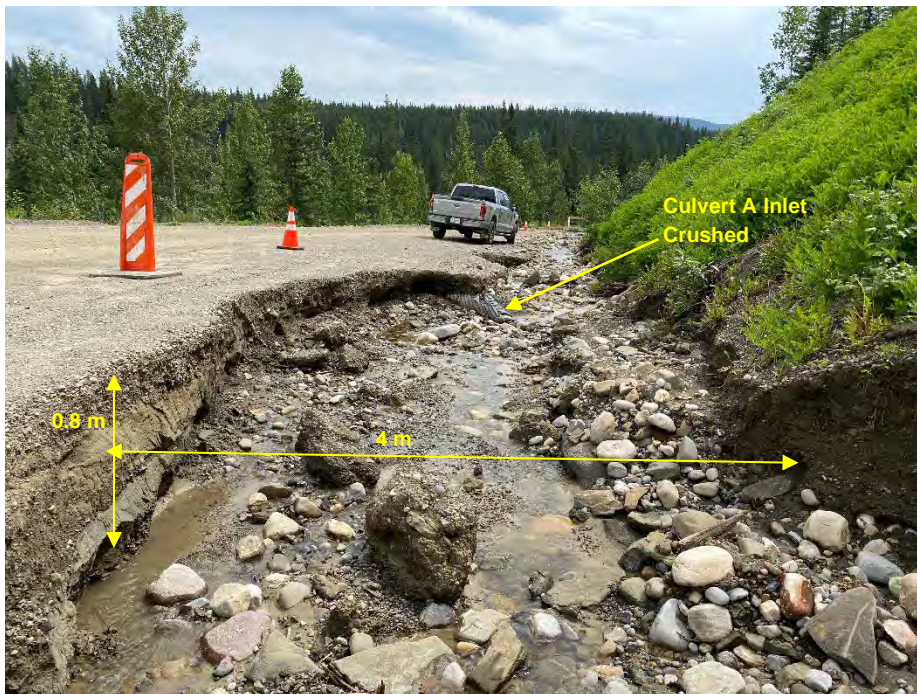
- A third culvert (Culvert A) of unknown size was observed about 30 m north of the wash-out. The inlet was completely crushed (Photo 6). The outlet appeared to be hanging over the downslope side of the highway by about 0.3 m. An erosion channel and partially washed-out mountain side could be observed adjacent and downslope of the outlet (Photo 7). A few fallen and leaning trees were also observed near the outlet.

Photo 6: Severe erosion along west edge of SBL. Culvert A inlet crushed within ditch. Looking southeast.

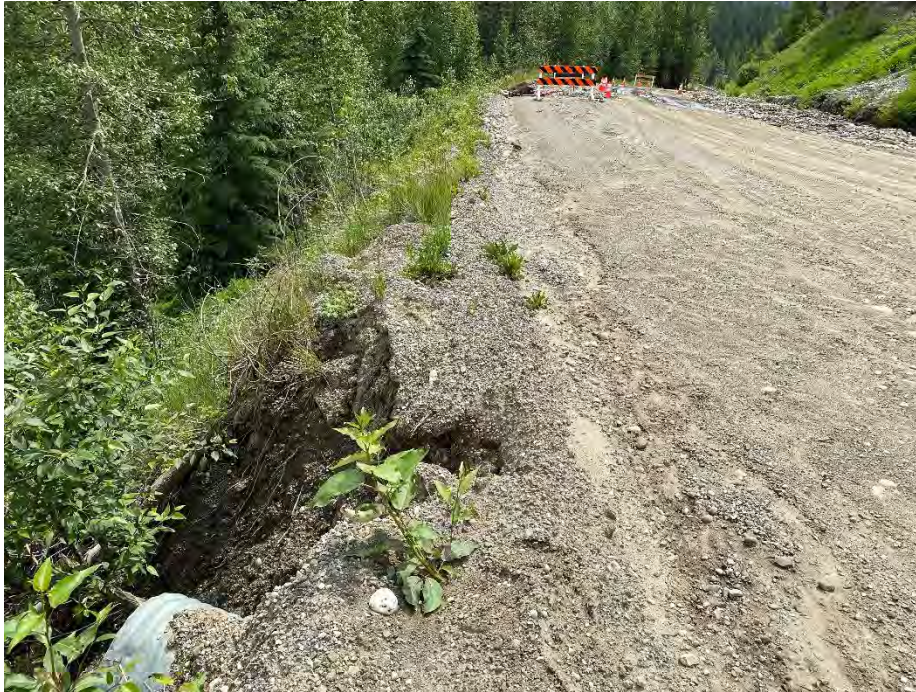
Photo 7: Overhang at Culvert A outlet. Shoulder erosion adjacent to the outlet. Looking southeast.

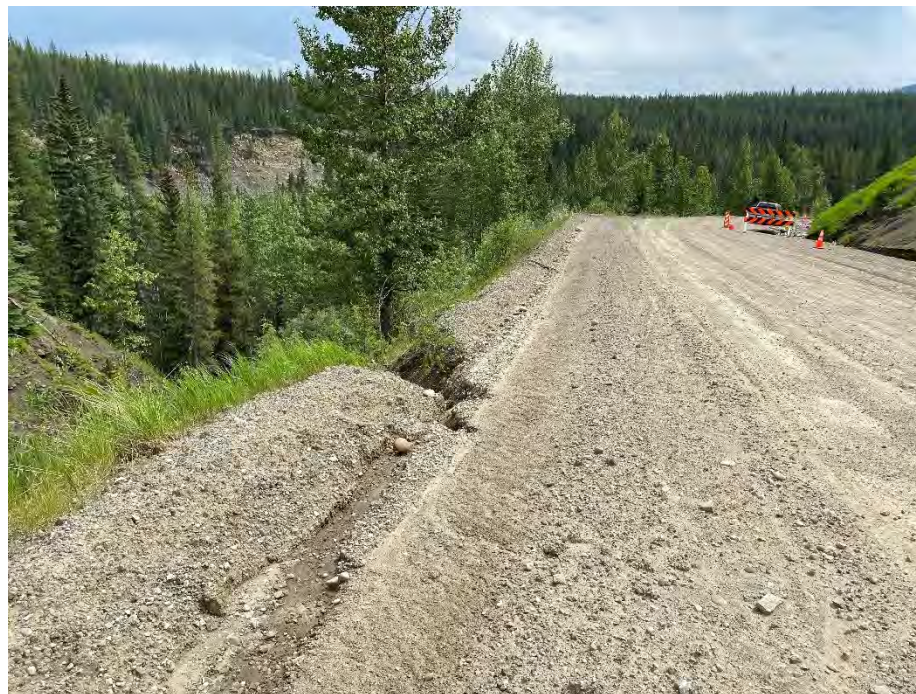
Photo 8: Eroded shoulder of NBL. Looking southeast.

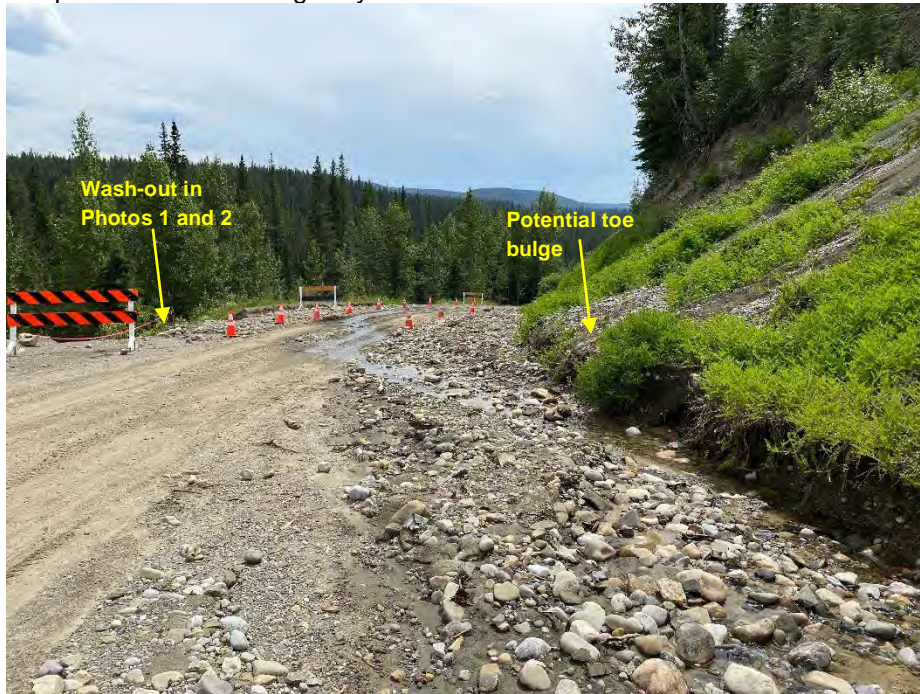
- Due to a lack of a ditch near the wash-out, the ditch flow in the SBL was observed to be crossing the highway approximately 20 m south of the third culvert (Photo 9). A potential old toe bulge was observed at the expected ditch location which may have diverted water flow across the road. At the time of the inspection, the water did not reach the washed-out area. Instead, the water flowed approximately along the highway centerline down to another (fourth) culvert and BF77316. It is surmised that the highway was washed out due to significant surface water flow across the highway, likely during the prolonged and heavy rain events received about two weeks prior to the site inspection.

Photo 9: No ditch in SBL resulting in surface water flow towards washed-out roadway. Looking south.

- The area at the southeast toe should be restricted for use as campgrounds to reduce the risk to public safety.
- A small swale should be cut along the west side of the highway to direct surface water flow from the washed-out highway area. This should be completed immediately to reduce the risk of losing more ground.

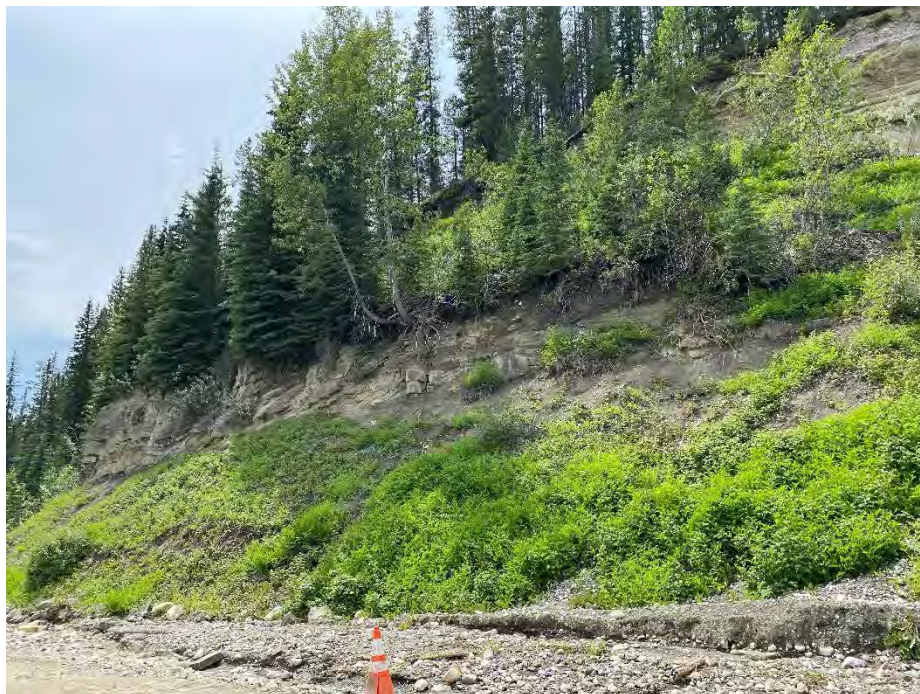
Photo 10: Curved trees along mountainside to the west. Looking southwest.

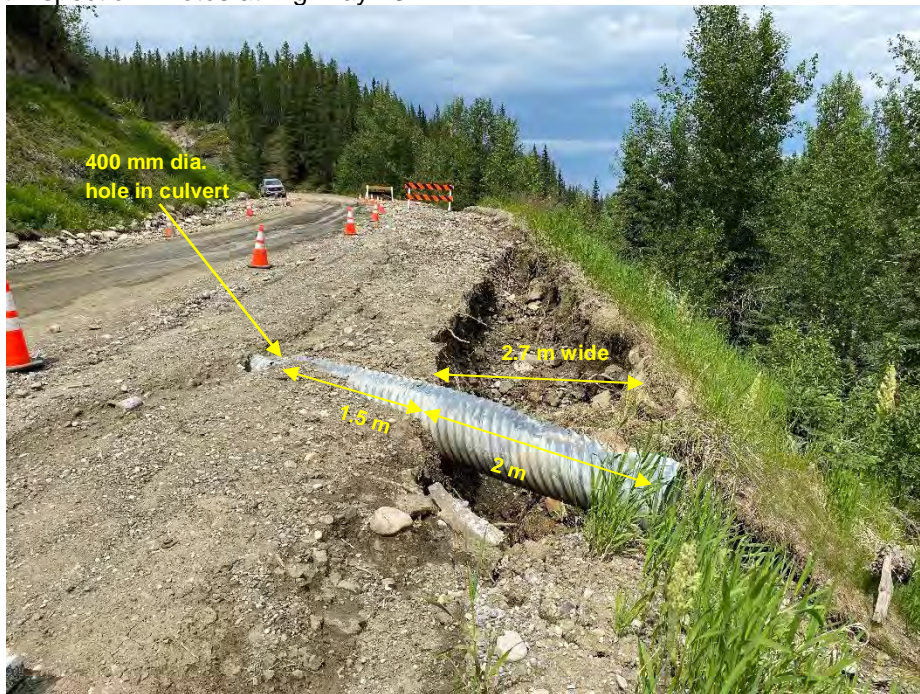
- A 13 m long erosion channel had developed about 20 m south of the wash-out area (Photo 11). The erosion channel tapered from 0.4 m wide to 2.7 m wide and deepened from about 0.7 m to 2 m deep. At the south end of the erosion channel, a fourth culvert (Culvert E) with an estimated 450mm dia. was observed. The culvert outlet was hanging over the erosion channel by about 2 m. A 400 mm dia. hole was observed at the top of Culvert E about 3.5 m in from the outlet. The inlet was almost completely buried within the ditch and is likely infilled with sediment (Photo 12). Stantec believes that this culvert could have been installed as a response to Thurber's 2003 recommendations to divert water away from the west ditch.

Photo 11: Erosion channel undermining Culvert E. Looking north.

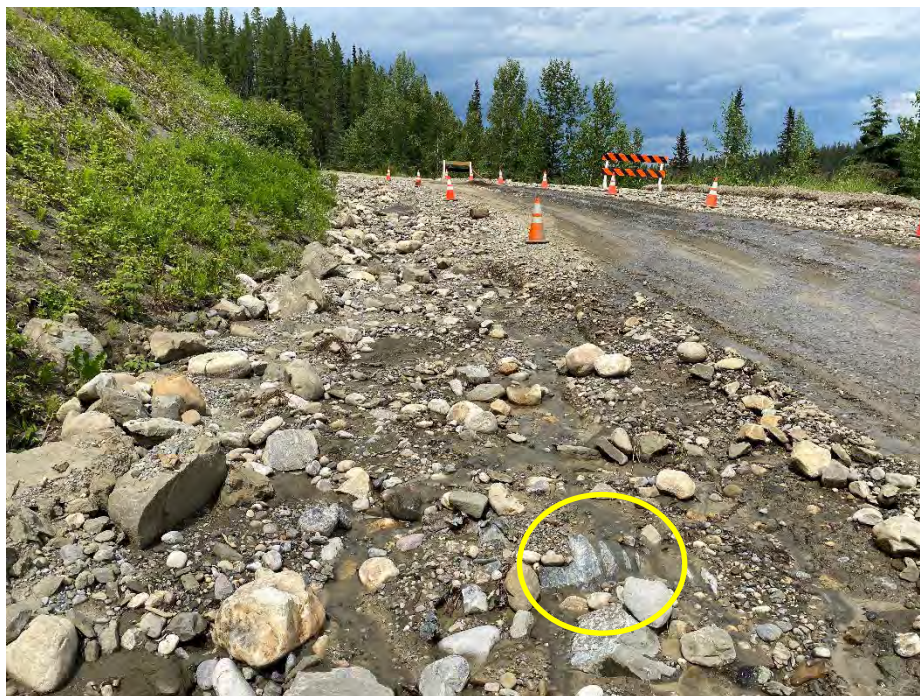
Photo 12: Culvert E inlet buried. Some water flow back to SBL ditch.

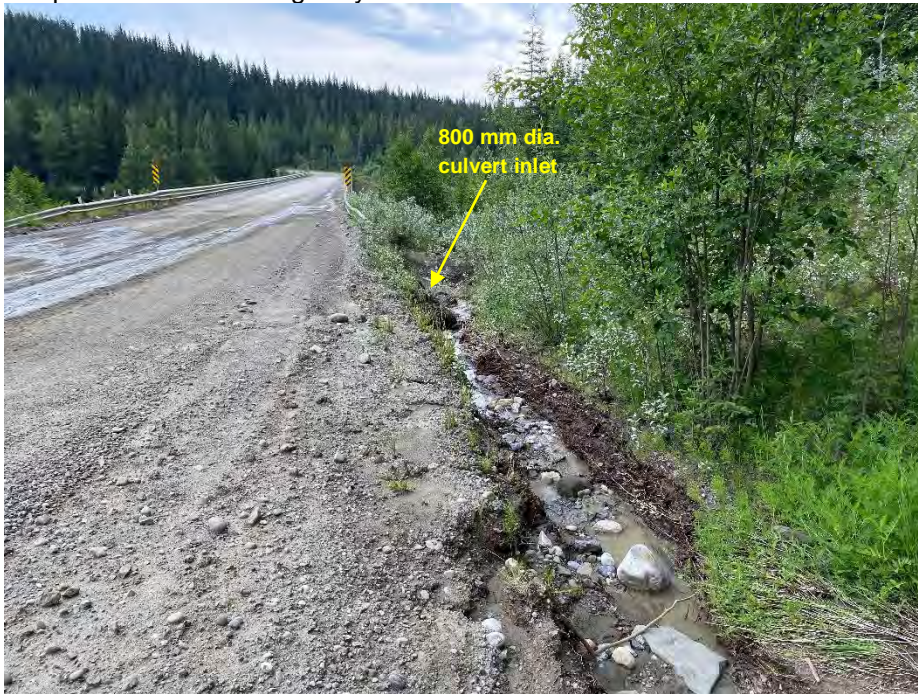
- A fifth culvert (Culvert F, 800 mm dia.) was observed just north of BF77316. This culvert appeared to be in good condition (Photos 13 and 14).
- Based on the site history, there appears to be a history of surface water issues (icing and erosion).

Photo 13: Erosion along SBL leading up to Culvert F. Note water flow along road coming from geohazard site uphill. Looking south.

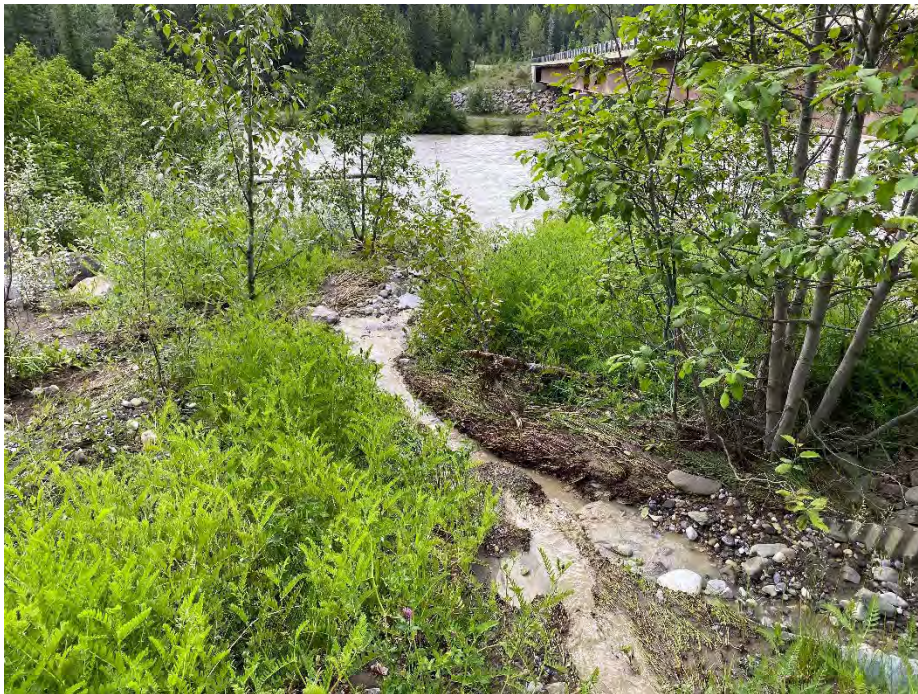
Photo 14: Culvert F discharging near Brazeau River. Note sediment buildup at beveled end. Looking south.
