SITE NUMBER AND NAME: NC109 – Highway 734 North of BF77316	HIGHWAY AND KM: 734:22, km 27.437	PREVIOUS INSPECTION: June 2, 2023	CURRENT INSPECTION: June 12, 2024
LEGAL DESCRIPTION: NW-16-45-18-W5	NAD83 COORDINATES: UTM11U 5859050 N, 529722 E		RISK ASSESSMENT: PF: 6 CF: 3 Total: 18
AVERAGE ANNUAL DAILY TRAFFIC (AADT): 40 (2023)		CONTRACTOR MAINTENANCE AREA (CMA): 508

Client/Project
Alberta Transportation and Economic Corridors
Geohazard Monitoring Program,
NC109 Highway 734:22

2024 Inspection Photos at NC109

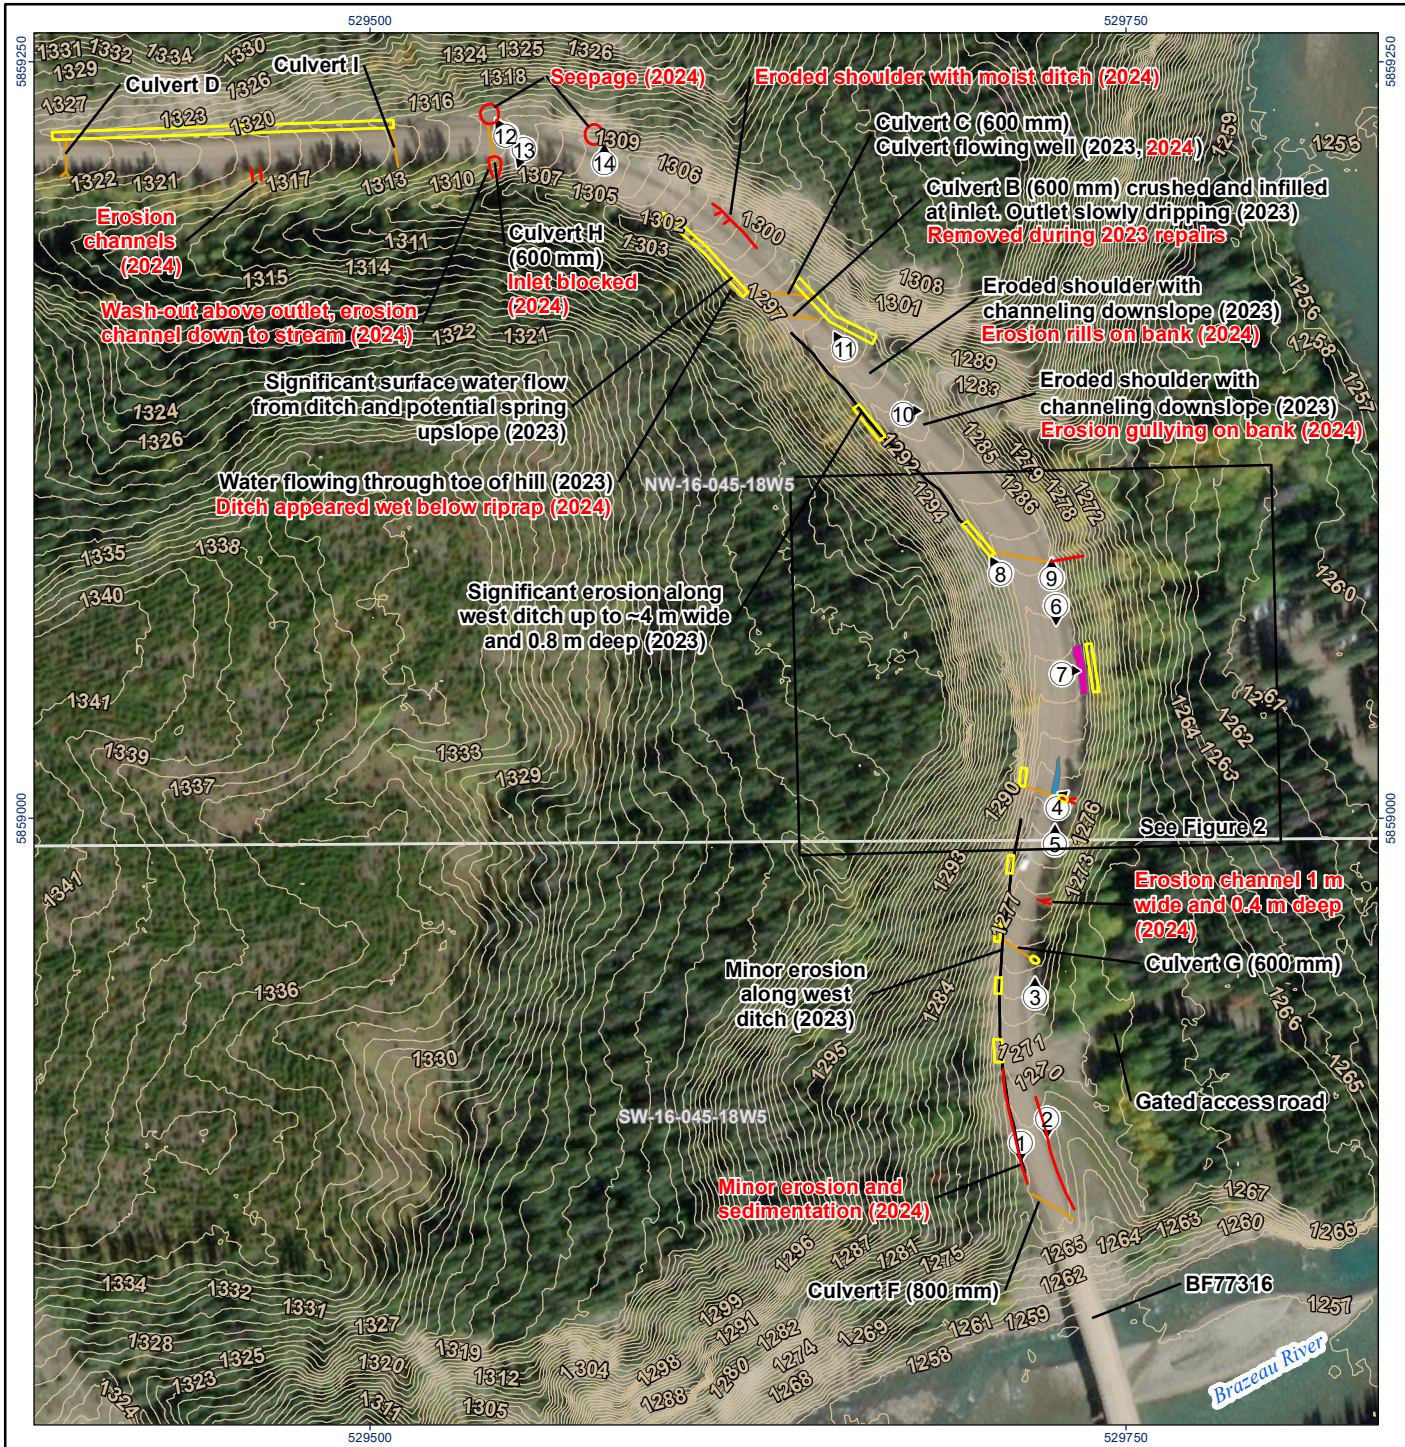
Figure No.
1

ITEM	CONDITION EXISTS		DESCRIPTION AND LOCATION	NOTICEABLE CHANGE FROM LAST INSPECTION	
	YES	NO		YES	NO
Pavement Distress	X		Shoulder of road surface has washed above the outlet of Culvert H (See Figure 1).	X	
Slope Movement	X		Mature curved trees along upper portion of west backslope.		X
Erosion	X		Erosion gullies and rills along downslope embankment, erosion and sedimentation in ditches.		X
Seepage	X		Possible springs in backslope to the west of culverts B and C. Seepage observed in backslope to the northeast, east of culvert H.	X	
Bridge/Culvert Distress	X		2 of the 6 CSP culverts (H and E) are partially blocked with sediment/ material at the inlets.	X

- Culvert B observed to be infilled with soil and debris during the 2023 call-out inspection was removed during recent repairs.
- Culvert H (600 mm dia.) was observed at the corner northwest from Culvert C (See Figure 1). The inlet, located in the north ditch, is blocked with wet material from the backslope (Photo 12). Partial loss of roadway was observed upslope from the outlet. The slope below the outlet of the culvert is wet, and erosion is present. Two safety cones are downslope, possibly having been placed at the edge of the highway (Photo 13).

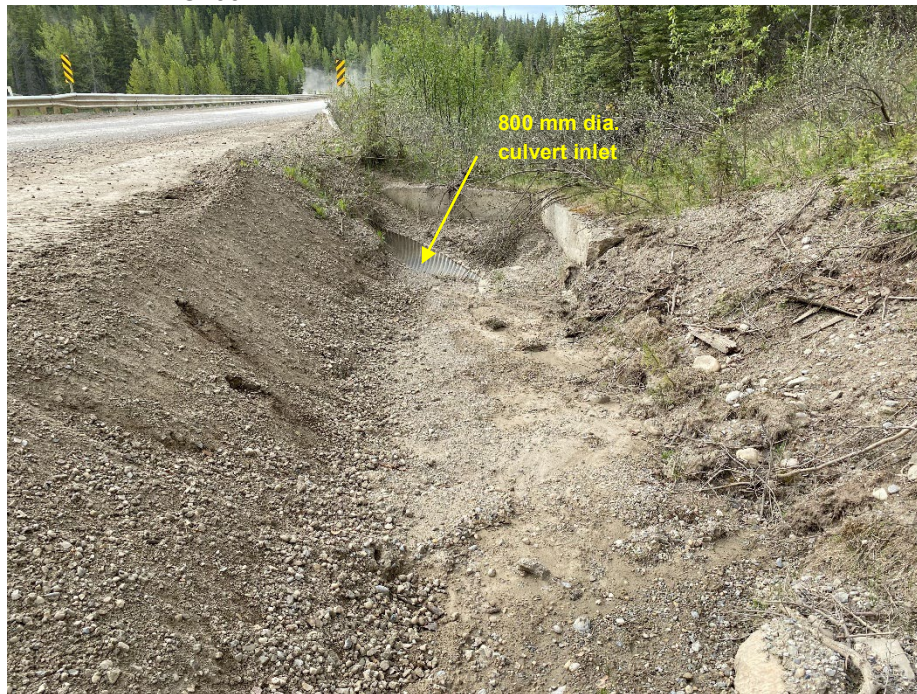
COMMENTS
<ul style="list-style-type: none"> Highway 734:22 continues to be a gravel surfaced road. Culvert F (800 mm dia., just north of BF77316) appeared to be in good condition, similar to the previous inspection. The ditch north of the inlet has a lot of sediment, with sediment building up in the inlet as well. An erosion channel exists within the ditch north and south from the inlet with sediment gathering in this ditch (Photos 1 and 2).

Photo 1: Erosion and sedimentation in SBL ditch leading to Culvert F. Sediment built up at beveled inlet. Looking south.

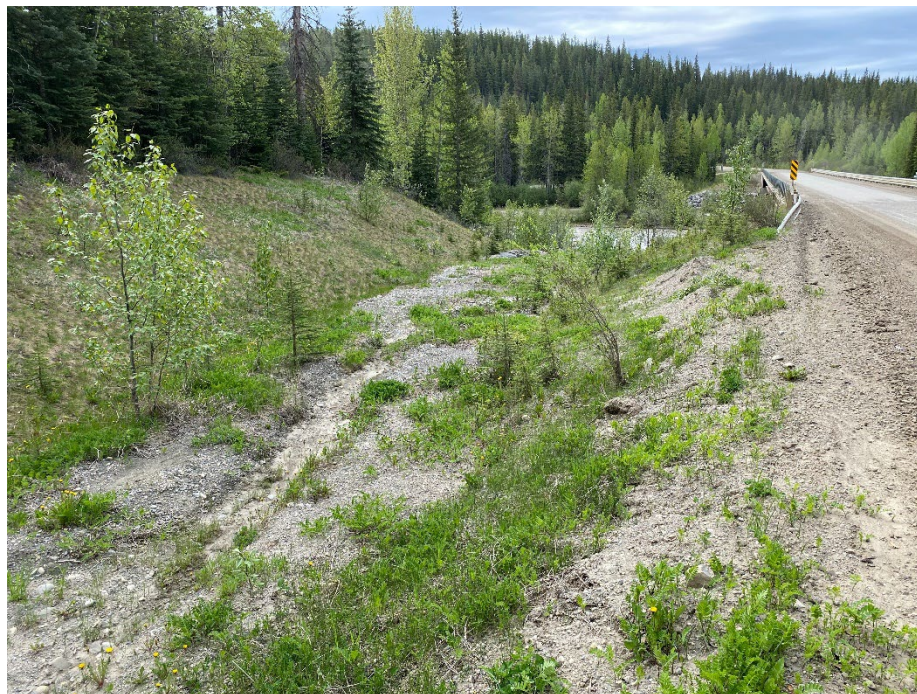
Photo 2: Erosion and sedimentation in ditch next to NBL leading up to outlet of Culvert F. Looking south.

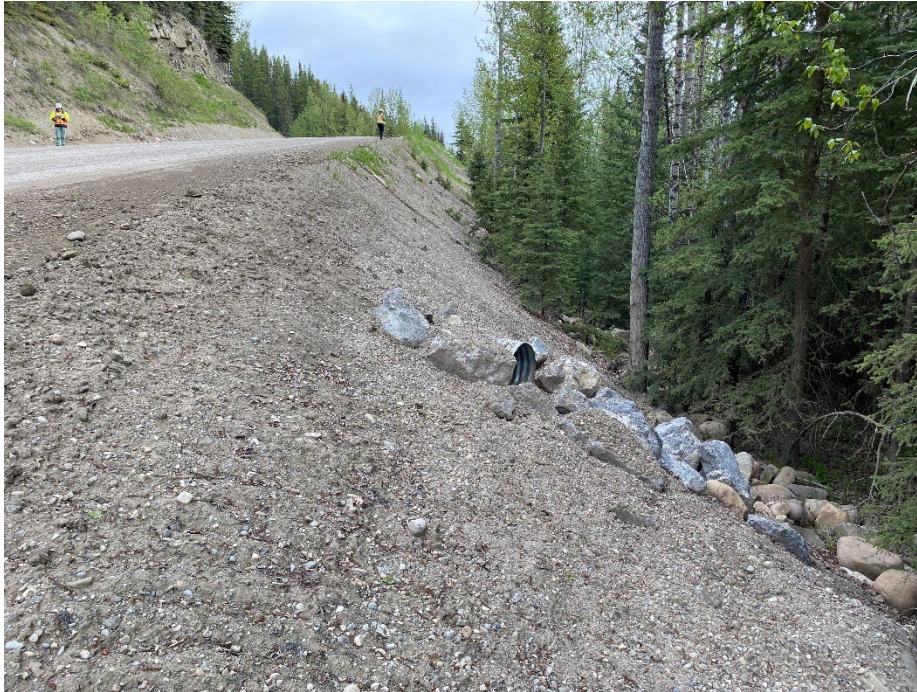
- Culvert G (600 mm dia.) has been installed north of the entrance to the gated access road between Culverts F and E. The inlet and outlet are both surrounded with riprap to protect the ditch and bank from erosion (Photo 3).

Photo 3: 600 mm diameter Culvert G installed between Culverts E and F. Outlet lined with riprap. Looking north.

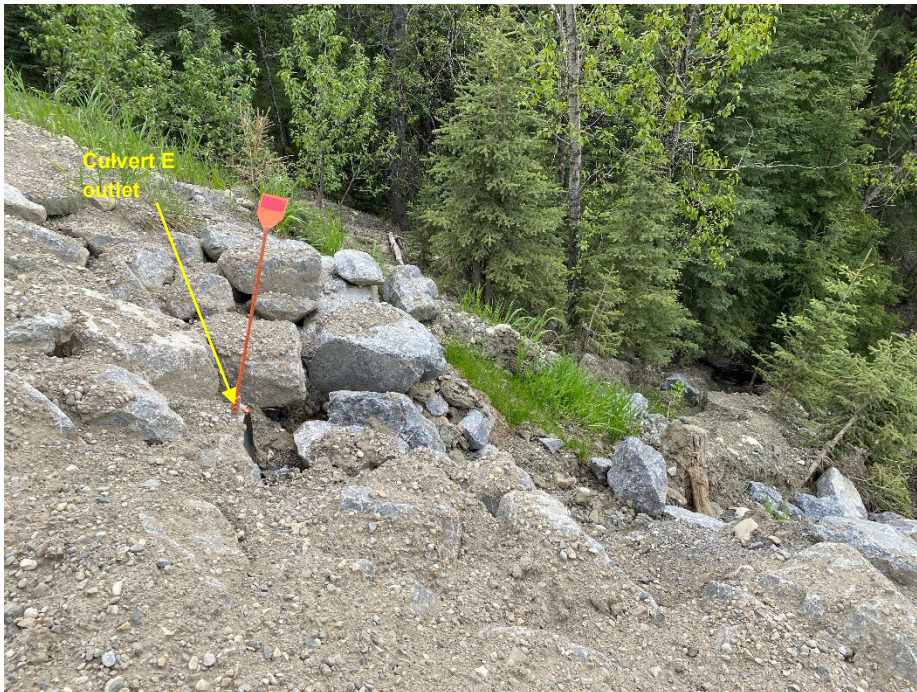
- Erosion was observed on the east bank, approximately halfway between Culverts E and G. The channel was up to 1 m wide and up to 400 mm deep.
- Culvert E was replaced and upgraded to 600 mm dia. during the reconstruction of the NBL. A rock dam has been constructed on the lower side of the inlet and riprap has been placed in the ditch leading up to the inlet. The outlet is surrounded with riprap to protect the west ditch and the east bank from erosion. The riprap is partially blocking the outlet, and two erosion channels have formed down the slope, up to 1 m wide and 0.4 m deep. Some of the riprap had been displaced downslope (Photo 4).

Photo 4: Bank at Culvert E lined with riprap. Erosion channel forming below. Looking northeast.

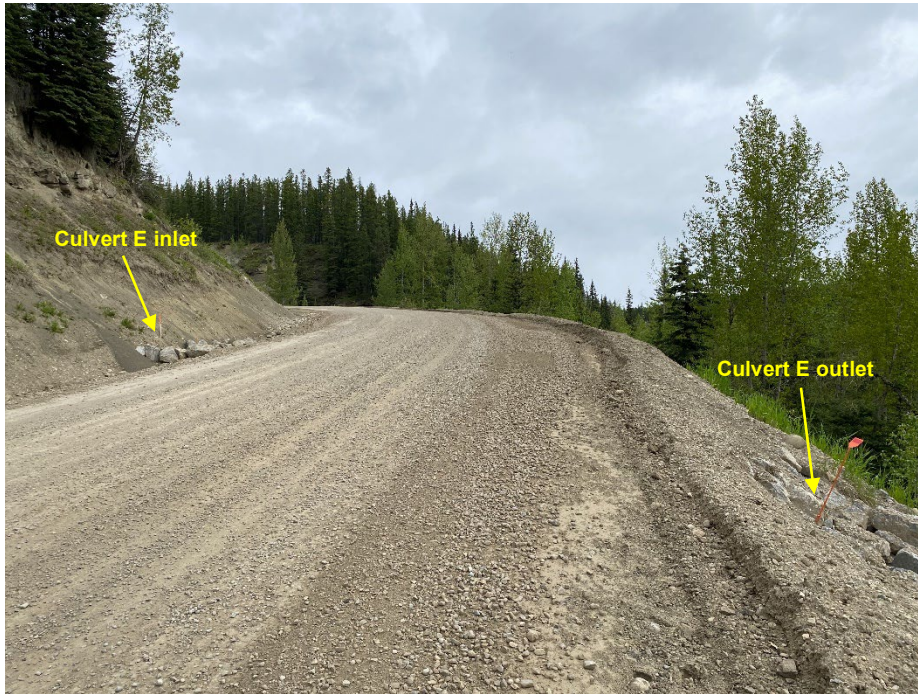
- A riprap buttress has been constructed at the location of the landslide observed during the 2023 call-out inspection and the NBL has been reinstated (Photos 5 and 6). The riprap is visible for approximately 10 m across the slope, at approximately 1/3 of the way down the slope (Photo 7).

Photo 5: South end of NBL wash-out repair. Culvert E inlet and outlet lined with riprap. Looking north.

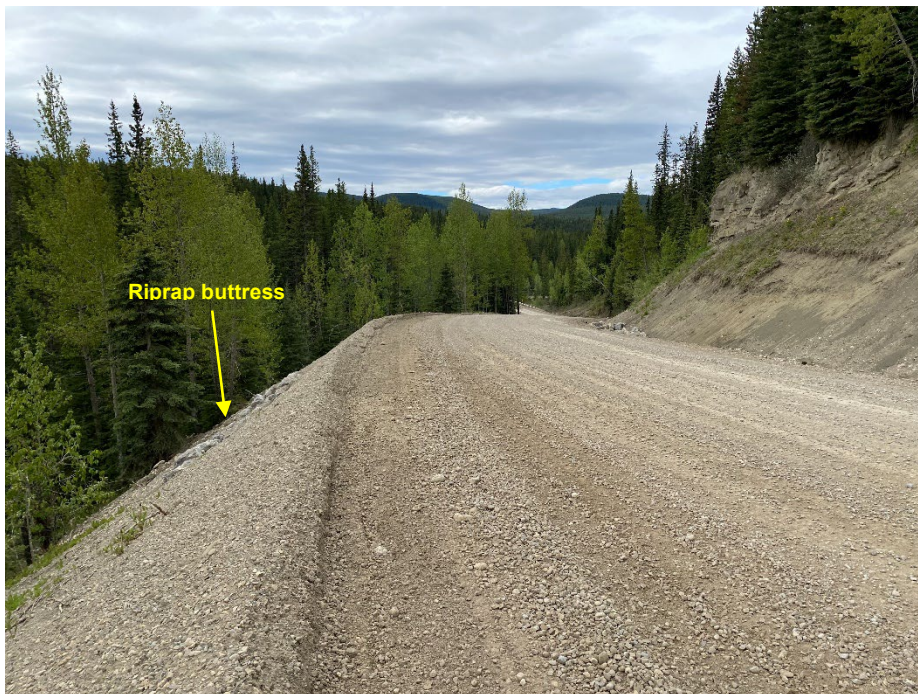
Photo 6: North end of washed-out NBL. Looking south.

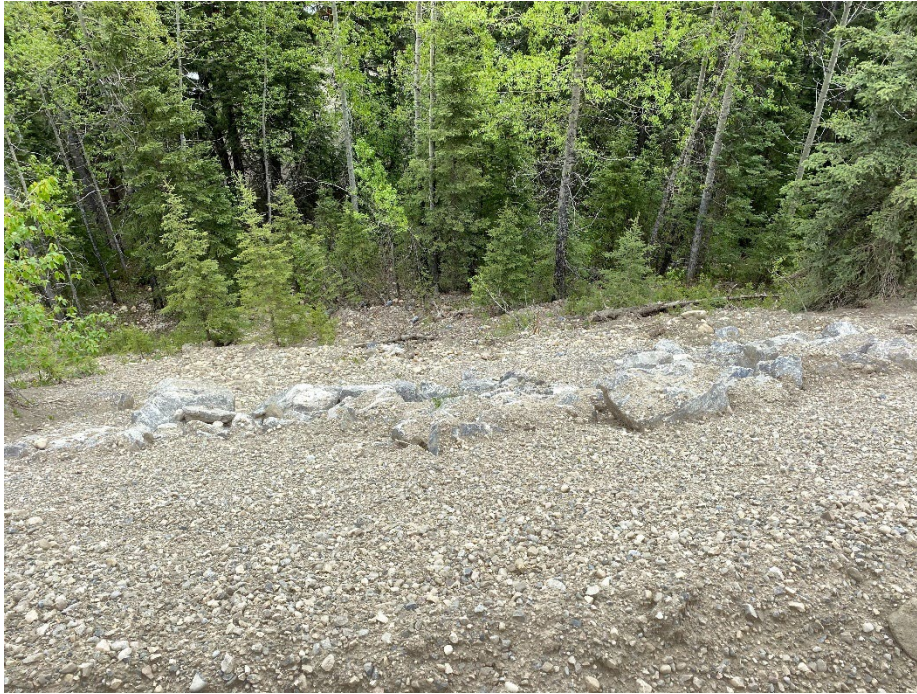
Photo 7: Riprap buttress constructed at location of NBL wash-out repair. Looking southeast.

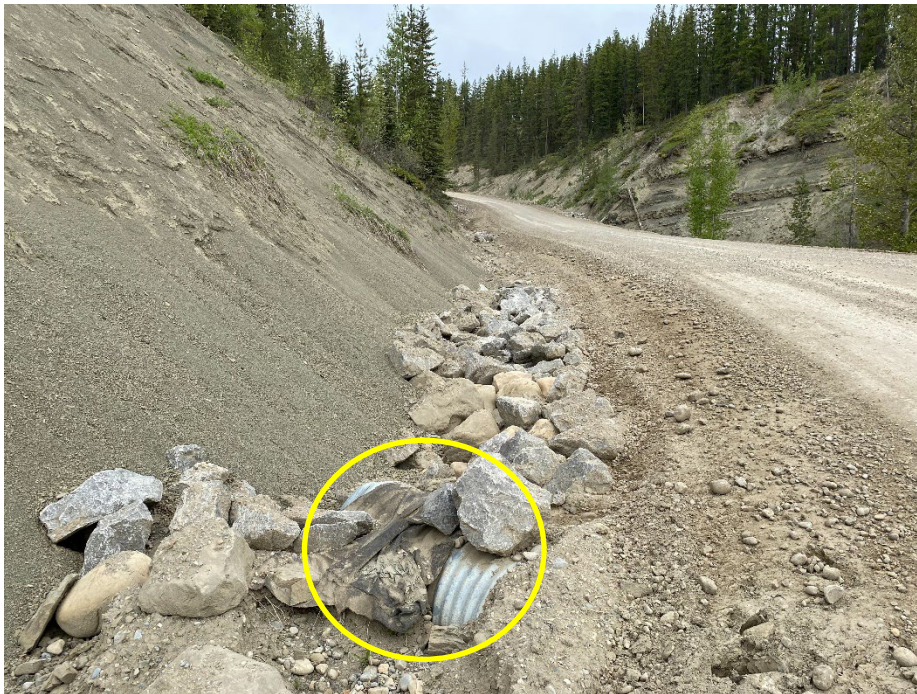
- An erosion channel approximately 1 m wide and up to 0.1 m deep was observed on the east slope, south from the outlet of Culvert A.
- The inlet of Culvert A (600 mm dia.) was observed to be open and surrounded by riprap (Photo 8). Sediment off the west backslope is being deposited above the riprap but was not blocking the inlet during this inspection. The outlet was hanging over the downslope side of the highway by about 0.3 m. The erosion channel and partially washed-out mountain side observed during the 2023 call-out inspection appeared relatively unchanged. A few fallen and leaning trees were also observed near the outlet (Photo 9).

Photo 8: Culvert A inlet in SBL ditch, open and dry. Riprap lining ditch north of inlet. Looking north.

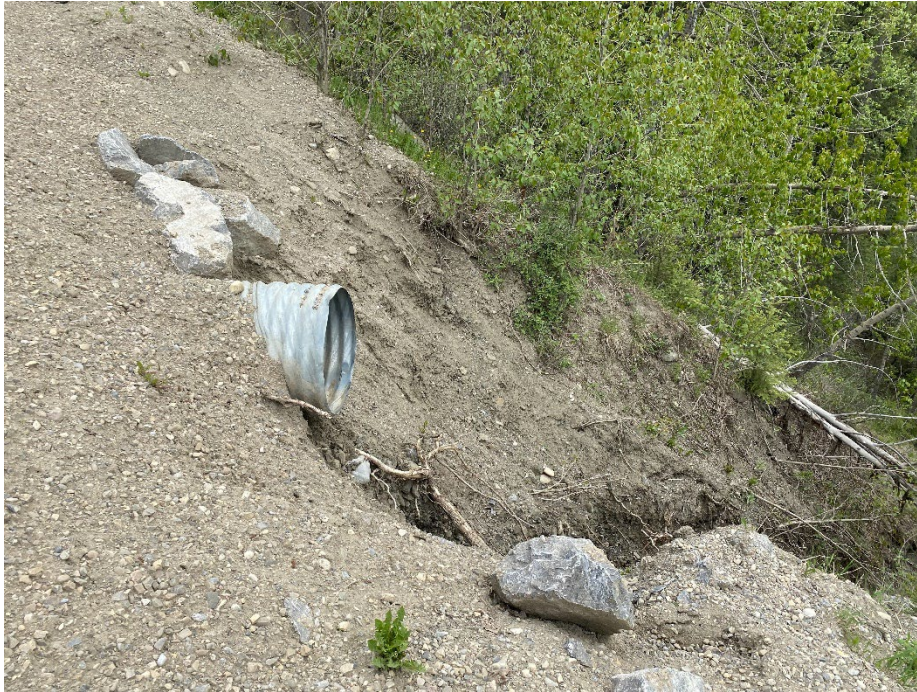
Photo 9: Overhang at Culvert A outlet. Washout and erosion gully below outlet. Looking north.

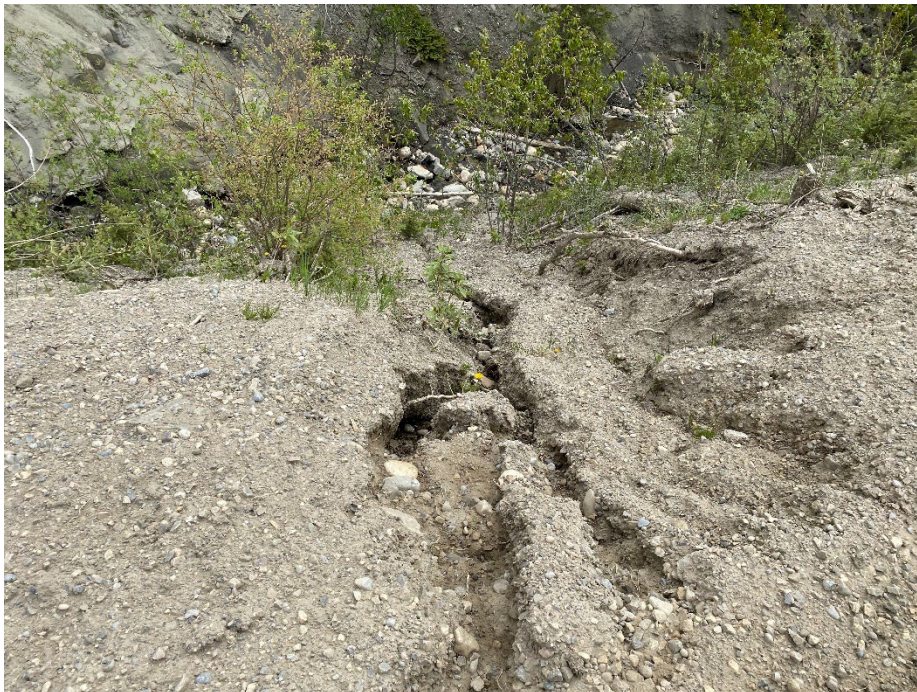
- Riprap lines the west ditch for approximately 10 m north from the inlet of Culvert A (Photos 15 and 16).
- Several erosion rills and gullies were observed between the outlets of Culvert C and Culvert A on the downslope side of the highway, to the creek (Photos 10 and 16). The erosion begins at the edge of the highway. The 4 m wide and 0.8 m deep erosion channel observed during the 2023 call-out inspection has been repaired and was not observed.

Photo 10: Erosion gully on shoulder of NBL into drainage, between Culverts A and C. Looking east.

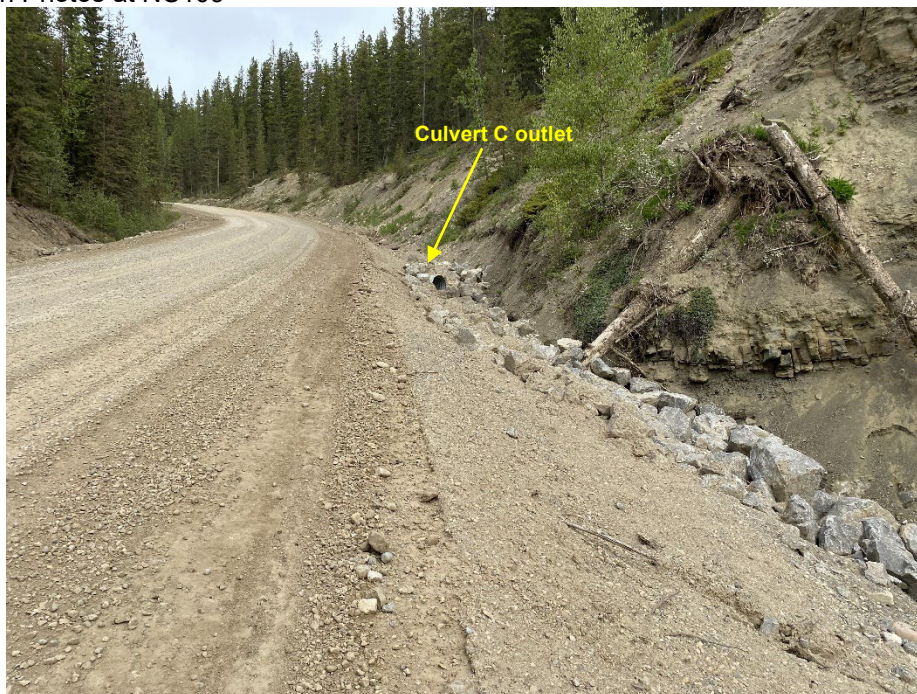
- Culvert C (600 mm dia.) was observed to have been repaired, and riprap placed along the ditch upslope of the inlet and downslope of the outlet (Photo 11). Surficial erosion and sedimentation was observed in the east ditch north from the outlet of Culvert C. Water was steadily flowing through the culvert during the inspection.

Photo 11: Culvert C outlet into eroded ditch lined with riprap. Looking northwest.

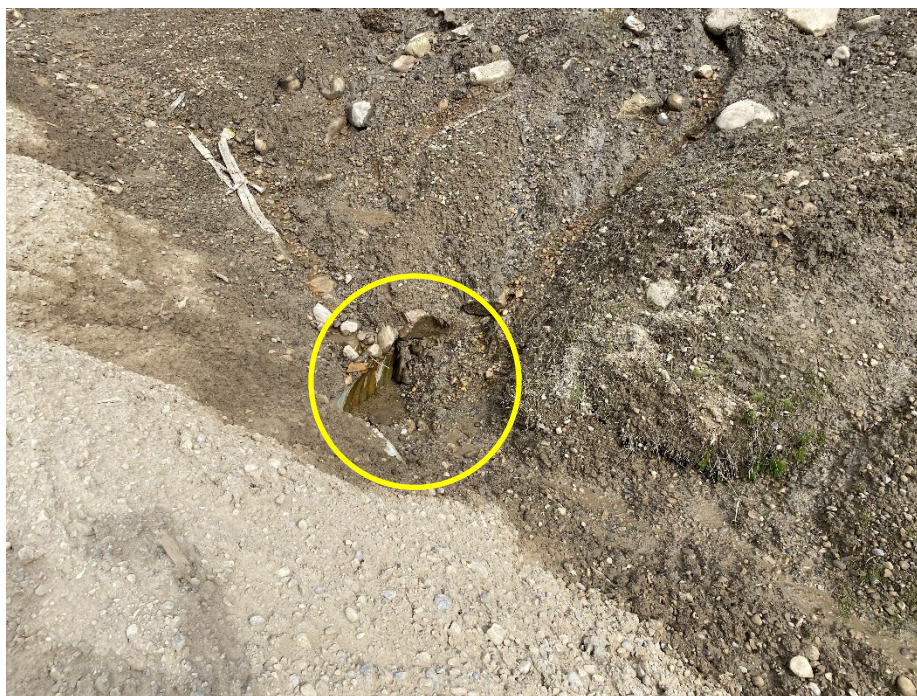
Photo 12: Inlet to Culvert H is blocked with wet material off backslope. Looking northwest.

- Use of the area at the southeast toe should be restricted to reduce the risk to public safety.
- All culverts should be inspected regularly to maintain functionality. Damaged culverts should be replaced, and inlets/outlets should be cleaned out. Additional riprap could be placed at the outlets of the culverts to reduce further erosion of the embankment.
- Given the icing concerns noted in the history of the site, guardrails could be installed around the bend to enhance public safety.
- Erosion gullies should be repaired by backfilling with similar soils to reinstate the grade and placing riprap at eroded locations for protection against further erosion.

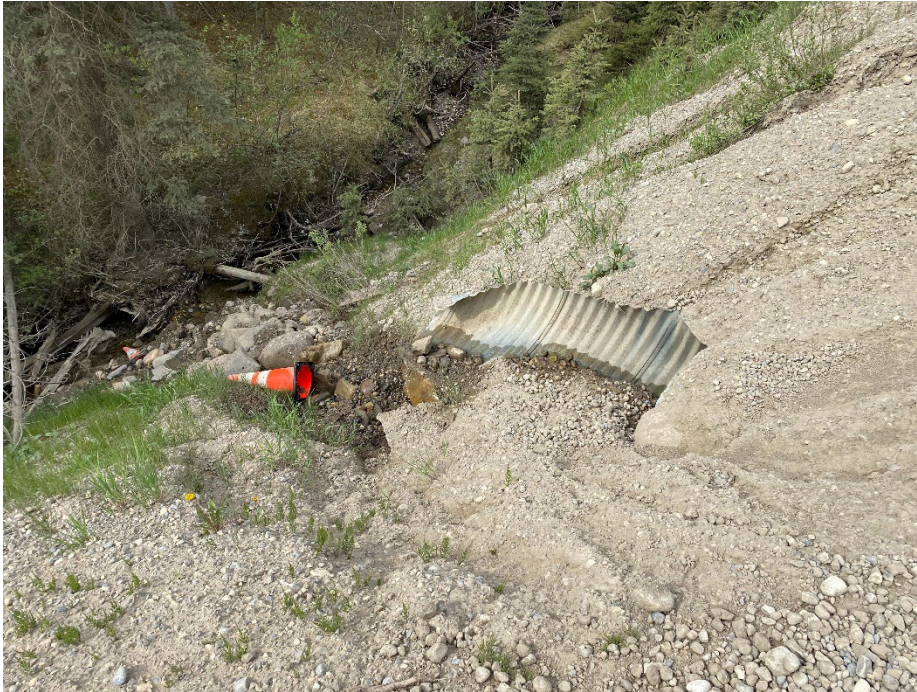
Photo 13: Outlet of Culvert H positioned above stream in south ditch. Slope above outlet washed out at the edge of the highway. Looking southwest.

- The embankment above the outlet for Culvert H should be repaired before additional material is lost from the edge of the highway. This can be done by backfilling with similar soils to reinstate the grade, and riprap should be placed around the culvert outlet for erosion protection. In the near term, delineators could be placed at the edge of road to warn motorists of the loss of roadway.
- The site should continue to be inspected once per contract cycle.

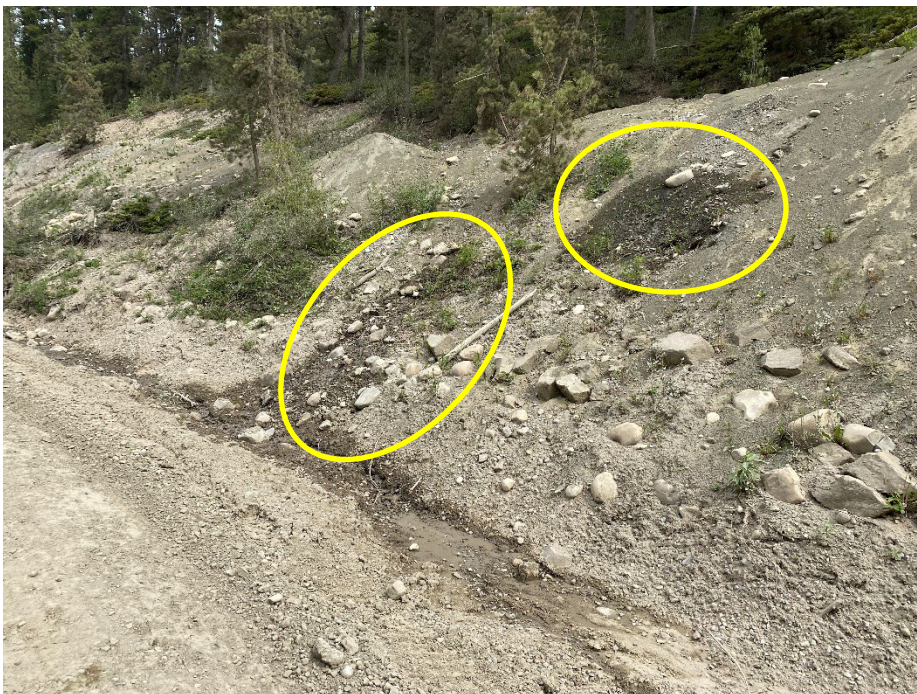
- Erosion was observed on the shoulder of the NBL, between the outlets of Culvert H and Culvert C. The ditch appeared moist in this section.
- Seepage was observed on the backslope on the north / northeast side of the highway, above the inlet to Culvert H and approximately 50 m southeast from Culvert H. Areas of the slope appear moist, as does the ditch below this portion of this slope (Photo 14).

Photo 14: Seepage observed on backslope northeast of highway, south from Culvert H. Looking north.

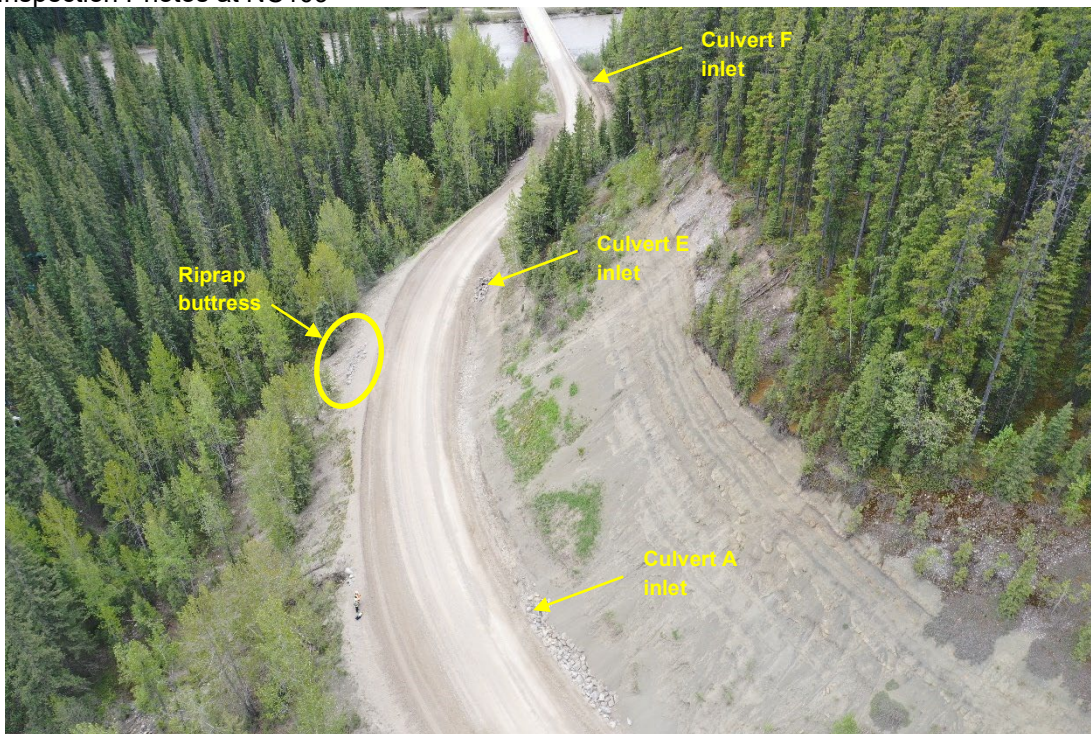
Photo 15: Overview of Highway 734 between Culvert A to the Brazeau River. Photo taken by drone, looking south.

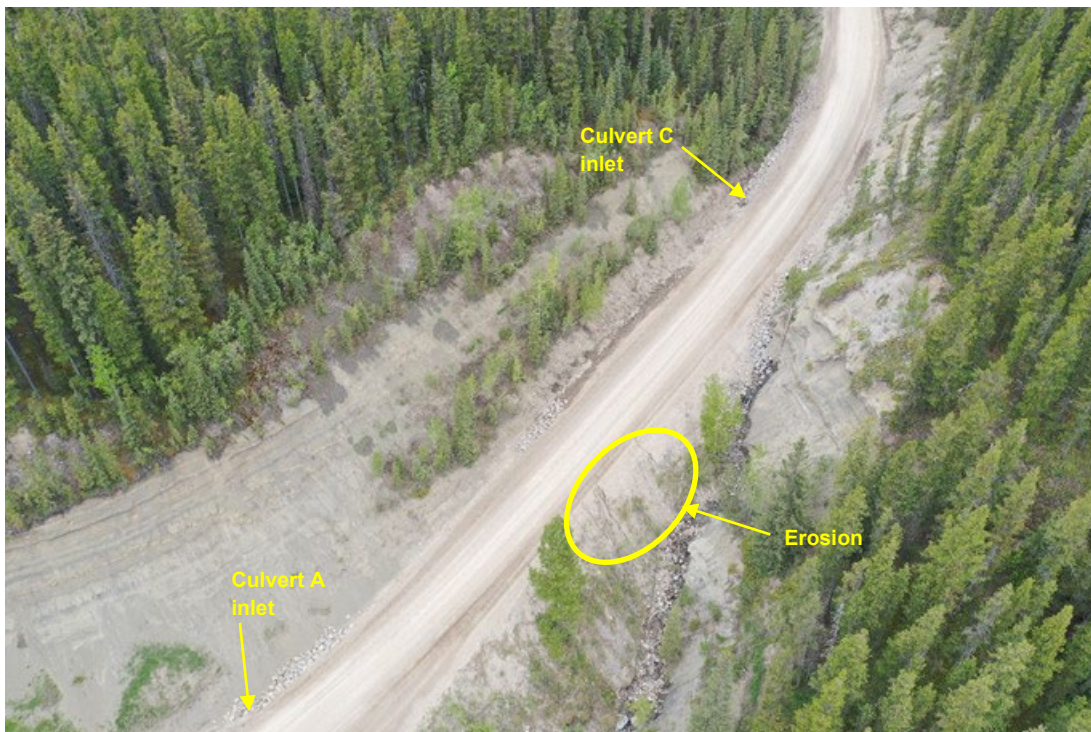
Photo 16: Overview of Highway 734 between Culverts C and A. Photo taken by drone, looking west.

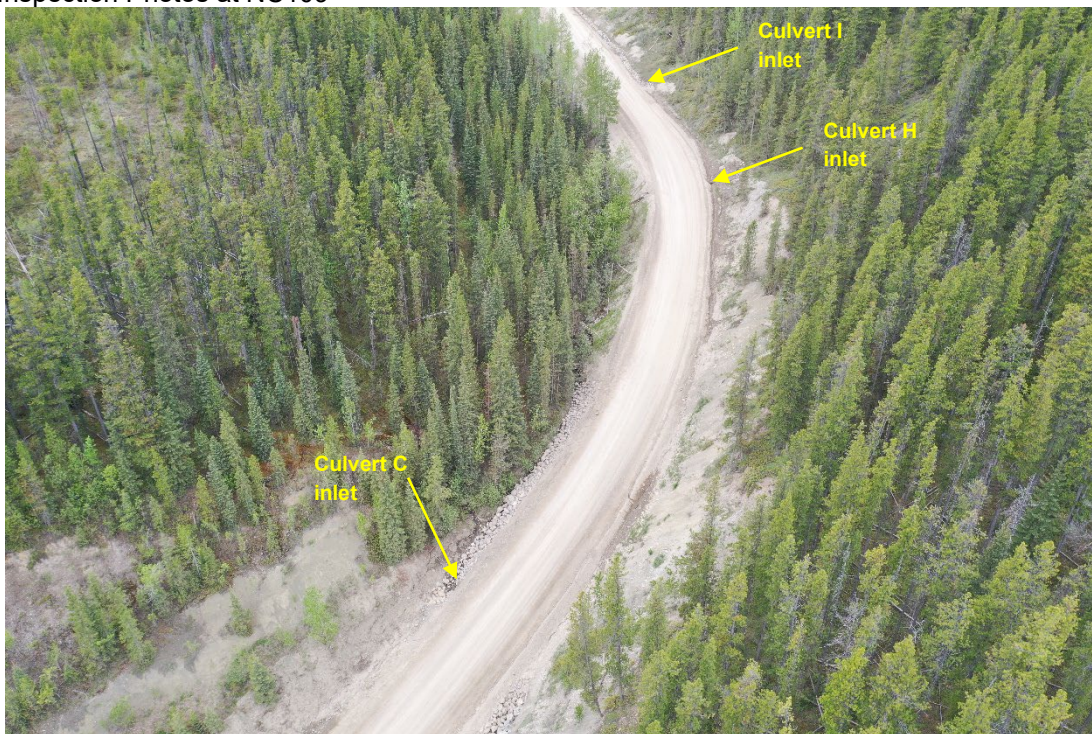
Photo 17: Overview of Highway 734 between Culverts C and I. Photo taken by drone, looking west.

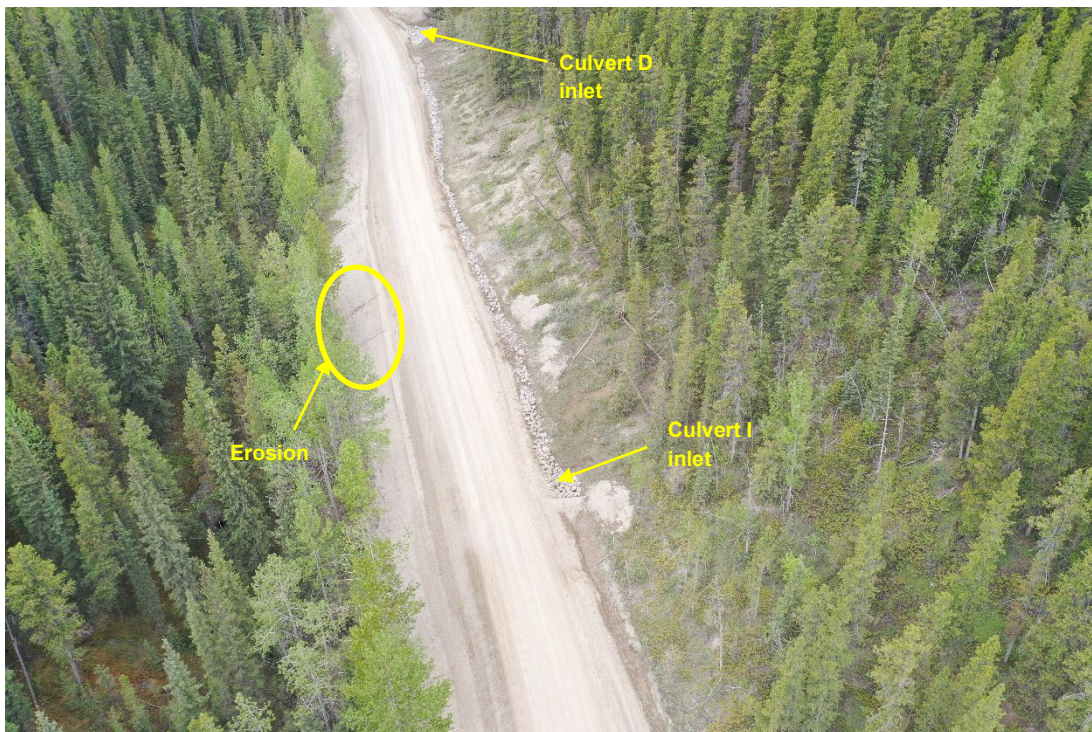
- Culvert I was observed through drone photos, and is approximately 50 m west from Culvert H (Photo 18). The diameter is unknown, however a berm appears to have been constructed east of the inlet, and the outlet is surrounded by riprap. The slope below the outlet appears to be moist.

- Riprap has been placed in the north ditch between Culverts I and D (Photo 18).
- Two erosion channels, both less than 1 m wide, were observed on the south embankment between Culverts I and D (Photo 18).

Photo 18: Overview of Highway 734 between Culverts H and I. Photo taken by drone, looking west.
