GEOHAZARD RISK MANAGEMENT PROGRAM
North Central Region – Edson Area
2015 Inspection Report

Site Number	Site Name	Hwy	km
NC32	North of Tomahawk	759:04	N/A
Legal Land Description		UTM Coordinates (NAD83)	
NW 13-51-6-W5M and NE 14-51-6-W5M		Zone 11U	N5920211 E648666
Operational Site Instrumentation		Slope Inclinometers	2
		Pneumatic Piezometers	5
		Vibrating Wire Piezometers	0
		Standpipe Piezometers	0
Date of Last Instrumentation Readings		May 12, 2015

NC32 – NORTH OF TOMAHAWK
2015 Annual Inspection Photographs

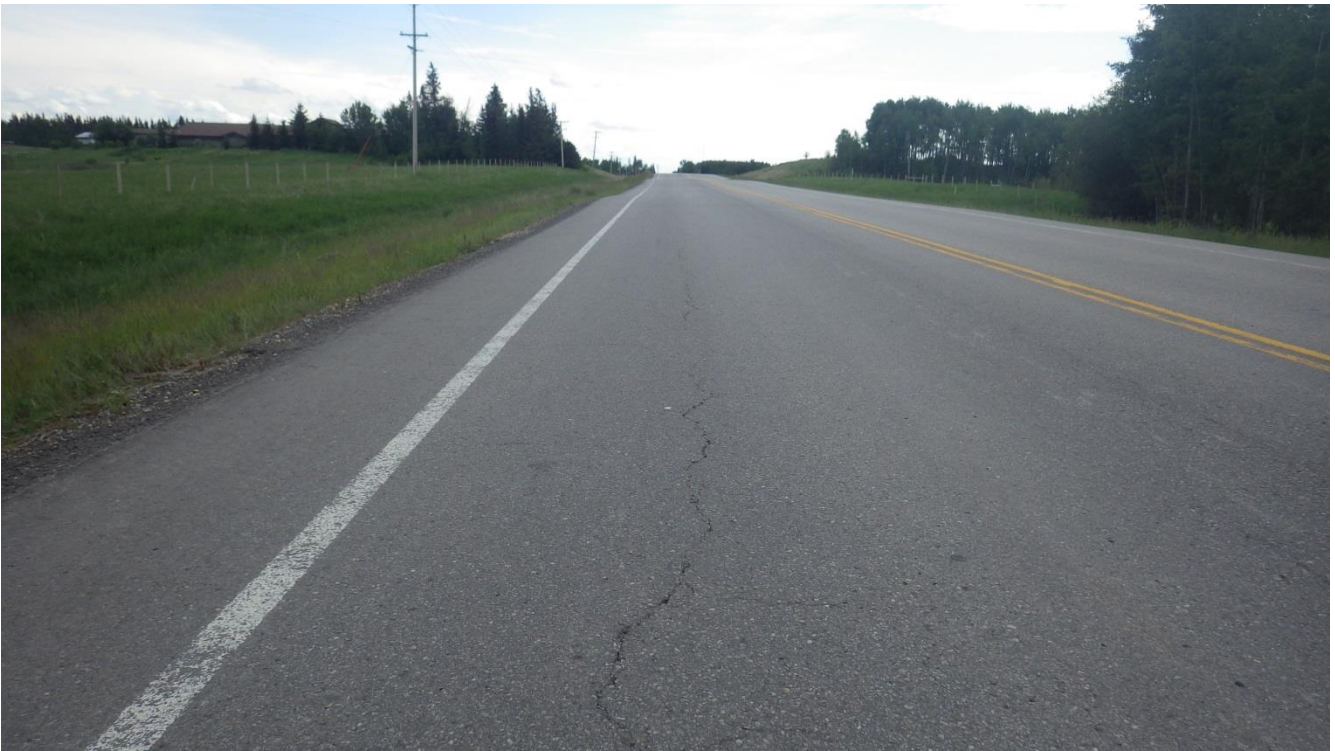
PHOTOGRAPH 1: Pavement crack at north end of site in northbound lane, facing south.

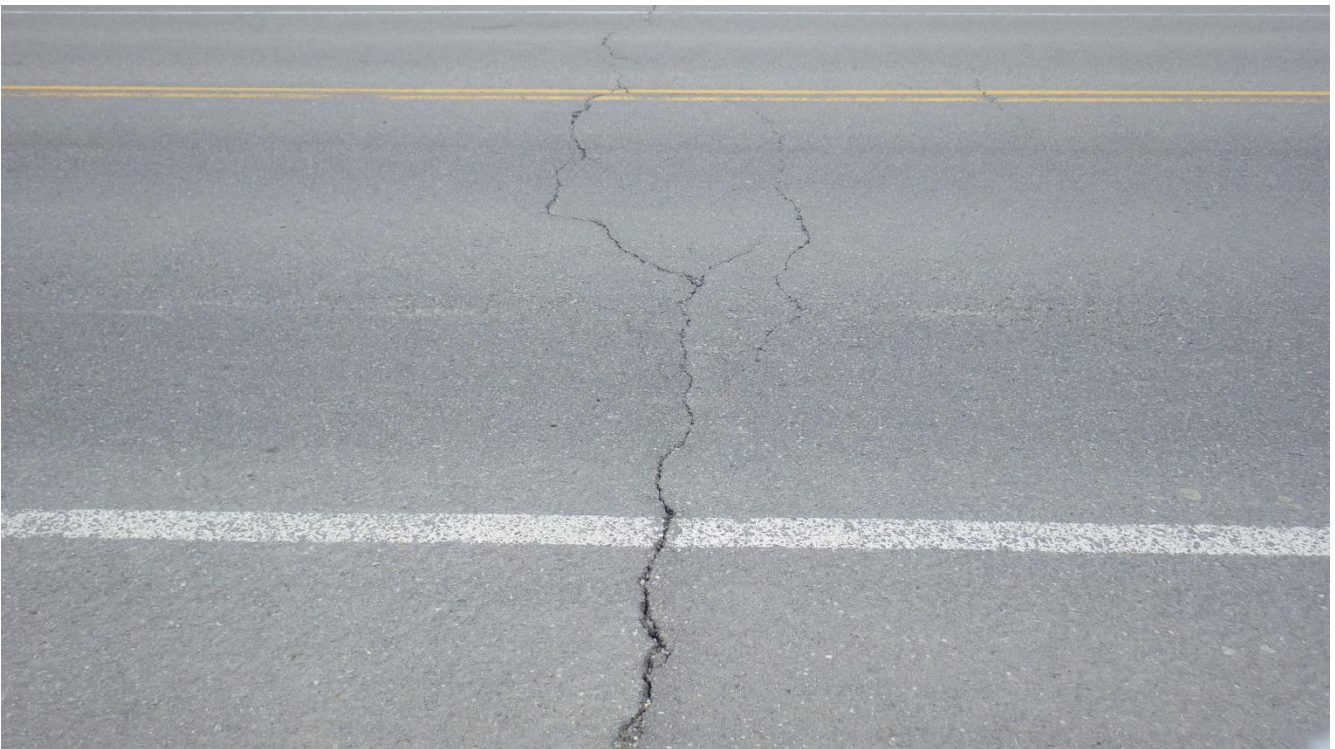
PHOTOGRAPH 2: Transverse pavement crack at north end of site, facing west.

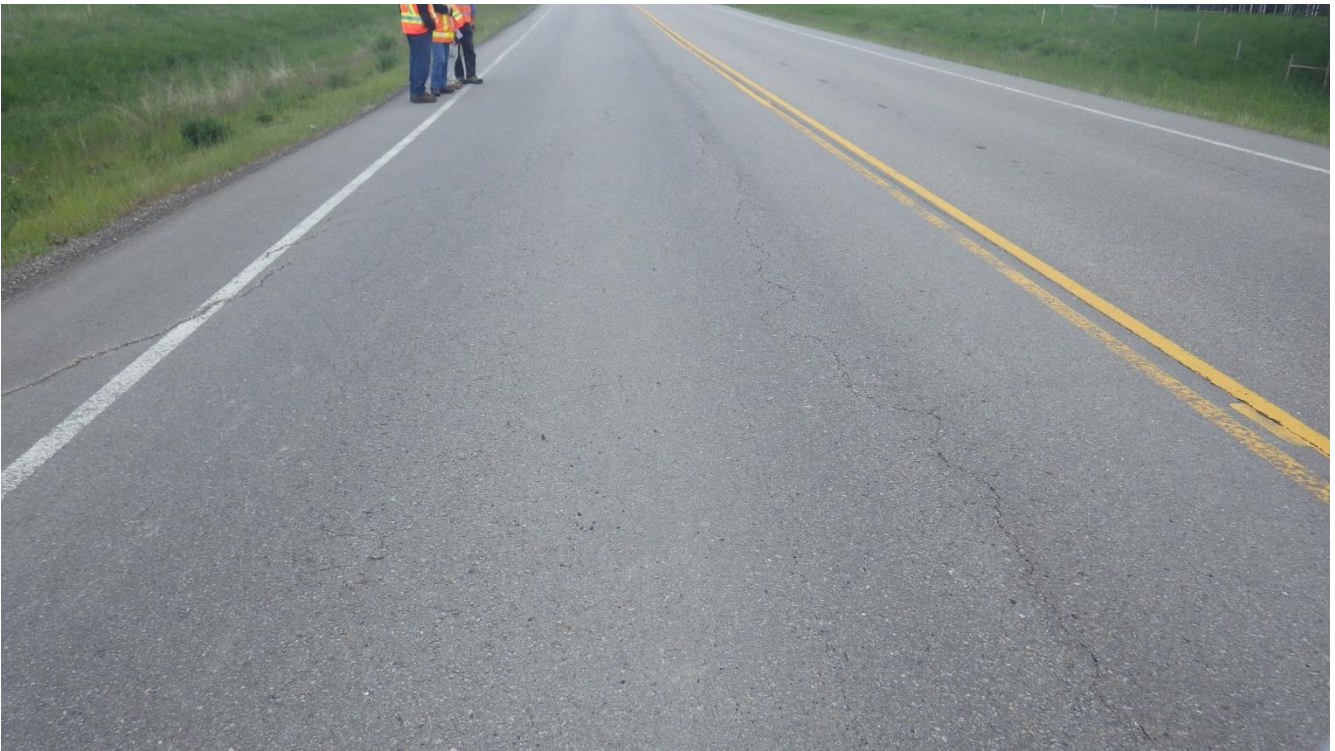
PHOTOGRAPH 3: Pavement distress near midpoint of site in northbound lane, facing south.

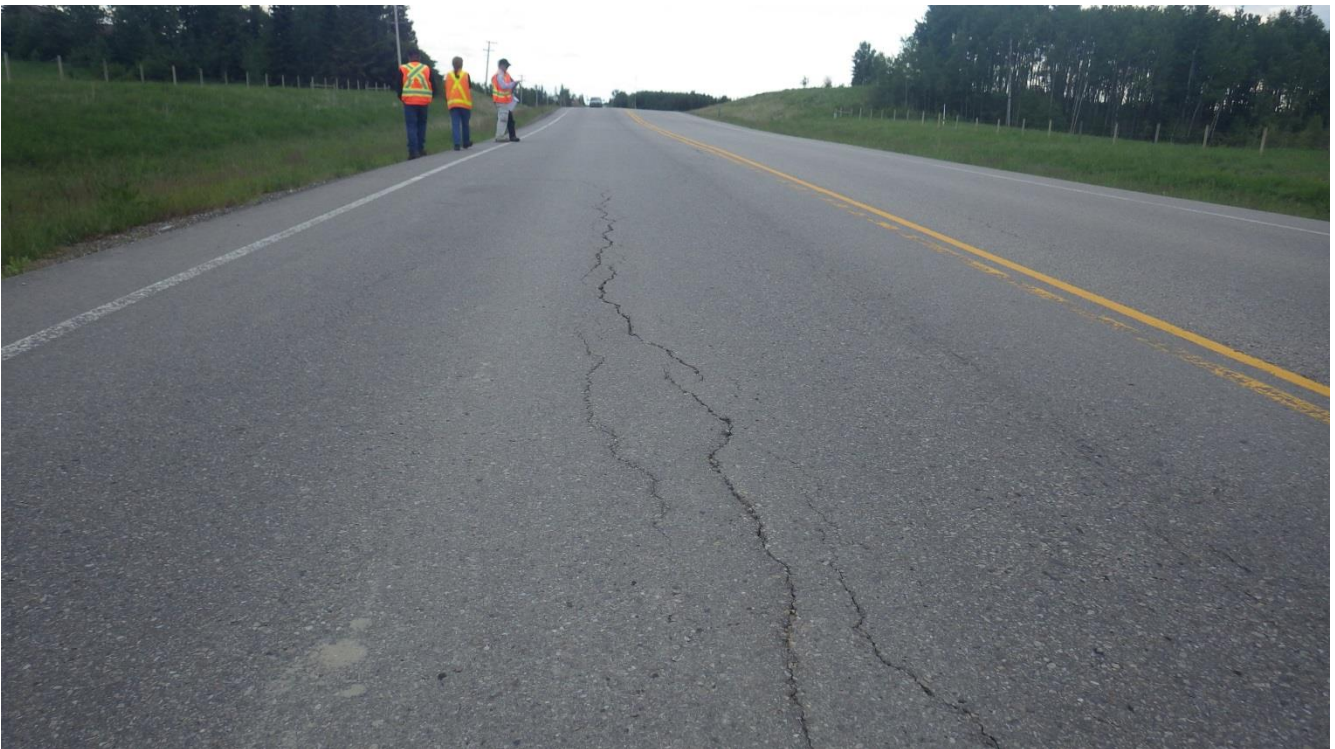
PHOTOGRAPH 4: Pavement near midpoint of site in northbound lane, facing south.

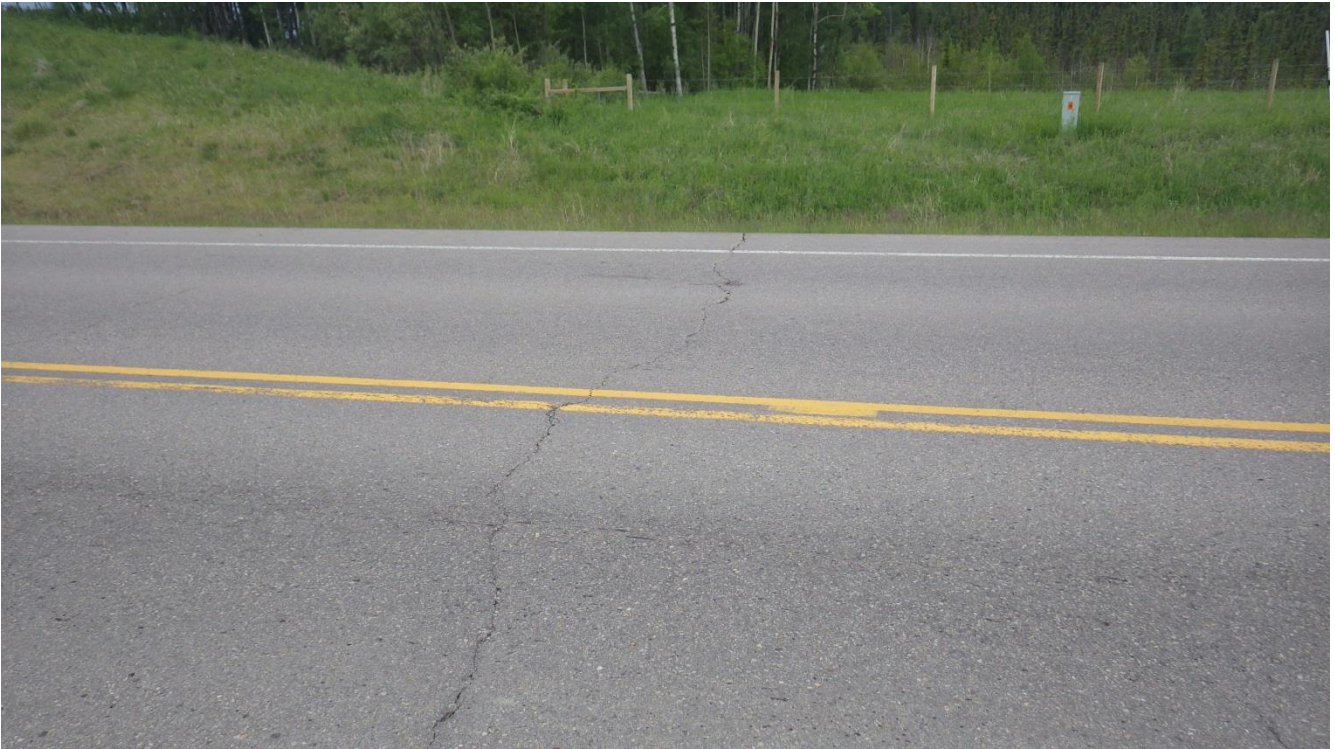
PHOTOGRAPH 5: Transverse crack at south end of site, facing west.

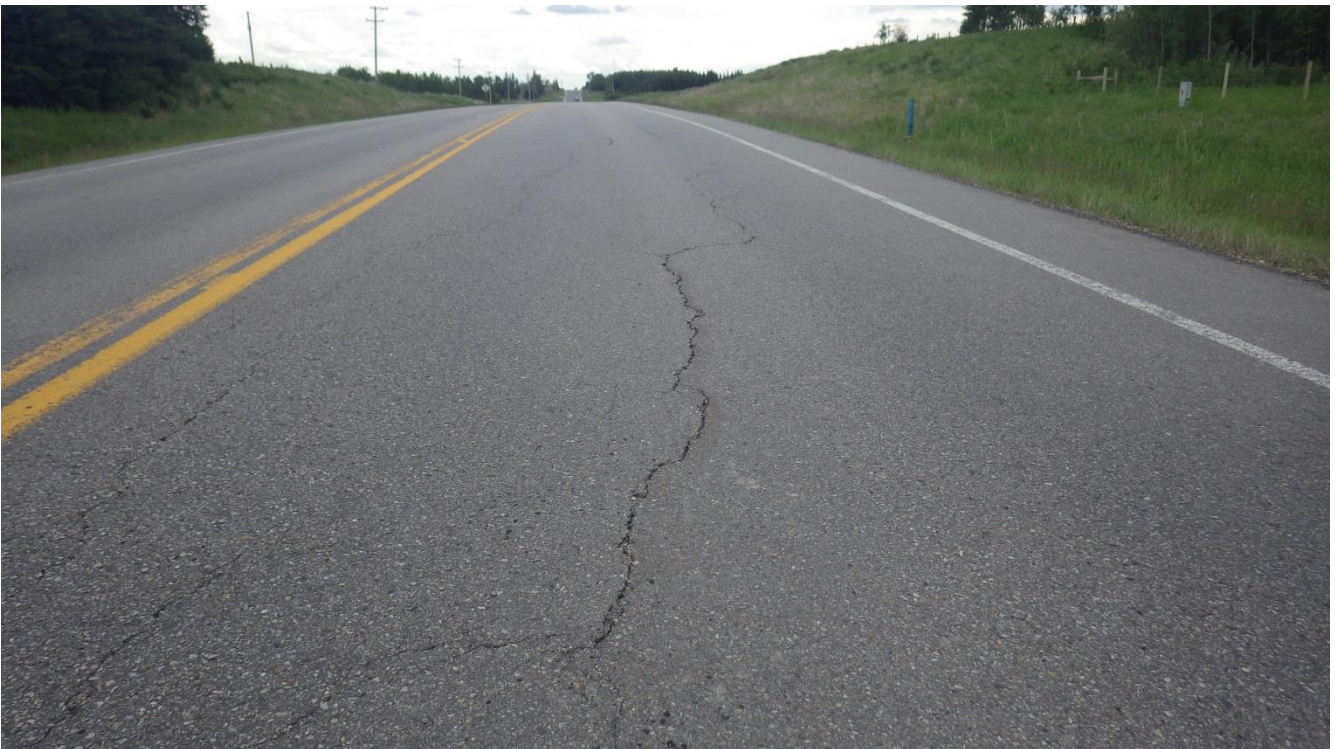
PHOTOGRAPH 6: Pavement distress at south end of site in southbound lane, facing south.

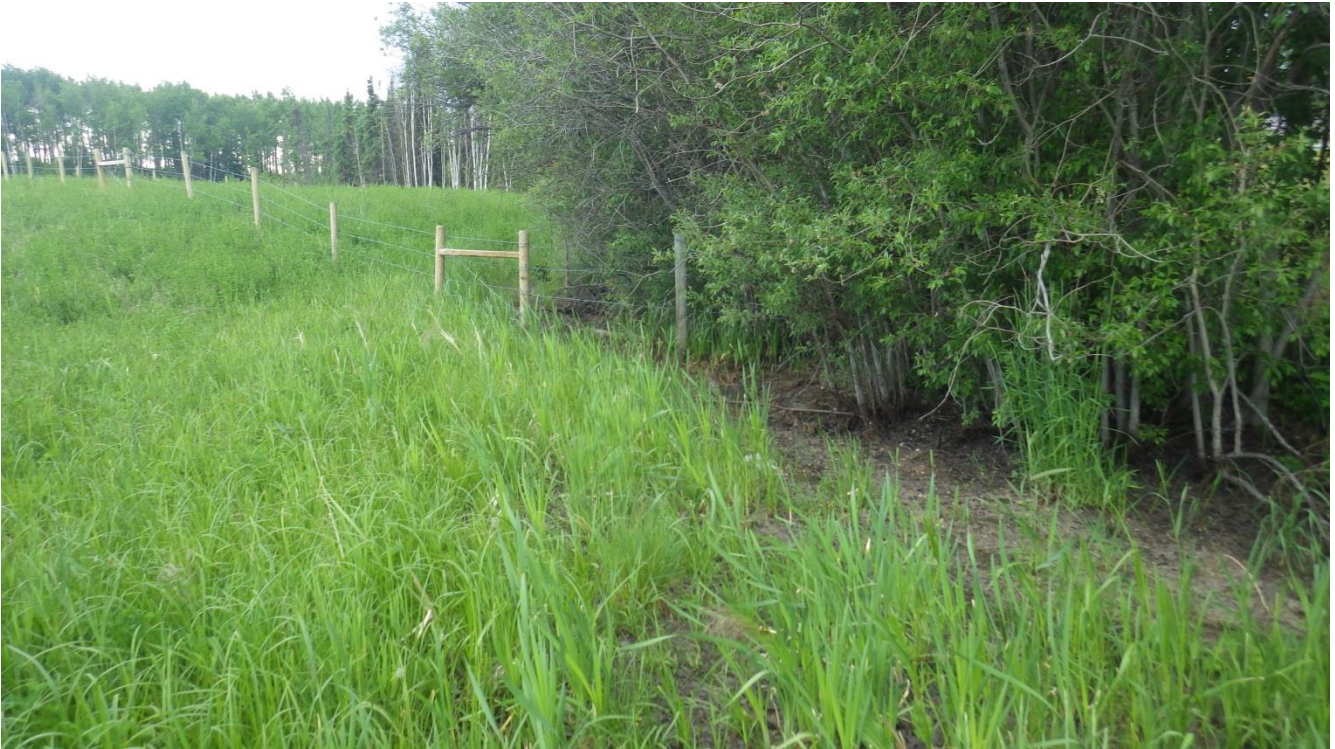
PHOTOGRAPH 7: Ponded water on the north side of the west berm no longer present, facing southwest.

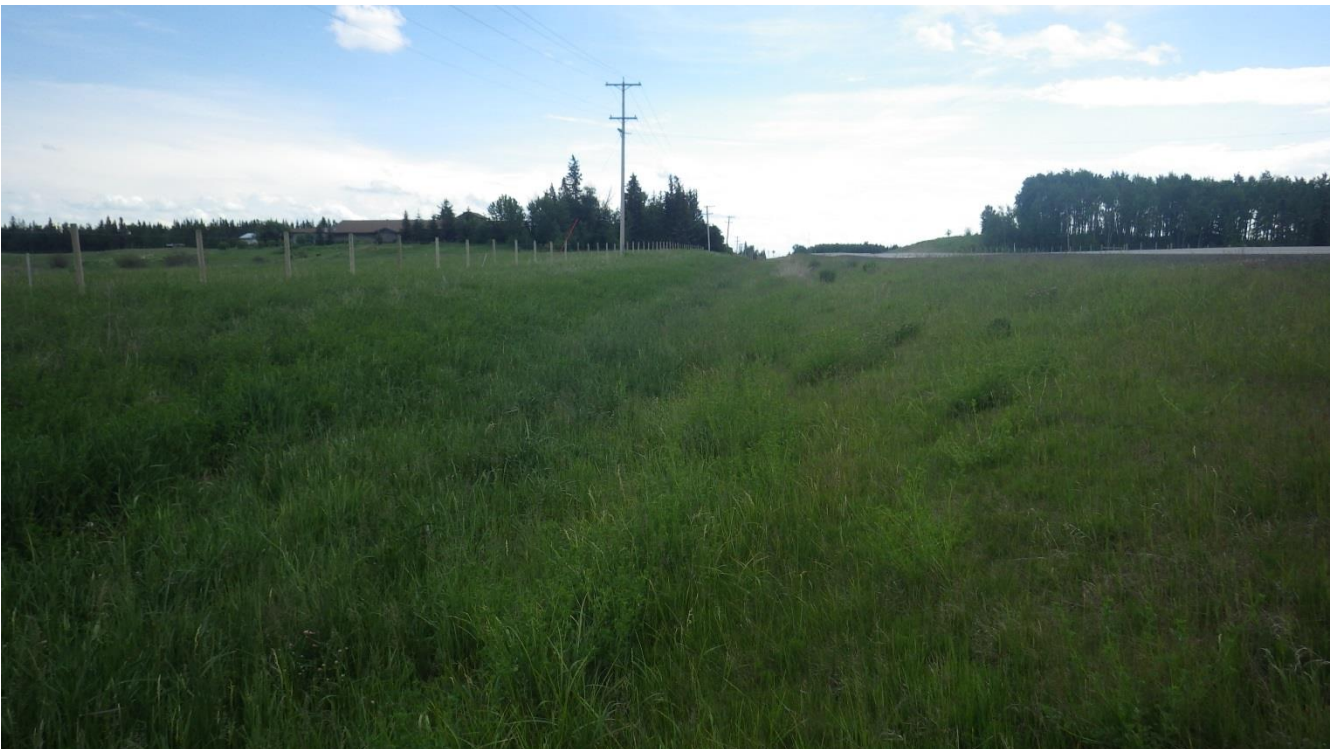
PHOTOGRAPH 8: Ditch along east side of highway has become overgrown, facing south.
