GEOHAZARD RISK MANAGEMENT PROGRAM North Central Region – Edson / Stony Plain Area

2017 Inspection Report

Site Number	Site Name		Hwy	km
NC32	North of Tomahawk		759:04	N/A
Legal Land Description	NW 13-51-6-W5M and NE 14-51-6-W5M			
UTM Coordinates (NAD 83)	Zone 11U	N5920211	E648666	
Operational Site Instrumentation	Slope Inclinometers		2	
	Pneumatic Piezometers		5 (2 damaged and 1 could not be located)	
	Vibrating Wire Piezometers		0	
	Standpipe Piezometers		0	
Date of Last Instrumentation Readings	May 15, 2017

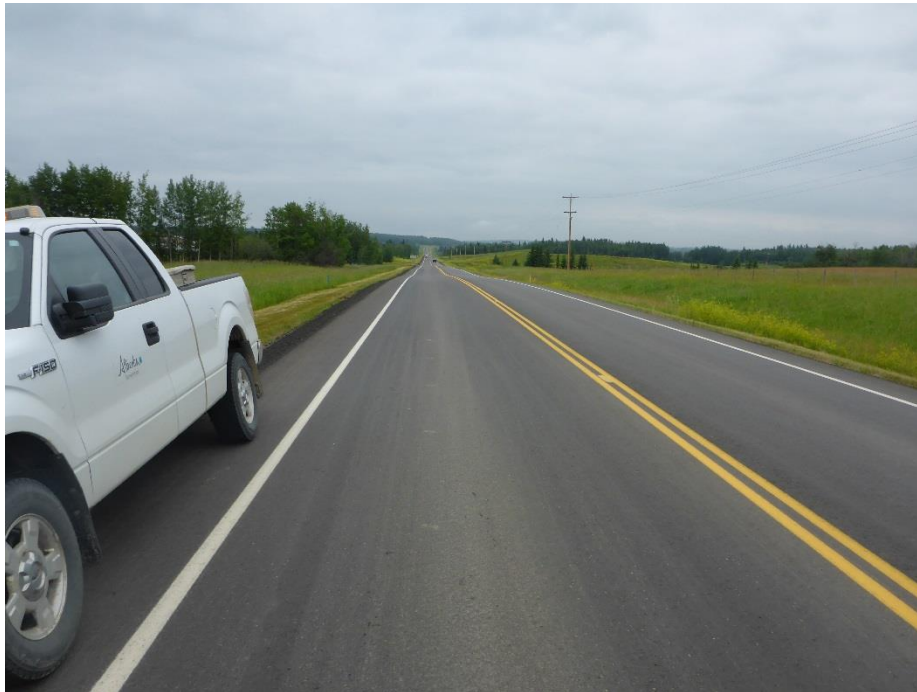
Discussion	<p>Pavement cracks were not observed as the highway was recently milled and paved as shown in Photo 1. As a result of the paving, a relatively steep pavement edge was observed on the northbound lane near the north limits of the site as shown in Photo 2. The highway also appeared to be "rolling" as shown in Photo 3.</p> <p>The culvert that was observed with standing water on the north side of the site near the overhead powerline crossing was removed. A patch of rip rap was left at the culvert location as shown in Photo 4.</p> <p>Thick grass growth had covered the tension cracks observed on top of the hill on the south end of the site. In general, the slumping hill/backslope appears unchanged since the previous inspection. An overall view of the backslope is shown on Photo 5.</p>
Assessment	<p>Only 2 of the 5 piezometers were functional at the time of measurement with both being within historic trends. The groundwater levels at the site are still relatively high with readings up to approximately 2.5 m below ground surface (bgs).</p> <p>Slope inclinometer readings indicate movement rates less than 1 mm/year indicating that the slope has stabilized since berm construction in 2013. The pavement distresses observed in previous years may be due to increased truck traffic from a nearby gravel pit.</p> <p>The thick grass growth coupled with the lack of fresh tension cracks suggest that the backslope had not moved much since the previous inspection. Ditch drainage has not been impinged.</p>

Photo 1: Pavement recently overlayed. Looking north.

Recommendations	<p>Since the highway was recently milled and paved, no crack sealing is required at this time. However, due to the steepness of the edge of the northbound lane, consideration for installing rumble strips should be given to improve traffic safety.</p> <p>Long term remediation is not required since the constructed berms appear to be reducing the amount of slope movement.</p> <p>During the site inspection, it was decided by Alberta Transportation and Stantec that NC32 be removed from the annual inspection list. Additionally, instrumentation readings at the site should continue to be collected once per year in the spring.</p>
------------------------	---

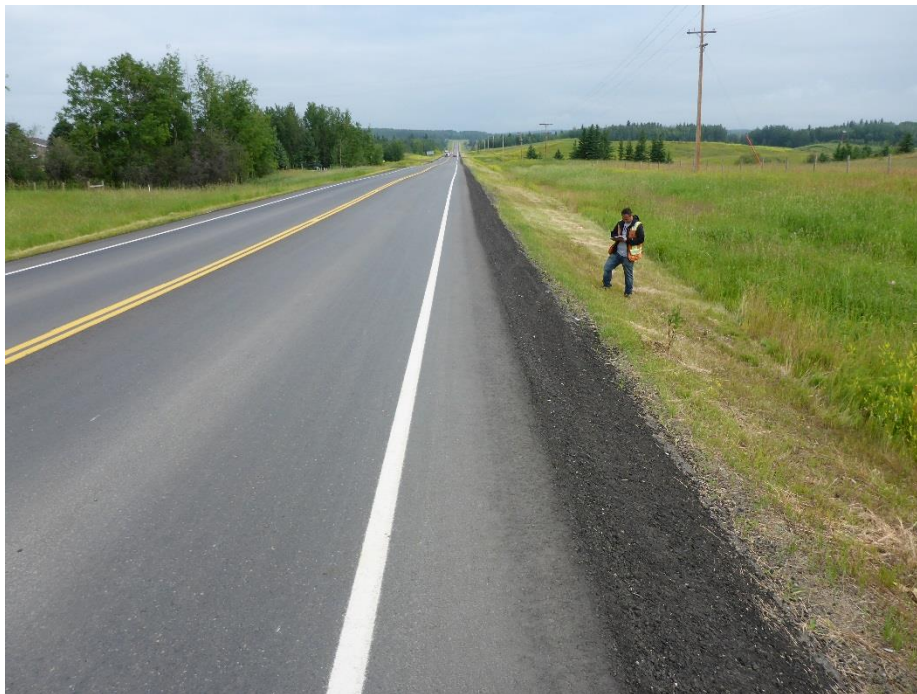
Photo 2: Steep east edge from recent overlay. Looking north.

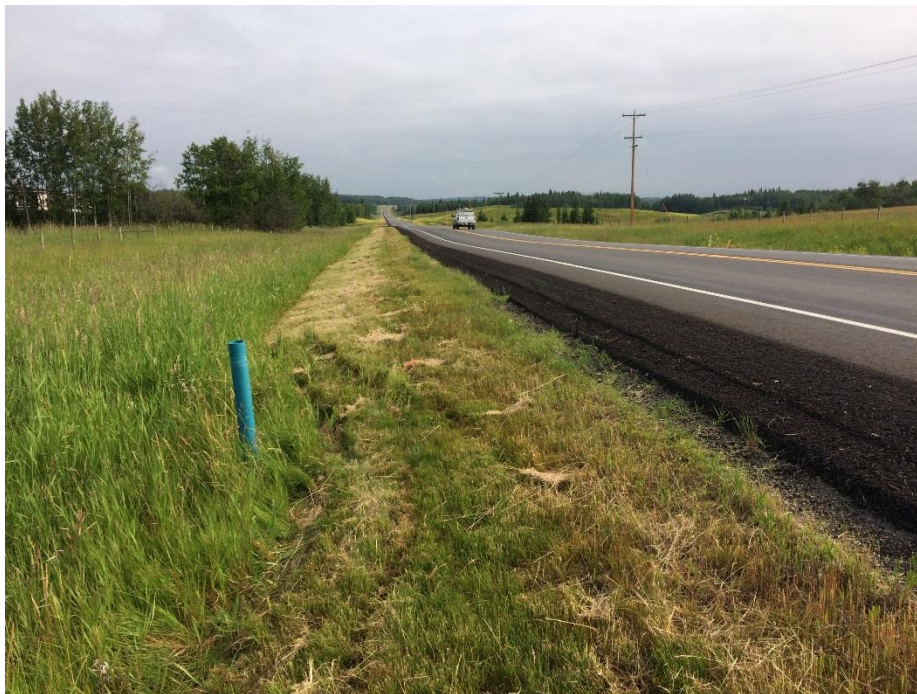
Photo 3: North end of highway has “rolling” appearance. Looking north.

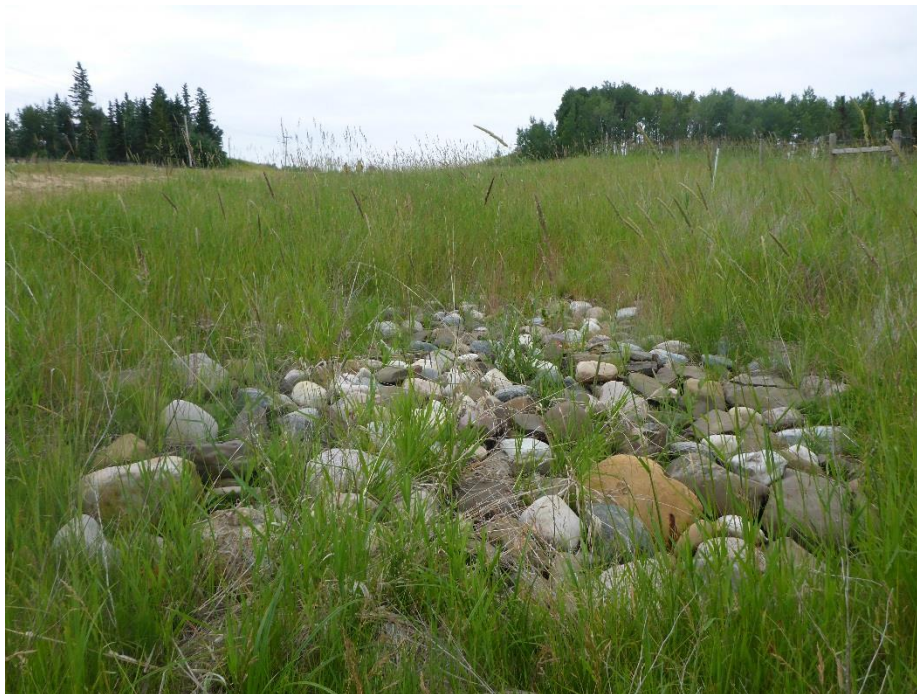
Photo 4: Culvert paralleling overhead powerline missing. Patch of riprap remains. Looking south.

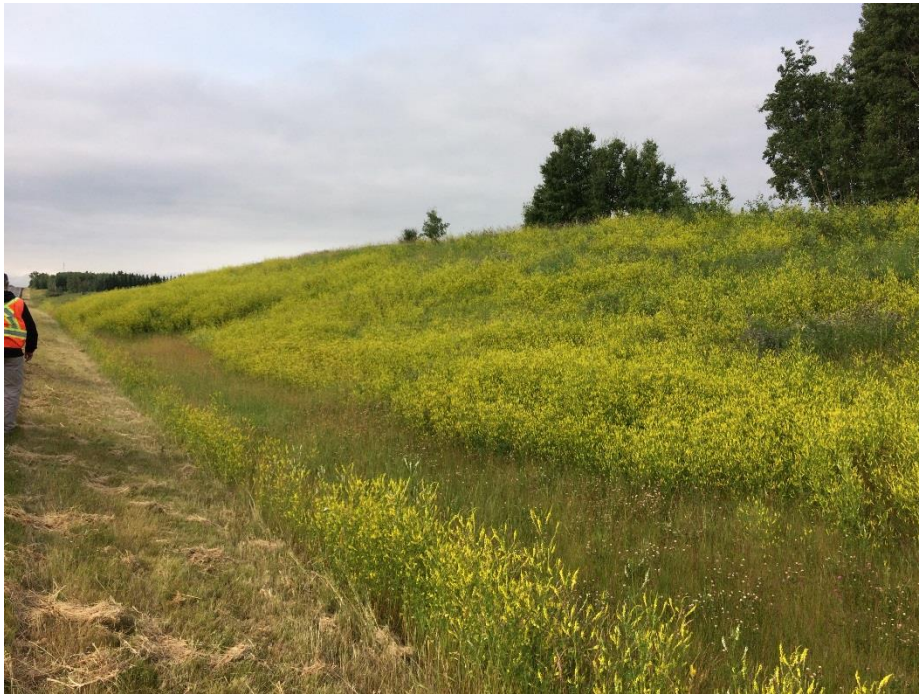
Photo 5: Grass growth over slumping hill at south end of site. Looking southwest.
