To:	Bernard Ching Alberta Transportation	From:	Leslie Cho and Carrie Murray Stantec Consulting Ltd.
File:	123315222	Date:	August 18, 2021

Reference: North Central Region, Edson/Stony Plain, Site NC32 – Highway 759:04 North of Tomahawk, Spring 2021 Instrumentation Monitoring Report

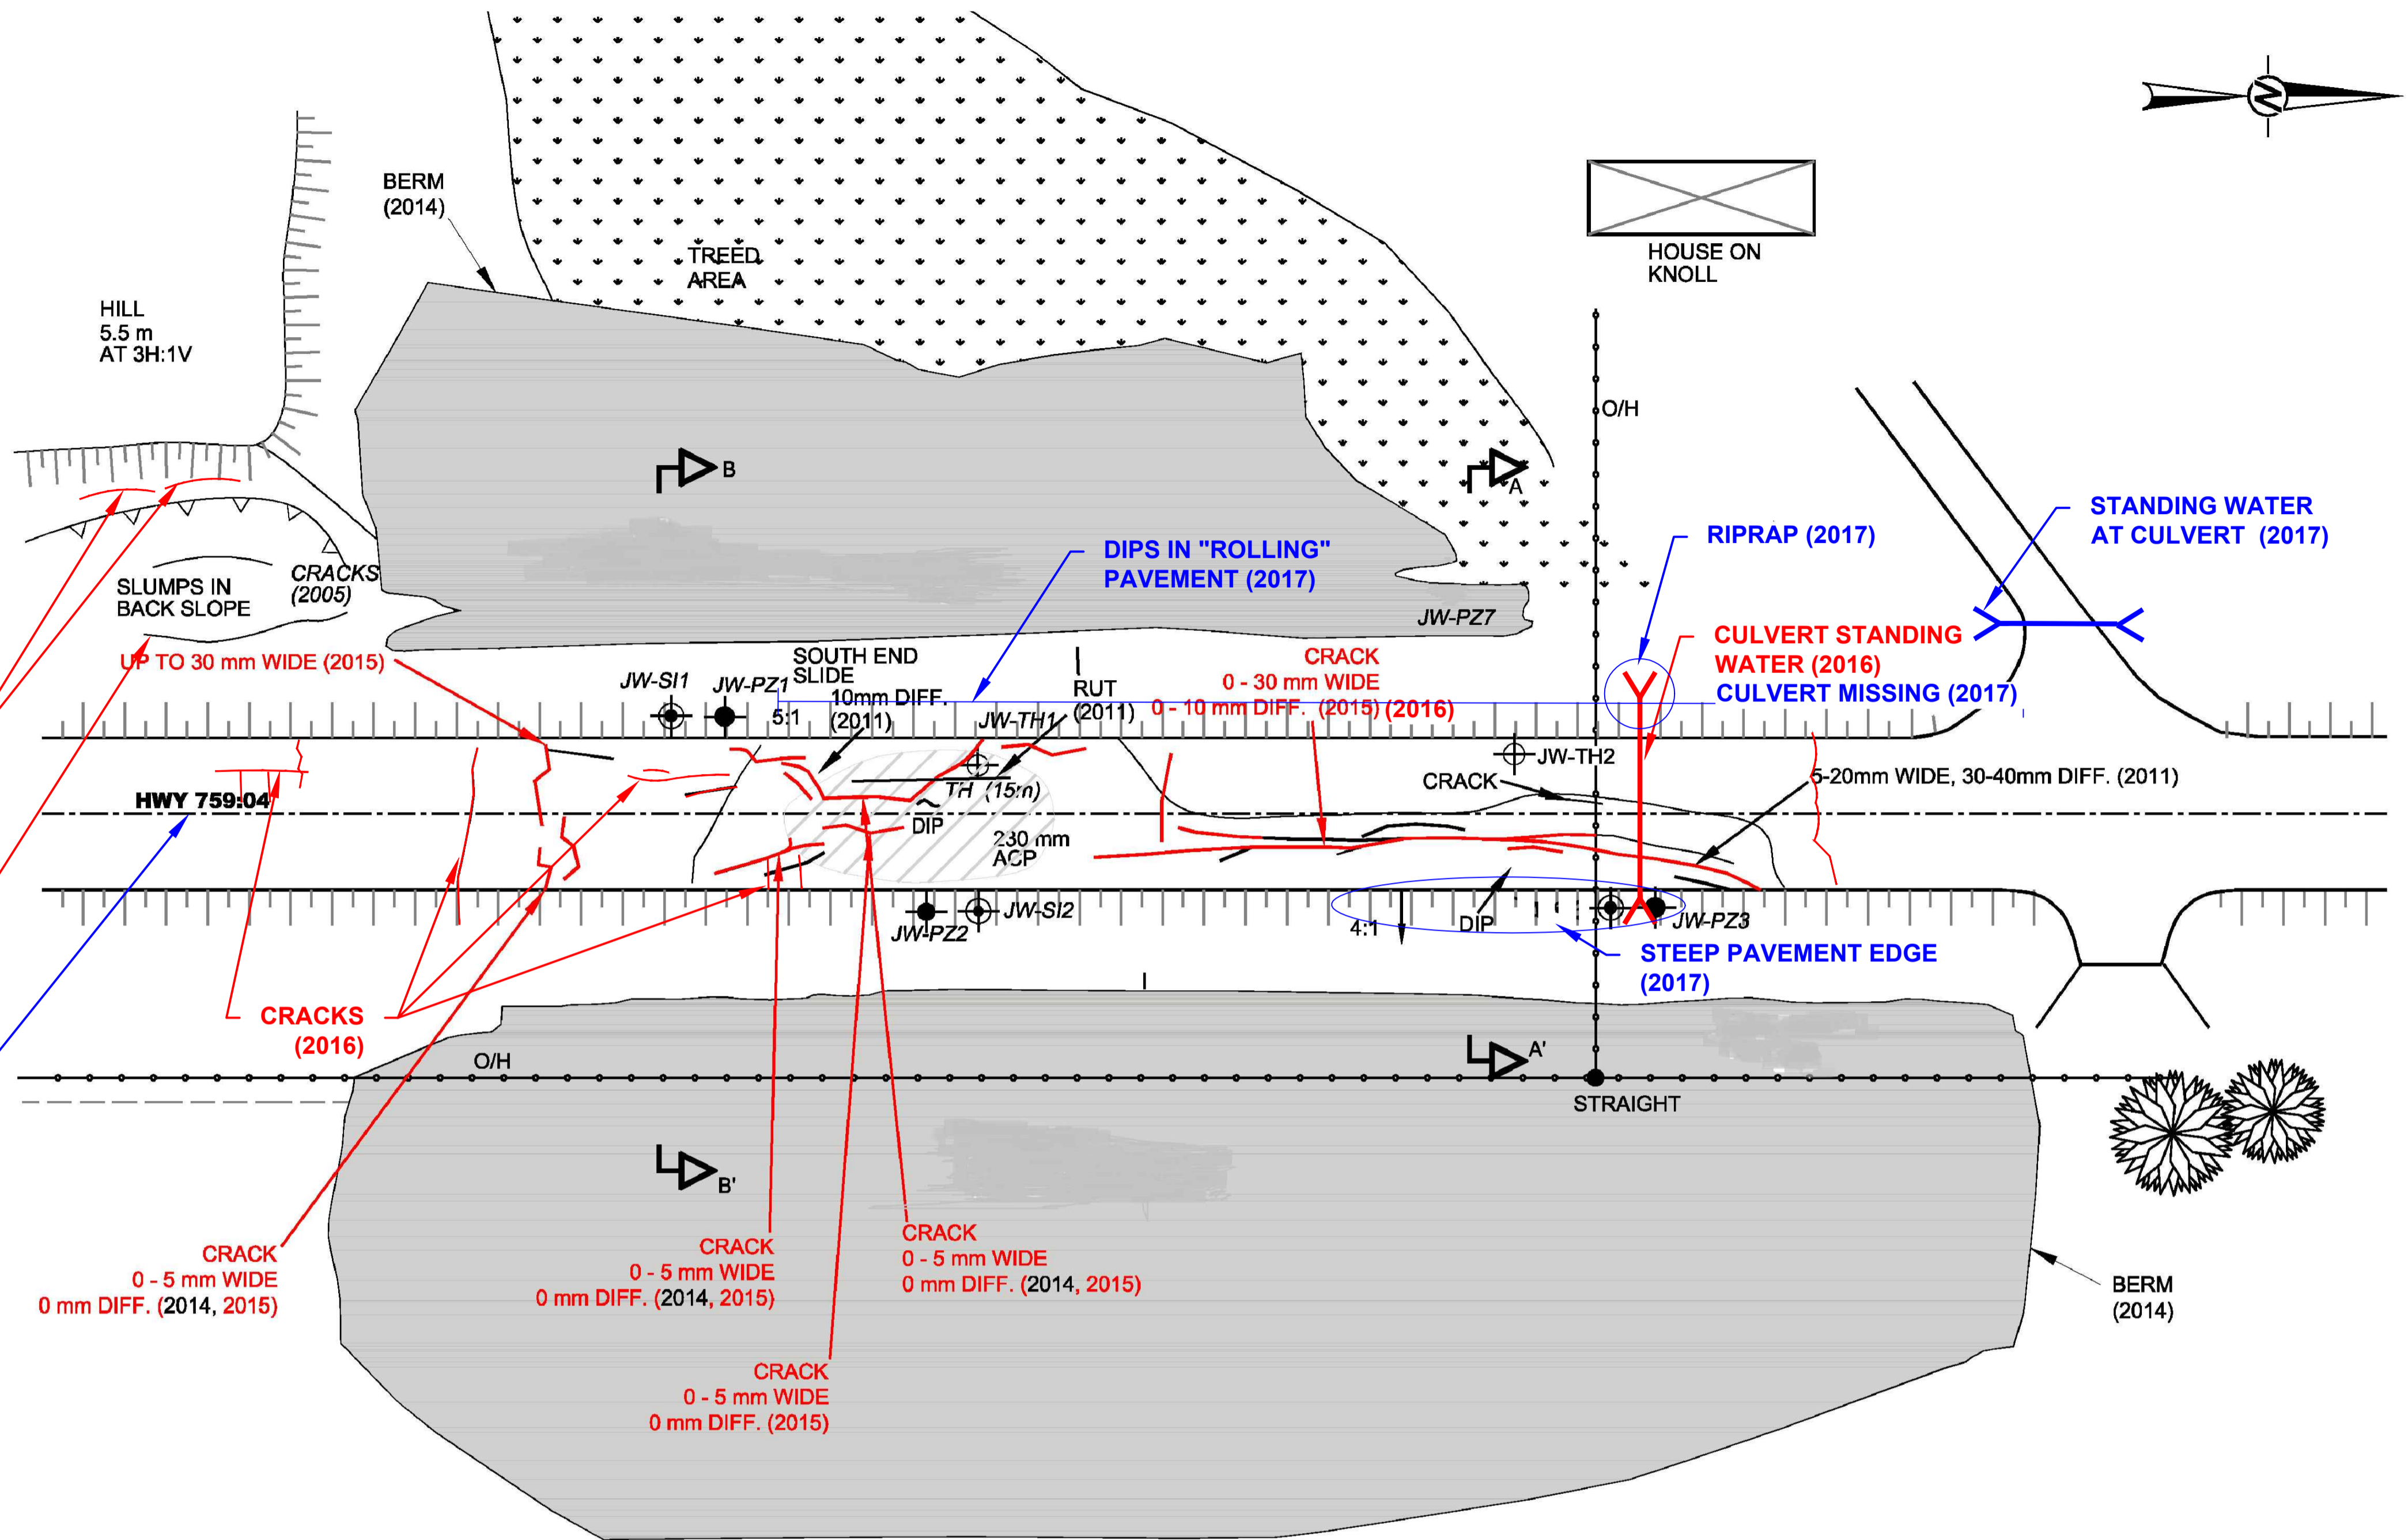
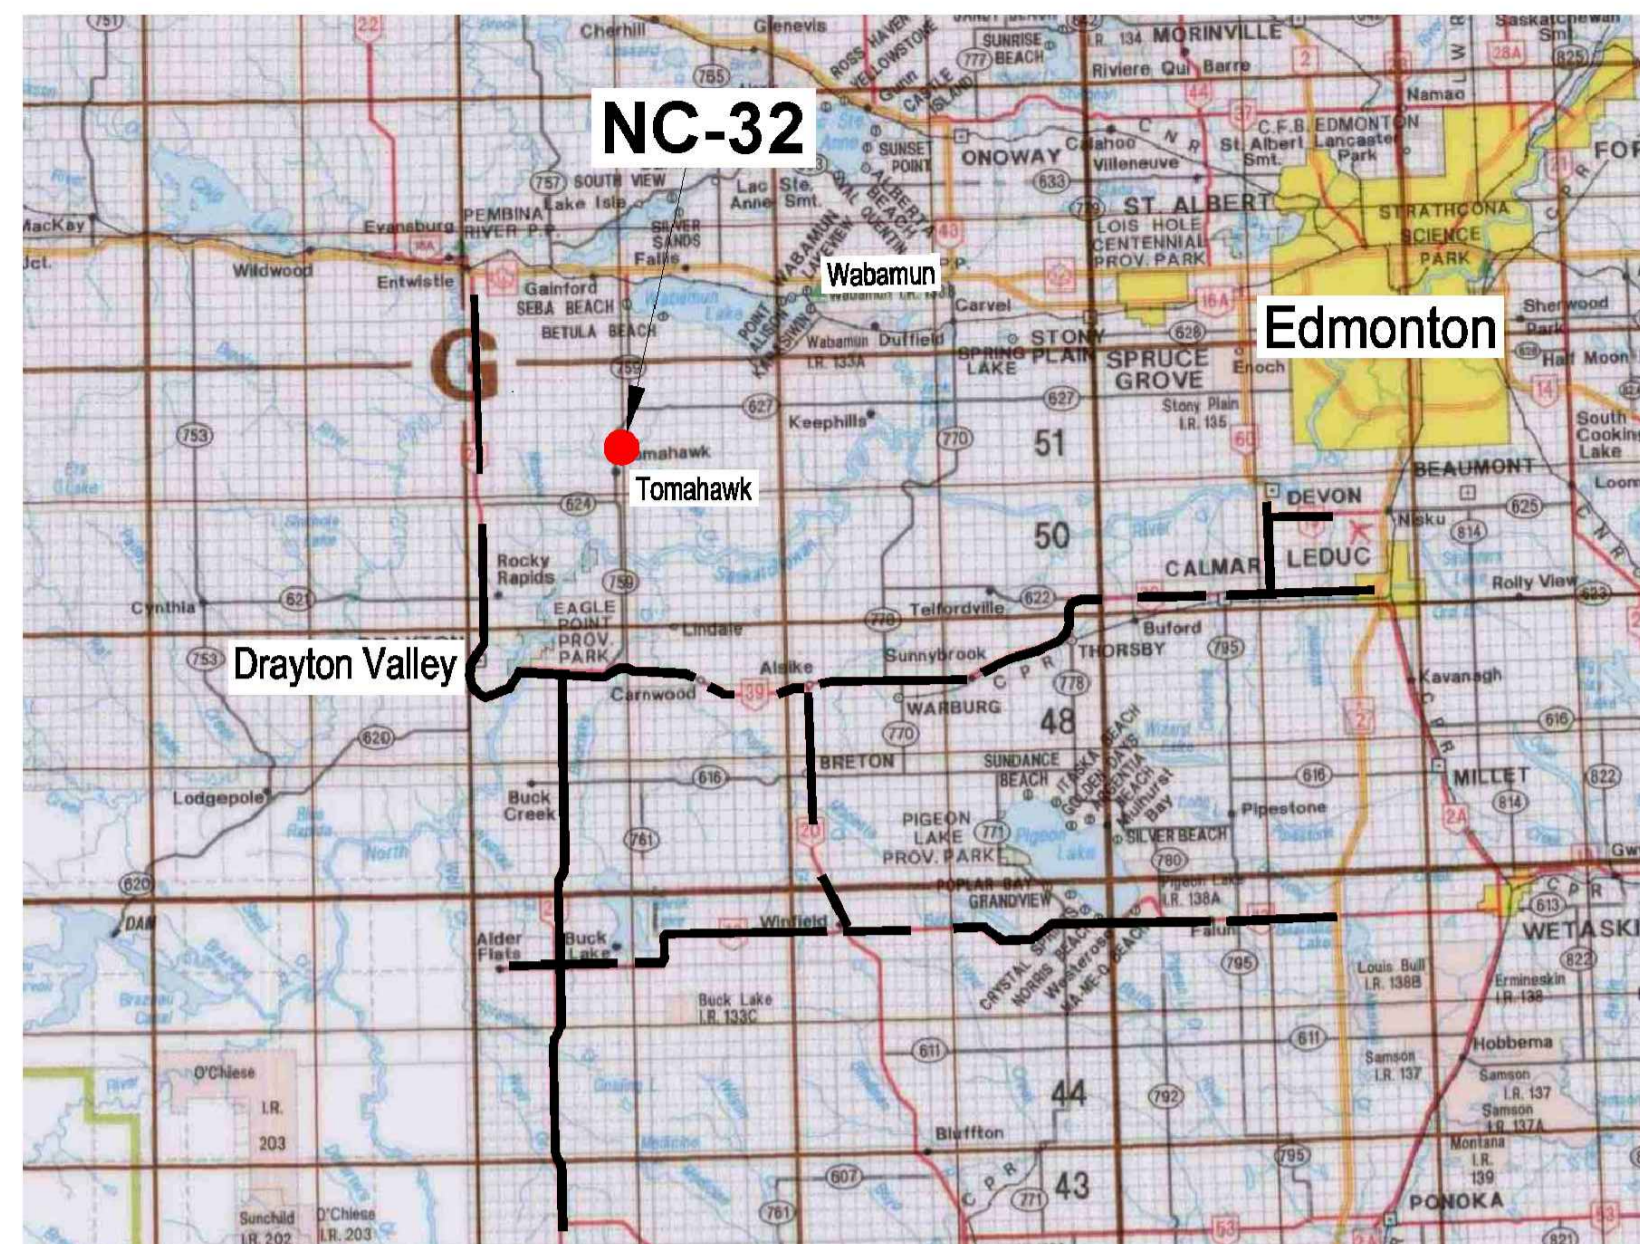
FIGURE - 1

**FRESH CRACKS,
0mm DIFFERENCE
~ 30mm - 40mm
WIDE (2016)**

**SLUMP MATERIAL
ENCROACHING ON DITCH
DRAINAGE (2016)
GRASSED OVER (2017)**

**2017 HWY
MILLED AND OVERLAID**

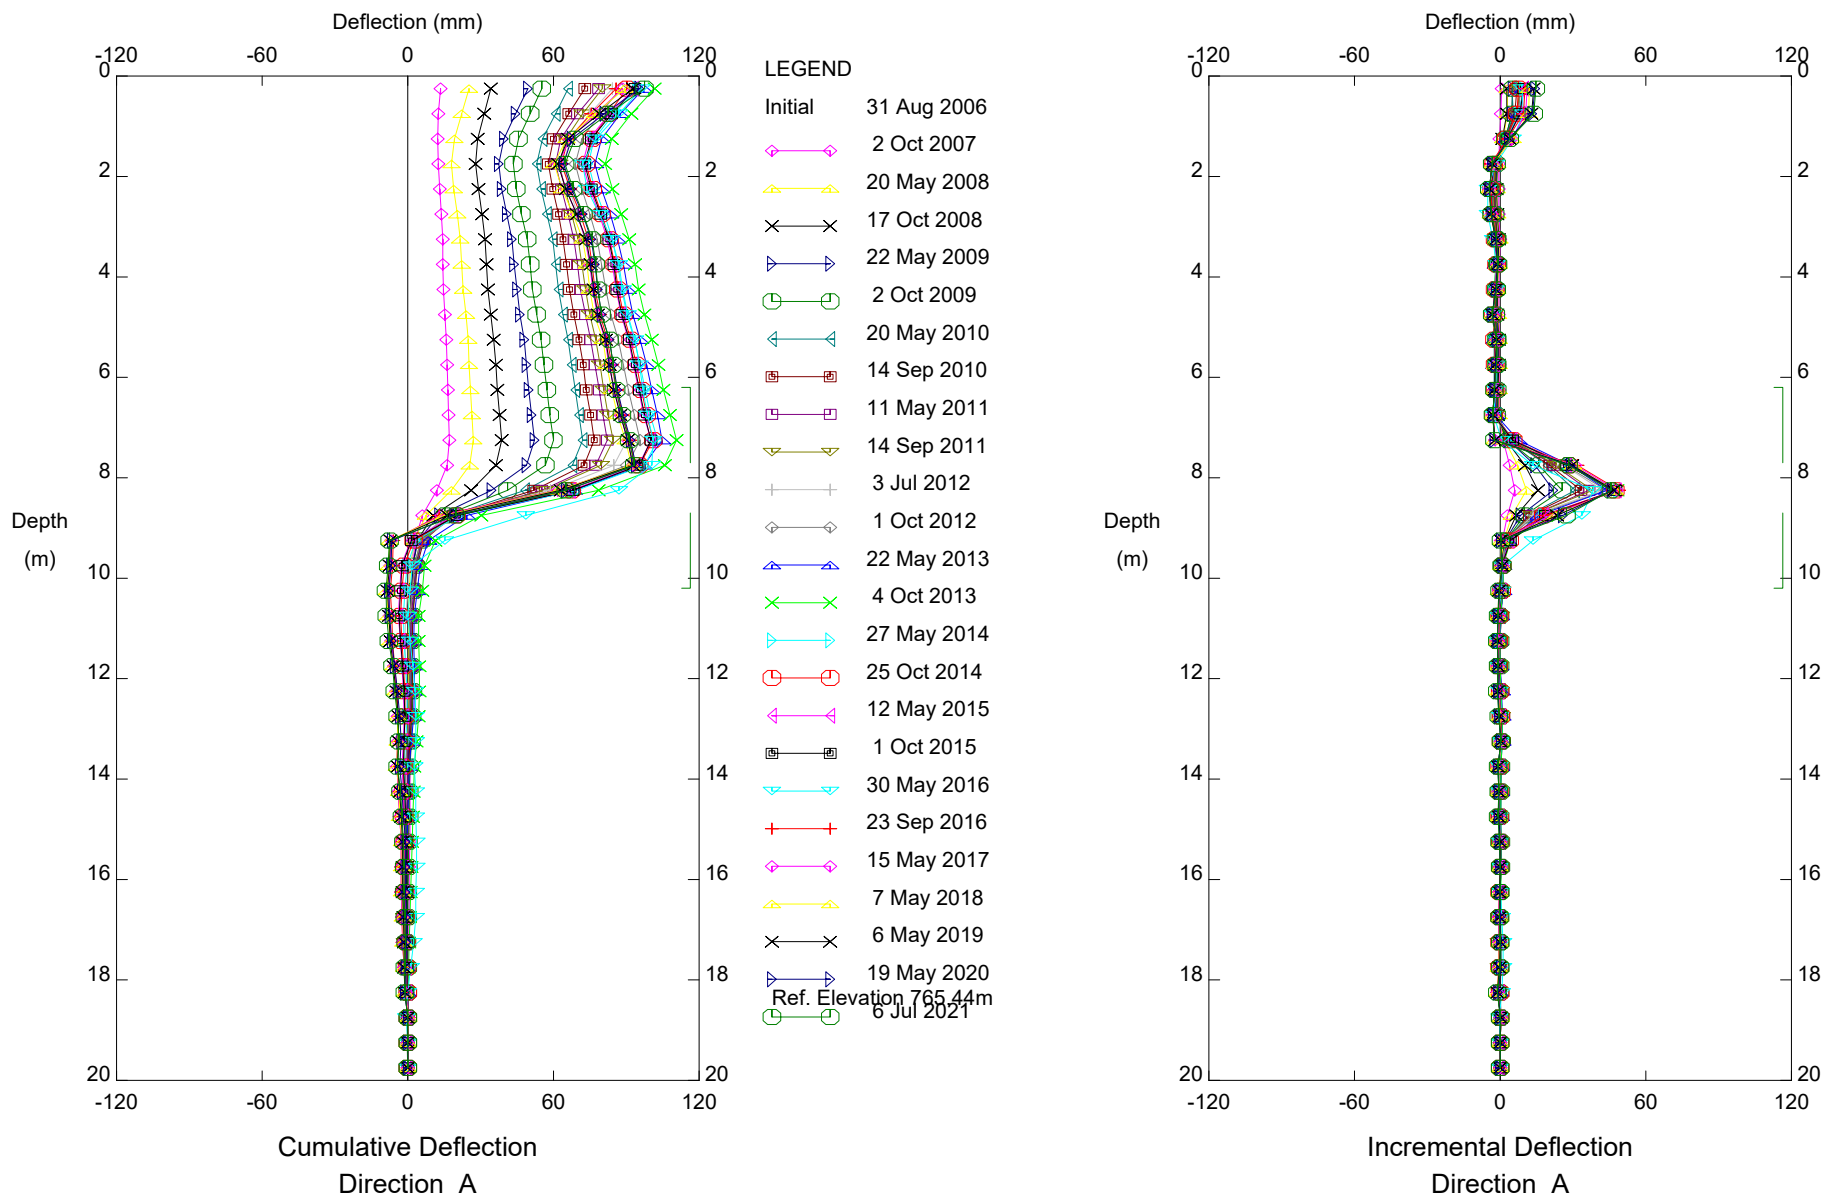
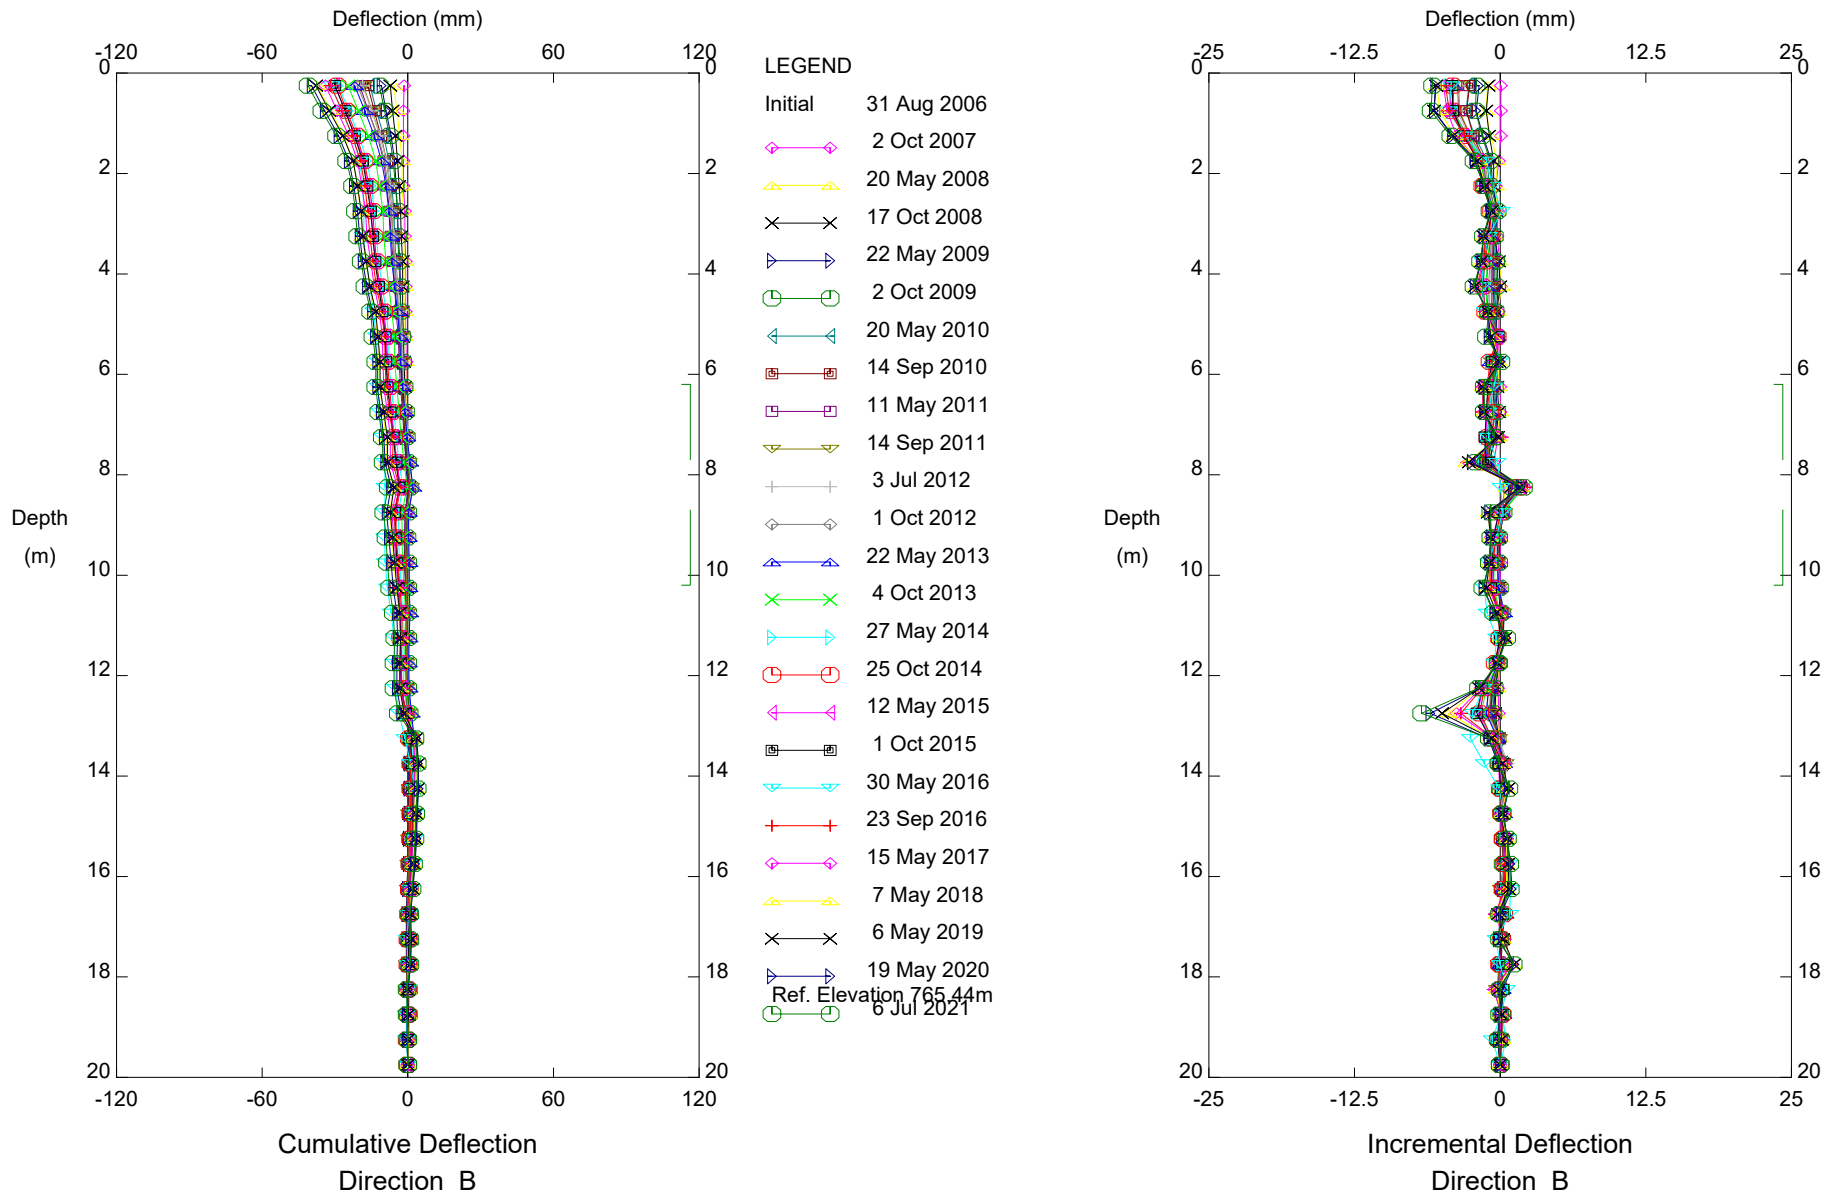
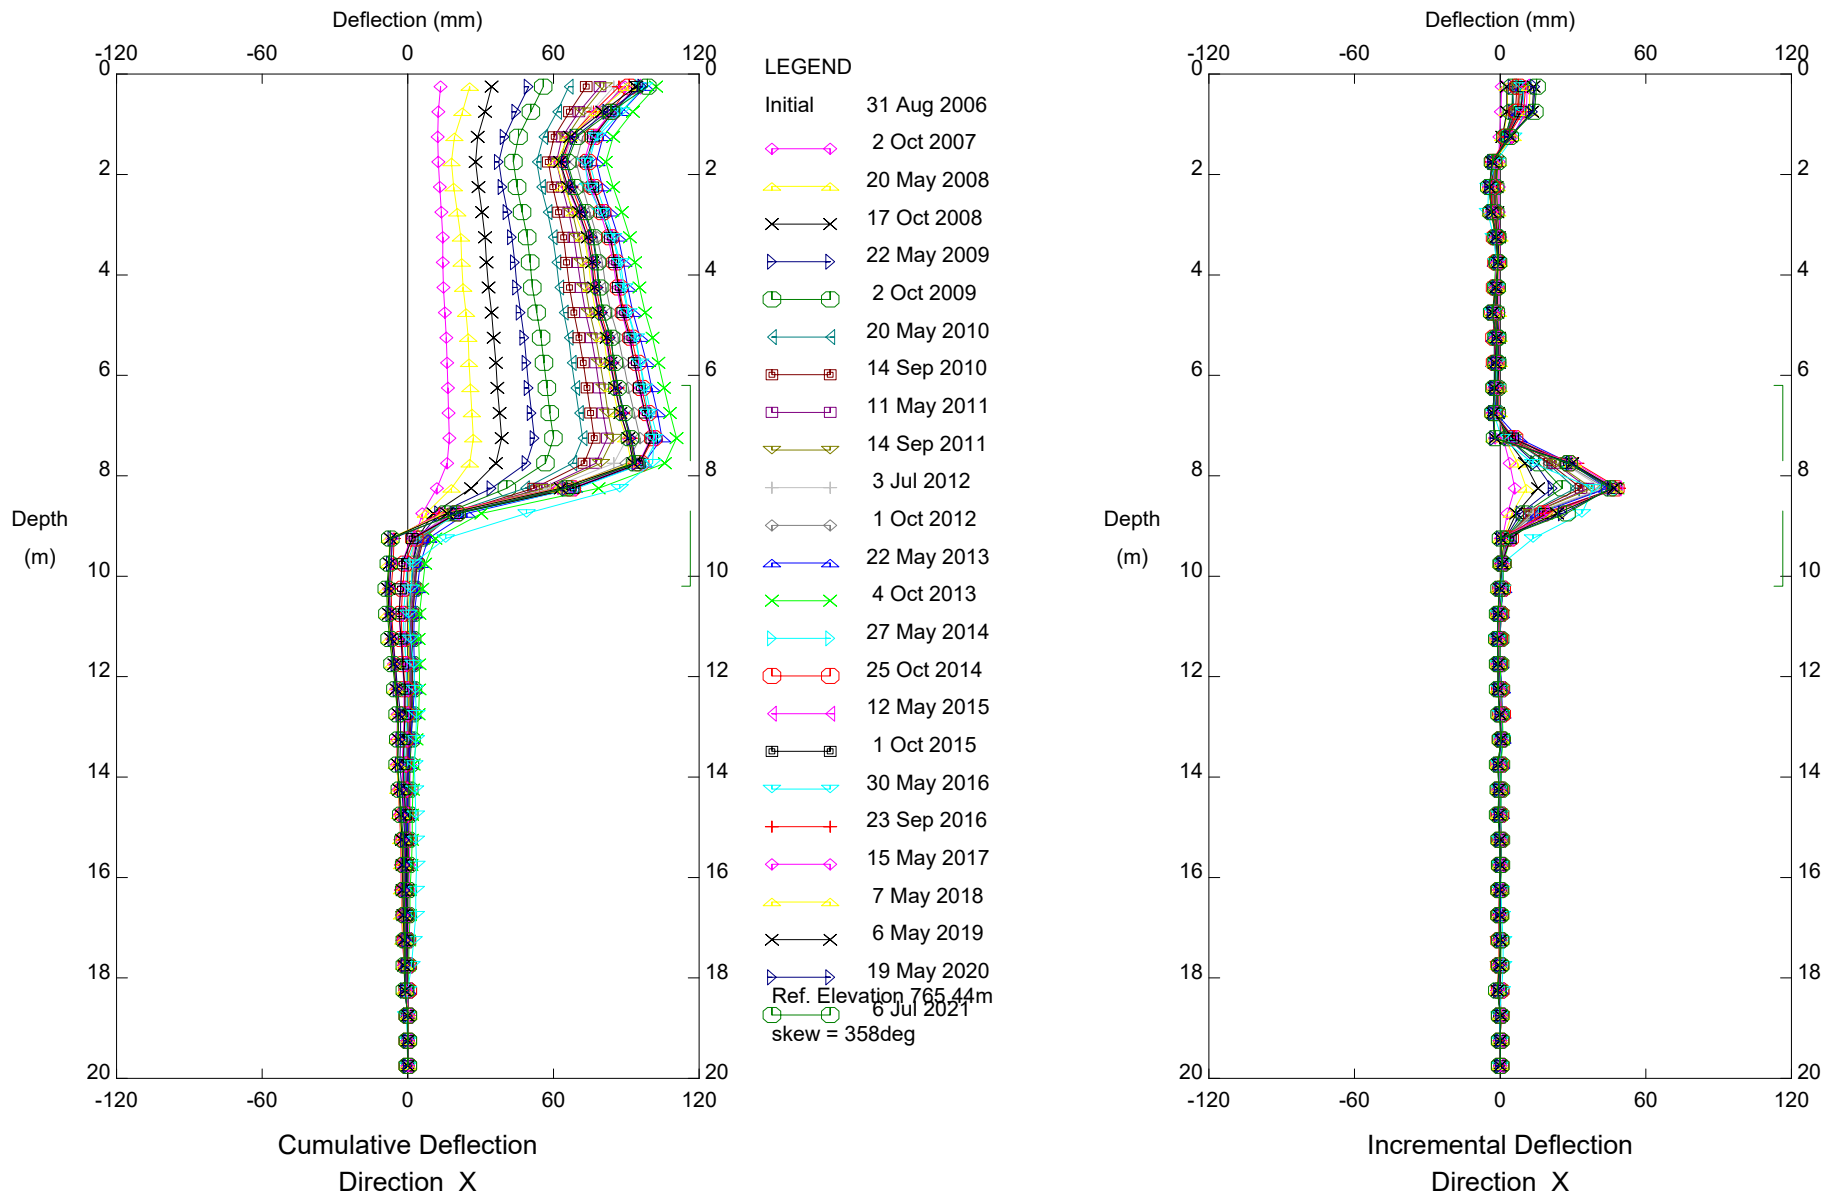
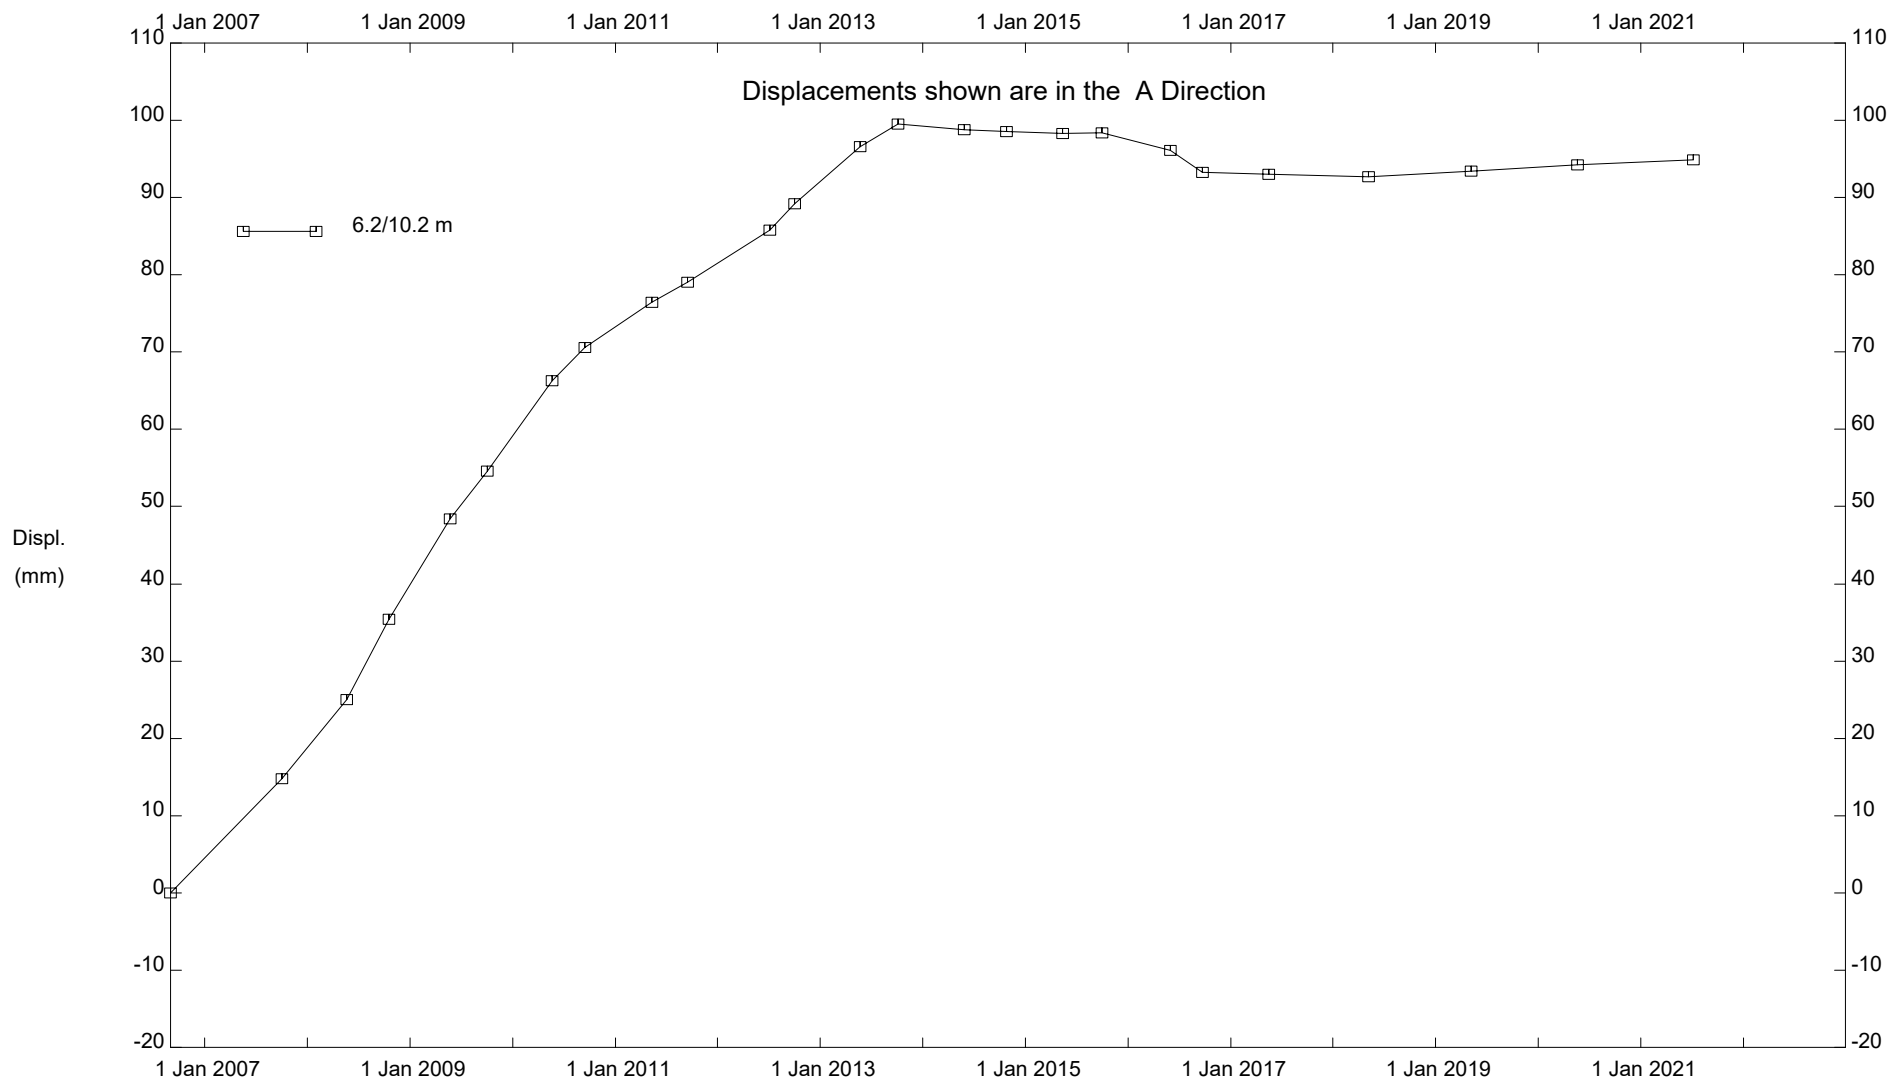
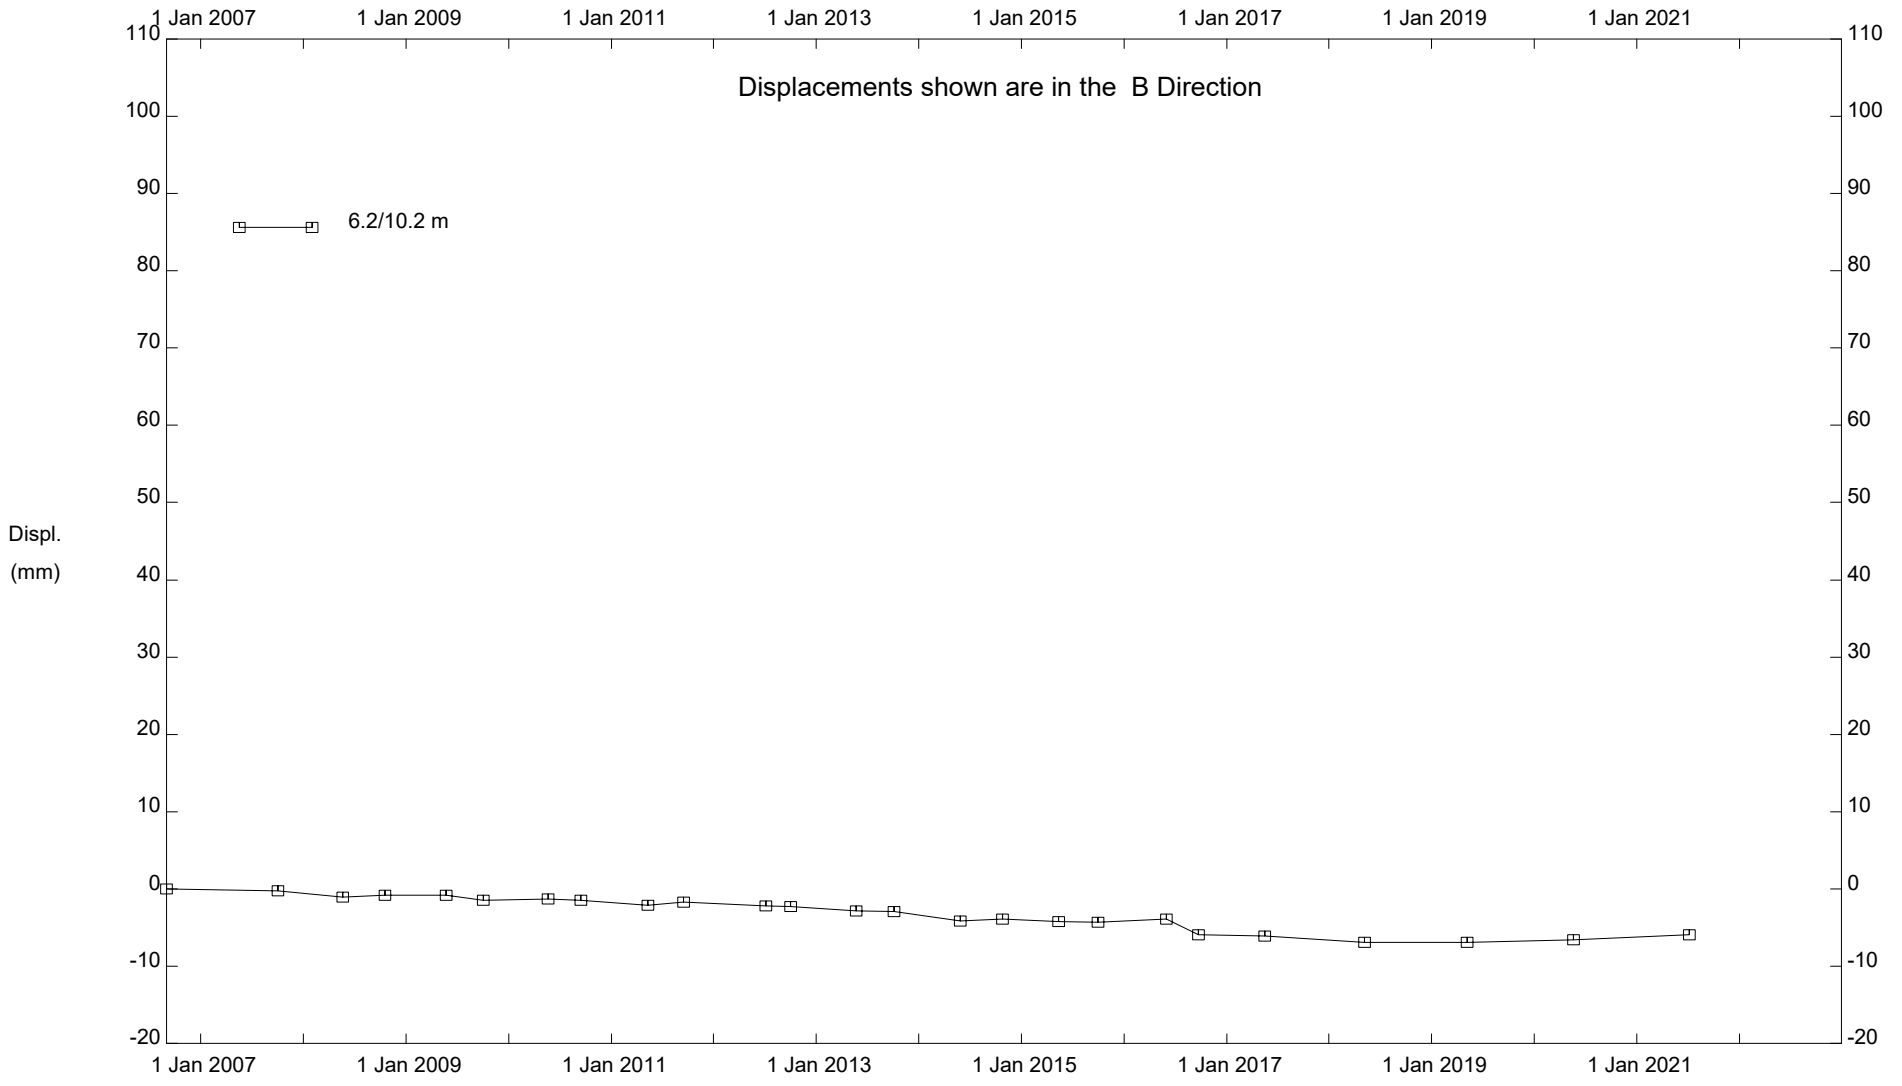
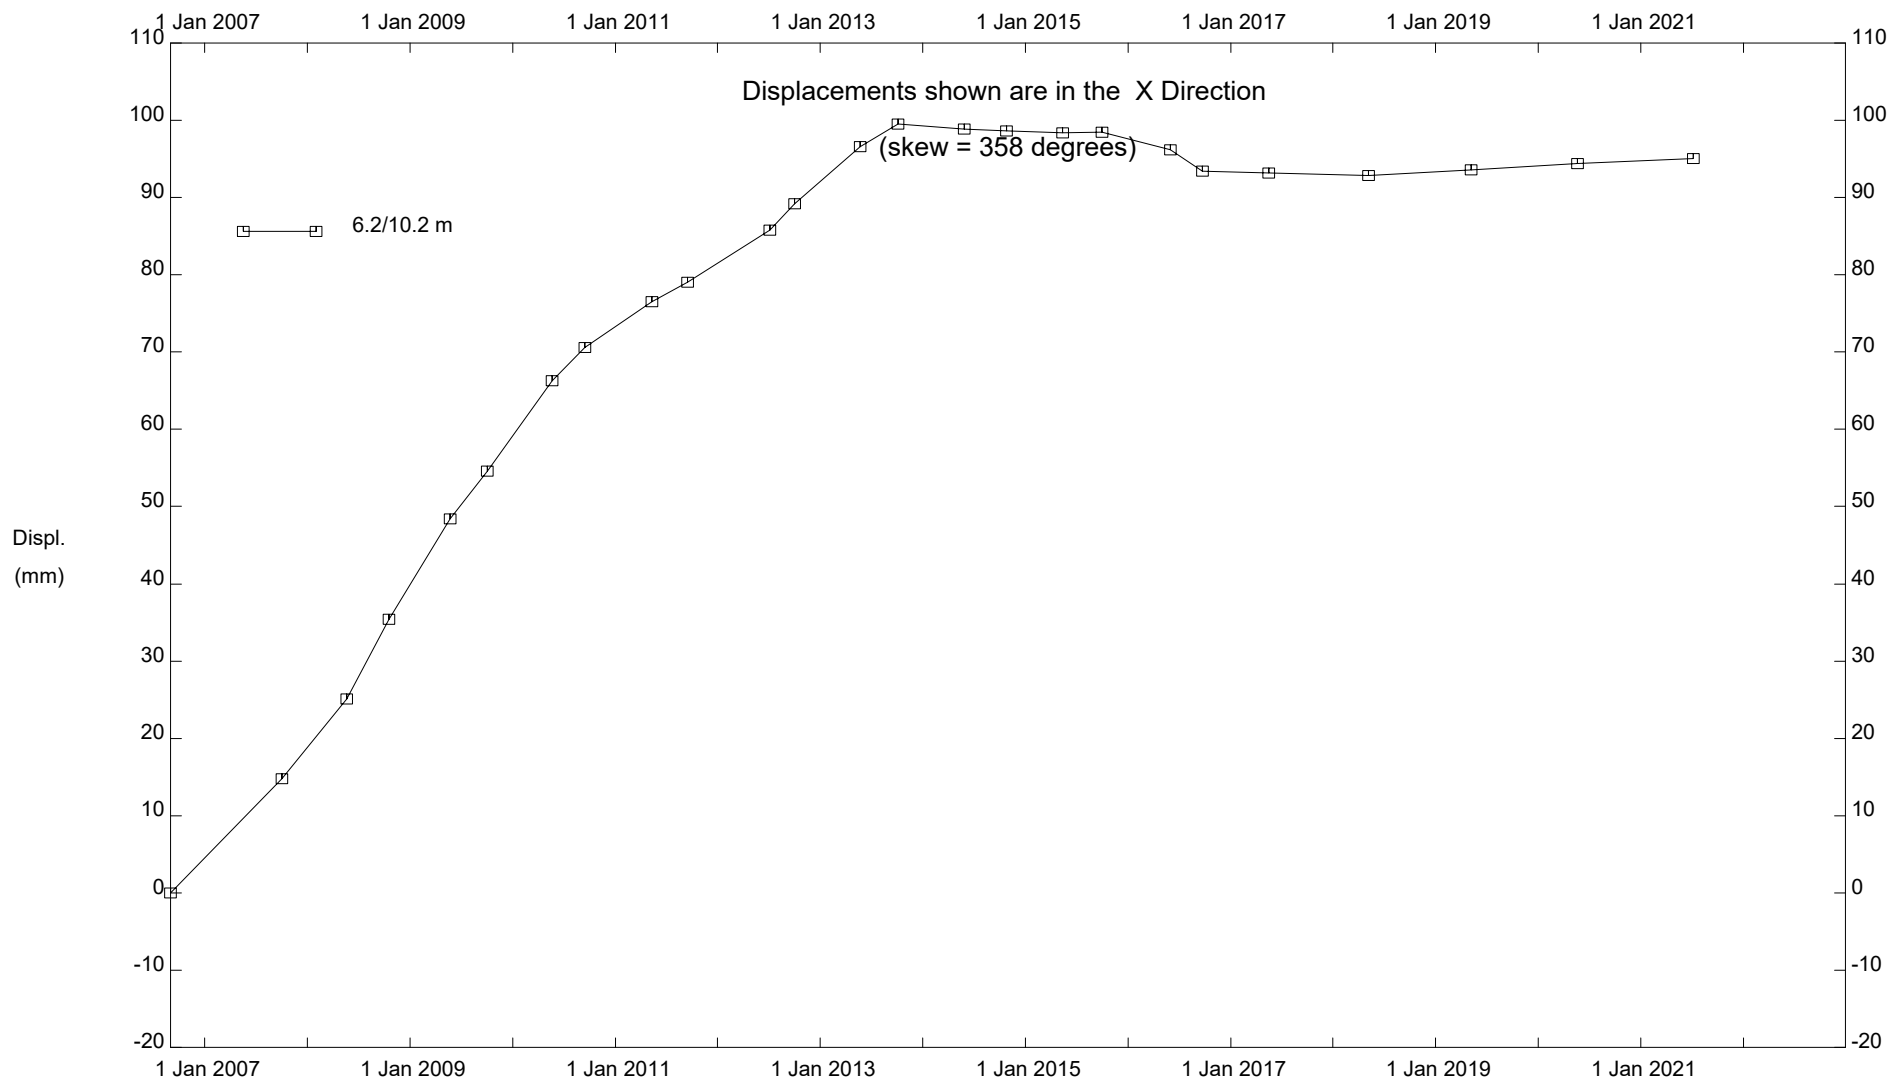
Hwy 759:04 N. of Tomohawk (NC32), Inclinator SI-2
 Alberta Transportation

SI-2 has a movement zone from about 6 m to 10 m bgs. The overall rate of movement was approximately 14 mm/yr from 2009 to 2013. A decrease in overall movement rate to less than 1 mm/year was observed after berm construction. The Spring 2021 reading cycle shows a rate of movement of less than 1 mm/yr.

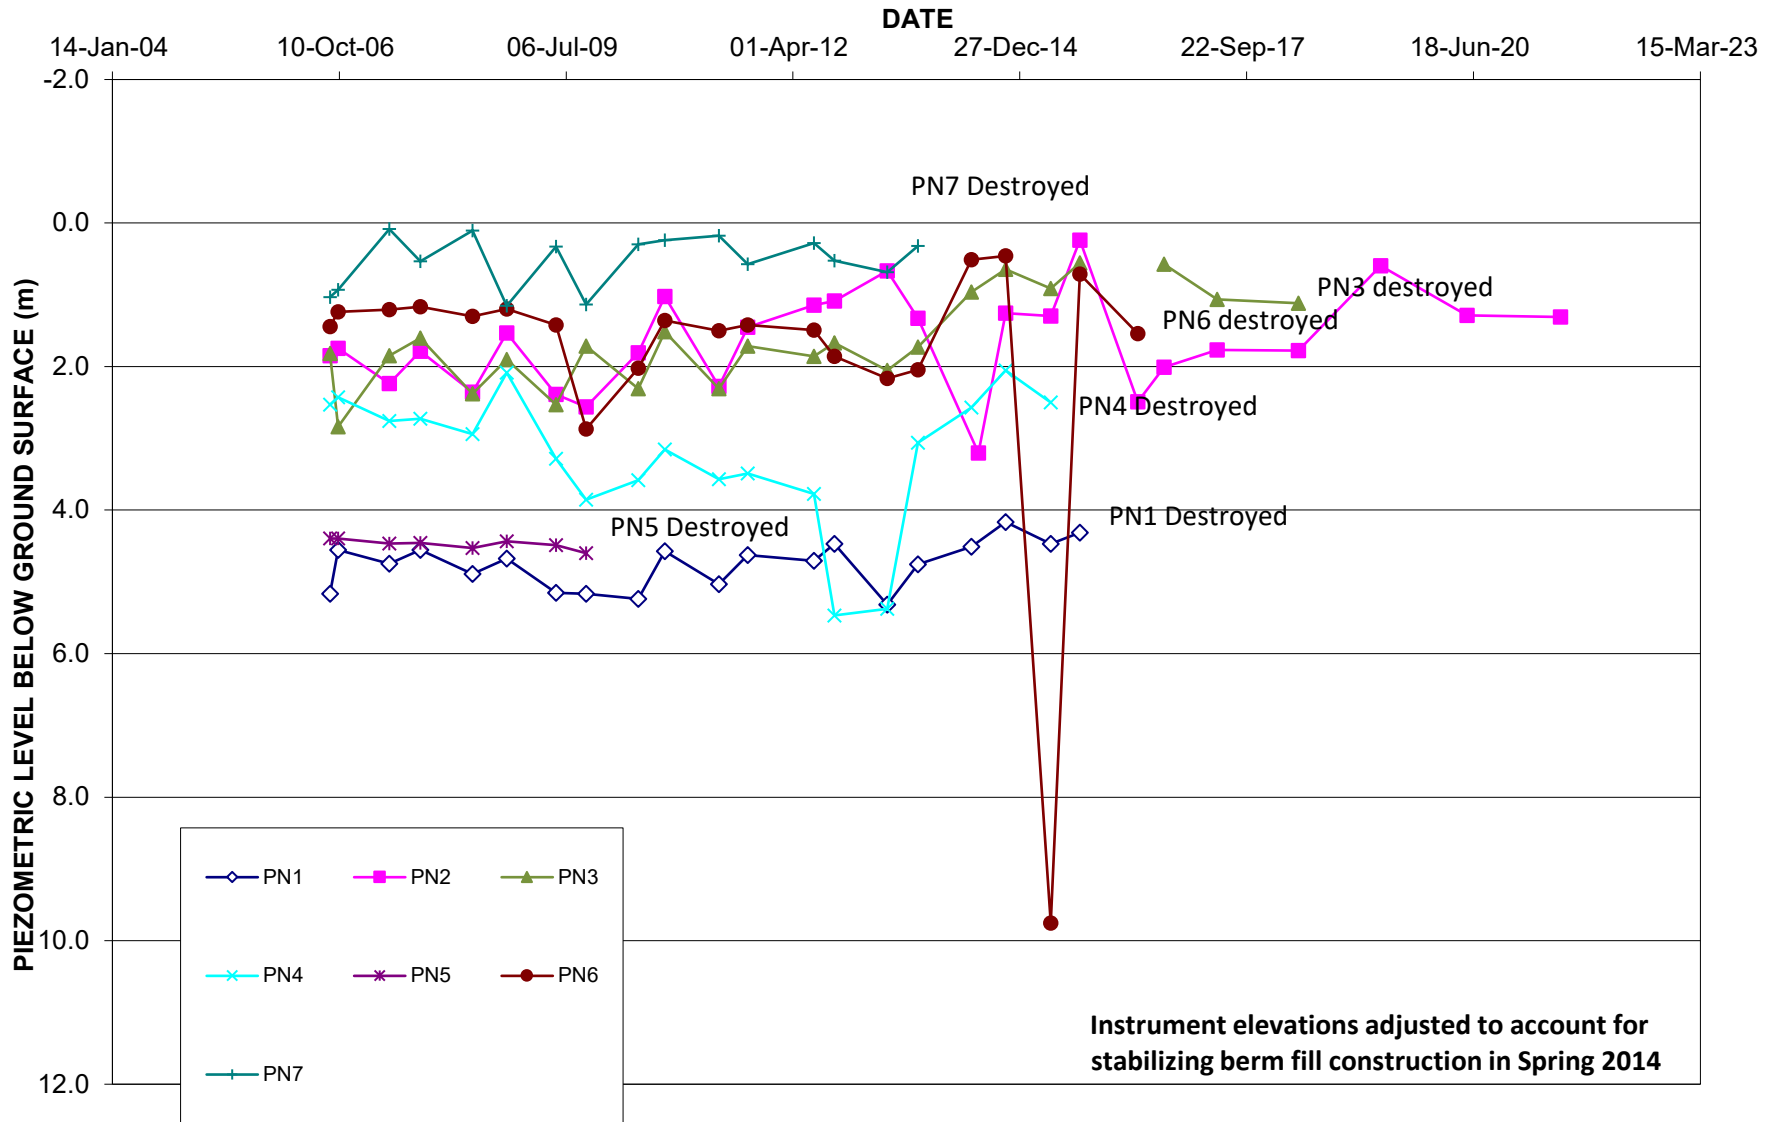
North Central Region
Edson Area
NC32: HWY 759:04, North of Tomahawk
PNEUMATIC PIEZOMETER DATA

One PN was read and has been summarized in **Table NC32-2**. **PN2** showed negligible change in water level since the previous reading.
