To:	Amy Driessen Alberta Transportation	From:	Leslie Cho and Carrie Murray Stantec Consulting Ltd.
File:	123315222	Date:	June 12, 2022

Reference: North Central Region, Edson, Site NC018 - Highway 764:02 Pembina River Bridge (N. of Cherhill), Spring 2022 Instrumentation Monitoring Report

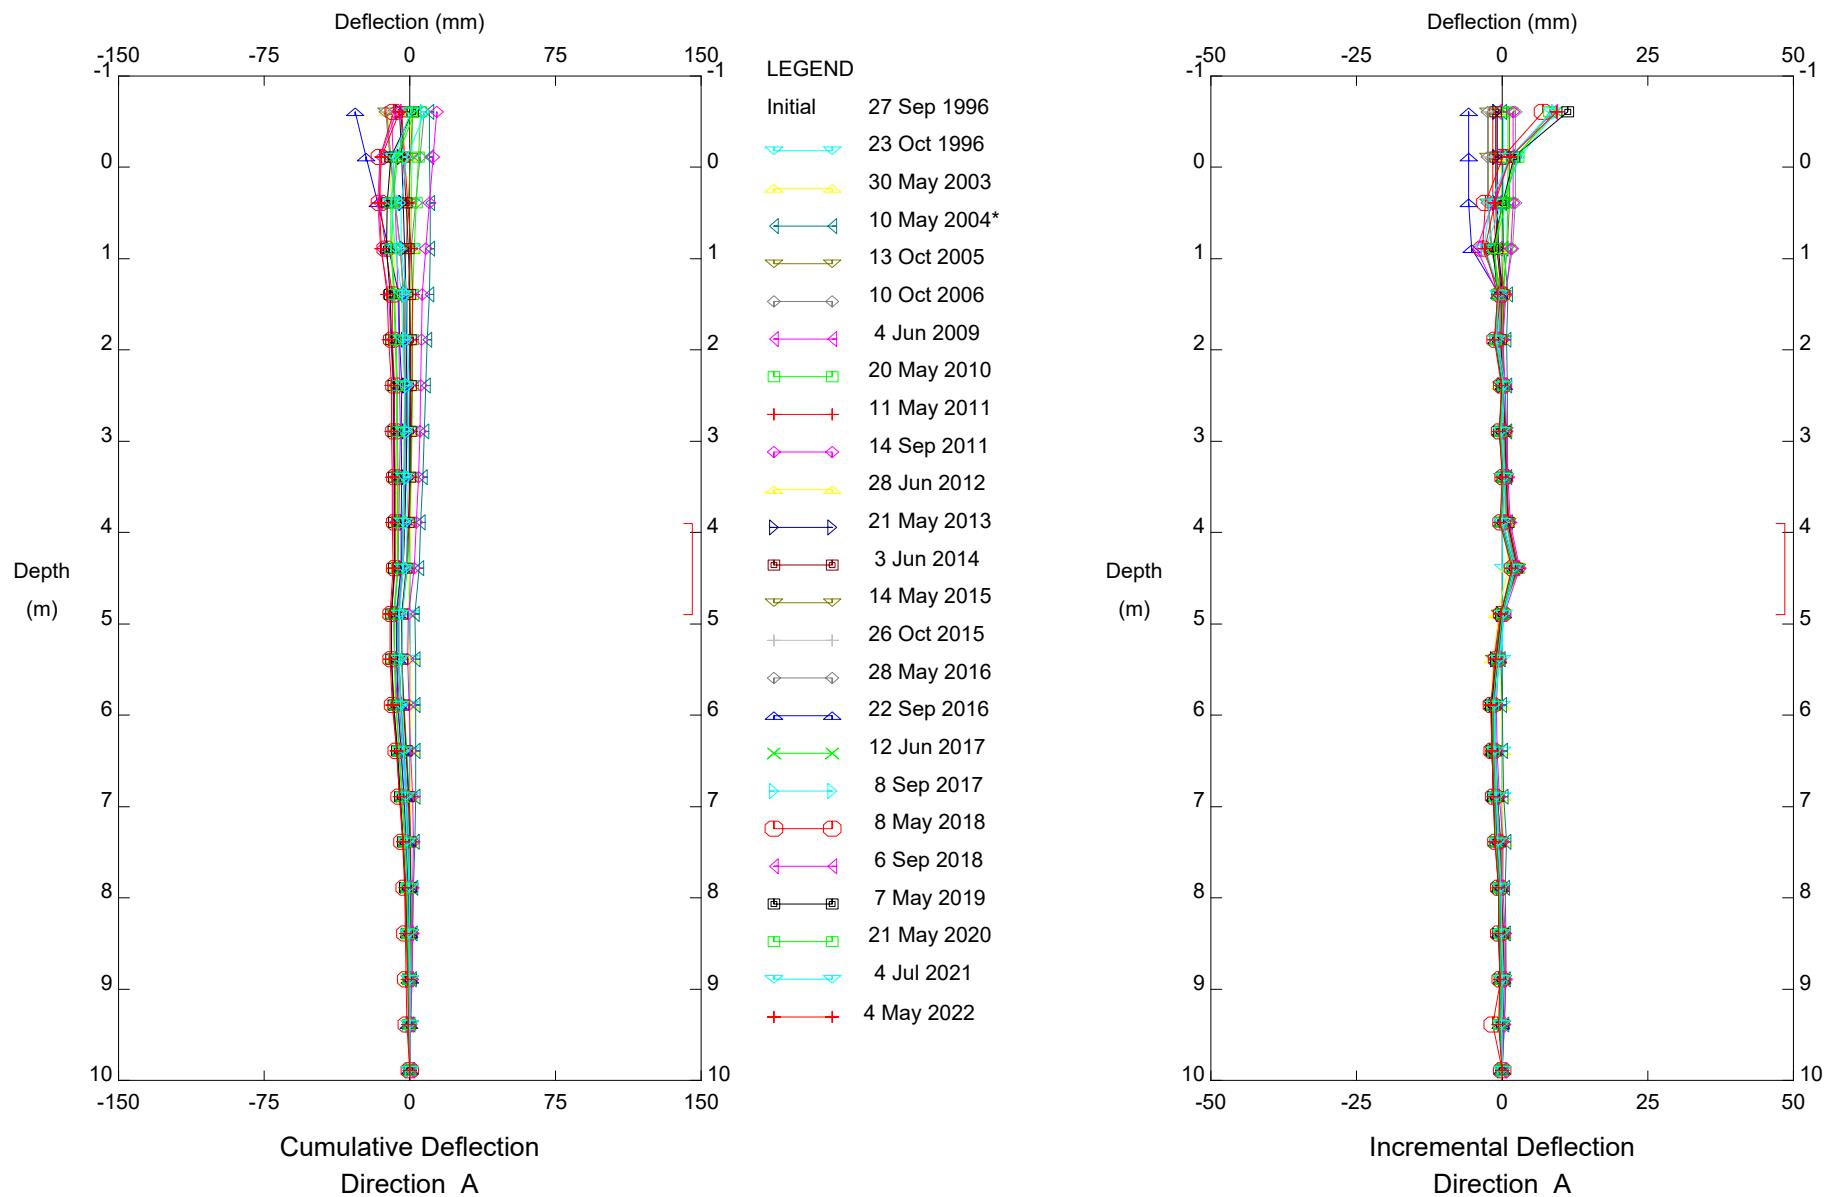
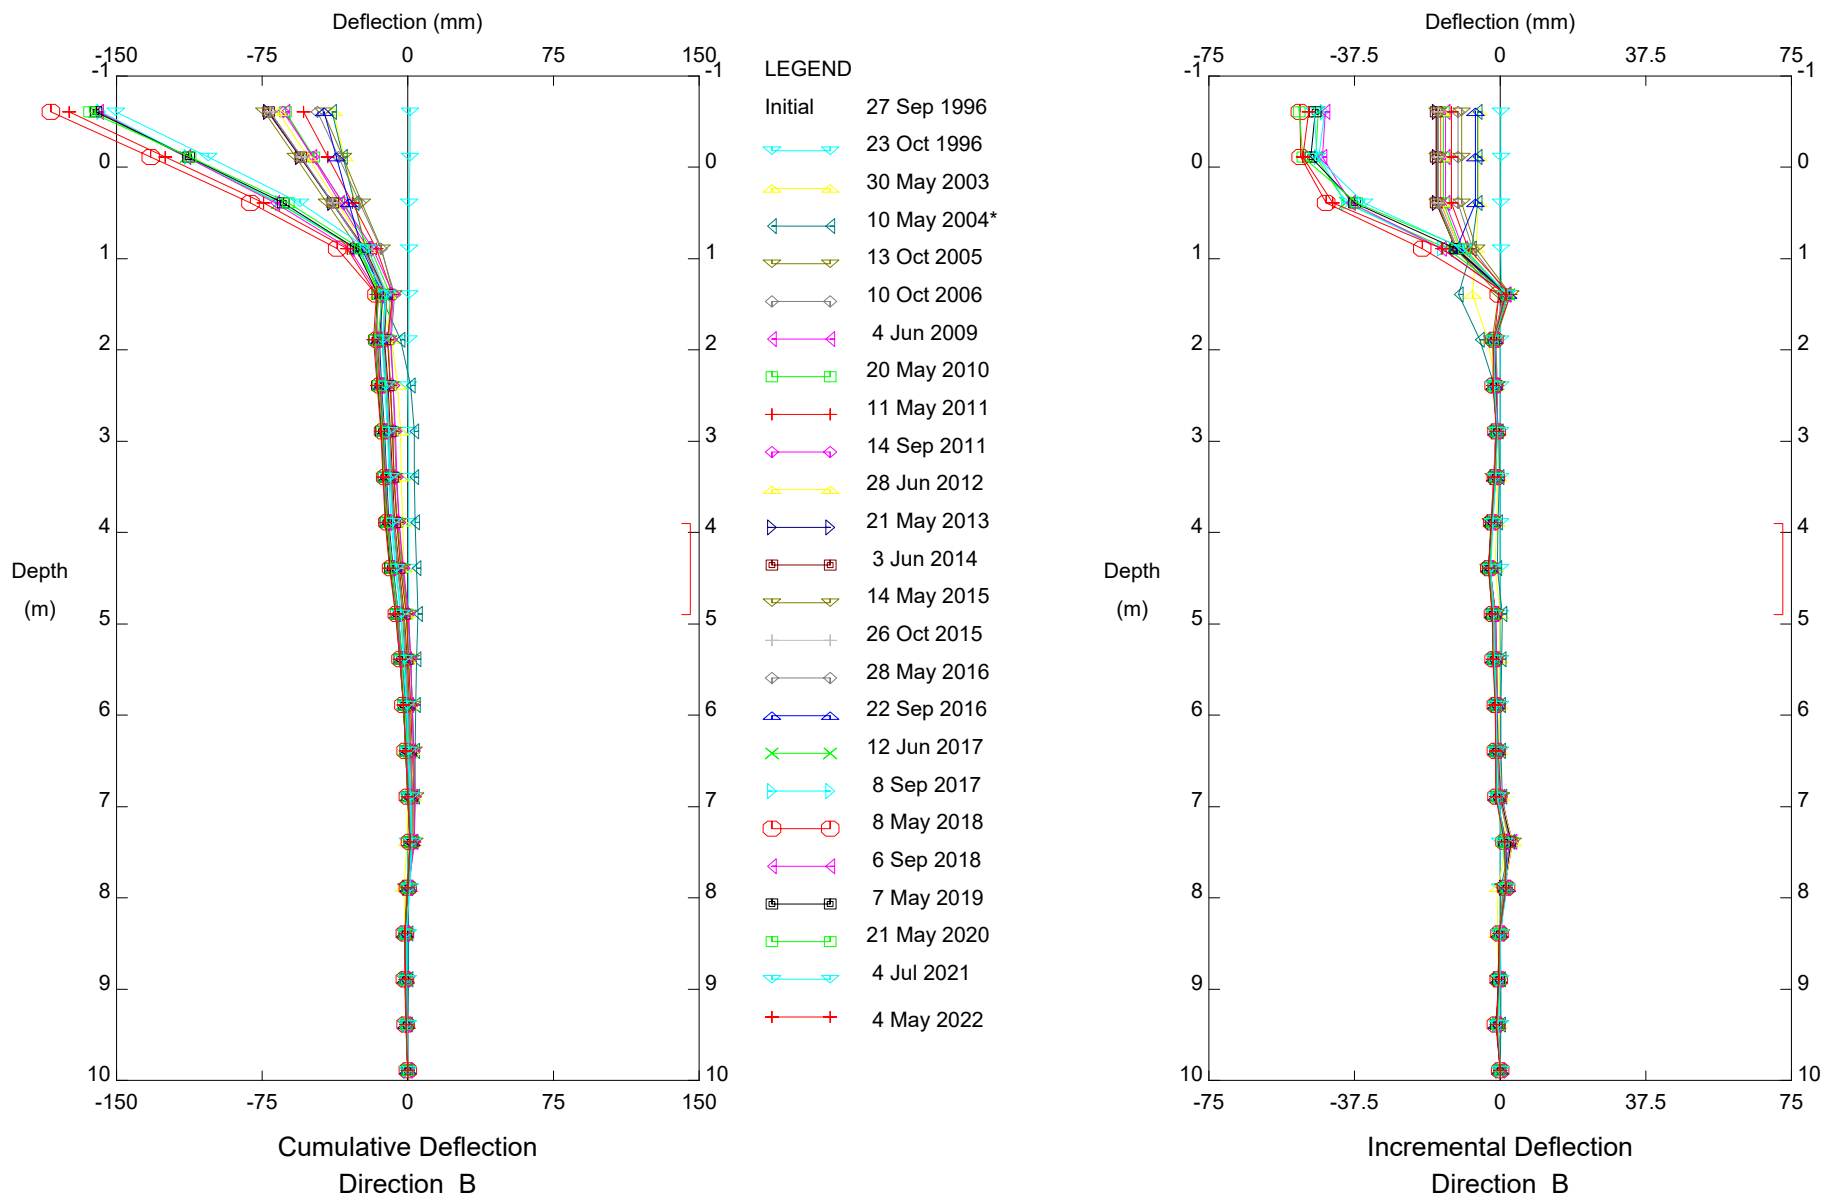
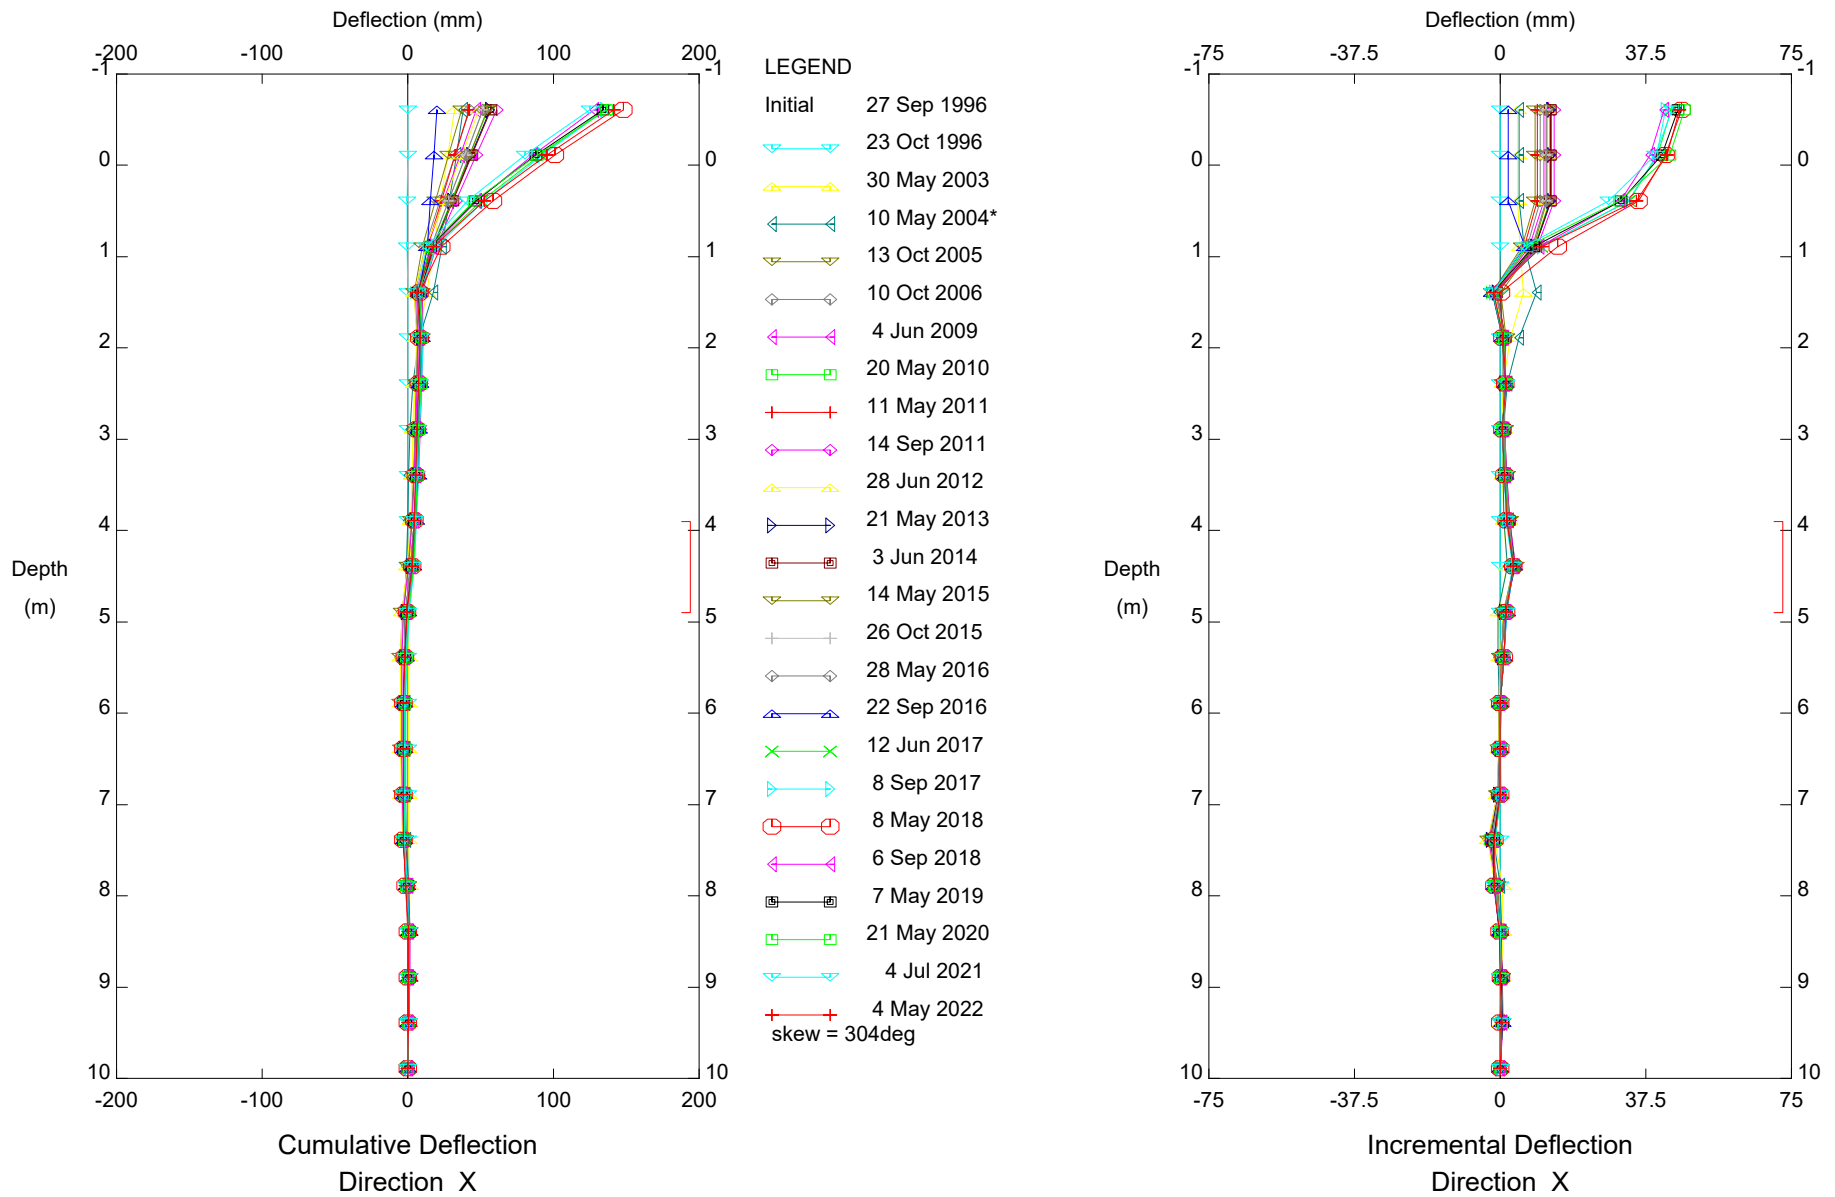
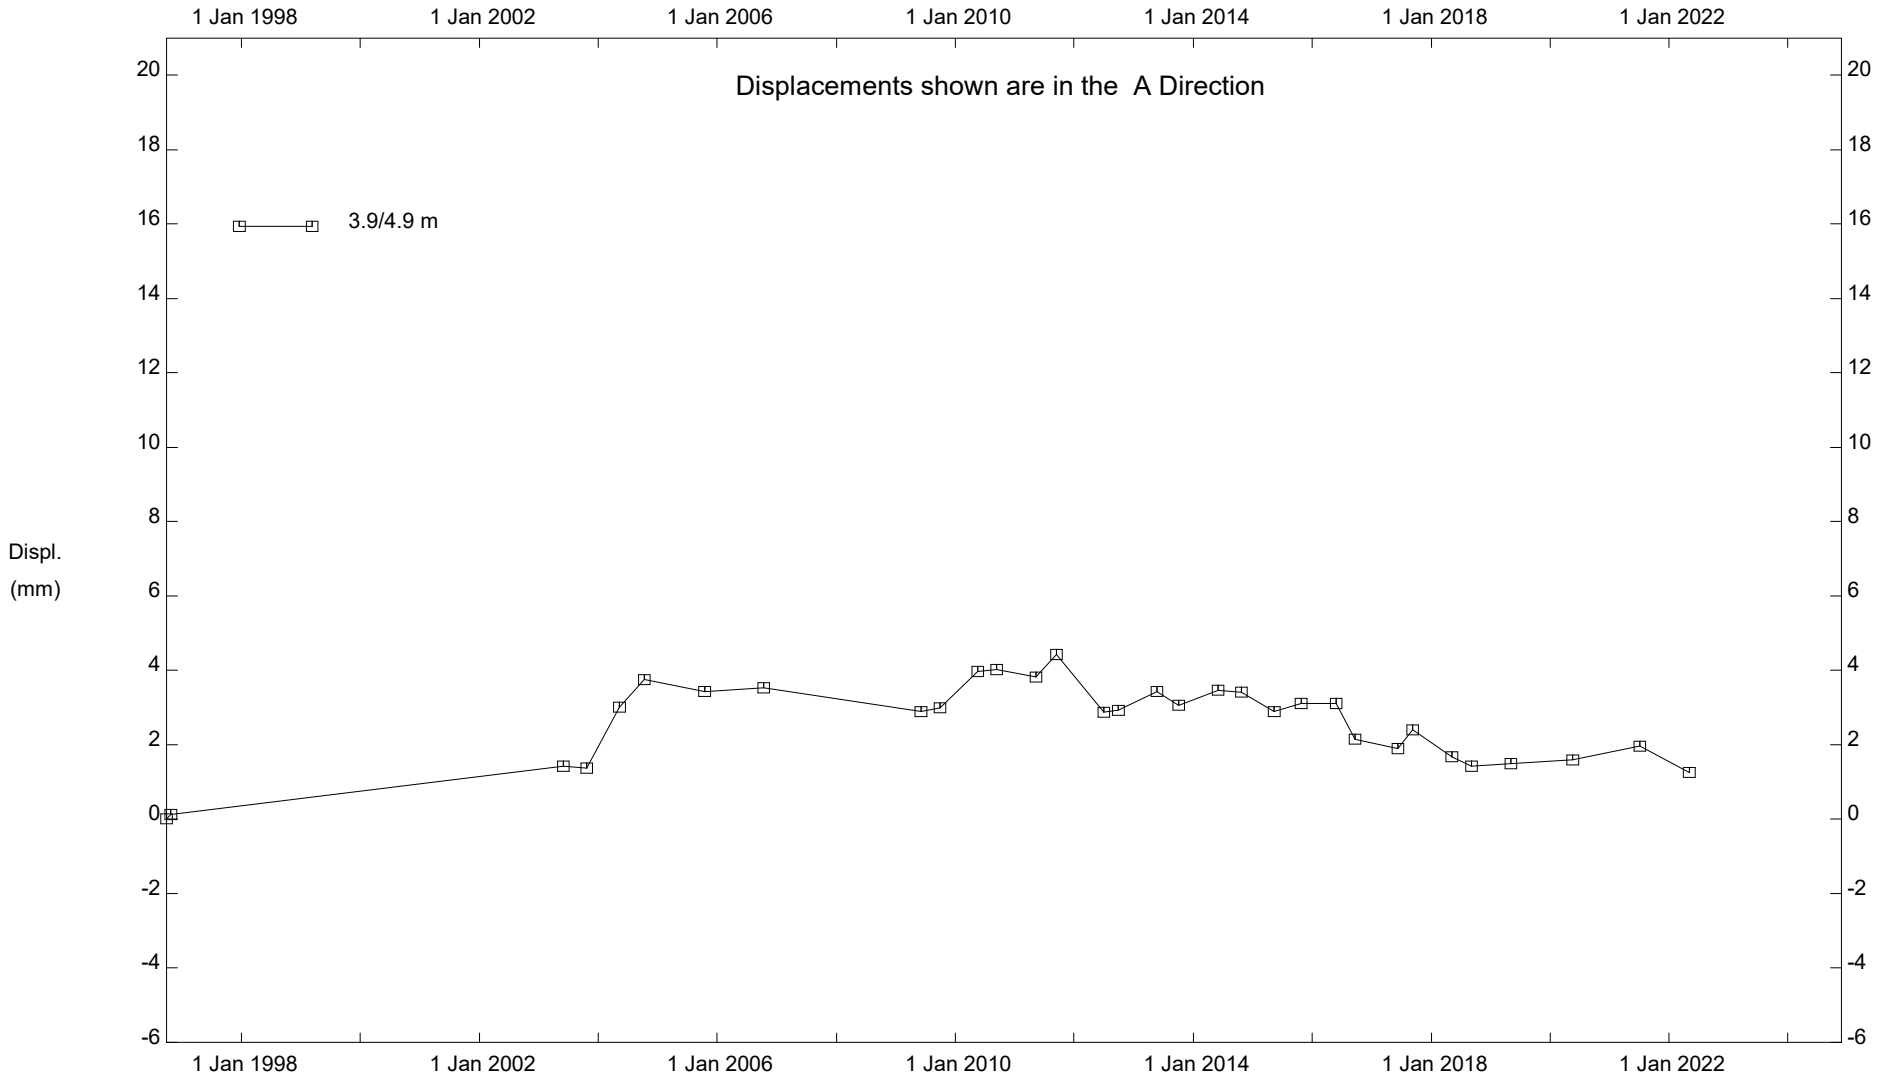
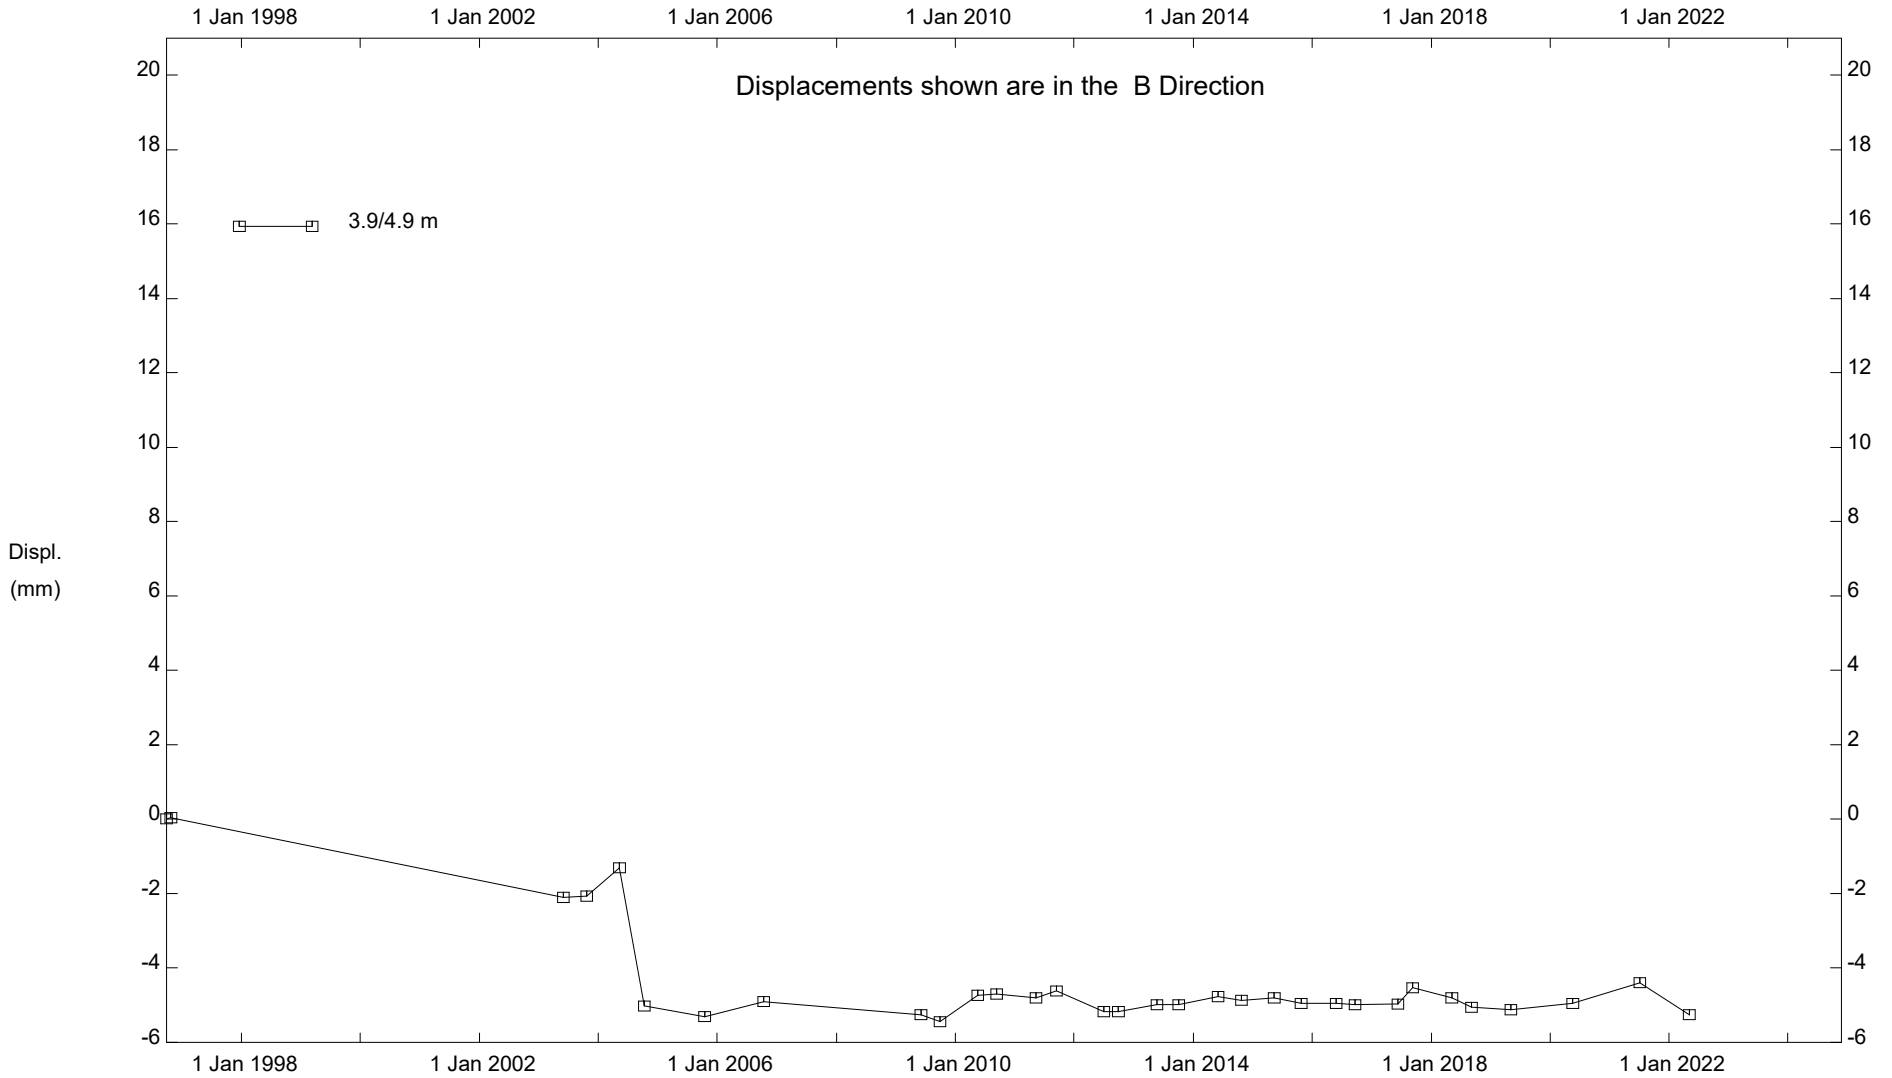
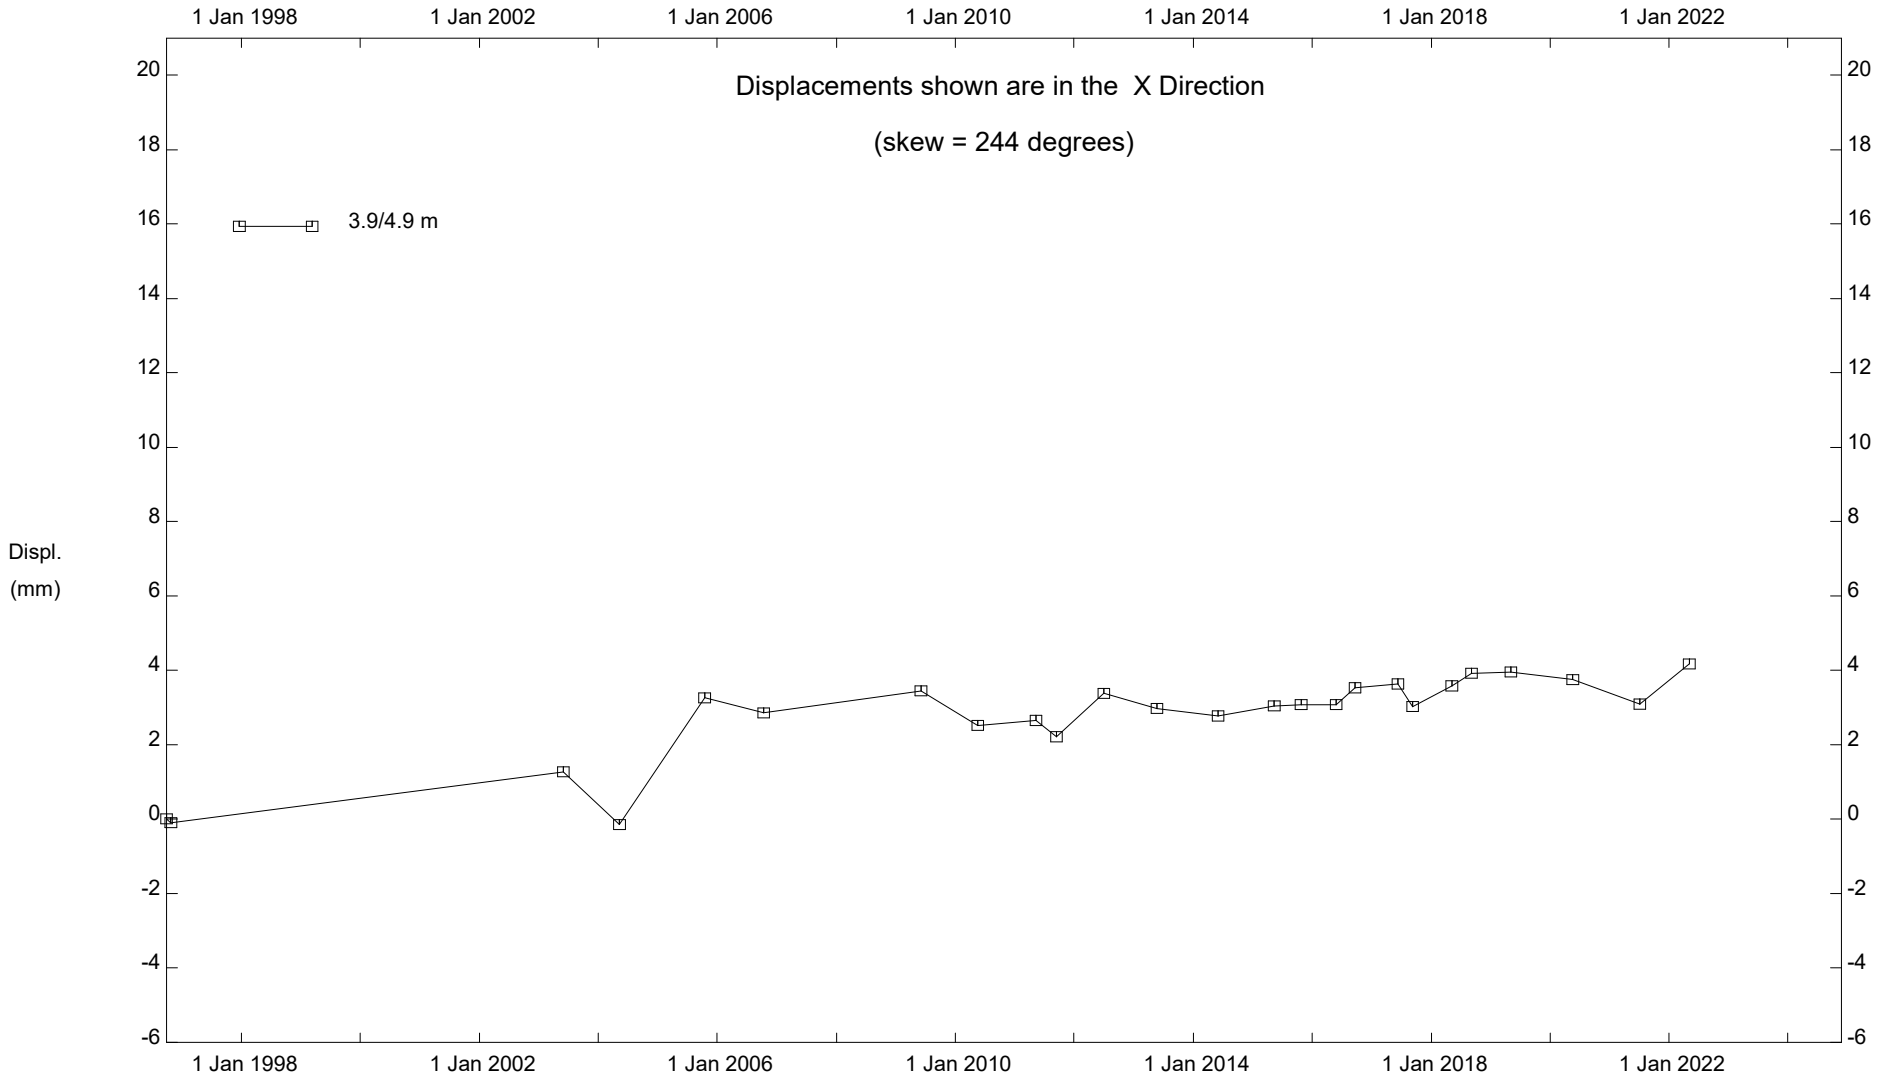
SI-7, SI-8, SI-9 showed a negligible rate of movement (less than 1 mm/yr) since Fall 2017.
