To:	Amy Driessen Alberta Transportation	From:	Leslie Cho and Carrie Murray Stantec Consulting Ltd.
File:	123315222	Date:	June 12, 2022

Reference: North Central Region, Edson, Site NC018 - Highway 764:02 Pembina River Bridge (N. of Cherhill), Spring 2022 Instrumentation Monitoring Report

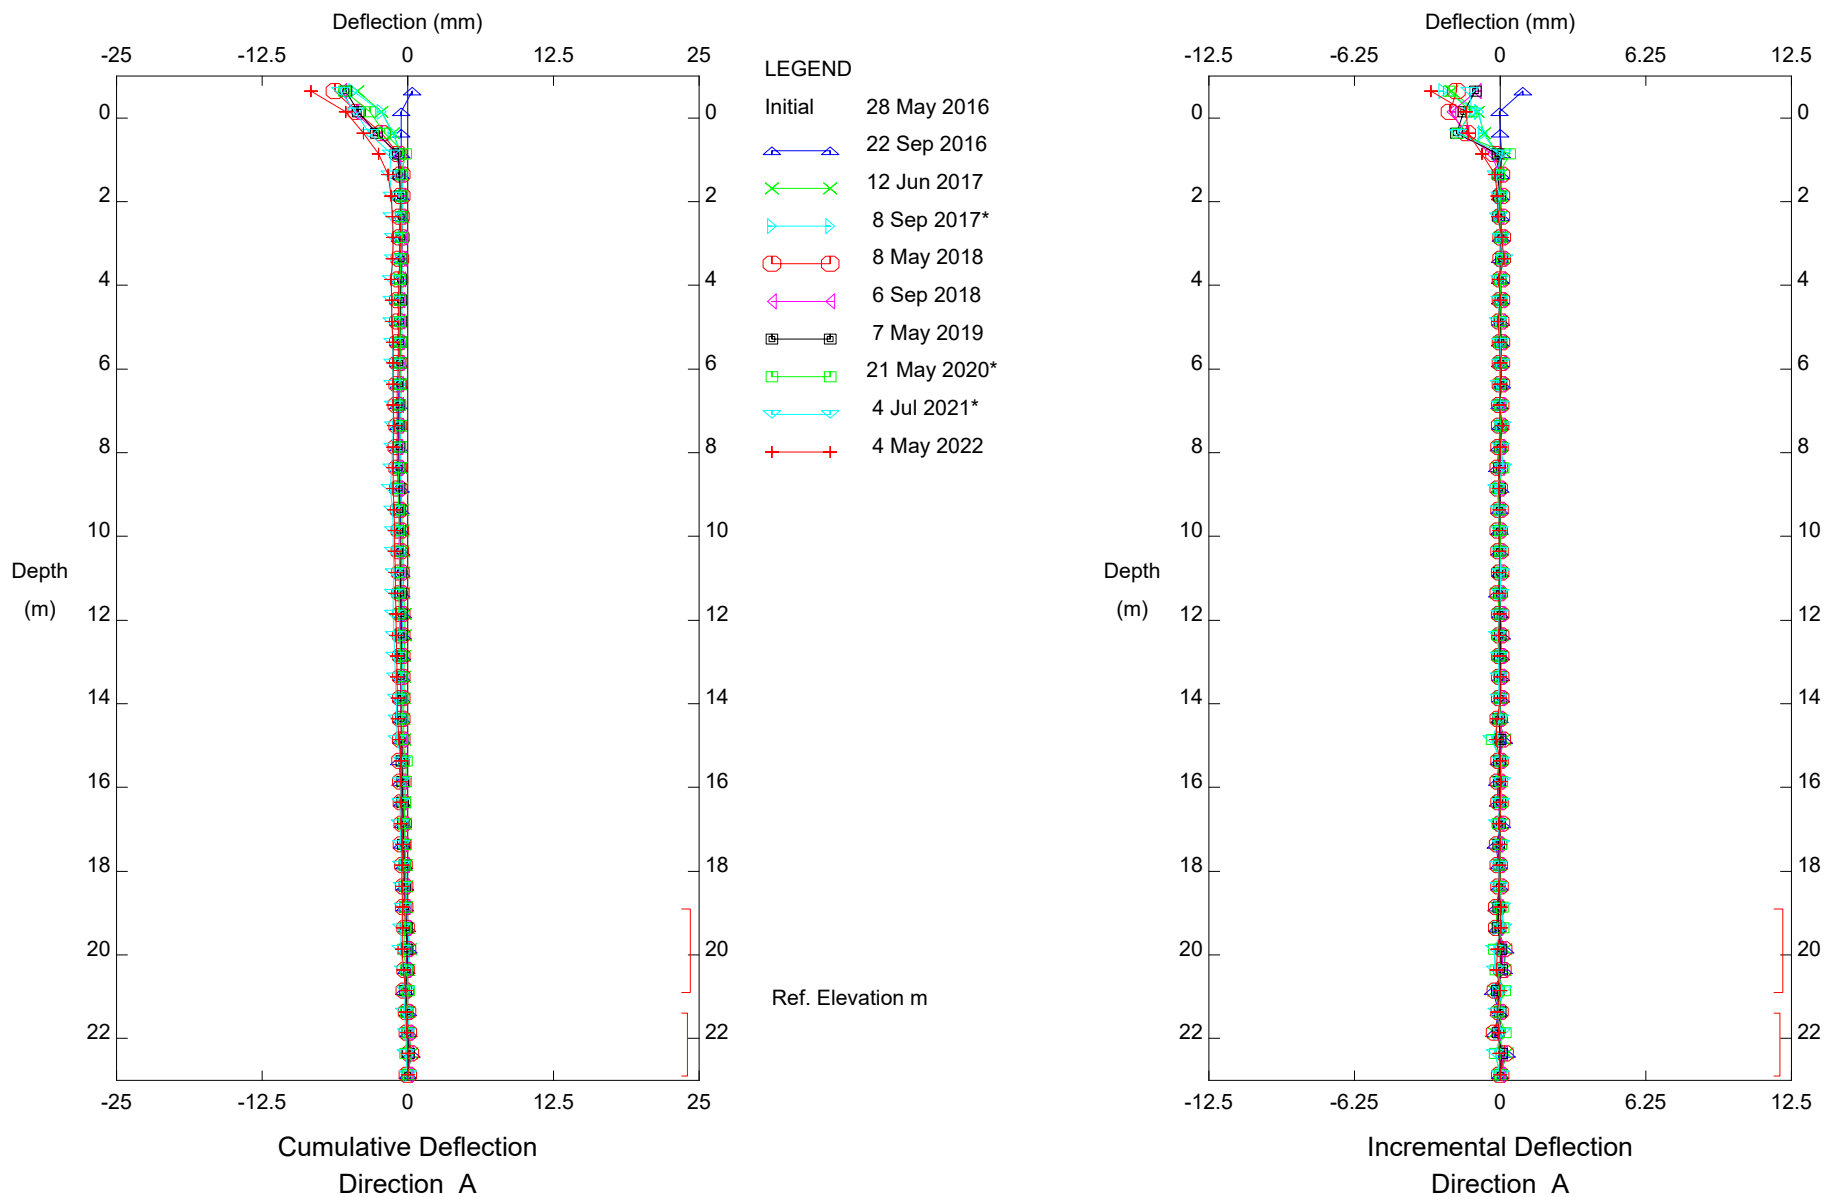
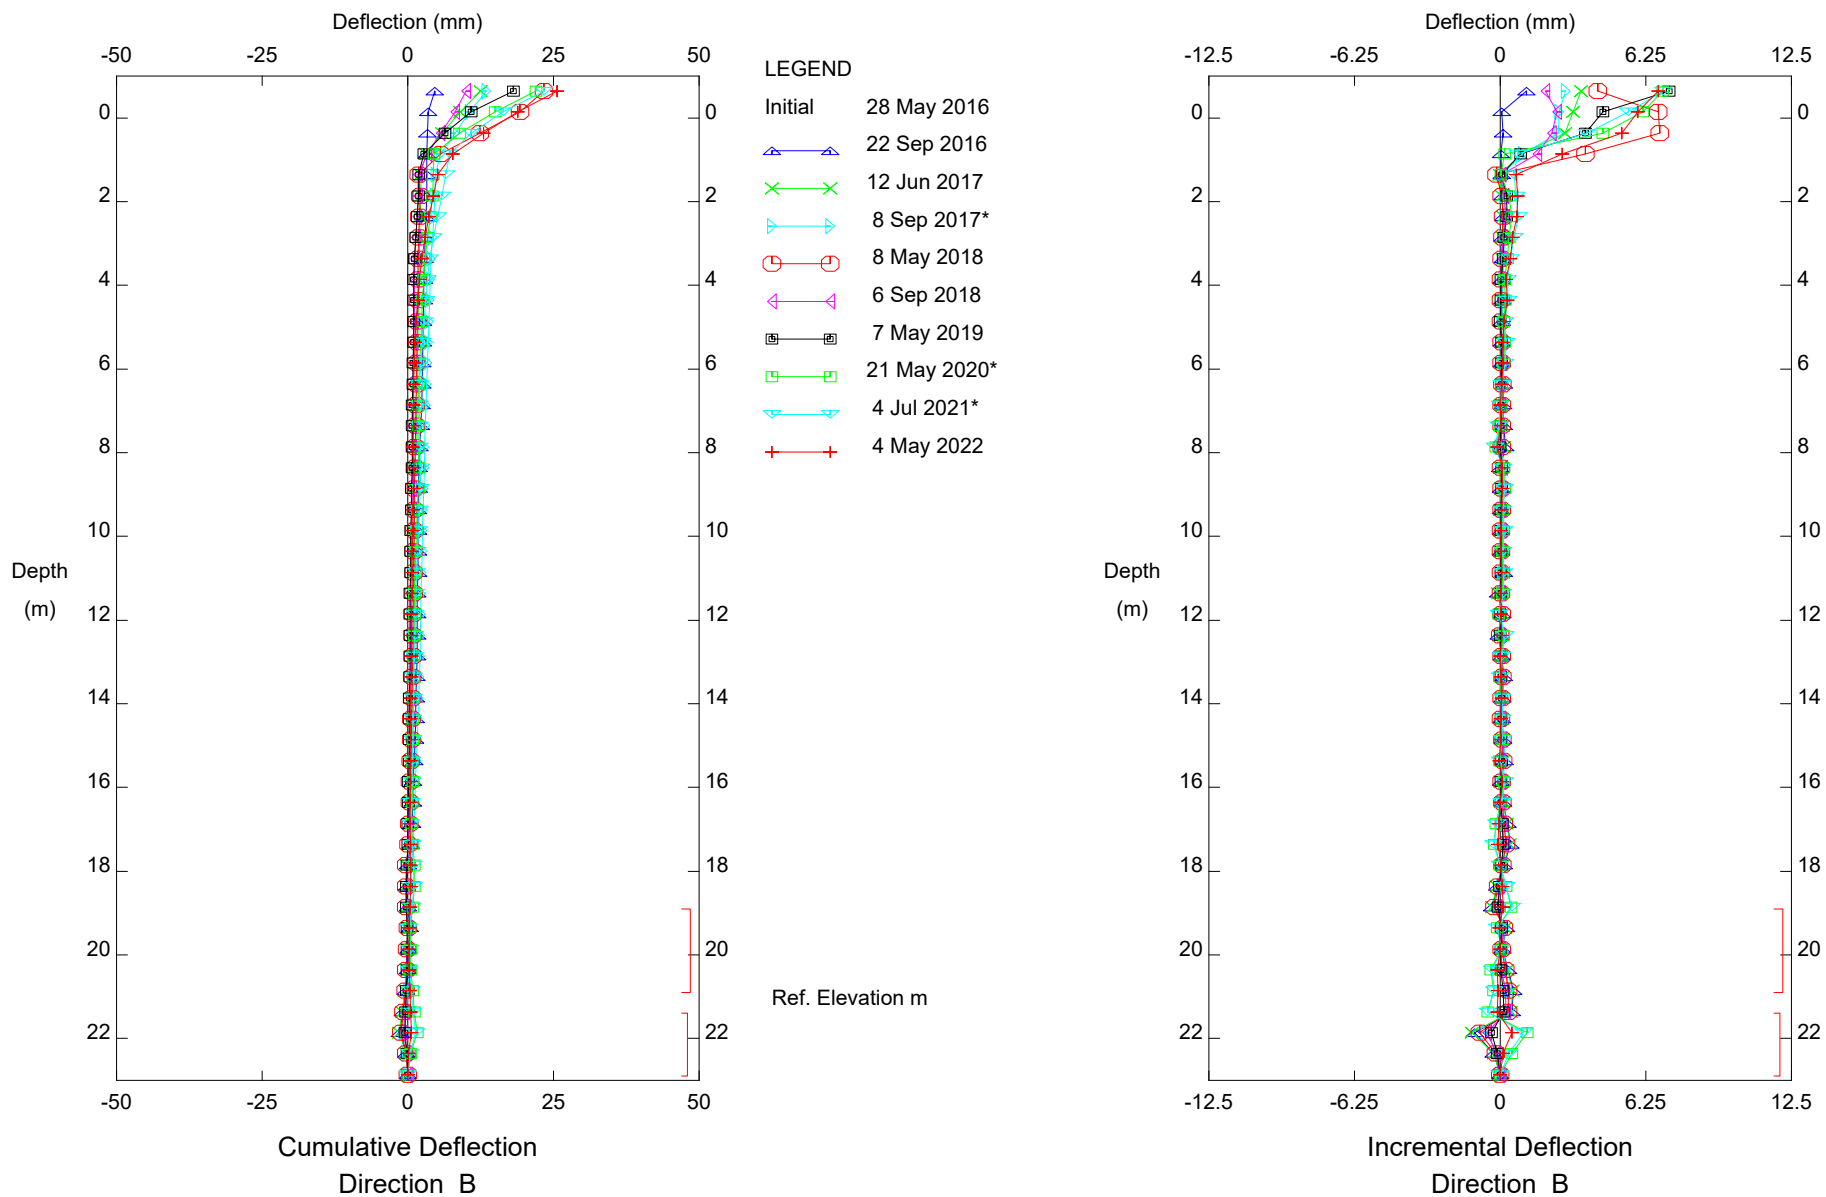
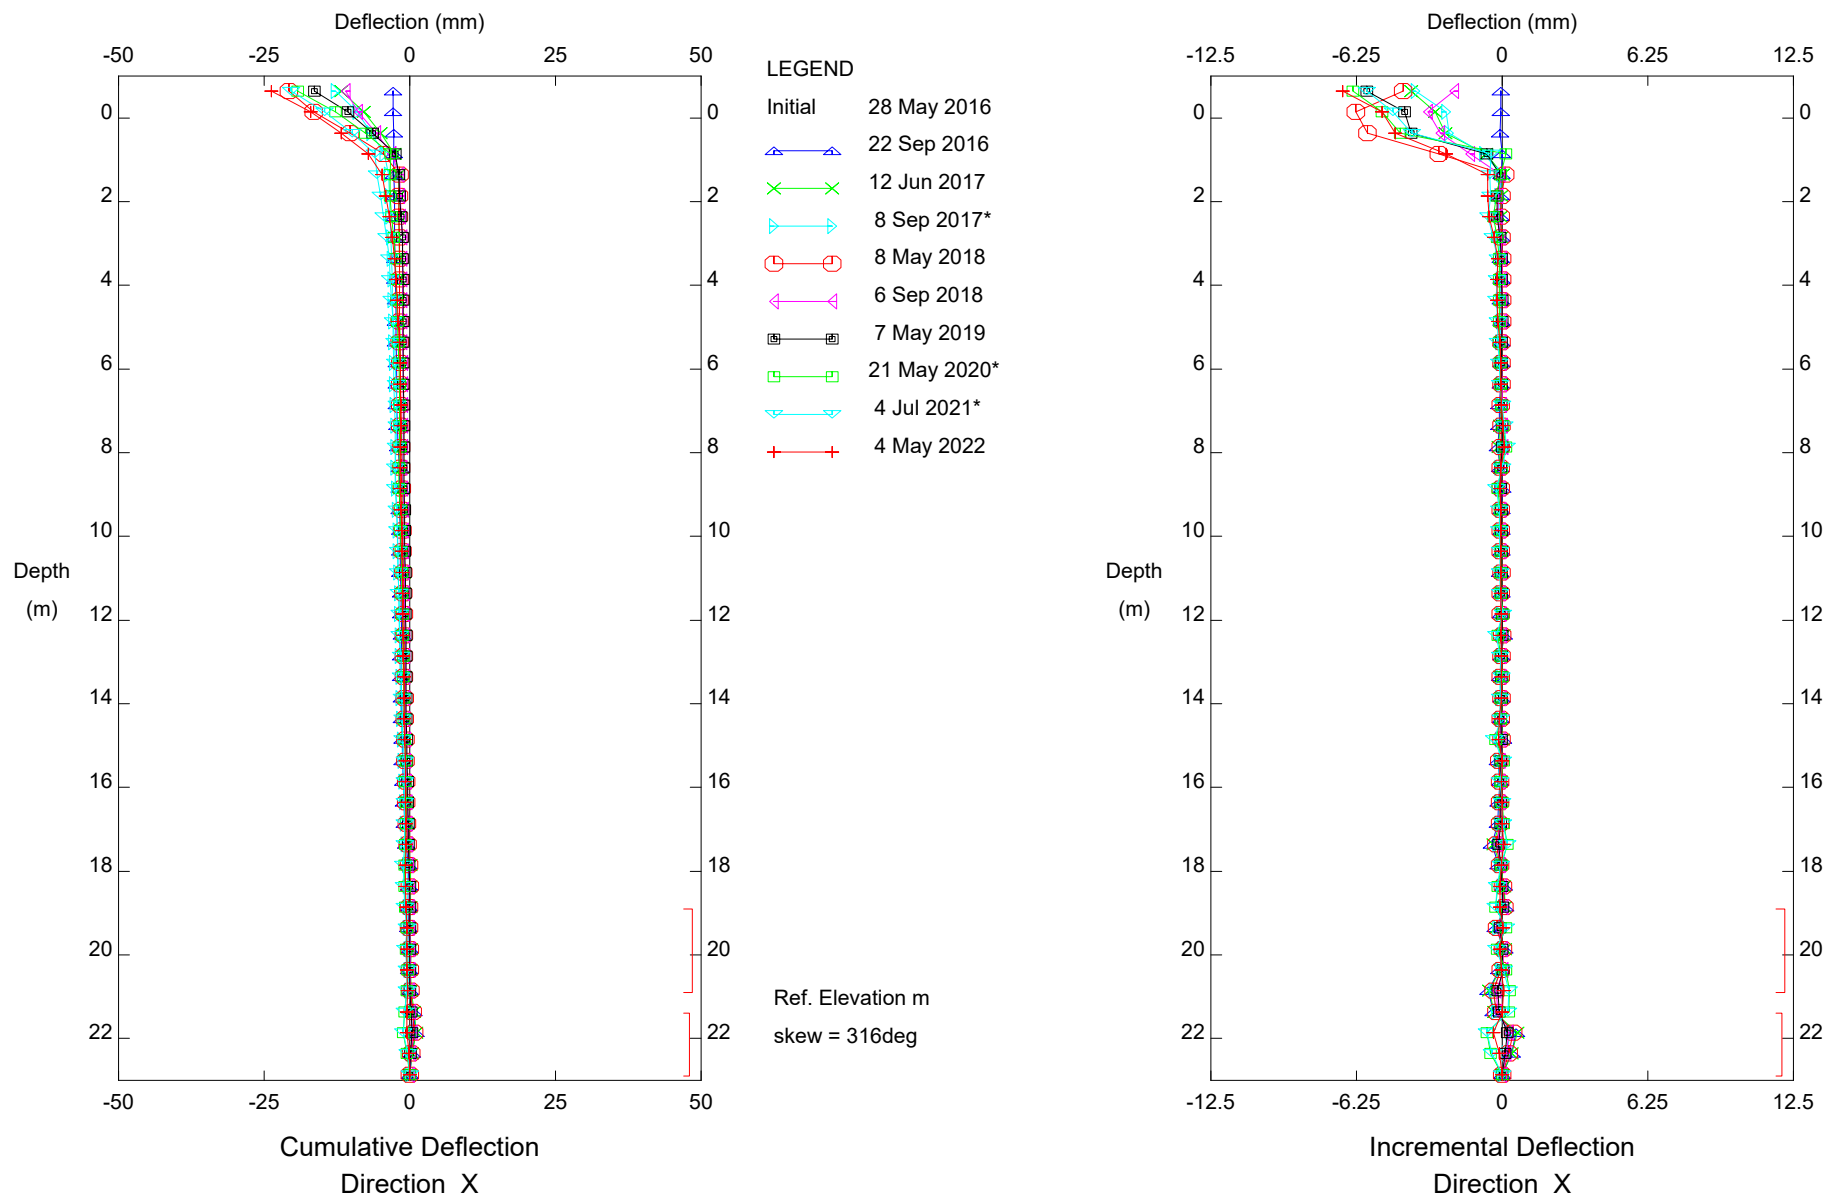
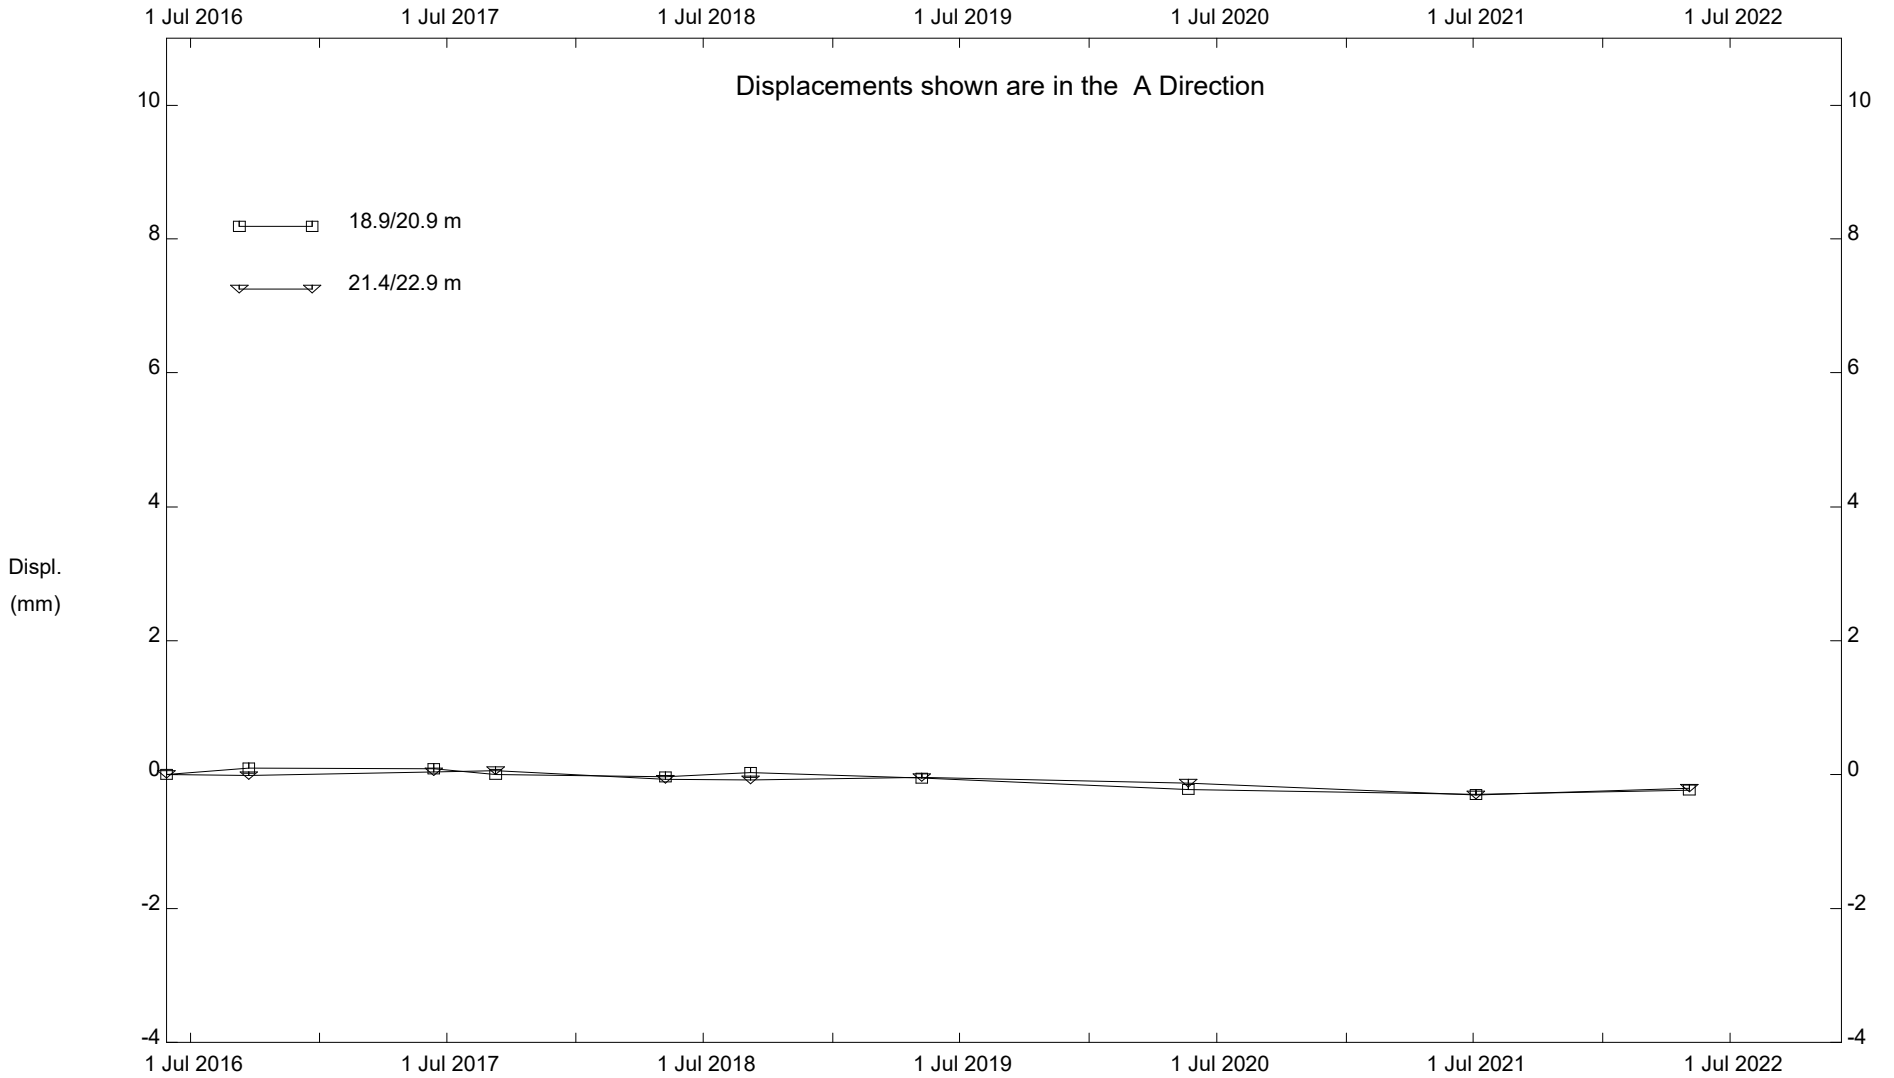
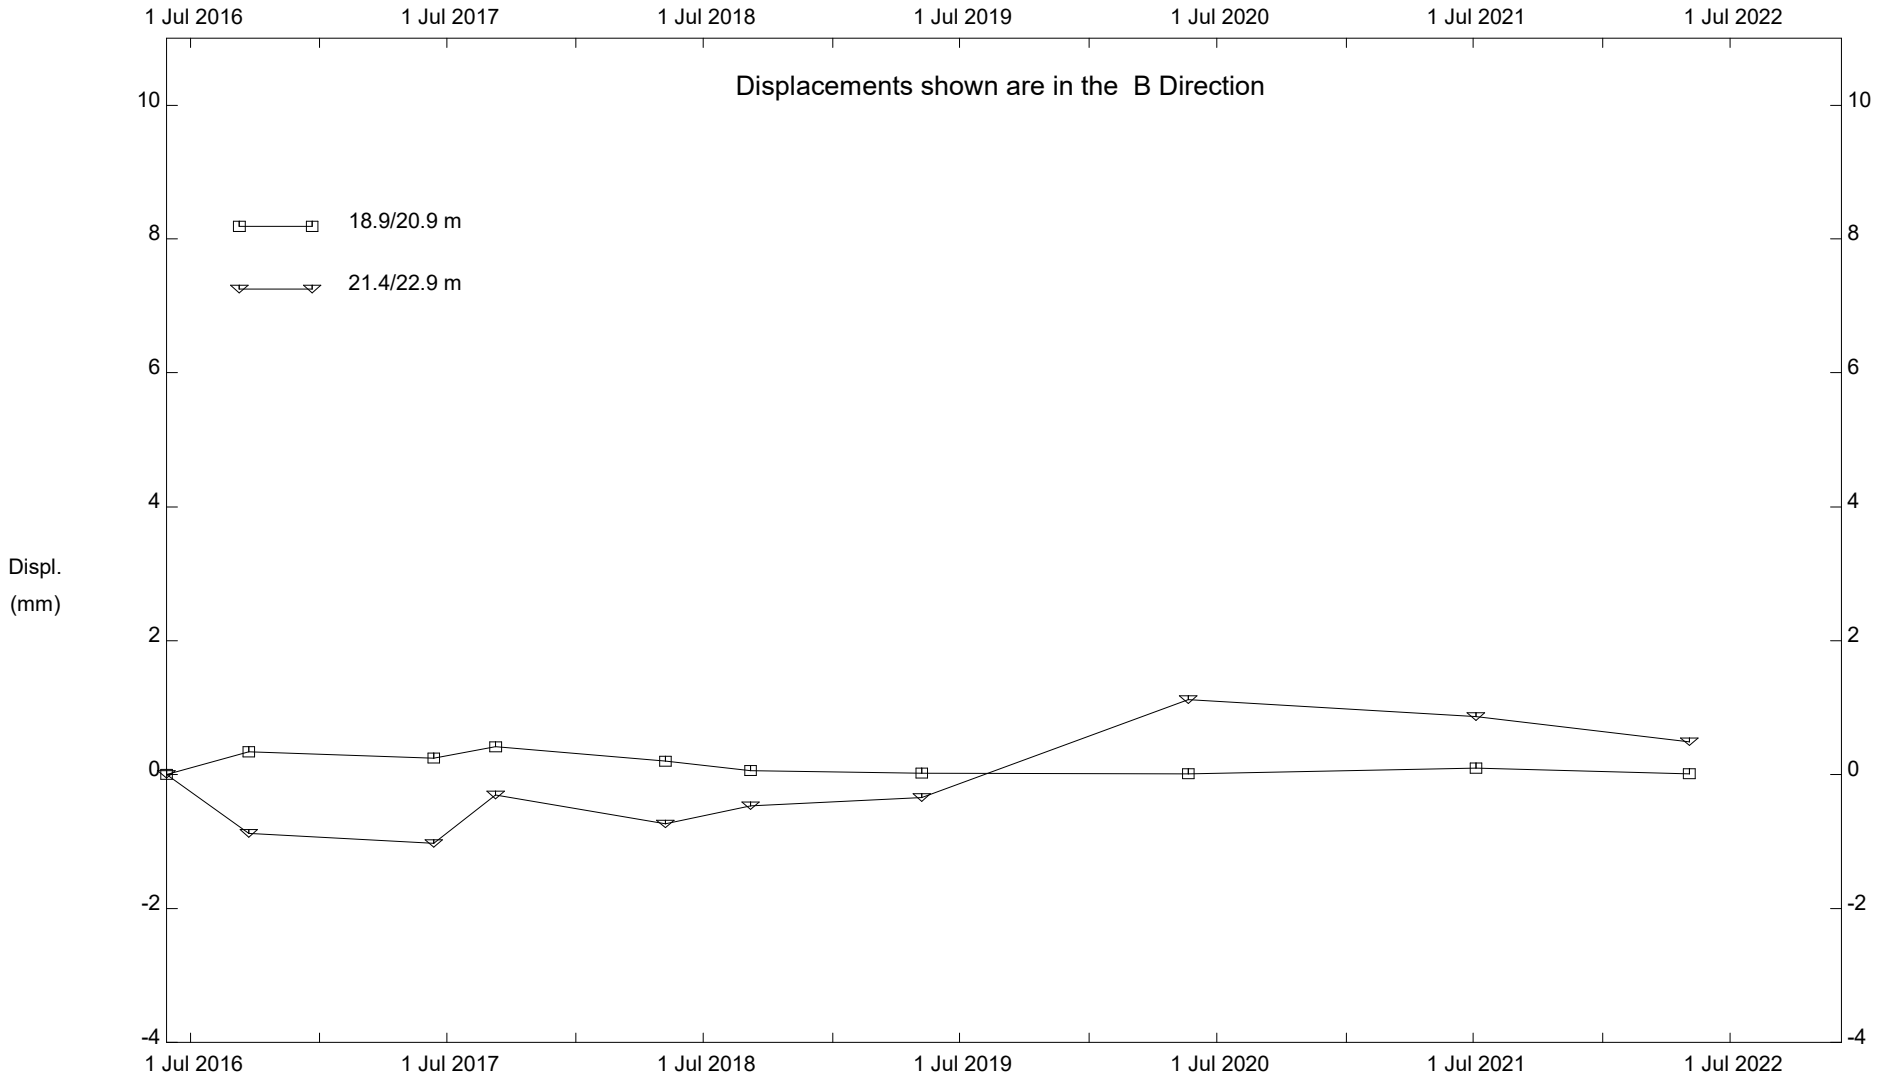
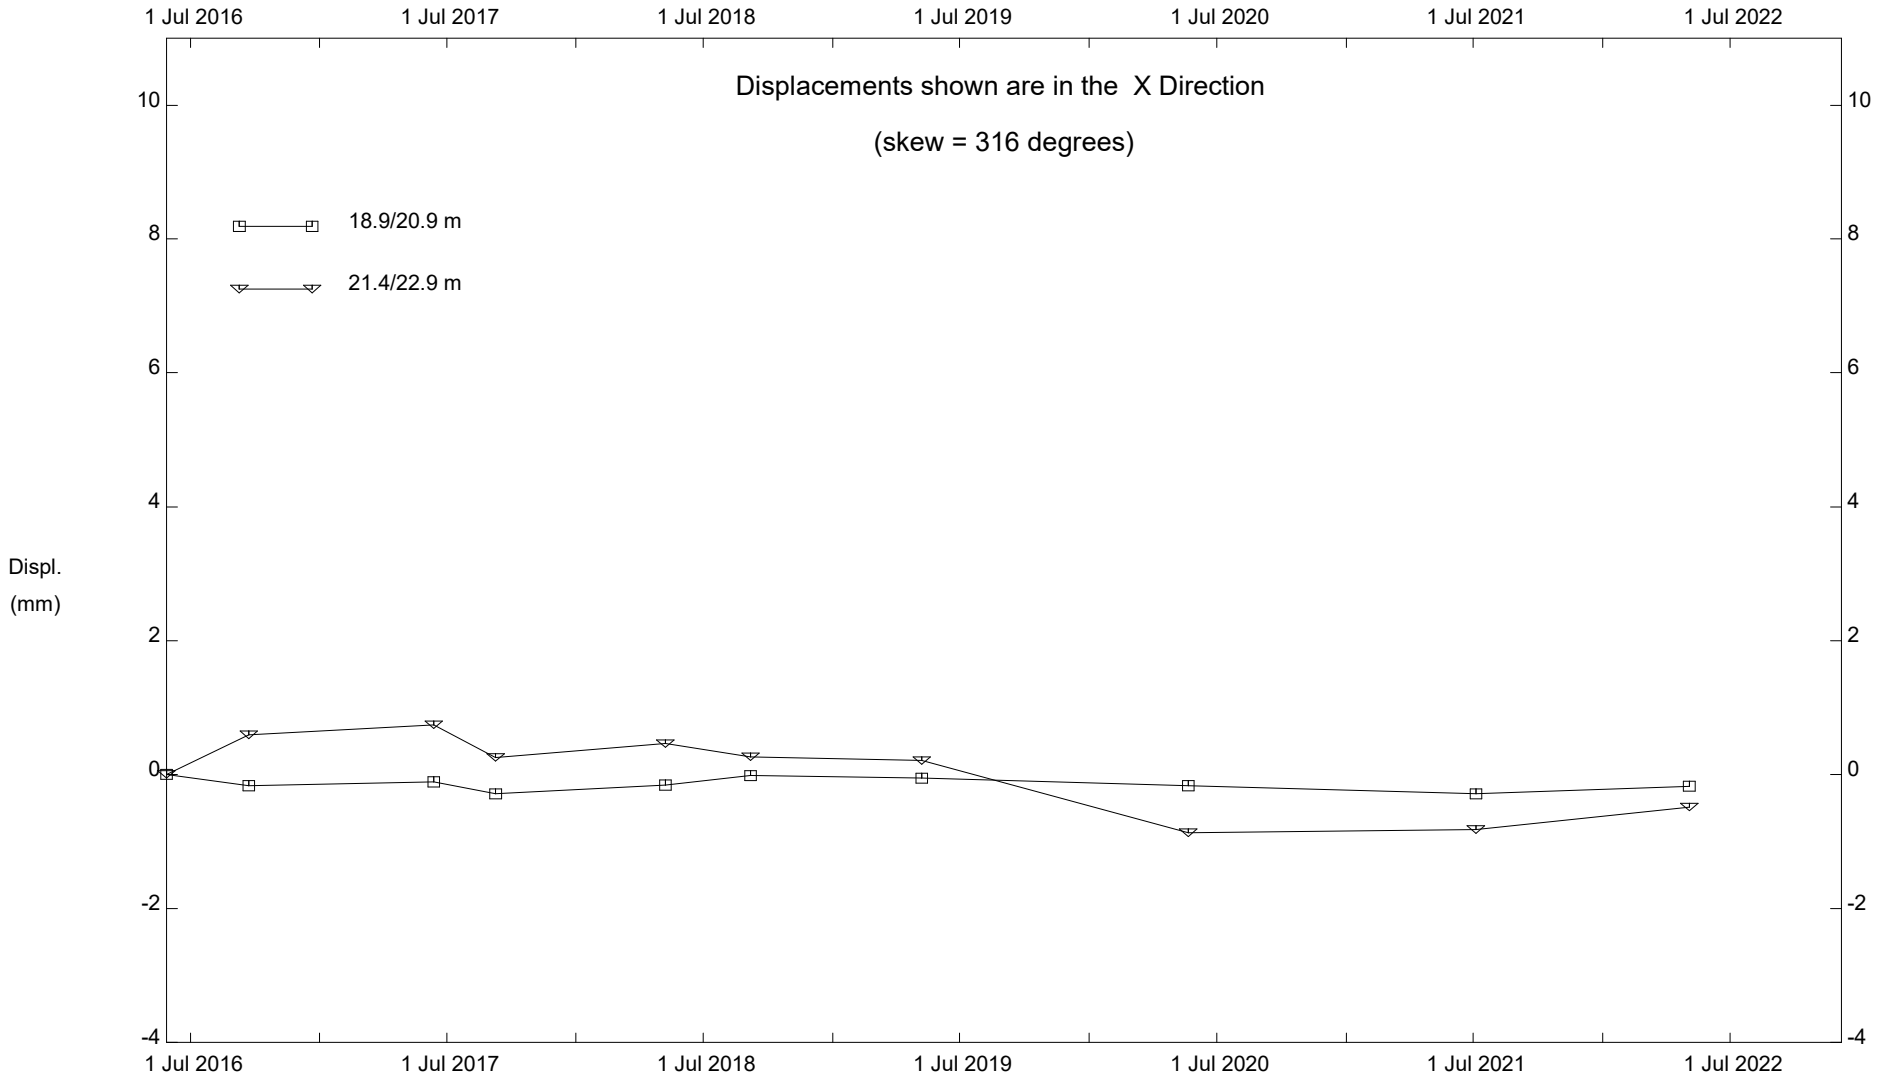
SI-7, SI-8, SI-9 showed a negligible rate of movement (less than 1 mm/yr) since Fall 2017.

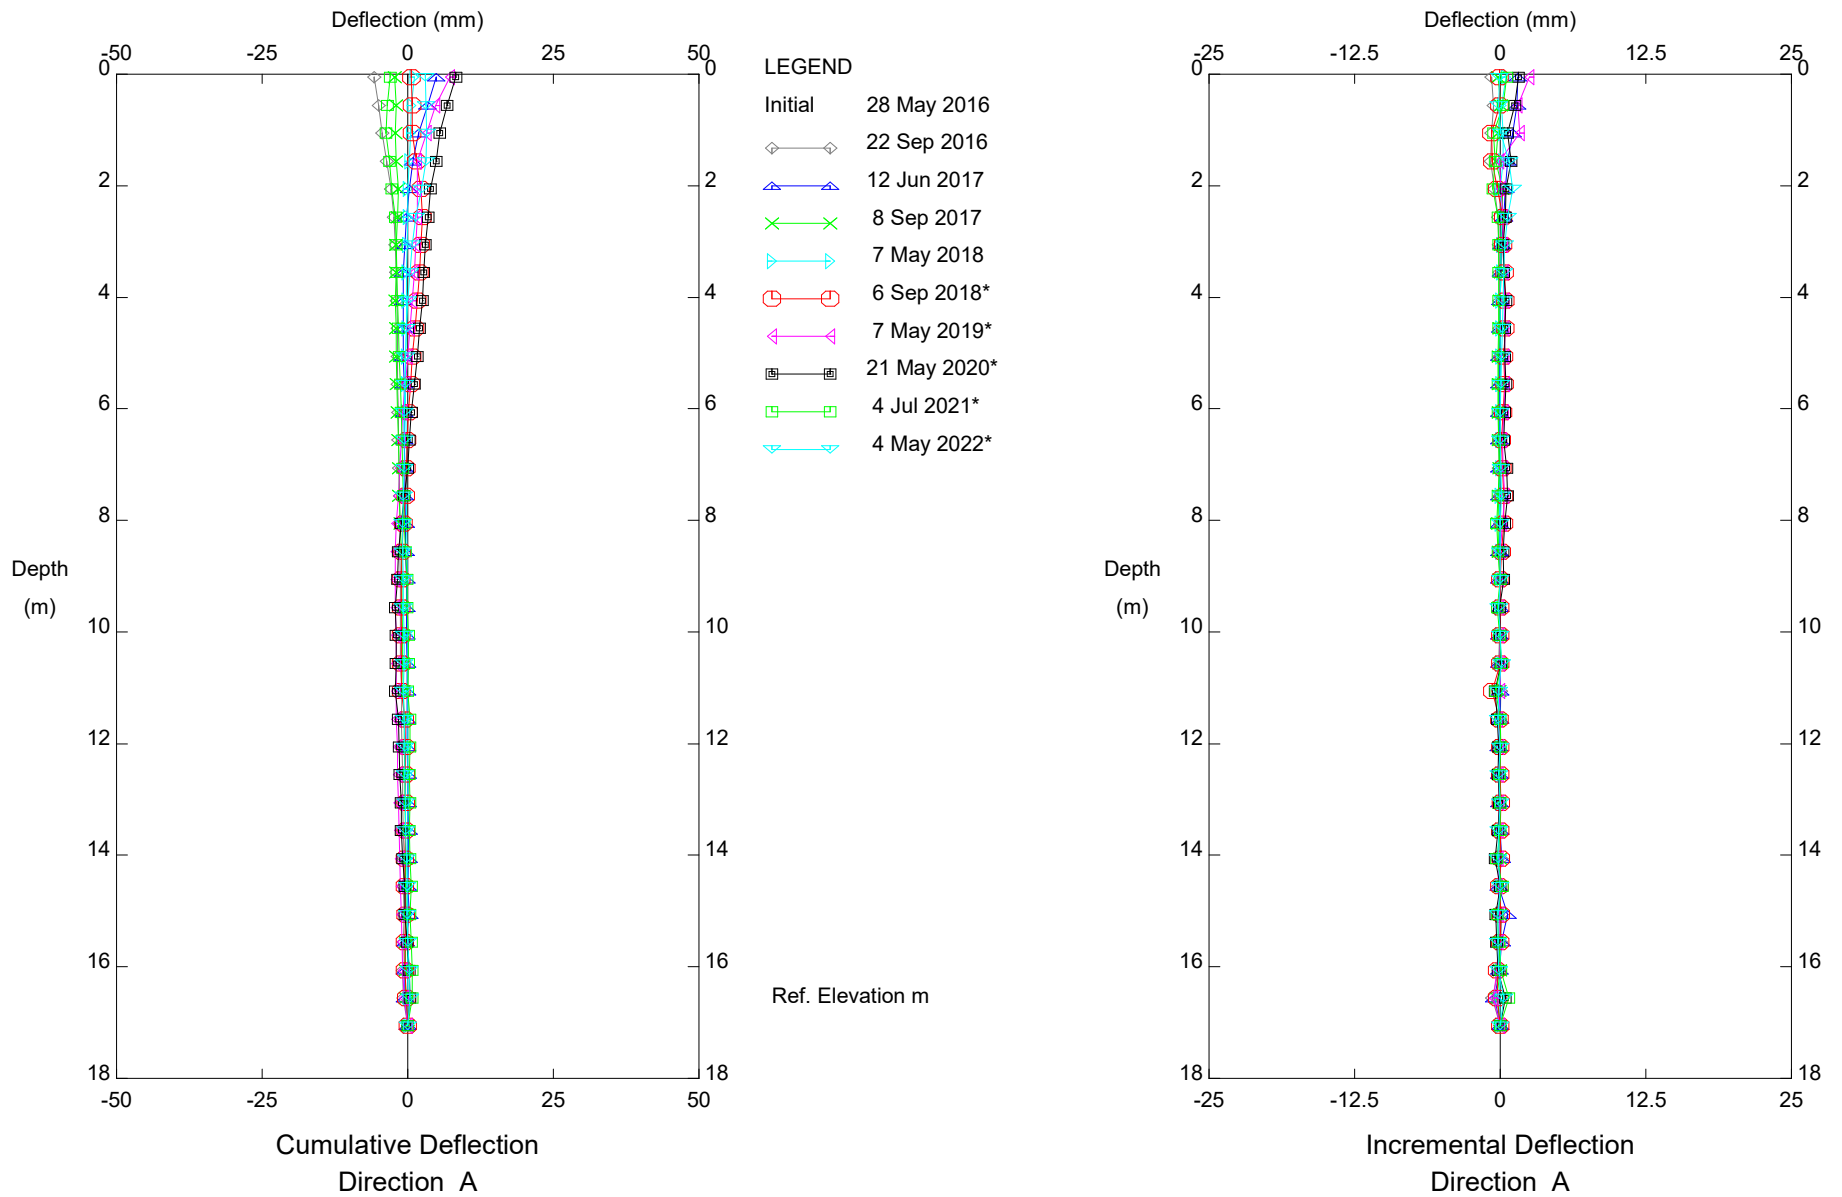
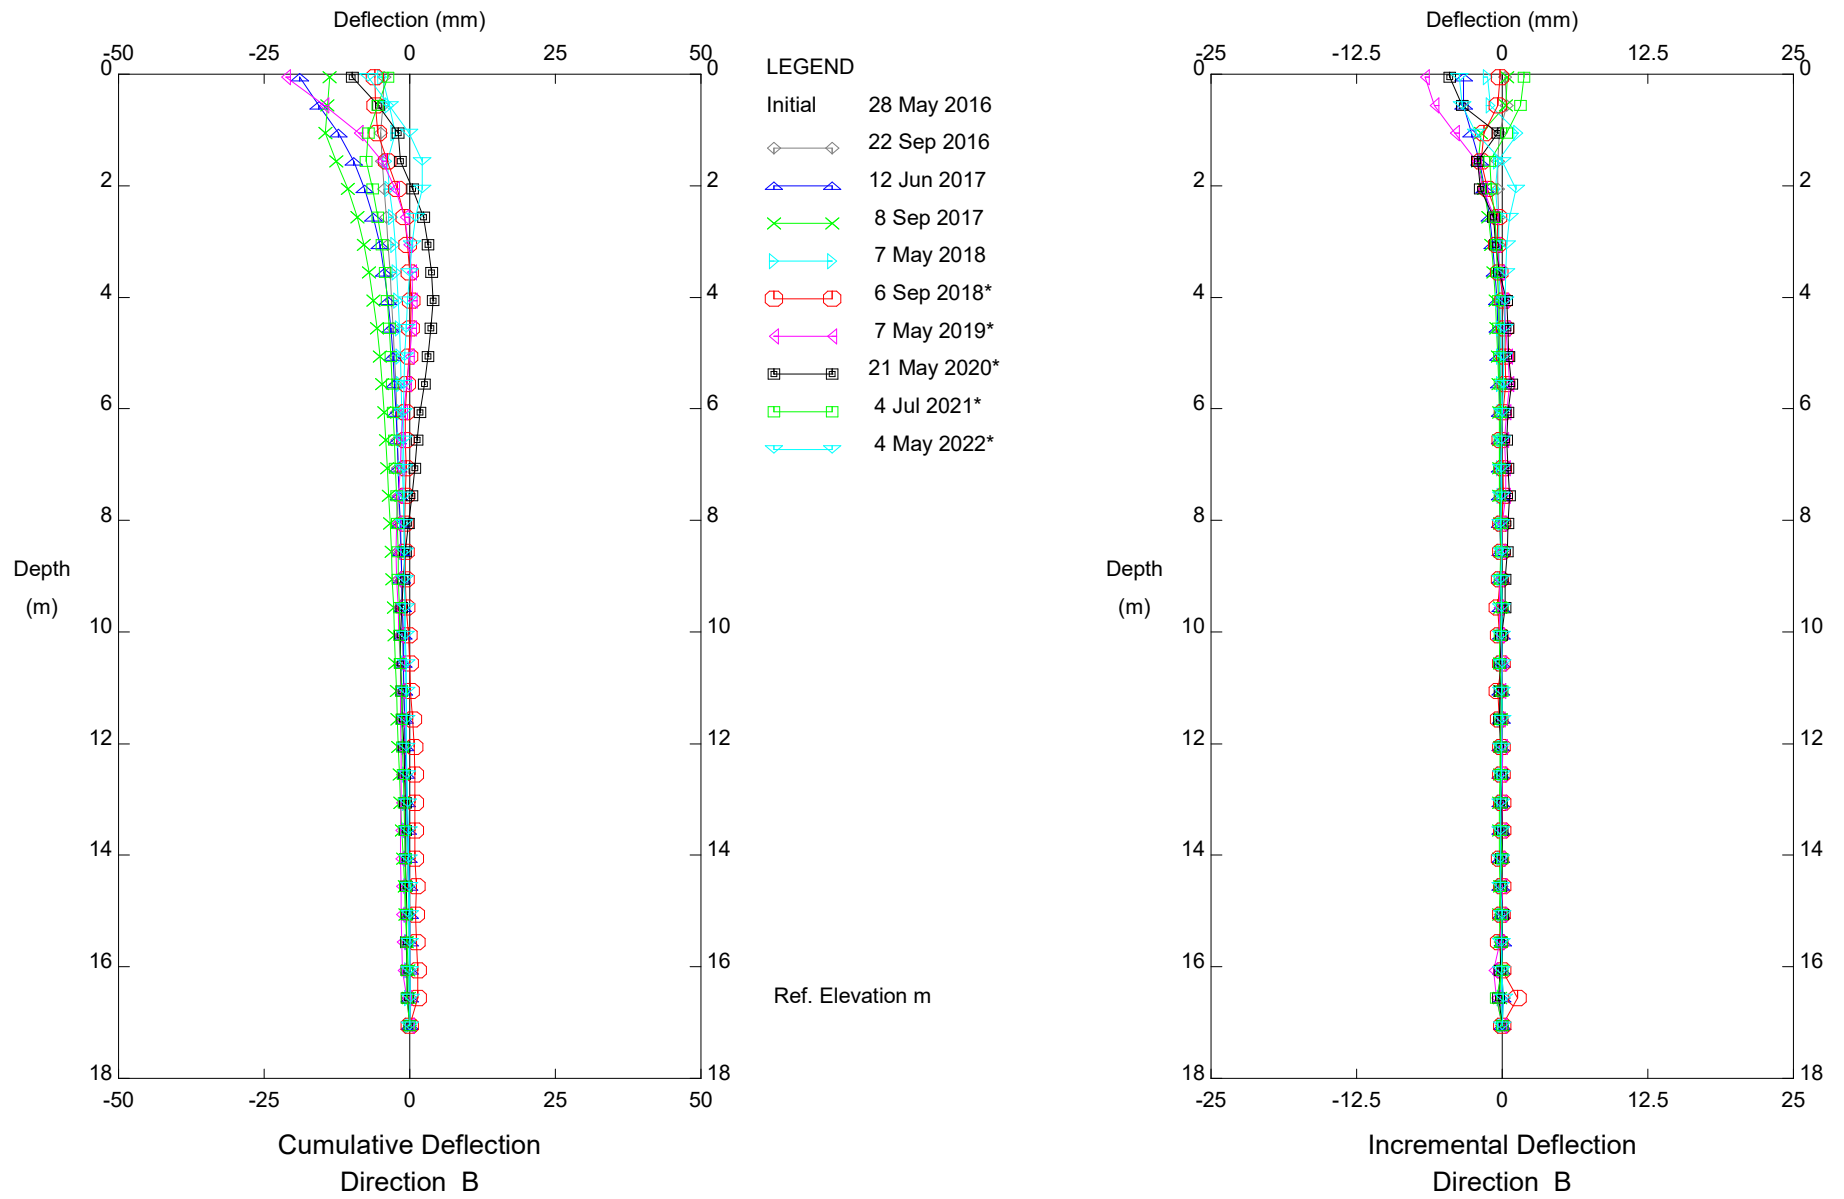
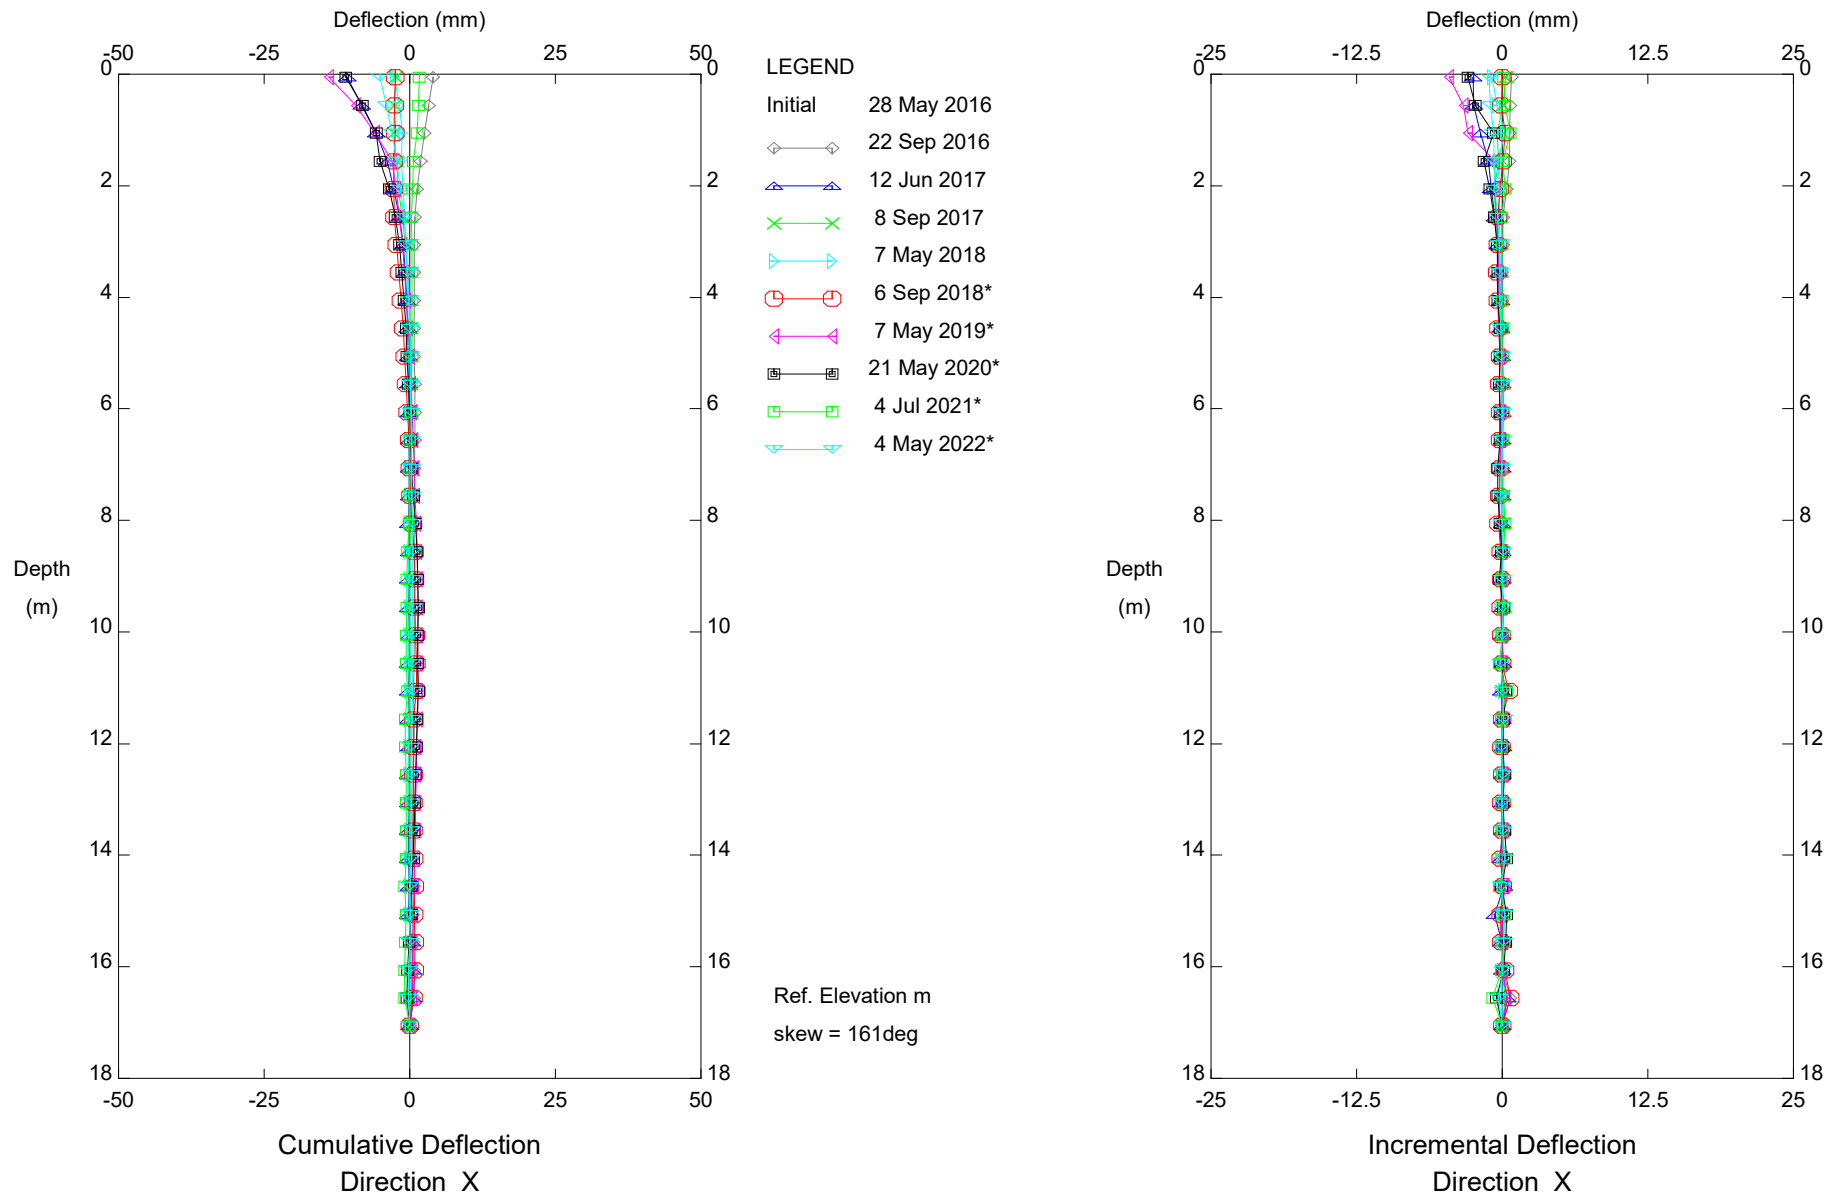
SI-22 does not contain any discernable movement zones. Note that during the work transfer to Stantec in 2016, a slight depth discrepancy was observed in SI-22 due to different unit of measurements used during data collection. In order to present more accurate information, data prior to 2016 has been excluded from the SI plots but the cumulative movement since initialization has been included on the SI table.
